## HXH/4a Contract Specification (Masonry Repair and Waterproofing Installation)

**Client name:** National Highways – Historical Railways Estate  
**Project name:** HRE Works Framework  
**Client reference:** HXH/4a  
**Document no:** 0451200  
**Revision no:** 03  
**Date:** May 2023  
**Project no:** B38380DE  
**Project manager:** Nigel Robson  
**Prepared by:** Christopher Doig  
**File name:** HXH 4a NEC ECC

### **HRE WORKS FRAMEWORK HXH/4a 'WHEATLEY VIADUCT' CONTRACT FOR REMEDIAL REPAIRS AND WATERPROOFING**

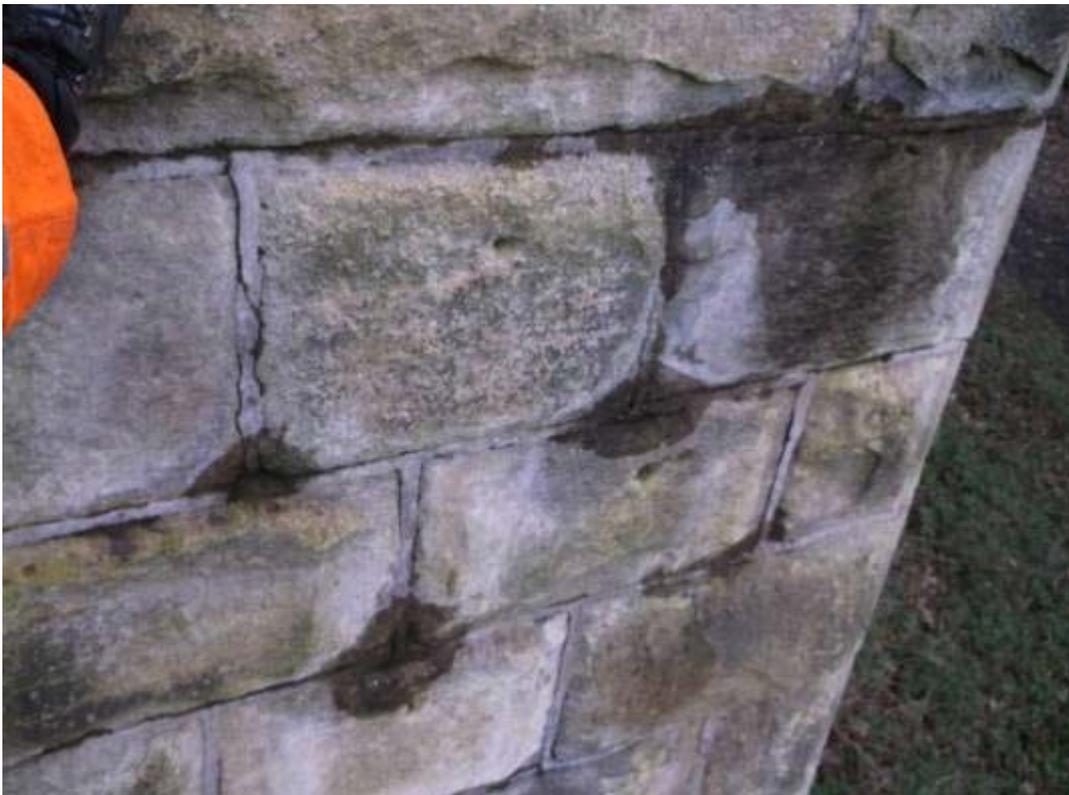
**Photo No. 69: Area of fractured mortar with seepage to south east elevation of pier 9**

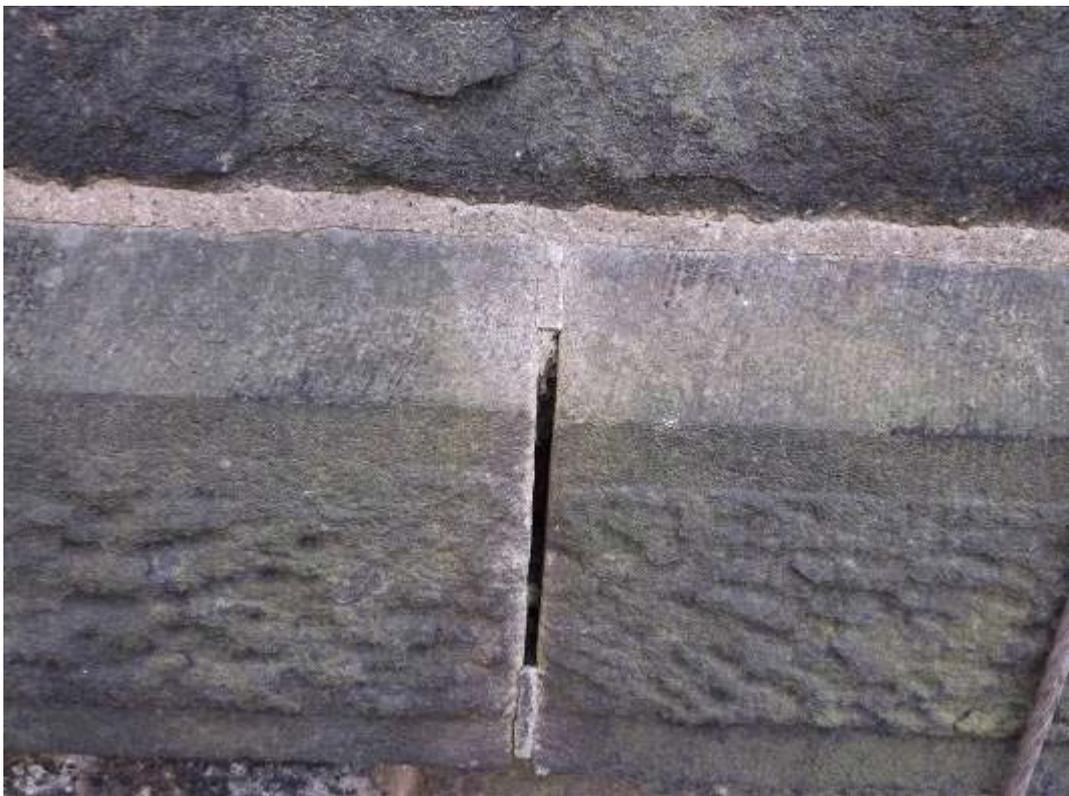
**Photo No. 70: Typical mortar loss to vertical joint of string course to north west elevation of span 1**

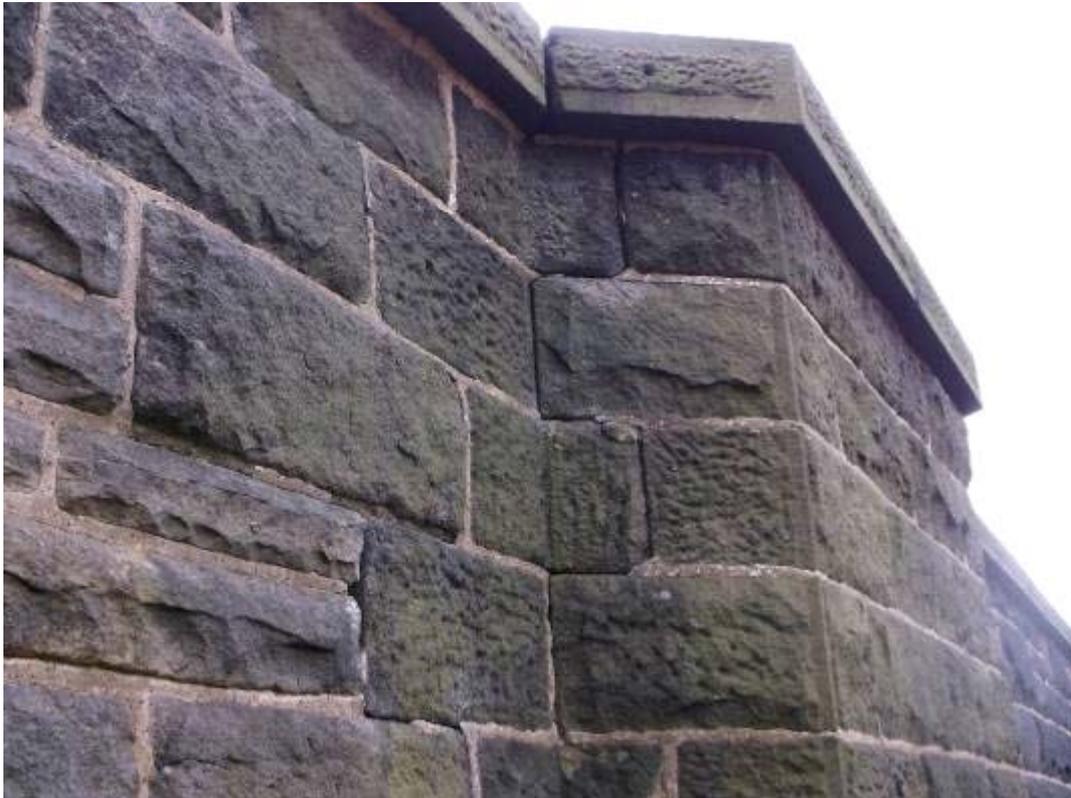
**Photo No. 71: Vertical toothed fracture to parapet of north west elevation of span 1**

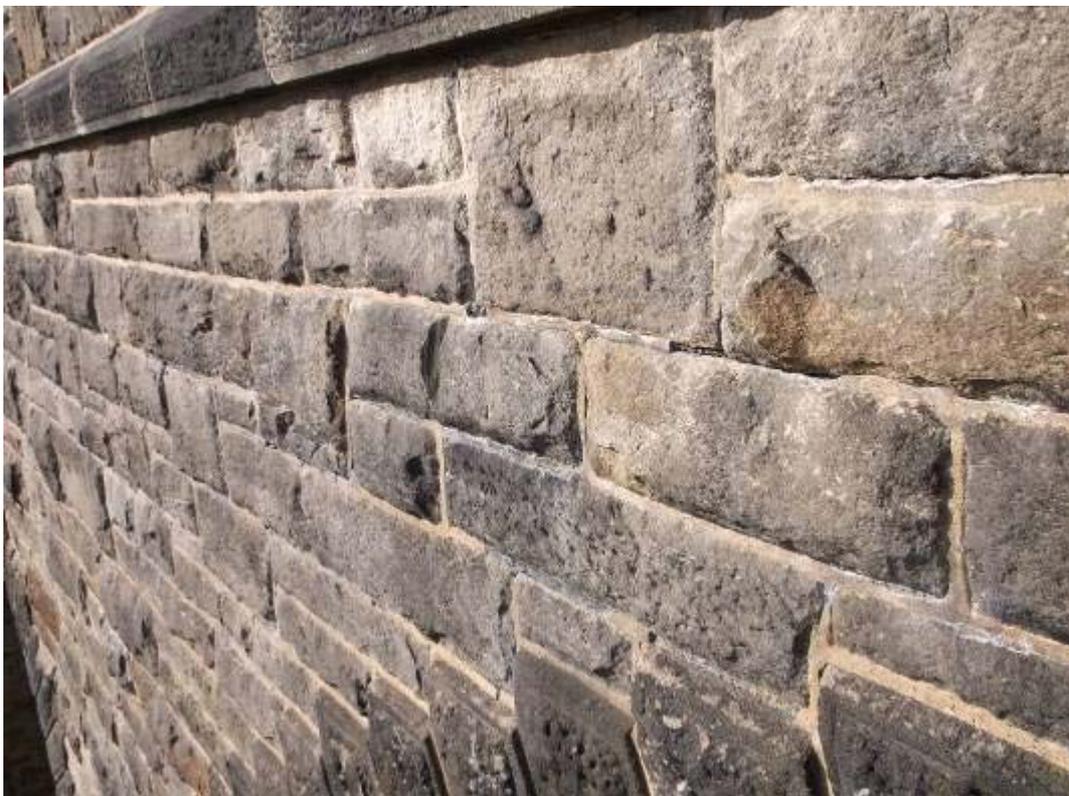
**Photo No. 72: Typical spot mortar loss to spandrel of south east elevation of span 1**

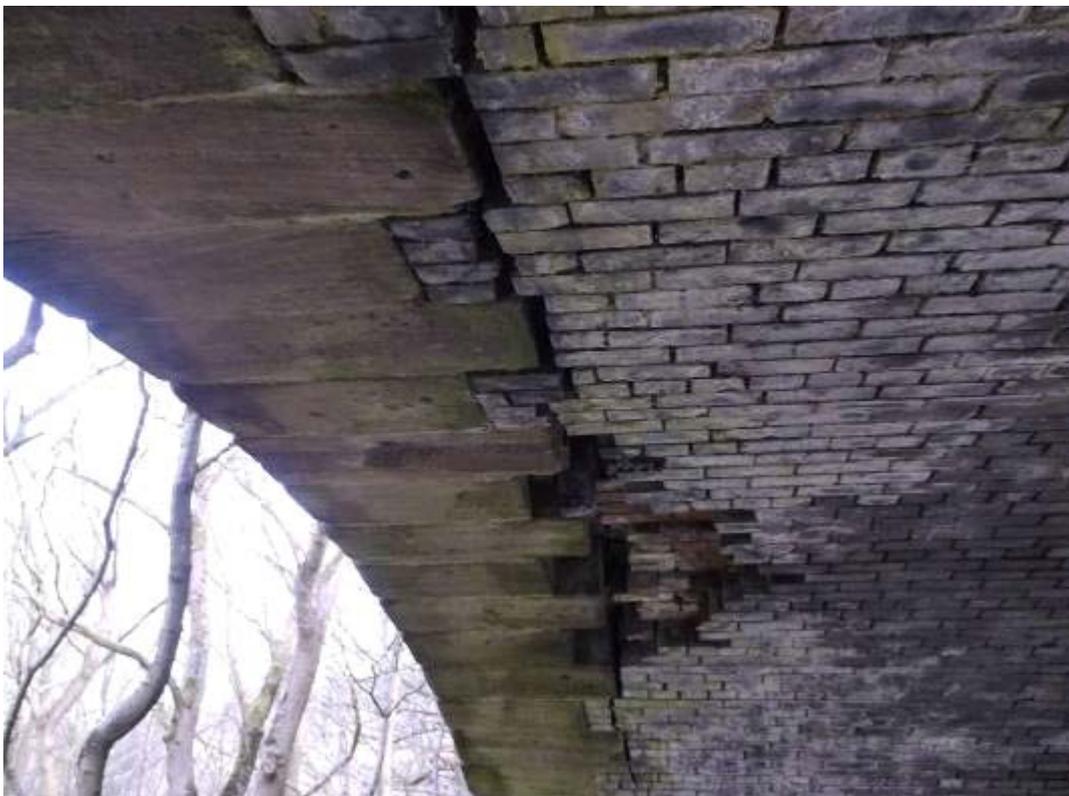
**Photo No. 74: Longitudinal fracture with drummy & missing brickwork to soffit of span 1**

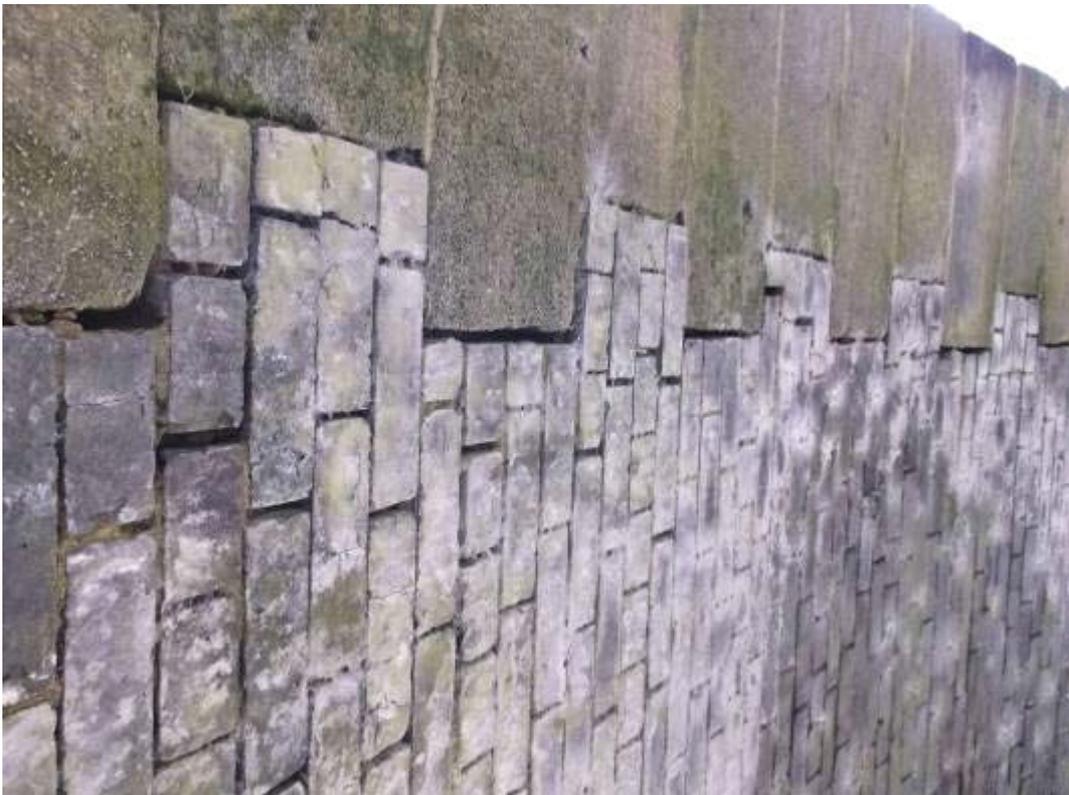
**Photo No. 75: Longitudinal fracture with drummy brickwork to soffit of span 1**

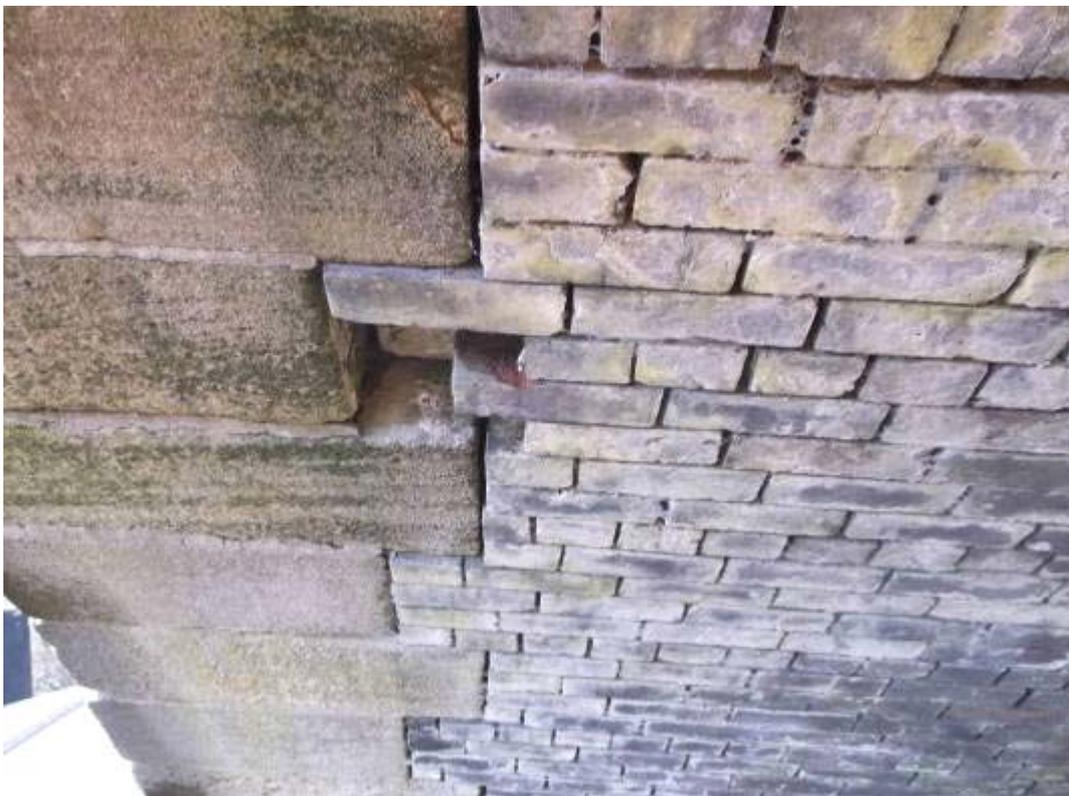
**Photo No. 76: Area of missing brickwork to soffit of span 1**

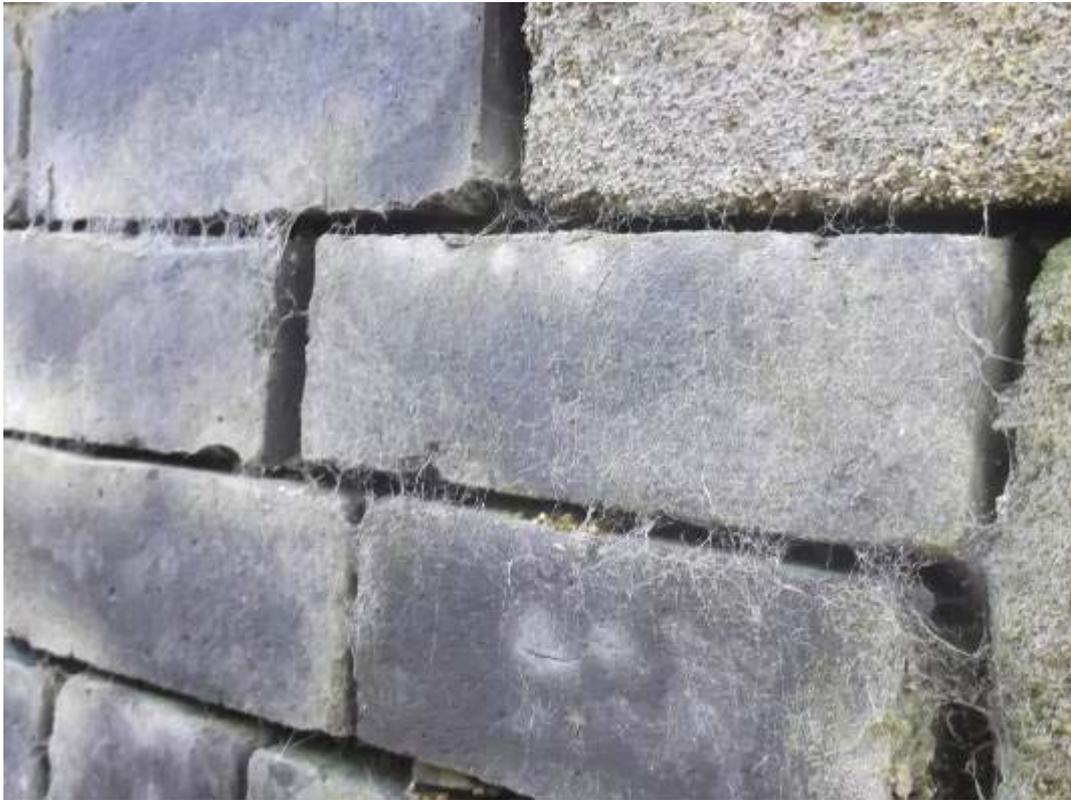
**Photo No. 77: Area of loose to hammer brickwork & mortar loss to soffit of span 1**

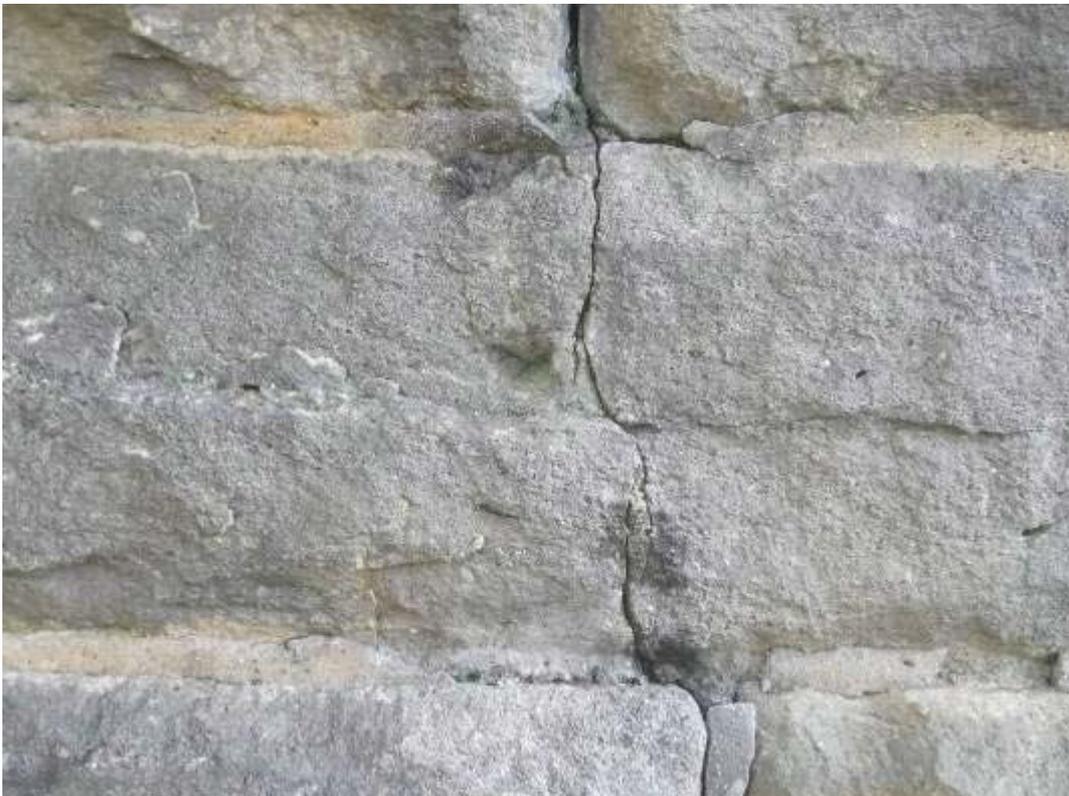
**Photo No. 78: Vertical fracture to spandrel of north west elevation of span 2**

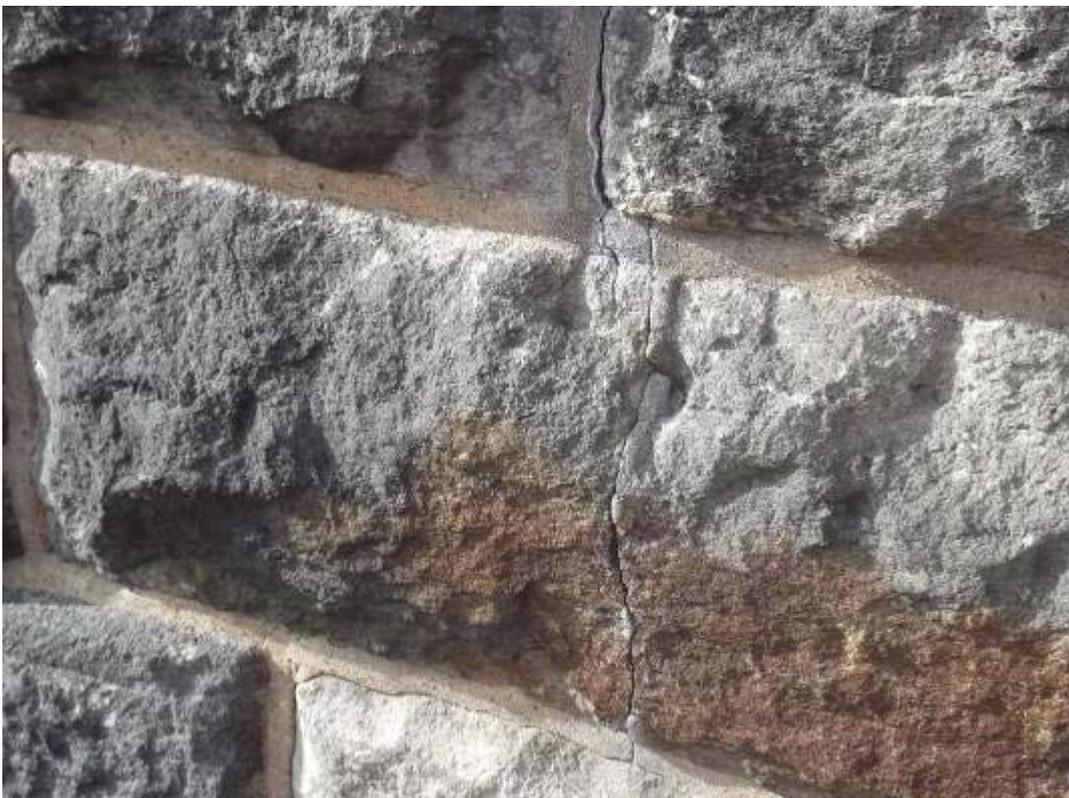
**Photo No. 80: Vertical fracture to spandrel of south east elevation of span 2**

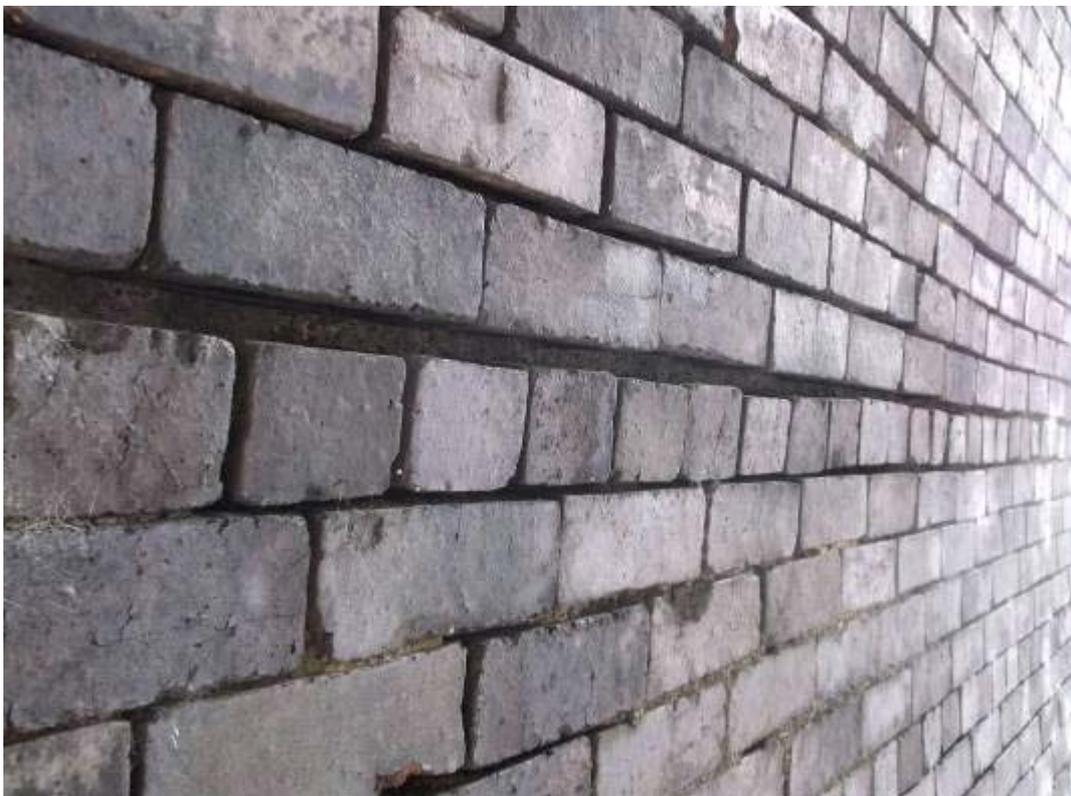
**Photo No. 84: Area of mortar loss to soffit of span 2**

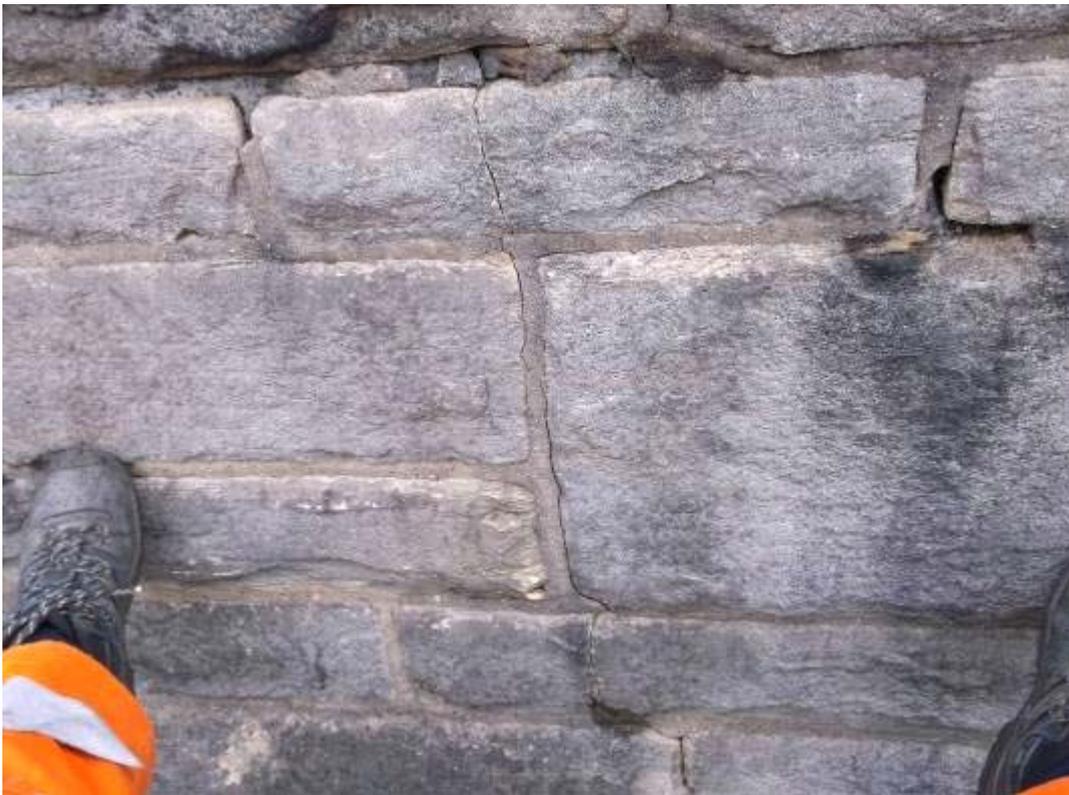
**Photo No. 85: Vertical fracture to spandrel of north west elevation of span 3**

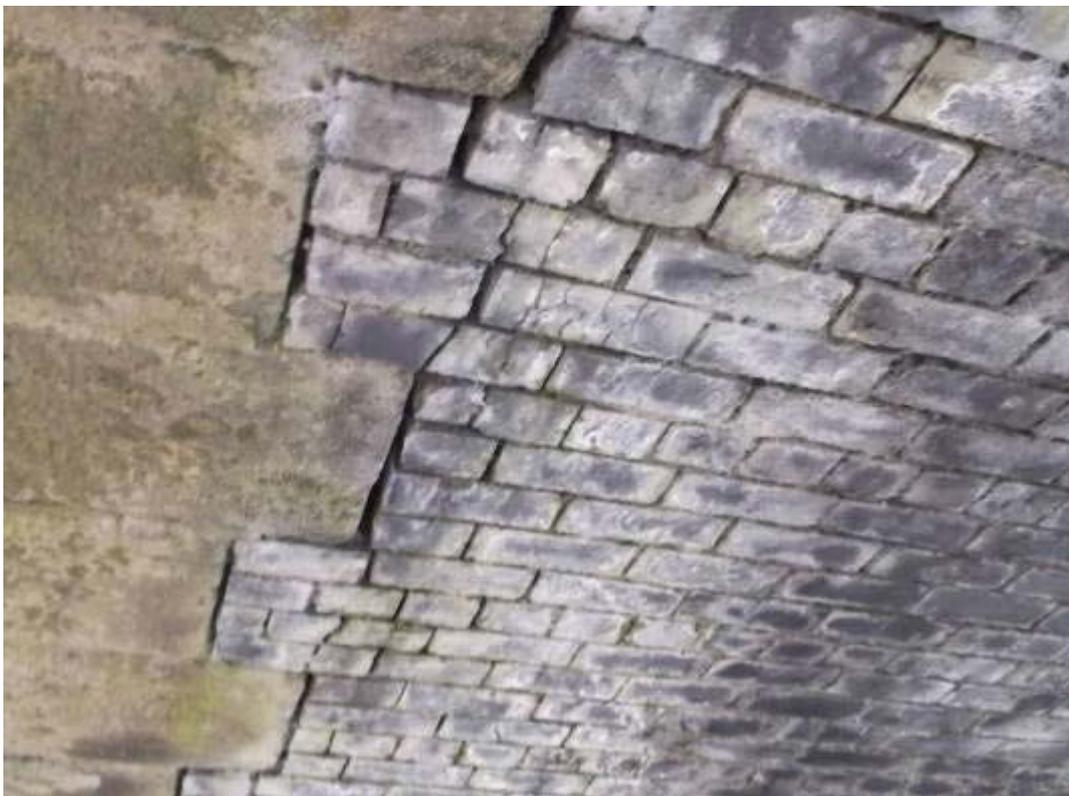
**Photo No. 90: Longitudinal fracture & mortar loss to soffit of span 3**

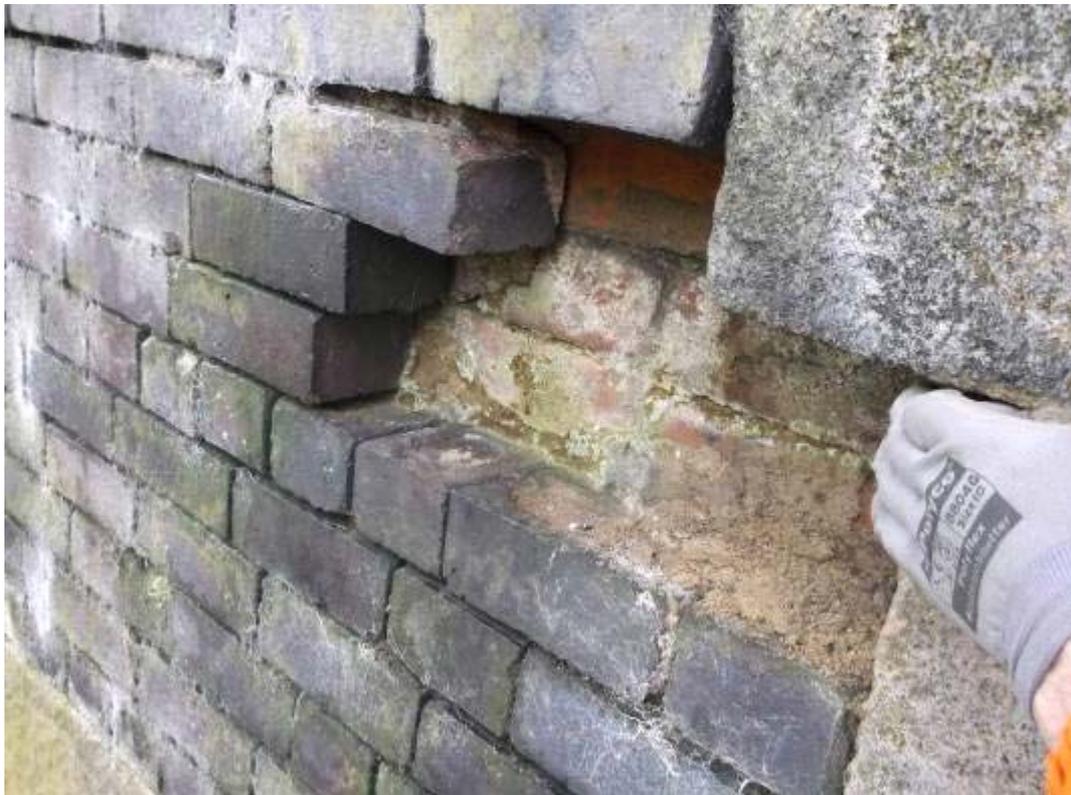
**Photo No. 99: Area of missing brickwork to soffit of span 4**

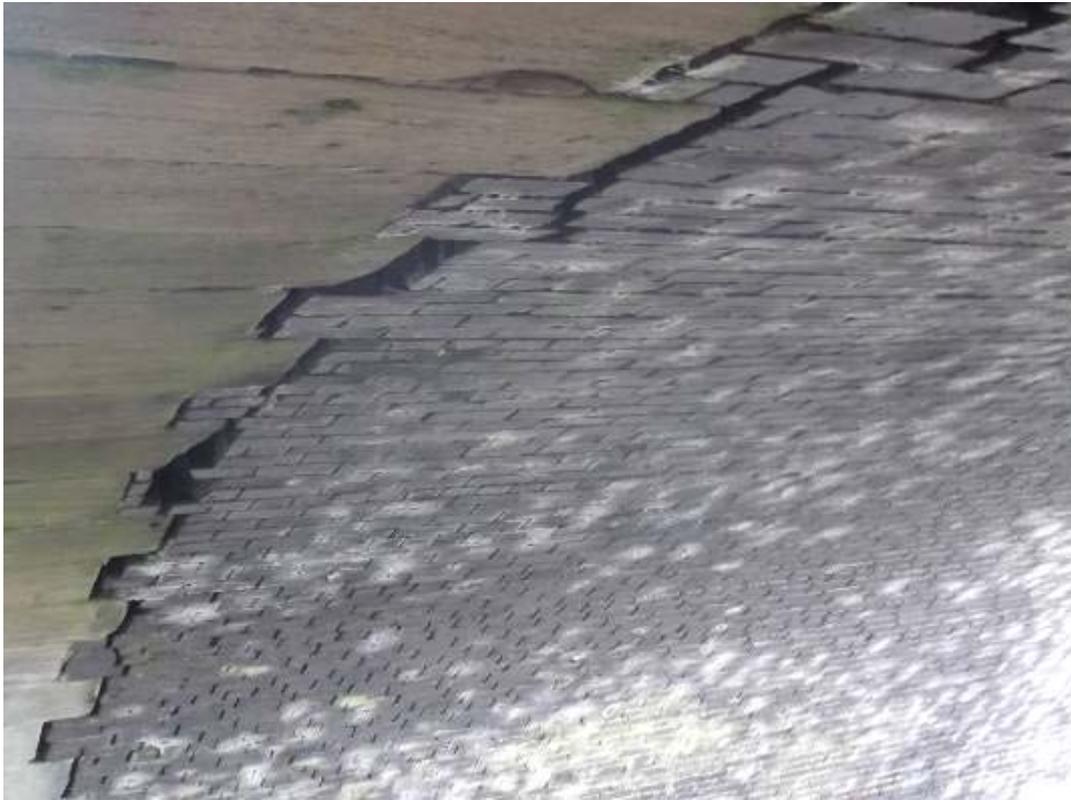
**Photo No. 105: Longitudinal fracture with missing brickwork to soffit of span 5**

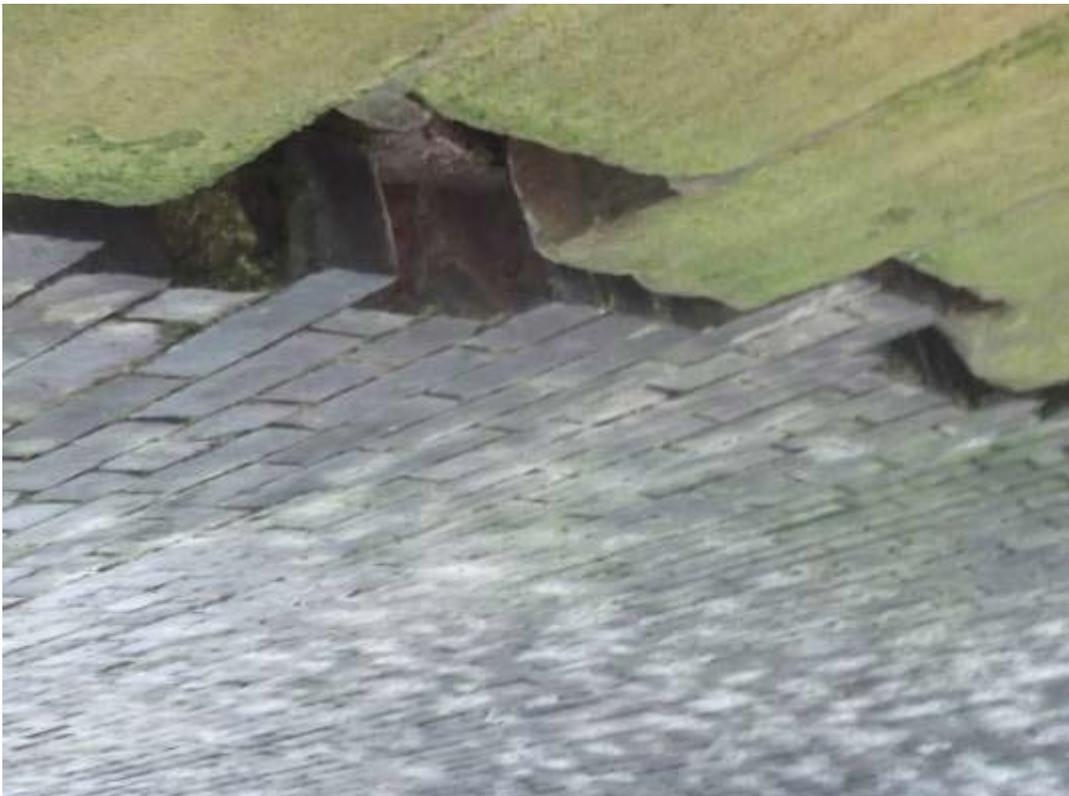
**Photo No. 106: Typical area of missing brickwork to soffit of span 5**

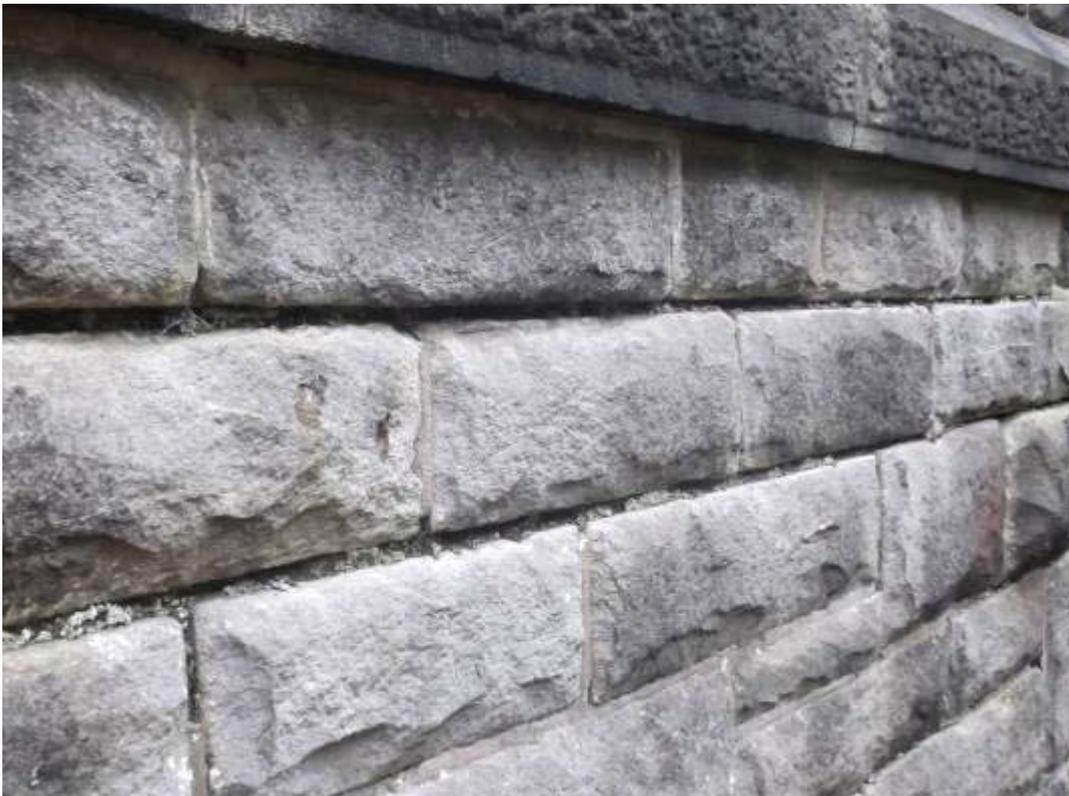
**Photo No. 108: Area of mortar loss to spandrel of north west elevation of span 6**

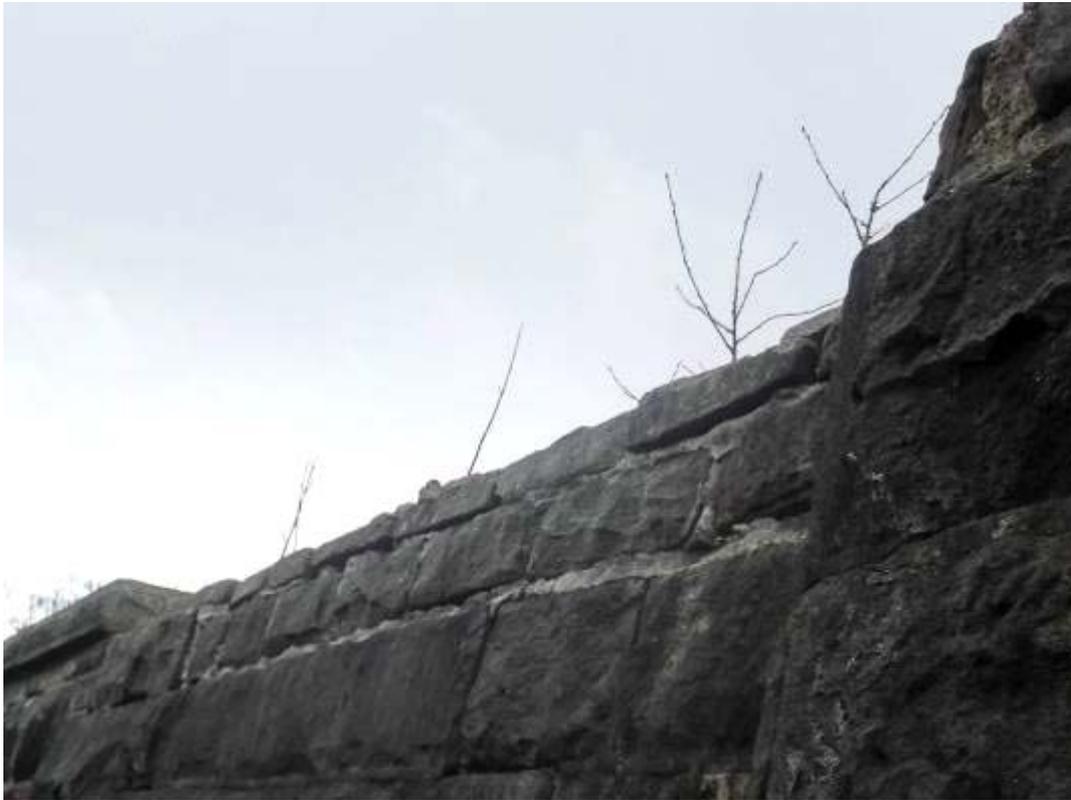
**Photo No. 109: Area of missing coping to south east elevation of span 6**

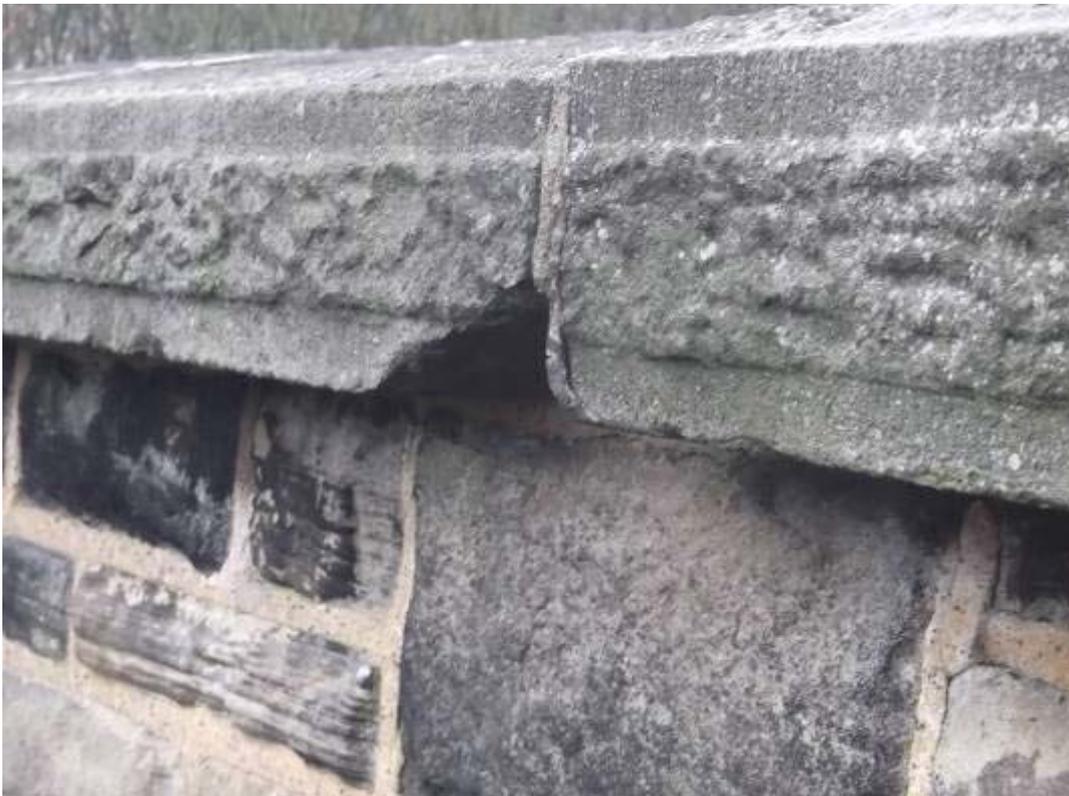
**Photo No. 110: Area of spalled coping to south east elevation of span 6**

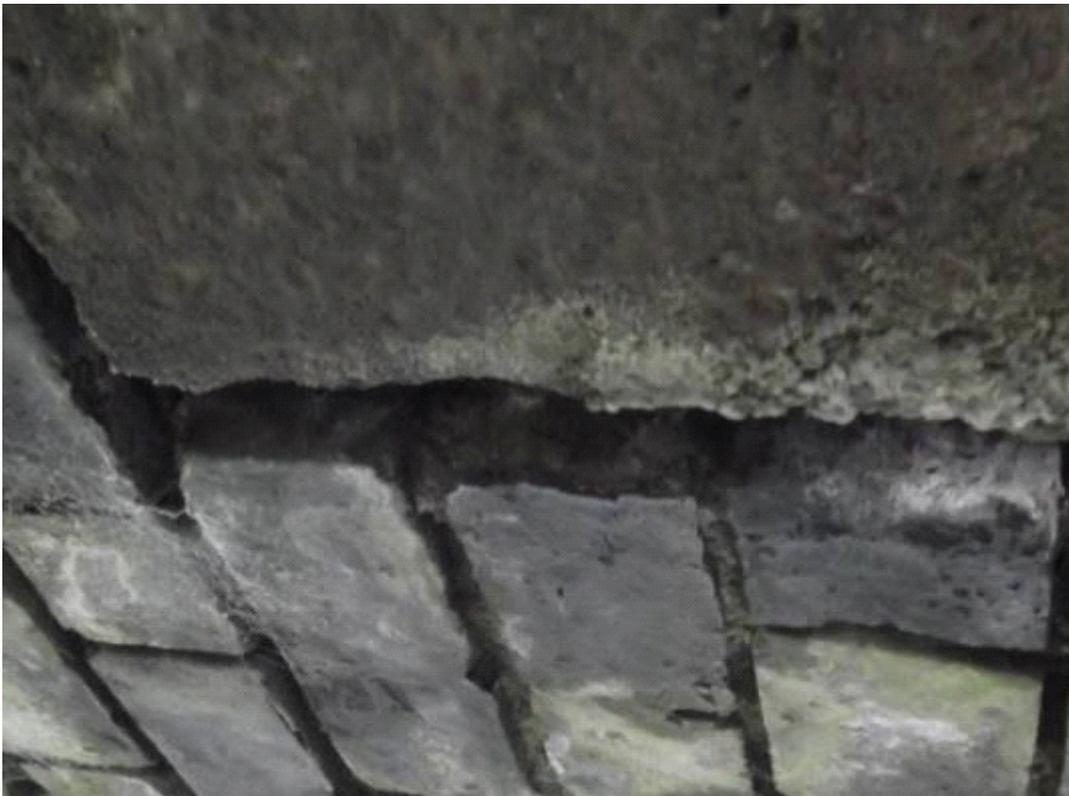
**Photo No. 112: Longitudinal fracture with mortar loss to soffit of span 6**

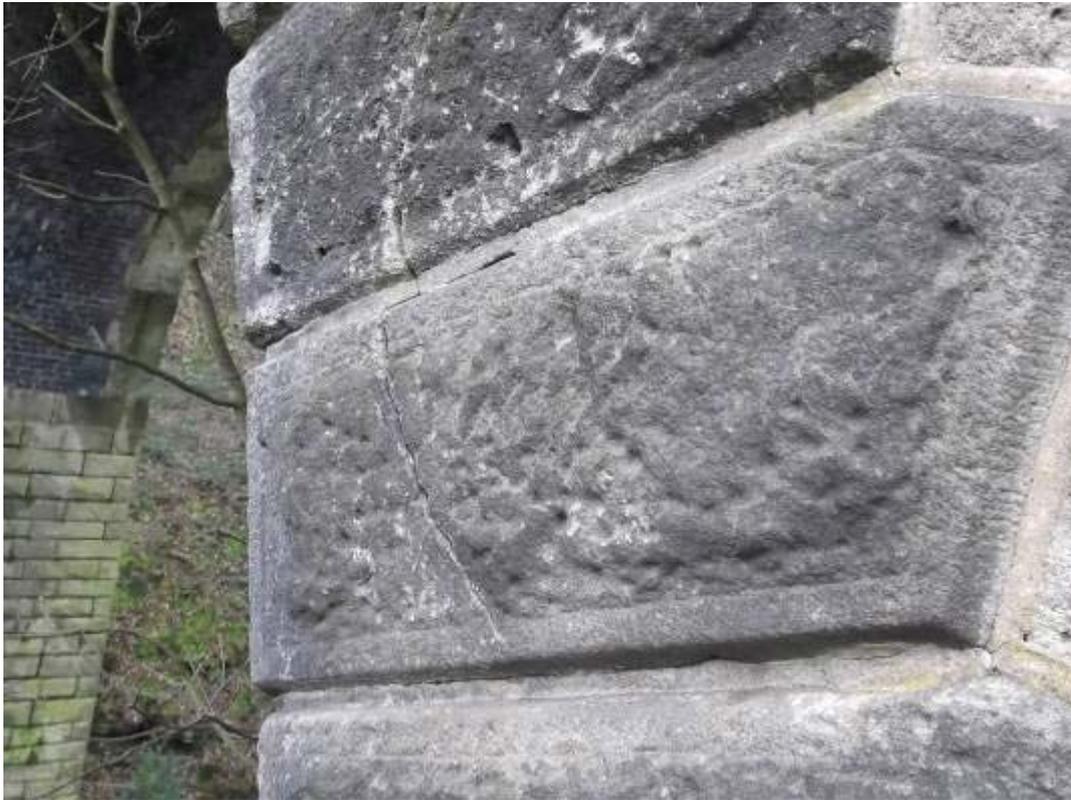
**Photo No. 115: Diagonal stepped fracture to voussoirs of south east elevation of span 7**

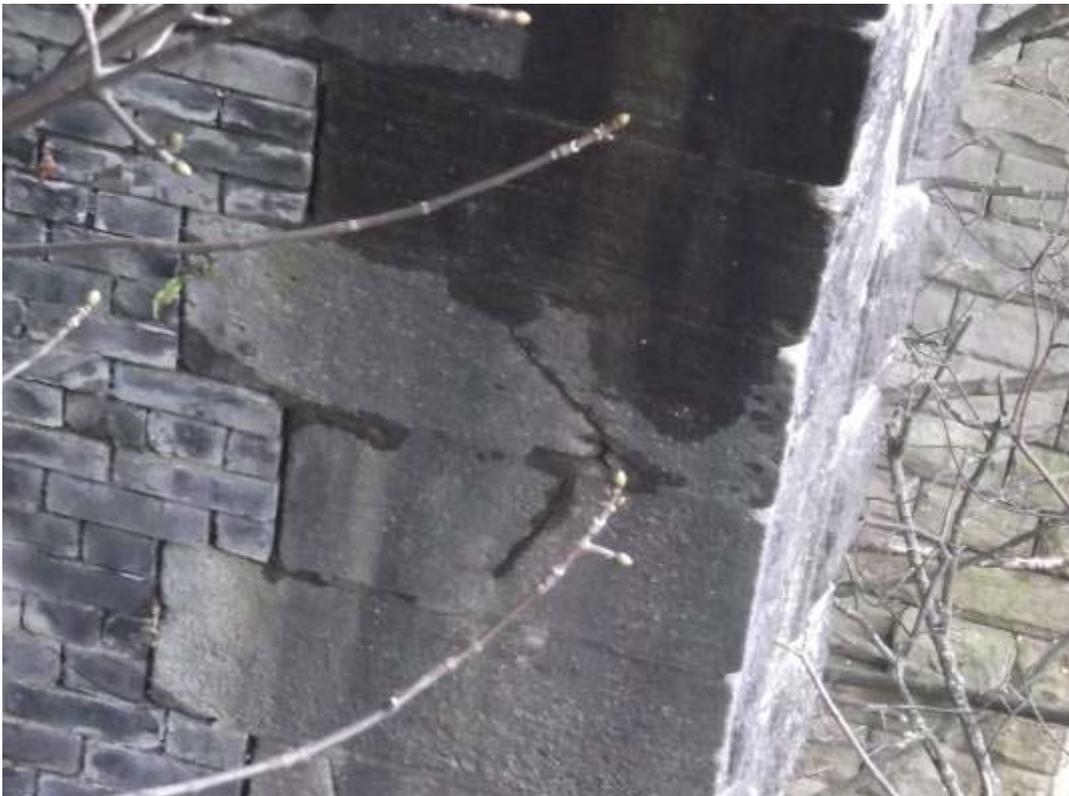
**Photo No. 116: Area of seepage & diagonal fracture to soffit of span 7**

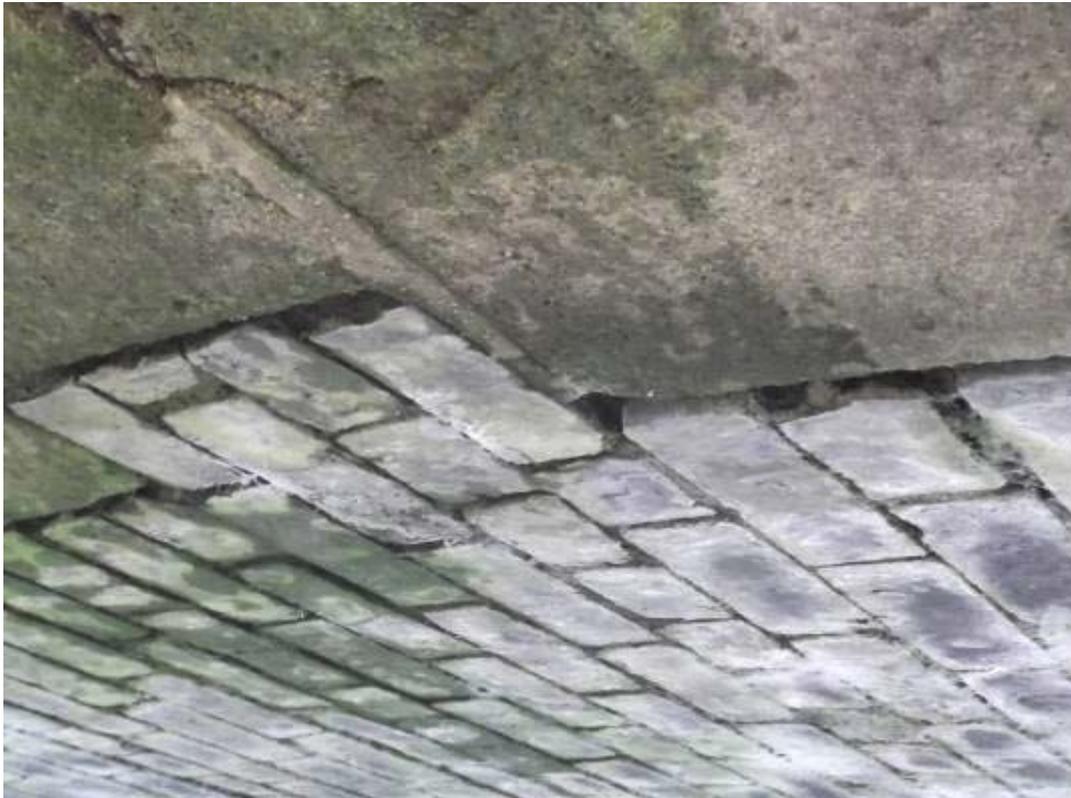
**Photo No. 117: Longitudinal fracture with mortar loss to soffit of span 7**

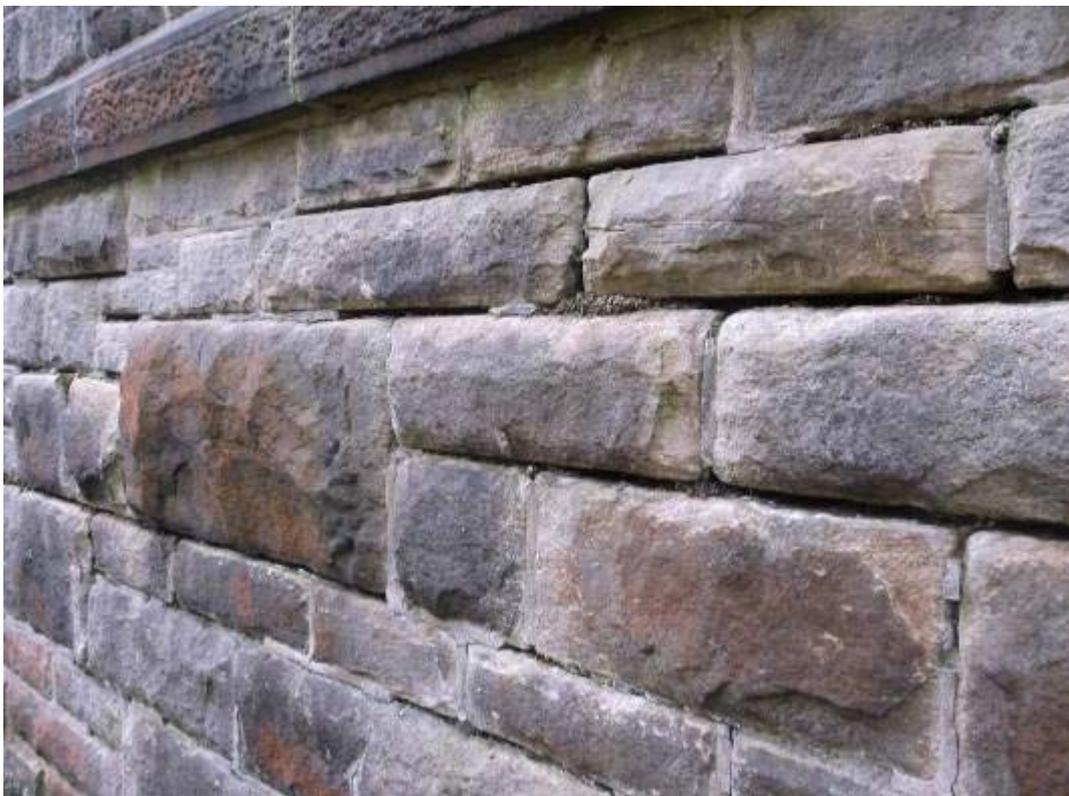
**Photo No. 118: Typical mortar loss to north west elevation of span 8**

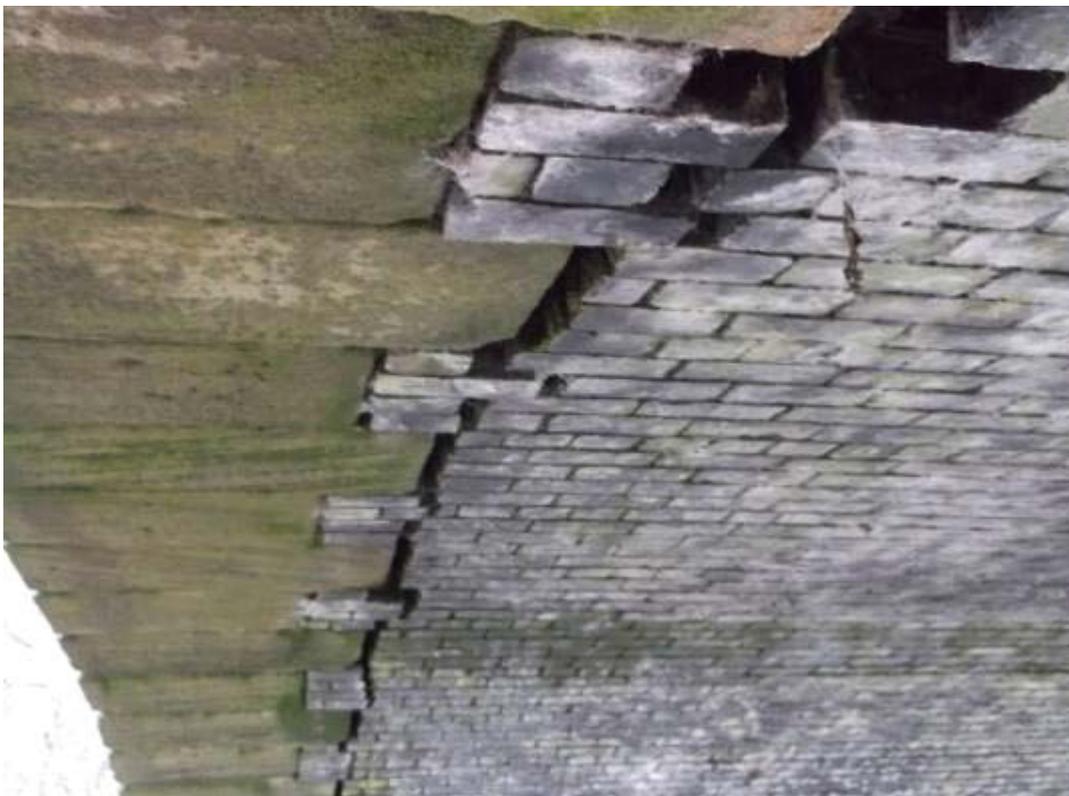
**Photo No. 120: Longitudinal fracture with missing brickwork to soffit of span 8**

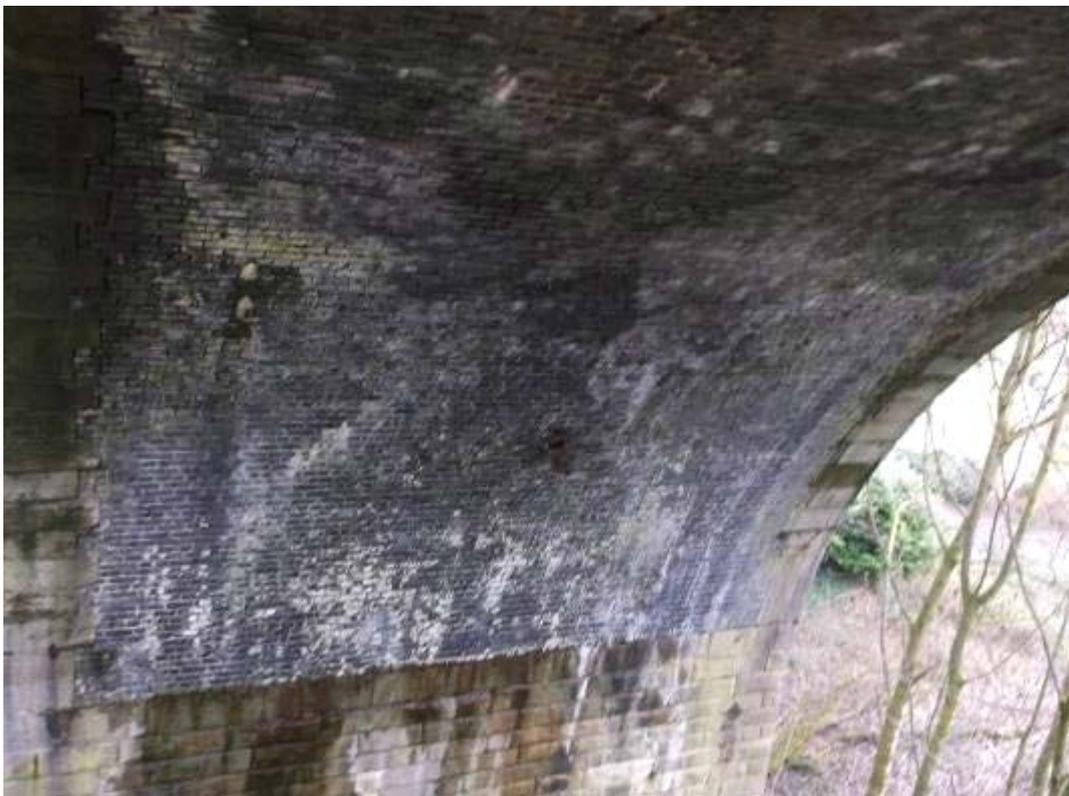
**Photo No. 134: Typical leachate deposits & spot seepage to soffit of span 9**
