## HXH/4a Contract Specification (Masonry Repair and Waterproofing Installation)

**Client name:** National Highways – Historical Railways Estate  
**Project name:** HRE Works Framework  
**Client reference:** HXH/4a  
**Document no:** 0451200  
**Revision no:** 03  
**Date:** May 2023  
**Project no:** B38380DE  
**Project manager:** Nigel Robson  
**Prepared by:** Christopher Doig  
**File name:** HXH 4a NEC ECC

### **HRE WORKS FRAMEWORK HXH/4a 'WHEATLEY VIADUCT' CONTRACT FOR REMEDIAL REPAIRS AND WATERPROOFING**

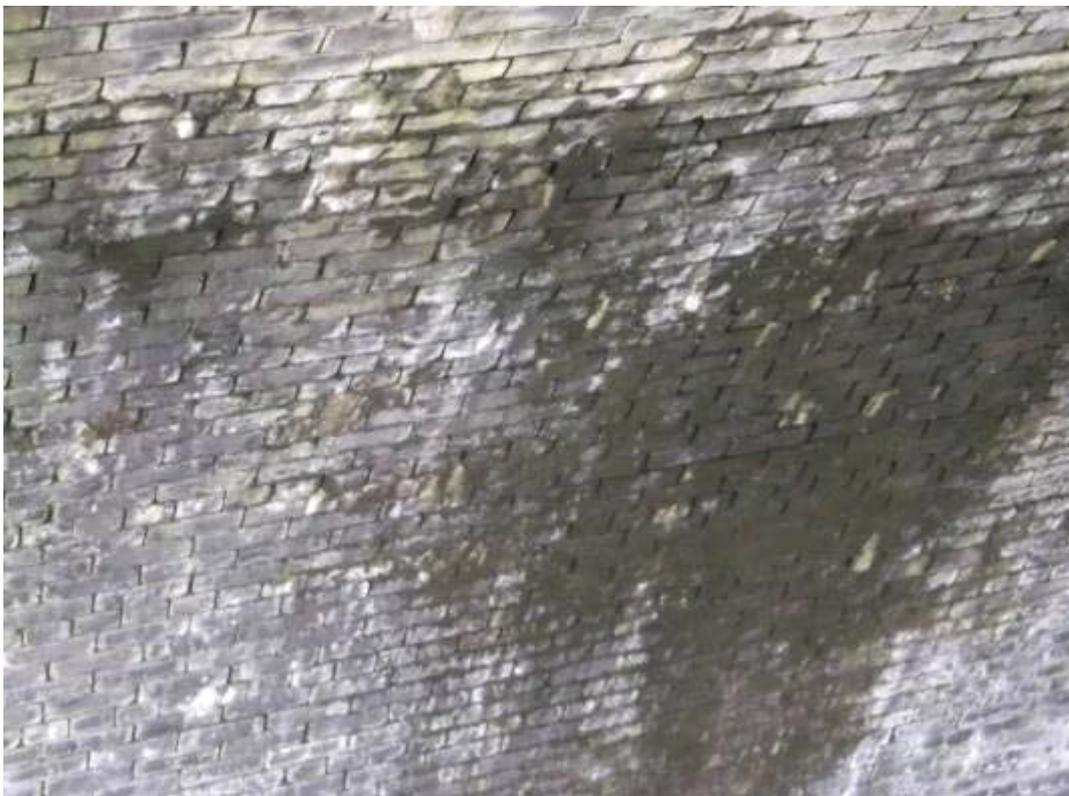
**Photo No. 136: Area of mortar loss and seepage to soffit of span 9**

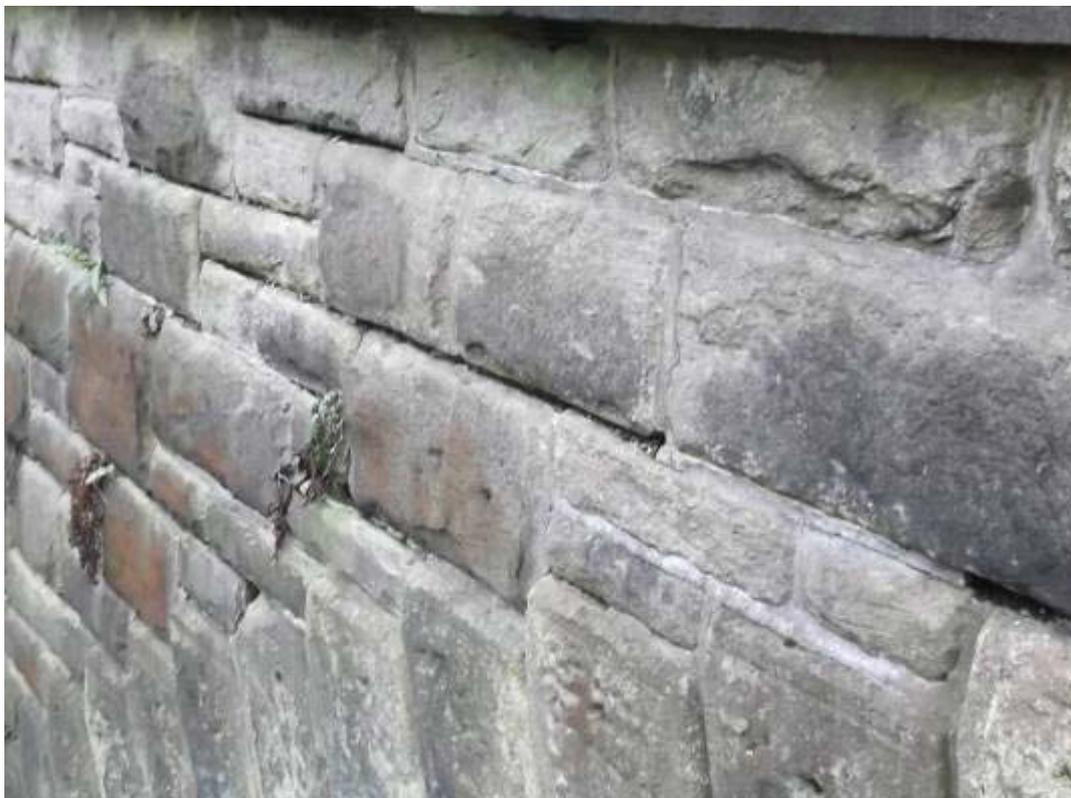
**Photo No. 138: Area of mortar loss & vegetation growth to spandrel of north west elevation of span 10**

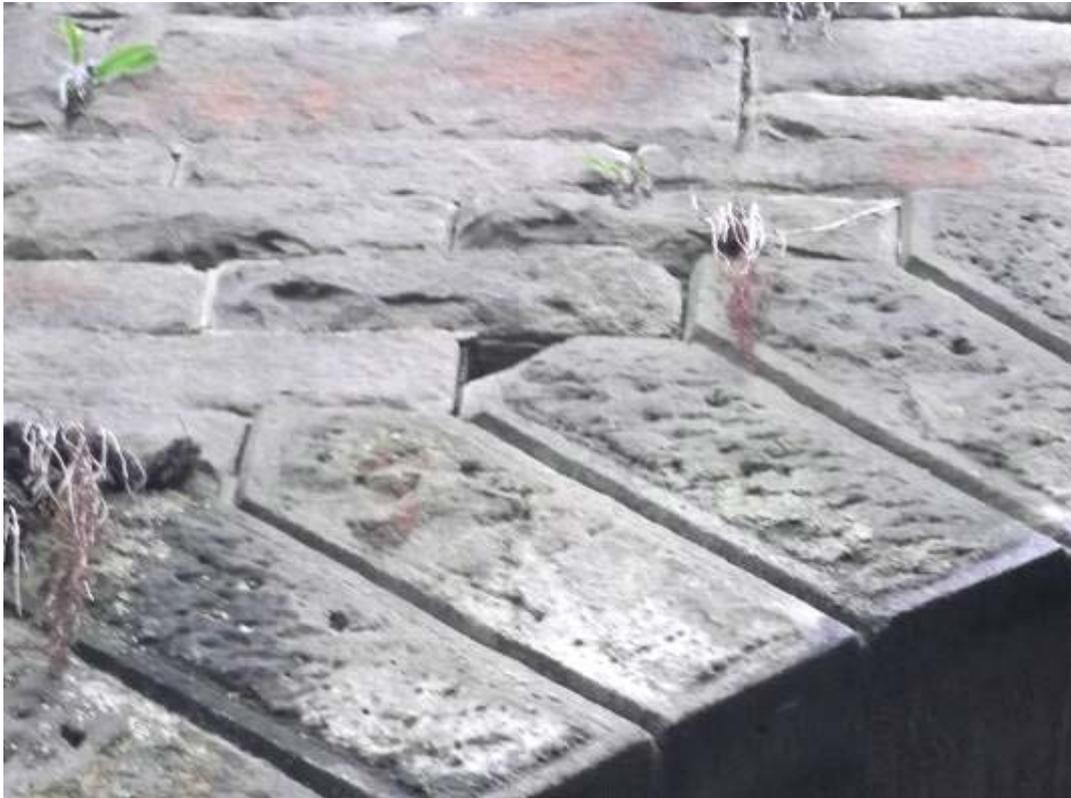
**Photo No. 139: Area of spalling to voussoirs of north west elevation of span 10**

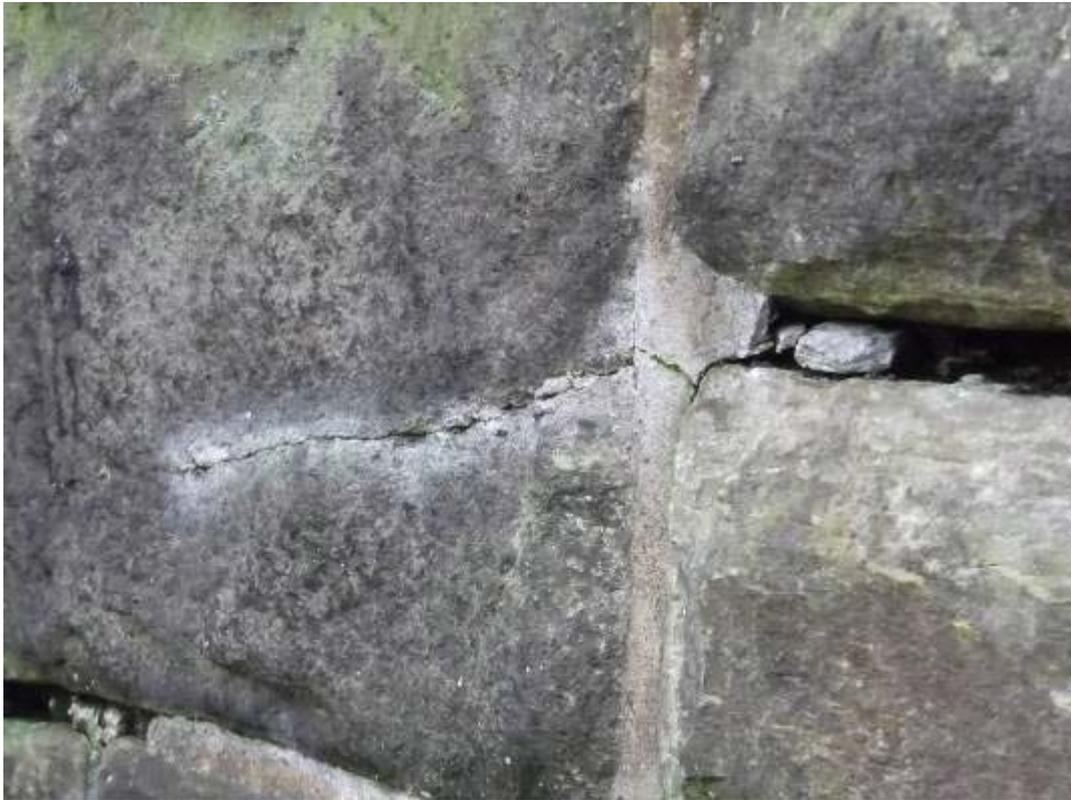
**Photo No. 141: Horizontal fracture to spandrel of south east elevation of span 10**

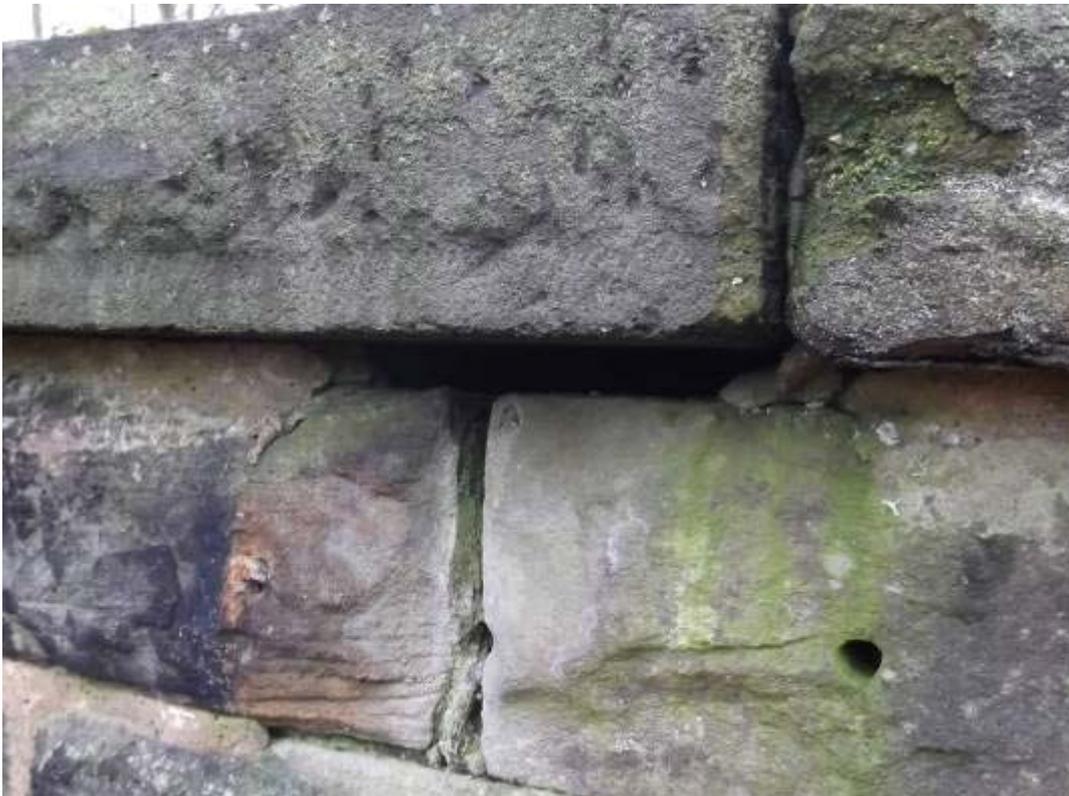
**Photo No. 142: Line of mortar loss to spandrel of south east elevation of span 10**

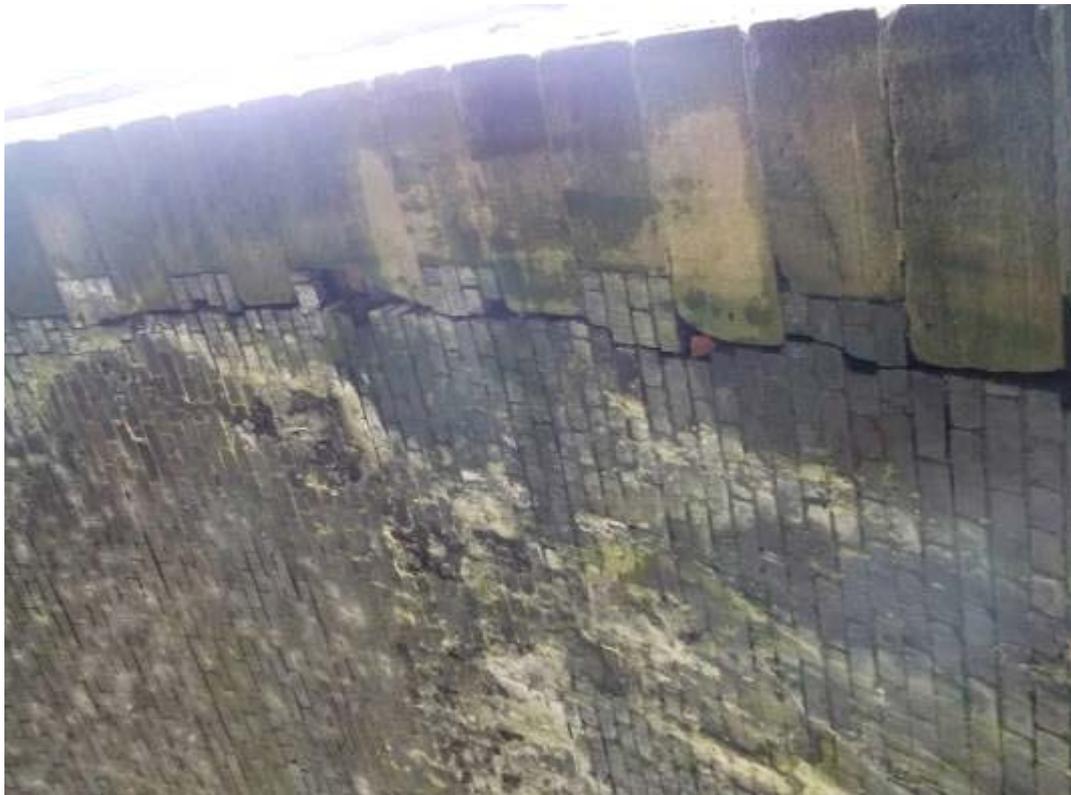
**Photo No. 145: Longitudinal fracture with seepage to soffit of span 10**

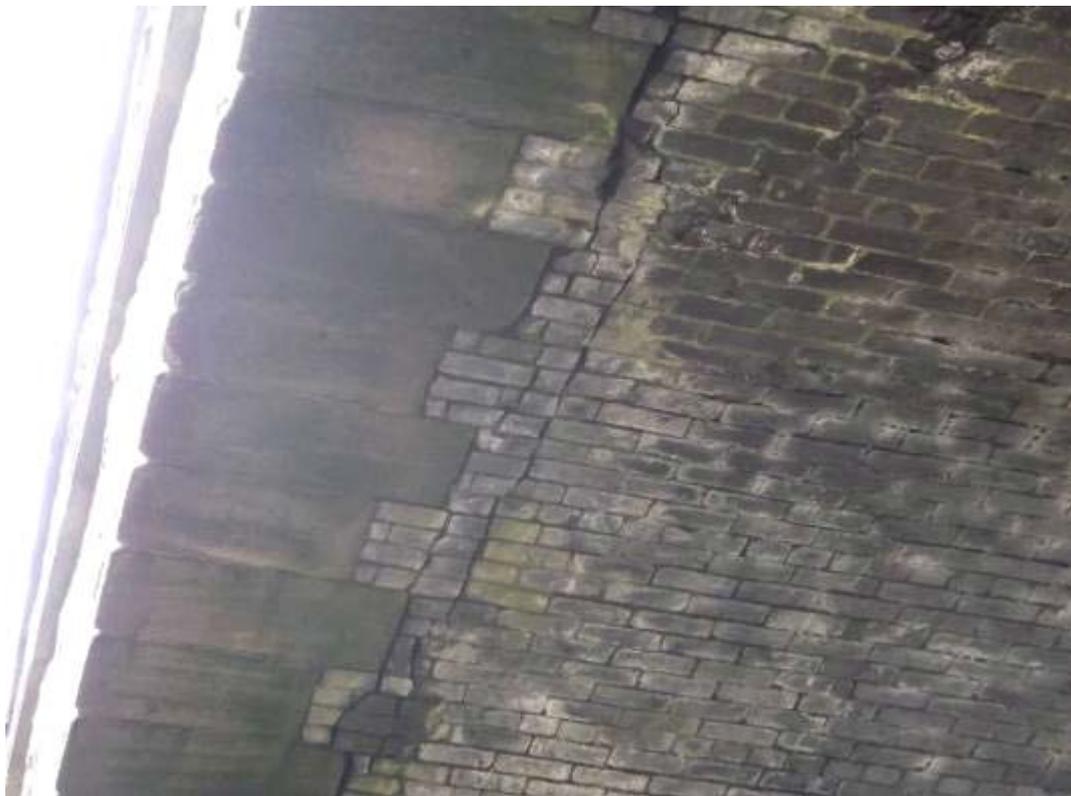
**Photo No. 146: 2No. longitudinal fractures with seepage to soffit of span 10**
