**Inspection of: Link Bridge
St. Catherine's College
Priory Road
Eastbourne
BN23 7BL**

Project No: 778
Document Title: Special Inspection
Document No: CRM060619778
Revision: Rev 4.
Date: Tuesday 30th August 2022

Principal Inspection of Link Bridge – St Catherine’s College

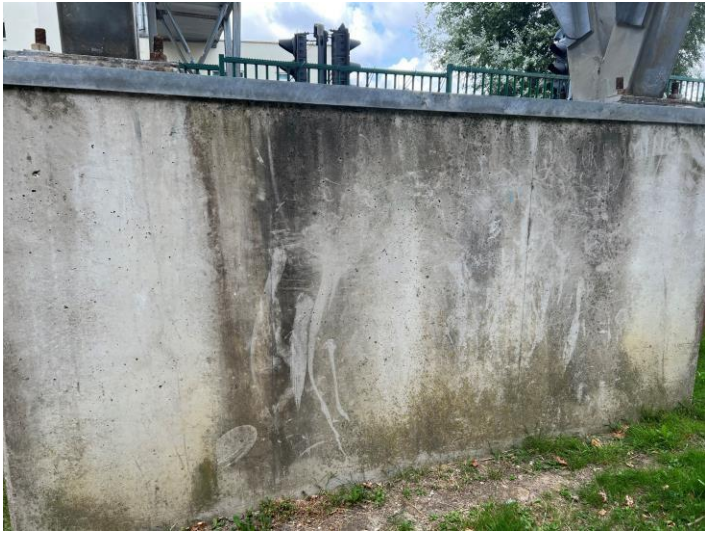
Figure 1: Foundation block East

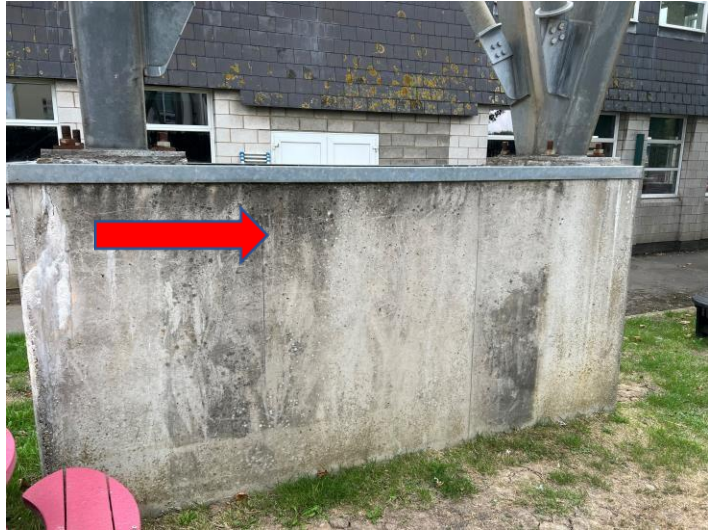
Figure 5: Staining to foundation block

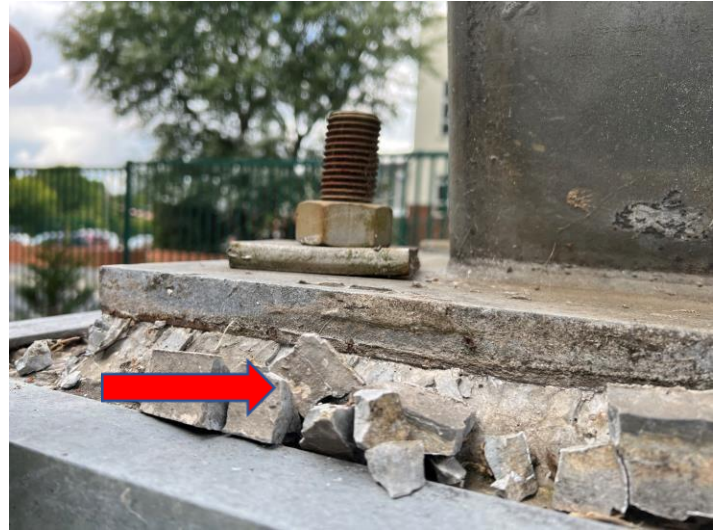
Figure 8: Degradation to grout

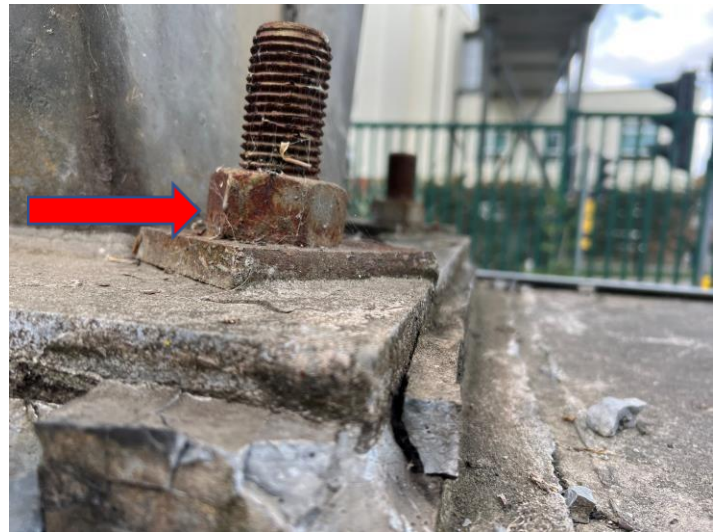
Figure 9: Degradation to grout & corrosion to pier

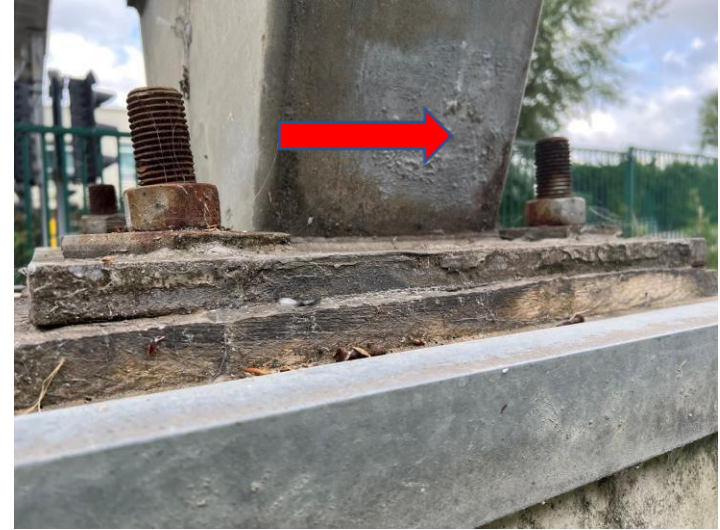
Figure 12: Corrosion to pier

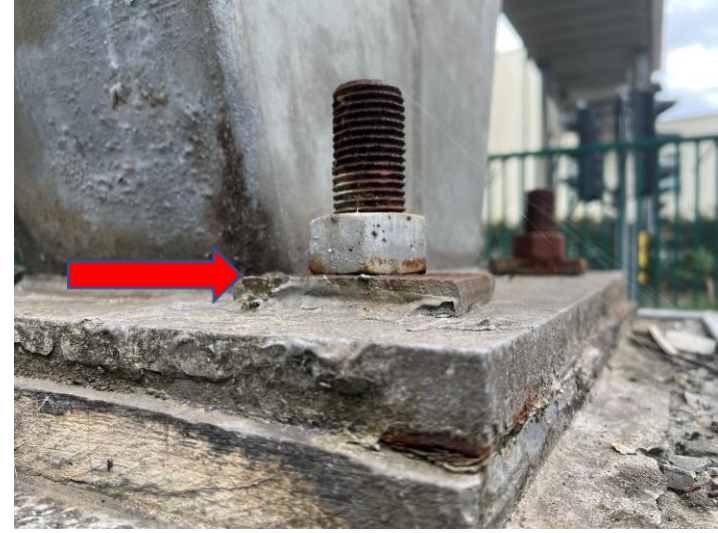
Figure 14 – corrosion to base plate and HD bolt

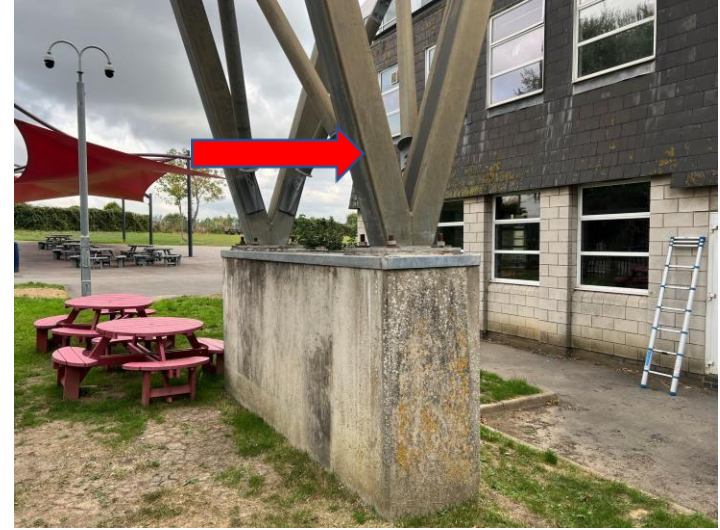
Figure 16: Light corrosion to pier

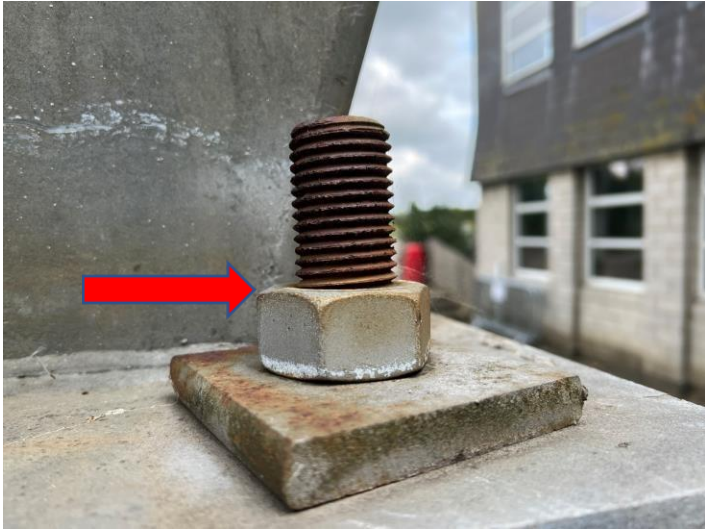
Figure 17: Light corrosion to HB bolt & thread

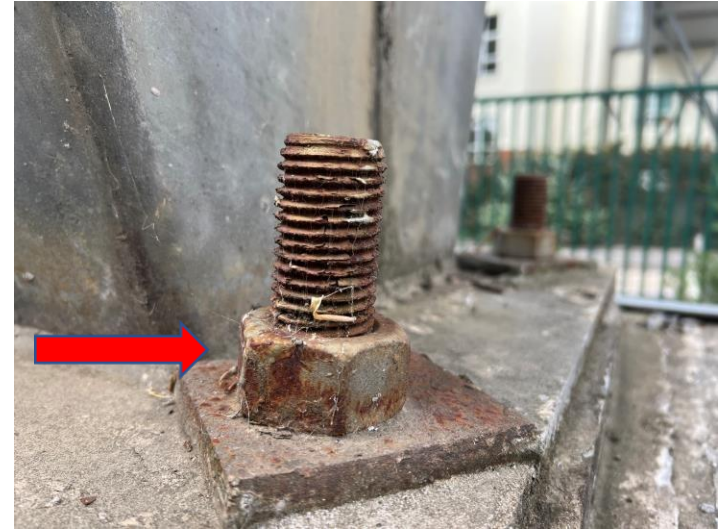
Figure 18: Moderate corrosion to HD bolt & packer

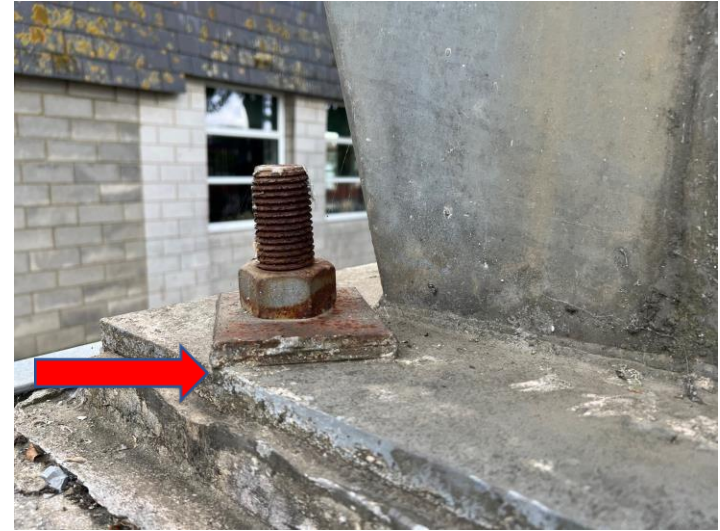
Figure 19: Moderate corrosion

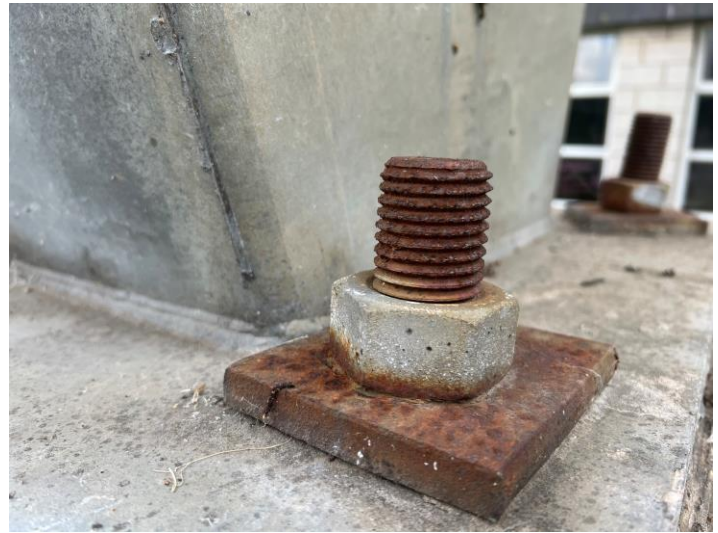
Figure 22 – Corrosion to HD bolt and washer

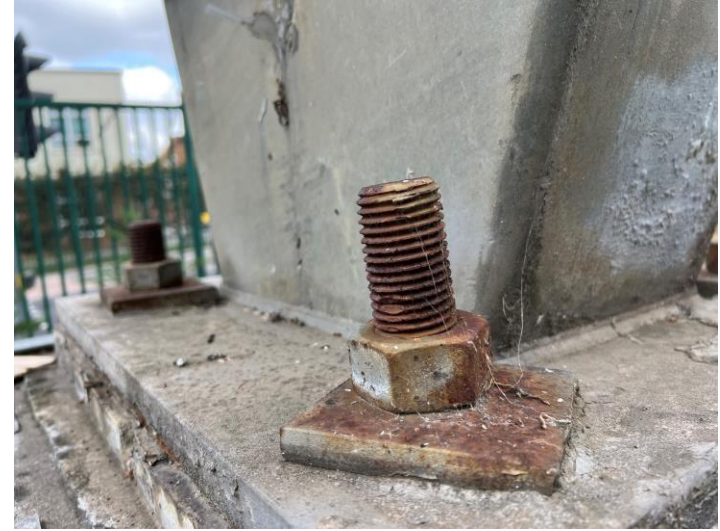
Figure 23 – Corrosion to HD bolt and washer

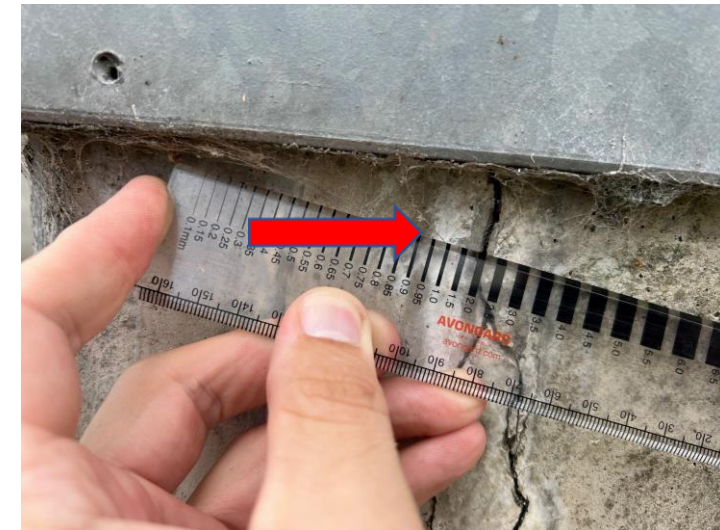
Figure 27: Cracking to East block upper section

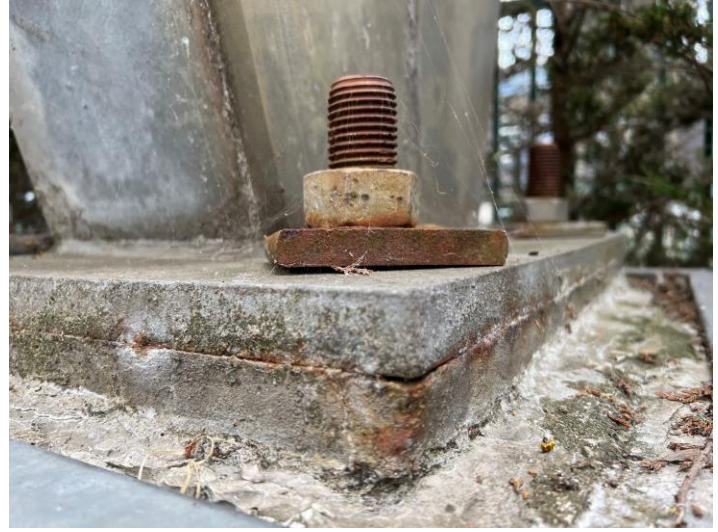
Figure 32: Light staining to West Block

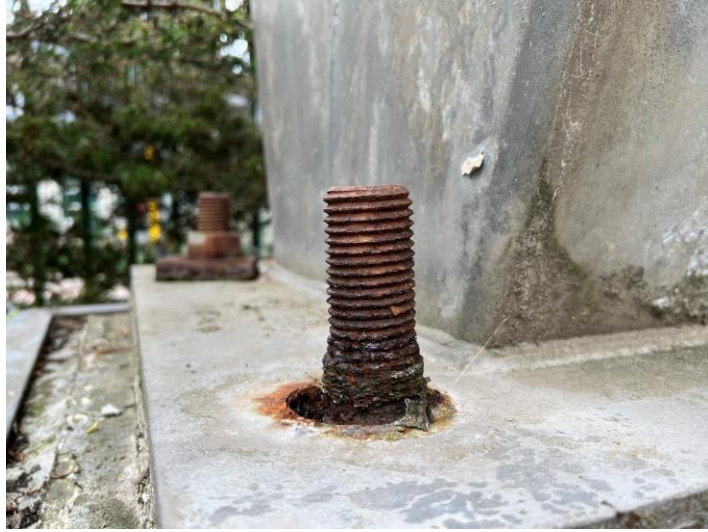
Figure 33: Light corrosion to HD Bolt & Packer

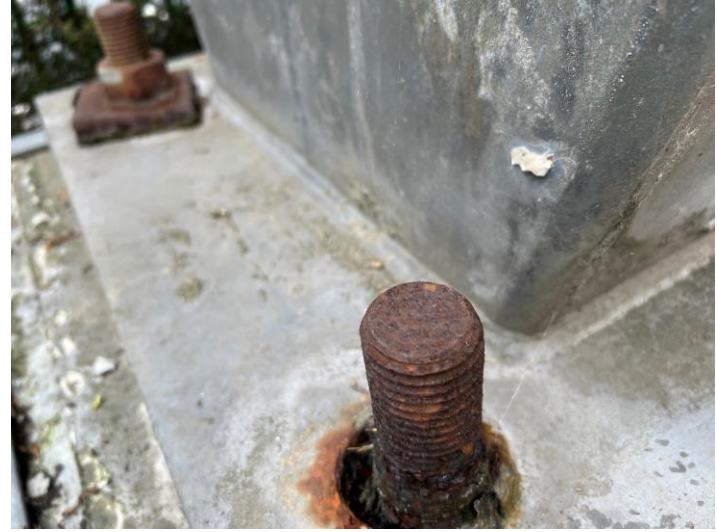
Figure 34: Missing HD Bolt West

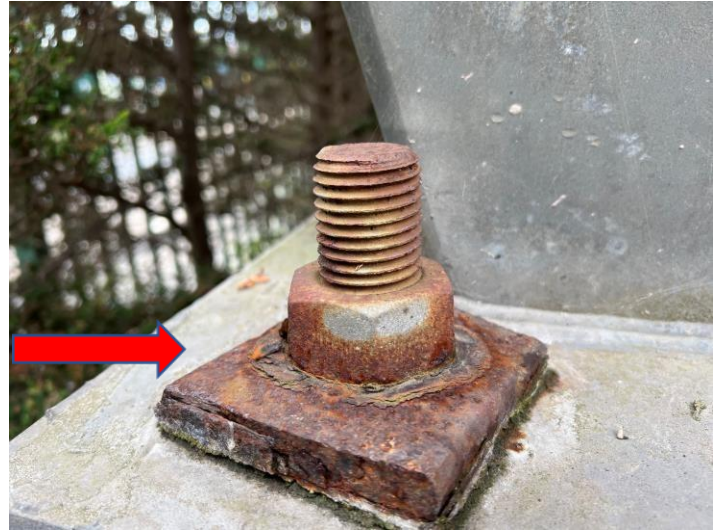
Figure 37: Moderate corrosion

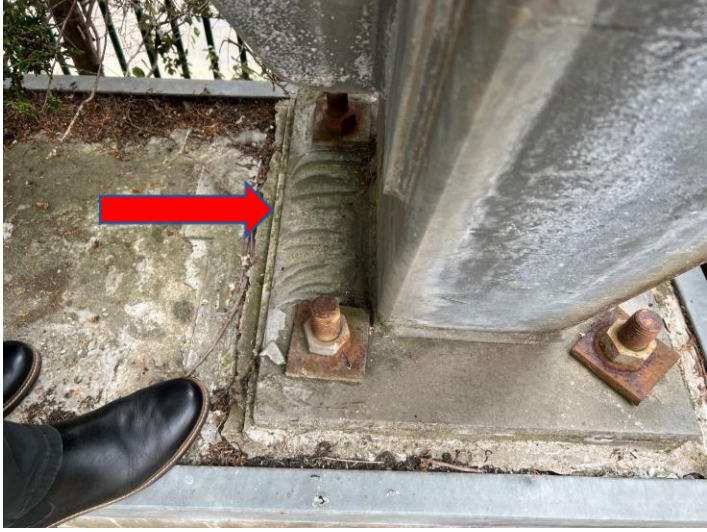
Figure 39: Moderate corrosion

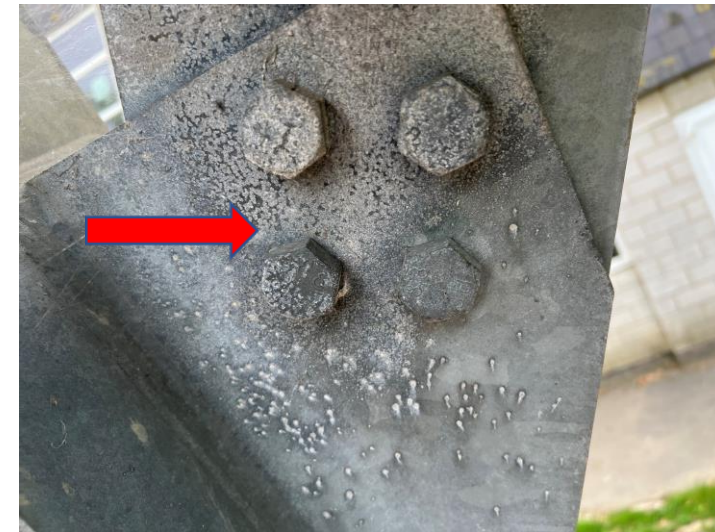
Fig 7: Pitting & light corrosion

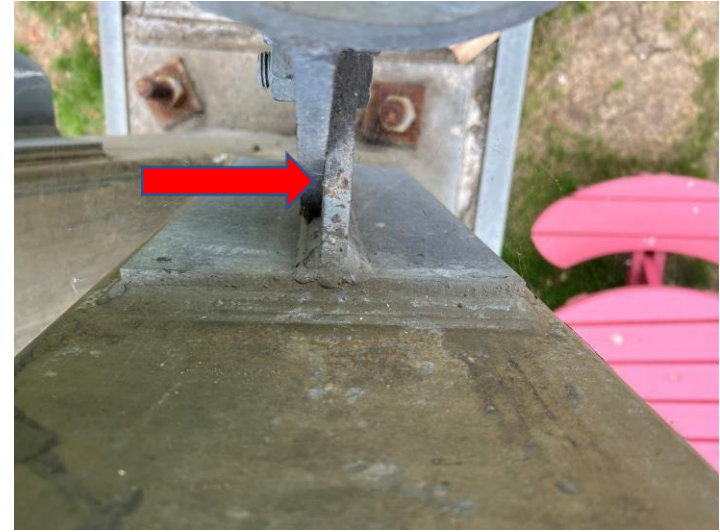
Fig 20: Light corrosion minor displacement

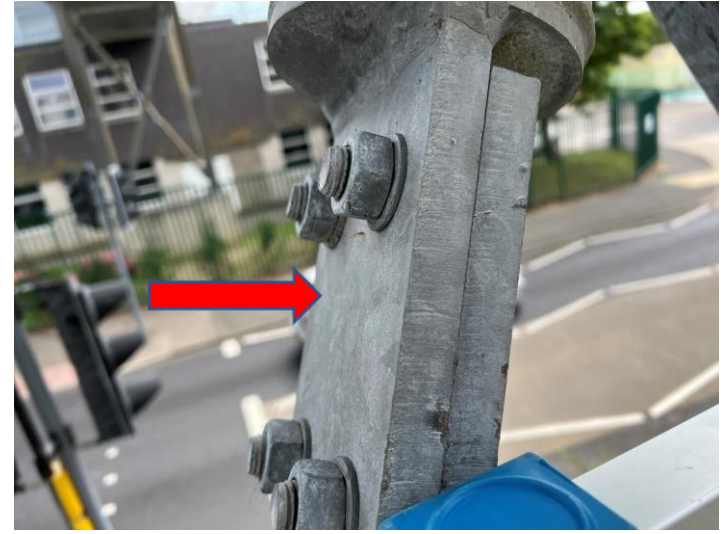
Fig 25: Strut junction light damage

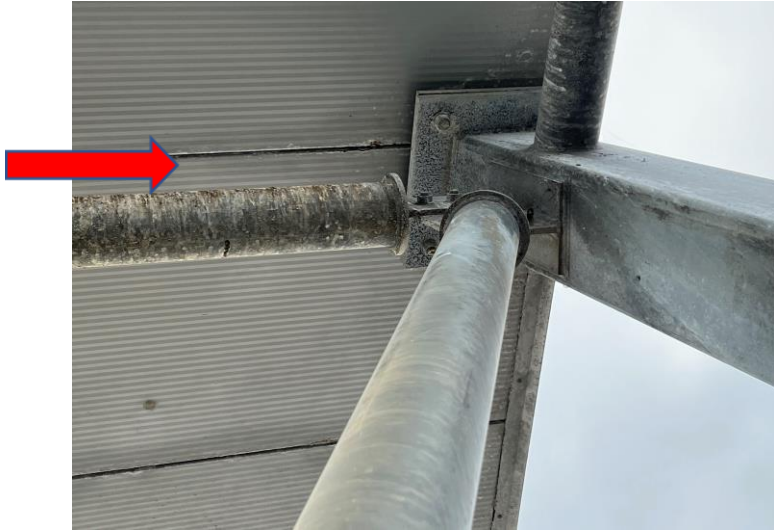
Fig 37: Moderate corrosion & pitting
& pigeon guano

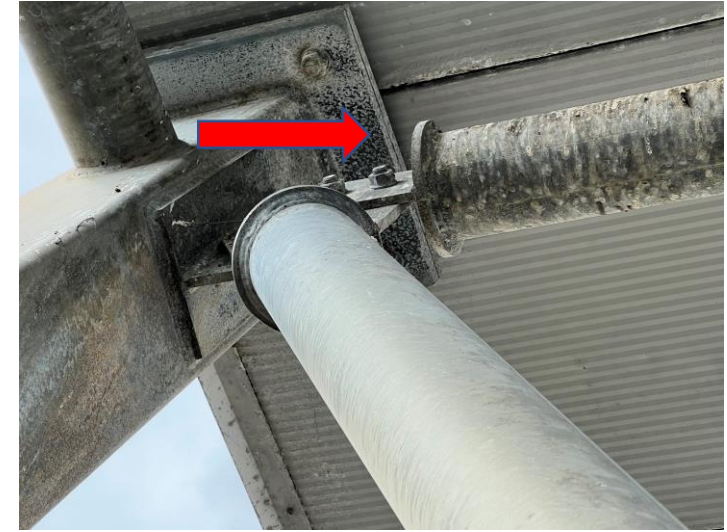
Fig 38: Moderate corrosion & pitting &
pigeon guano

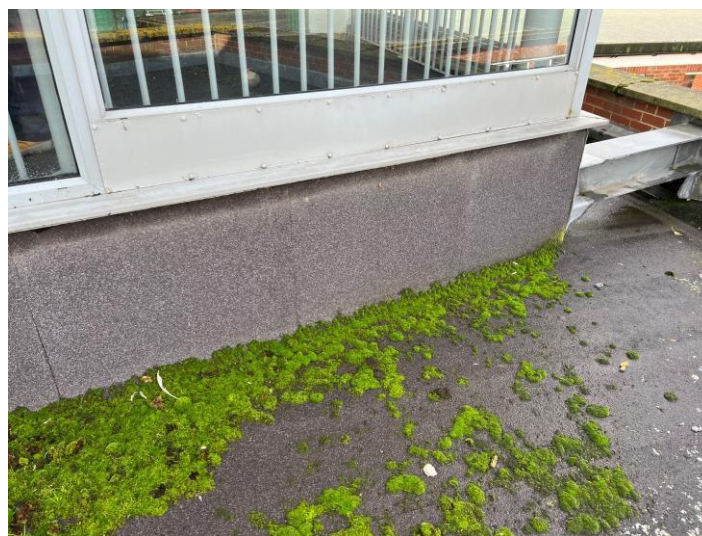
Figure 3 : Slip hazard to link access

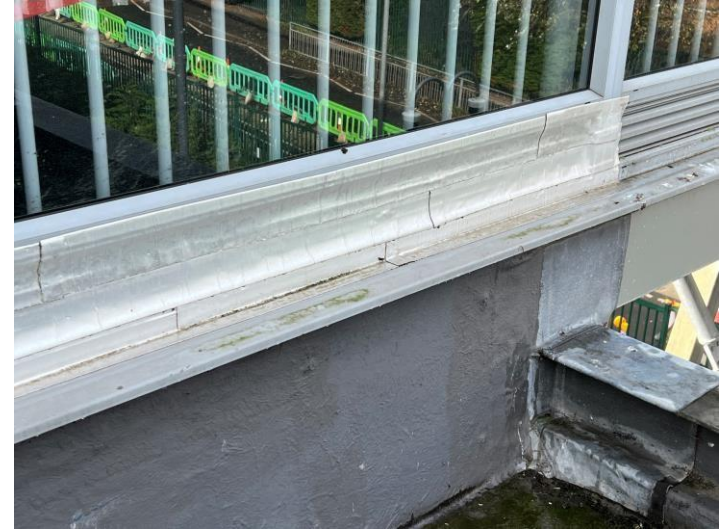
Image 6: Flash band to external cladding

The cladding to this section of the bridge appears to have been repaired at a number of locations. Flash band has been used to address these areas. This should be seen as a temporary fix and consideration will need to be given to the permanent repair and replacement of these sections.

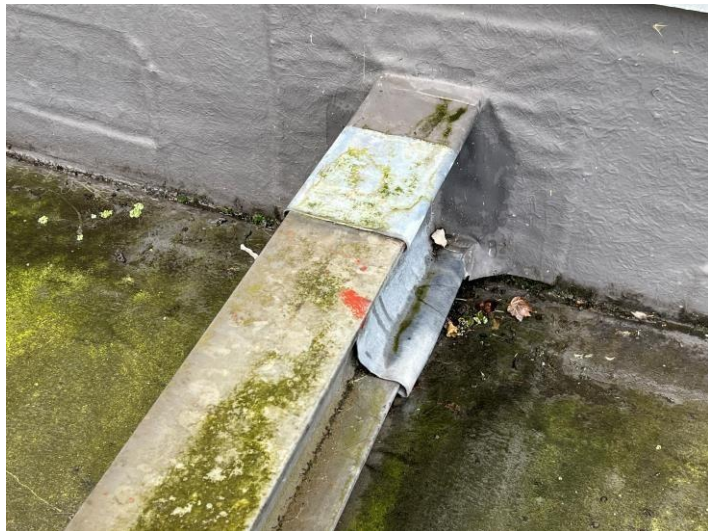
Image 10: Moss to roof slip hazard

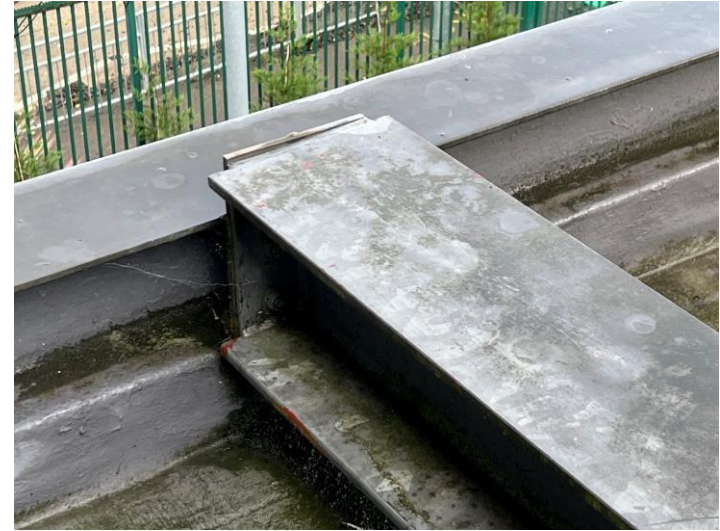
Image 14: Light corrosion

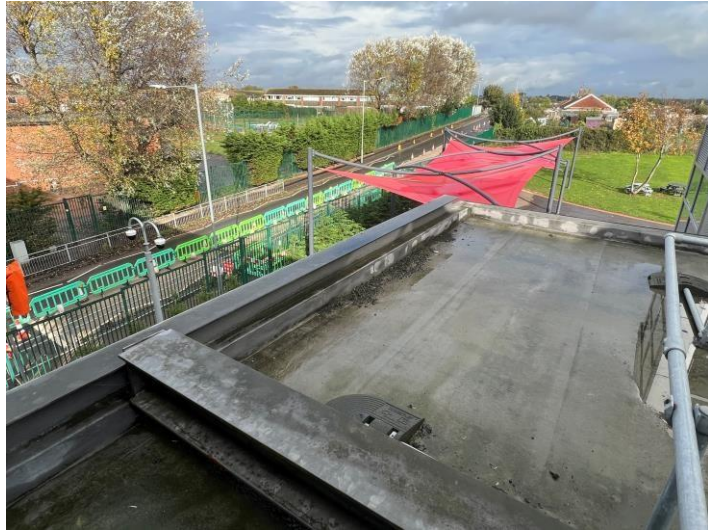
Image 15: Lack of edge protection

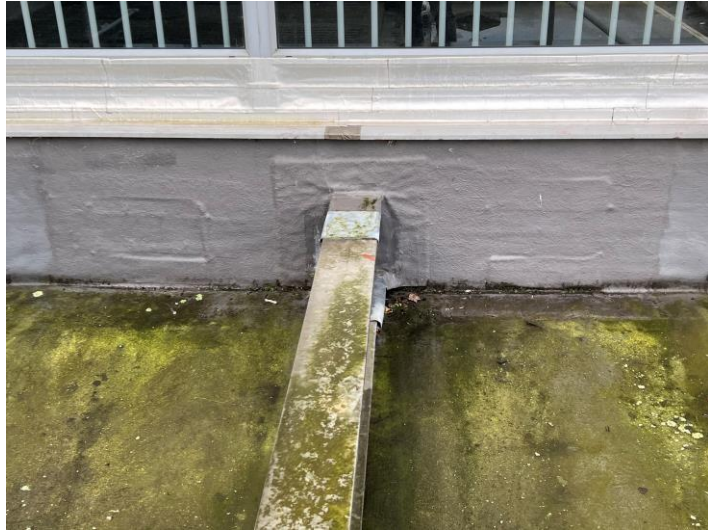
Image 18: Moss & light corrosion

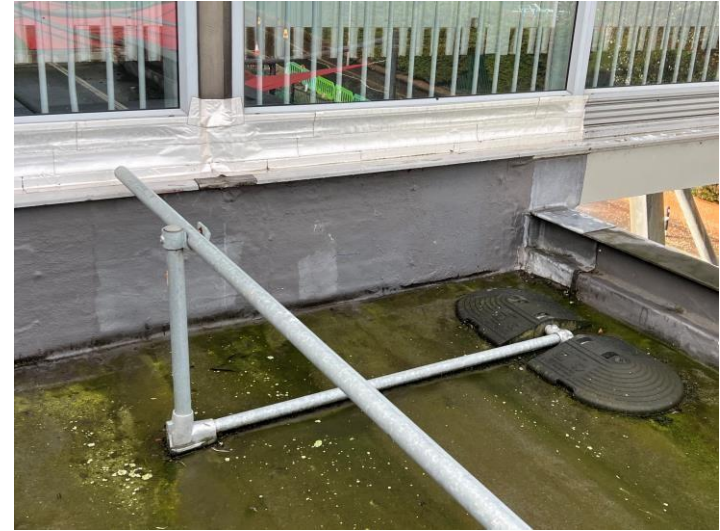
Image 19: Poor repairs

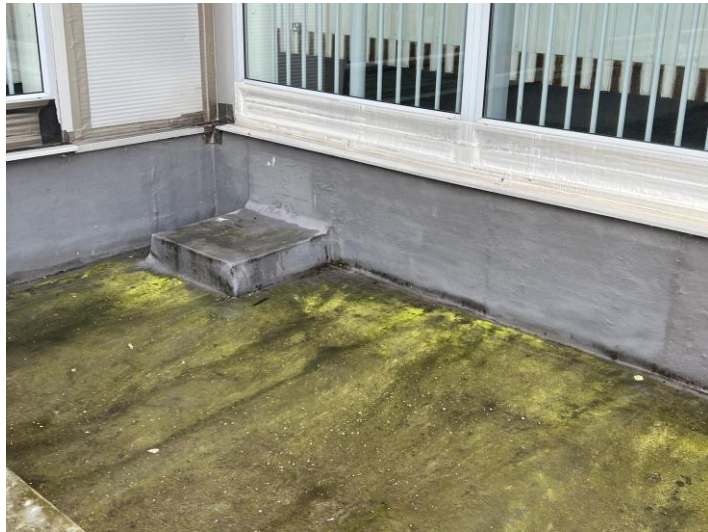
Image 20: Poor repairs

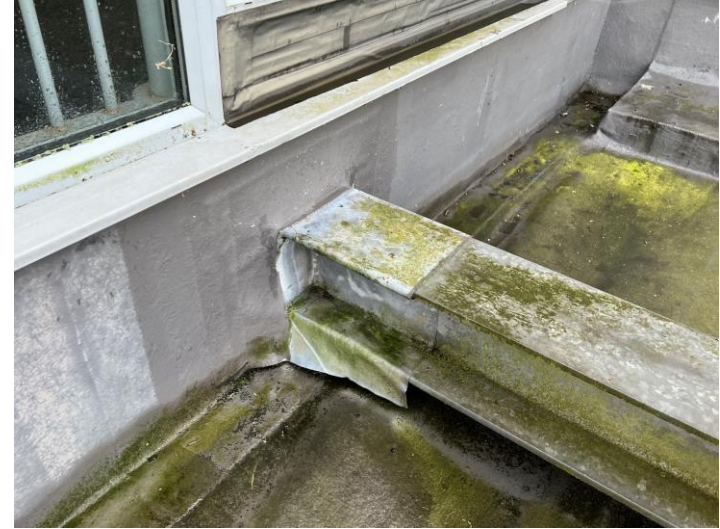
Image 23: Lack of edge protection

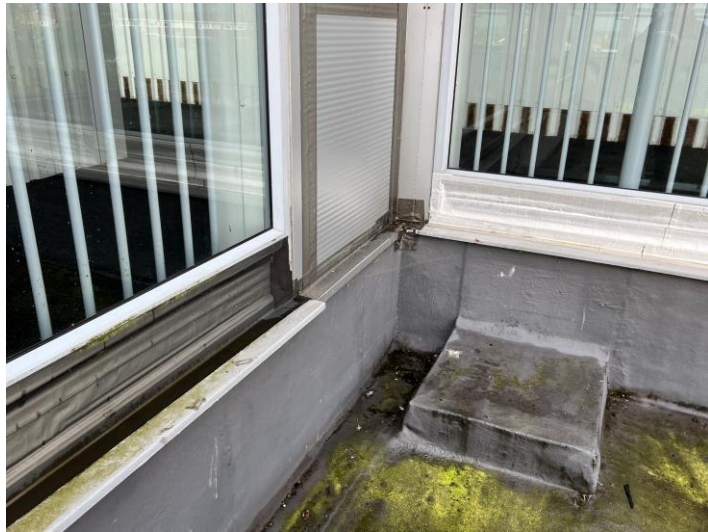
Image 26: Poor repairs

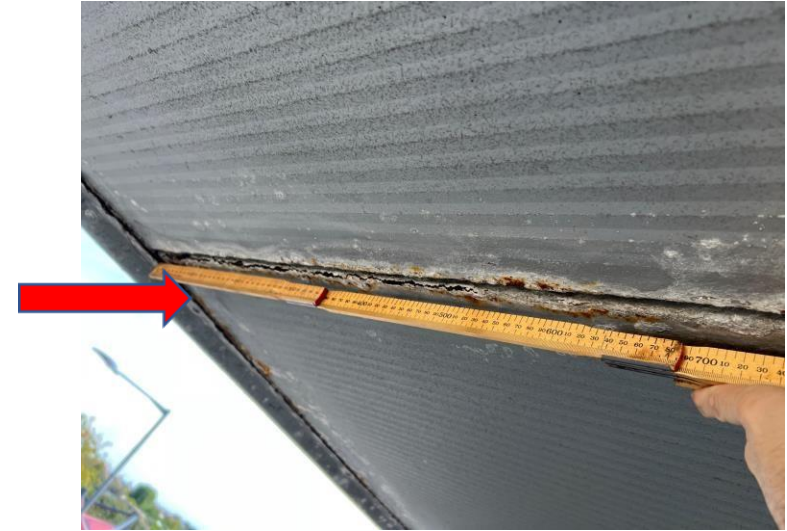
Fig 2 Heavy corrosion

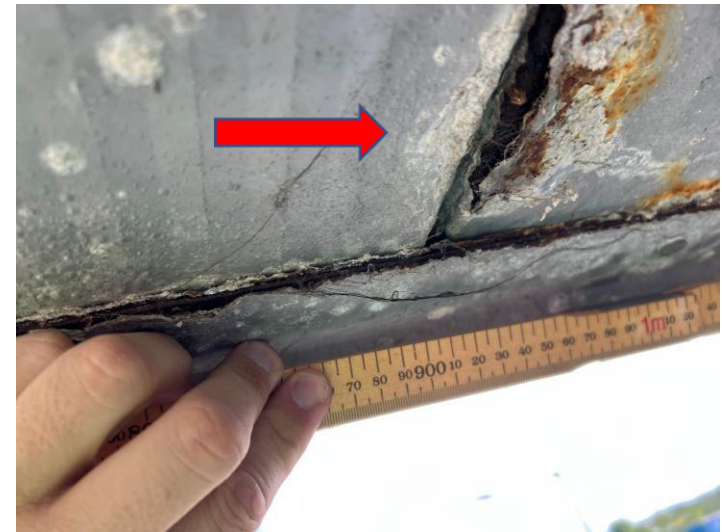
Fig 3 Heavy corrosion at joint

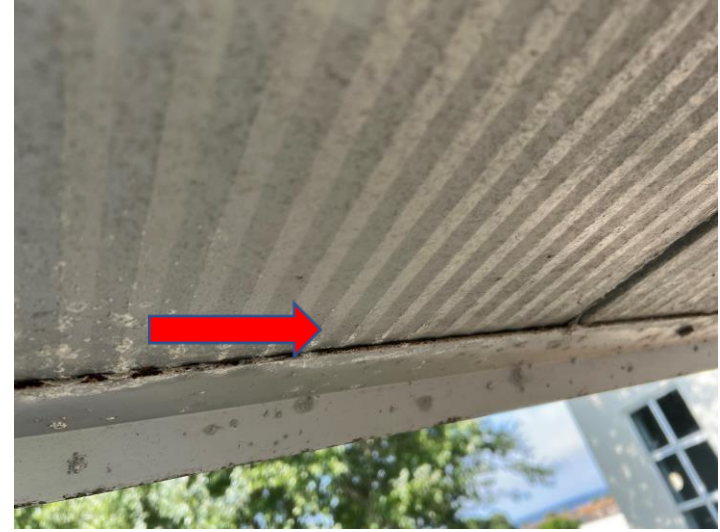
Fig 7 Moderate corrosion

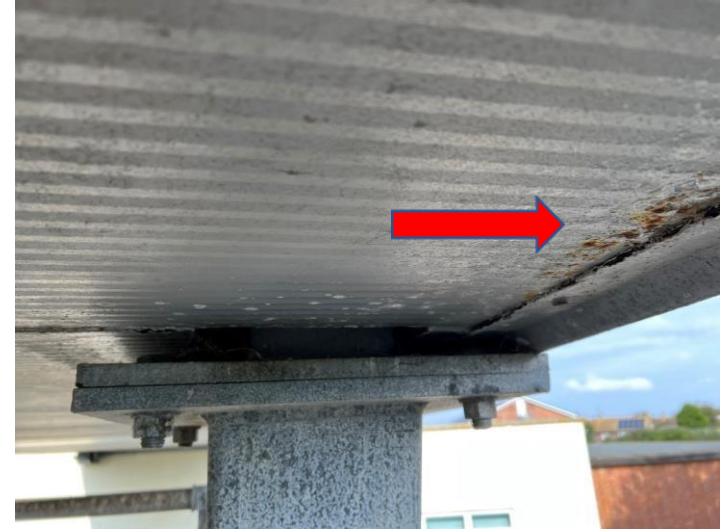
Fig 9 Moderate corrosion

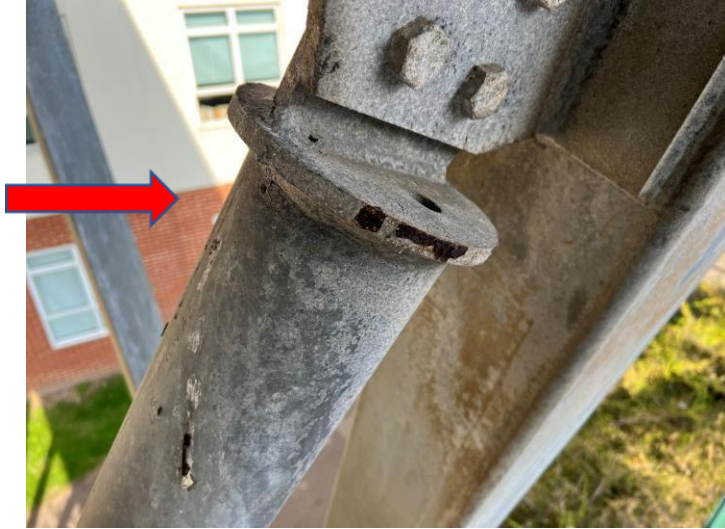
Fig 10 Moderate corrosion

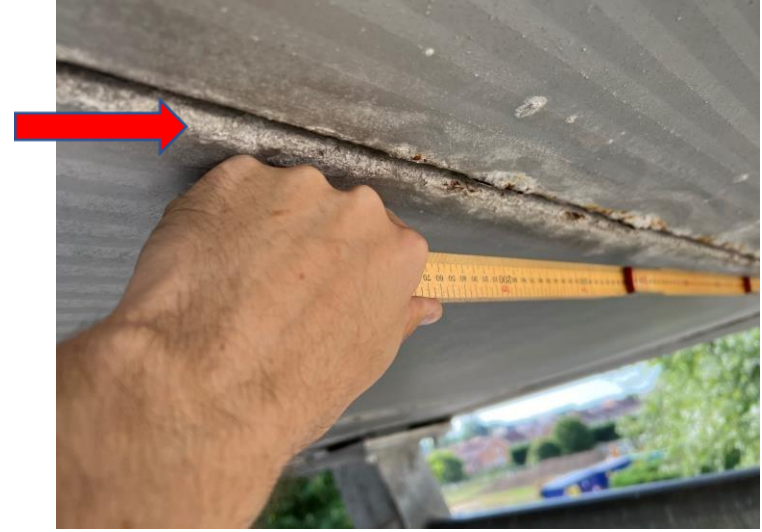
Fig 14 Moderate corrosion

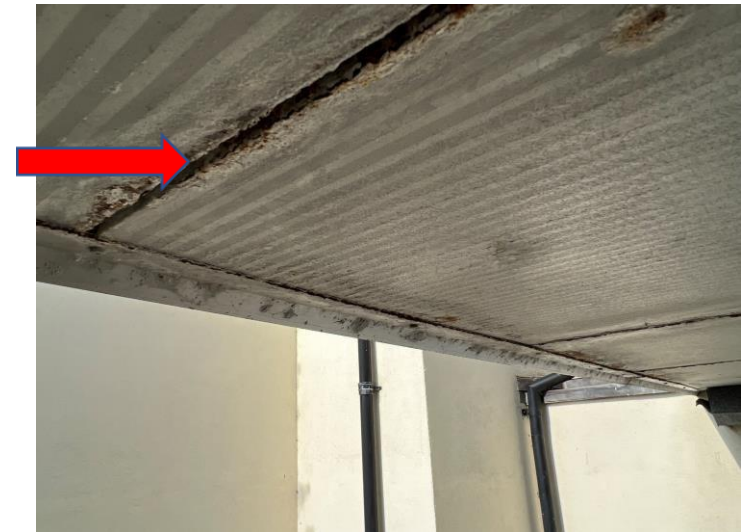
Fig 17 Moderate corrosion

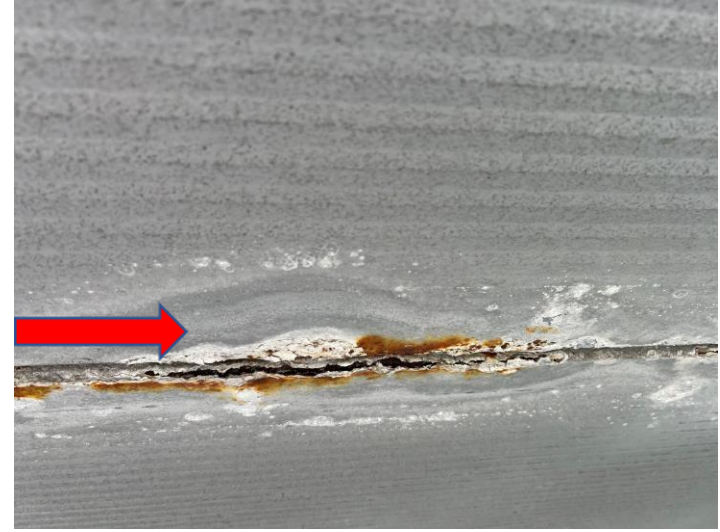
Fig 21 Heavy corrosion & delamination

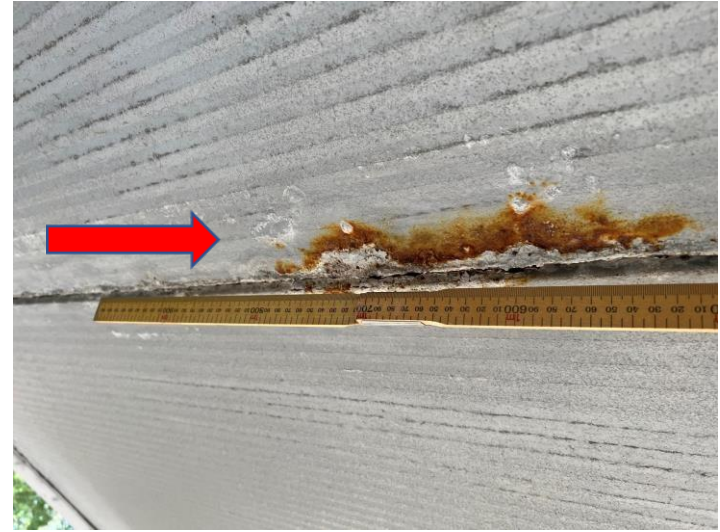
Fig 24 Heavy corrosion

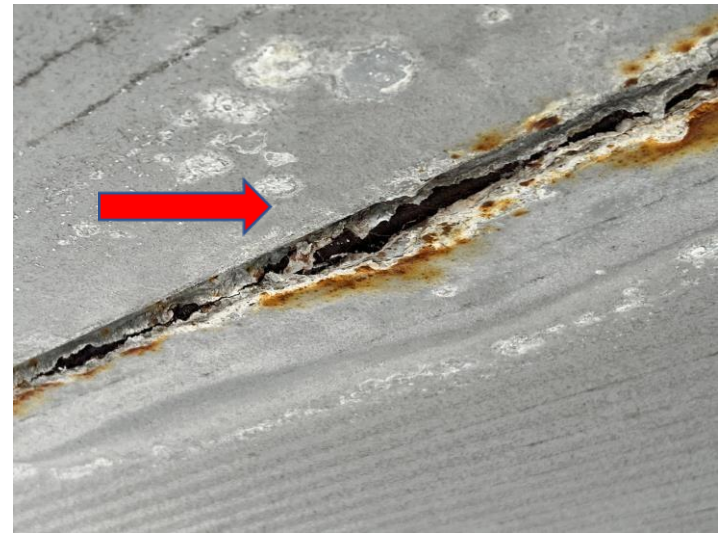
Fig 25 Delamination & heavy corrosion

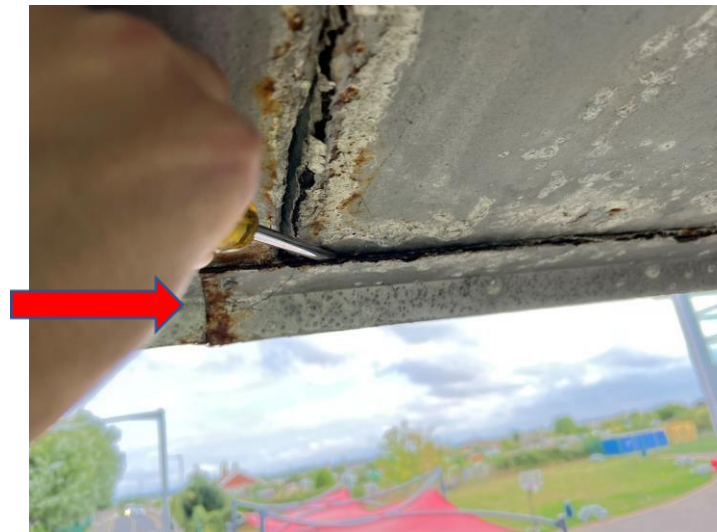
Fig 29 Heavy corrosion

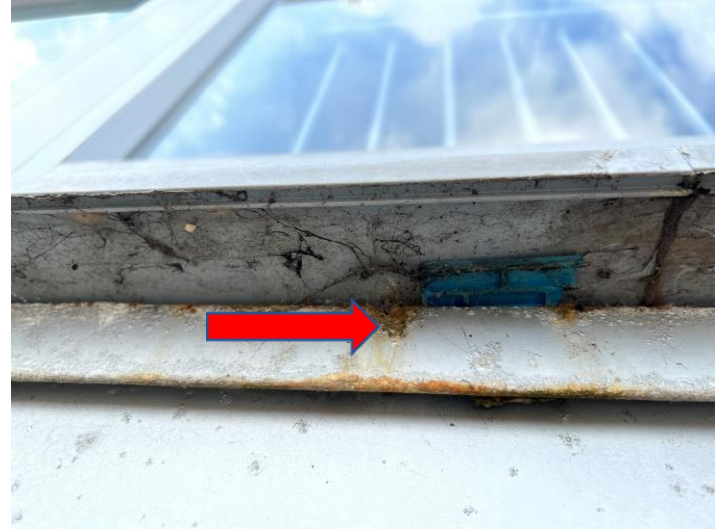
Fig 31 Heavy corrosion

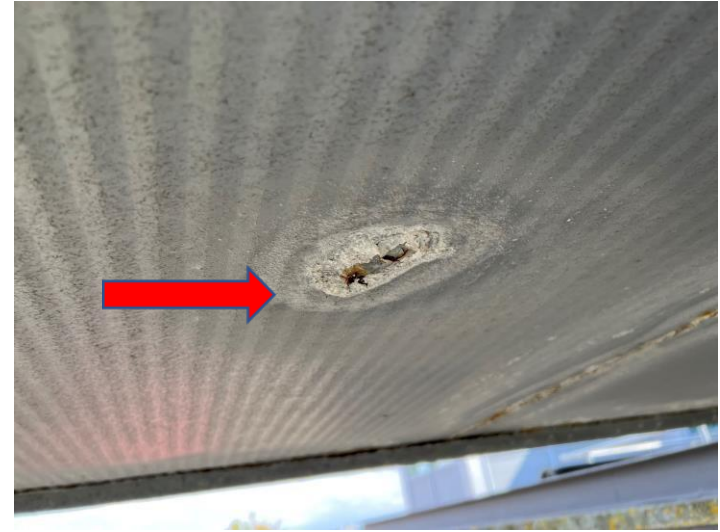
Fig 38 Heavy mid panel corrosion

The secondary center span elements would appear to have suffered from the most corrosion. The under deck panels to this location are suffering from heavy corrosion at the joints and connections. Some panels are affected to the center of the panel also. Drainage outlets are also present at this location which free drain on to the deck structure. Pitting and blistering to the panels is evident across the entire span. These elements will need to be removed and replaced. A number of the panels could be penetrated by hand using a demolition screwdriver. (Under deck section Photos 1-38).

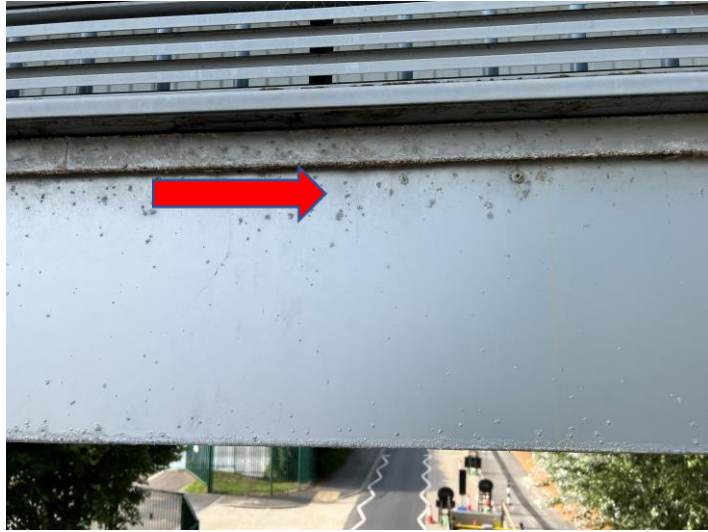
Fig 1 Light corrosion

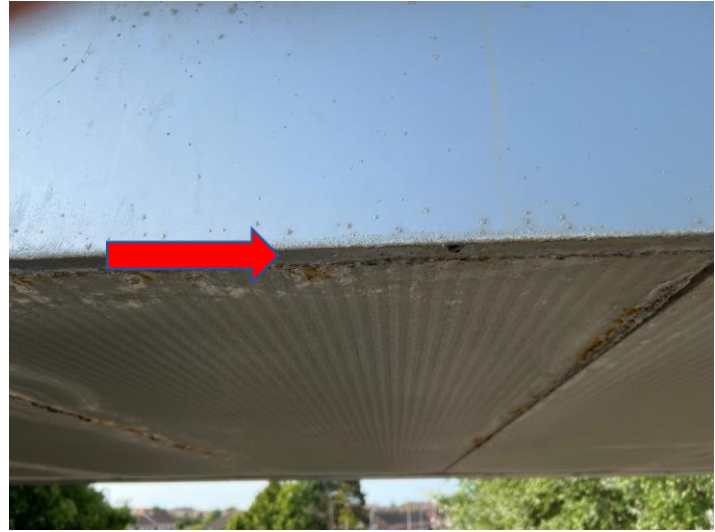
Fig 2 Light corrosion

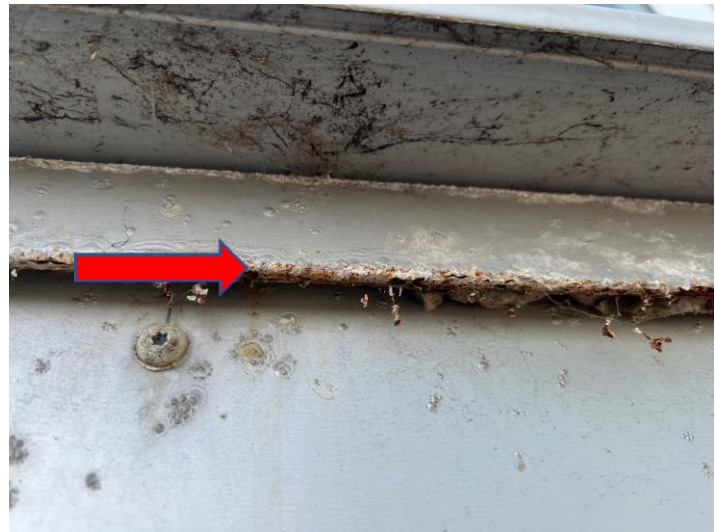
Fig 3 Light pitting

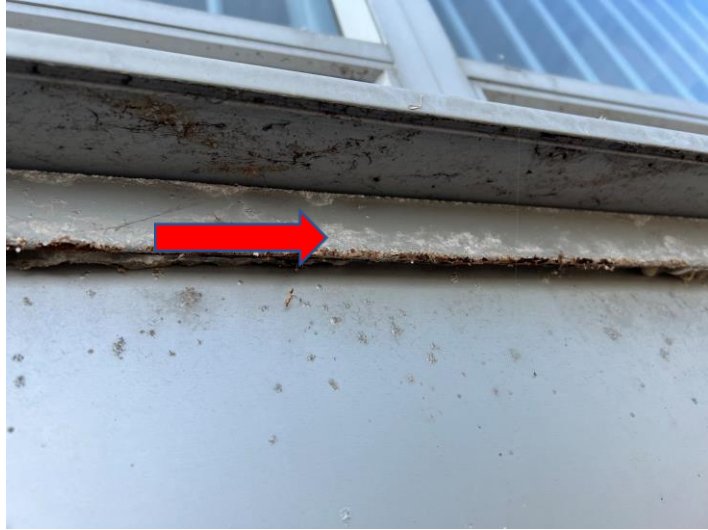
Fig 4 Moderate corrosion

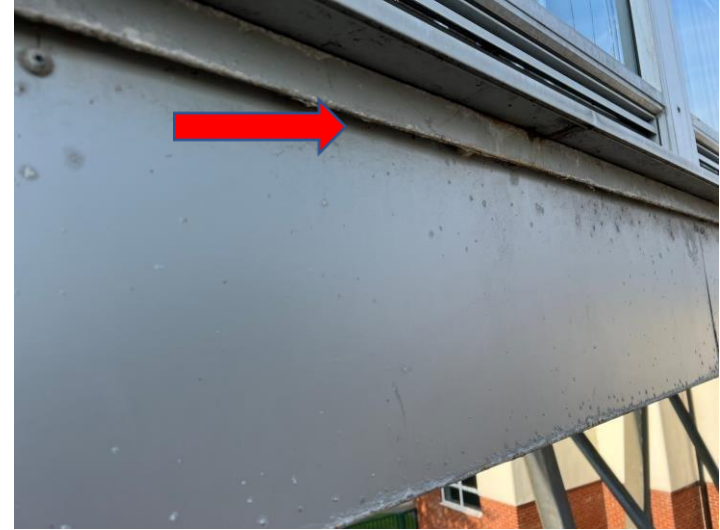
Fig 5 Moderate corrosion

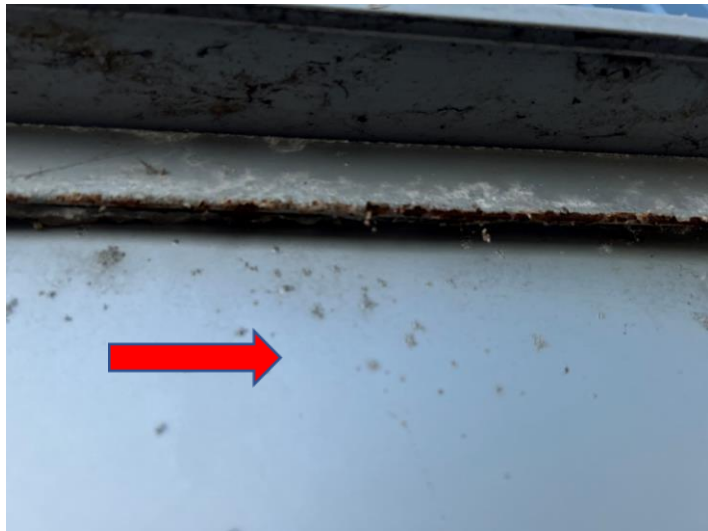
Fig 6 Moderate corrosion

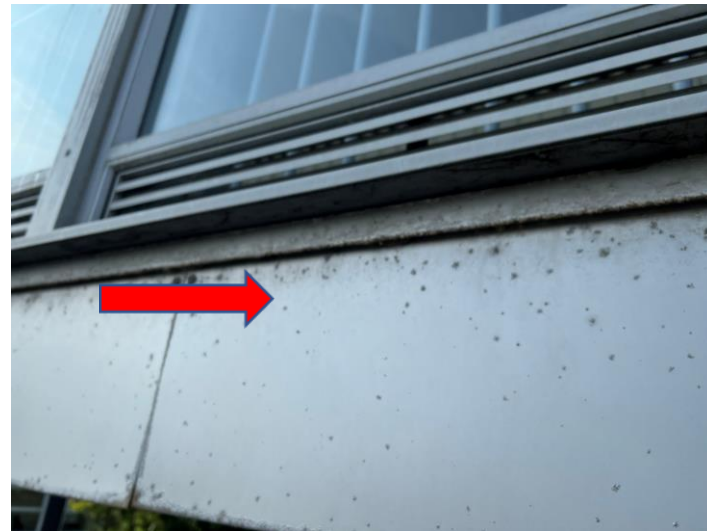
Fig 7 Moderate pitting

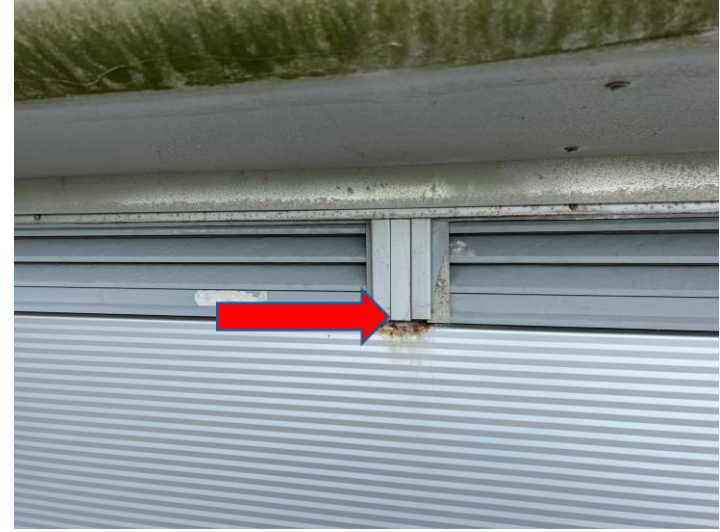
Fig 10 moderate corrosion

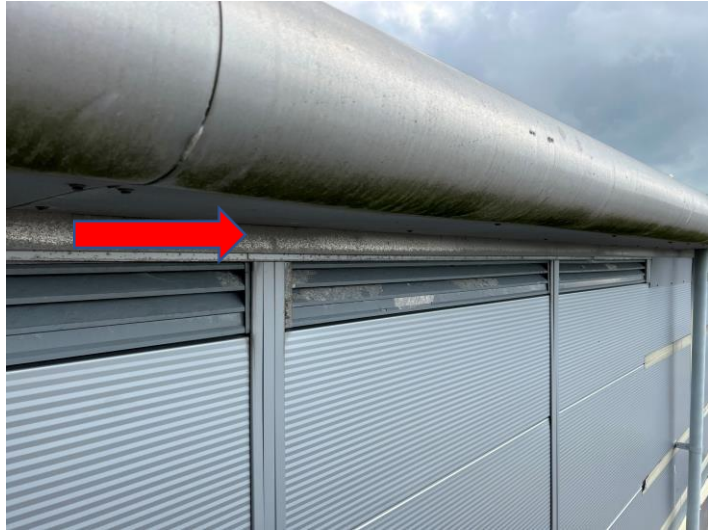
Fig 11 Moderate pitting

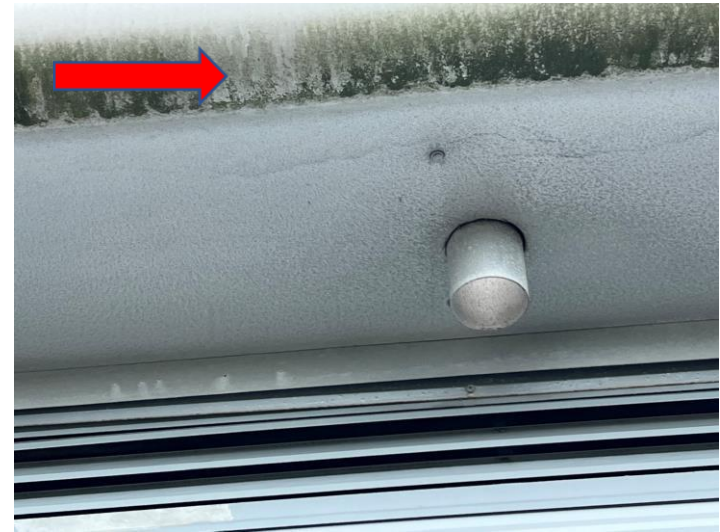
Fig 13 Light corrosion
