HMS Alliance, Gosport - Bow access, Cofferdam, and fill

The NMRN have concerns regarding the condition of the cofferdam fill and associated structures supported within (Bow Platform and Forward bow access staircase) site survey's where completed on 17.11.20 approx. 15:00hrs (High water 5.01m ACD at 12:24hrs) and 20.11.20 approx. 07:30hrs (low water 1.50m ACD at 07:51hrs) observations and recommendations are as follows.

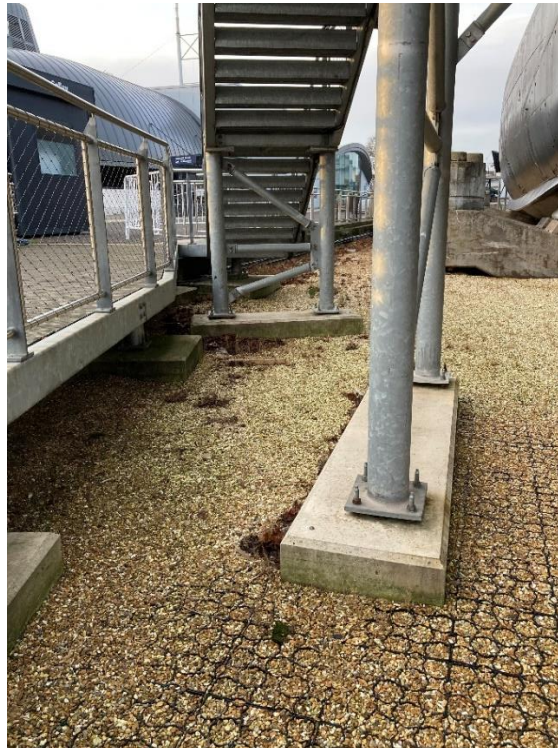
Defects and assumptions noted at time of surveys**1. Access bow staircase**

The bow access staircase is currently in contact with the boat (HMS Alliance) and it is assumed has been touching/ leaning on the hull for some-time indicating the outer most foundation pad could be inactive/ unsupportive as the foundation pad is secured/ suspended from the column base feet adding additional load/ stress to the hull contact point and staircase structure assembly itself.

The forward staircase should be jacked of the hull using the existing stud fixing arrangements on each foundation pad and add additional steel shim plates as necessary as soon as practical. If the above is not achievable then additional measures should be actioned, i.e. Provide suitable temporary support systems to the access staircase to enable further works and continuation of use (install temporary support systems i.e. Acrow support props and clipped scaffold)

Once the staircase has been adjusted and stabilised (not in contact with HMS Alliance) remove and replace the existing stud connections with stainless steel adjustable jacking feet on the northern foundation pad (closest to Alliance), to which each column support should have a natural UHMW-PE 10mm thick plate fixed to the foundation pad to act as a bearing plate for the new adjustable stud feet to bear onto.

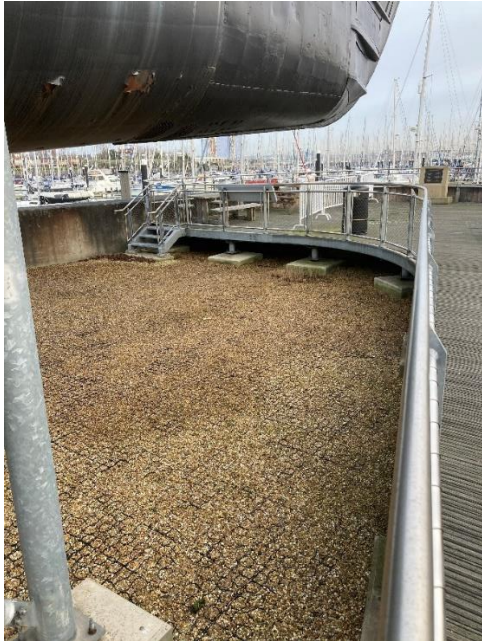
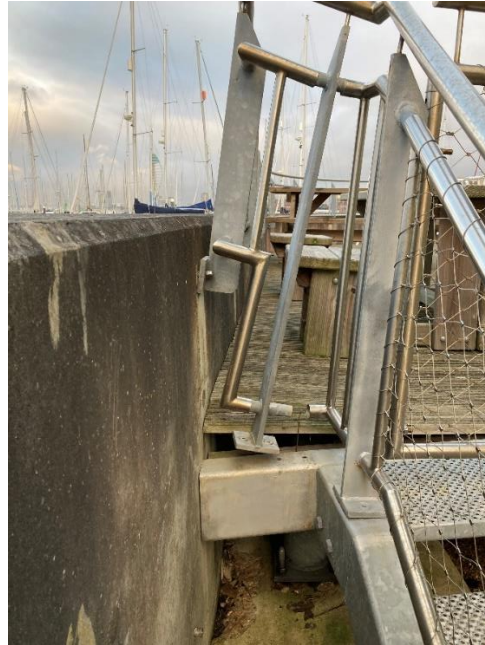
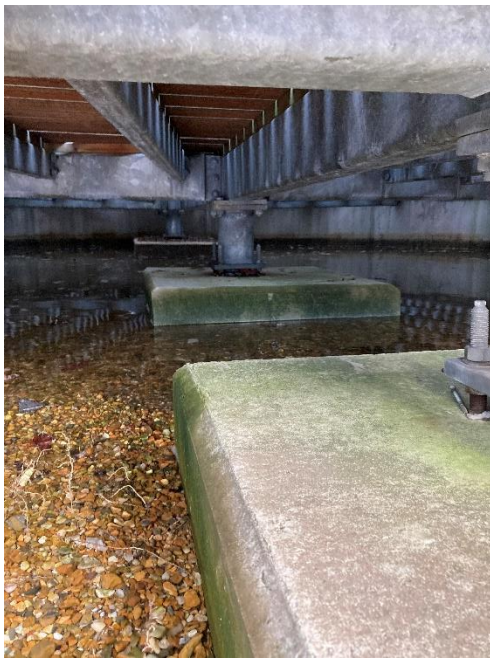
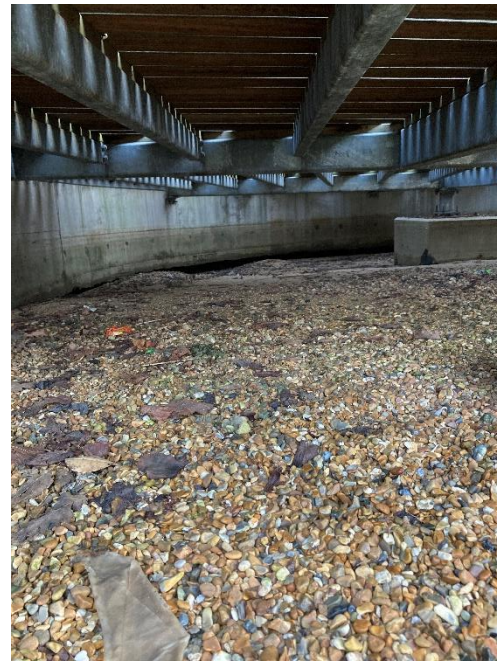
High water (17.11.20)

The bow platform to the northern side at the maintenance entrance, has collapsed as the foundation footings below have lowered in height to which has dragged the main front platform support beam down. Where the platform frame is attached to the cofferdam ring beam, this section remains at the installation height, so subsequently the handrailing, decking adjacent is very stressed and has failed in all directions making the whole platform very unstable and not safe for public or staff usage.

It is thought the cofferdam fill area around the bow has lowered some 200/300mm whereby the granular materials have compacted through the constant ebbing and flowing of tide through its substrates. This action would have started from the outset and although it is in more recent times that the northern platform corner has collapsed it is my assumption that the surrounding supporting decking/ handrailing has been over stressed for a considerable time to which has finally given way in more recent times.

Firstly, the bow deck platform should be barriered off and closed from access in the short term for health and safety concerns. The platform structure should then be jacked up, packed, levelled, and temporarily supported as soon as practical.

To two locations, disconnect the foundation block to the base of the staircase and the foundation block closest to the sheet pile ring beam on the northern quarter (under stairs) breakout and remove concrete pads complete. Design, supply and install a new support bracket arrangement for the platform edge beam end, fixed to the cofferdam concrete ring beam. Replace to seven foundation block locations, new type stud connection fixings on natural UHMWPE plate, as per staircase column repair scheme above.

Remove as necessary and make good the stainless-steel handrails, stanchion, and gate to the northern quarter. In addition, manufacture and install an additional stair tread to compensate for the removal of the foundation block at the base of the staircase, the new tread to be as per existing type/ style, suspended at a suitable height off the existing staircase stringers.

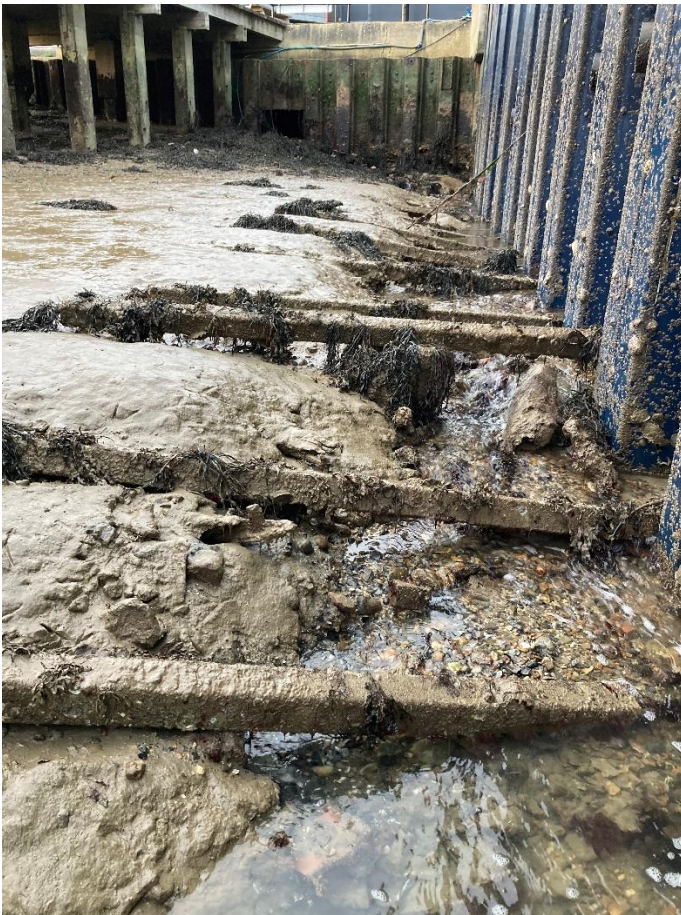
Anode bars

The cofferdam sheet piling system has a cathodic protection system installed to which on the southern side (at low water below) you can clearly see the anodes laying on the seabed connected via earth bonding cables, to which from distance all seem fully intact.

The cathodic protection system is unknown on design life and if any means of testing the system have been installed. Ideally this information should be in the Builders maintenance file and copies should be sourced.

Further survey and testing of the cathodic protection system should be undertaken once more design information is available from the 'As build' file and design life details acquired.

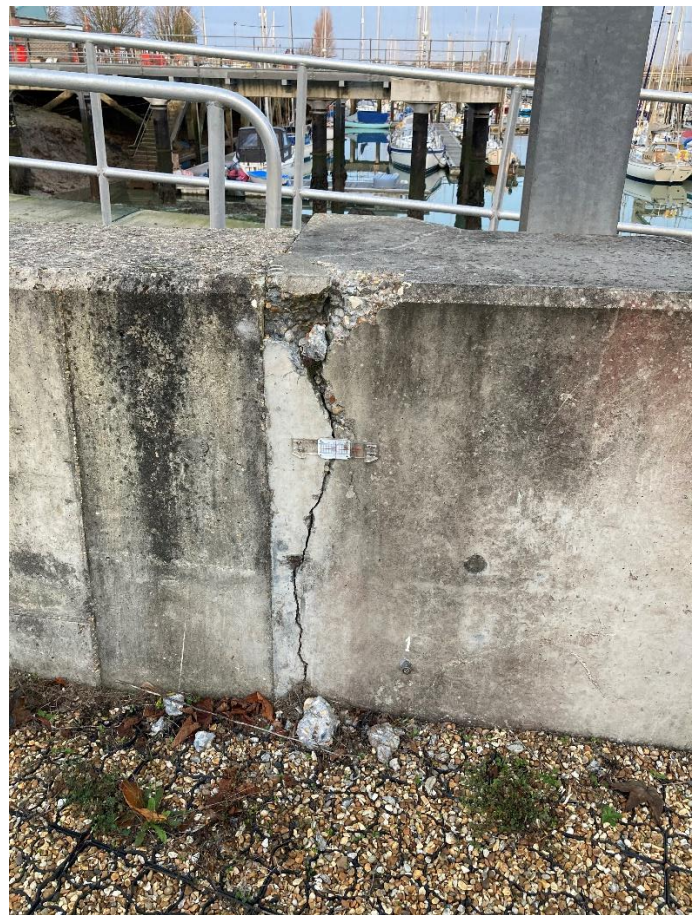
The steel sheet piling has been installed with a good quality paint system and only minor areas of corrosion are present at some clutch joints. All through tie bar end caps seem fully intact. The main capping beam is fully intact, and no significant cracks are present other than one at the transition joint connection at the ramping end.

Transition joint cofferdam to ramp (crack)

The concrete crack at the transition point between the main cofferdam ring beam and casted ramp wall should have a larger expansion joint between to allow movement (hence the joint has cracked, and a section has broken away). Make good with a concrete repair locally and increase the gap between the two concrete casted sections to a 15mm opening as far as access allows down to ground level, insert suitable expansion joint material (fibreboard) and seal with a suitable mastic sealant.

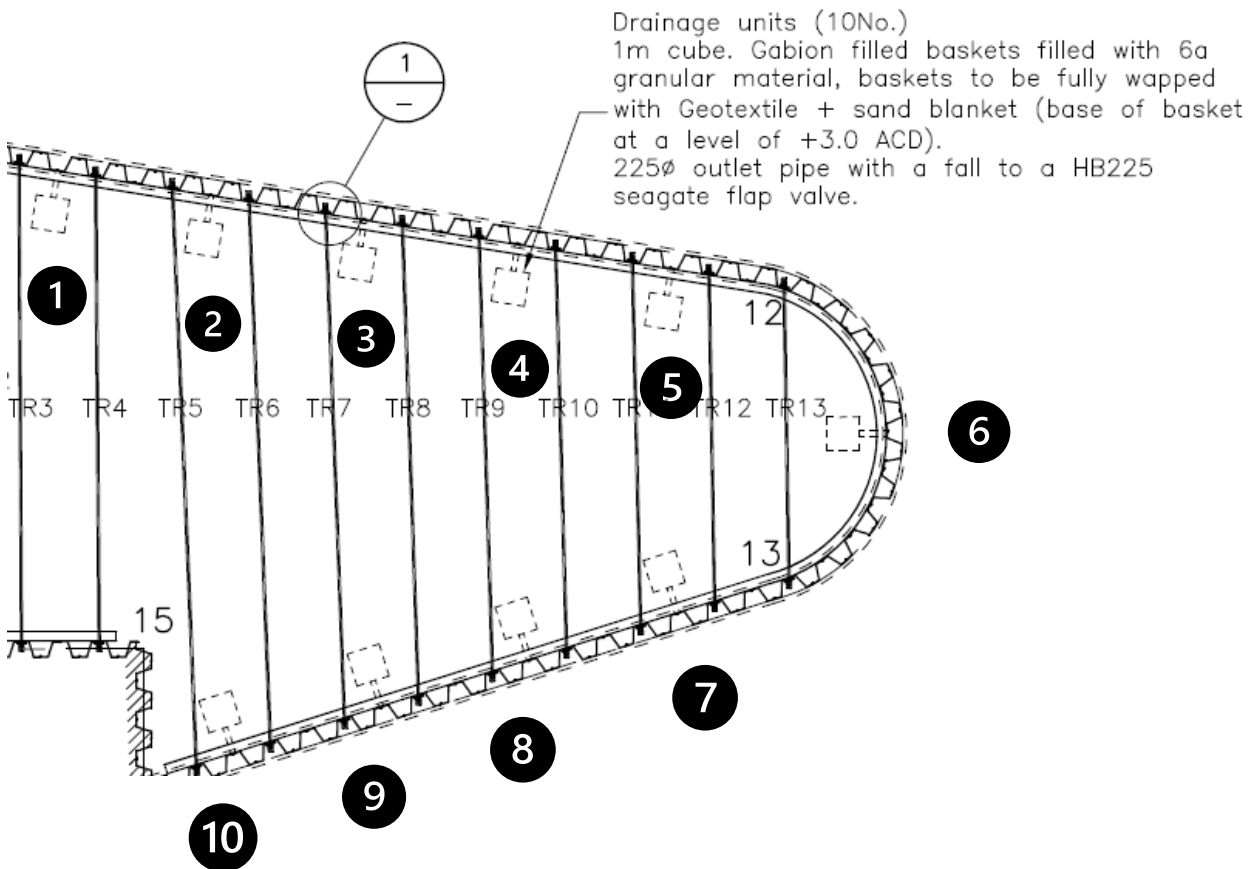
As part of the cofferdam installation, a series of drainage flaps have been installed to the eastern end deepest fill point to enable the drainage of the ebb and flow of tidal waters through the substrates. During the survey some were inspected on the low water survey to which drainage flaps 4, 5 & 6 are collapsing and or blocked completely. Drainage points 1, 2, 3, 7, 8, 9 although all not inspected fully due to access issues, each are assumed to be intact as flaps 3 & 7 were accessed and are fully functionable 1,2, 8, 9 & 10 lead to shallower fill areas.

Each drainage point although indicated on the Gifford preliminary drawing (extraction above from Drg. 16676/MR/008) the Build details are each drainage flap; fitted to sidewall flange of sheet pile, 225mm duct bend has been installed to give route to assumed, installed gabion 6a granular material filled baskets with geotextile wrap and sand blanketing to give through drainage as Gifford design detail.

It should also be noted, that between drainage points 3 & 5 the sea wall sheet piling collapsed during the construction and the capping beam has been casted to account for the heavily leaning sheet piling local to this area. Suggesting ground conditions locally are unstable more fluid like as well as being the deepest part of the cofferdam fill.

Conformation of the builders 'as built' details of the drainage soakaways which feed the drainage flap points should be sourced.

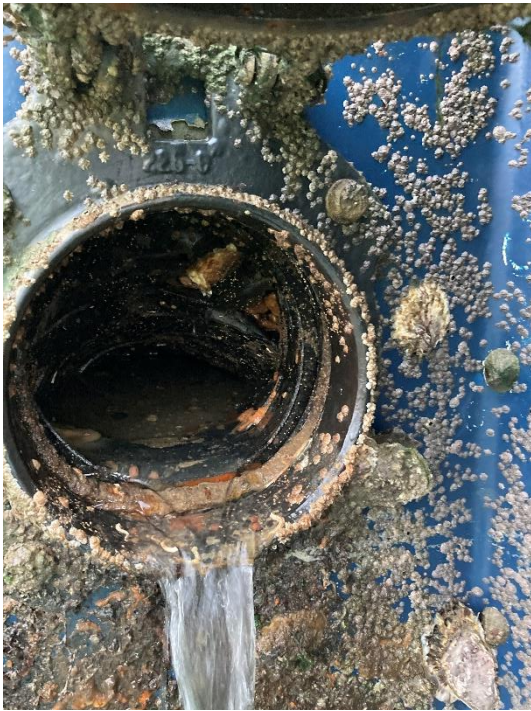
Drainage point 4 (collapsing breaking away)

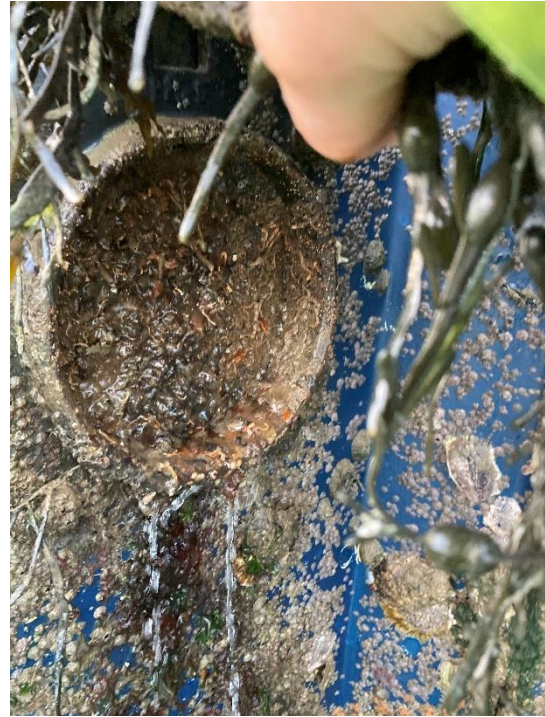
Drainage point 5 (collapsed and blocked)

Further Investigate of drainage flap number 5 should be undertaken along with clearing debris and marine growth behind flap, insert stainless steel mesh grill to prevent any further material loss from drainage point.

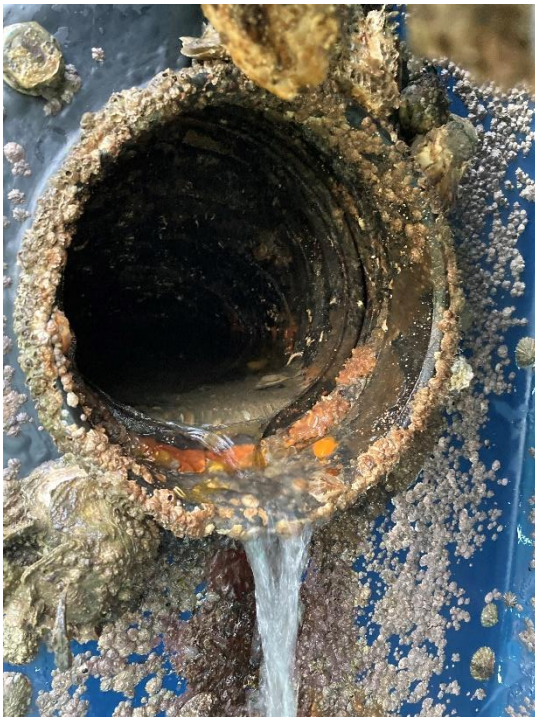
Drainage point 6 (collapsing)

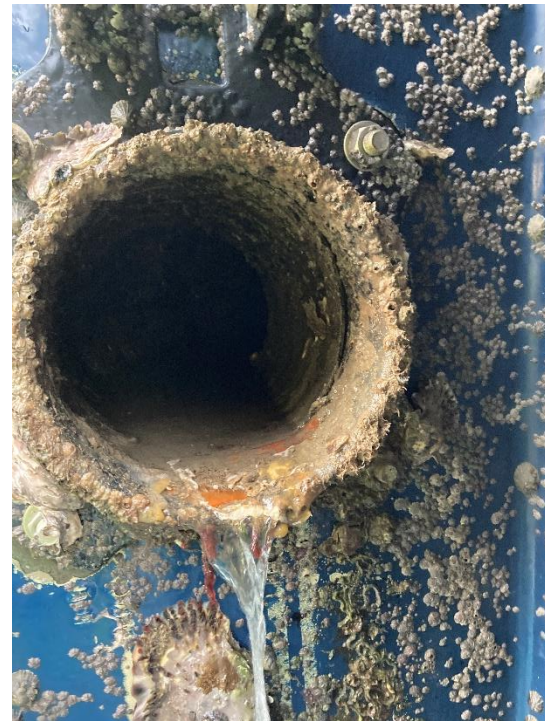
Drainage point 7 (good, drainage 3 is the same)

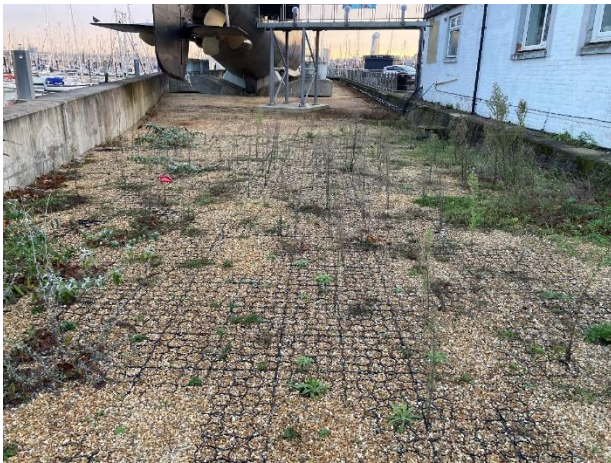
The cofferdam fill ramp area (western end) since construction has now established itself with fine granular materials so allowing growth of weeds, moss, and alike vegetation. To each of the main boat support piles (two set of four), the fill material has compacted and lowered as well as to some of the perimeter edging to the cofferdam ring beam. The fill area below the bow platform is significantly lower than the main fill by circular 500mm although this was the case (Refer to Drg. MLD 12-121-10 AB) once fill was completed. area installed at a lower area and has reduced in high some 300/400mm at the ring beam edge.

Ramp end

To various areas of the cofferdam fill (western ramped area mainly) remove all weeds and vegetational growth, apply strong weed killer.

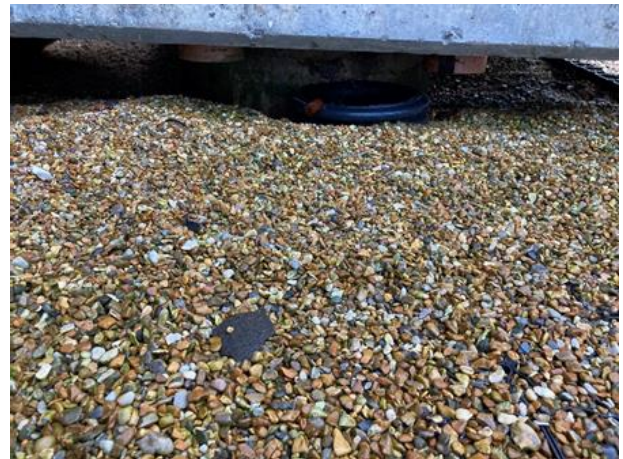
Compacting materials under main pile sets

To the cofferdam fill areas sunken around the main support piles, under platform deck and ring beam edge, replenish the fill levels back up to 4.9m ACD & 4.4m ACD under platform deck area so in accordance with intended design levels. Fill material being a 10mm pea shingle aggregate, estimated 5 cubic metres required.

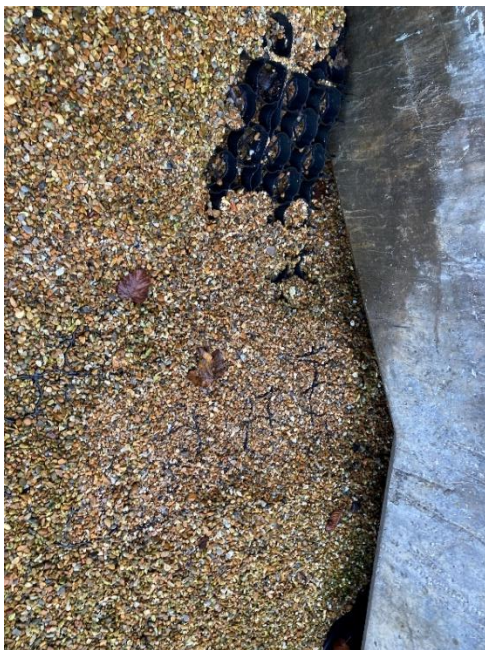
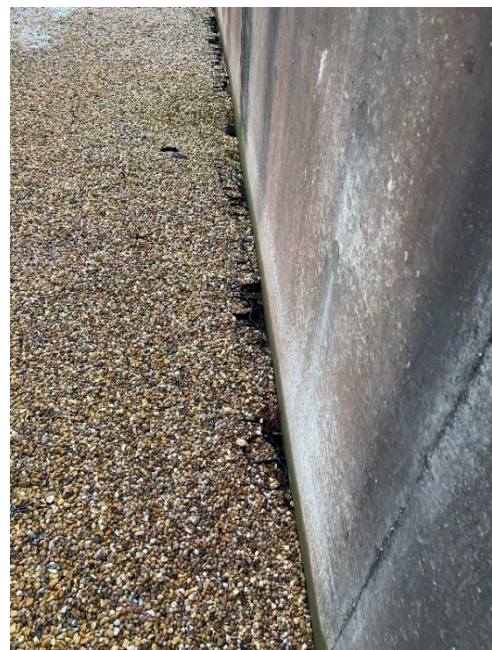
Cofferdam ring beam fill material compacting around edges

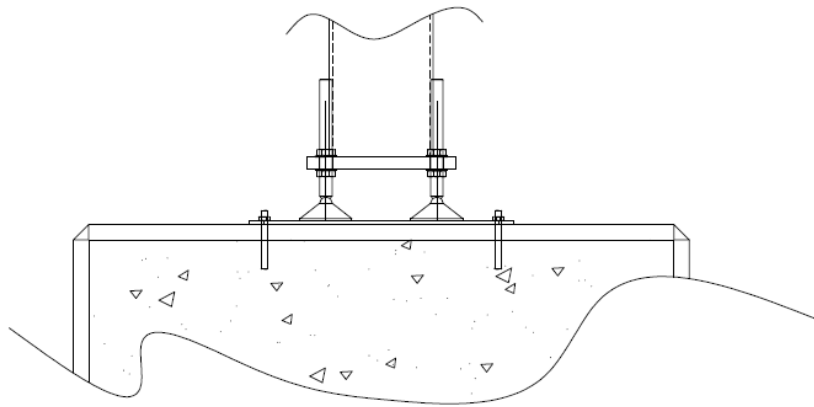
Typical staircase foundation pad with new type of connection/ support

Note – For all new adjustable stainless-steel stud fixings, each should have bimetallic corrosion protection (Isolation between dissimilar materials using nylon washers or similar) and Denso tape wrapped around threads for future maintenance.
