**BASSET CENTRE & WHITE HOUSE, CAMBORNE:
STRUCTURAL SURVEY OF EXISTING GRADE II LISTED BUILDINGS**

Revision:	Date:	Notes:
C1	03.04.24	Issue for planning submission

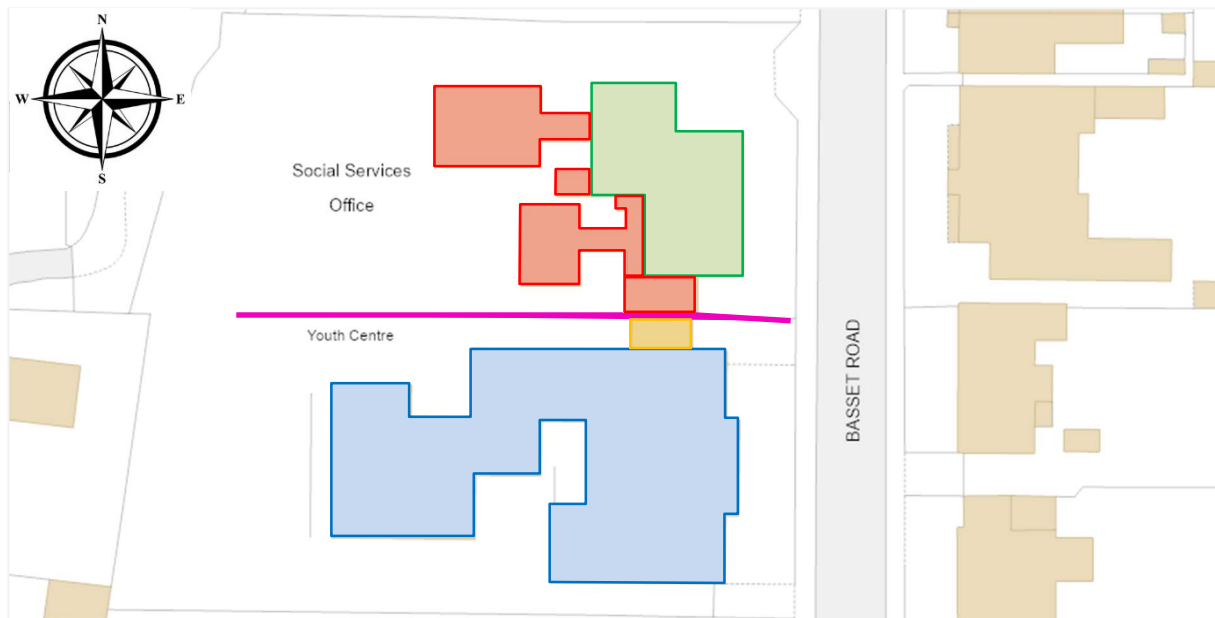
Figure 1: Site plan showing the Basset Centre, White House, and other key features

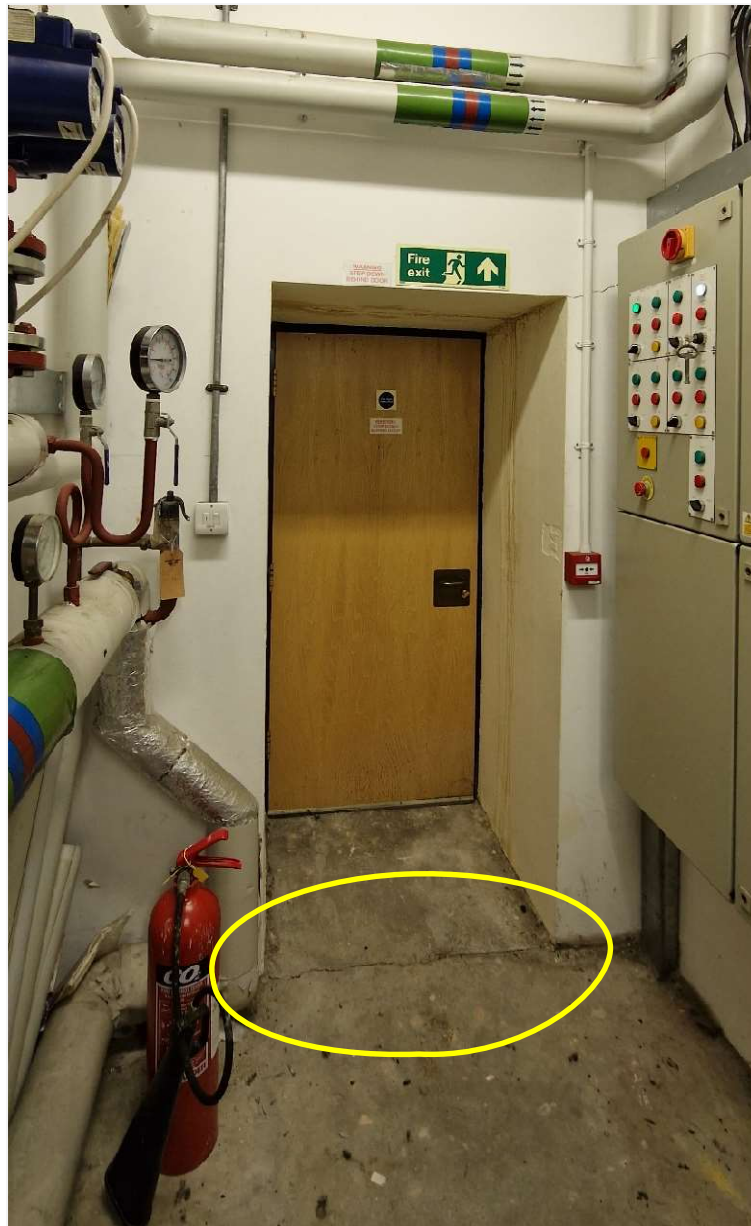
Figure 4: Photograph of first floor plant room showing cracked floor

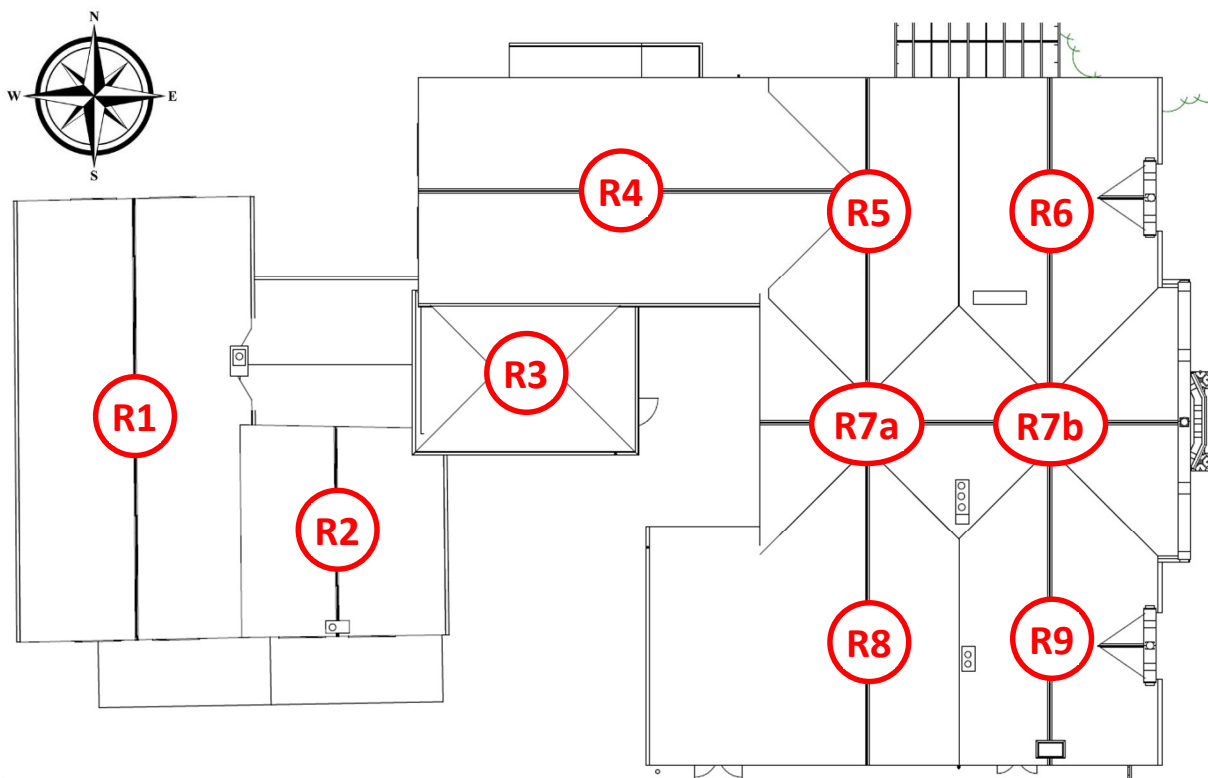
Figure 5: Plan on Basset Centre at roof level showing area references

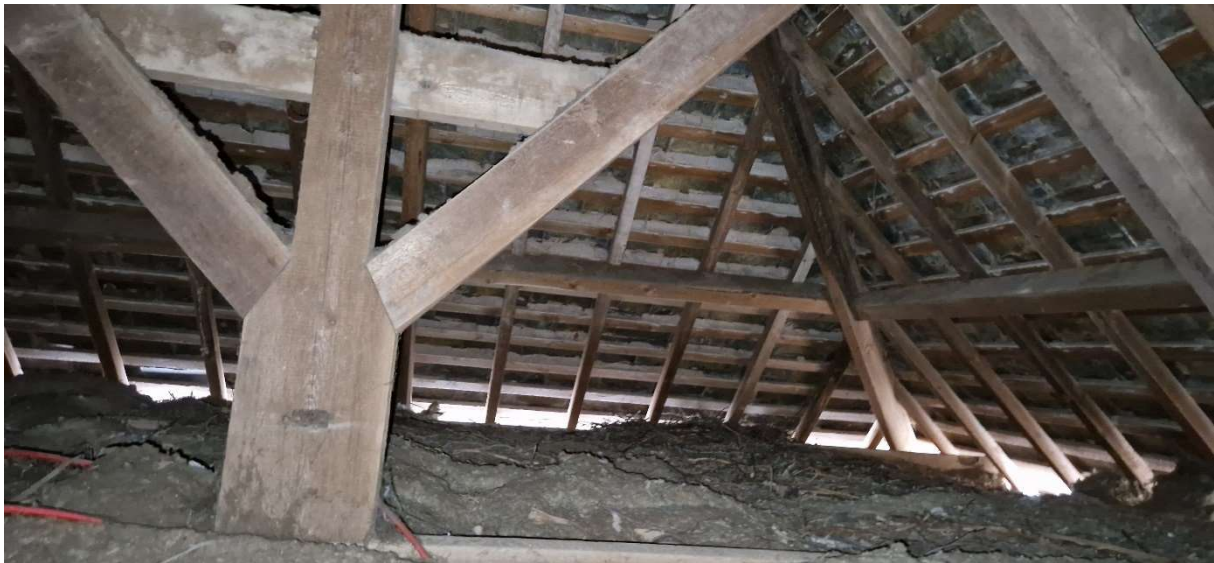
Figure 6: Photograph within roof space R3 showing King Post truss and evidence of animal ingress

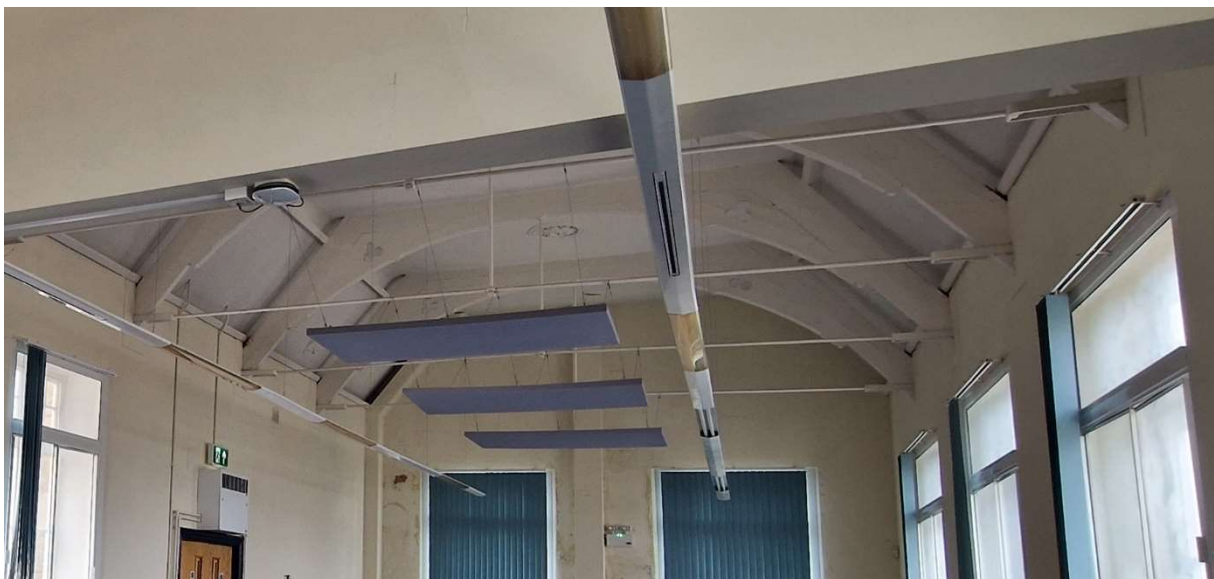
Figure 7: Photograph of roof area R4 showing underside of arched braced collar tied trusses

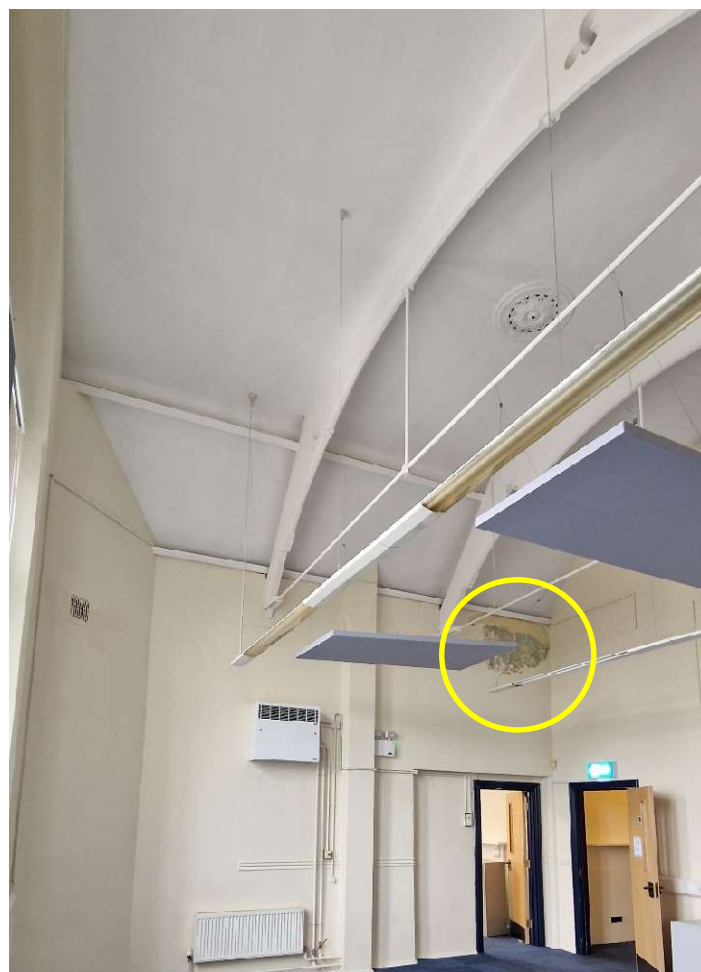
Figure 8: Photograph in Area R5 showing evidence of water ingress

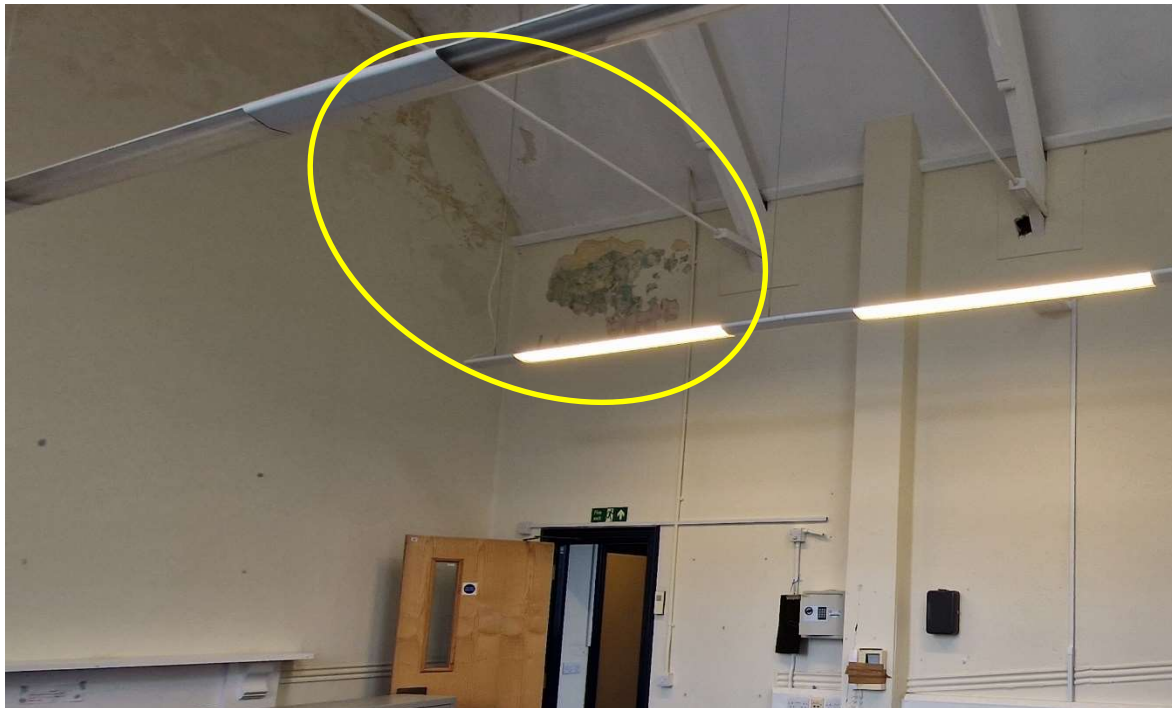
Figure 9: Photograph in Area R6 showing evidence of water ingress

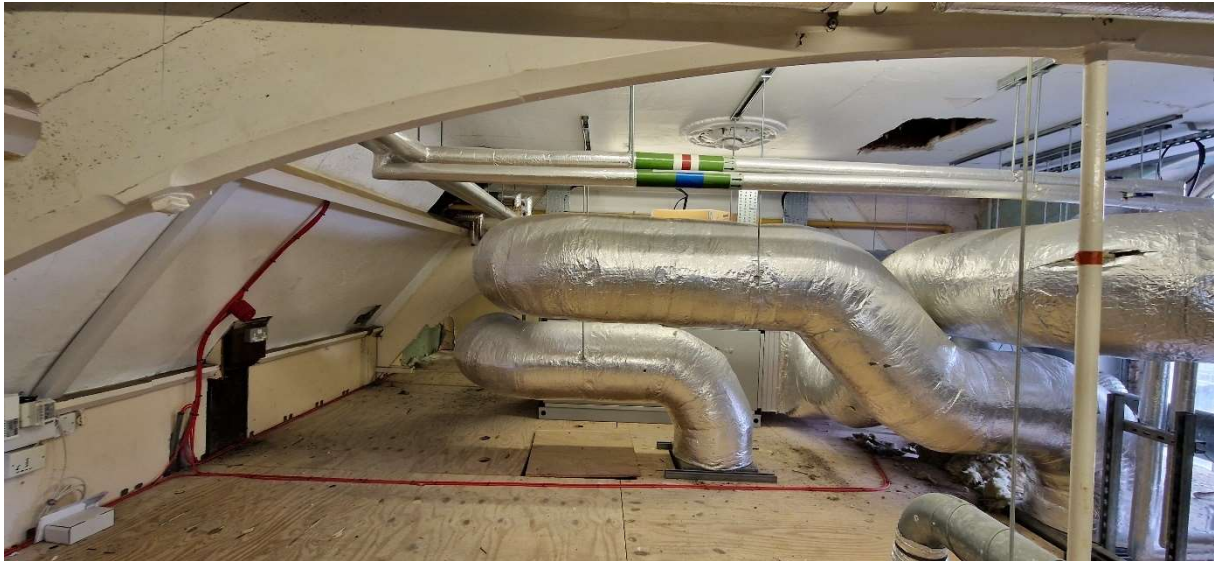
Figure 10: Photograph in Area R7a showing plant deck

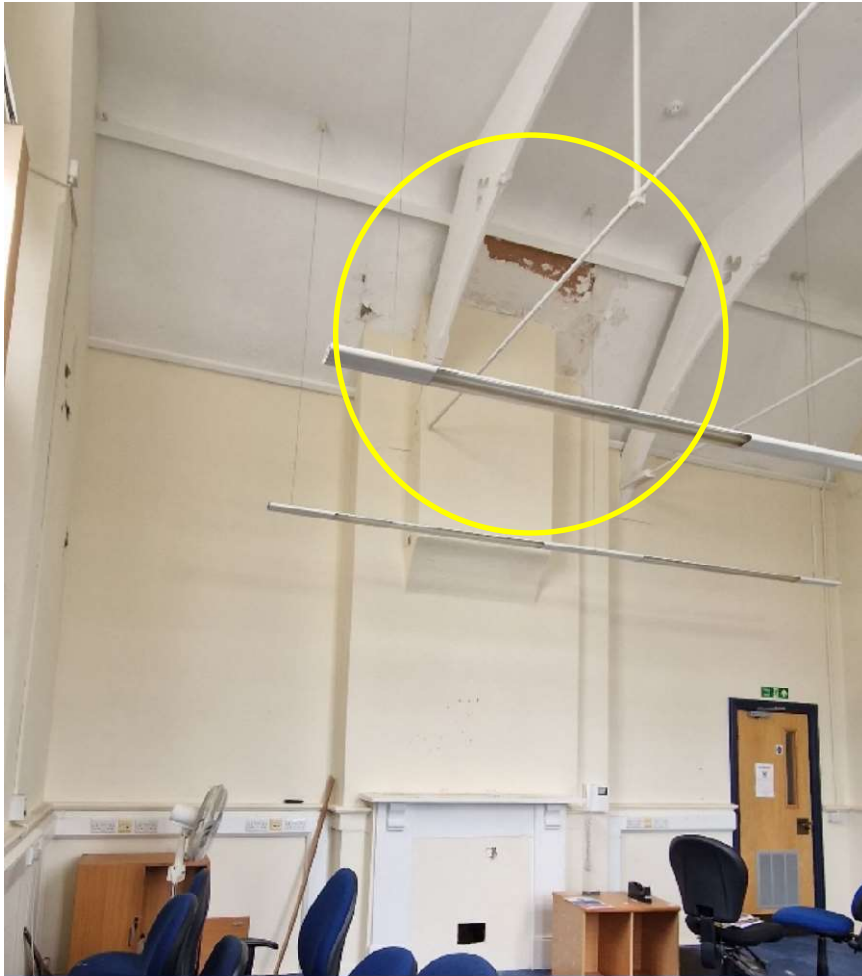
Figure 12: Photograph of Area R9 showing evidence of water ingress around chimney

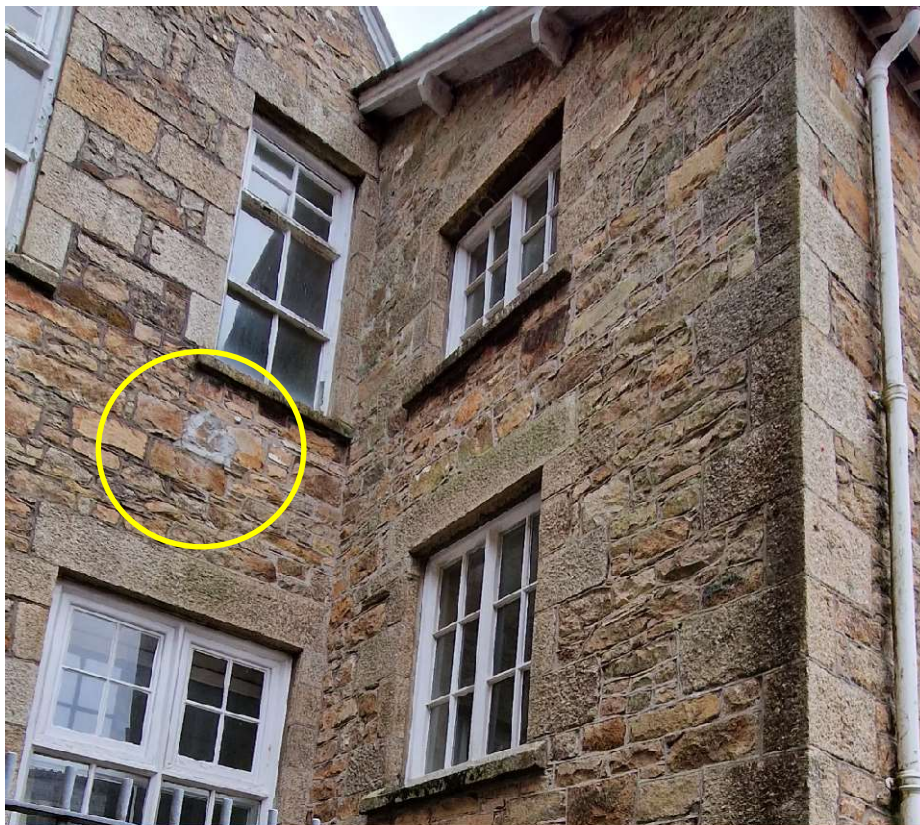
Figure 13: Photograph showing masonry repair with cementitious mortar

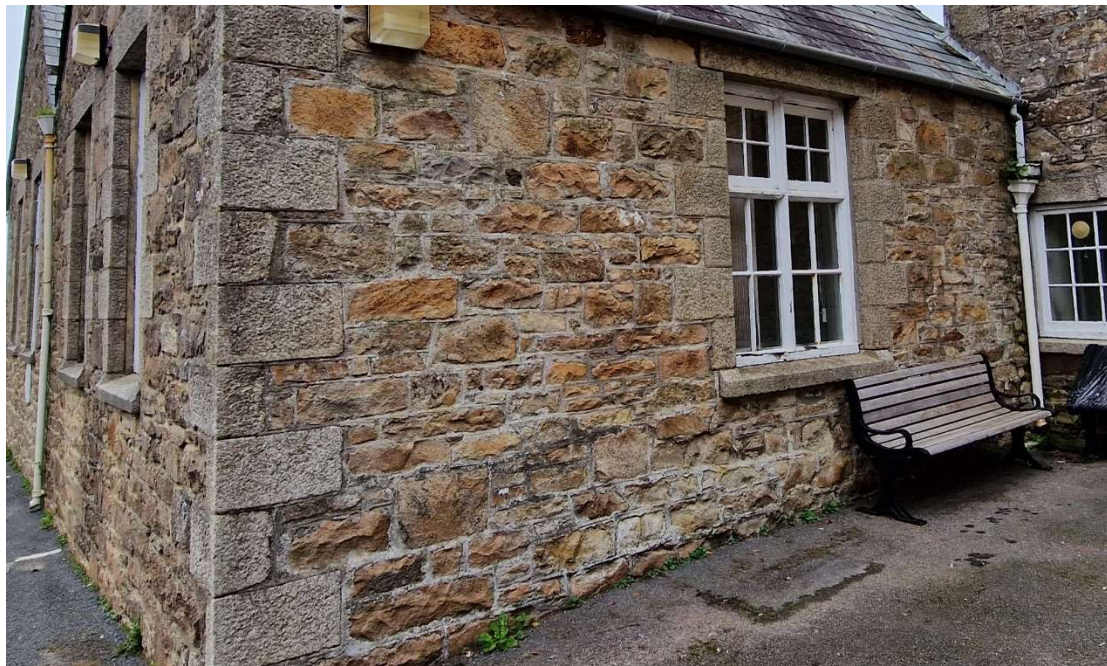
Figure 14: Photograph showing 'battered' or 'strap' pointed masonry

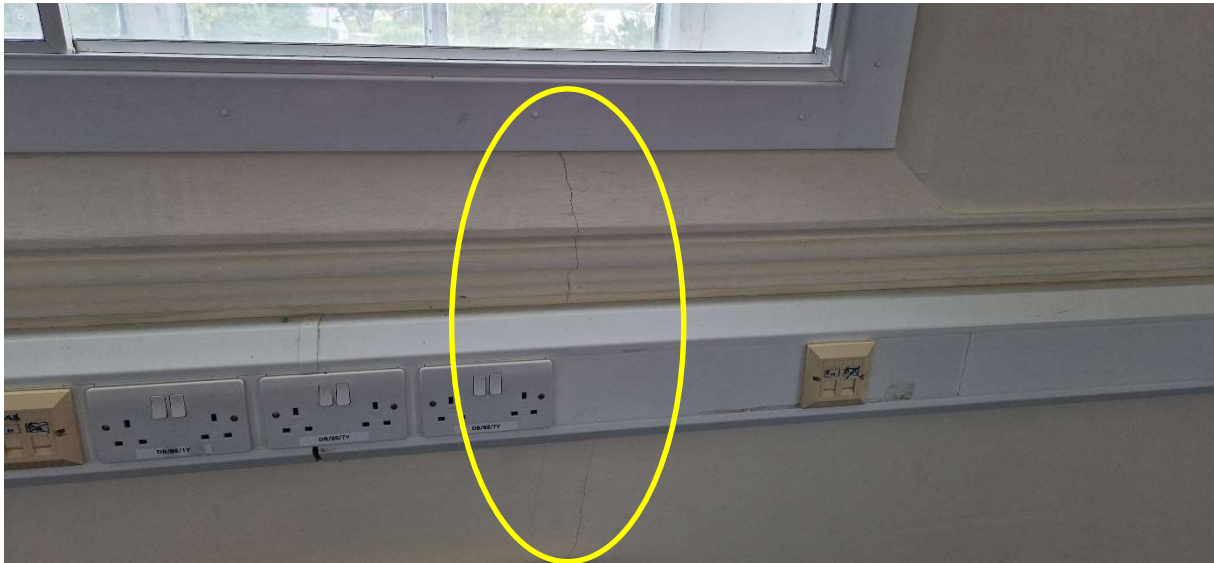
Figure 15: Photograph of vertical cracking beneath first floor window openings

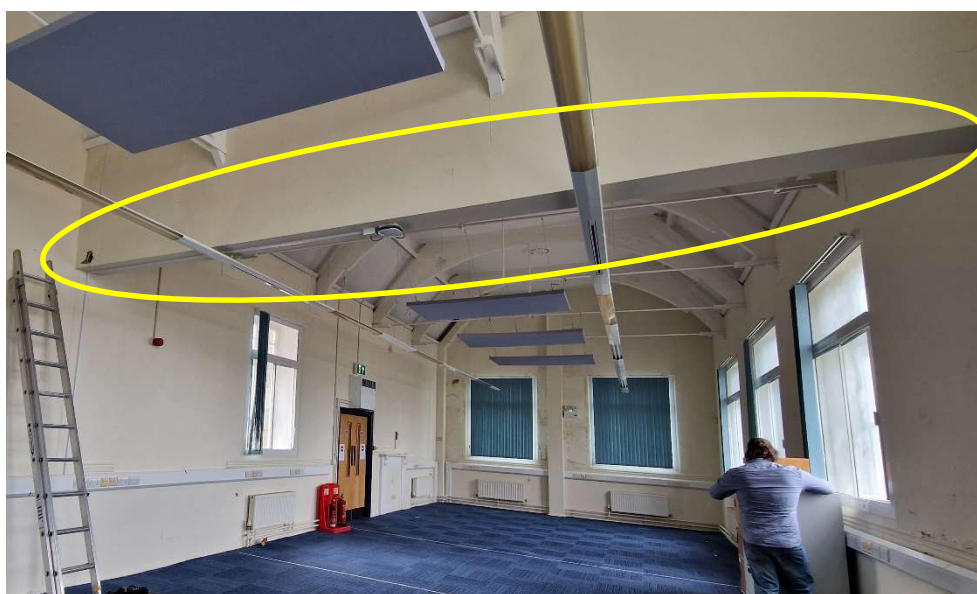
Figure 16: Photograph of bulkhead enclosing 203x102UB steel beam

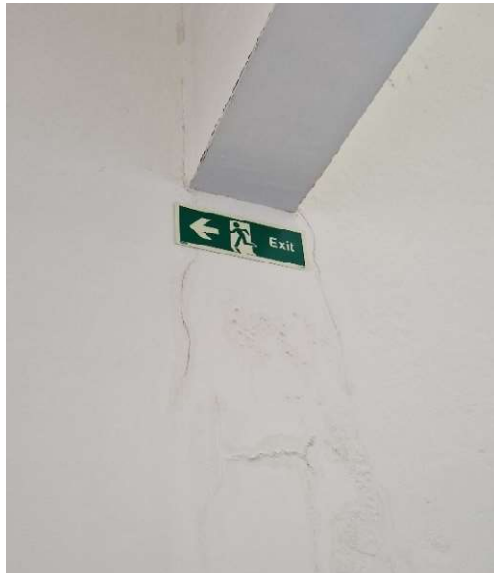
Figure 17: Photograph showing cracking at first floor steel beam bearing

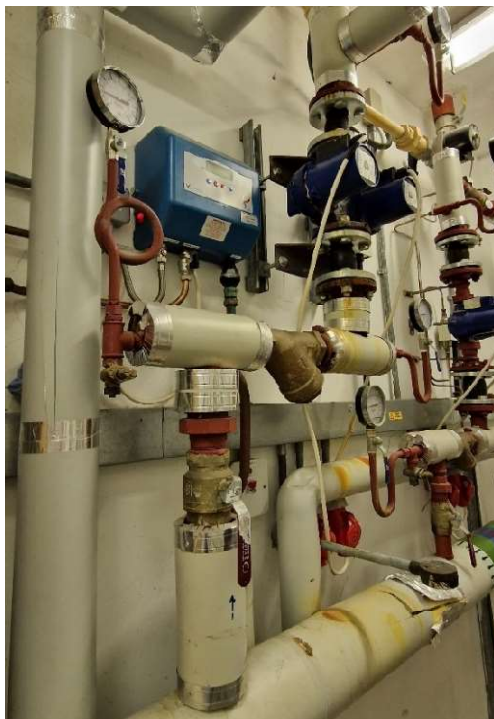
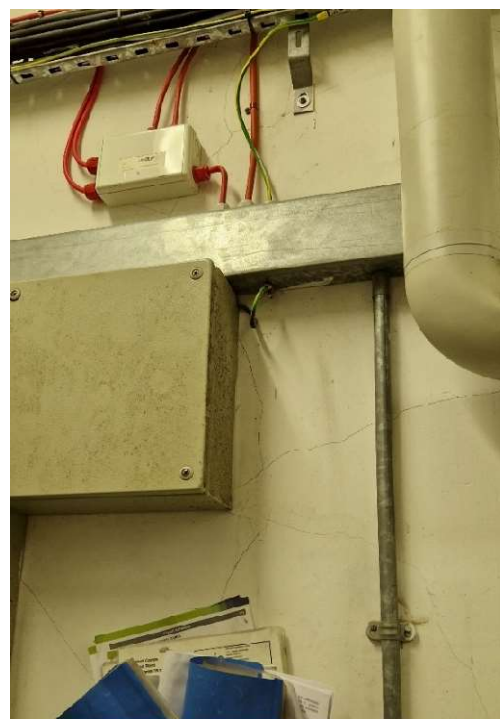
Figures 18 & 19: Photographs showing plant room walls

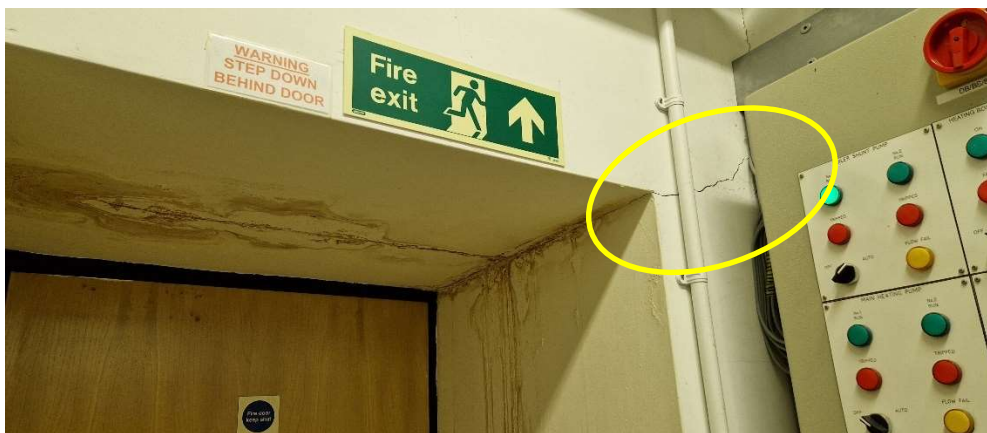
Figure 20: Photograph showing cracking around the plant room door opening

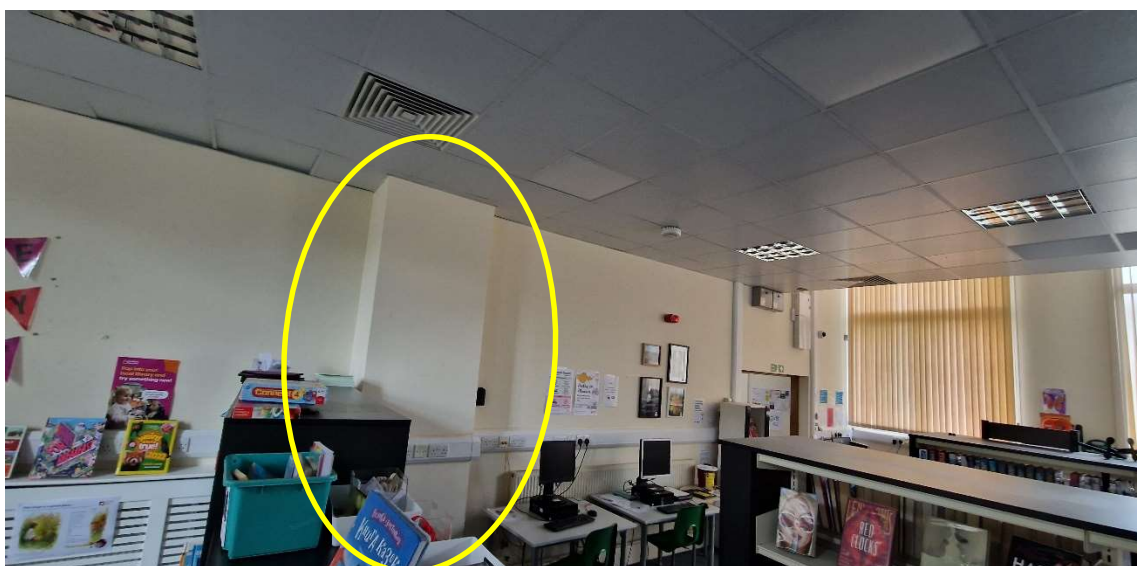
Figure 21: Photograph at ground floor level showing masonry pier

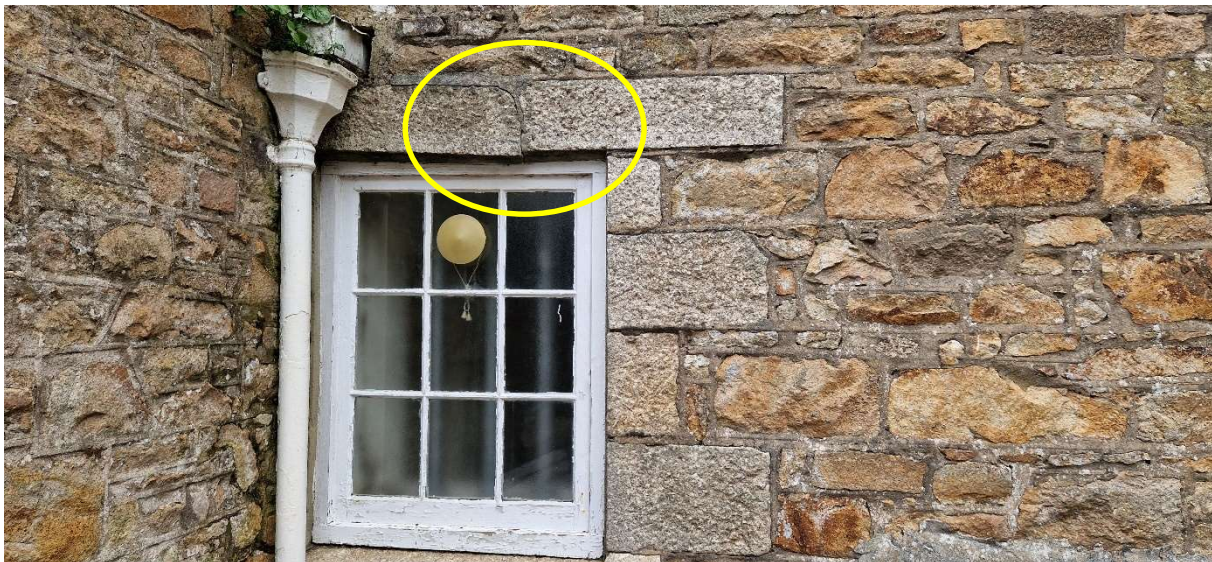
Figure 22: Photograph showing lintel failure over ground floor window opening

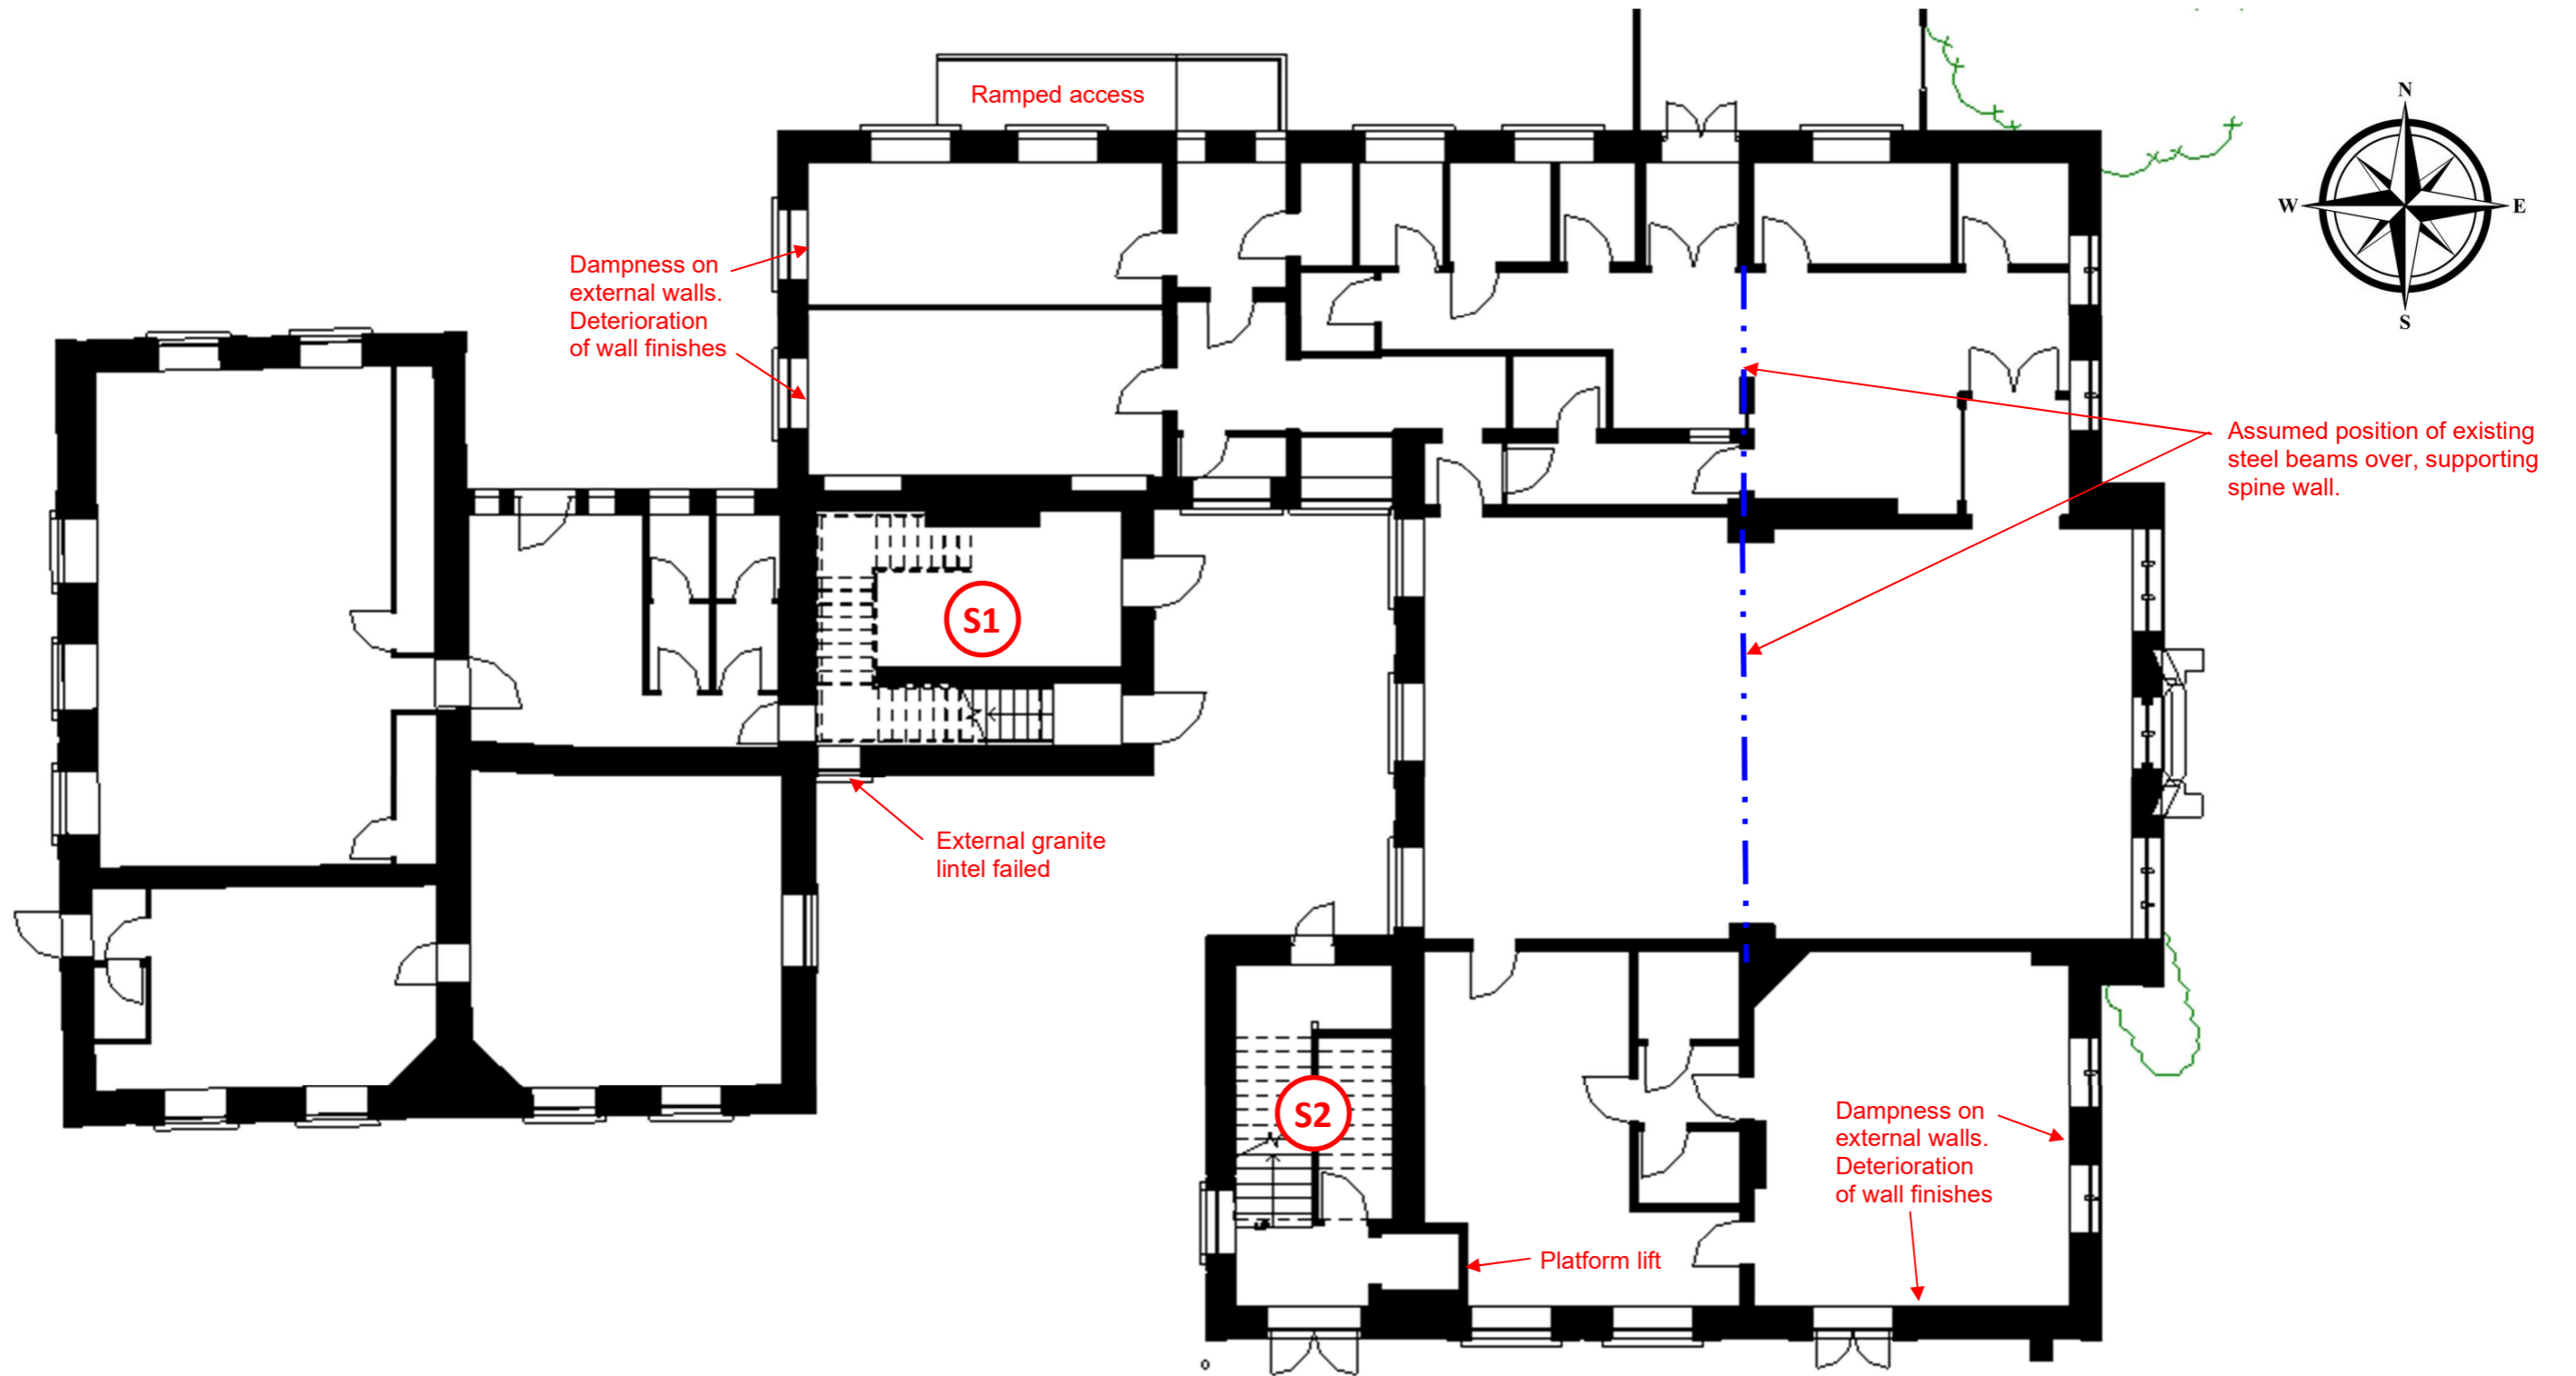
Figure 23: Basset Centre annotated ground floor plan

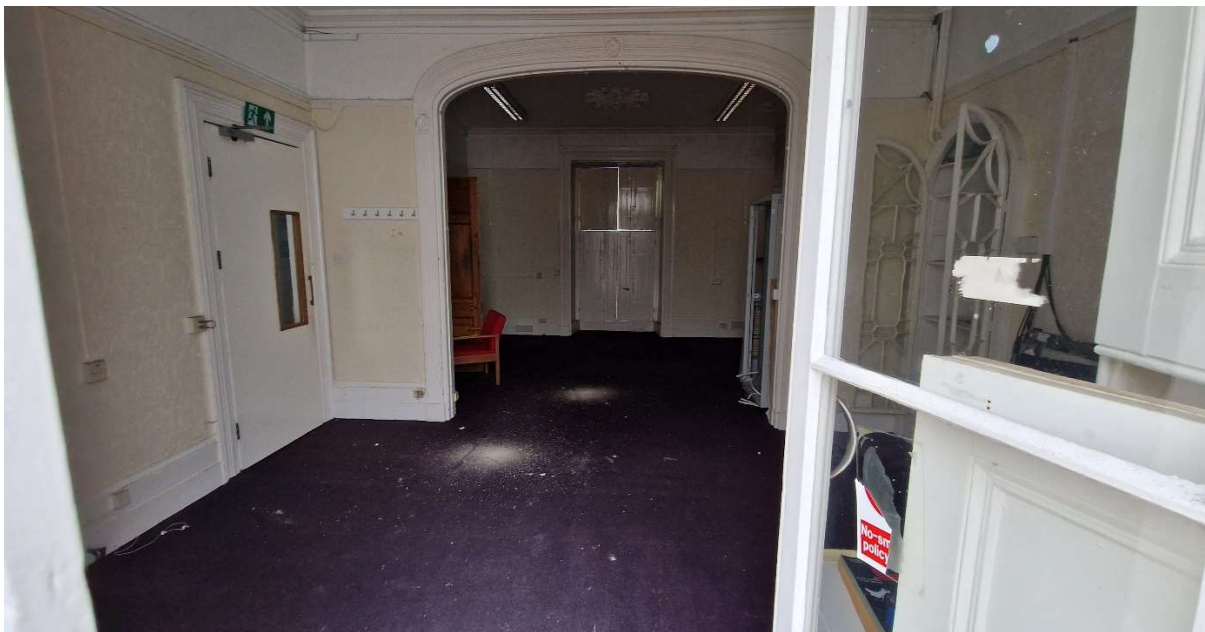
Figure 26: Photograph showing typical ground floor room

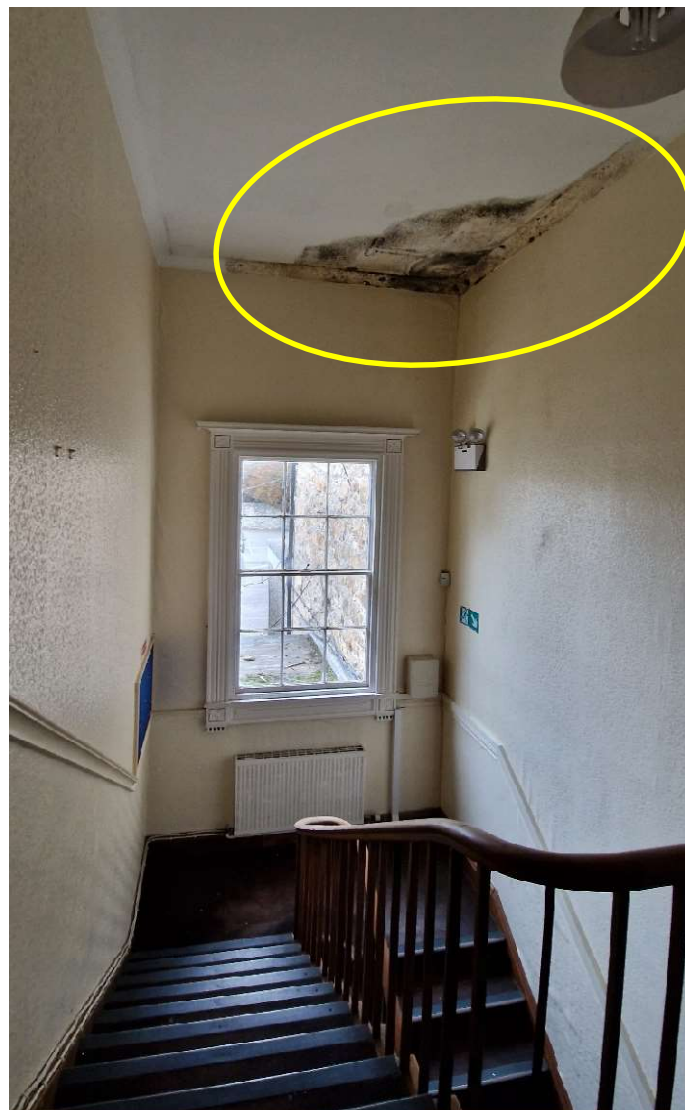
Figure 27: Photograph showing water ingress over main stair half landing

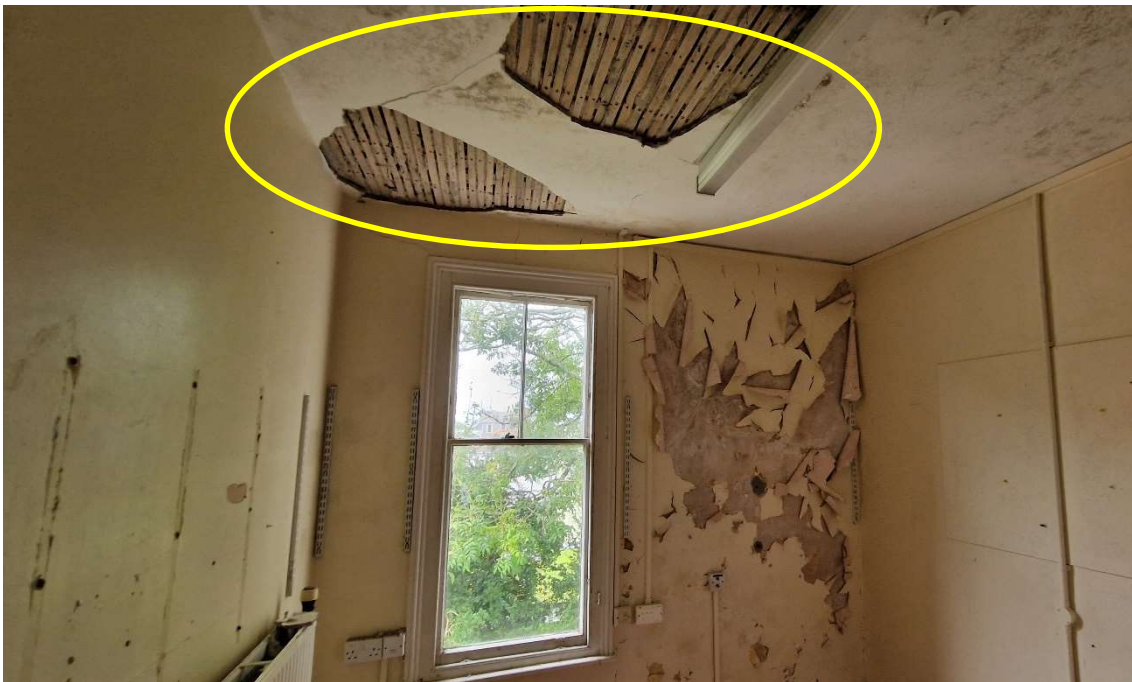
Figure 28: Photograph taken at first floor level showing lathe and plaster ceiling

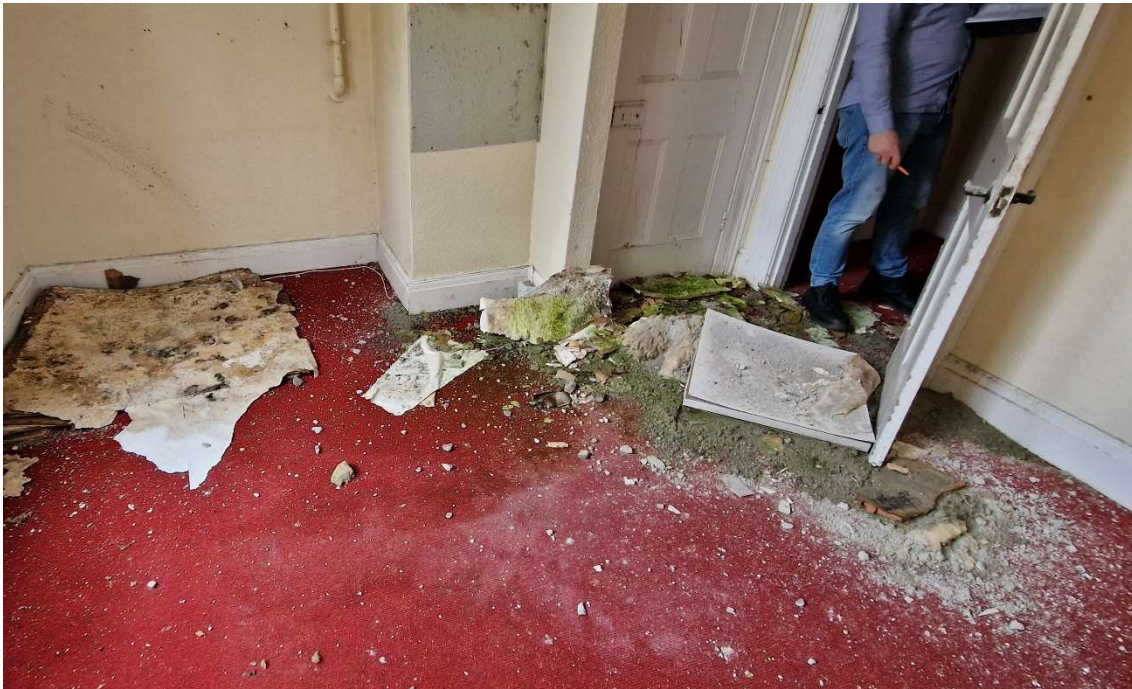
Figure 29: Photograph showing remnants of collapsed ceiling at first floor

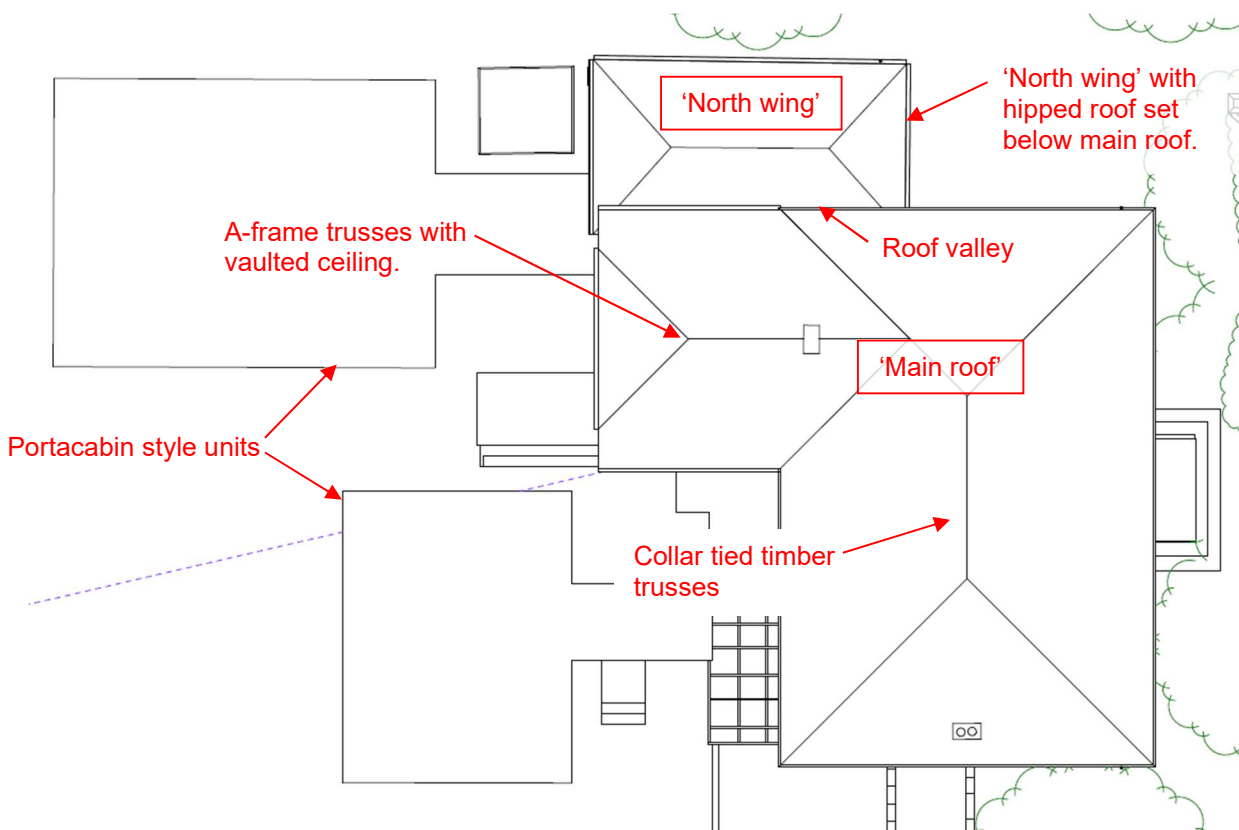
Figure 30: Plan on White House at roof level showing area references

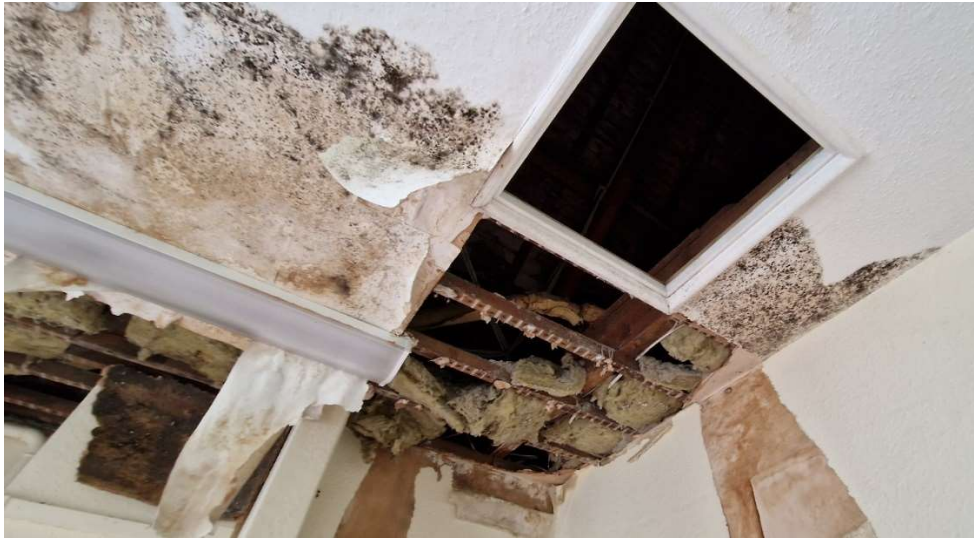
Figure 31: Photograph of collapsed ceiling around access hatch

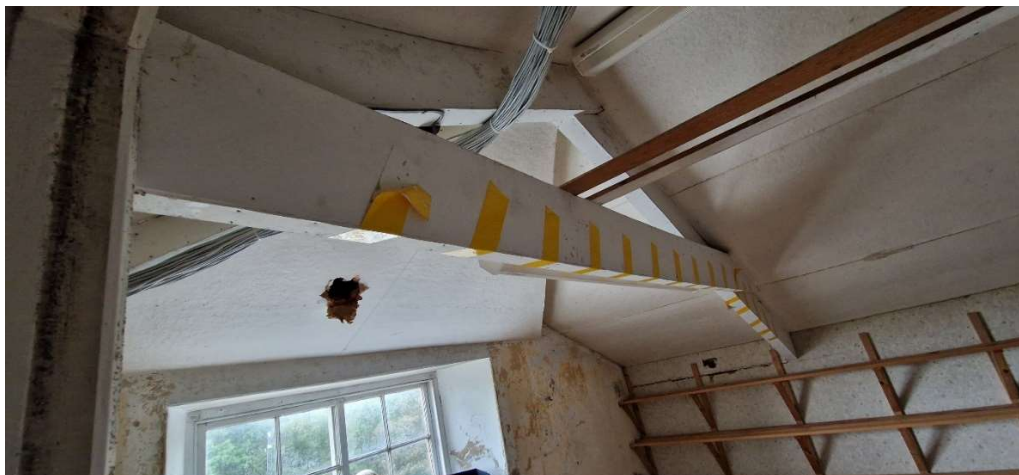
Figure 32: Photograph of 'A-frame' or 'raised collar tied' trusses to north wing

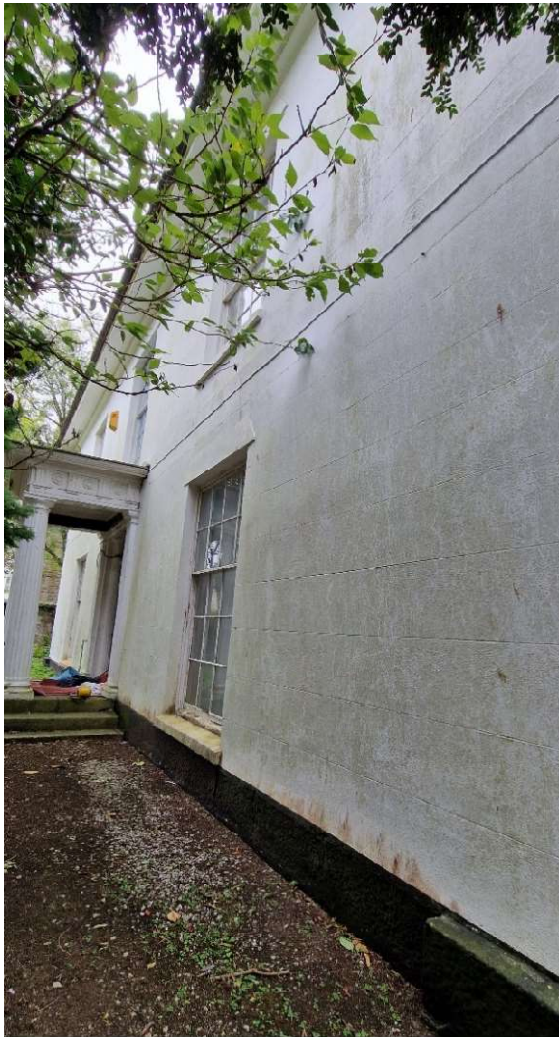
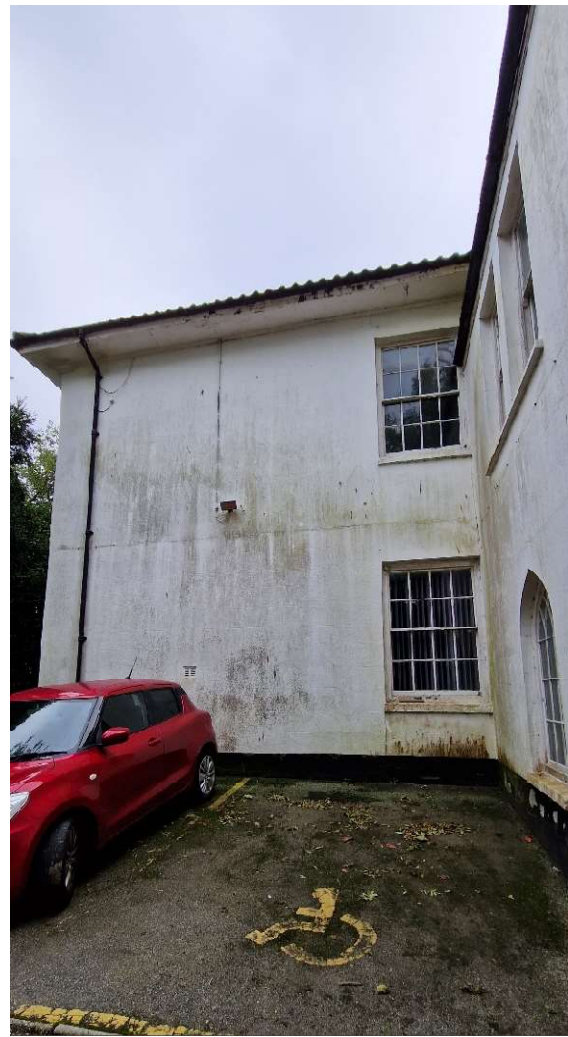
Figures 33 & 34: Photographs showing front (east) elevation and north elevation respectively
