**BASSET CENTRE & WHITE HOUSE, CAMBORNE:
STRUCTURAL SURVEY OF EXISTING GRADE II LISTED BUILDINGS**

Revision:	Date:	Notes:
C1	03.04.24	Issue for planning submission

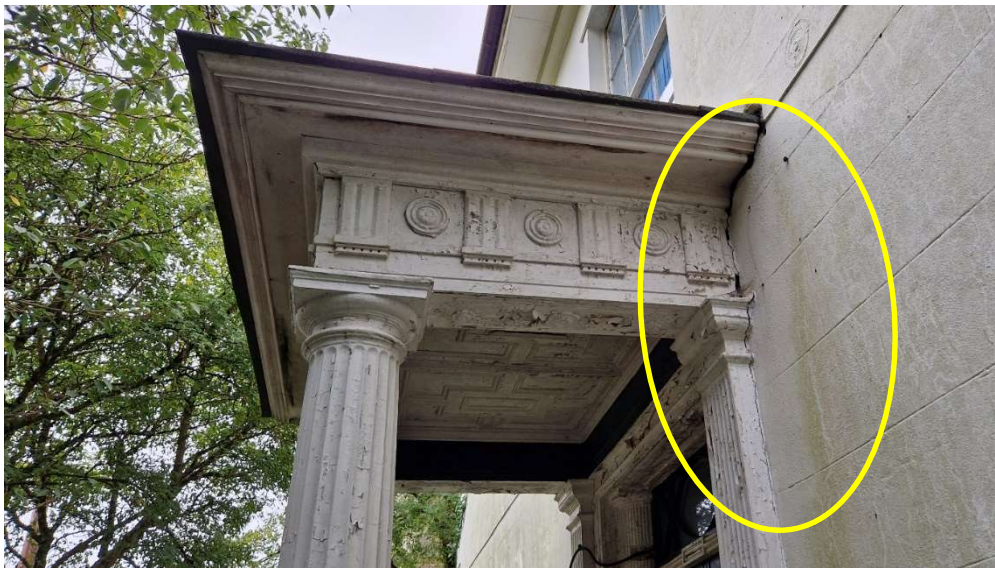
*Figure 35: Photograph showing porch over main entrance to White House.
Minor cracking/separation highlighted at interface with wall*

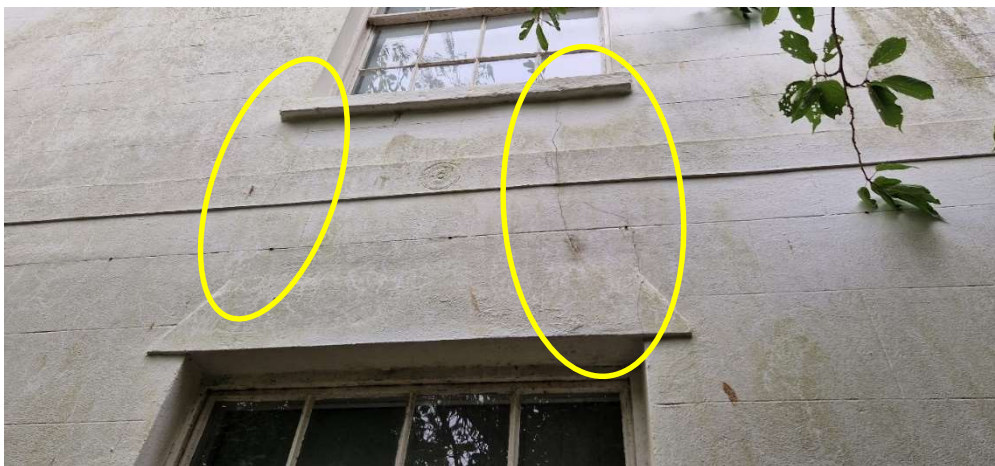
Figure 36: Photograph showing vertical cracking between window openings on front elevation

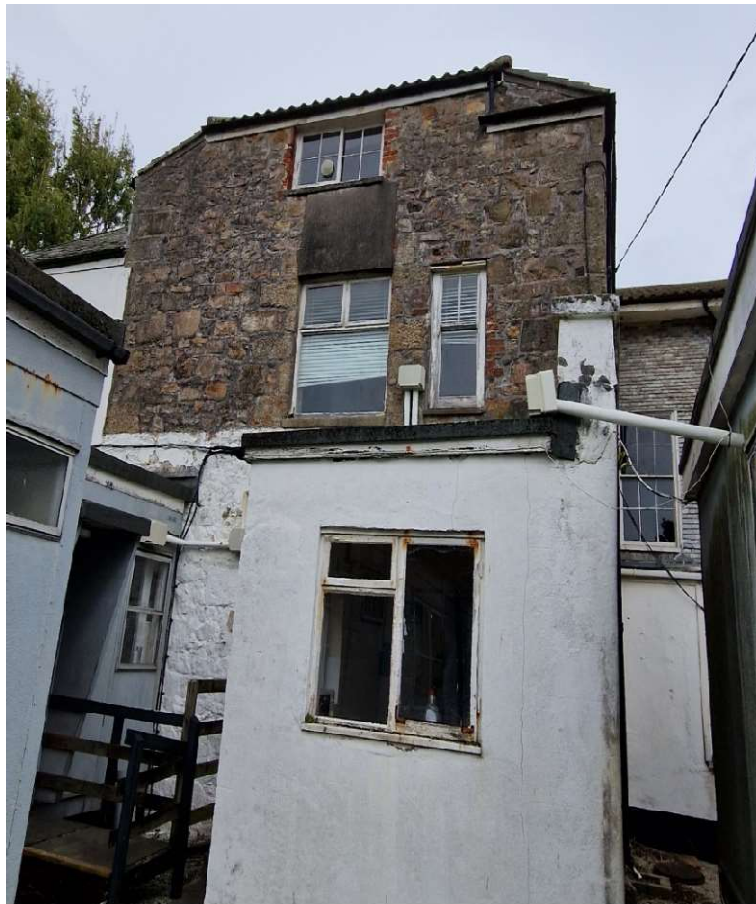
Figure 37: Photograph showing rear (west) elevation of White House

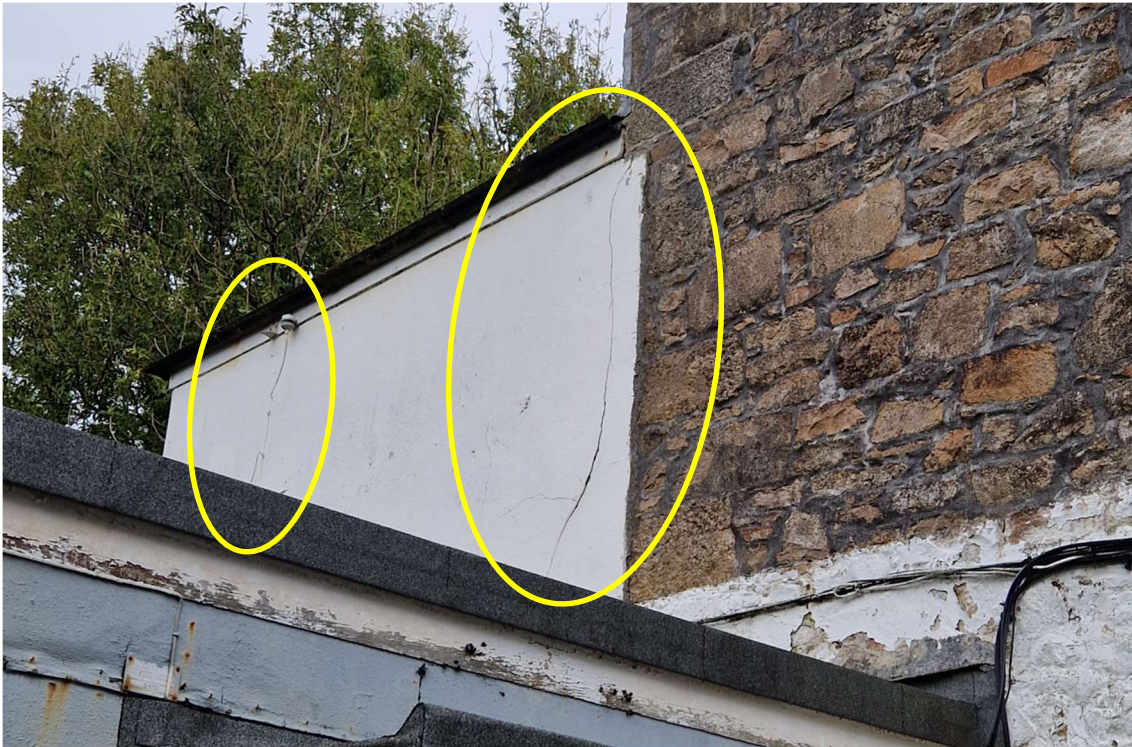
Figure 38: Photograph showing vertical crack on the west elevation of White House

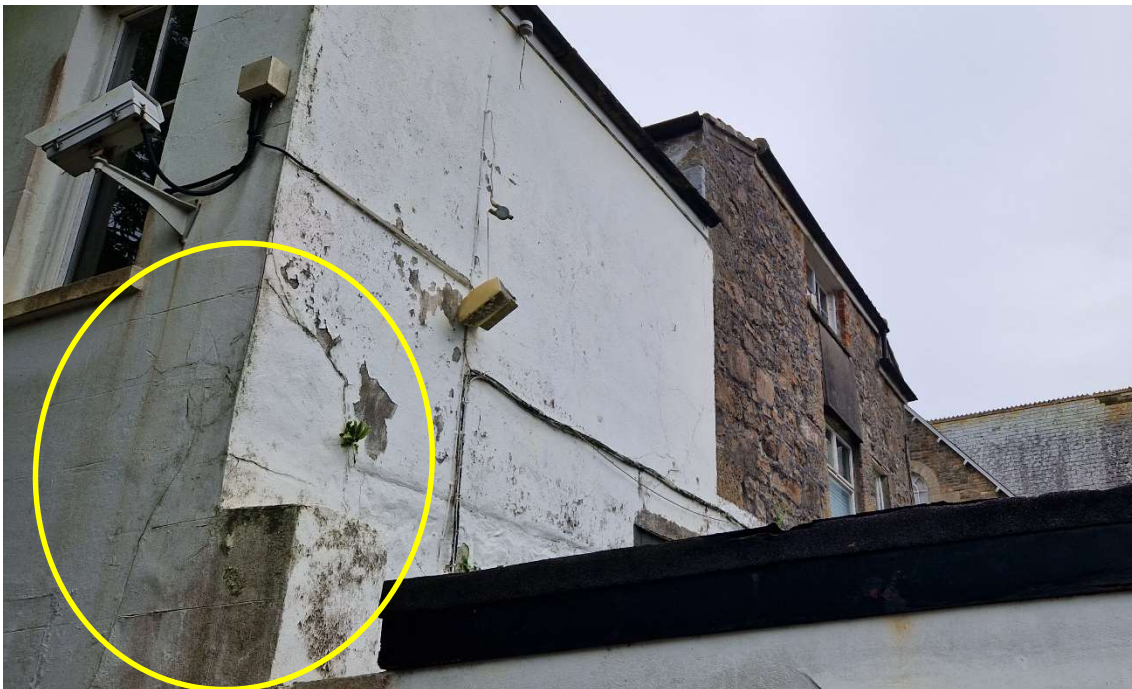
Figure 39: Photograph showing west elevation of White House

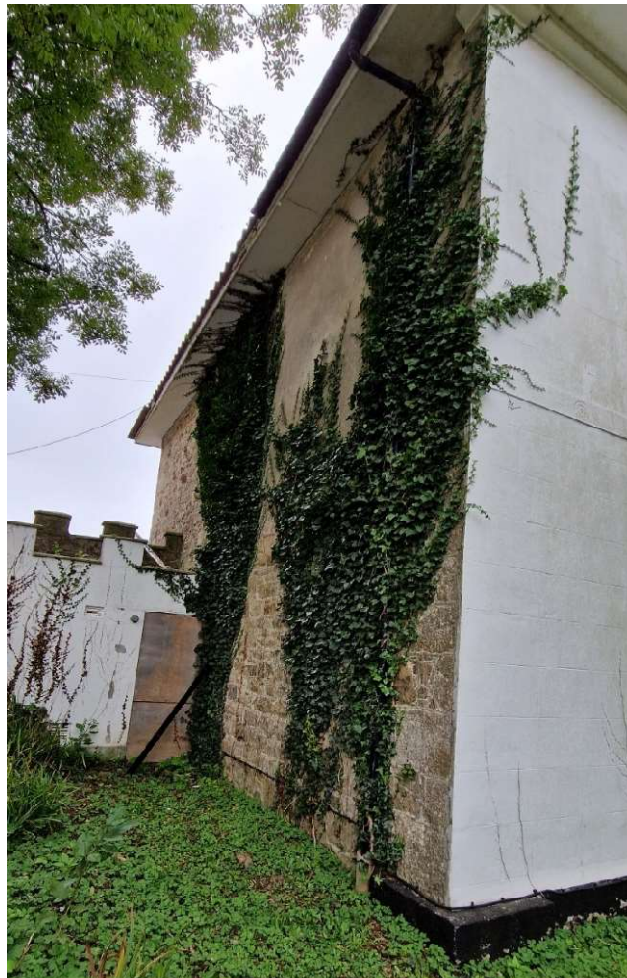
Figure 40: Photograph showing south elevation of White House

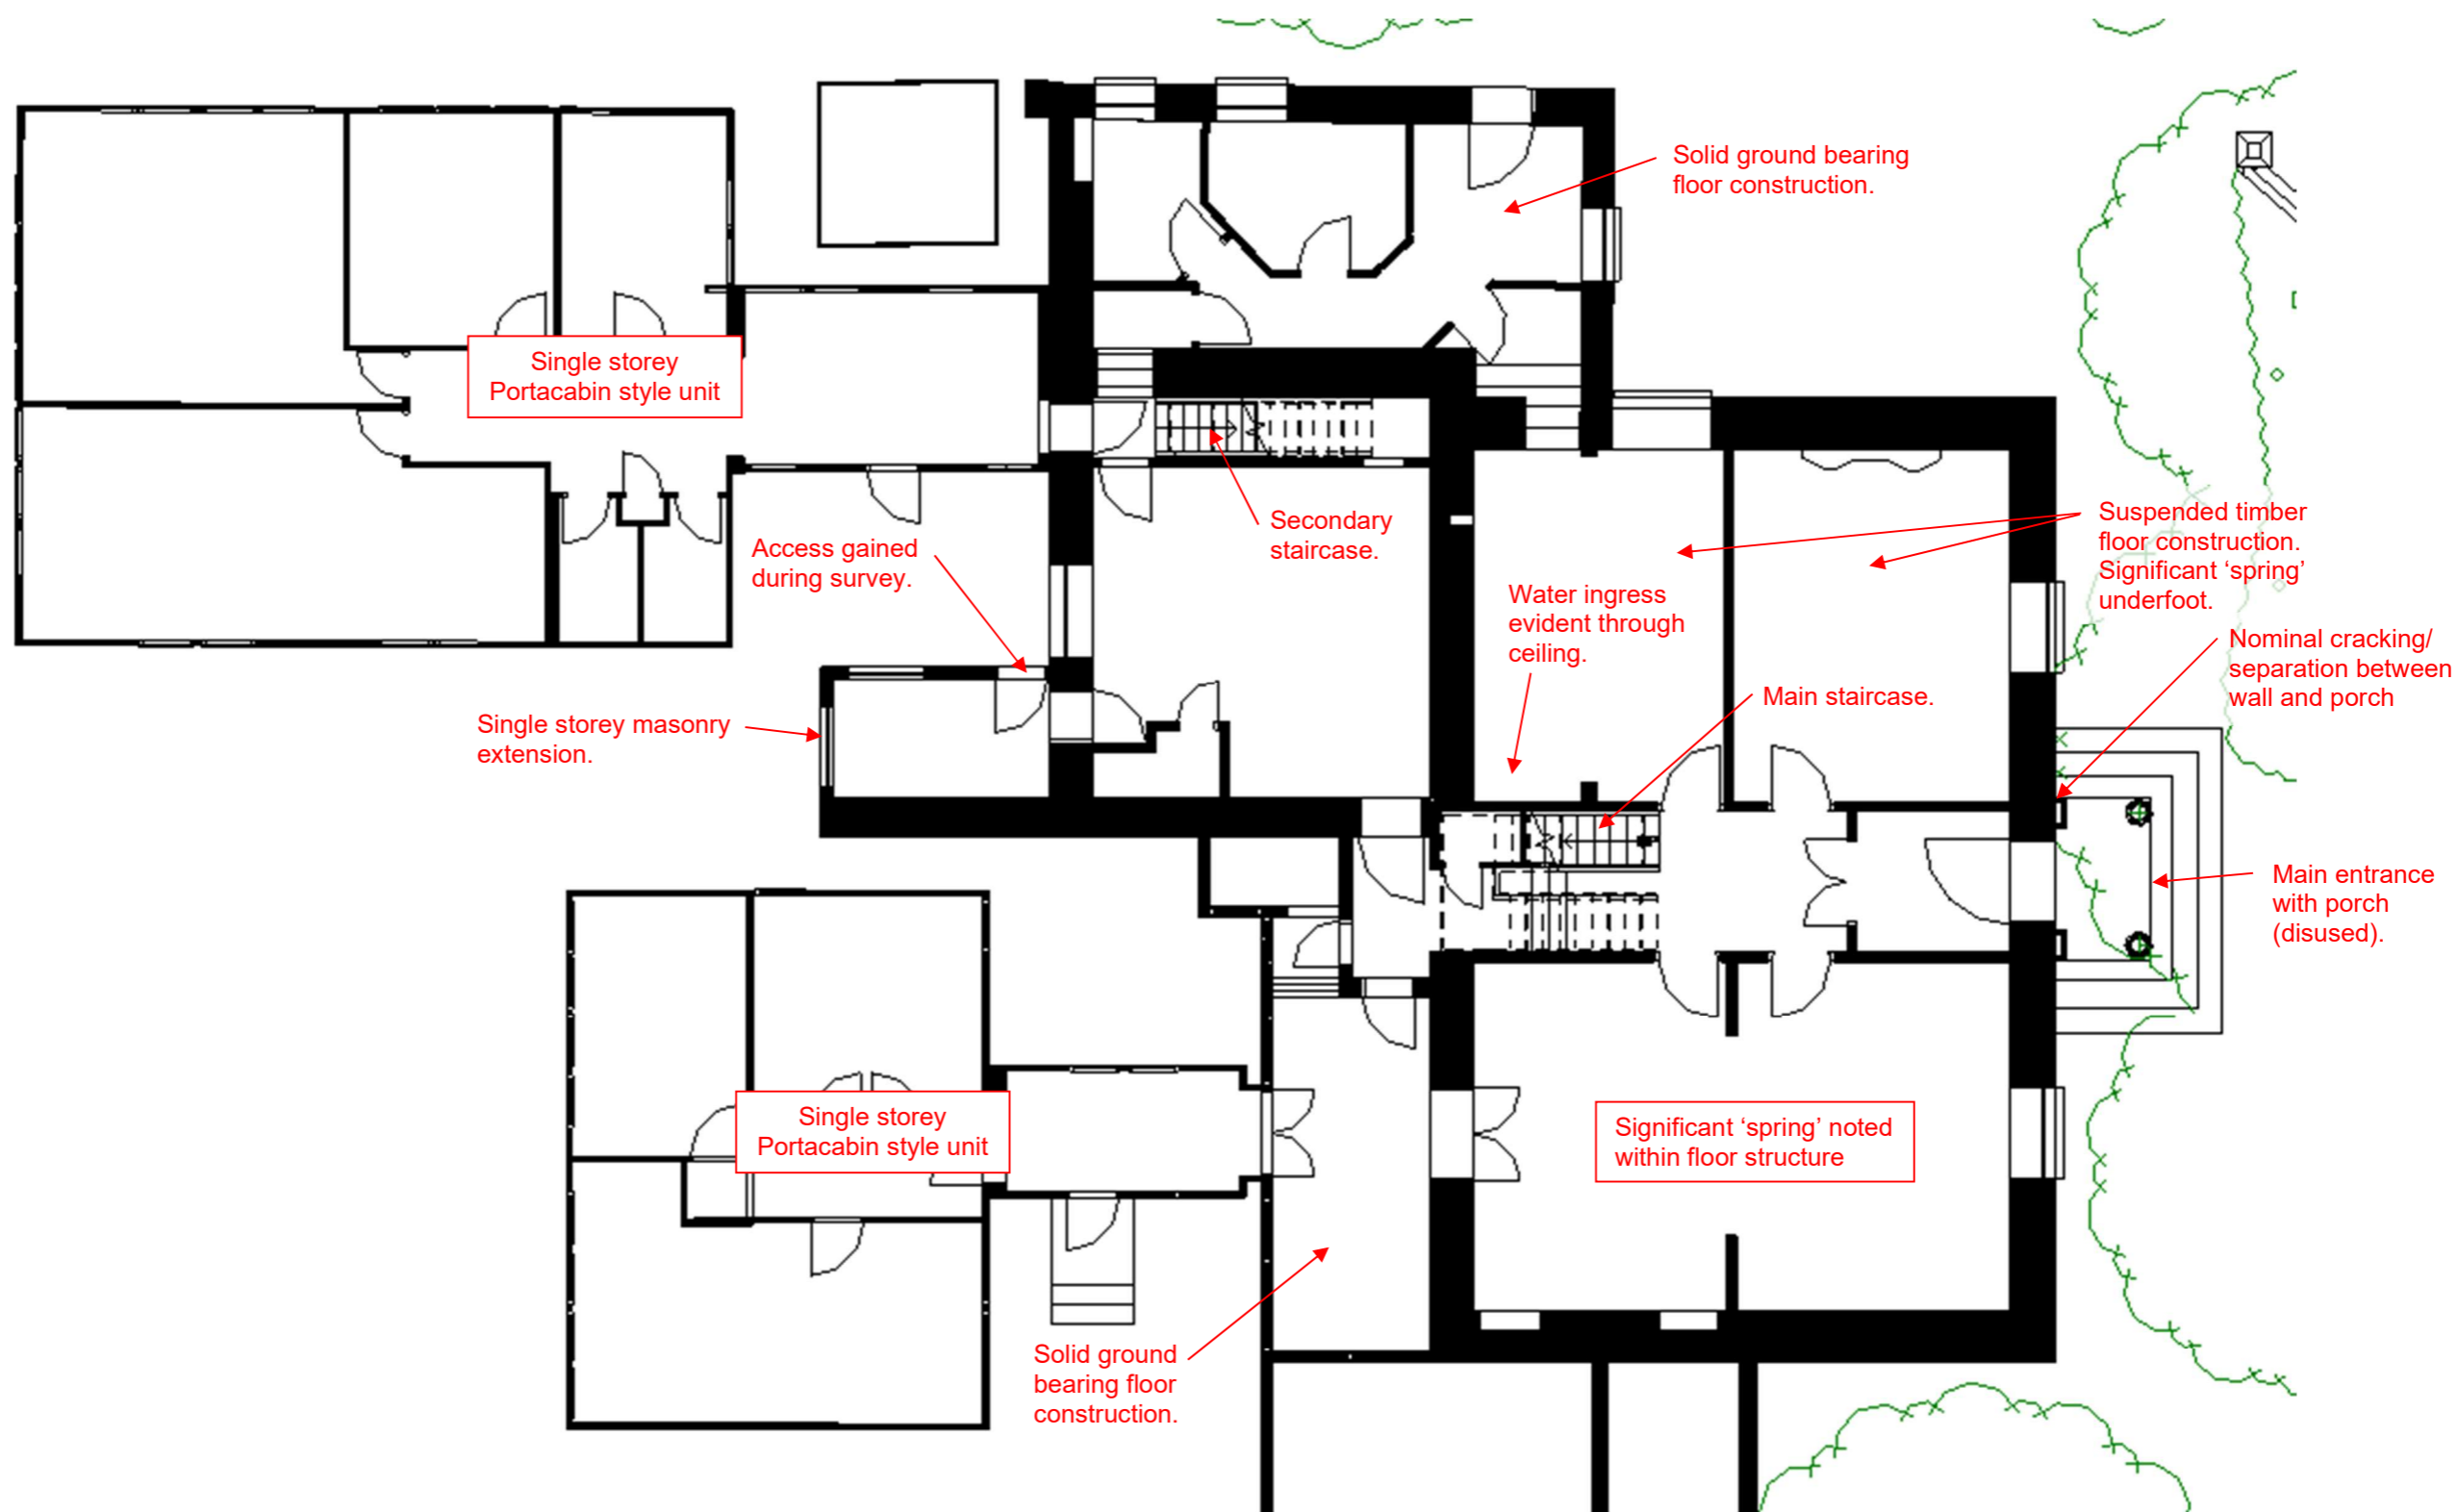
Figure 41: White House annotated ground floor plan
