CBC Asbestos Refurbishment & Demolition Survey Report Farmstead Road – Shops Parade, Corby April 2019

CBC Asbestos Refurbishment & Demolition Survey Report Farmstead Road – Shop Parade, Corby April 2019

Reference:				
Issue			Prepared by	Verified by
V1	Apr 19	DP

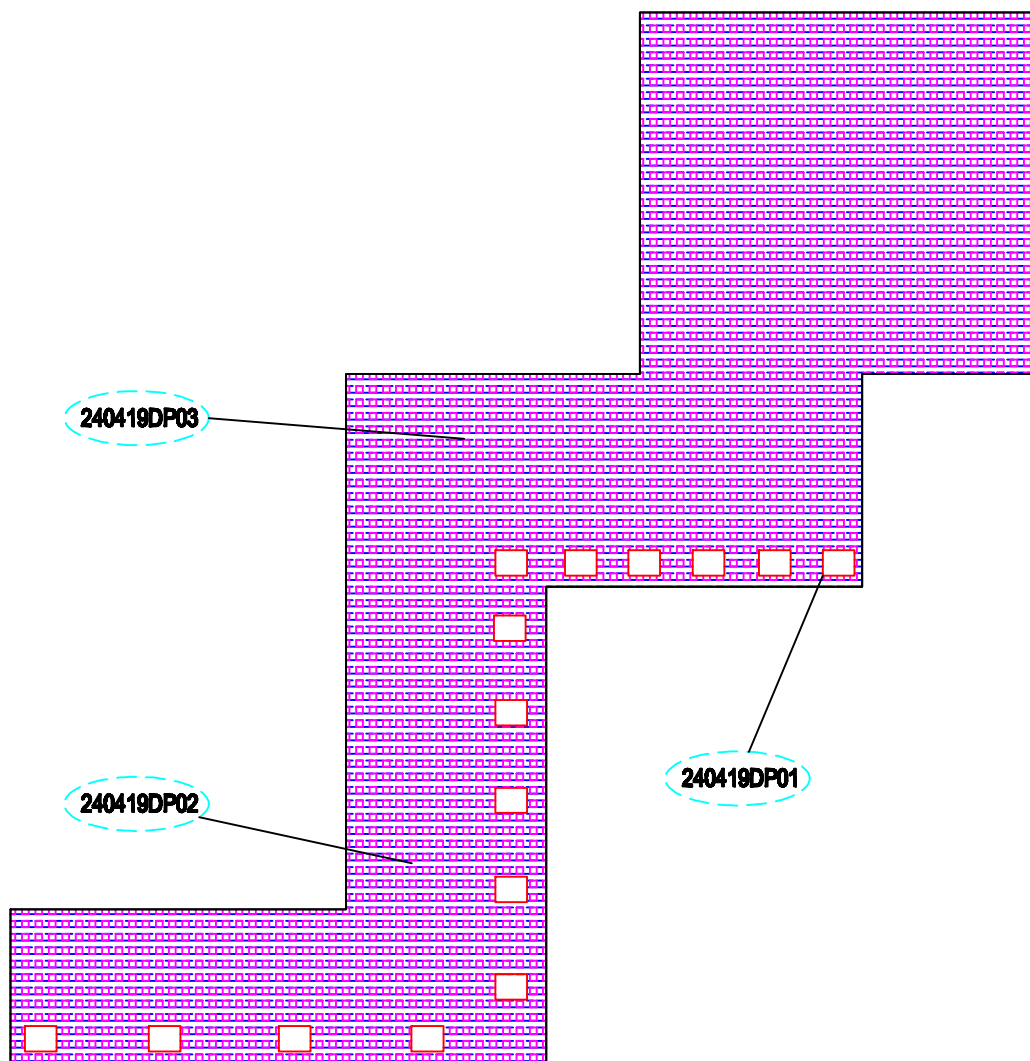
Drawing Title:
Corby Borough Council
Asbestos Survey Plan

Asbestos Bitumen roof lining

Textured coating - Render

Textured coating - Render to columns
