the **play inspection** company

Annual Inspection

Houghton Regis Town Council

Tithe Farm Recreation Ground

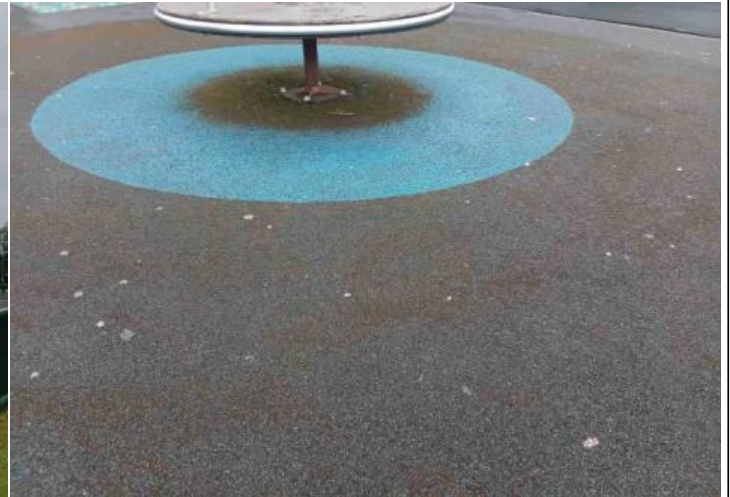
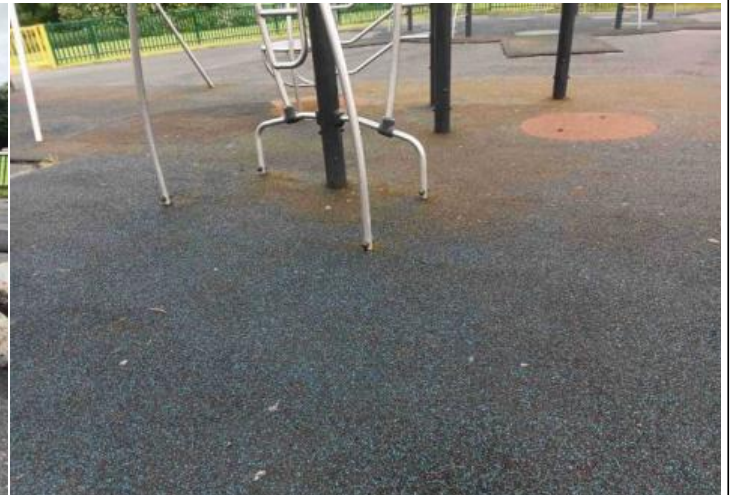
Finding: There is algae, silt or moss growth on the surface resulting in slippery conditions

Action: Clean and treat appropriately

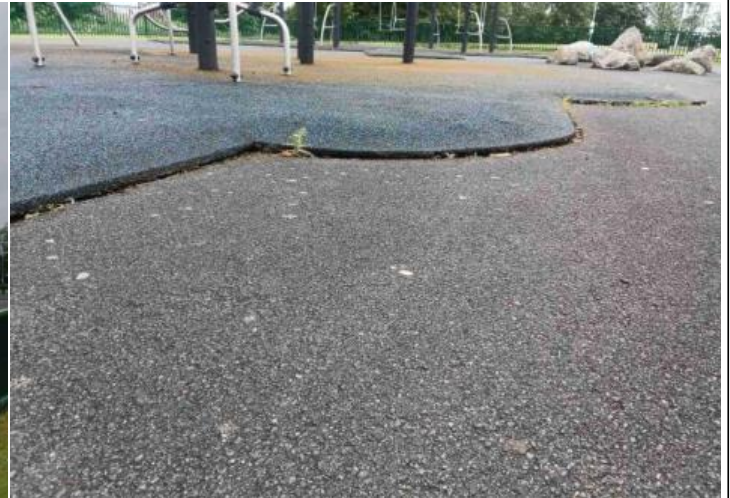
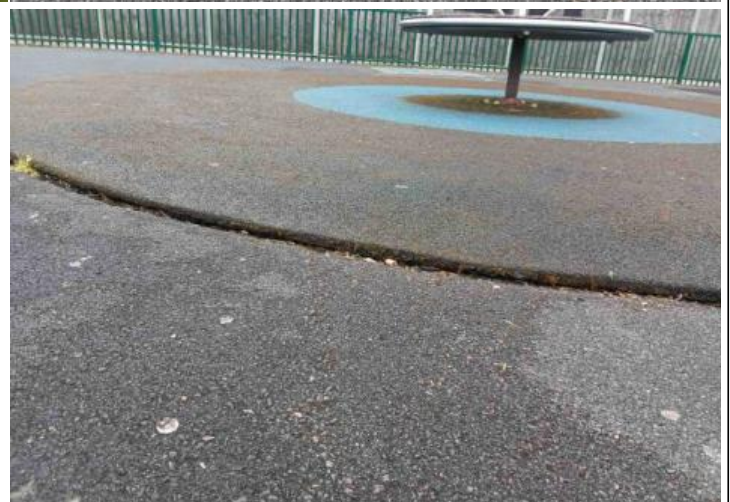
Finding: The surface is lifting at the edges and creating trip points
Action: Repair perimeter of surfacing to remove trip points

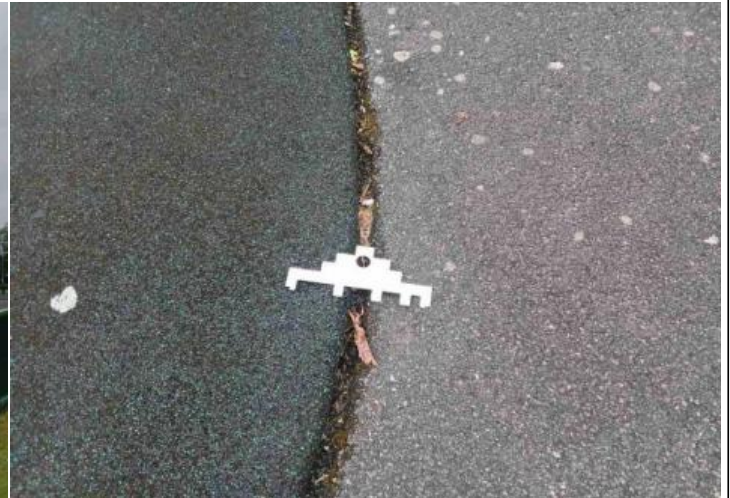
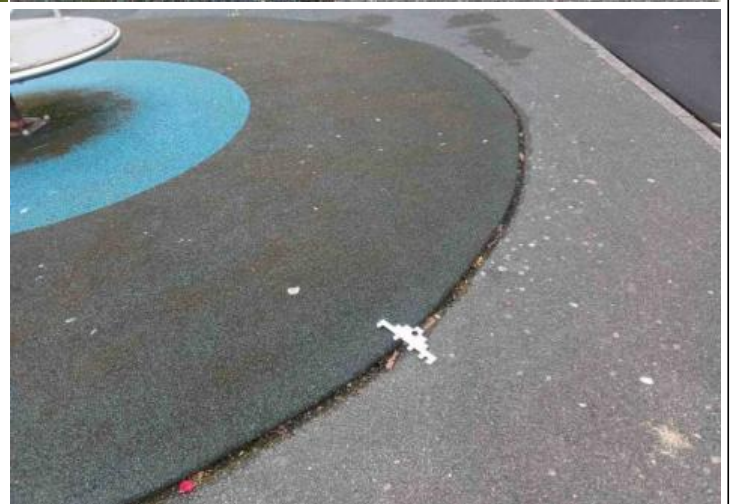
Finding: There are significant gaps (over 30mm) between the surface and the edging or between the joints in the surface; these are large enough for a small foot to enter

Action: Repair surfacing

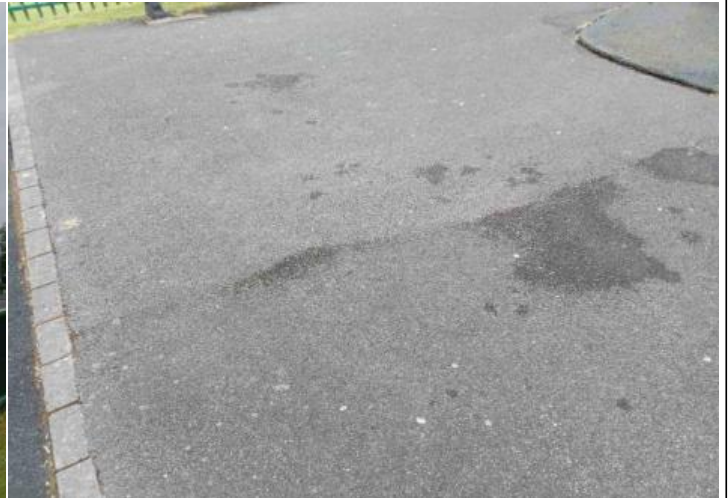
Finding: The bitumen surface is worn or damaged

Action: Repair the bitumen to provide a uniform surface

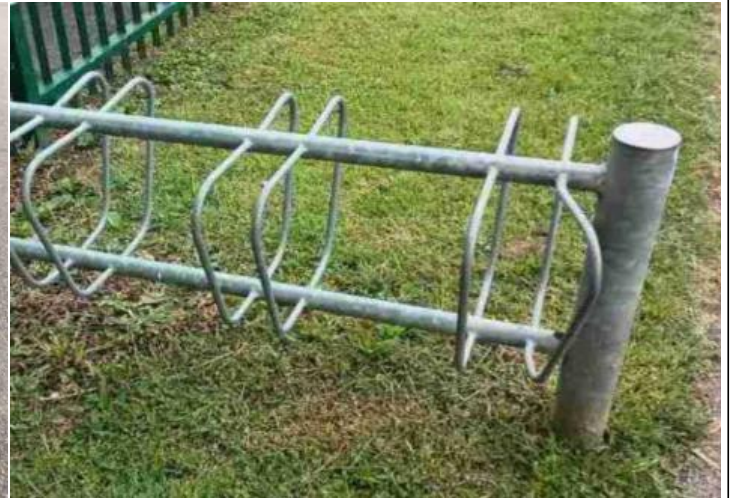
Finding: The item has been damaged

Action: Monitor for any further deterioration and replace as required

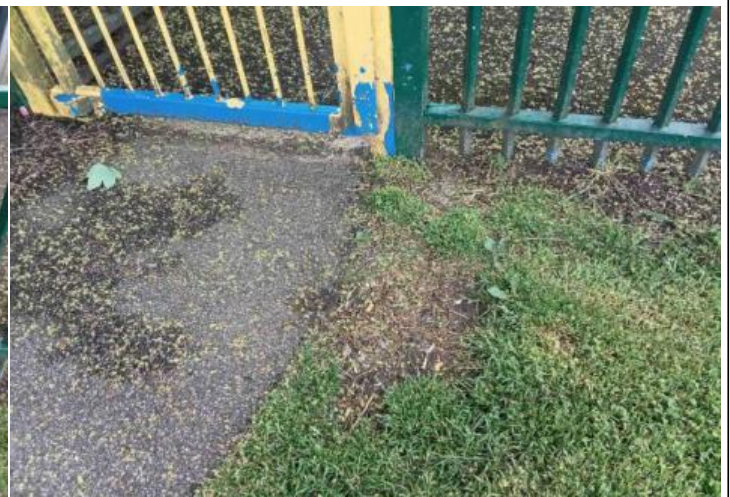
Finding: The surface has eroded in some areas and may be slippery in wet conditions

Action: Reinstate the surface

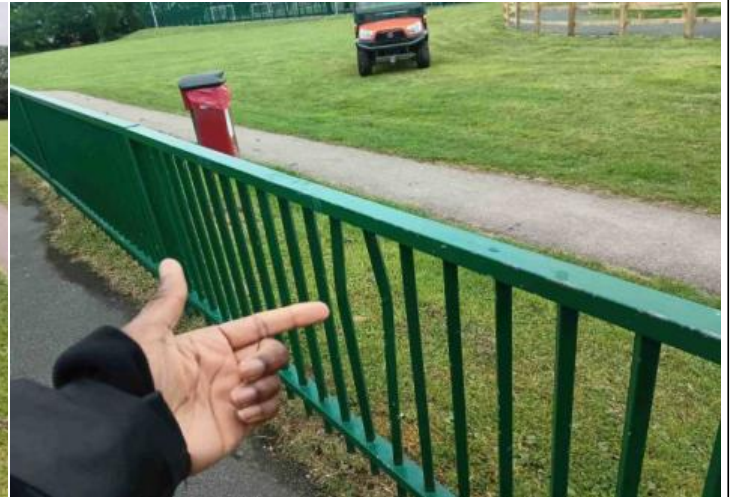
Finding: There is some damage to the fence sections

Action: Monitor for any further deterioration and repair as required

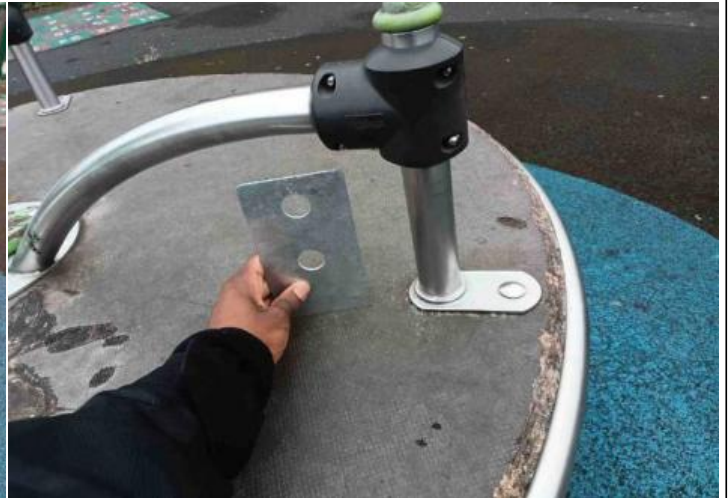
Finding: The item fails to meet the requirements of BS EN 1176 Part 1 4.2.7.2 for head and neck entrapment in the handgrip

Action: Monitor - No remedial work recommended

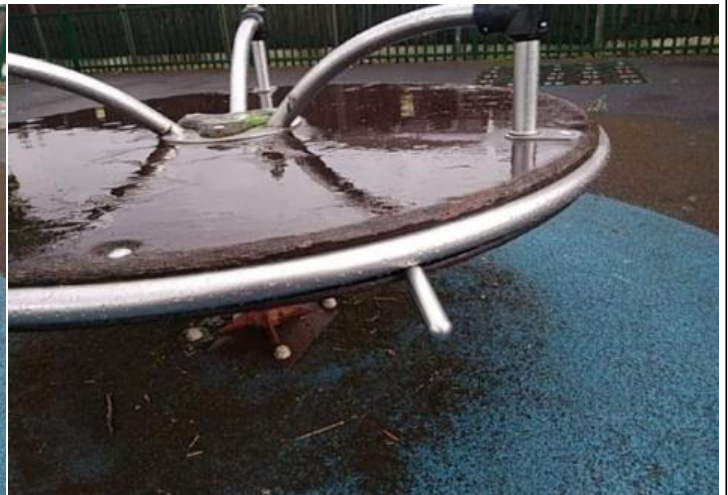
Finding: There is/are finger entrapment/s in the underside of the platform and the item fails to meet the requirements of BS EN 1176 Part 1 4.2.7.6 Entrapment of fingers

Action: Replace underside timber platform

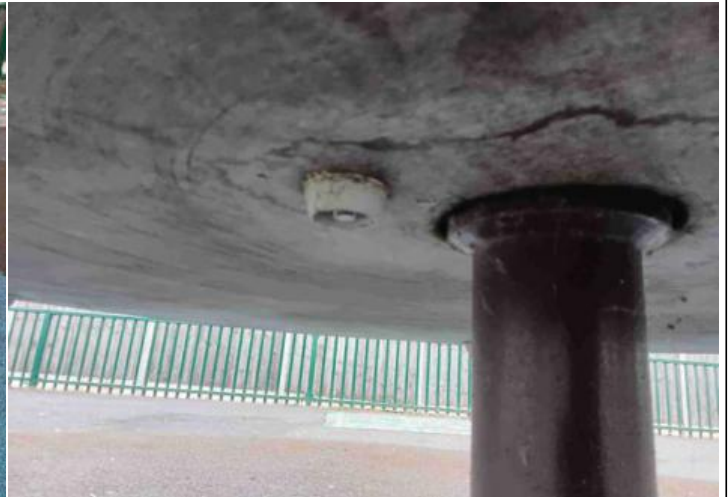
Finding: There is/are bolt cap covers missing or damaged on the item

Action: Replace missing or damaged bolt cap covers

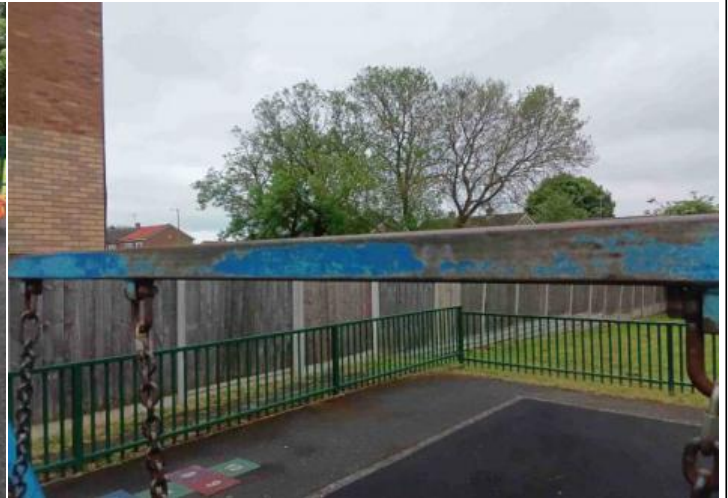
Finding: The paintwork on this item has been damaged or worn exposing the metal underneath which is rusting / corroding

Action: Treat affected areas and repaint

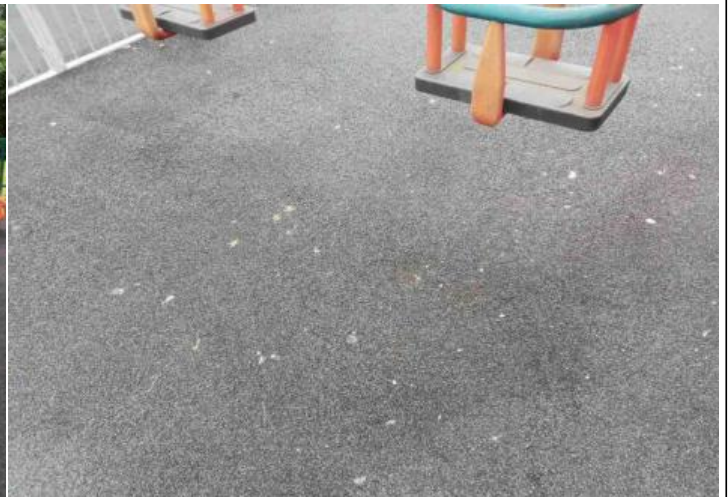
Finding: The safety surface around the area is beginning to wear

Action: Monitor for any further deterioration and repair as required

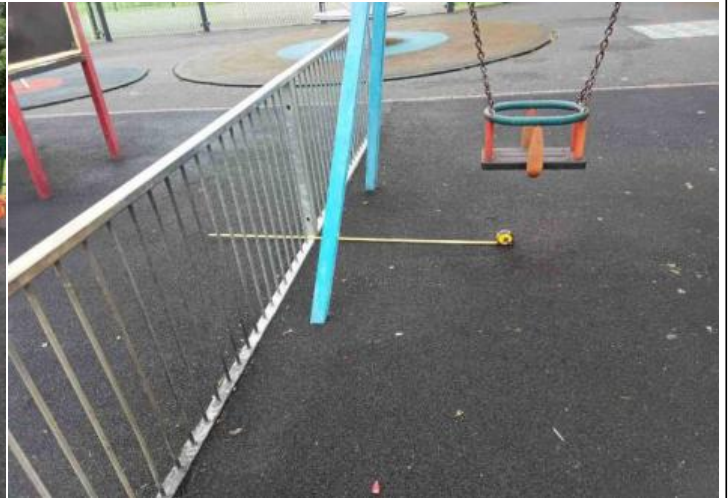
Finding: BS EN 1176 Part 2: Annex A makes a recommendation that fences or enclosures should be upto 1.50m from the edges of the swing seat to the sides, and subject to risk assessment, from the edge of the impact area. This is however, a low risk finding and no remedial action is recommended.

Action: Monitor - No remedial work recommended

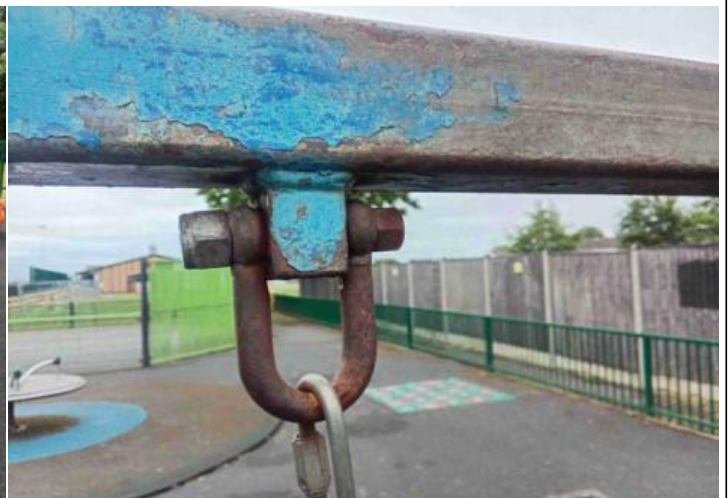
Finding: The bushes are showing signs of wear

Action: Monitor for any further deterioration and replace as required

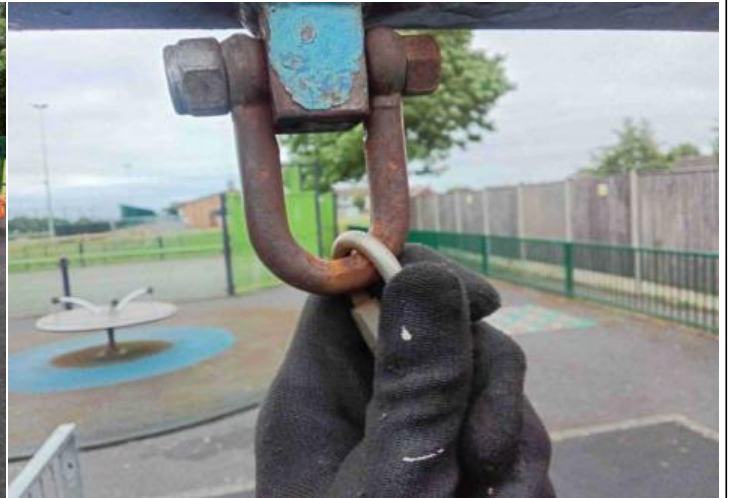
Finding: There is some wear to the shackles.

Action: Monitor for any further deterioration and replace when 40% worn

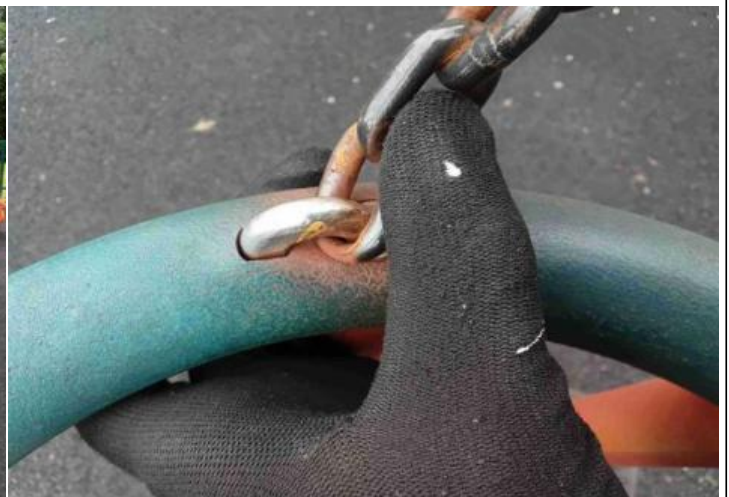
Finding: The chain links are worn excessively and require renewing

Action: Replace worn chains

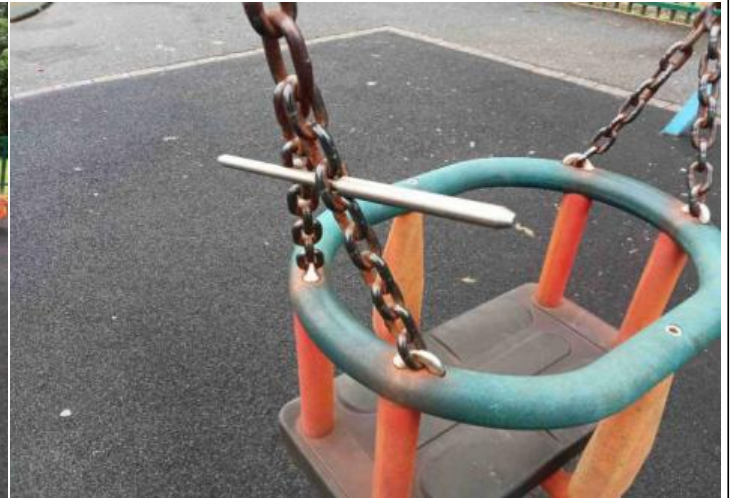
Finding: The chain openings are in excess of the 8.6mm as recommended by BS EN 1176 **Action:** Monitor - No remedial work recommended

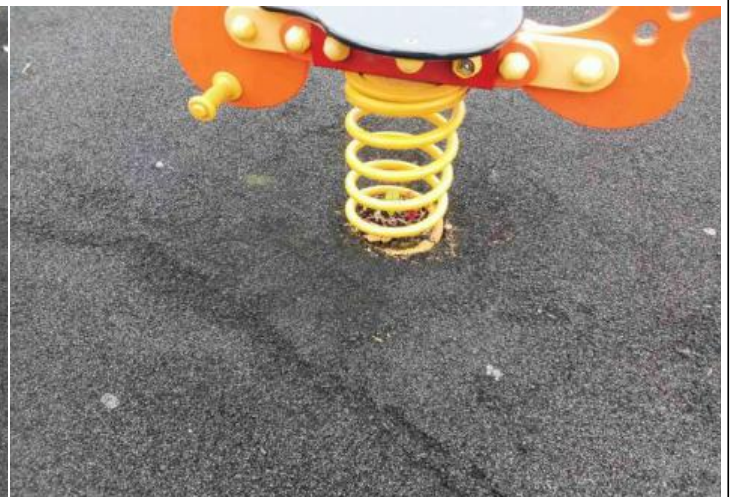
Finding: The surface has subsided in some areas **Action:** Monitor for any further deterioration and repair as required

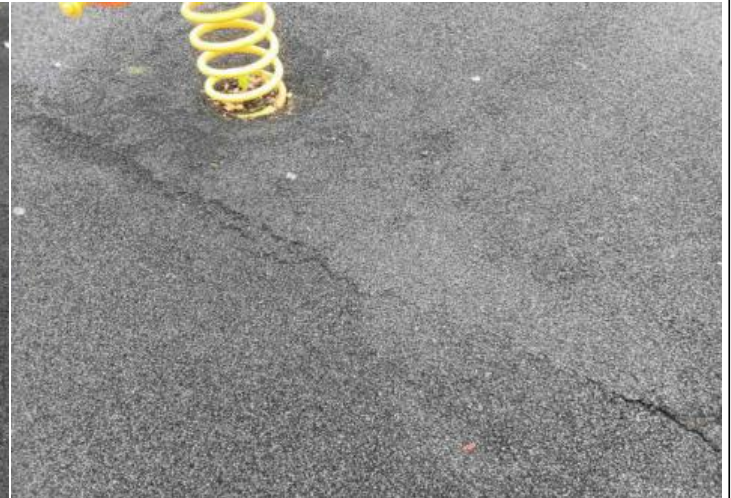
Finding: There is some minor damage to the surface

Action: Monitor for any further deterioration and repair as required

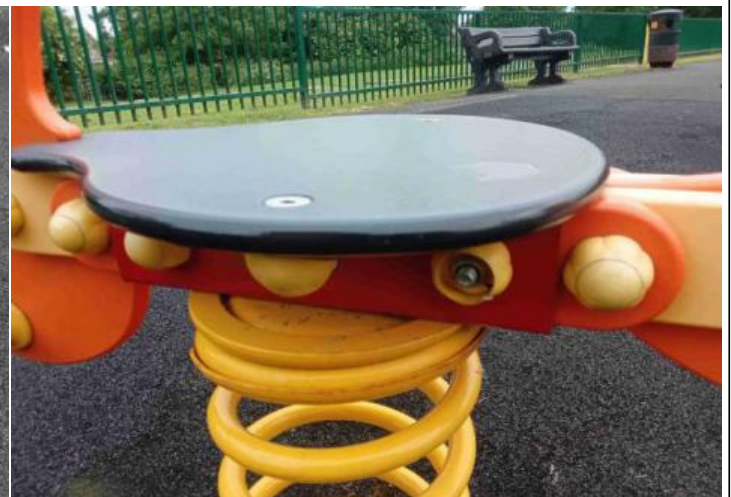
Finding: There is/are bolt cap covers missing or damaged on the item

Action: Replace missing or damaged bolt cap covers

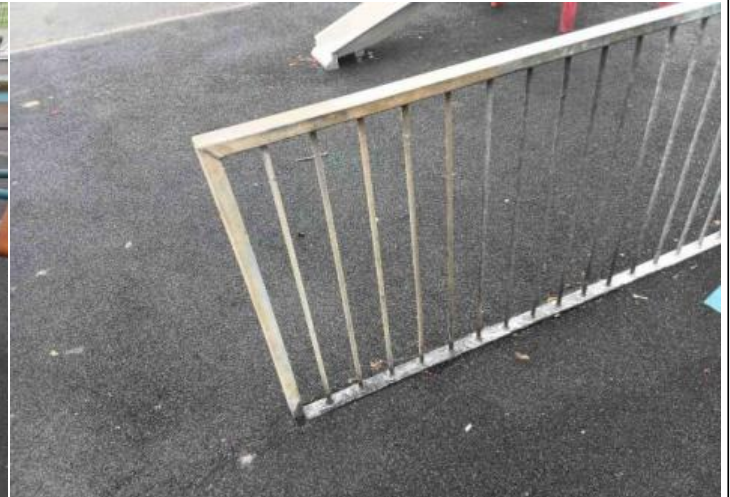
Finding: There is some evidence of fire damage to the item

Action: Monitor for any further deterioration and repair as required

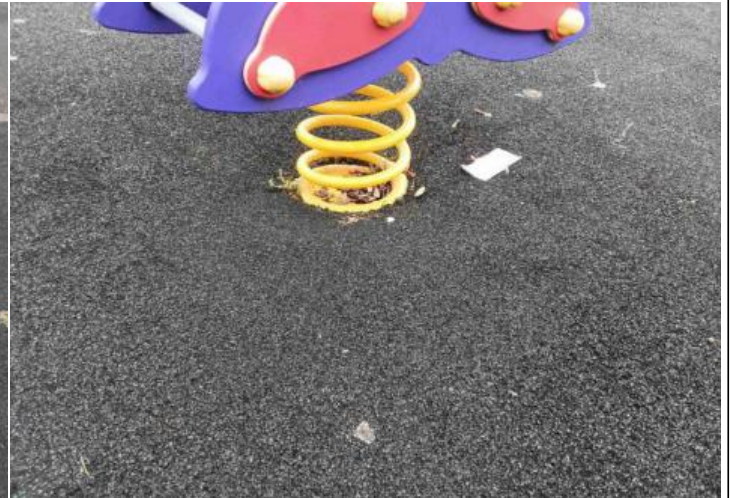
Finding: The surface has subsided in some areas

Action: Monitor for any further deterioration and repair as required

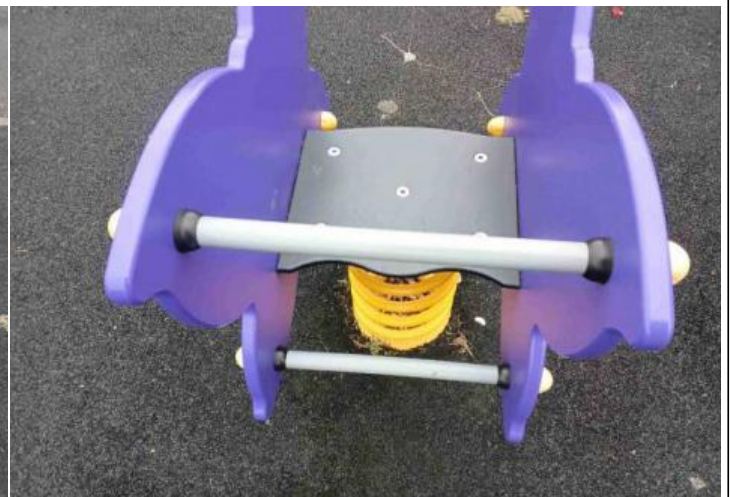
Finding: The Handgrips/Footrests rotate and may cause an unexpected movement for the user

Action: Secure Handgrips/Footrests to prevent rotation.

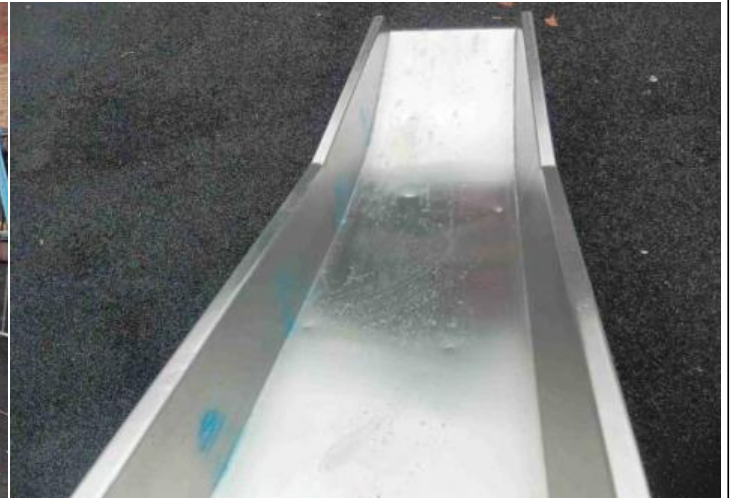
Finding: There are a number of dents in the slide surface

Action: Monitor for any further deterioration and repair as required

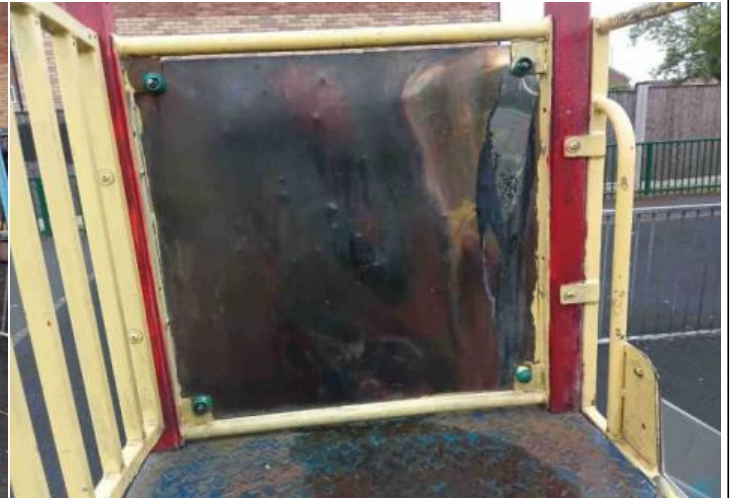
Finding: There is some evidence of fire damage to the item **Action:** Monitor for any further deterioration and repair as required

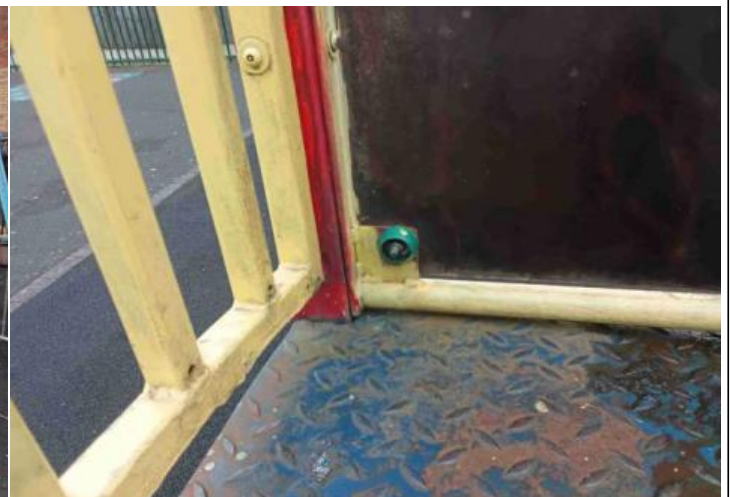
Finding: There is/are bolt cap covers missing or damaged on the item **Action:** Replace missing or damaged bolt cap covers

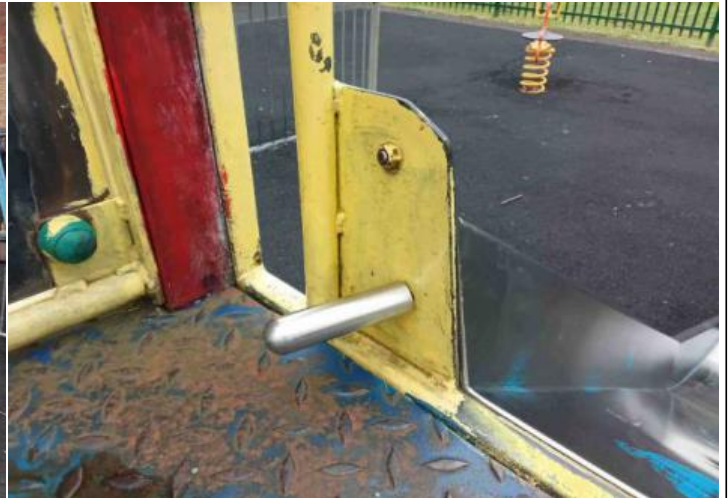
Finding: There is a missing fixing creating a finger entrapment in the slide entry and the item fails to meet the requirements of BS EN 1176 Part 1 4.2.7.6 Entrapment of fingers

Action: Replace the fixing to remove finger entrapment

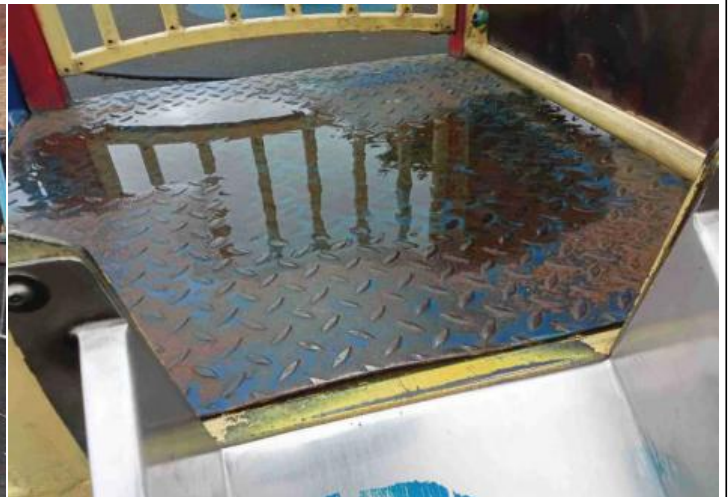
Finding: The paintwork on this item has been damaged or worn exposing the metal underneath which is rusting / corroding

Action: Treat affected areas and repaint

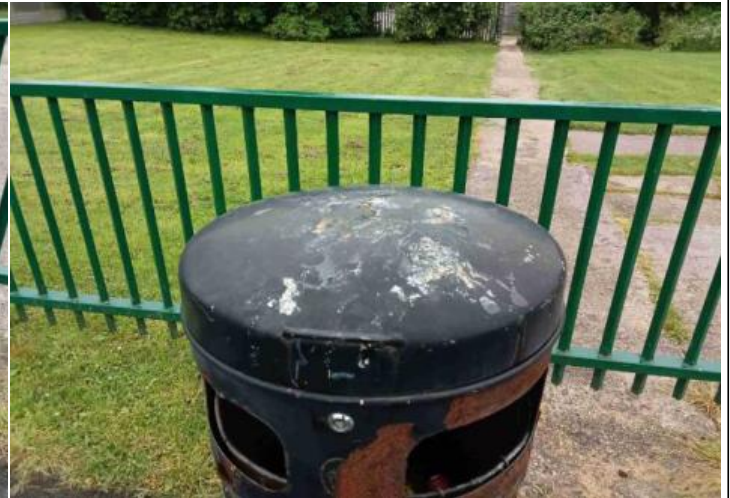
Finding: There is some evidence of fire damage to the item
Action: Monitor for any further deterioration and repair as required

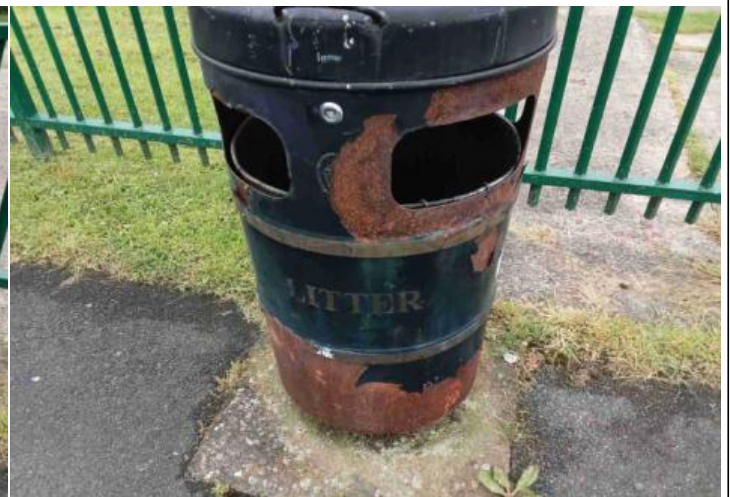
Finding: The paintwork on this item has been damaged or worn exposing the metal underneath which is rusting / corroding
Action: Treat affected areas and repaint

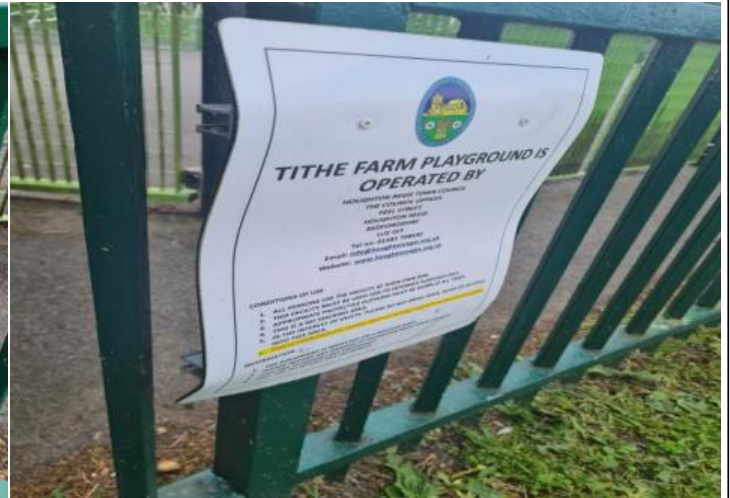
Finding: The item has been damaged

Action: Monitor for any further deterioration and replace as required

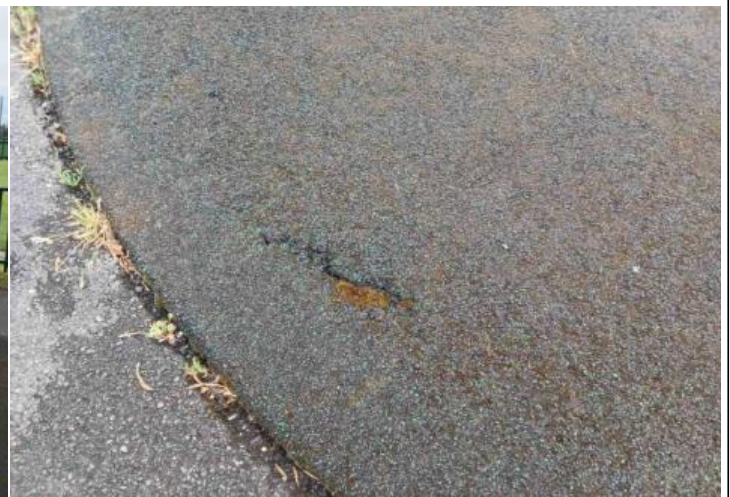
Finding: There is some minor damage to the surface

Action: Monitor for any further deterioration and repair as required

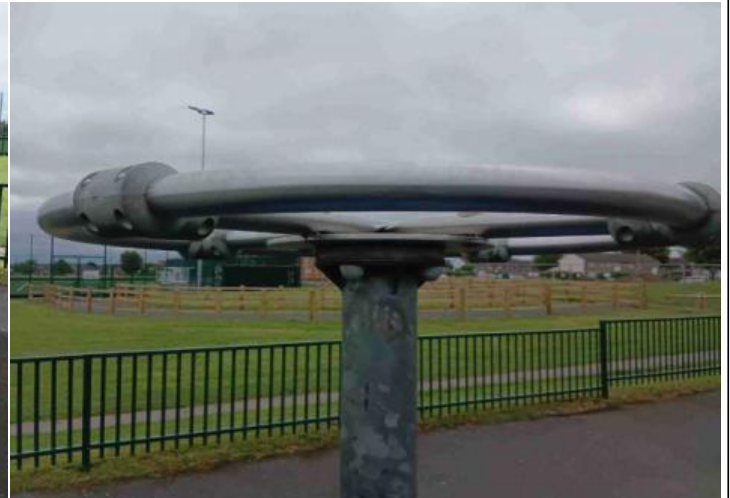
Finding: The bearing is showing signs of wear

Action: Monitor for any further deterioration and replace as required

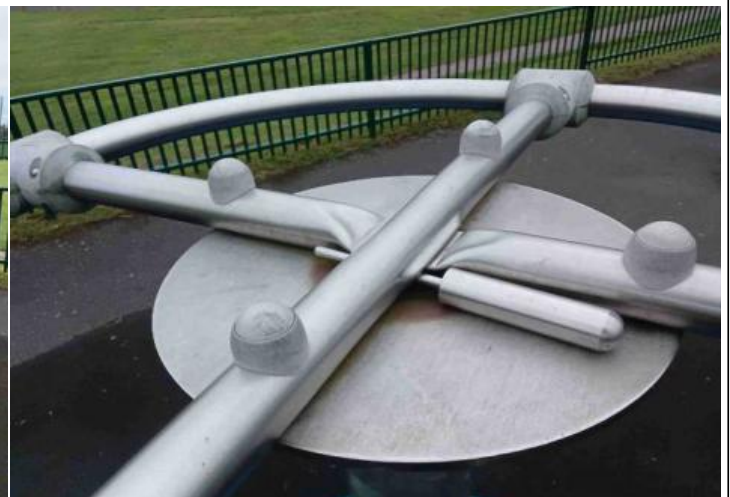
Finding: There is/are finger entrapment/s in the handgrip and the item fails to meet the requirements of BS EN 1176 Part 1 4.2.7.6 Entrapment of fingers

Action: Monitor - No remedial work recommended

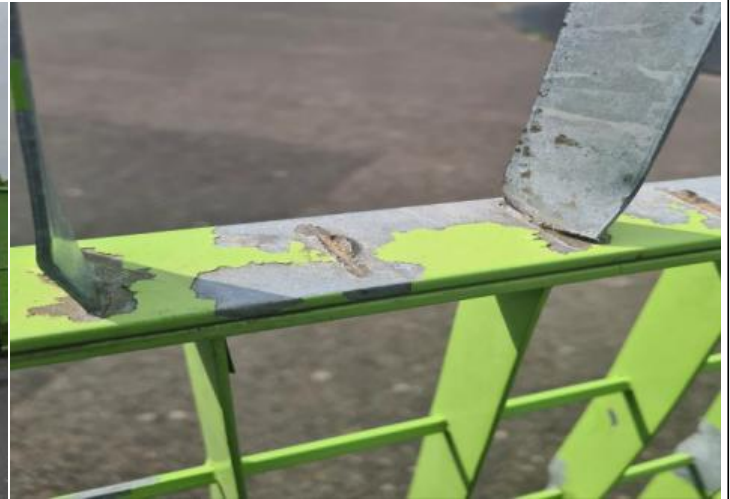
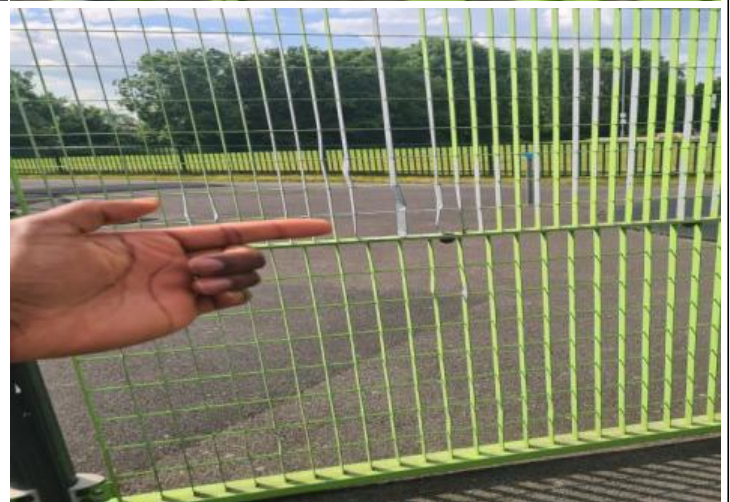
Finding: The weld(s) on this item have failed leaving sharp edges **Action:** Repair item

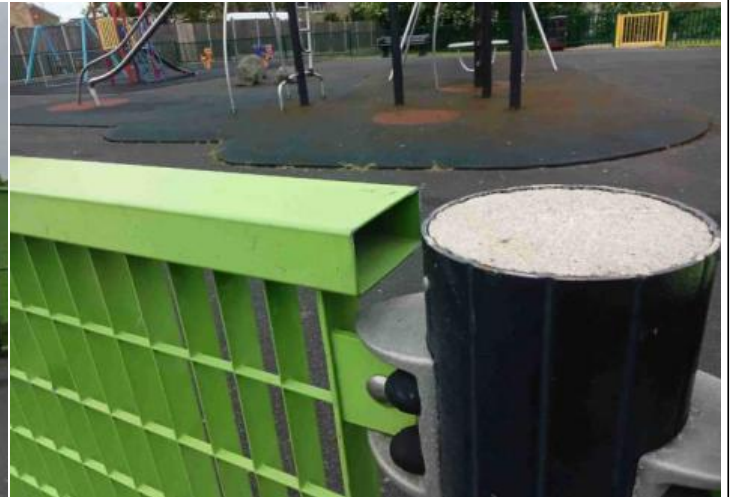
Finding: There are post / end caps missing from the item

Action: Replace missing post caps

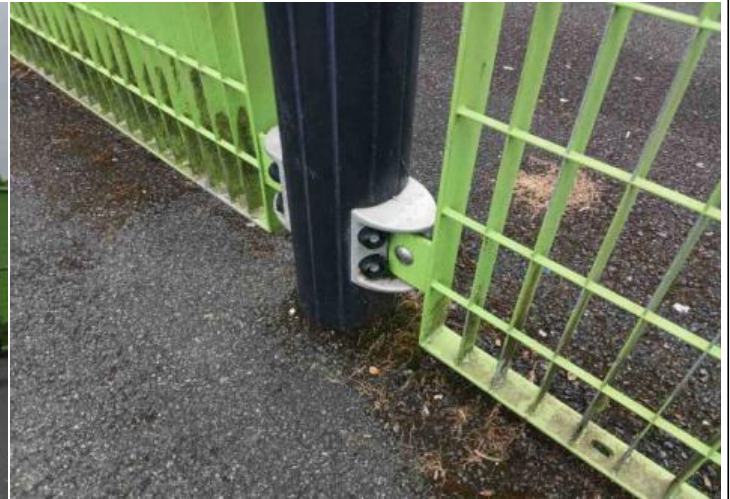
Finding: There is/are bolt cap covers missing or damaged on the item

Action: Replace missing or damaged bolt cap covers

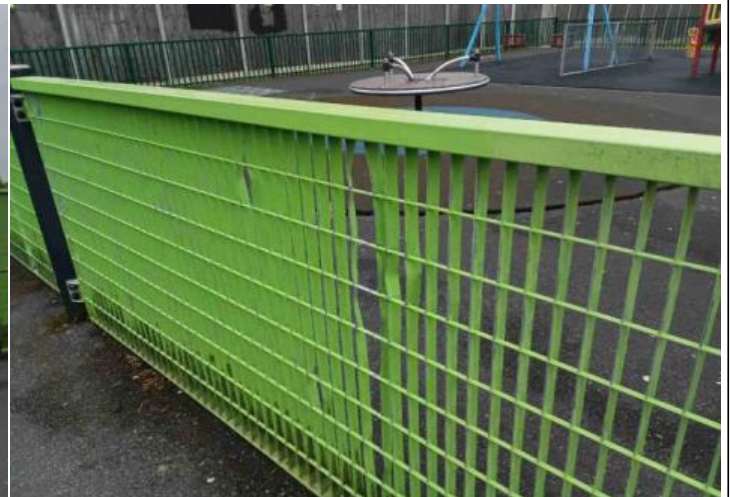
Finding: The item has been damaged

Action: Monitor for any further deterioration and replace as required

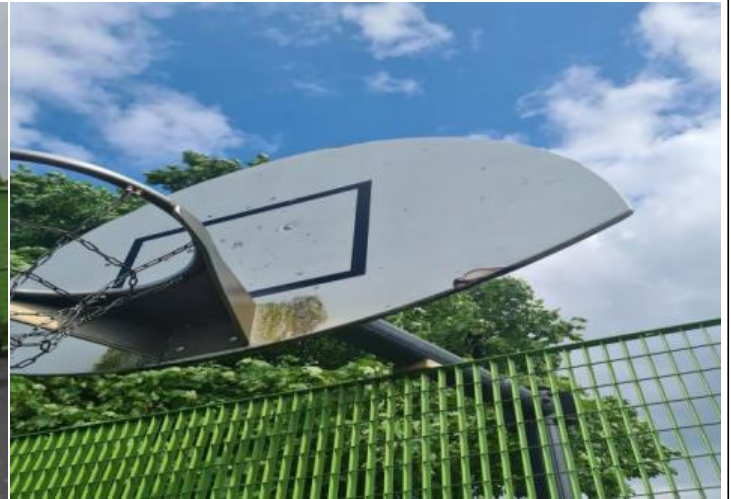
Finding: The backboard is damaged

Action: Monitor for any further deterioration and repair as required

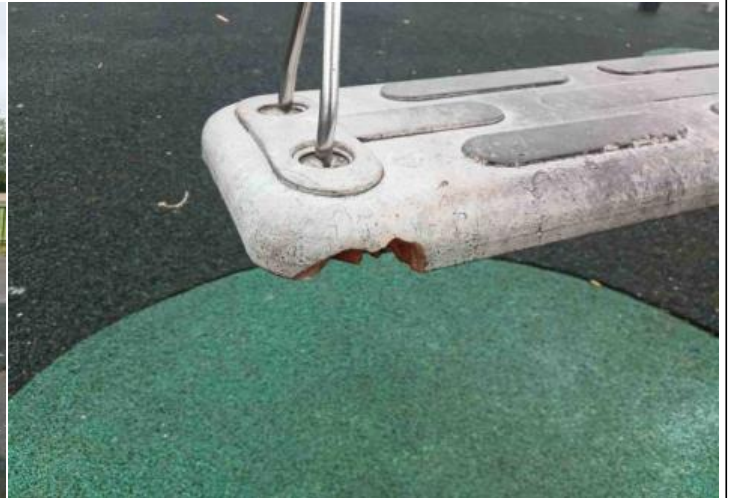
Finding: The seat has minor damage or wear

Action: Monitor for any further deterioration and replace as required

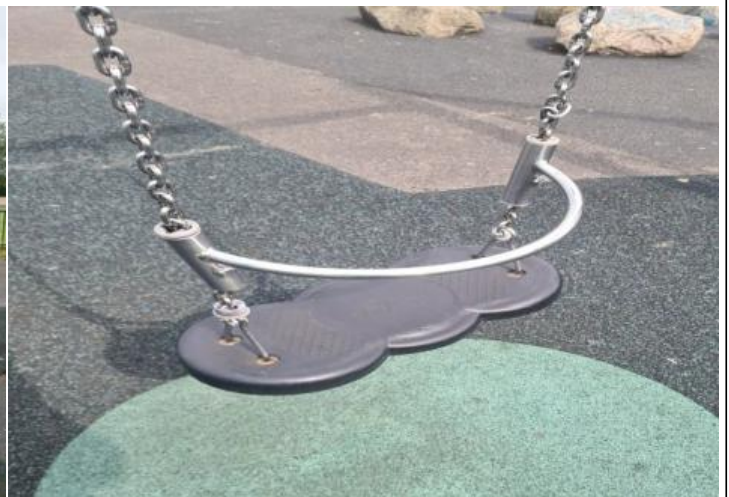
Finding: The item has missing component(s) handgrip cover

Action: Replace missing components

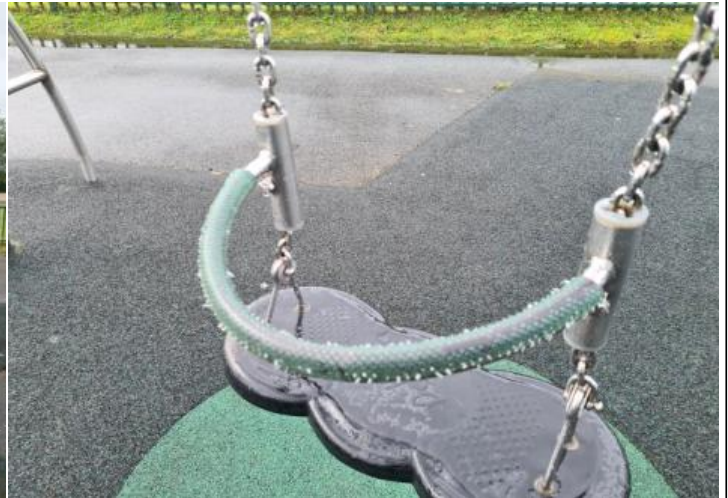
Finding: The item has been damaged

Action: Replace handgrip

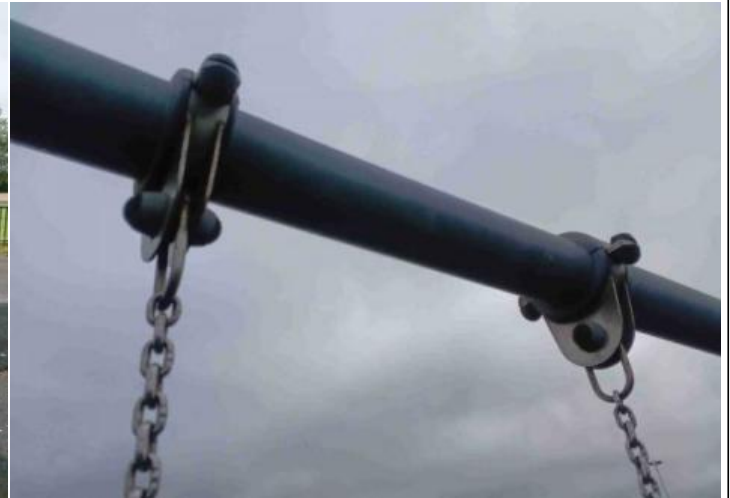
Finding: The bushes are showing signs of wear

Action: Monitor for any further deterioration and replace as required

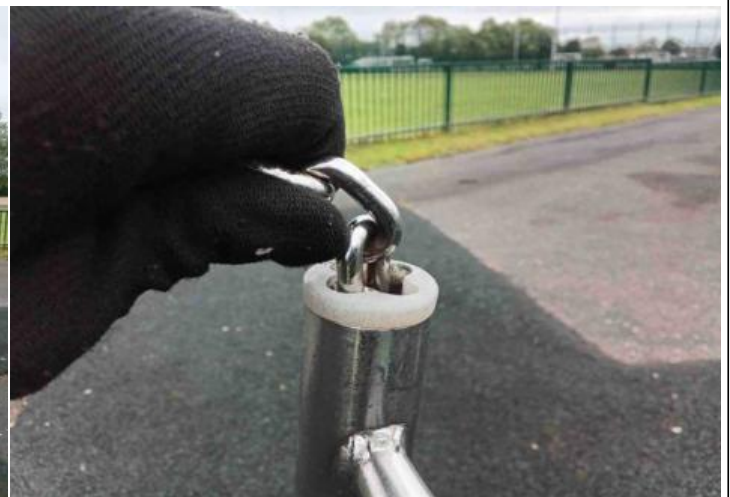
Finding: There is some notable evidence of chain wear

Action: Monitor for any further deterioration and replace when 40% worn

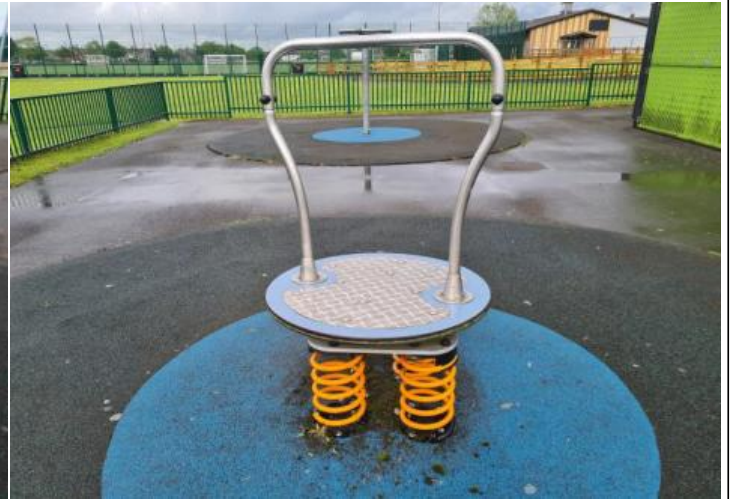
Finding: The bearing is worn / damaged and the item is not operating correctly
Action: Repair / replace

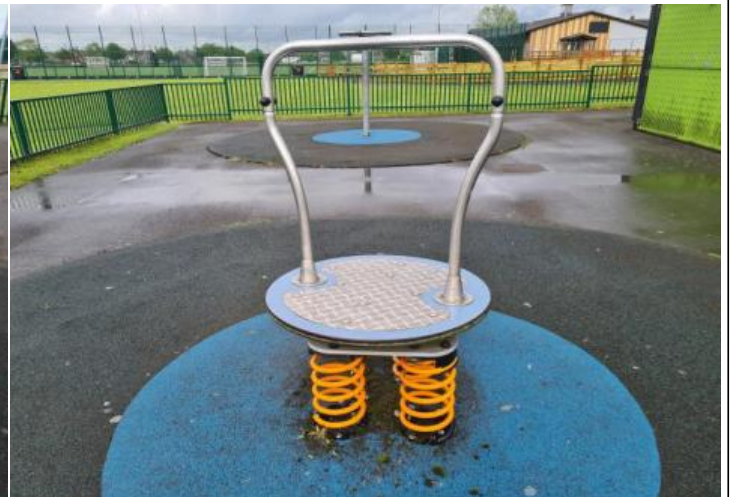
Finding: The item has missing component(s) handgrip
Action: Consider replacing missing components

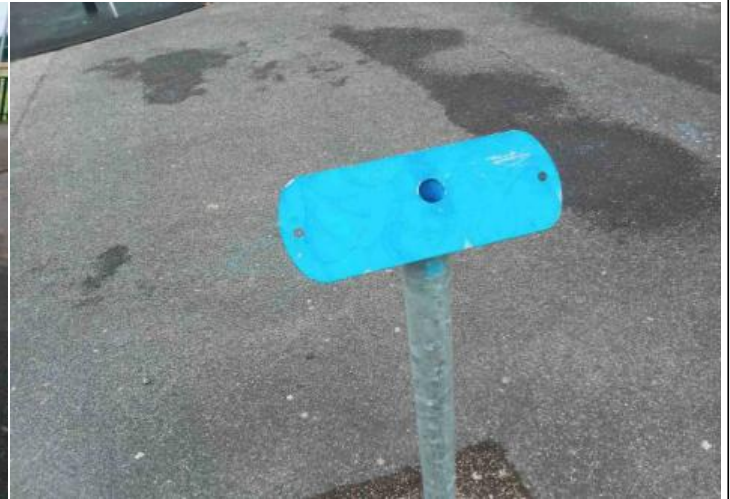
Finding: Signage is missing

Action: Replace sign

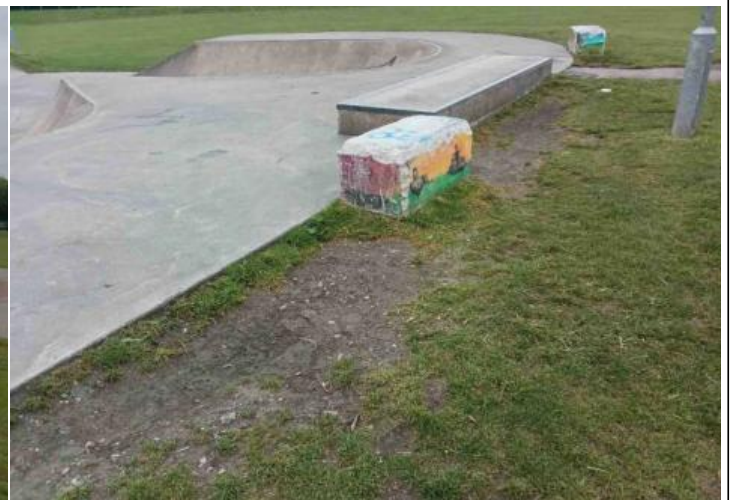
Finding: The surface has eroded in some areas and may be slippery in wet conditions

Action: Reinstate the surface

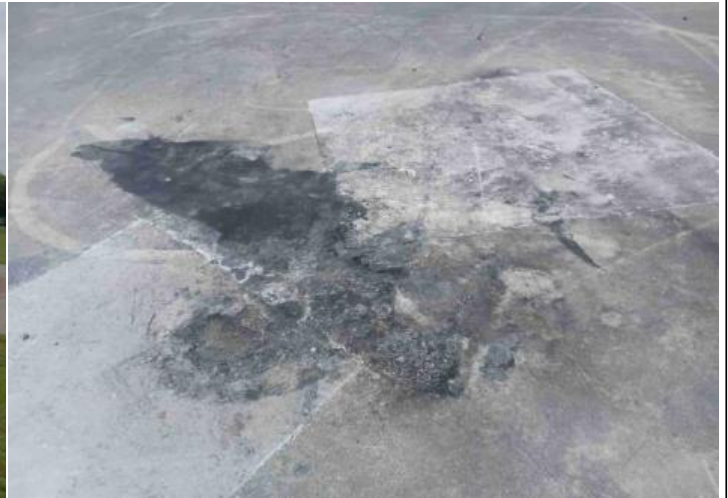
Finding: There is some evidence of fire damage to the surfacing

Action: Monitor for any further deterioration and repair as required

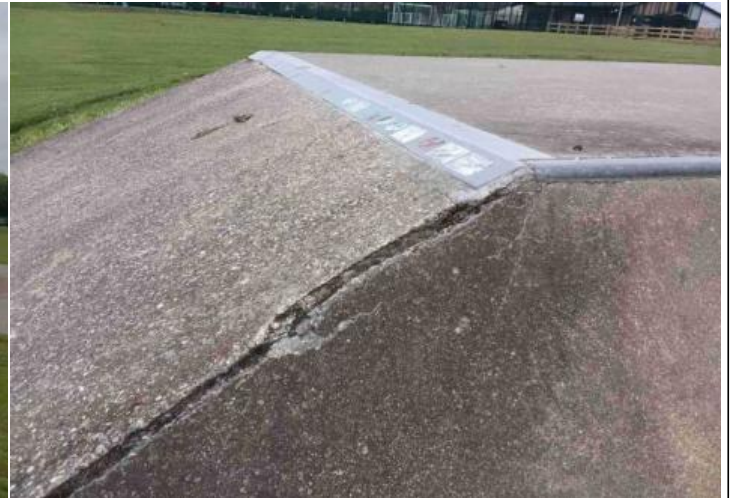
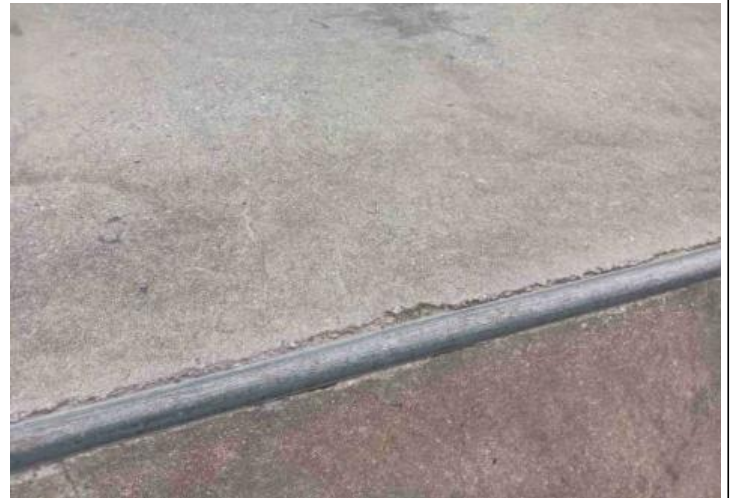
Finding: The riding surface has minor damage apparent

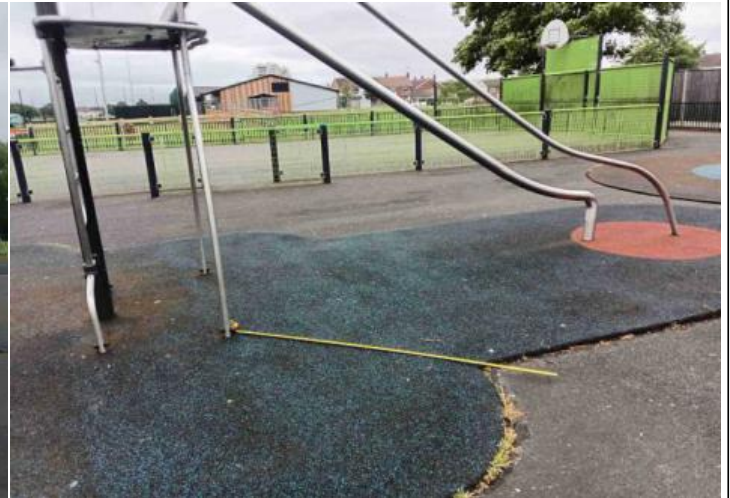
Finding: The surfacing dimensions are short and do not meet with the requirements of the current applicable standard

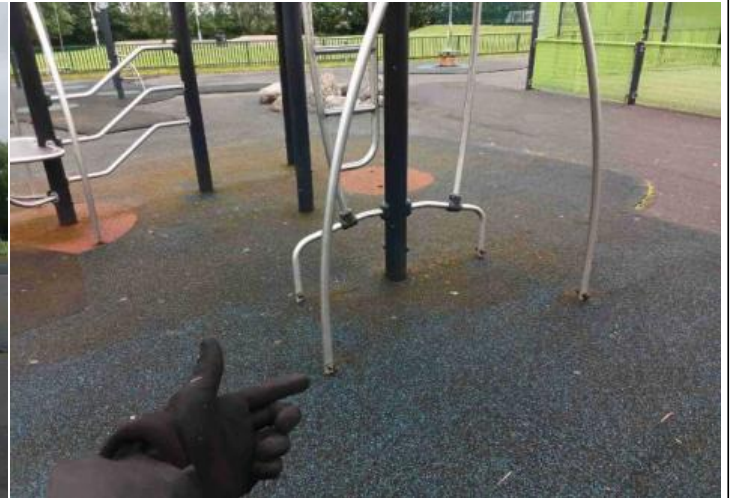
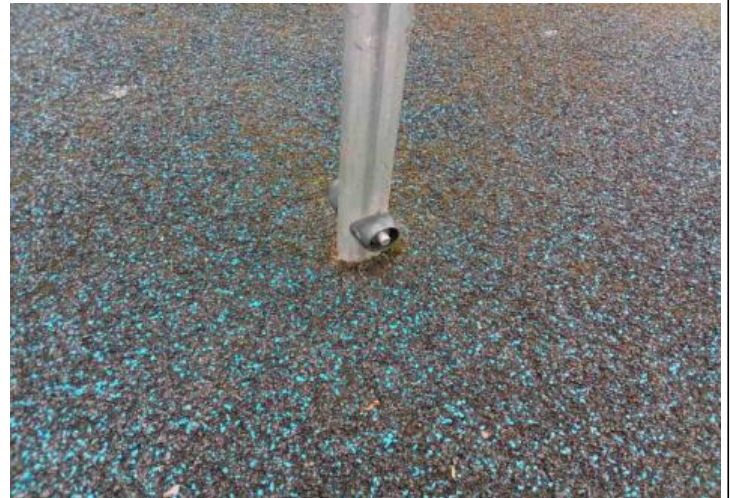
Finding: There is/are bolt cap covers missing or damaged on the item
