the **play inspection** company

Annual Inspection

Houghton Regis Town Council

Tithe Farm Recreation Ground

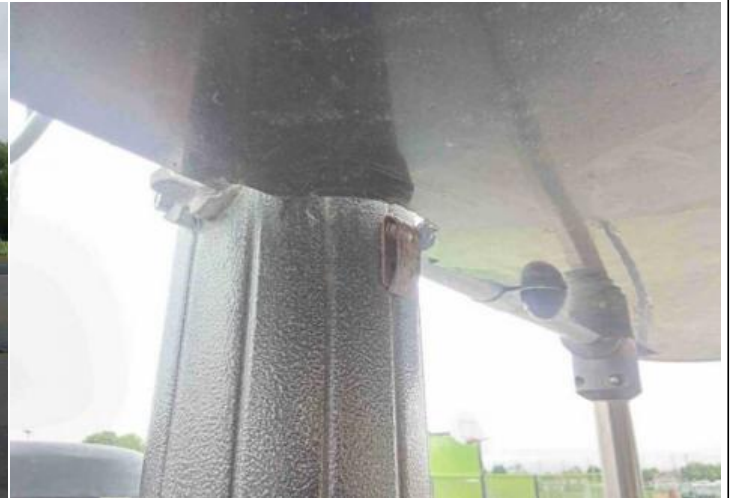
Finding: There is or are fixings missing on the item

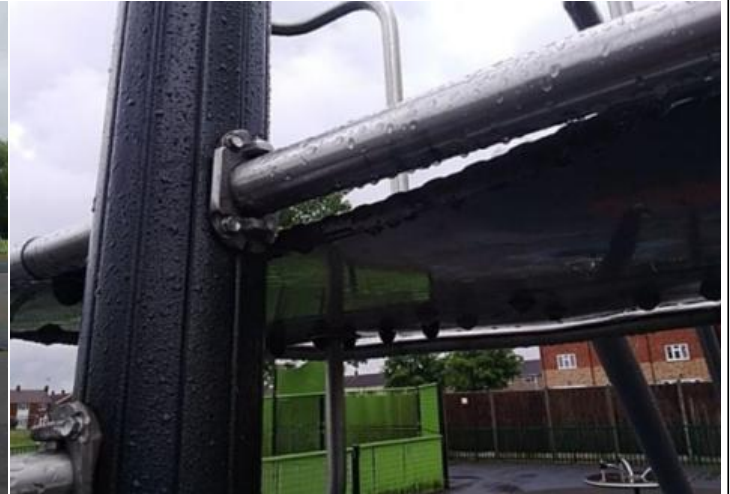
Finding: The platform has been damaged

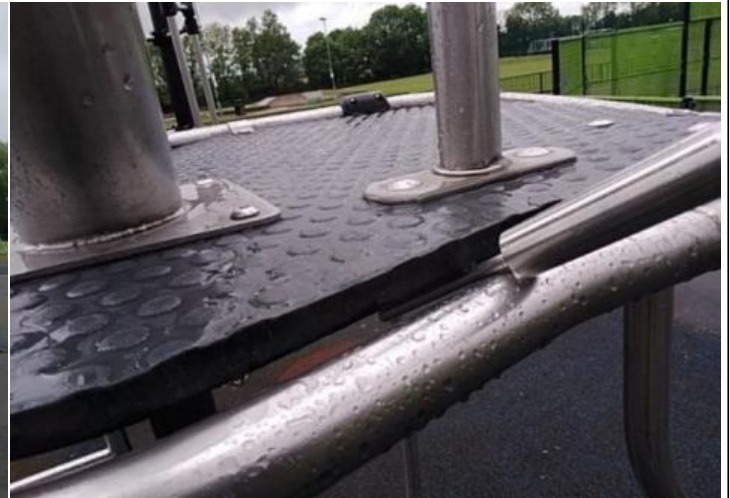
Finding: There is/are finger entrapment/s in the platform and the item fails to meet the requirements of BS EN 1176 Part 1 4.2.7.6 Entrapment of fingers

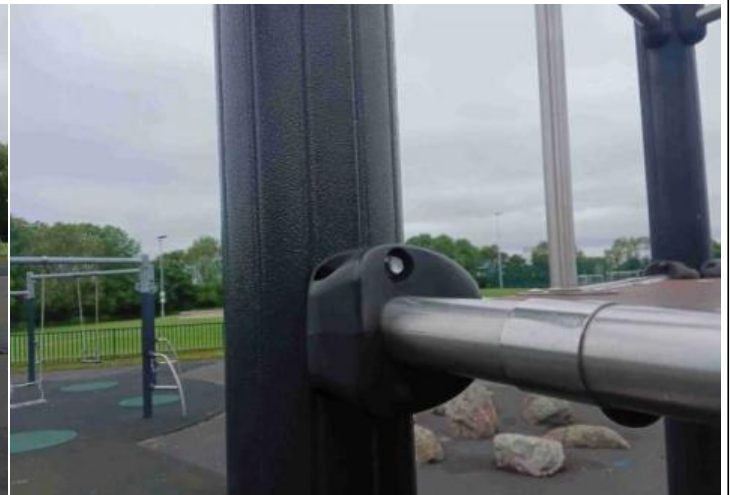
Finding: There is/are inserts missing

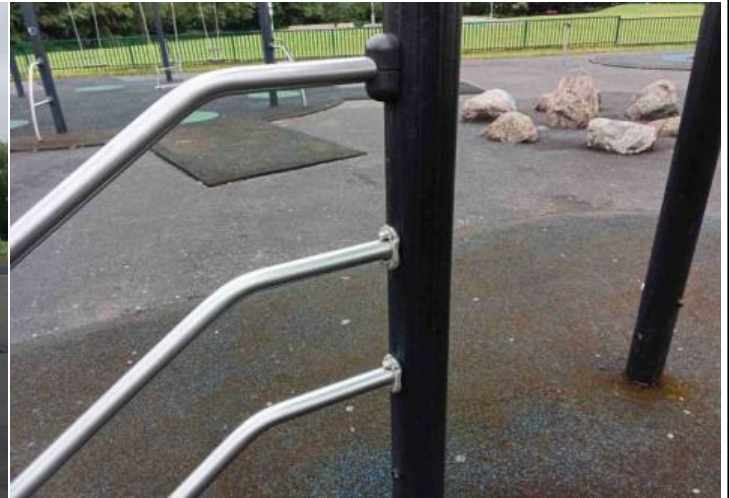
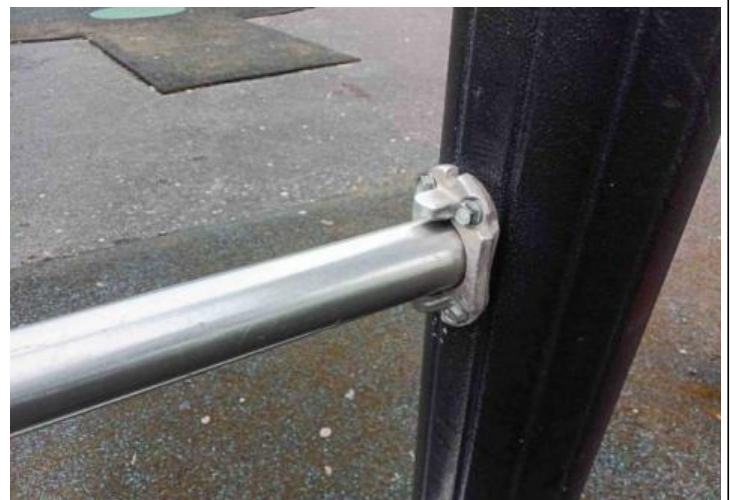
Finding: There is/are bolt cap covers missing or damaged on the item

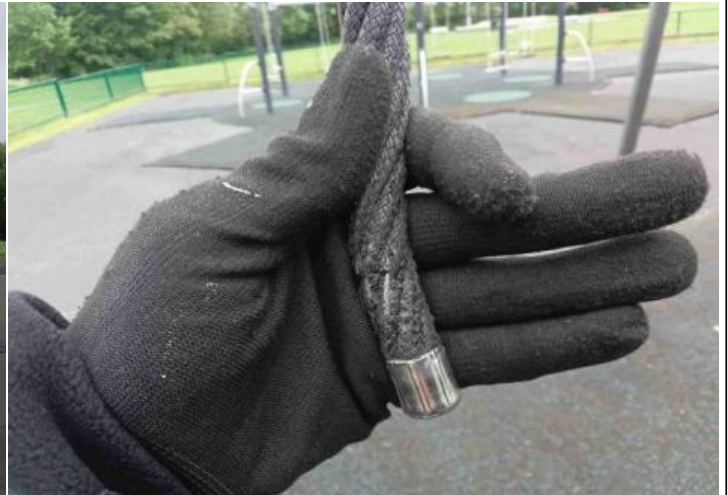
Finding: The ropes/nets are worn/damaged in places

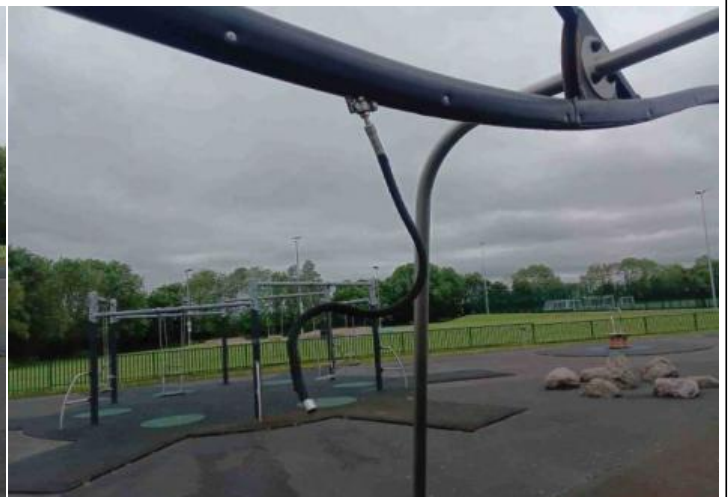
Finding: The item has missing component(s)

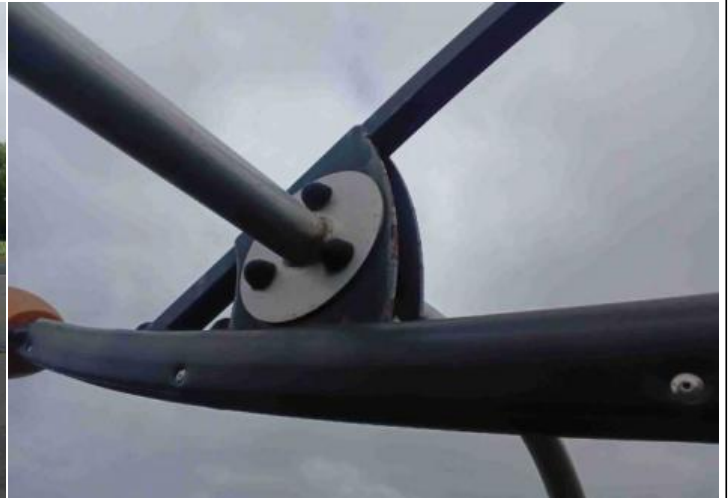
Finding: The paintwork on this item has been damaged or worn exposing the metal underneath which is rusting / corroding

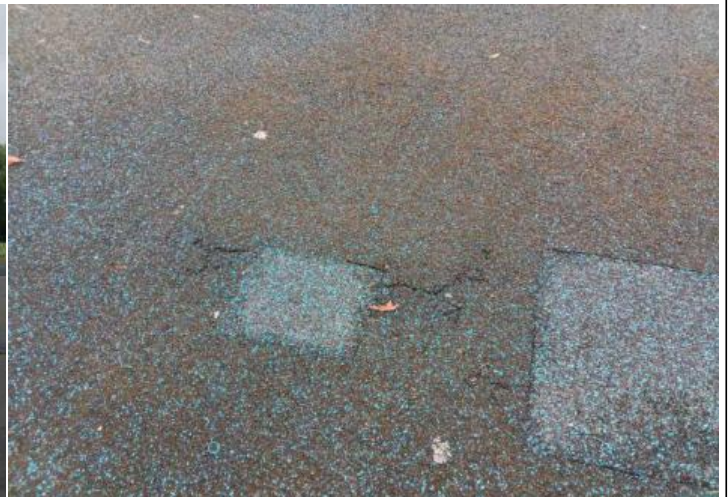
Finding: There is some minor damage to the surface

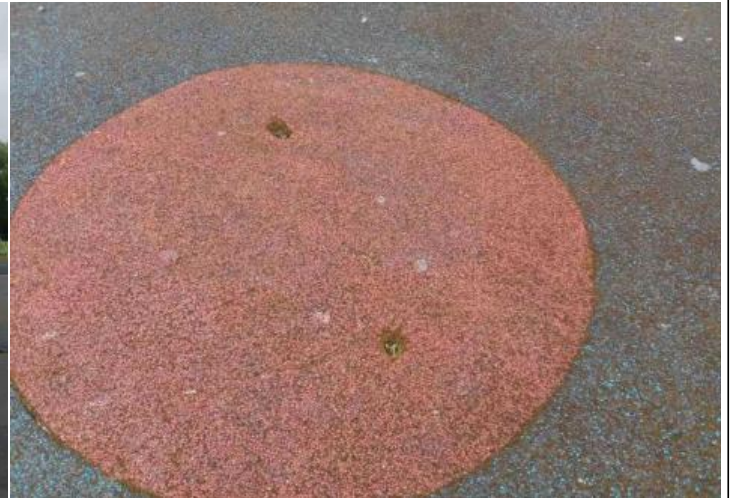
Finding: There is moderate damage to the surface

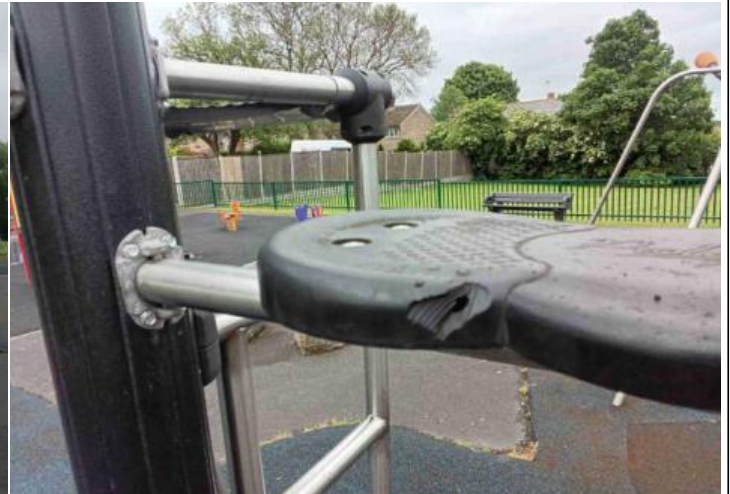
Finding: The item has been damaged
