## Asbestos Refurbishment/Demolition Survey for West Parley Sports & Social Club

West Parley Sports & Social Club  
275 Christchurch Road  
West Parley  
Ferndown  
Dorset  
BH22 8SQ

Project Number: AS9823

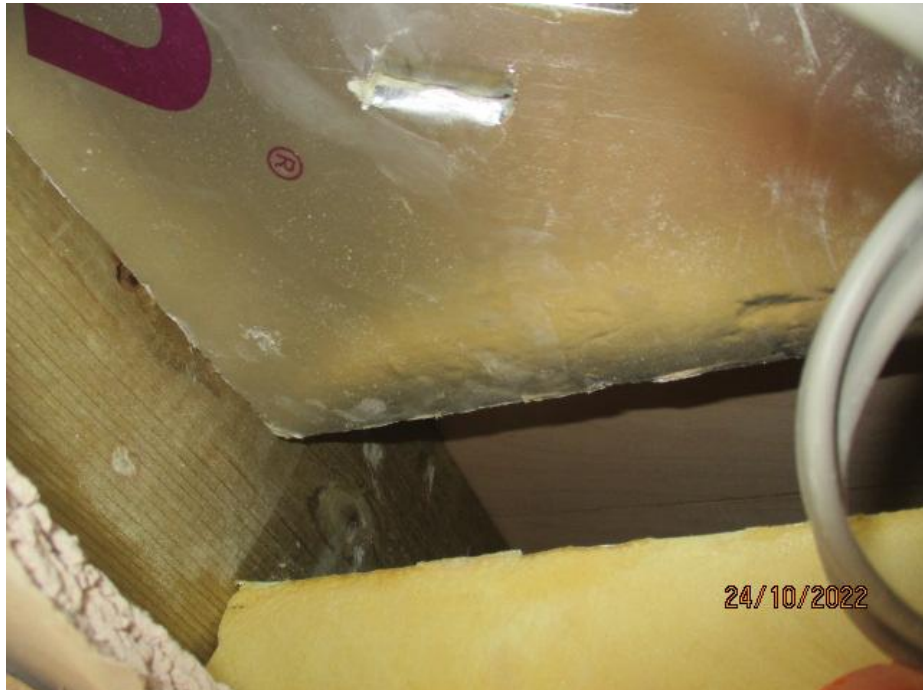
Location ID:	68328	Survey Type:	RDS
Location Ref:	Visual ID	Product Type:	Not Applicable
Product:	Non Asbestos Materials	Damage:	Not Applicable
Area:	01	Treatment:	Not Applicable
Floor:	First floor	Asbestos Type:	Not Applicable
Room:	Bedroom	Identification:	
Surveyor Name:	Andrew Mayes	Quantity:	
Drawing Ref:	01		
Asbestos ?	No		
Date:	24 October 2022		
Next Inspection:	Not Applicable

Ceiling void accessed to show timber and foam insulation. No ACM's present where inspected.

No Action Required

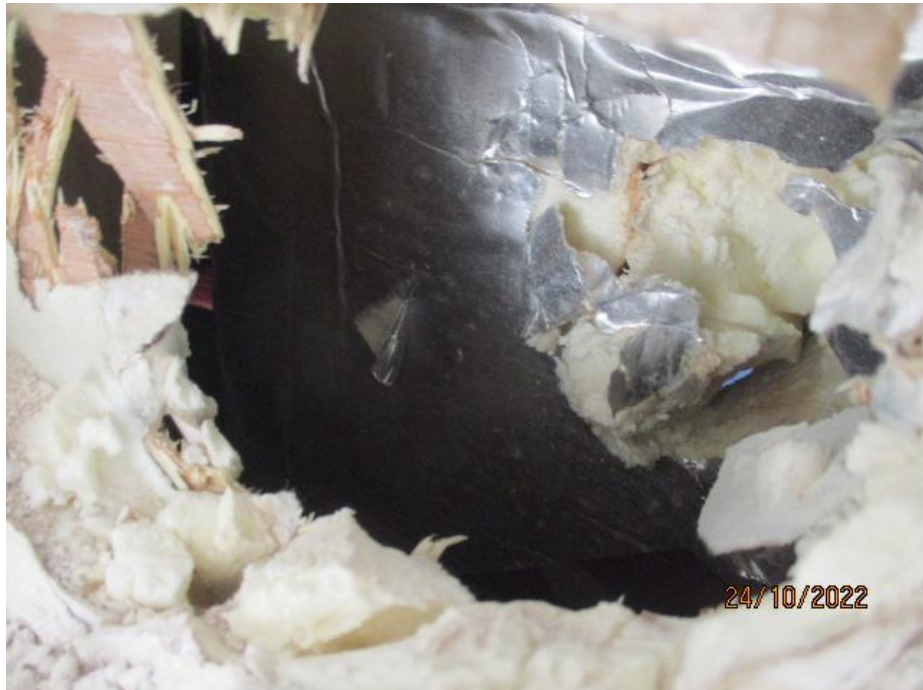
Location ID:	68330	Survey Type:	RDS
Location Ref:	Visual ID	Product Type:	Not Applicable
Product:	Non Asbestos Materials	Damage:	Not Applicable
Area:	01	Treatment:	Not Applicable
Floor:	First floor	Asbestos Type:	Not Applicable
Room:	Bedroom	Identification:	
Surveyor Name:	Andrew Mayes	Quantity:	
Drawing Ref:	01		
Asbestos ?	No		
Date:	24 October 2022		
Next Inspection:	Not Applicable

Wall void accessed to show foam insulation. No ACM's present where inspected.

No Action Required

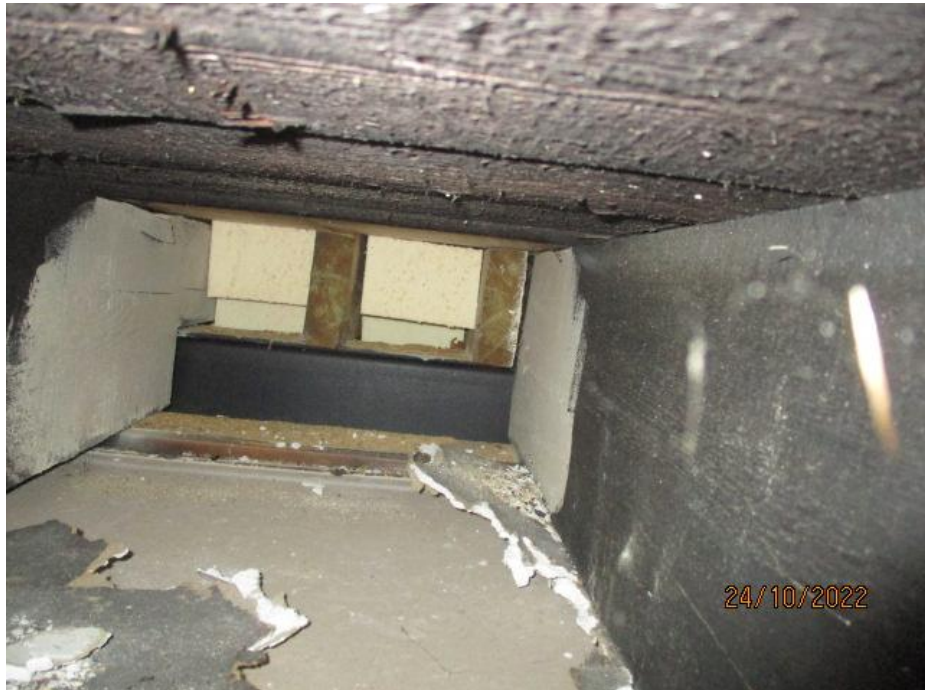
Location ID:	68327	Survey Type:	RDS
Location Ref:	Visual ID	Product Type:	Not Applicable
Product:	Limited Access	Damage:	Not Applicable
Area:	01	Treatment:	Not Applicable
Floor:	First floor	Asbestos Type:	Not Applicable
Room:	Bedroom	Identification:	
Surveyor Name:	Andrew Mayes	Quantity:	
Drawing Ref:	01		
Asbestos ?	No		
Date:	24 October 2022		
Next Inspection:	Not Applicable

Material Comments: Limited access to floor void. No ACM's present where inspected.

Action: Proceed With Caution

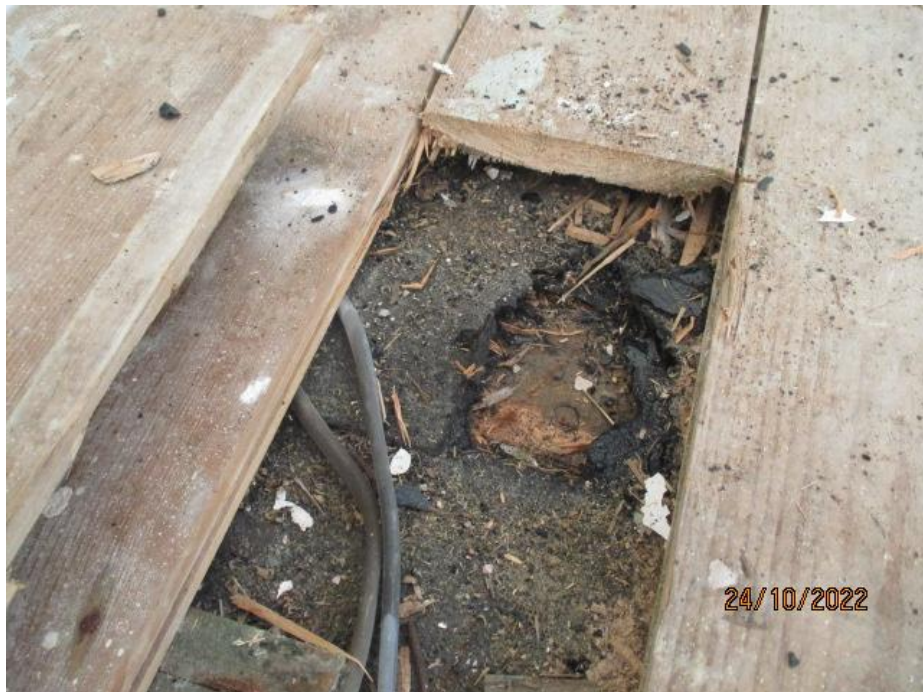
Location ID:	68331	Survey Type:	RDS
Location Ref:	Sample 1	Product Type:	NADIS
Product:	Textured coating	Damage:	NADIS
Area:	02	Treatment:	NADIS
Floor:	First floor	Asbestos Type:	NADIS
Room:	Bedroom	Identification:	Identified
Surveyor Name:	Andrew Mayes	Quantity:	Throughout
Drawing Ref:	02		
Asbestos ?	No		
Date:	24 October 2022		
Next Inspection:	Not Applicable

Bitumen to timber under floor board where roof has previously been. Presumed to run throughout the floor void on the first floor.

No Action Required

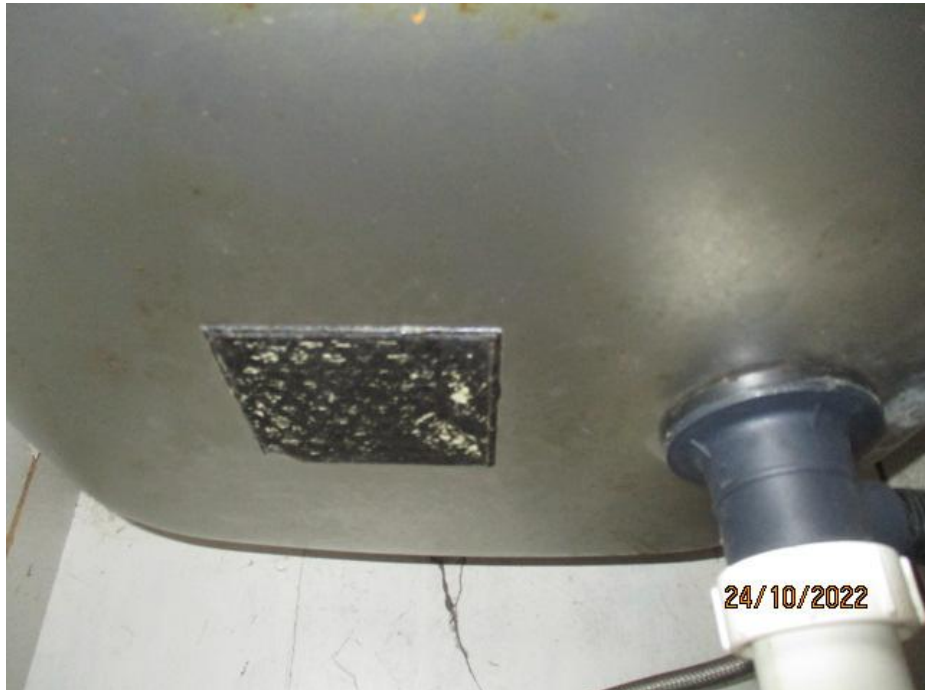
Location ID:	68332	Survey Type:	RDS
Location Ref:	Sample 2	Product Type:	NADIS
Product:	Sink & Drainer Pads	Damage:	NADIS
Area:	04	Treatment:	NADIS
Floor:	First floor	Asbestos Type:	NADIS
Room:	Kitchen	Identification:	Identified
Surveyor Name:	Andrew Mayes	Quantity:	Small
Drawing Ref:	04		
Asbestos ?	No		
Date:	24 October 2022		
Next Inspection:	Not Applicable

Sink pad to underside of sink.

No Action Required

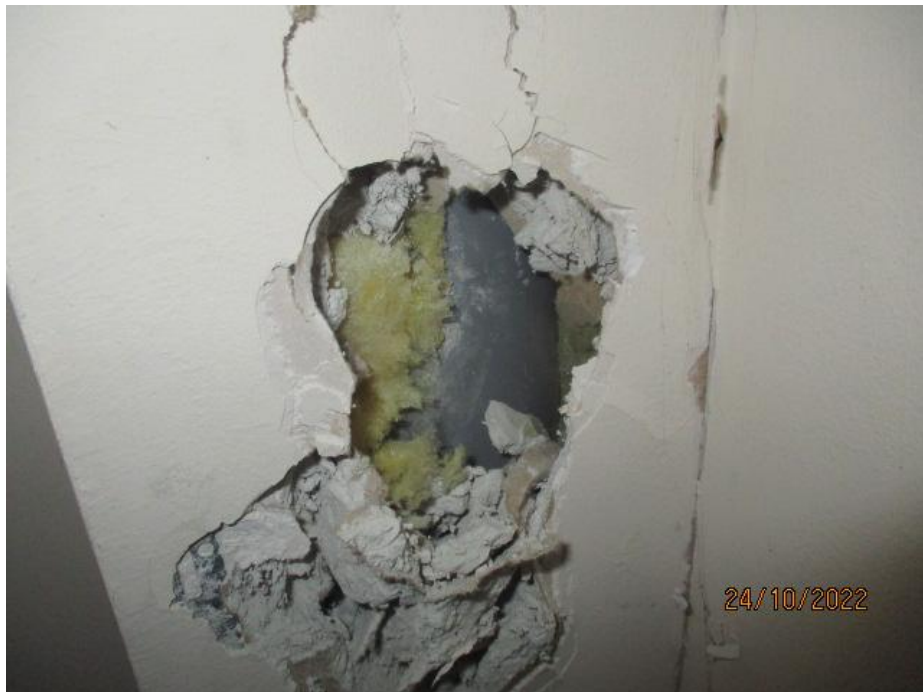
Location ID:	68334	Survey Type:	RDS
Location Ref:	Visual ID	Product Type:	Not Applicable
Product:	Non Asbestos Materials	Damage:	Not Applicable
Area:	05	Treatment:	Not Applicable
Floor:	First floor	Asbestos Type:	Not Applicable
Room:	Toilet	Identification:	
Surveyor Name:	Andrew Mayes	Quantity:	
Drawing Ref:	05		
Asbestos ?	No		
Date:	24 October 2022		
Next Inspection:	Not Applicable

Riser accessed to show soil stack pipe. No ACM's present where inspected.

No Action Required

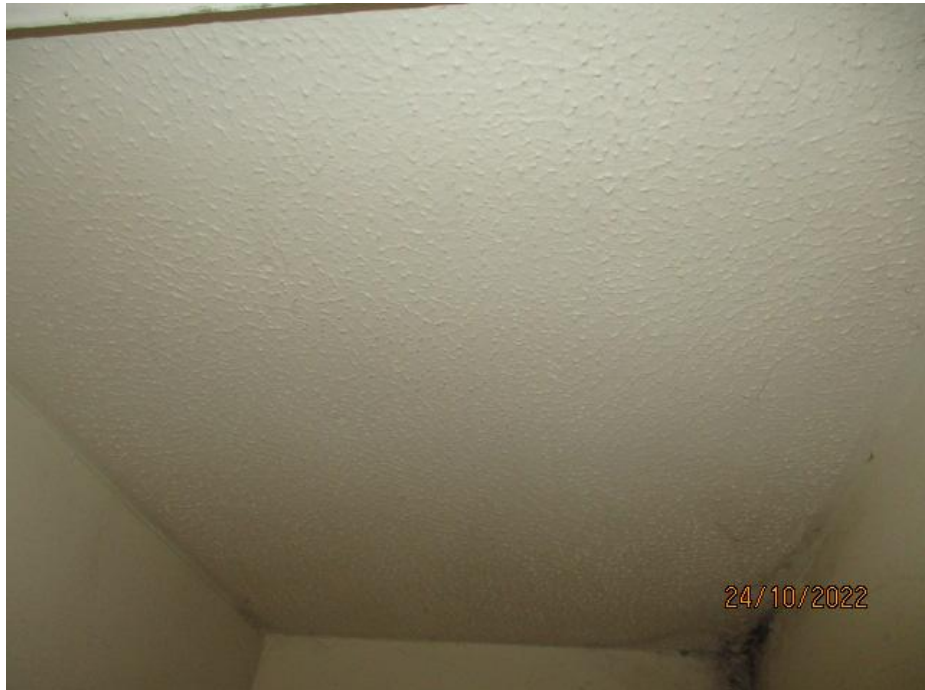
Location ID:	68333	Survey Type:	RDS
Location Ref:	Sample 3	Product Type:	Textured coatings
Product:	Textured coating	Damage:	Good condition
Area:	06	Treatment:	Decorative Paints
Floor:	First floor	Asbestos Type:	Chrysotile
Room:	Stairs & landing	Identification:	Identified
Surveyor Name:	Andrew Mayes	Quantity:	2m <sup>2</sup>
Drawing Ref:	06		
Asbestos ?	Yes		
Date:	24 October 2022		
Next Inspection:	24 October 2023

Textured coating to plasterboard ceiling within x2 cupboards.

Removal if works require

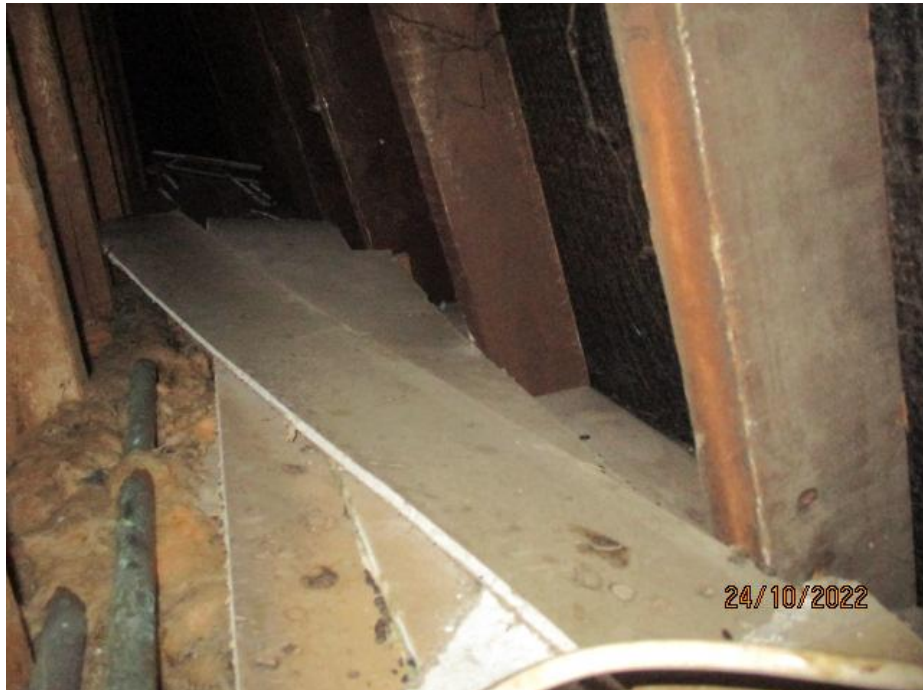
Location ID:	68335	Survey Type:	RDS
Location Ref:	Visual ID	Product Type:	Not Applicable
Product:	Limited Access	Damage:	Not Applicable
Area:	06	Treatment:	Not Applicable
Floor:	First floor	Asbestos Type:	Not Applicable
Room:	Stairs & landing	Identification:	
Surveyor Name:	Andrew Mayes	Quantity:	
Drawing Ref:	06		
Asbestos ?	No		
Date:	24 October 2022		
Next Inspection:	Not Applicable

Limited access to undercroft due to lack of crawl space. No ACM's present where inspected.

Proceed With Caution

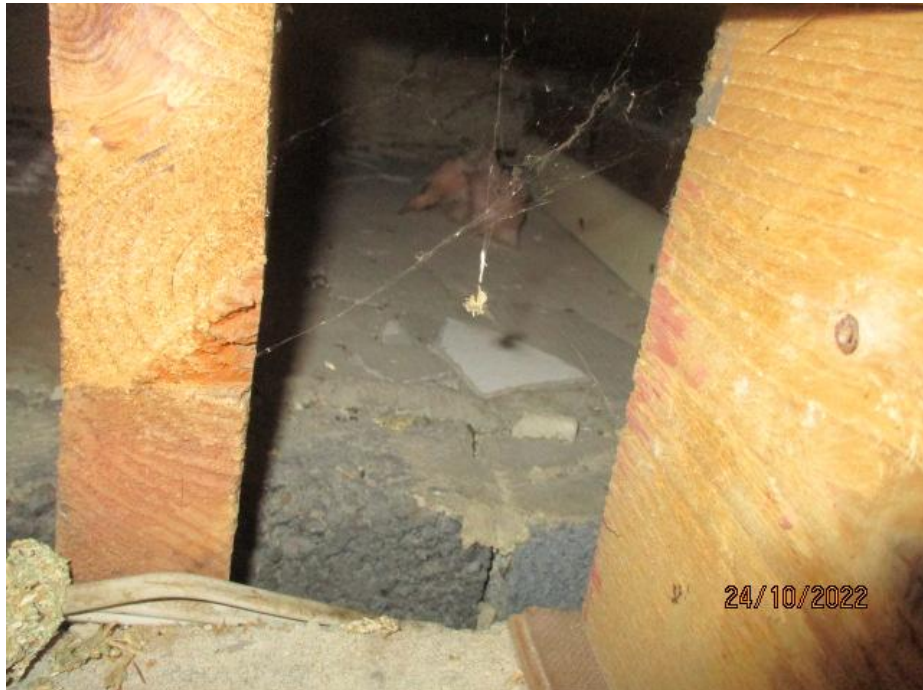
Location ID:	68337	Survey Type:	RDS
Location Ref:	Sample 5	Product Type:	Asbestos cement
Product:	Cement	Damage:	High damage: Visible debris
Area:	07	Treatment:	Debris
Floor:	First floor	Asbestos Type:	Chrysotile
Room:	Changing room 1	Identification:	Identified
Surveyor Name:	Andrew Mayes	Quantity:	Small
Drawing Ref:	07		
Asbestos ?	Yes		
Date:	24 October 2022		
Next Inspection:	24 October 2023

Asbestos cement debris within floor void.

Remove As Per CAR 2012 In Compliance With HSE

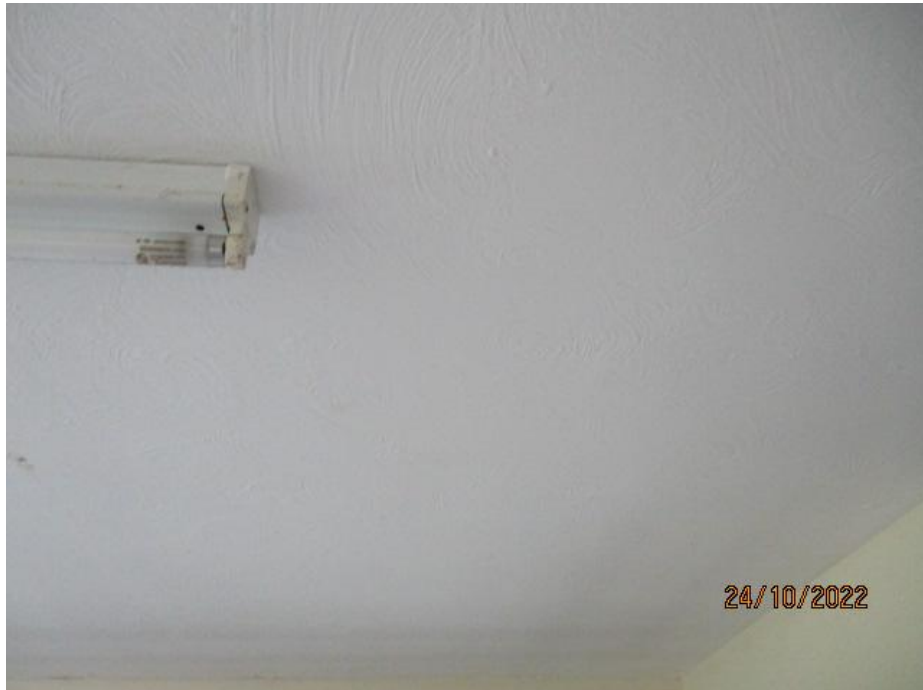
Location ID:	68336	Survey Type:	RDS
Location Ref:	Sample 4	Product Type:	NADIS
Product:	Textured coating	Damage:	NADIS
Area:	07	Treatment:	NADIS
Floor:	First floor	Asbestos Type:	NADIS
Room:	Changing room 2	Identification:	Identified
Surveyor Name:	Andrew Mayes	Quantity:	18m <sup>2</sup>
Drawing Ref:	07		
Asbestos ?	No		
Date:	24 October 2022		
Next Inspection:	Not Applicable

Textured coating to plasterboard ceiling.

No Action Required

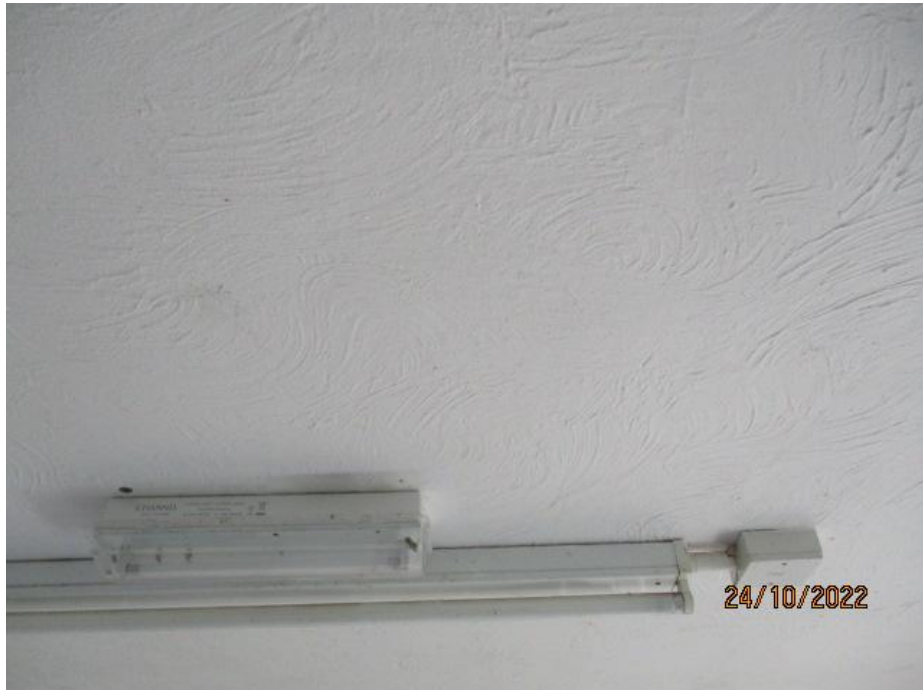
Location ID:	68338	Survey Type:	RDS
Location Ref:	Visual ID To Sample 4	Product Type:	NADIS
Product:	Textured coating	Damage:	NADIS
Area:	08	Treatment:	NADIS
Floor:	First floor	Asbestos Type:	NADIS
Room:	Changing room 1	Identification:	Identified
Surveyor Name:	Andrew Mayes	Quantity:	18m <sup>2</sup>
Drawing Ref:	08		
Asbestos ?	No		
Date:	24 October 2022		
Next Inspection:	Not Applicable

Textured coating to plasterboard ceiling.

No Action Required

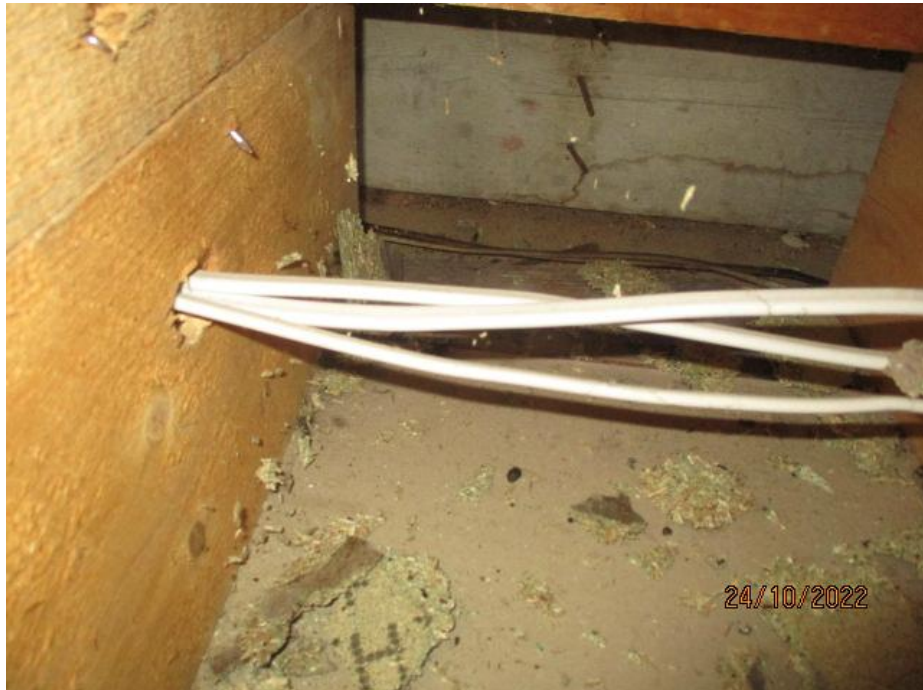
Location ID:	68339	Survey Type:	RDS
Location Ref:	Visual ID	Product Type:	Not Applicable
Product:	Limited Access	Damage:	Not Applicable
Area:	08	Treatment:	Not Applicable
Floor:	First floor	Asbestos Type:	Not Applicable
Room:	Changing room 1	Identification:	
Surveyor Name:	Andrew Mayes	Quantity:	
Drawing Ref:	08		
Asbestos ?	No		
Date:	24 October 2022		
Next Inspection:	Not Applicable

Limited access to floor void. No ACM's present where inspected.

No Action Required

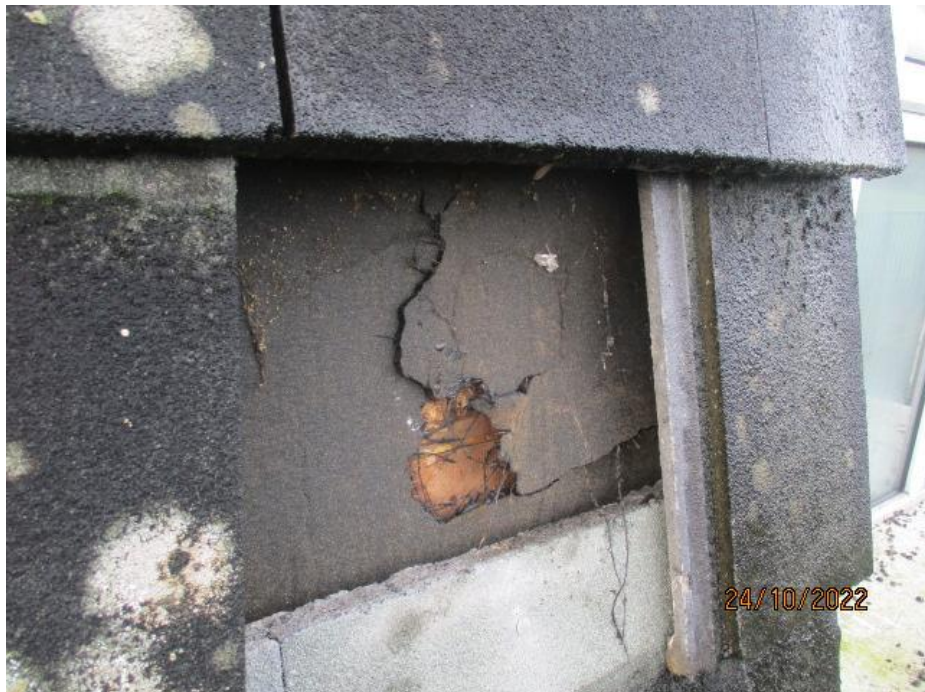
Location ID:	68341	Survey Type:	RDS
Location Ref:	Sample 7	Product Type:	Not Applicable
Product:	Sarking Felt	Damage:	Not Applicable
Area:	09	Treatment:	Not Applicable
Floor:	First floor	Asbestos Type:	Not Applicable
Room:	Externals	Identification:	
Surveyor Name:	Andrew Mayes	Quantity:	
Drawing Ref:	09		
Asbestos ?	No		
Date:	24 October 2022		
Next Inspection:	Not Applicable

Material Comments: Sarking felt to first floor upstands & external cladding.

Action: No Action Required

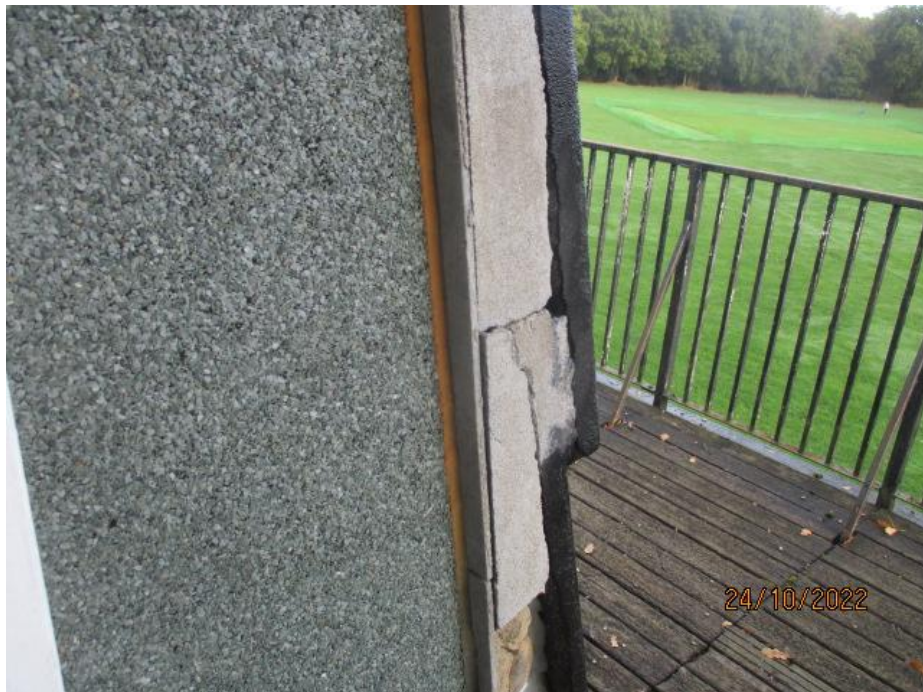
Location ID:	68340	Survey Type:	RDS
Location Ref:	Sample 6	Product Type:	NADIS
Product:	Undercloaking	Damage:	NADIS
Area:	09	Treatment:	NADIS
Floor:	First floor	Asbestos Type:	NADIS
Room:	Externals	Identification:	Identified
Surveyor Name:	Andrew Mayes	Quantity:	>30 Linear Metres
Drawing Ref:	09		
Asbestos ?	No		
Date:	24 October 2022		
Next Inspection:	Not Applicable

Cement undercloaking to ends of wall.

No Action Required

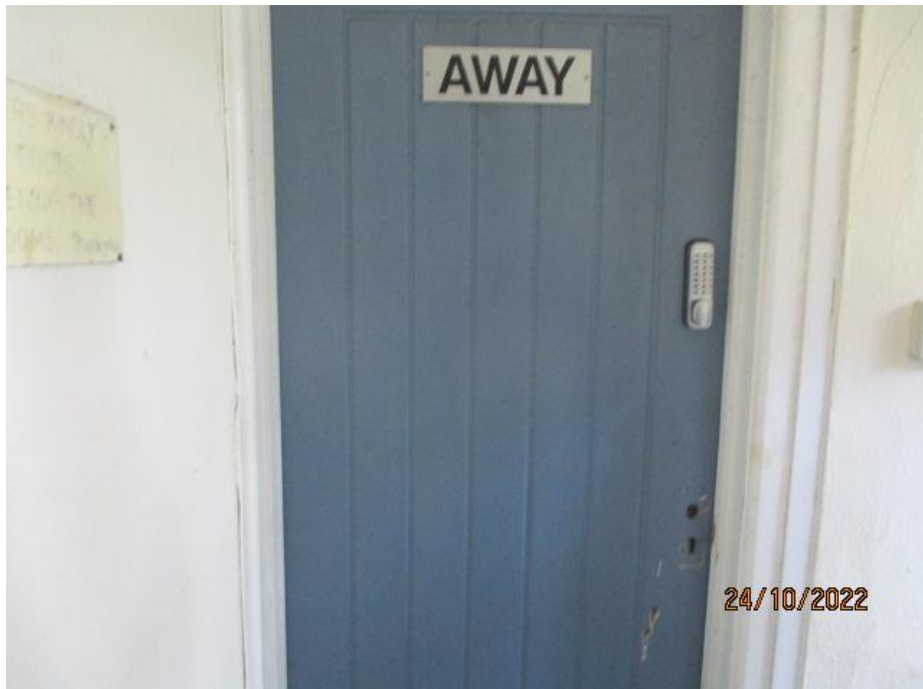
Location ID:	68343	Survey Type:	RDS
Location Ref:	Visual ID	Product Type:	Not Applicable
Product:	No Access	Damage:	Not Applicable
Area:	11	Treatment:	Not Applicable
Floor:	Ground floor	Asbestos Type:	Not Applicable
Room:	Away Changing Room	Identification:	
Surveyor Name:	Andrew Mayes	Quantity:	
Drawing Ref:	11		
Asbestos ?	No		
Date:	24 October 2022		
Next Inspection:	Not Applicable

Material Comments: Area not accessed at time of survey as locked and no key provided. Assumed similar in construction type to adjoining rooms.

Action: Proceed With Caution

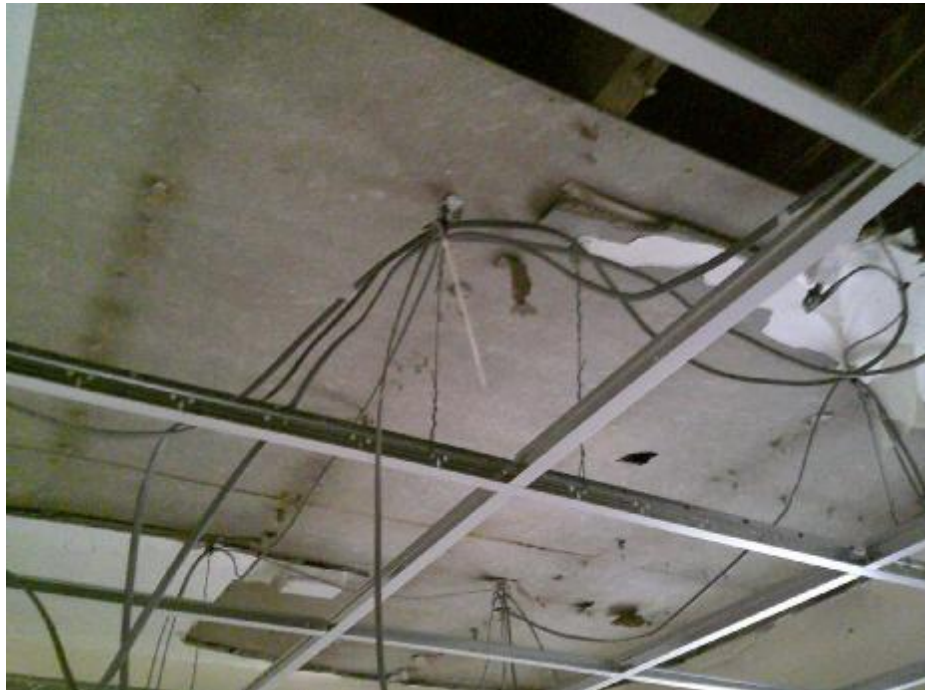
Location ID:	71506	Survey Type:	RDS
Location Ref:	Visual ID	Product Type:	Asbestos cement
Product:	Cement	Damage:	Low damage
Area:	12	Treatment:	Asbestos cement sheets etc
Floor:	Ground floor	Asbestos Type:	Chrysotile
Room:	Toilets	Identification:	Strongly Presumed
Surveyor Name:	Andrew Mayes	Quantity:	6m <sup>2</sup>
Drawing Ref:	12		
Asbestos ?	Yes		
Date:	24 October 2022		
Next Inspection:	24 October 2023

Asbestos cement ceiling in female toilet only. There was a false plasterboard ceiling in place which still part remains.

Remove As Per CAR 2012 In Compliance With HSE

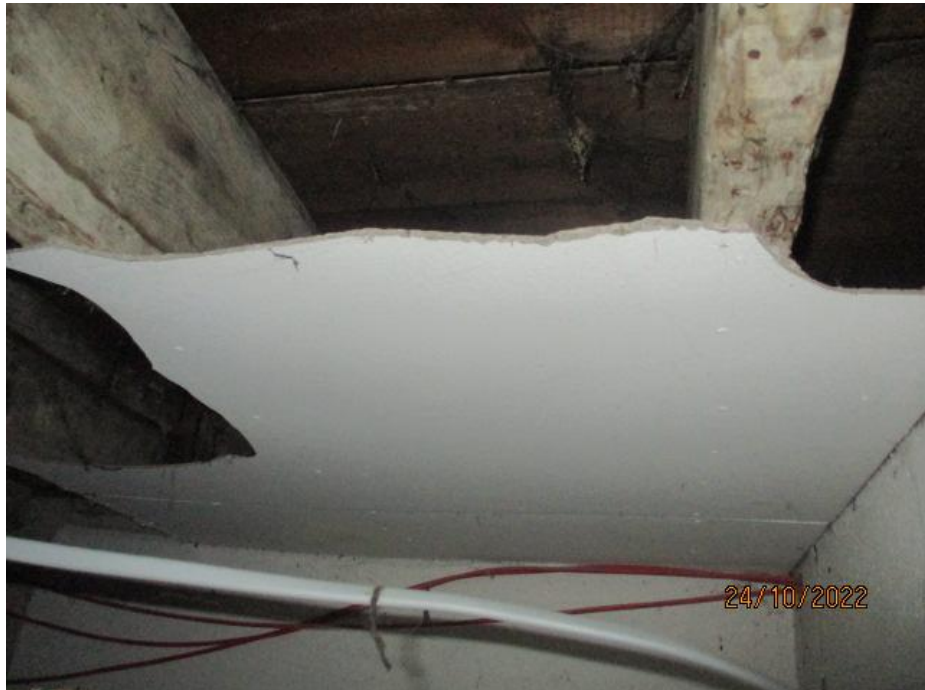
Location ID:	68345	Survey Type:	RDS
Location Ref:	Visual ID To Sample 8	Product Type:	Asbestos cement
Product:	Cement board	Damage:	Medium damage
Area:	14	Treatment:	Asbestos cement sheets etc
Floor:	Ground floor	Asbestos Type:	Chrysotile
Room:	Kitchen	Identification:	Strongly Presumed as previous sample
Surveyor Name:	Andrew Mayes	Quantity:	23m <sup>2</sup>
Drawing Ref:	14		
Asbestos ?	Yes		
Date:	24 October 2022		
Next Inspection:	24 October 2023

Asbestos cement sheets above suspended ceiling and plasterboard.

Removal if works require

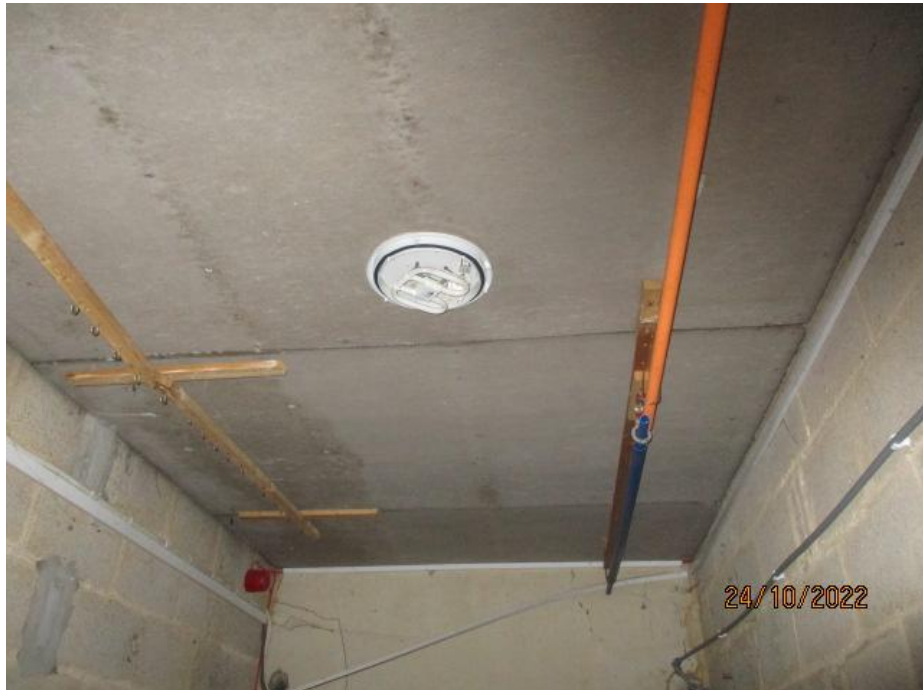
Location ID:	68344	Survey Type:	RDS
Location Ref:	Sample 8	Product Type:	Asbestos cement
Product:	Cement board	Damage:	Low damage
Area:	15	Treatment:	Asbestos cement sheets etc
Floor:	Ground floor	Asbestos Type:	Chrysotile
Room:	Tank room	Identification:	Identified
Surveyor Name:	Andrew Mayes	Quantity:	10m <sup>2</sup>
Drawing Ref:	15		
Asbestos ?	Yes		
Date:	24 October 2022		
Next Inspection:	24 October 2023

Material Risk Score:	4
Material Risk Band:	Very Low Risk
Priority Risk Score:	N/A

Material Comments: Cement board to ceiling within walkway towards tank room.

Action: Removal if works require

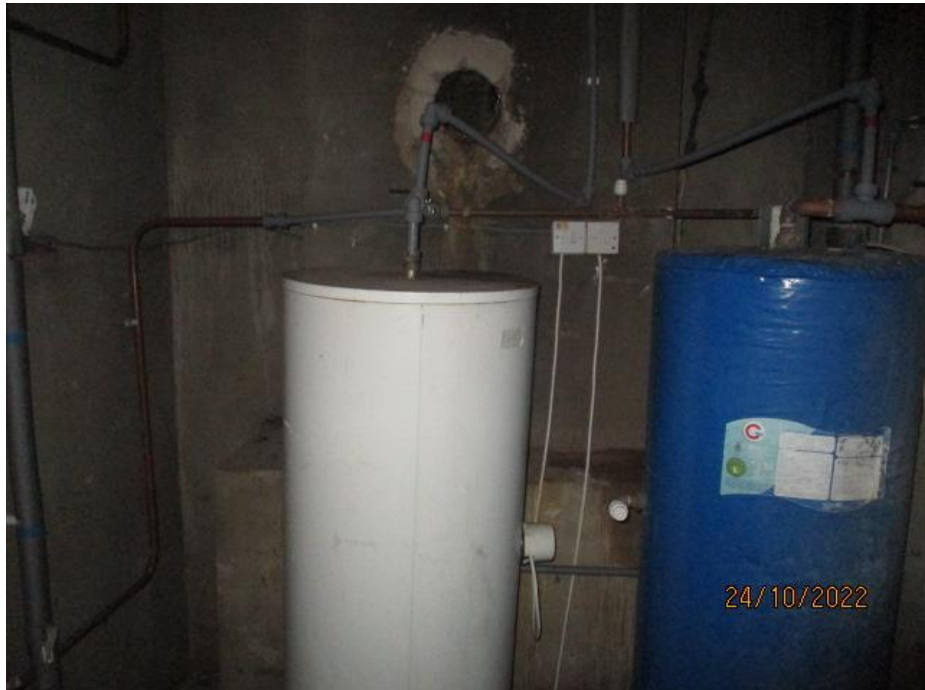
Location ID:	68346	Survey Type:	RDS
Location Ref:	Visual ID	Product Type:	Not Applicable
Product:	Non Asbestos Materials	Damage:	Not Applicable
Area:	15	Treatment:	Not Applicable
Floor:	Ground floor	Asbestos Type:	Not Applicable
Room:	Tank room	Identification:	
Surveyor Name:	Andrew Mayes	Quantity:	
Drawing Ref:	15		
Asbestos ?	No		
Date:	24 October 2022		
Next Inspection:	Not Applicable

Material Comments: Modern non asbestos containing tanks in place.

Action: No Action Required

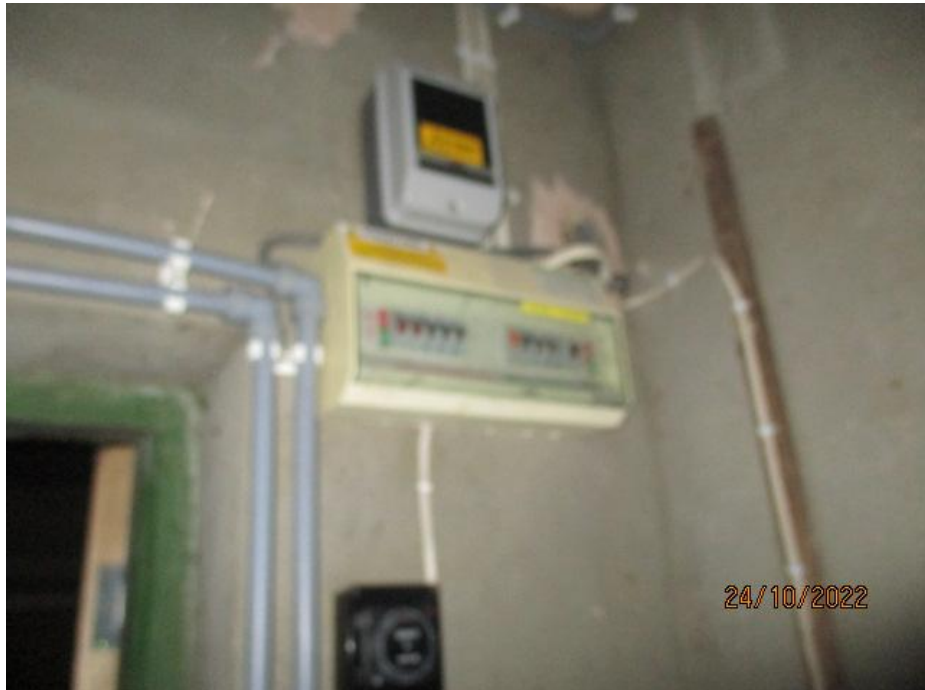
Location ID:	68347	Survey Type:	RDS
Location Ref:	Visual ID	Product Type:	Not Applicable
Product:	Non Asbestos Materials	Damage:	Not Applicable
Area:	15	Treatment:	Not Applicable
Floor:	Ground floor	Asbestos Type:	Not Applicable
Room:	Tank room	Identification:	
Surveyor Name:	Andrew Mayes	Quantity:	
Drawing Ref:	15		
Asbestos ?	No		
Date:	24 October 2022		
Next Inspection:	Not Applicable

Modern non asbestos containing fuse box in place.

No Action Required

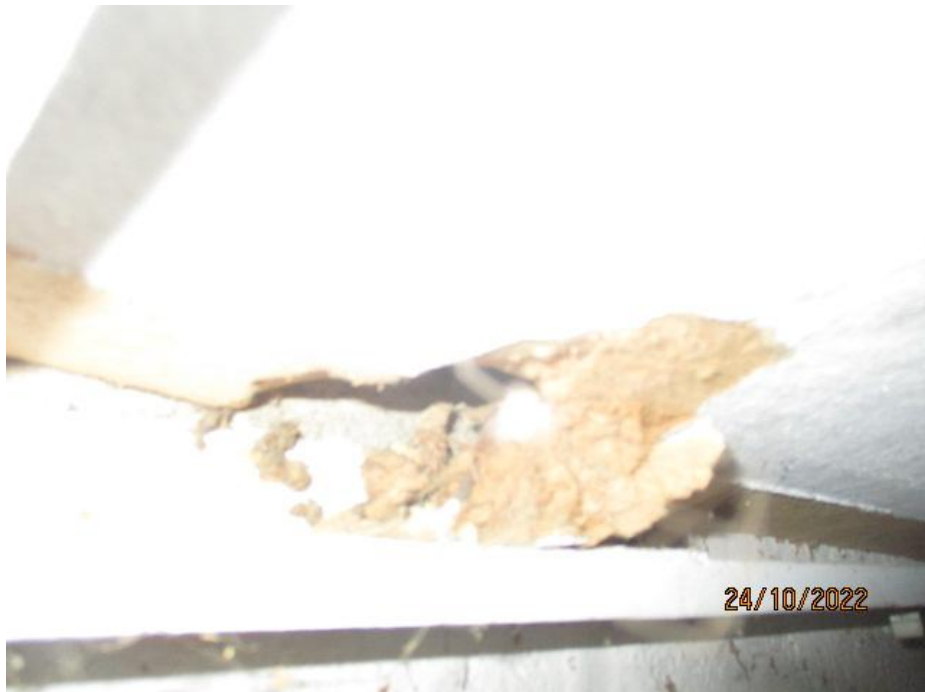
Location ID:	68348	Survey Type:	RDS
Location Ref:	Visual ID	Product Type:	Not Applicable
Product:	Fibreboard	Damage:	Not Applicable
Area:	16	Treatment:	Not Applicable
Floor:	Ground floor	Asbestos Type:	Not Applicable
Room:	Store	Identification:	
Surveyor Name:	Andrew Mayes	Quantity:	
Drawing Ref:	16		
Asbestos ?	No		
Date:	24 October 2022		
Next Inspection:	Not Applicable

Non asbestos fibreboard ceiling above suspended ceiling.

No Action Required

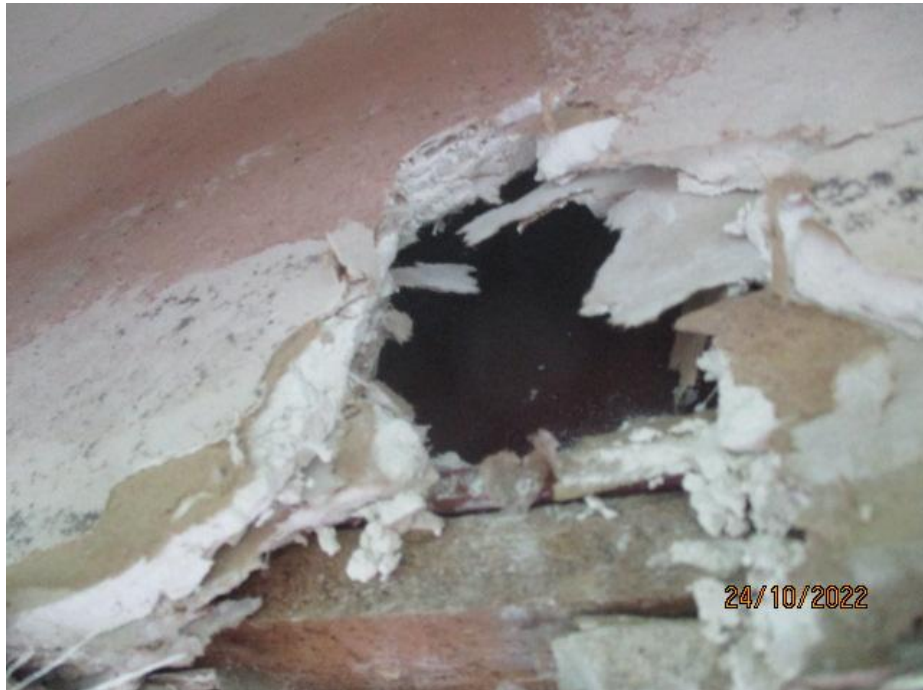
Location ID:	68349	Survey Type:	RDS
Location Ref:	Visual ID	Product Type:	Not Applicable
Product:	Non Asbestos Materials	Damage:	Not Applicable
Area:	17	Treatment:	Not Applicable
Floor:	Ground floor	Asbestos Type:	Not Applicable
Room:	Function Room	Identification:	
Surveyor Name:	Andrew Mayes	Quantity:	
Drawing Ref:	17		
Asbestos ?	No		
Date:	24 October 2022		
Next Inspection:	Not Applicable

Steel beam accessed to show timber and plasterboard cladding. No ACM's present where inspected.

No Action Required

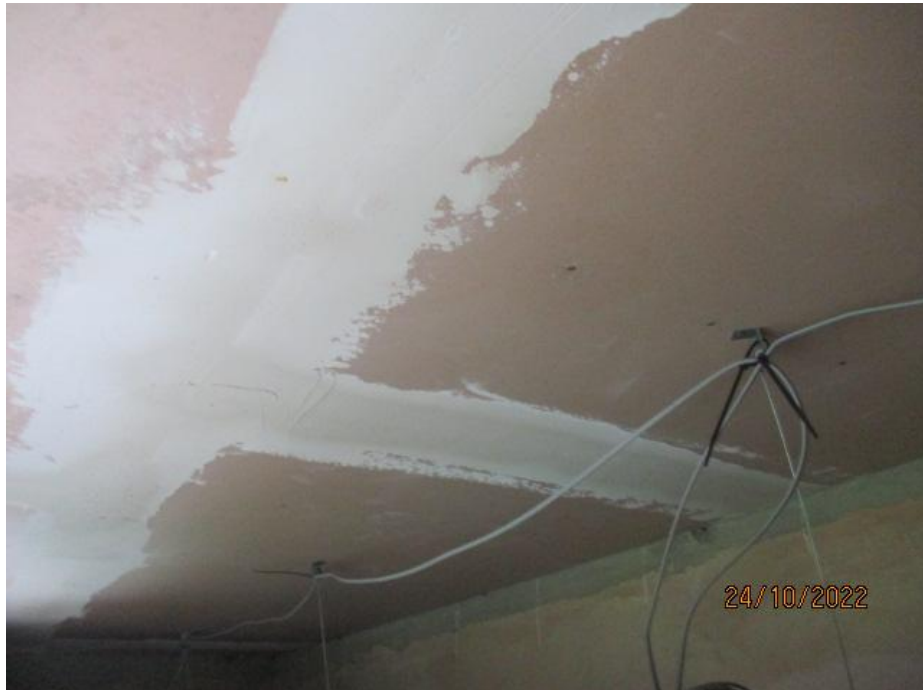
Location ID:	68350	Survey Type:	RDS
Location Ref:	Visual ID	Product Type:	Not Applicable
Product:	No Access	Damage:	Not Applicable
Area:	17	Treatment:	Not Applicable
Floor:	Ground floor	Asbestos Type:	Not Applicable
Room:	Function Room	Identification:	
Surveyor Name:	Andrew Mayes	Quantity:	
Drawing Ref:	17		
Asbestos ?	No		
Date:	24 October 2022		
Next Inspection:	Not Applicable

No access above plasterboard ceiling due to cement debris being present within void.

Proceed With Caution

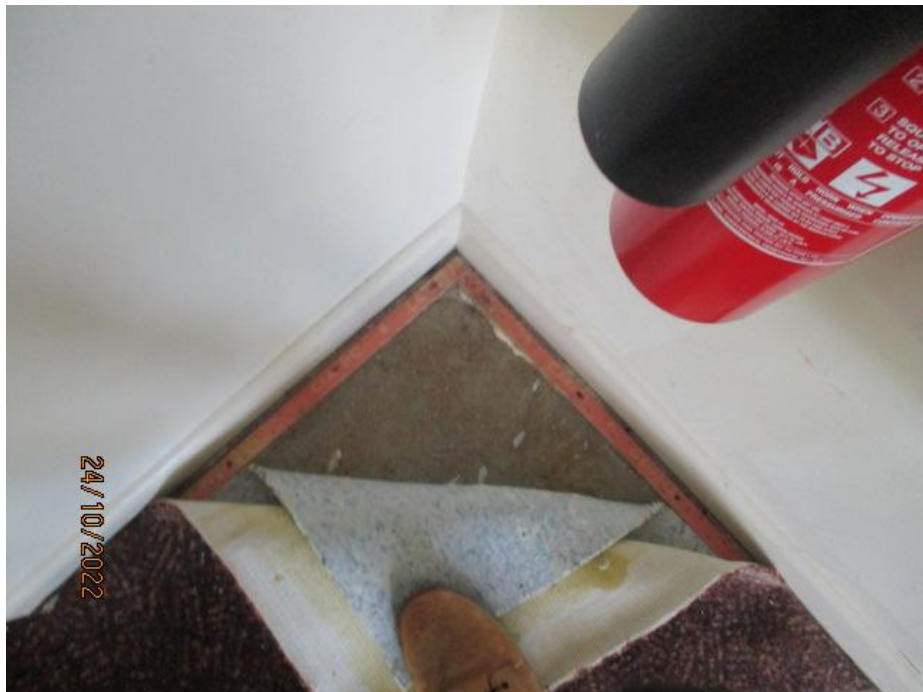
Location ID:	68352	Survey Type:	RDS
Location Ref:	Visual ID	Product Type:	Not Applicable
Product:	Non Asbestos Materials	Damage:	Not Applicable
Area:	18	Treatment:	Not Applicable
Floor:	Ground floor	Asbestos Type:	Not Applicable
Room:	Lounge	Identification:	
Surveyor Name:	Andrew Mayes	Quantity:	
Drawing Ref:	18		
Asbestos ?	No		
Date:	24 October 2022		
Next Inspection:	Not Applicable

Floor void accessed to show carpet over screed. No ACM's present where inspected.

No Action Required

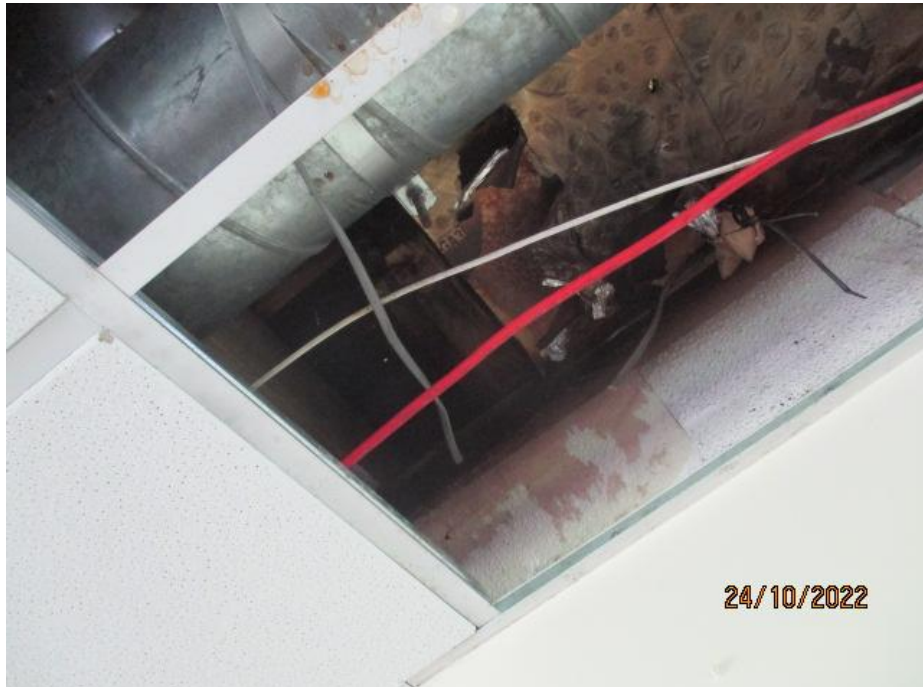
Location ID:	68351	Survey Type:	RDS
Location Ref:	Visual ID	Product Type:	Not Applicable
Product:	Non Asbestos Materials	Damage:	Not Applicable
Area:	18	Treatment:	Not Applicable
Floor:	Ground floor	Asbestos Type:	Not Applicable
Room:	Lounge	Identification:	
Surveyor Name:	Andrew Mayes	Quantity:	
Drawing Ref:	18		
Asbestos ?	No		
Date:	24 October 2022		
Next Inspection:	Not Applicable

Ceiling void accessed to show timber and foam insulation. No ACM's present where inspected.

No Action Required

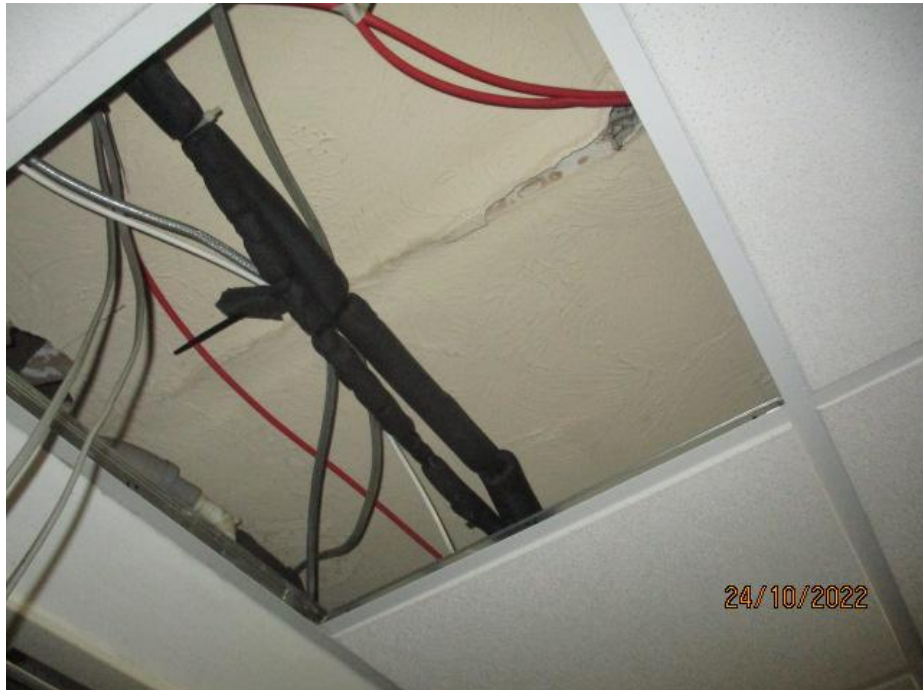
Textured coating to plasterboard ceiling above suspended ceiling.

No Action Required

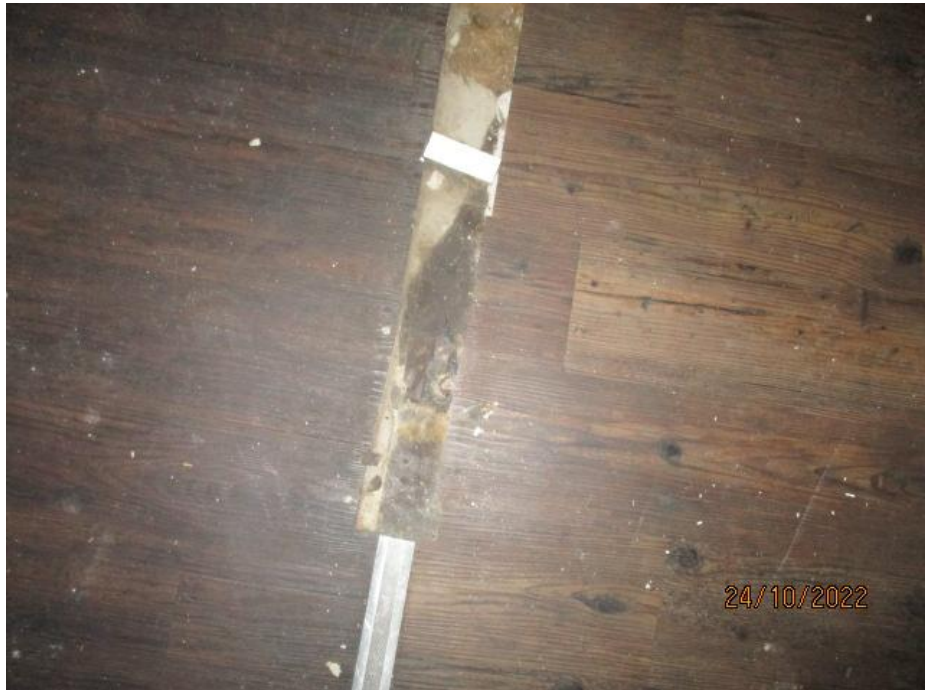
Floor tiles & bitumen adhesive under laminate floor and screed.

Removal if works require

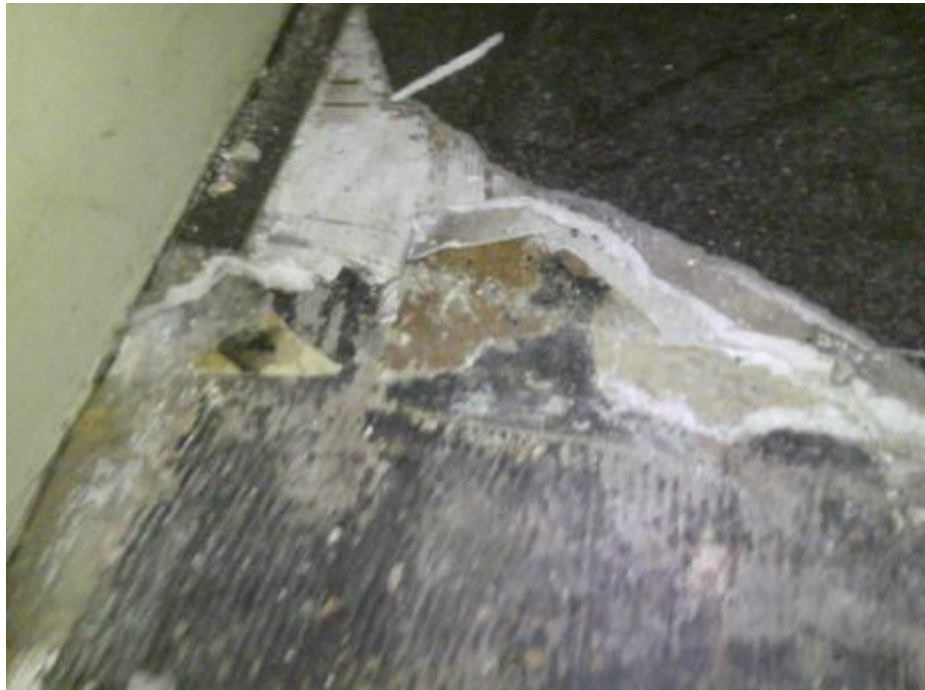
Bitumen adhesive to floor under modern vinyl floor roll & screed in serving area. Bitumen adhesive still present on concrete floor in bar area & rear of bar area under floor finishes.

Removal if works require

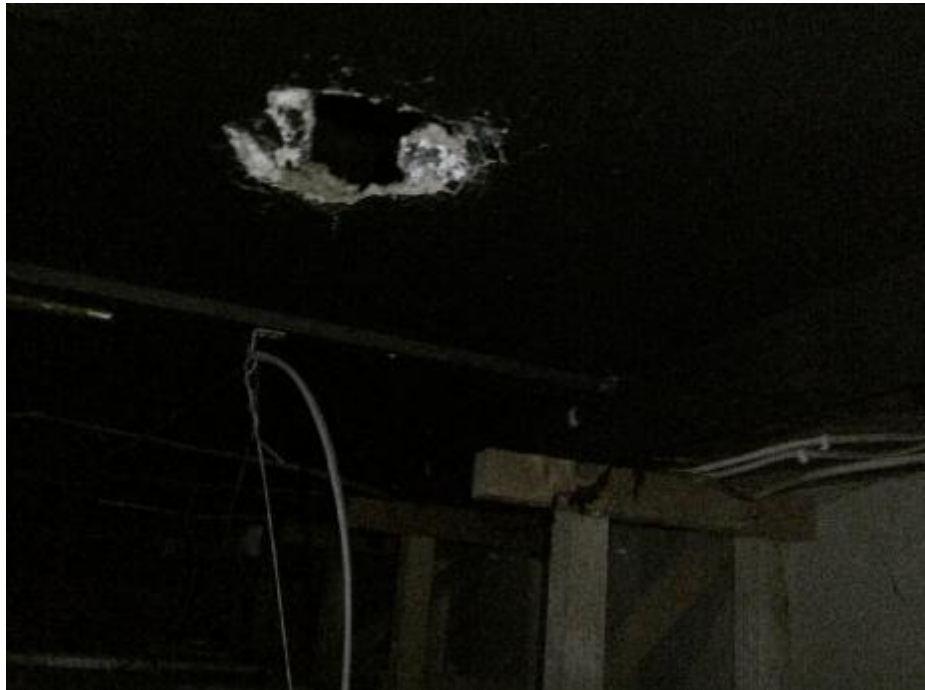
Paper lining to fibreboard ceiling panels above suspended ceiling above serving area of bar only.

No Action Required

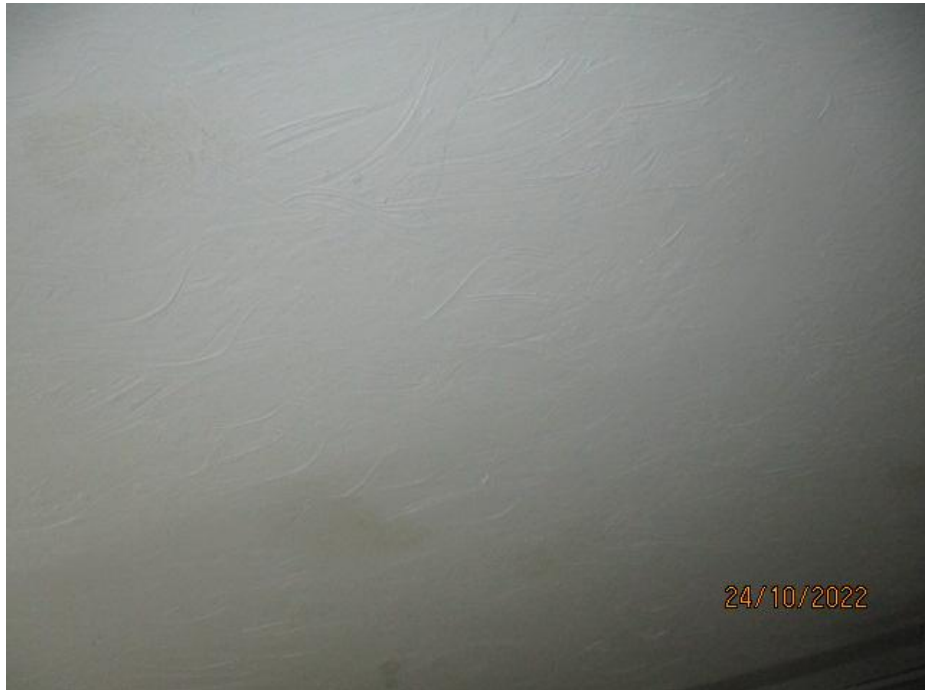
Textured coating to plasterboard ceiling.

No Action Required
