## Asbestos Refurbishment/Demolition Survey for West Parley Sports & Social Club

West Parley Sports & Social Club  
275 Christchurch Road  
West Parley  
Ferndown  
Dorset  
BH22 8SQ

Project Number: AS9823

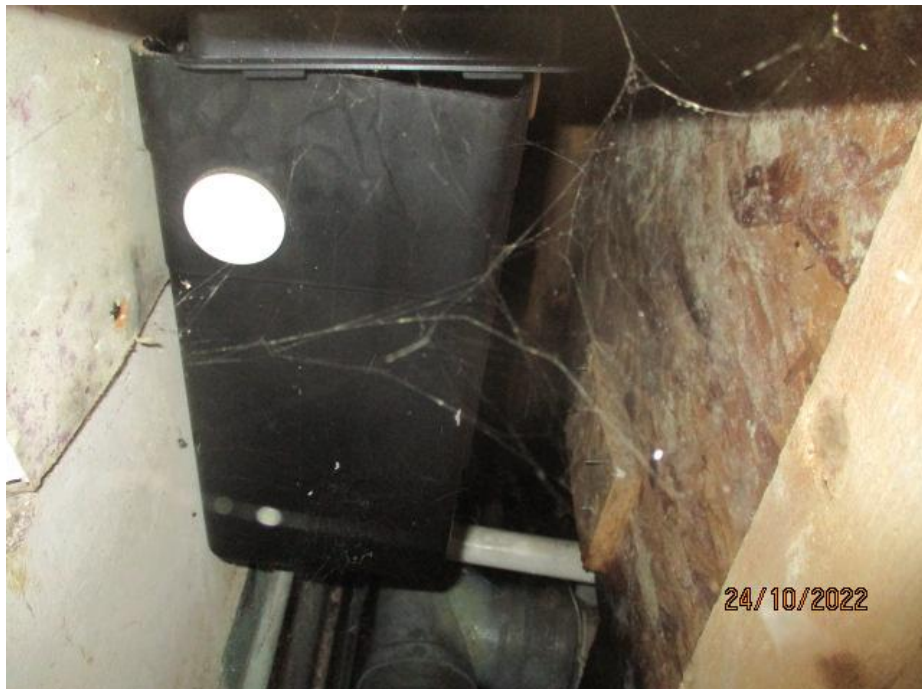
Voids for toilet cisterns accessed. No ACM's present where inspected.

No Action Required

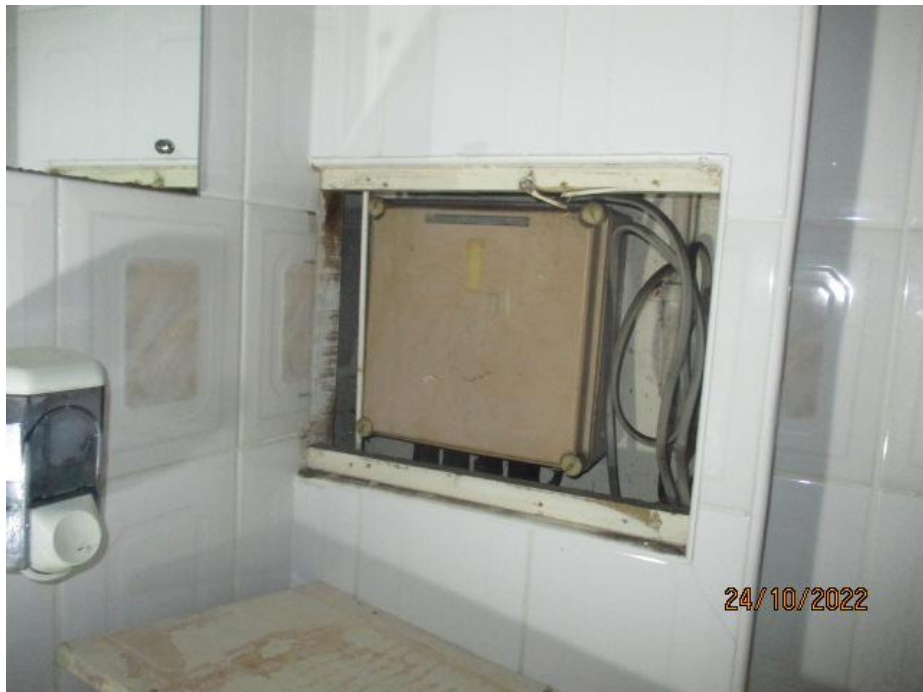
Riser accessed to show non asbestos containing fuse box in place.

No Action Required

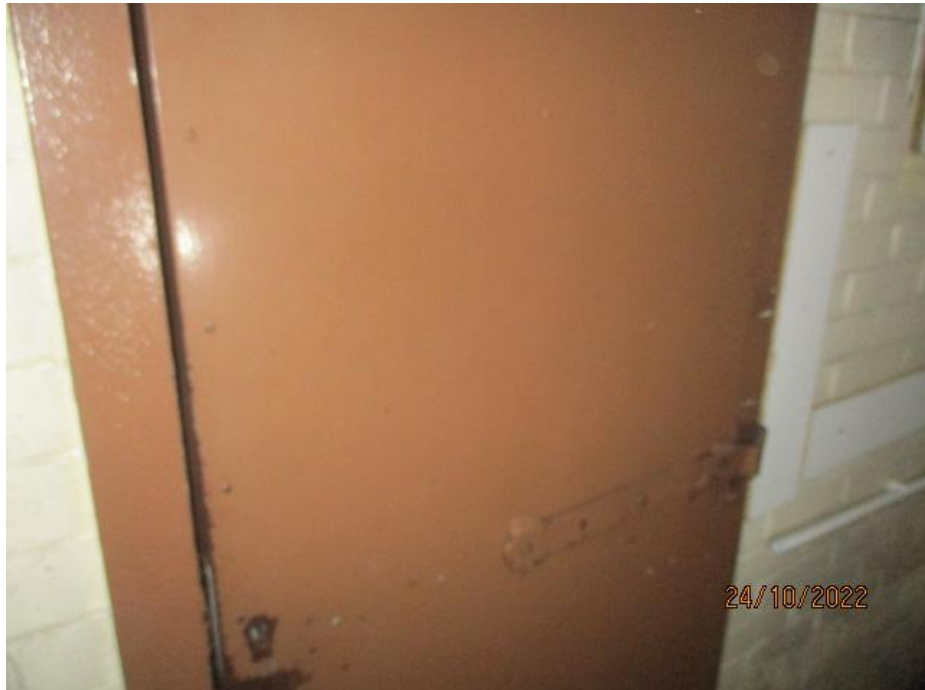
Area not accessed at time of survey as locked and no key provided. Assumed similar in construction type to adjoining rooms.

Proceed With Caution

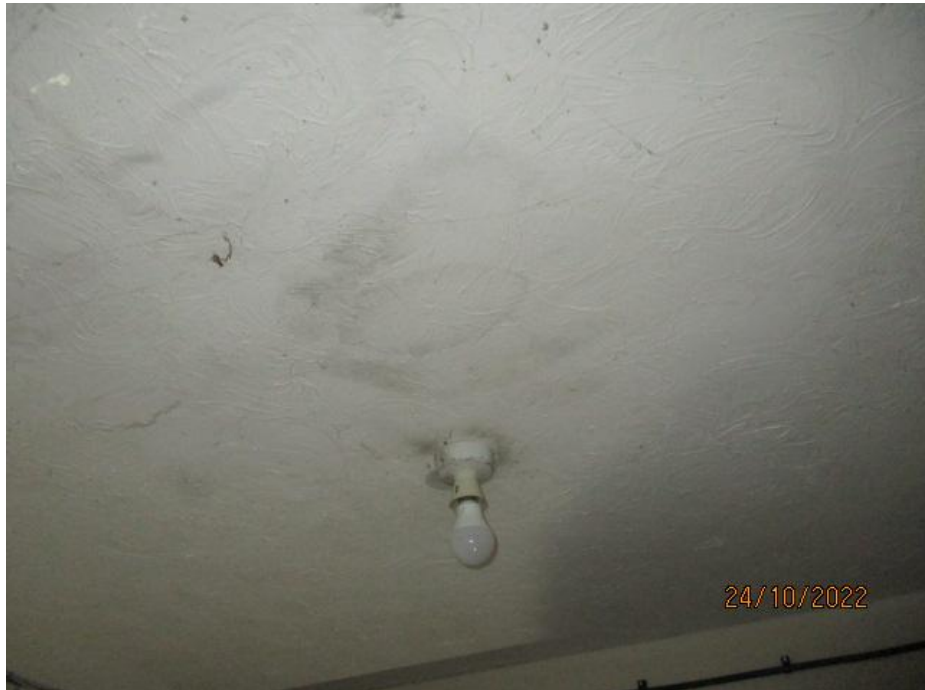
Textured coating to plasterboard ceiling.

No Action Required

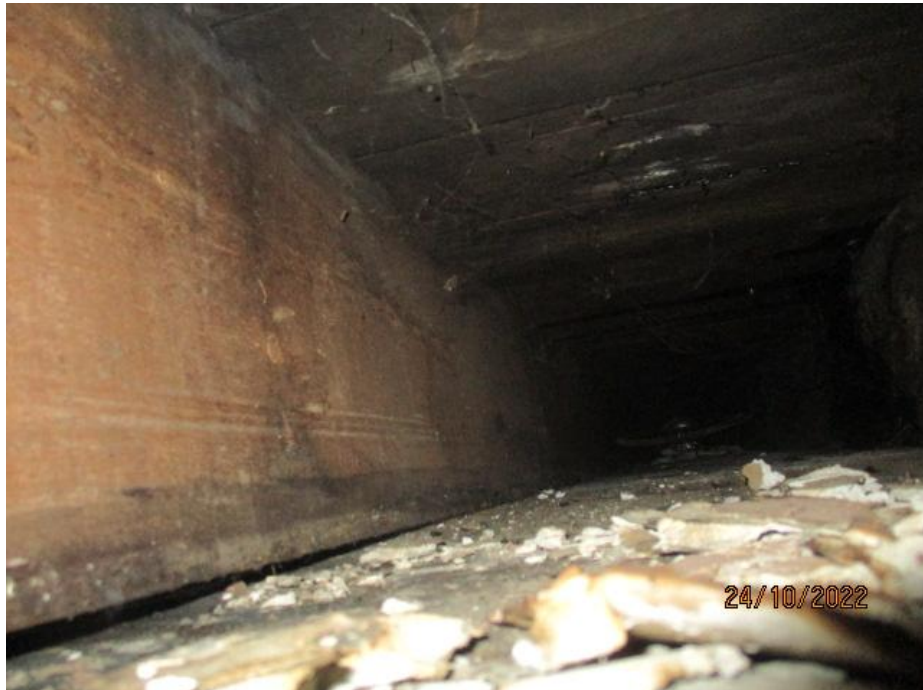
Limited access to ceiling void. No ACM's present where inspected.

Proceed With Caution

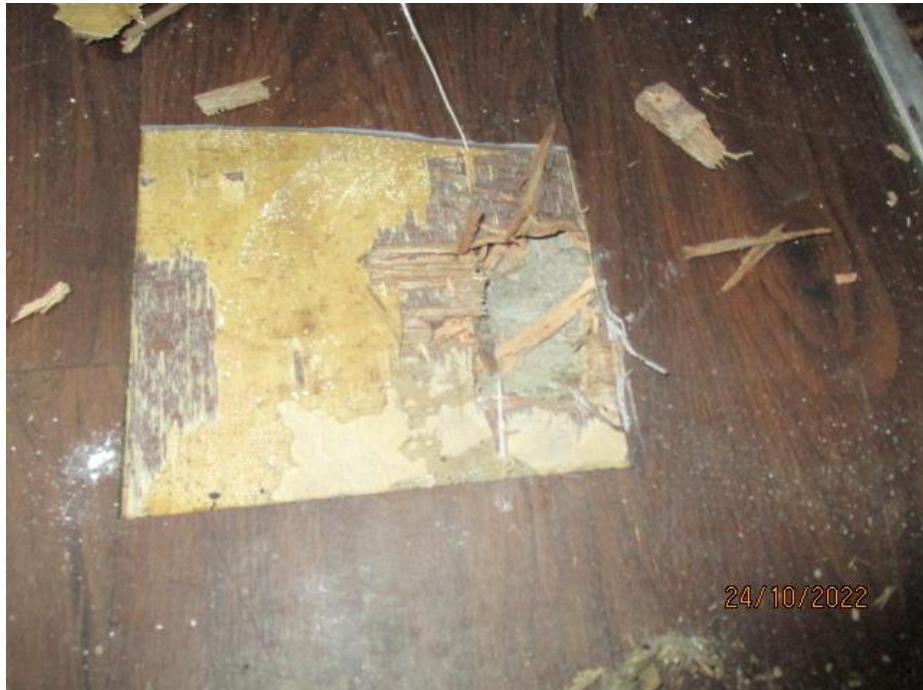
Limited access to floor to show carpet over laminate, wood and screed. No ACM's present where inspected.

No Action Required

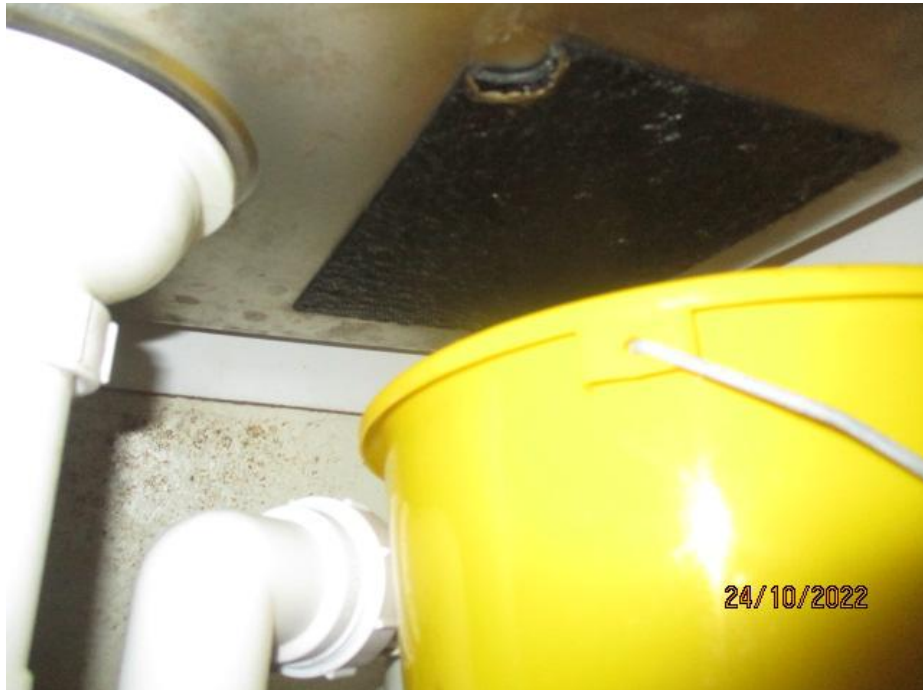
Sink pad to underside of sink.

No Action Required

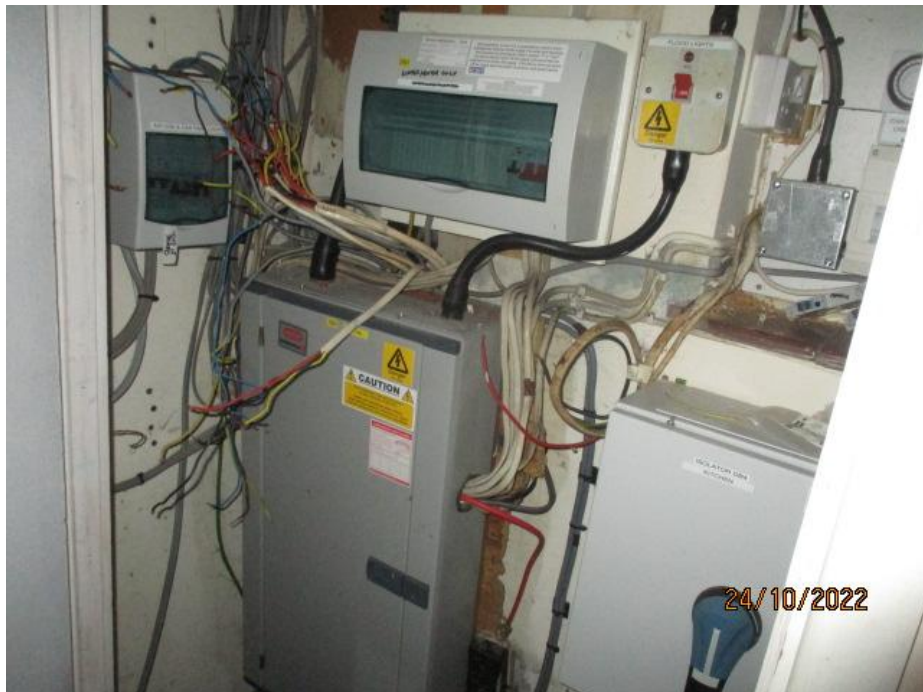
Material Comments: Modern non asbestos containing fuse box in place.

Action: No Action Required

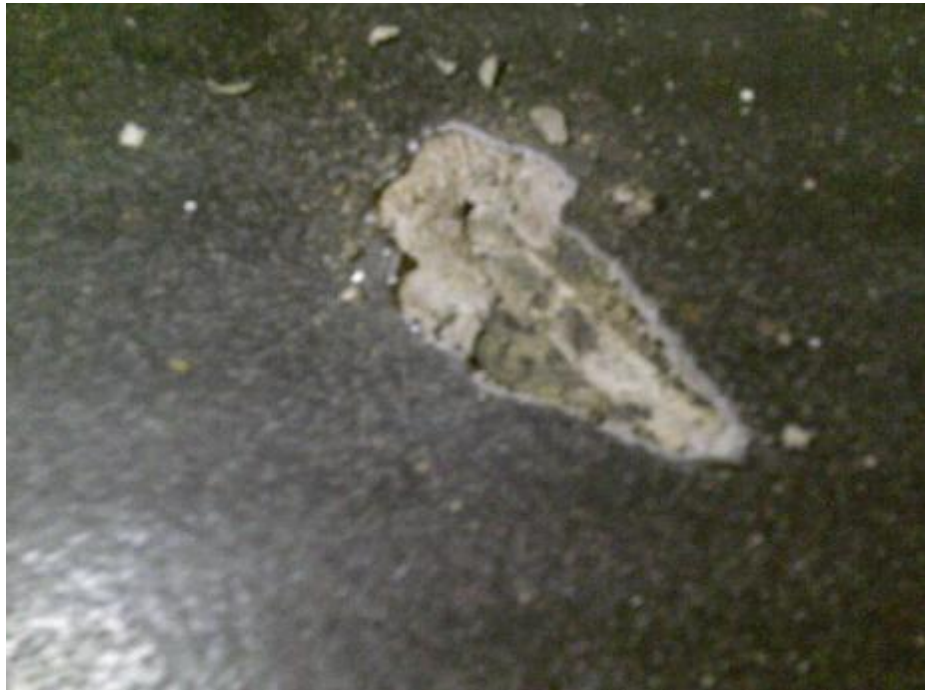
Bitumen adhesive to floor under modern vinyl floor roll & screed in wash up area & lobby between wash up area & bar serving area.

Removal if works require

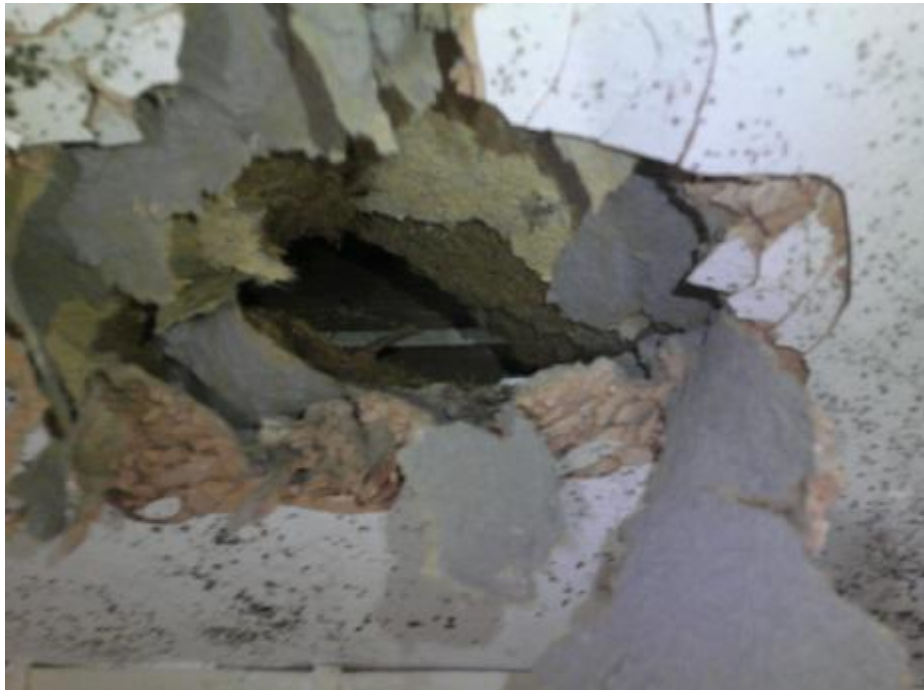
Paper lining to fibreboard ceiling panels above plasterboard ceiling in lobby to stairwell of flat.

No Action Required

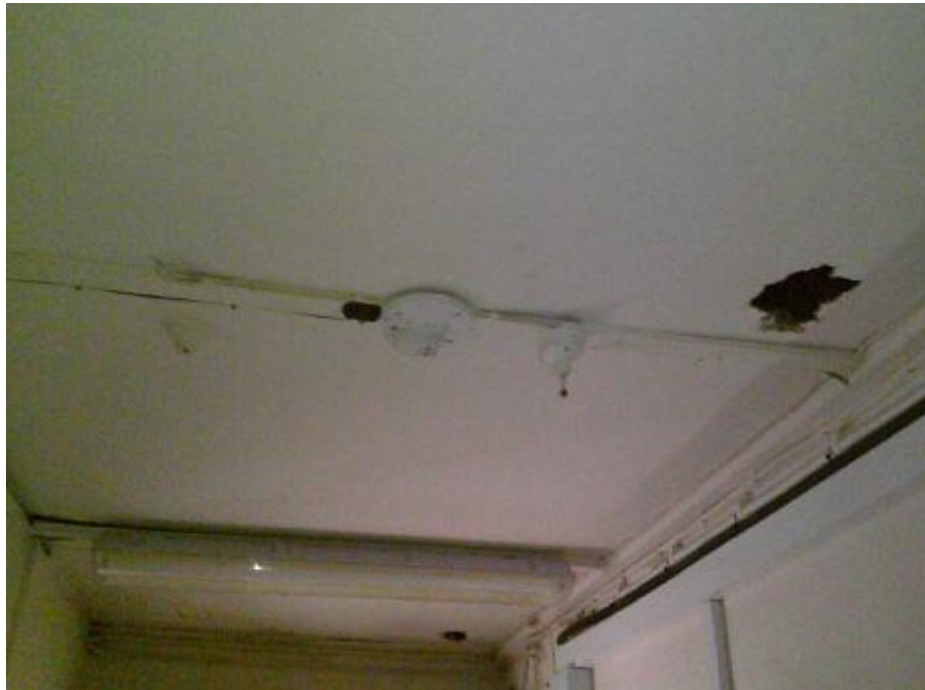
Paper lining to fibreboard ceiling panels in wash up area (next to stairs) of kitchenette only. Plasterboard ceiling present in lobby between kitchenette & bar serving area, no sign of fibreboard above where inspected.

No Action Required

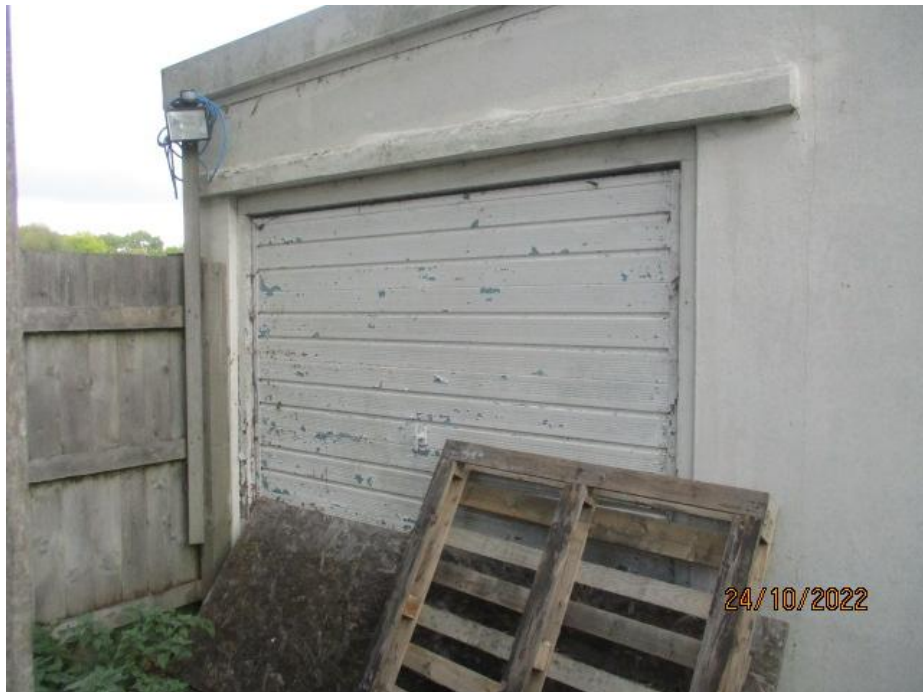
Area not accessed at time of survey as locked and no key provided. Assumed similar in construction type to adjoining rooms.

Proceed With Caution

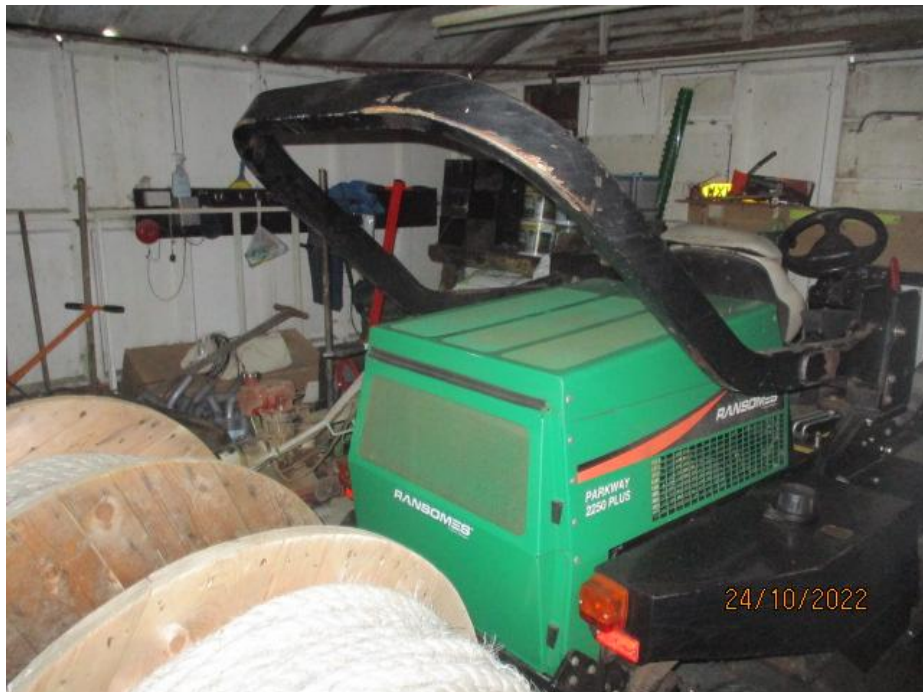
Limited visual access to shed through window. No ACM's present where inspected.

Proceed With Caution

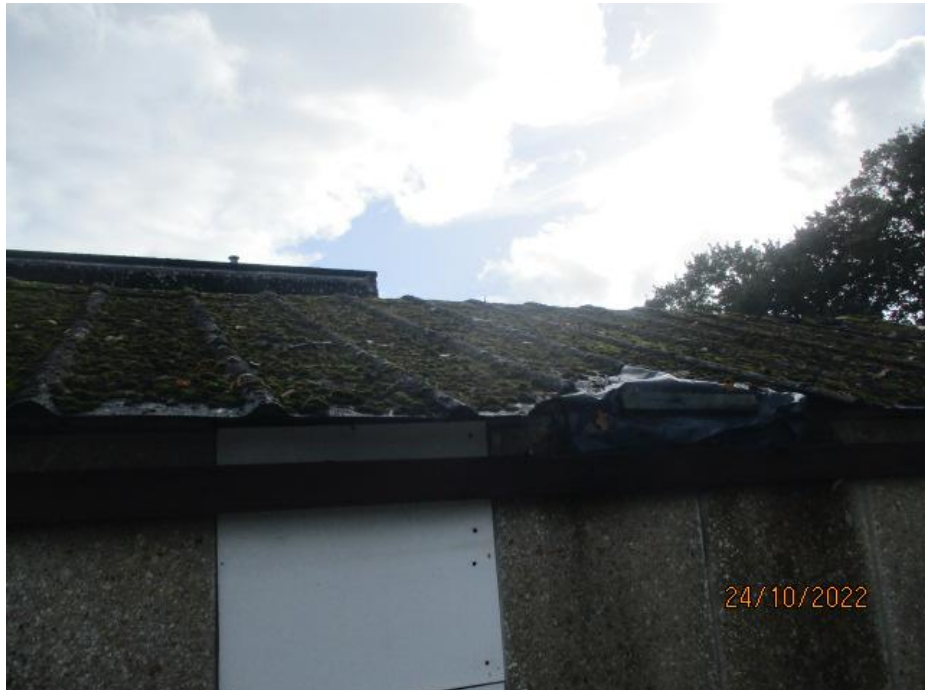
Cement sheets to shed roof.

Removal if works require

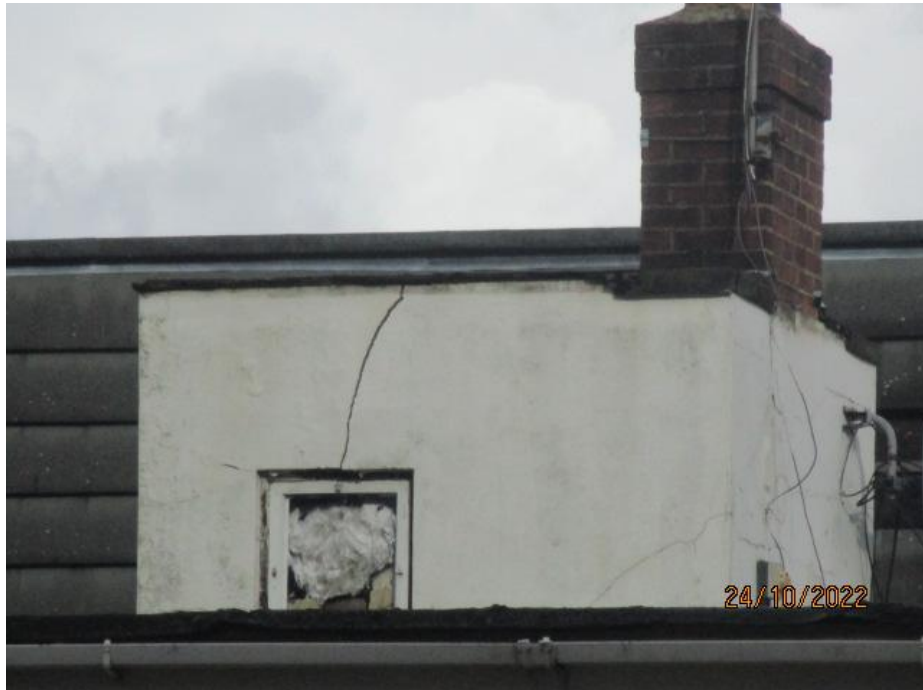
No access to high level tank housing and flue stack to flat roof.

Proceed With Caution

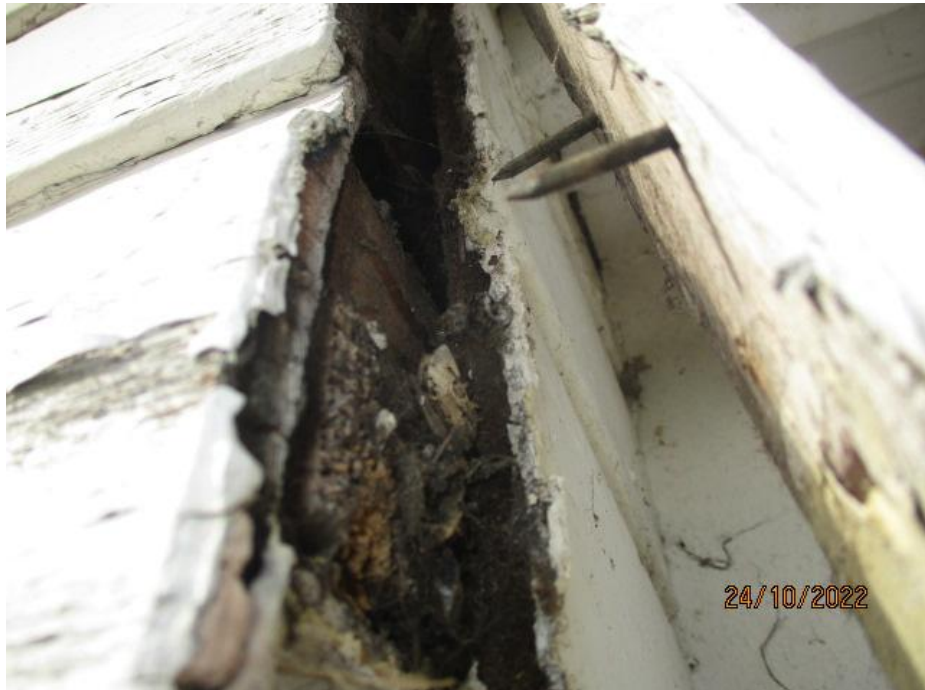
Timber cladding to external store.

No Action Required

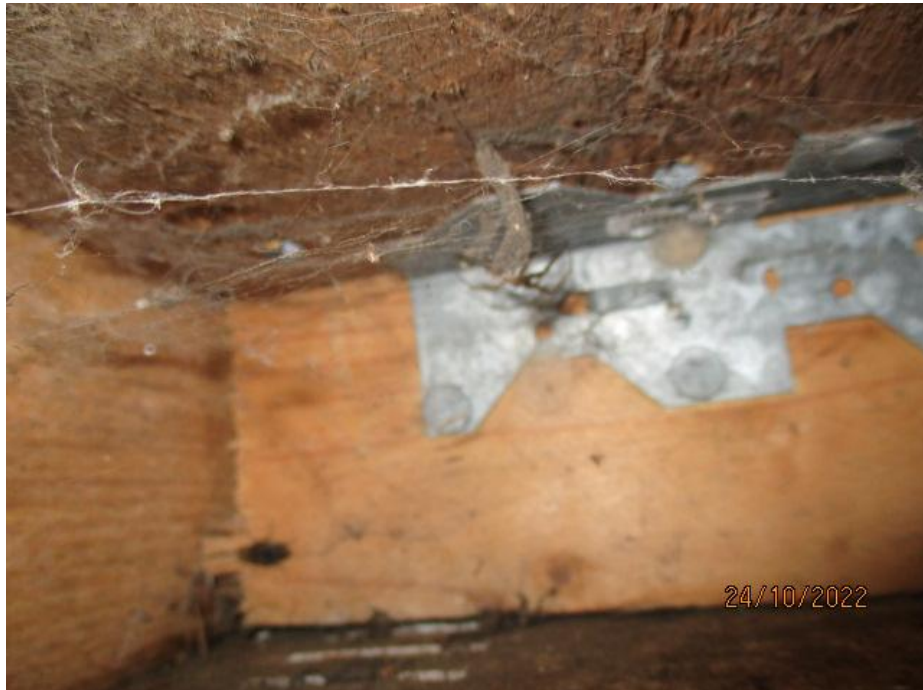
Soffits accessed in multiple areas around site to show timber under UPVC. No ACM's present where inspected.

No Action Required
