**Project Number A-01756 (6146)**

**Management  
Asbestos Survey Report**

**Bryher Fire Station**

**TR23**

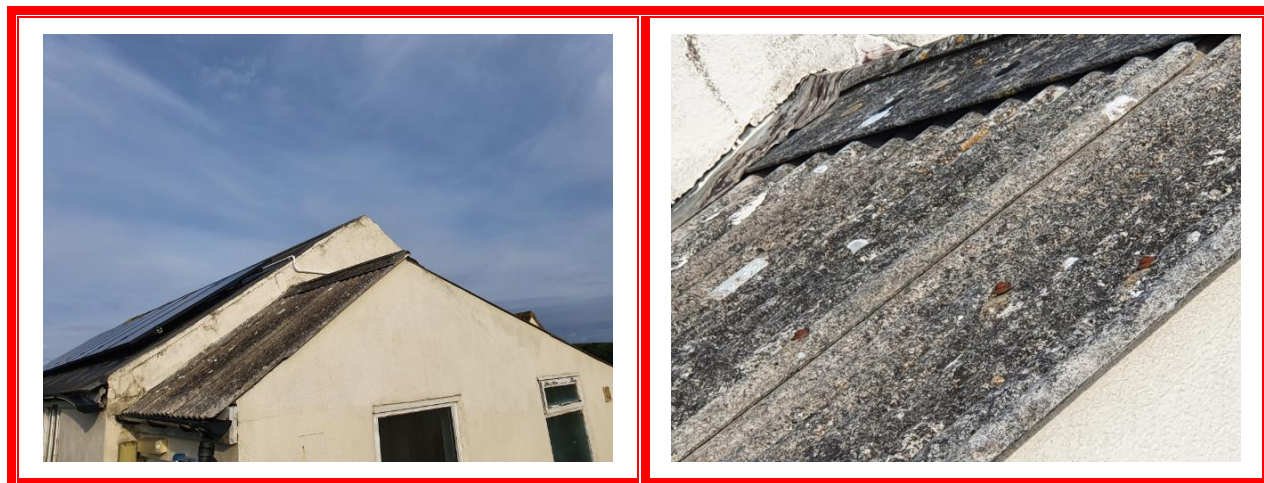
<b>Item No:</b>	<b>1</b>	<b>Sample No:</b>	<b>DK/01</b>
<b>Location:</b>	External - Lobby/WC 001

<b>Material Description:</b>	Profiled Cement Roof - Cement Product	
<b>Identification:</b>	Sampled - Asbestos Detected	
<b>Approx. quantity:</b>	10 m <sup>2</sup>	
<b>Accessibility</b>	Difficult	Assessment Score
<b>Product type:</b>	Cement	1
<b>Extent of Damage:</b>	Moderate damage	2
<b>Surface Treatment:</b>	Unsealed Cement	1
<b>Asbestos type:</b>	Chrysotile	1
<b>Material Assessment Score:</b>		5
<b>Risk Assessment Score:</b>		Low
<b>Action:</b>	Manage	
<b>Comments:</b>	N/A

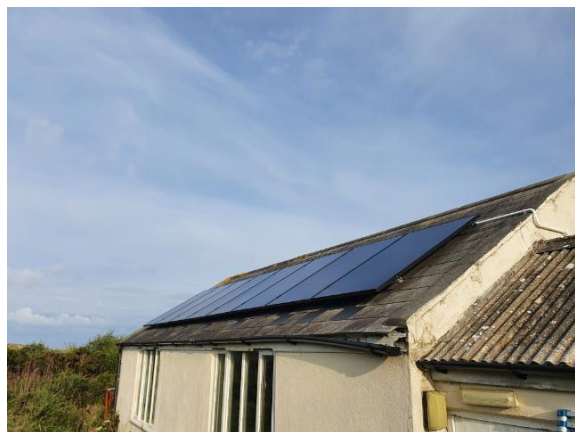
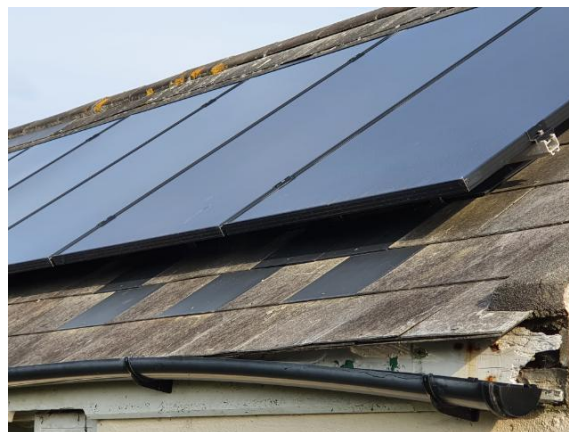
**Item No:** 2 **Sample No:** DK/02

<b>Material Description:</b>	Roof Tiles - Cement Product	
<b>Identification:</b>	Sampled - Asbestos Detected	
<b>Approx. quantity:</b>	60 m <sup>2</sup>	
<b>Accessibility</b>	Difficult	<i>Assessment Score</i>
<b>Product type:</b>	Cement	1
<b>Extent of Damage:</b>	Slight / minor damage	1
<b>Surface Treatment:</b>	Unsealed Cement	1
<b>Asbestos type:</b>	Chrysotile	1
<b>Material Assessment Score:</b>		4
<b>Risk Assessment Score:</b>		Negligible
<b>Action:</b>	Manage	
<b>Comments:</b>	N/A

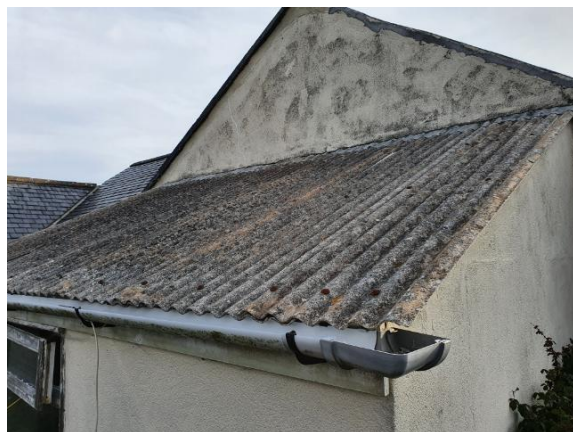
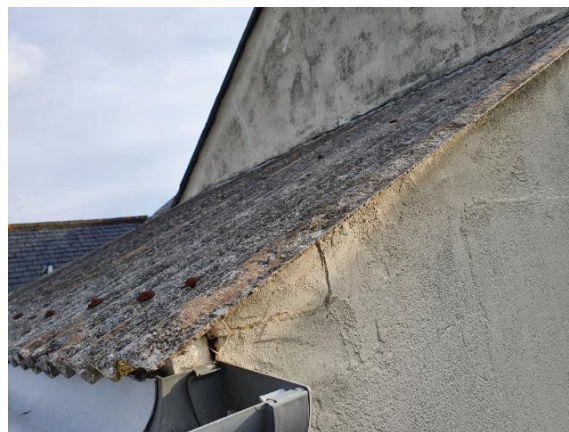
**Item No:** 4 **Sample No:** N/A

<b>Material Description:</b>	Profiled Cement Roof - Cement Product	
<b>Identification:</b>	As per sample DK/01 - Asbestos Detected	
<b>Approx. quantity:</b>	10 m <sup>2</sup>	
<b>Accessibility</b>	Difficult	<i>Assessment Score</i>
<b>Product type:</b>	Cement	1
<b>Extent of Damage:</b>	Slight / minor damage	1
<b>Surface Treatment:</b>	Unsealed Cement	1
<b>Asbestos type:</b>	Chrysotile	1
<b>Material Assessment Score:</b>		4
<b>Risk Assessment Score:</b>		Negligible
<b>Action:</b>	Manage	
<b>Comments:</b>	N/A

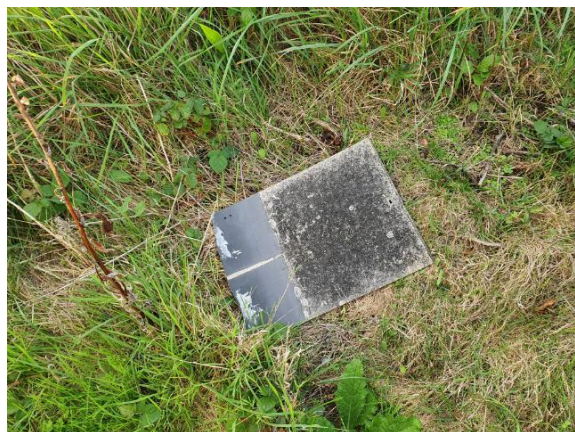
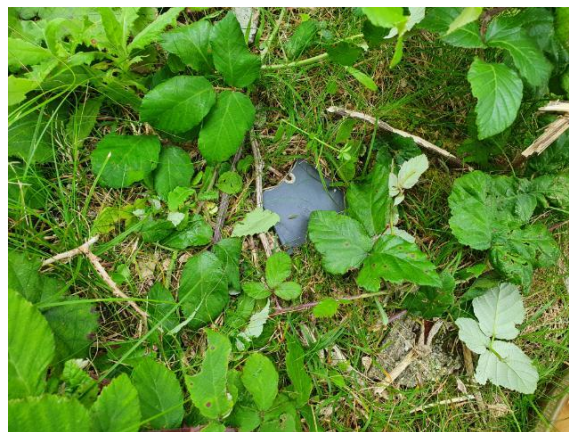
**Item No:** 6 **Sample No:** N/A

<b>Material Description:</b>	Roof Tile Debris - Cement Product	
<b>Identification:</b>	As per sample DK/02 - Asbestos Detected	
<b>Approx. quantity:</b>	1 m <sup>2</sup>	
<b>Accessibility</b>	Easy	<i>Assessment Score</i>
<b>Product type:</b>	Cement	1
<b>Extent of Damage:</b>	Major damage	3
<b>Surface Treatment:</b>	Unsealed Cement	1
<b>Asbestos type:</b>	Chrysotile	1
<b>Material Assessment Score:</b>		6
<b>Risk Assessment Score:</b>		Low
<b>Action:</b>	Remove	
<b>Comments:</b>	Found sporadically throughout externals, including whole roof sheets

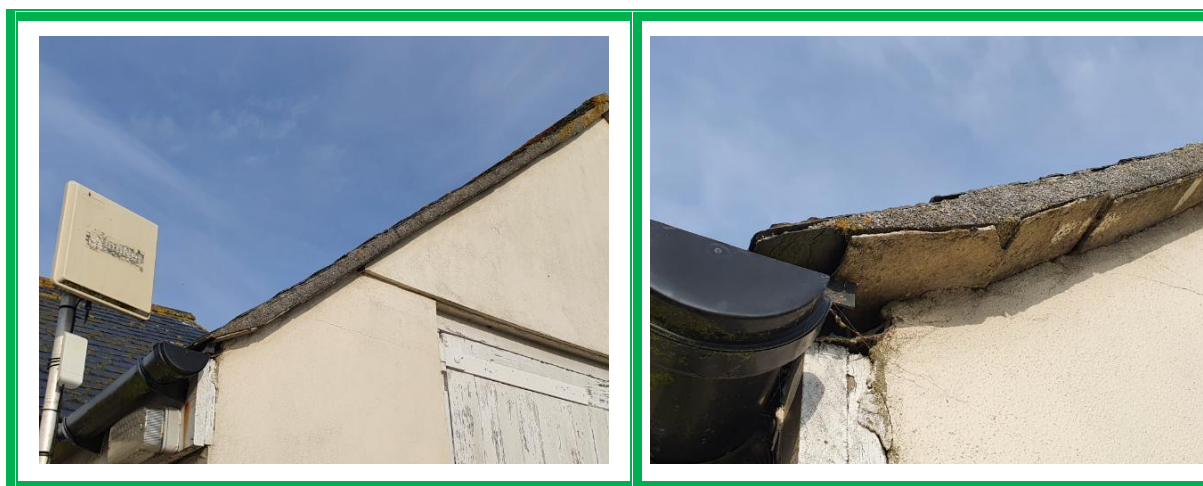
<b>Item No:</b>	<b>3</b>	<b>Sample No:</b>	<b>DK/03</b>
<b>Location:</b>	External - Garage 003

<b>Material Description:</b>	Undercloaking - Cement Product	
<b>Identification:</b>	Sampled - No Asbestos Found	
<b>Approx. quantity:</b>	N/A	
<b>Accessibility</b>	N/A	<i>Assessment Score</i>
<b>Product type:</b>	N/A	N/A
<b>Extent of Damage:</b>	N/A	N/A
<b>Surface Treatment:</b>	N/A	N/A
<b>Asbestos type:</b>	N/A	N/A
<b>Material Assessment Score:</b>		N/A
<b>Risk Assessment Score:</b>		N/A
<b>Action:</b>	N/A	
<b>Comments:</b>	N/A

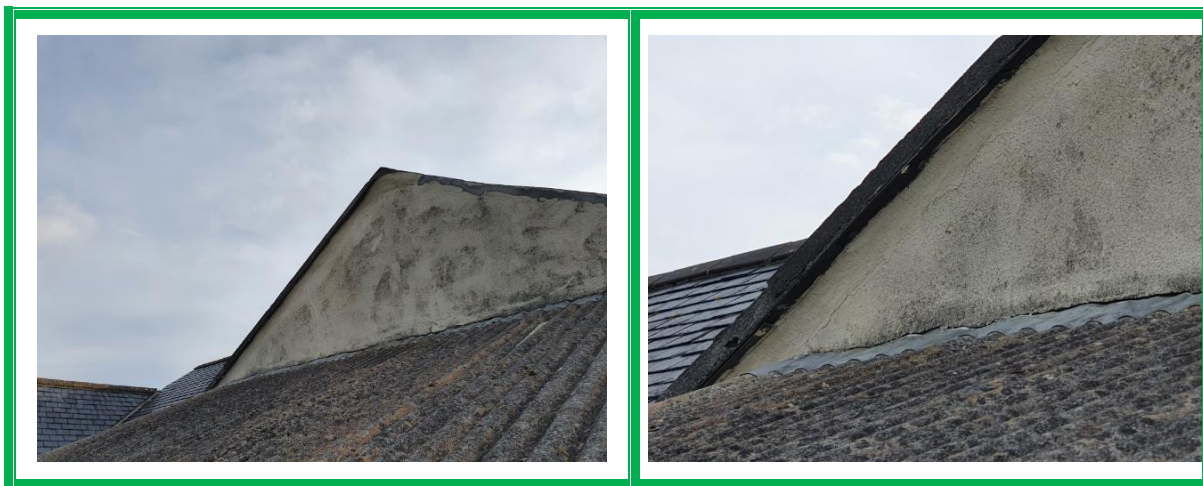
**Item No:** 5

<b>Material Description:</b>	Roof Tile Undercloaking - Cement Product	
<b>Identification:</b>	Sampled - No Asbestos Found	
<b>Approx. quantity:</b>	N/A	
<b>Accessibility</b>	N/A	<i>Assessment Score</i>
<b>Product type:</b>	N/A	N/A
<b>Extent of Damage:</b>	N/A	N/A
<b>Surface Treatment:</b>	N/A	N/A
<b>Asbestos type:</b>	N/A	N/A
<b>Material Assessment Score:</b>		N/A
<b>Risk Assessment Score:</b>		N/A
<b>Action:</b>	N/A	
<b>Comments:</b>	N/A

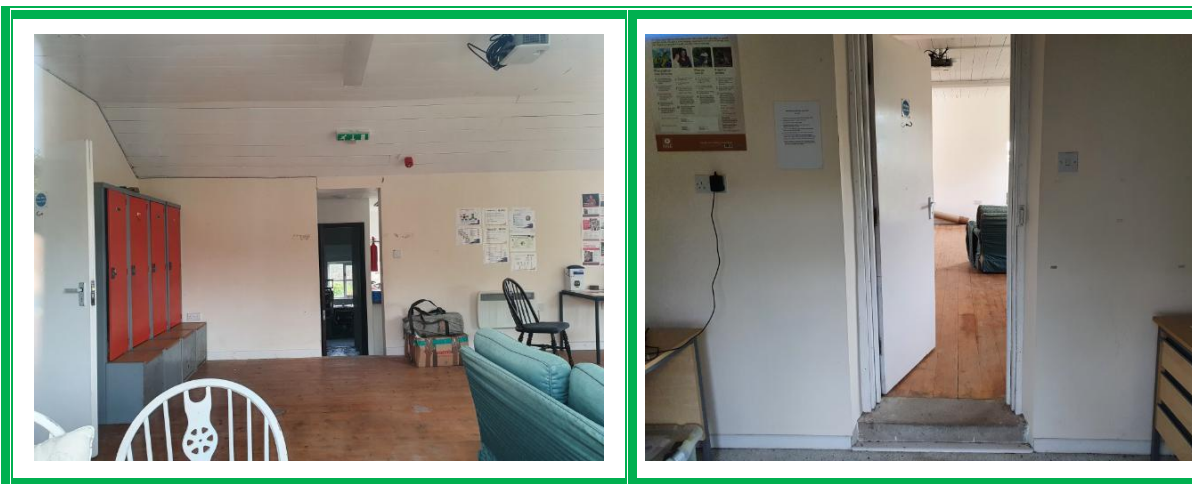
<b>Item No:</b>	<b>7</b>	<b>Sample No:</b>	<b>N/A</b>
<b>Location:</b>	Ground Floor - Staff Room, Office, Lobby and WC 007

<b>Material Description:</b>	No Suspect Materials Found	
<b>Identification:</b>	N/A	
<b>Approx. quantity:</b>	N/A	
<b>Accessibility</b>	N/A	<i>Assessment Score</i>
<b>Product type:</b>	N/A	N/A
<b>Extent of Damage:</b>	N/A	N/A
<b>Surface Treatment:</b>	N/A	N/A
<b>Asbestos type:</b>	N/A	N/A
<b>Material Assessment Score:</b>		N/A
<b>Risk Assessment Score:</b>		N/A
<b>Action:</b>	N/A	
<b>Comments:</b>	Timber and plasterboard ceilings

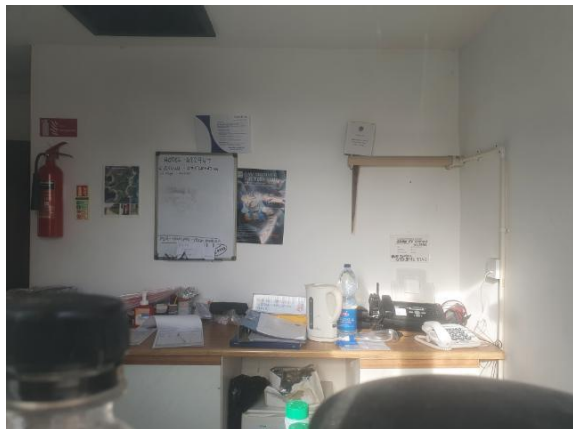
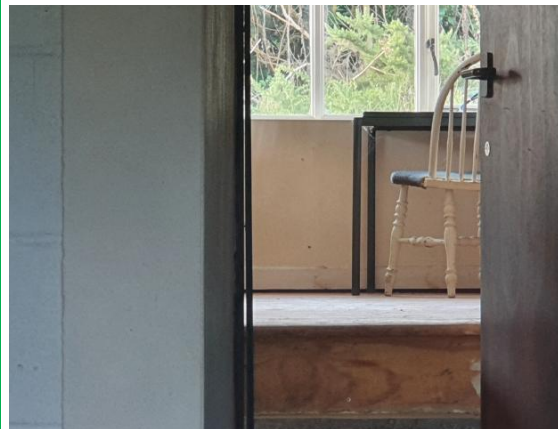
**Item No:** 8

<b>Material Description:</b>	No Suspect Materials Found	
<b>Identification:</b>	N/A	
<b>Approx. quantity:</b>	N/A	
<b>Accessibility</b>	N/A	<i>Assessment Score</i>
<b>Product type:</b>	N/A	N/A
<b>Extent of Damage:</b>	N/A	N/A
<b>Surface Treatment:</b>	N/A	N/A
<b>Asbestos type:</b>	N/A	N/A
<b>Material Assessment Score:</b>		N/A
<b>Risk Assessment Score:</b>		N/A
<b>Action:</b>	N/A	
<b>Comments:</b>	Plasterboard ceilings

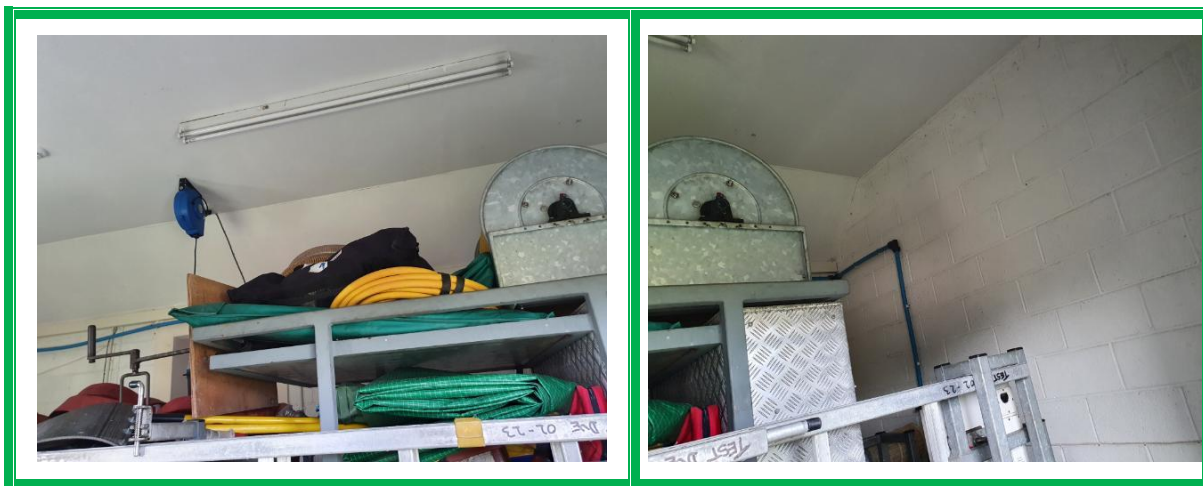
**Item No:** 9

<b>Material Description:</b>	No Suspect Materials Found	
<b>Identification:</b>	N/A	
<b>Approx. quantity:</b>	N/A	
<b>Accessibility</b>	N/A	<i>Assessment Score</i>
<b>Product type:</b>	N/A	N/A
<b>Extent of Damage:</b>	N/A	N/A
<b>Surface Treatment:</b>	N/A	N/A
<b>Asbestos type:</b>	N/A	N/A
<b>Material Assessment Score:</b>		N/A
<b>Risk Assessment Score:</b>		N/A
<b>Action:</b>	N/A	
<b>Comments:</b>	Plasterboard ceiling, concrete floor, modern electrics

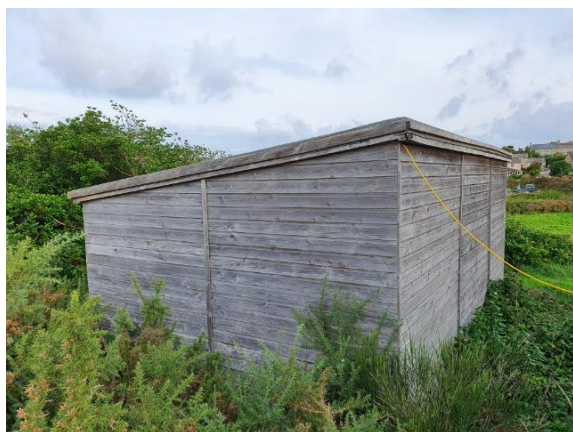
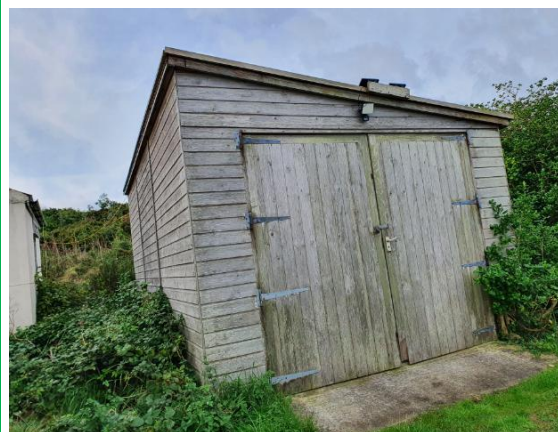
**Item No:** 10

<b>Material Description:</b>	No Suspect Materials Found	
<b>Identification:</b>	N/A	
<b>Approx. quantity:</b>	N/A	
<b>Accessibility</b>	N/A	<i>Assessment Score</i>
<b>Product type:</b>	N/A	N/A
<b>Extent of Damage:</b>	N/A	N/A
<b>Surface Treatment:</b>	N/A	N/A
<b>Asbestos type:</b>	N/A	N/A
<b>Material Assessment Score:</b>		N/A
<b>Risk Assessment Score:</b>		N/A
<b>Action:</b>	N/A	
<b>Comments:</b>	Timber walls and non-asbestos felt roof
