PROJECT NAME A36 BEMERTON INCL RBT AT MP63.0 NB & SB MP61.6 - 63.1 RS

DRAWING TITLE ST PAUL'S ROUNDABOUT DEFECT PLAN

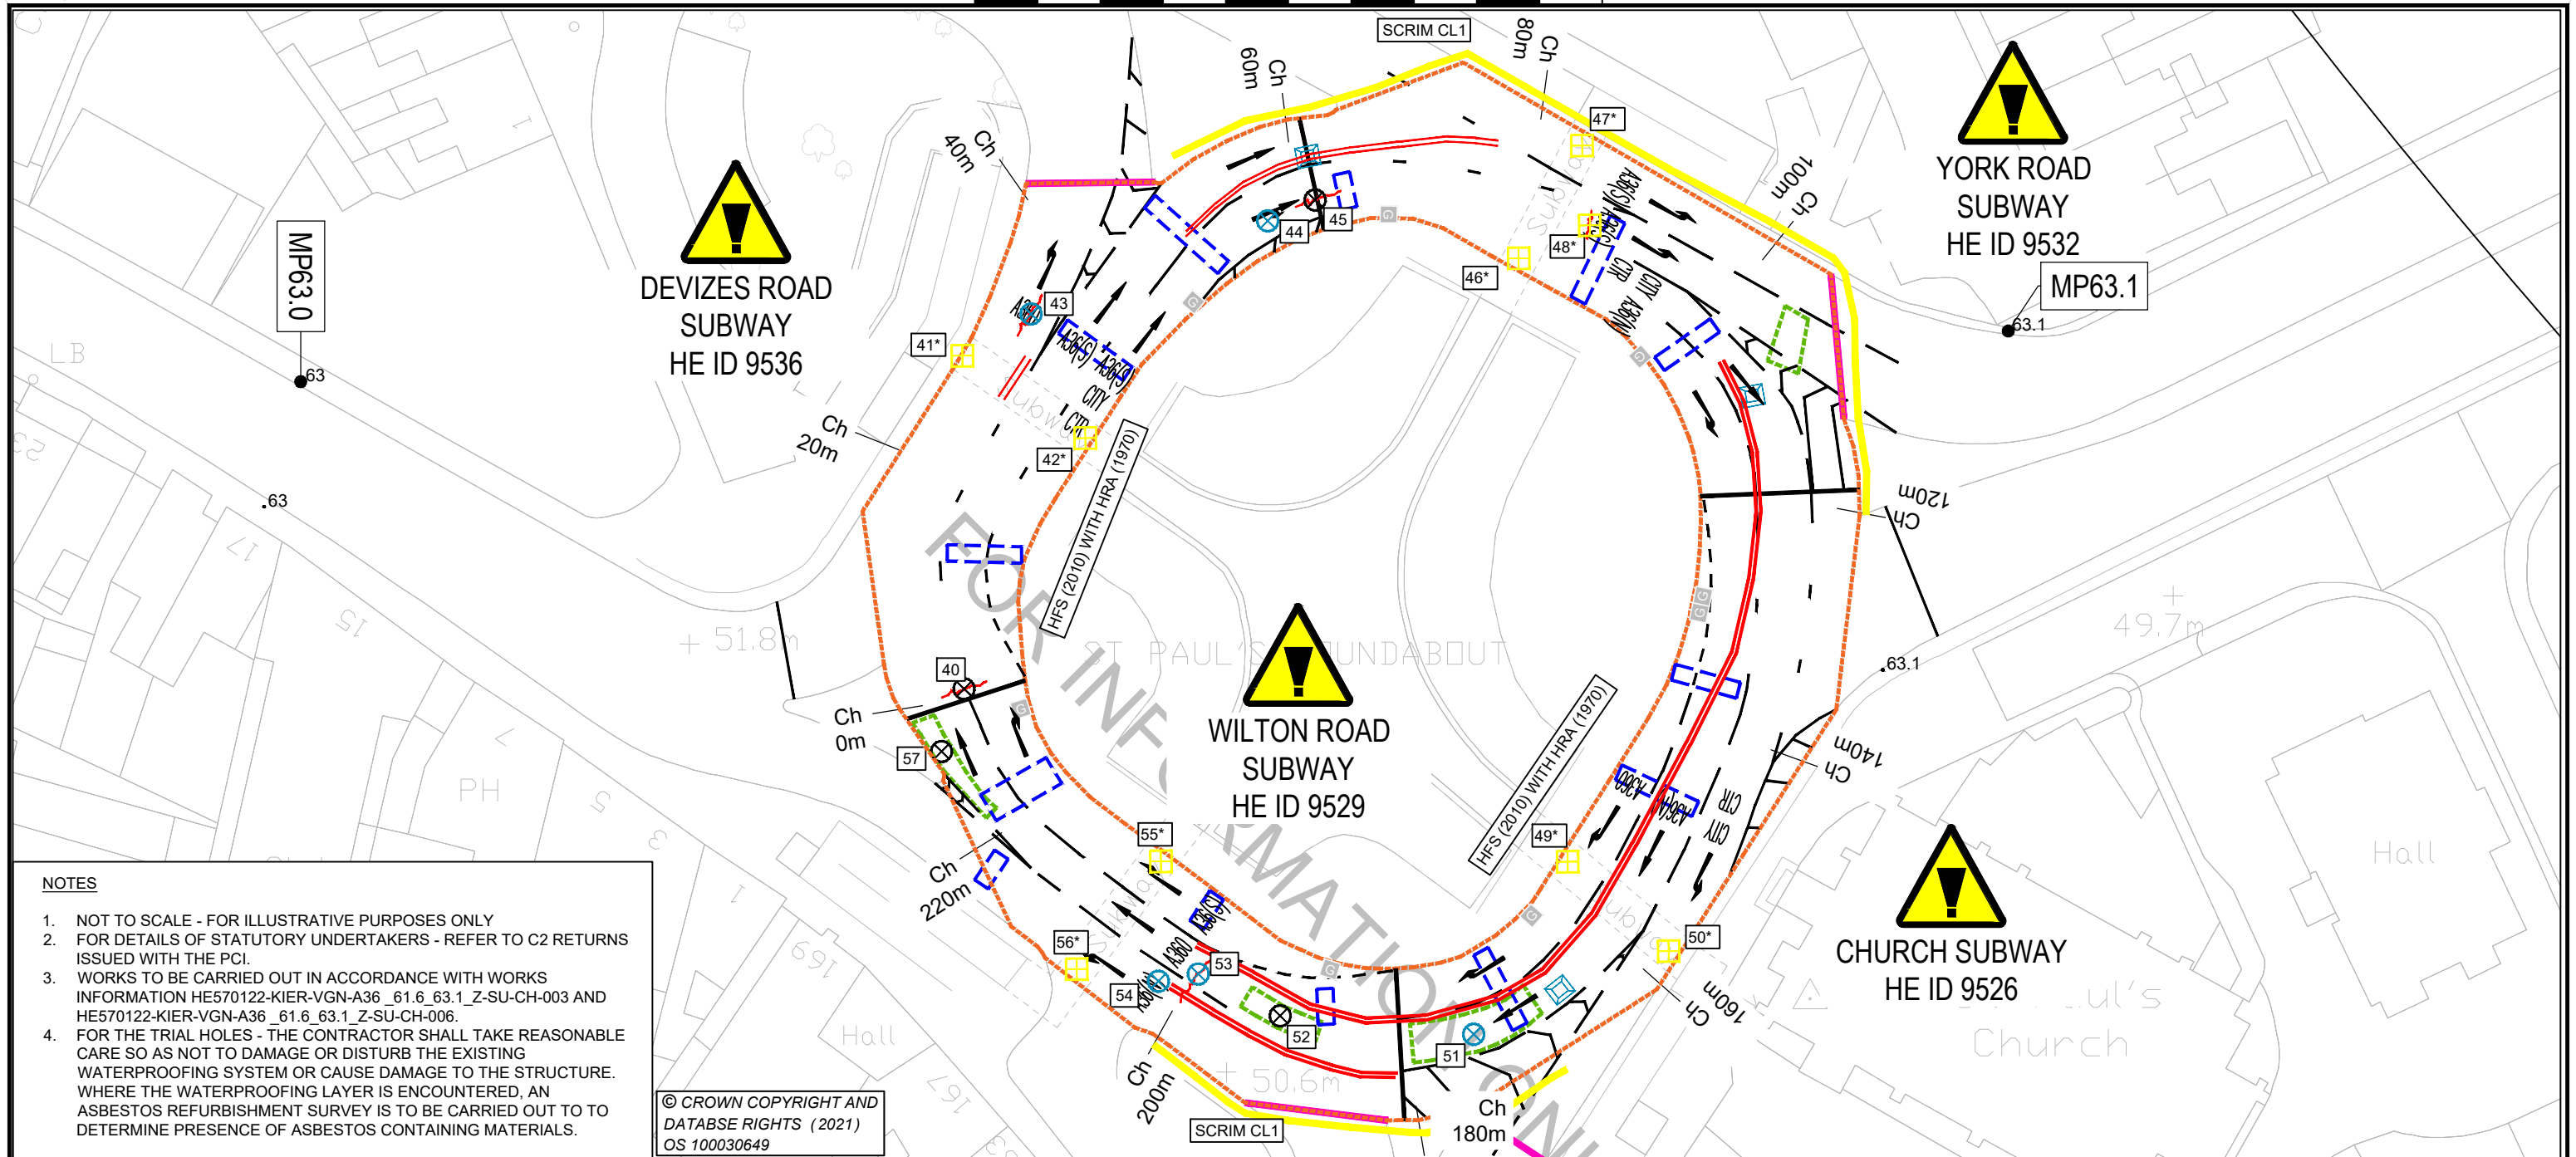
LOCATION TO BE TRIAL  
HOLED AND TESTED FOR  
ACM. (NOTE 4)
