Beverley Town Council New Town Hall Project Manager

TENDER PACK

Condition Report

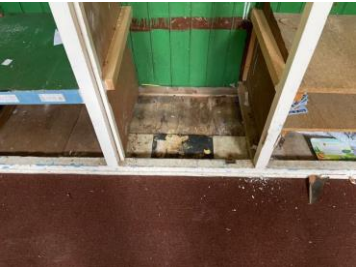
Inspection Date	Surveyor	Survey Type	Floor	Analysis	
	11/11/2022	Robin Walker	Refurbishment	Ground Floor	Chrysotile	
	Building	Room	Description	Extent		
	St Johns Ambulance	Store 010	Floor	Small amounts m²		
	Sample No / Inspection Ref	Product Type	Surface Treatment	Damage Extent	Material Risk Score	Priority Total
	A-20386 / S006 203512	Vinyl floor tiles	Composite	Good	3	N/A
	Normal Occupant Activity	Likelihood of Disturbance	Human Exposure Potential	Maintenance Activity	Risk Rating	Total Assessment Score
	N/A	N/A	N/A	N/A	Very Low	3
Recommendations / Actions	Non notifiable product - Remove under strict accordance with current and relevant legislation notes.					
Surveyor Comments	Mixed black and white vinyl floor tiles to floor				Review Date	N/A

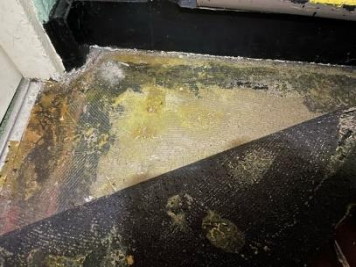
Inspection Date	Surveyor	Survey Type	Floor	Analysis	
	11/11/2022	Robin Walker	Refurbishment	Ground Floor	Chrysotile	
	Building	Room	Description	Extent		
	St Johns Ambulance	Entrance lobby 013	Floor	4 m²		
	Sample No / Inspection Ref	Product Type	Surface Treatment	Damage Extent	Material Risk Score	Priority Total
	A-20386 / S007 204835	Bituminous Product	Composite	Good	3	N/A
	Normal Occupant Activity	Likelihood of Disturbance	Human Exposure Potential	Maintenance Activity	Risk Rating	Total Assessment Score
	N/A	N/A	N/A	N/A	Very Low	3
Recommendations / Actions	Non notifiable product - Remove under strict accordance with current and relevant legislation notes.					
Surveyor Comments	Bitumen adhesive to floor				Review Date	N/A

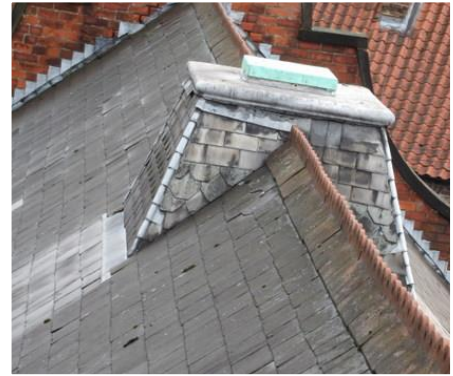
Cupola flashings slipped and missing. Cupola capped with copper.

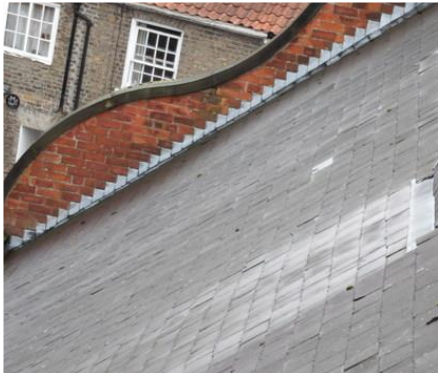
Missing/slipped slates to all slopes.

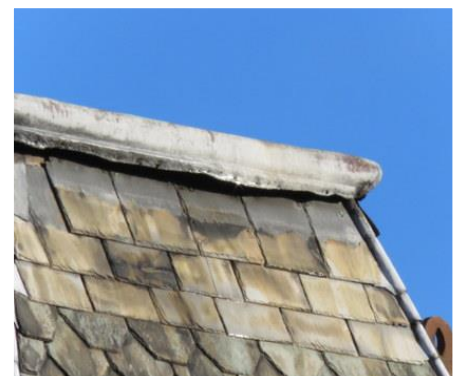
Missing flashing to cupola.

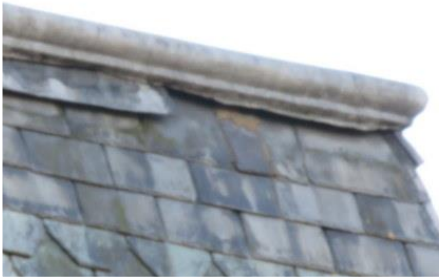
Missing flashing to cupola.

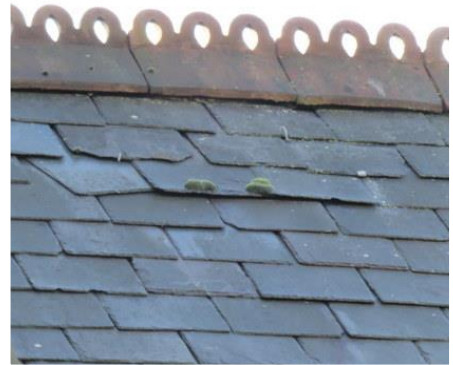
Pointing generally to ridge missing. Tingles in place in various locations.

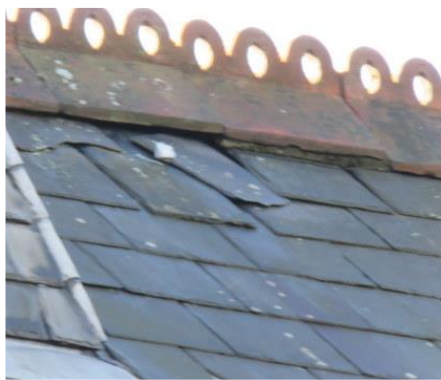
Slipped/missing slates to Morton Lane slope.

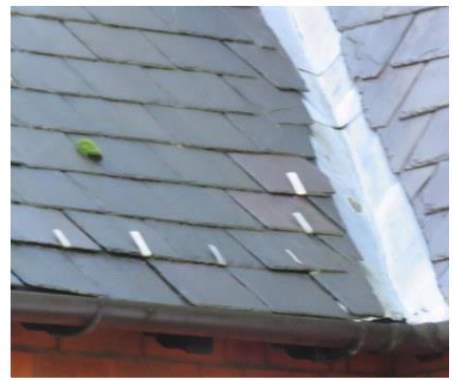
Tingles evident to entrance roof.

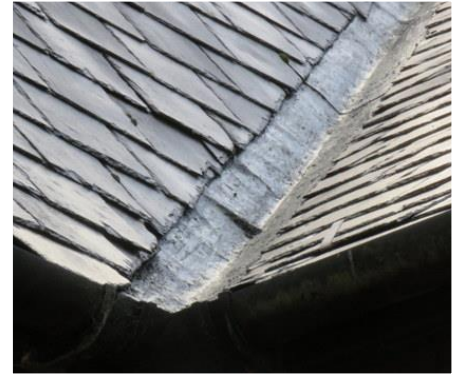
Liquid repair to valley gutter.

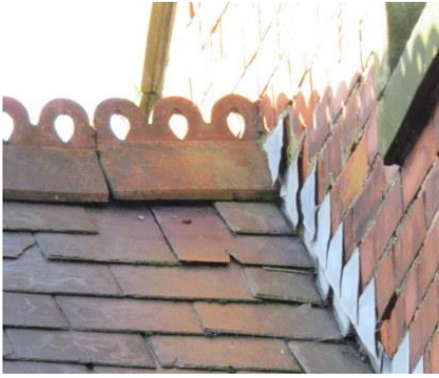
Poor flashings to gables.
Slipped/missing slate.

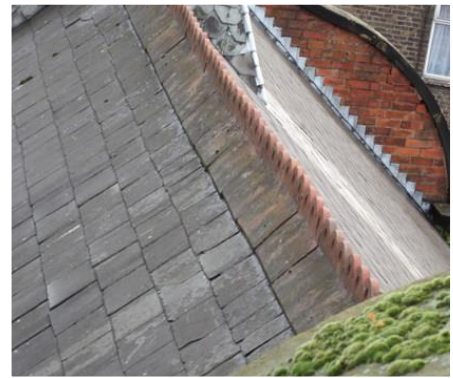
Deflection to main roof ridge.

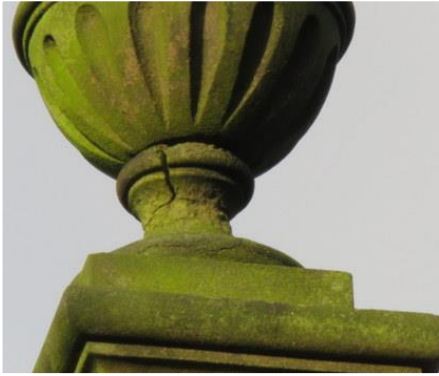
Cracking to stone support on finial on Wilbert lane gable.

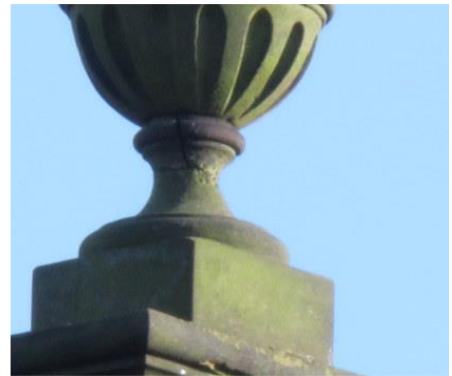
Cracking to stone support on finial on Wilbert lane gable.

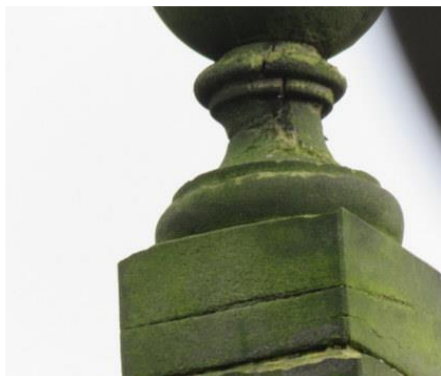
Cracking to stone support on finial on Morton lane gable.

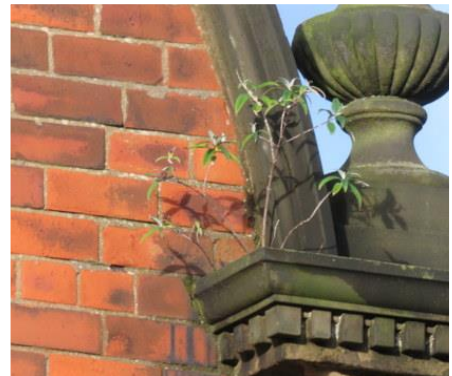
Plant growth to stone details on Wilbert Lane gable.

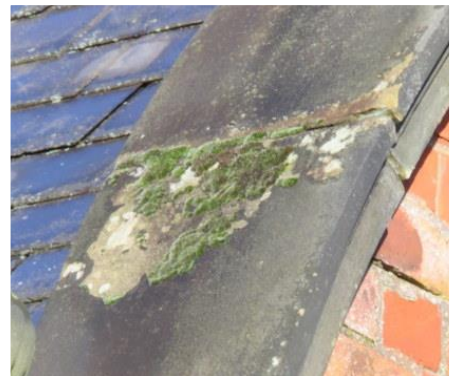
Stone starting to spall to parapet cappings.

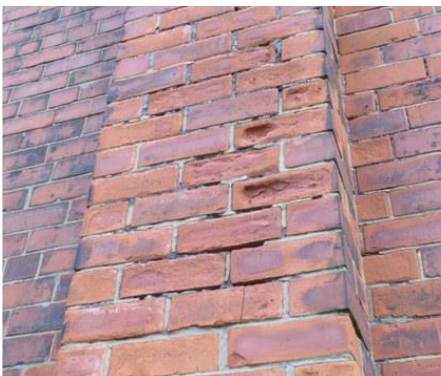
The chimney brickwork is generally spalled and with open brickwork joints, particularly near the top of the chimney and requires comprehensively overhauling.

Spalled bricks and open joints to chimney.

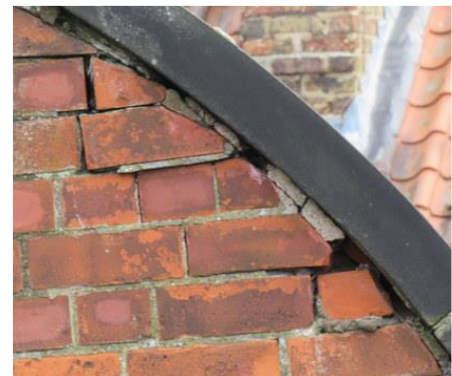
Loose brickwork and open joints to gable beneath capping stones.

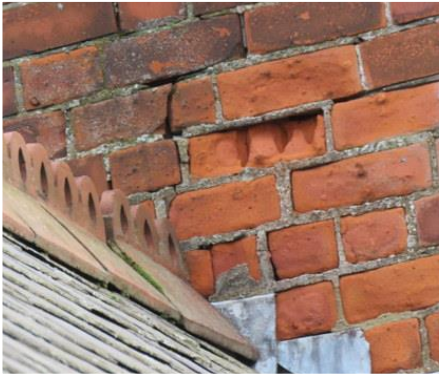
Spalled bricks, poor pointing to rear of Wilbert lane gable.

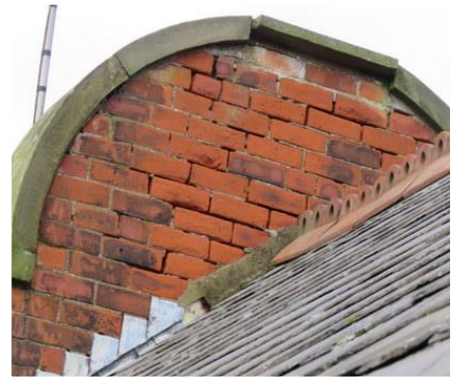
Poor pointing to rear of Morton Lane gable. Section of flashing replaced with sand cement.

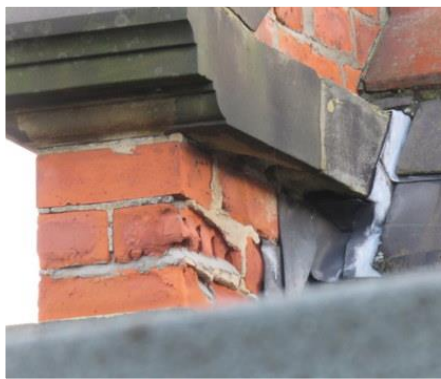
Spalled bricks/poor pointing behind Morton Lane entrance parapet.

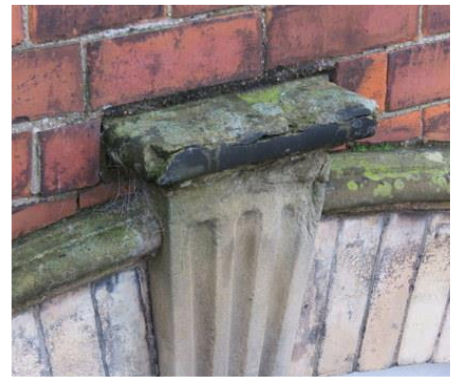
Stone details above windows spalling/cracked.

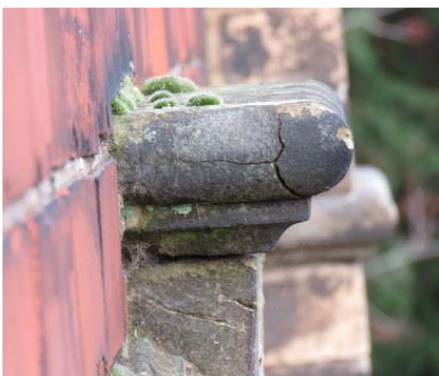
Stone details above windows spalling/cracked.

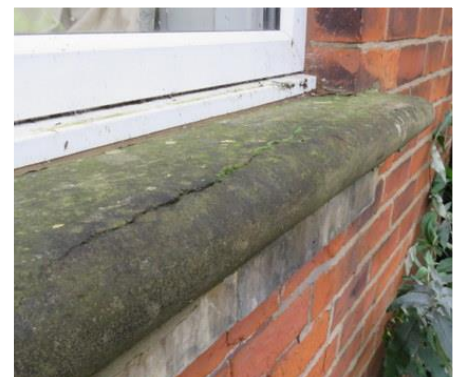
Stone cills cracking in various locations.

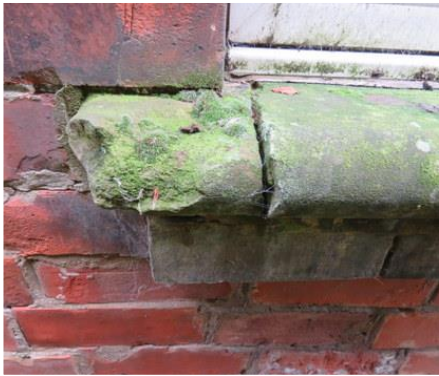
Damaged/cracked stone cills to a number of windows.

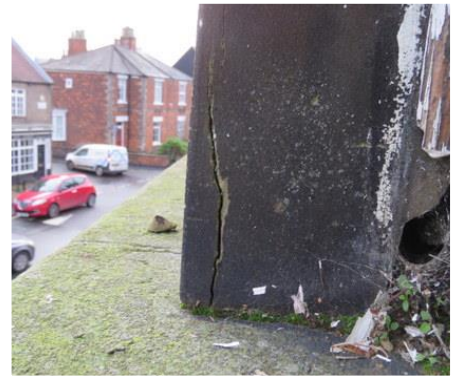
Cracking to face of stone column between Wilbert Lane gable window.

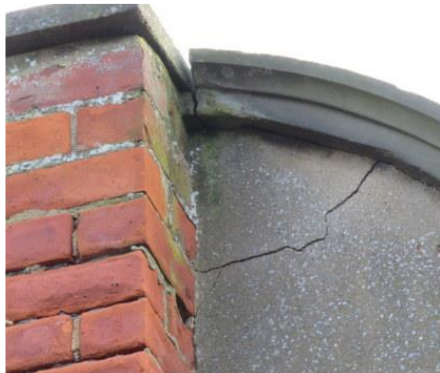
Cracking to high level render to chimney.

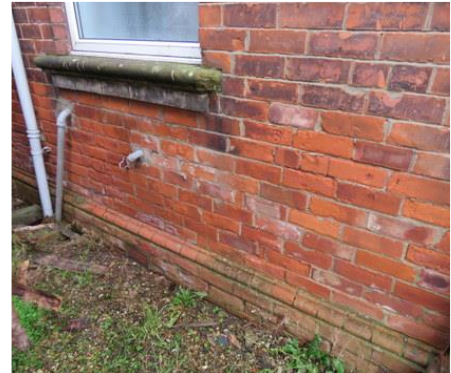
Poor pointing/spalled brick faces to a number of locations.

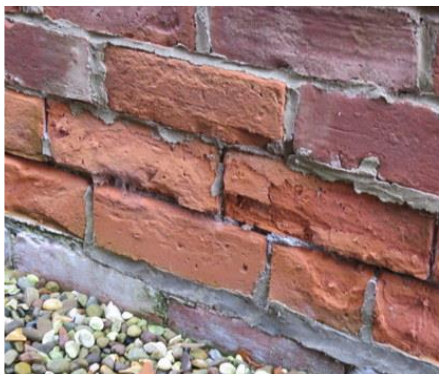
Low level brickwork spalled and pointing poor.

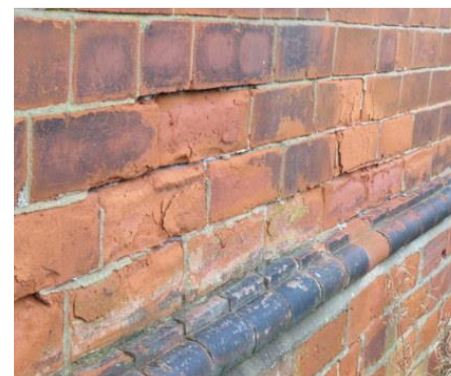
Poor pointing/spalled brick faces to a number of locations.

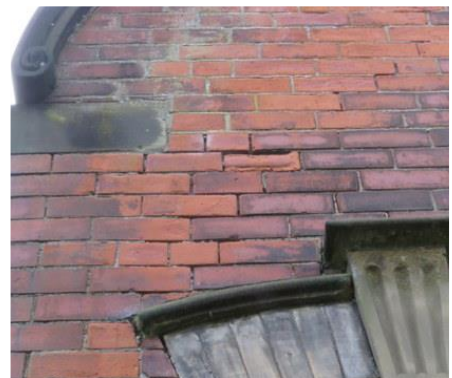
Stepped cracking above Morton Lane entrance.

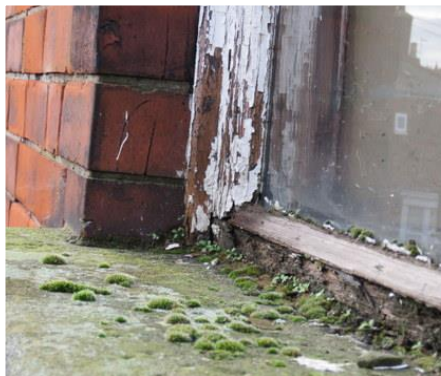
Decay to remaining timber windows.

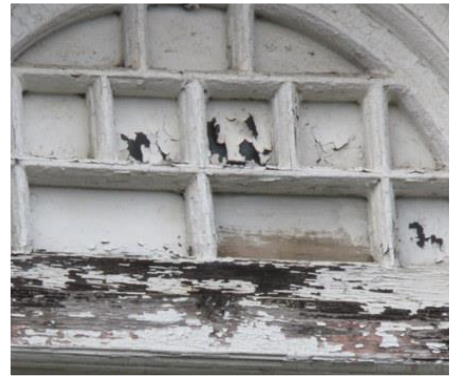
Decay to remaining timber windows.

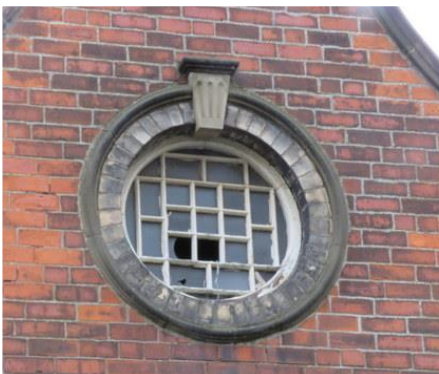
There is missing glazing to the circular window above the male WC window which requires replacing to prevent weather ingress and birds etc.

Broken glass to round window above Morton Lane entrance.

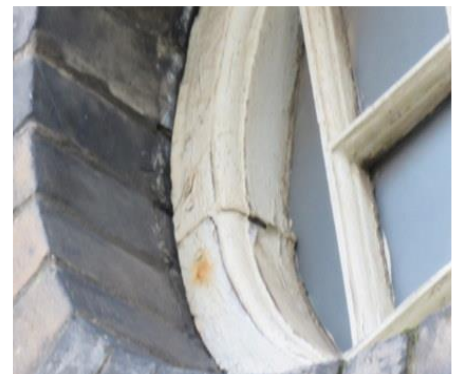
Seal around wooden windows have perished.

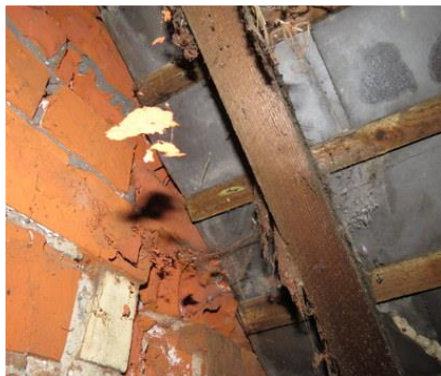
Spalled bricks to Wilbert lane gable.

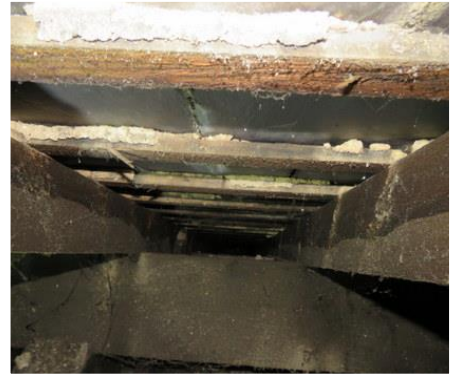
Void between roof and eaves parging loose and missing in various locations.

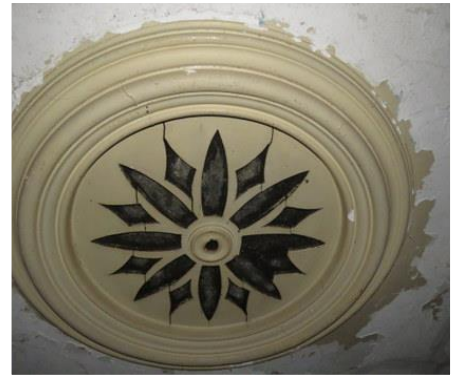
Damage to ceiling vents.

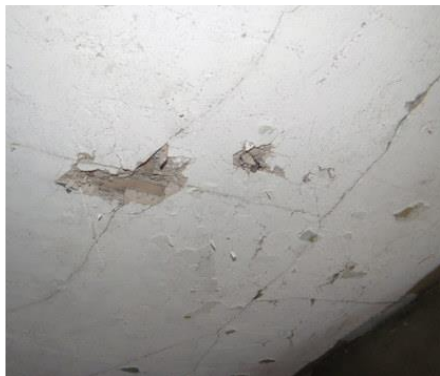
Delaminated sections of plaster
lath throughout first floor areas.

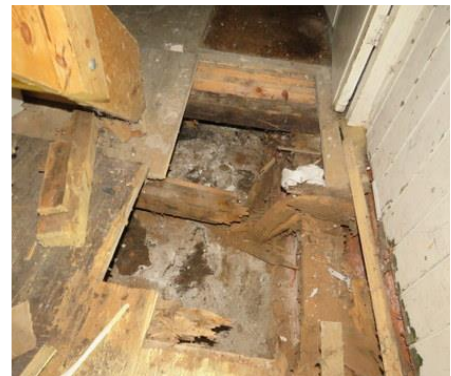
In the front entrance lobby the suspended timber floor has partially collapsed near the bottom of the staircase which may be due to rising dampness causing timber decay to the floor. We also observed woodworm to the floorboards in the front entrance lobby.

Timber decay and beetle activity to rotten floor beneath stairs.

We strongly advise that a specialist in dampness and timber, who is preferably a member of the Property Care Association, is requested to provide a quotation for, and advise as to the extent of the remedial work necessary to address the dampness in the walls which we anticipate will involve the installation of a remedial DPC and the re-plastering of walls to affected areas up to 1000mm high. We recommend that a 25 year insurance backed warranty is obtained from the specialist which is transferable to a third party.

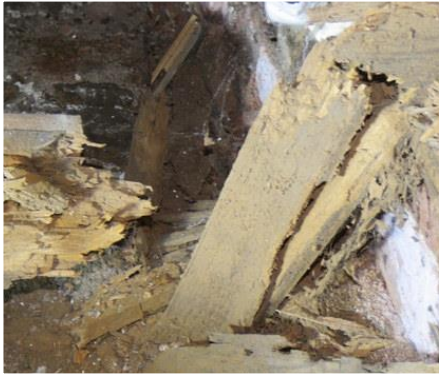
Timber decay to stairs floor void.

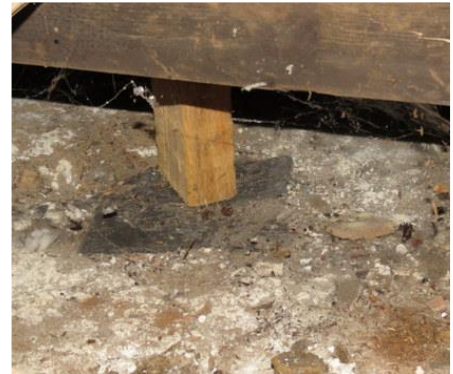
Additional supports fitted beneath damp joists to floor at Wilbert lane entrance.

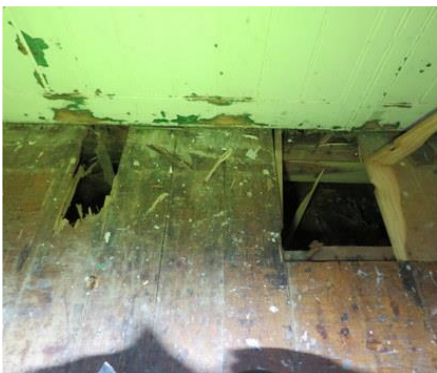
Rot to floor structure in main hall.

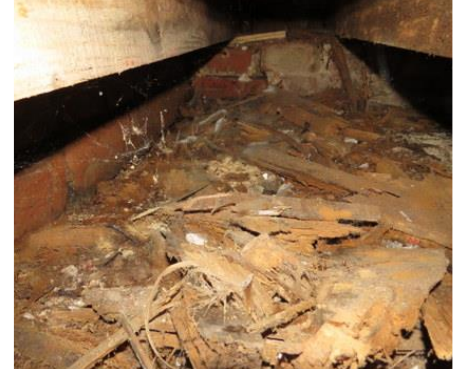
Debris and signs of wet rot to hall floor.

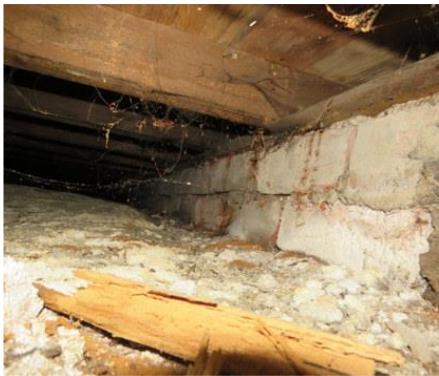
Mycellium evident below hall floor.

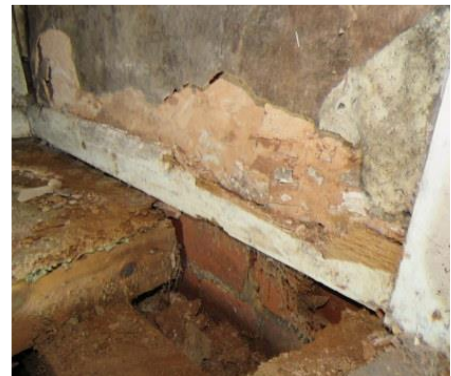
Rot to floor and skirtings in kitchen.

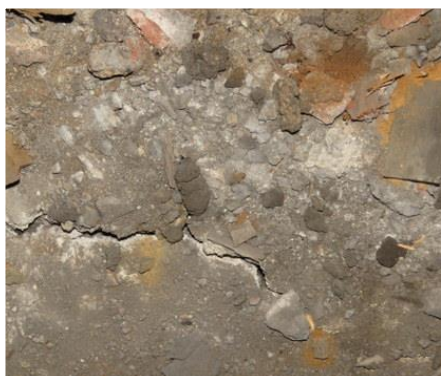
Floor beneath void has a degrading surface.

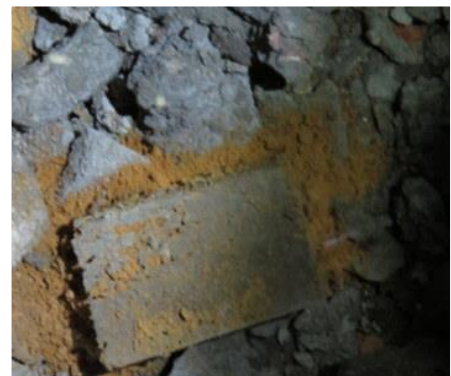
Beetle activity in floor void.

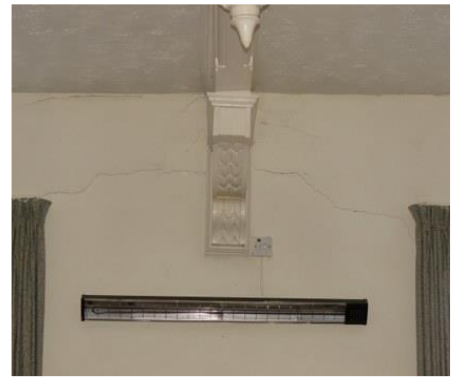
Cracking either side of roof structure in hall.

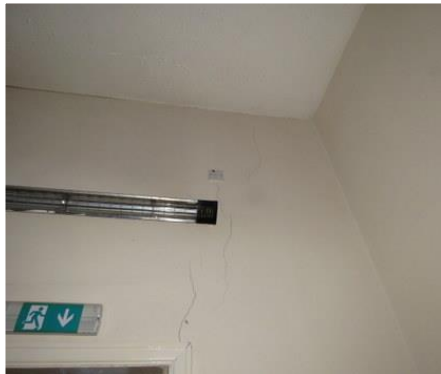
Cracking to wall above entrance into hall.

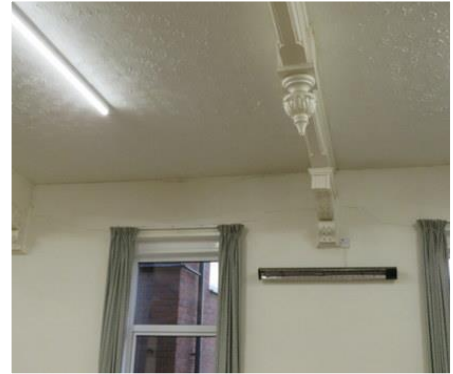
Cracking either side of roof structure in hall.

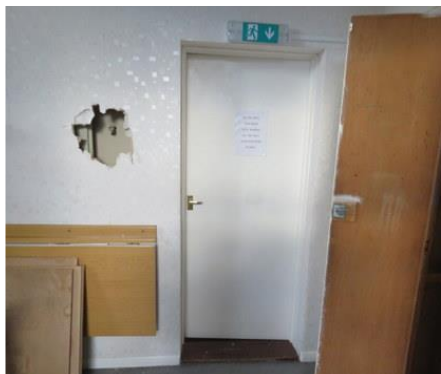
None fire doors to all areas.

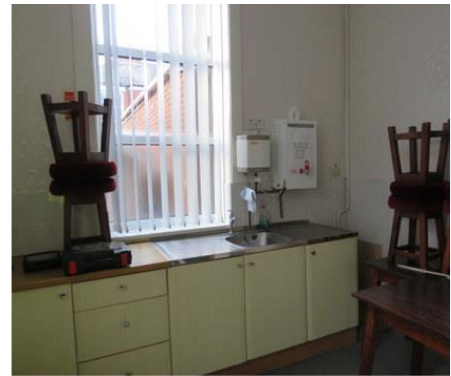
Kitchen dated, water heating dilapidated.
