# **Transforming Cornwall Museum and Art Gallery**

## Conditions Survey

**2024 UPDATED QUINQUENNIAL INSPECTION  
OF  
THE ROYAL CORNWALL MUSEUM  
FOR THE INSTITUTION OF CORNWALL**

**As inspected October-December 2012/18  
Re-inspected and updated 25<sup>th</sup> November 2024  
DNS/DC/7377**

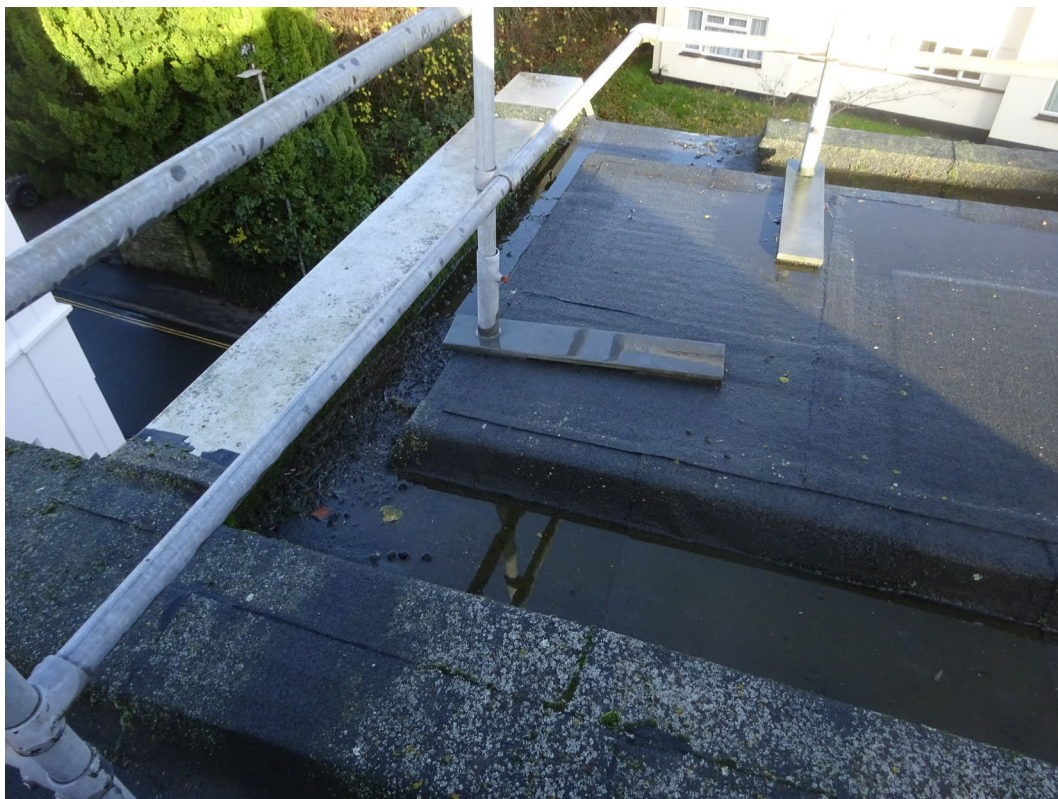
7. S3 ponding

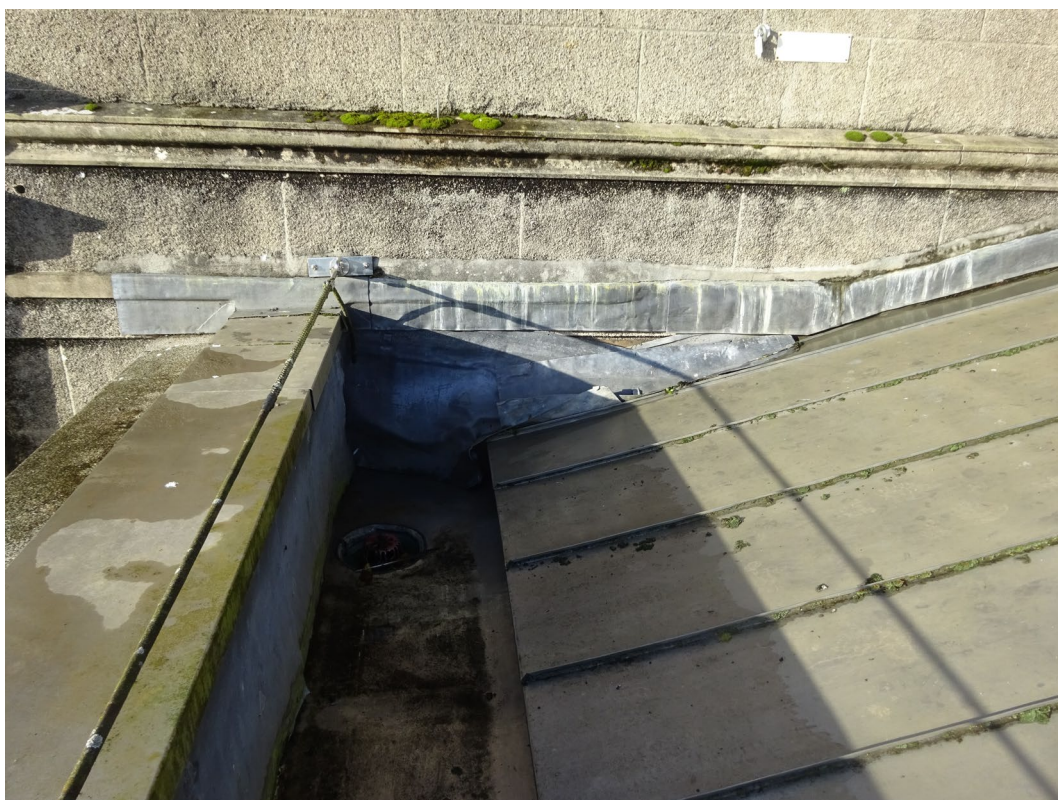
12. Displaced leadwork to S6 west
