# Lower Brook Street Toilets

## Refurbishment and Demolition Survey

### Asbestos Report – Copy 1

**Project No:** J3353

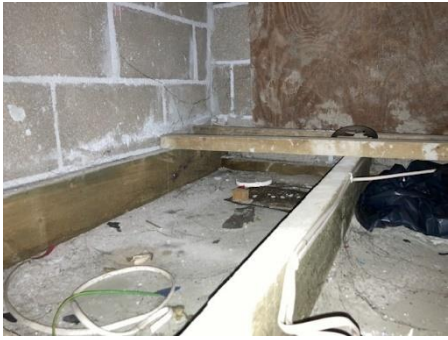
Floor	Location	Sample Number	Item Description	Photograph
Ground	Roof space	Visual	Block walls / plasterboard ceilings.

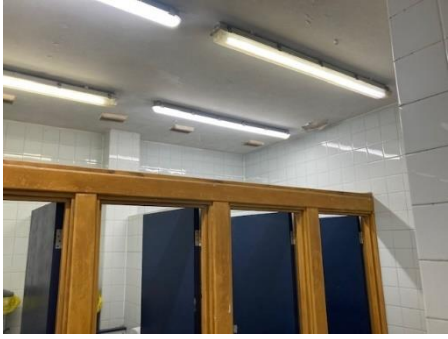
Ground	Ladies WC	Visual	Block walls / plaster ceiling.

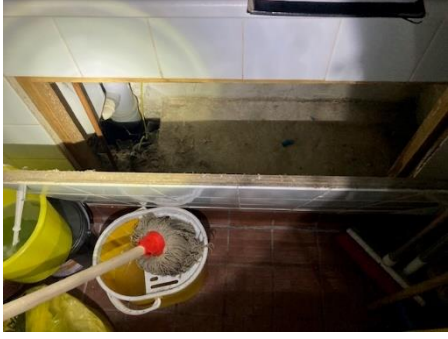
Ground	Cleaners	Visual	Timber ducting / plastic water pipes.

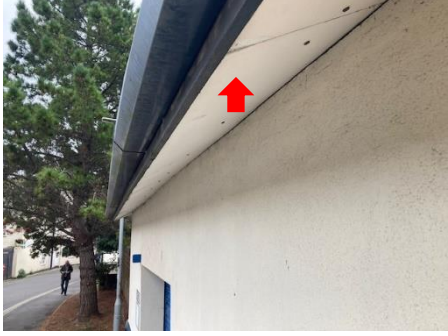
External	Roof	001	Soffit panels.

L.C.L. Sample Ref. Number	Sample Location/Clients Identification Number and Material Type	Asbestos Fibre Type
SC38600	1 - External, roof, soffit panels, cement	No asbestos detected

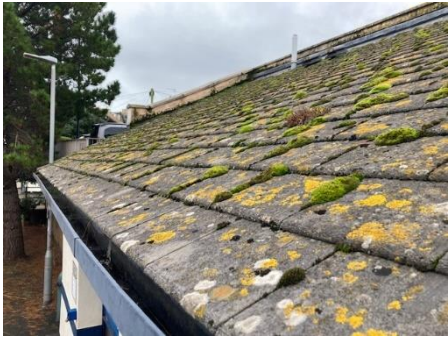
Floor	Location	Sample Number	Item Description	Photograph
External	Roof	Visual	Roof tiles.

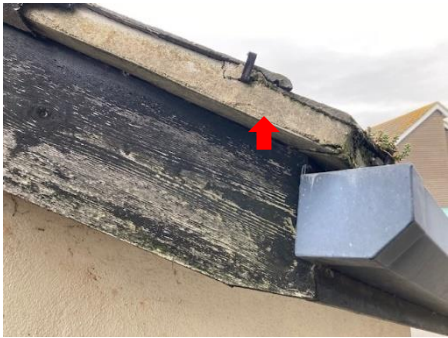
External	Roof	Visual	Undercloaking to roof eaves.
