A Amendments for tender			
Rev	Description	Drawn By	Date
Client:	Shaftesbury Town Hall	Drawn By:	SF
Dwg Title:	South & East Elevations	Checked By:	BW
Project:	Shaftesbury Town Hall, High Street, Shaftesbury, Dorset.	Scale	1:100
		Date:	27/3/23
Job No.:	5131	Dwg No.:	W06
		Revision:	A

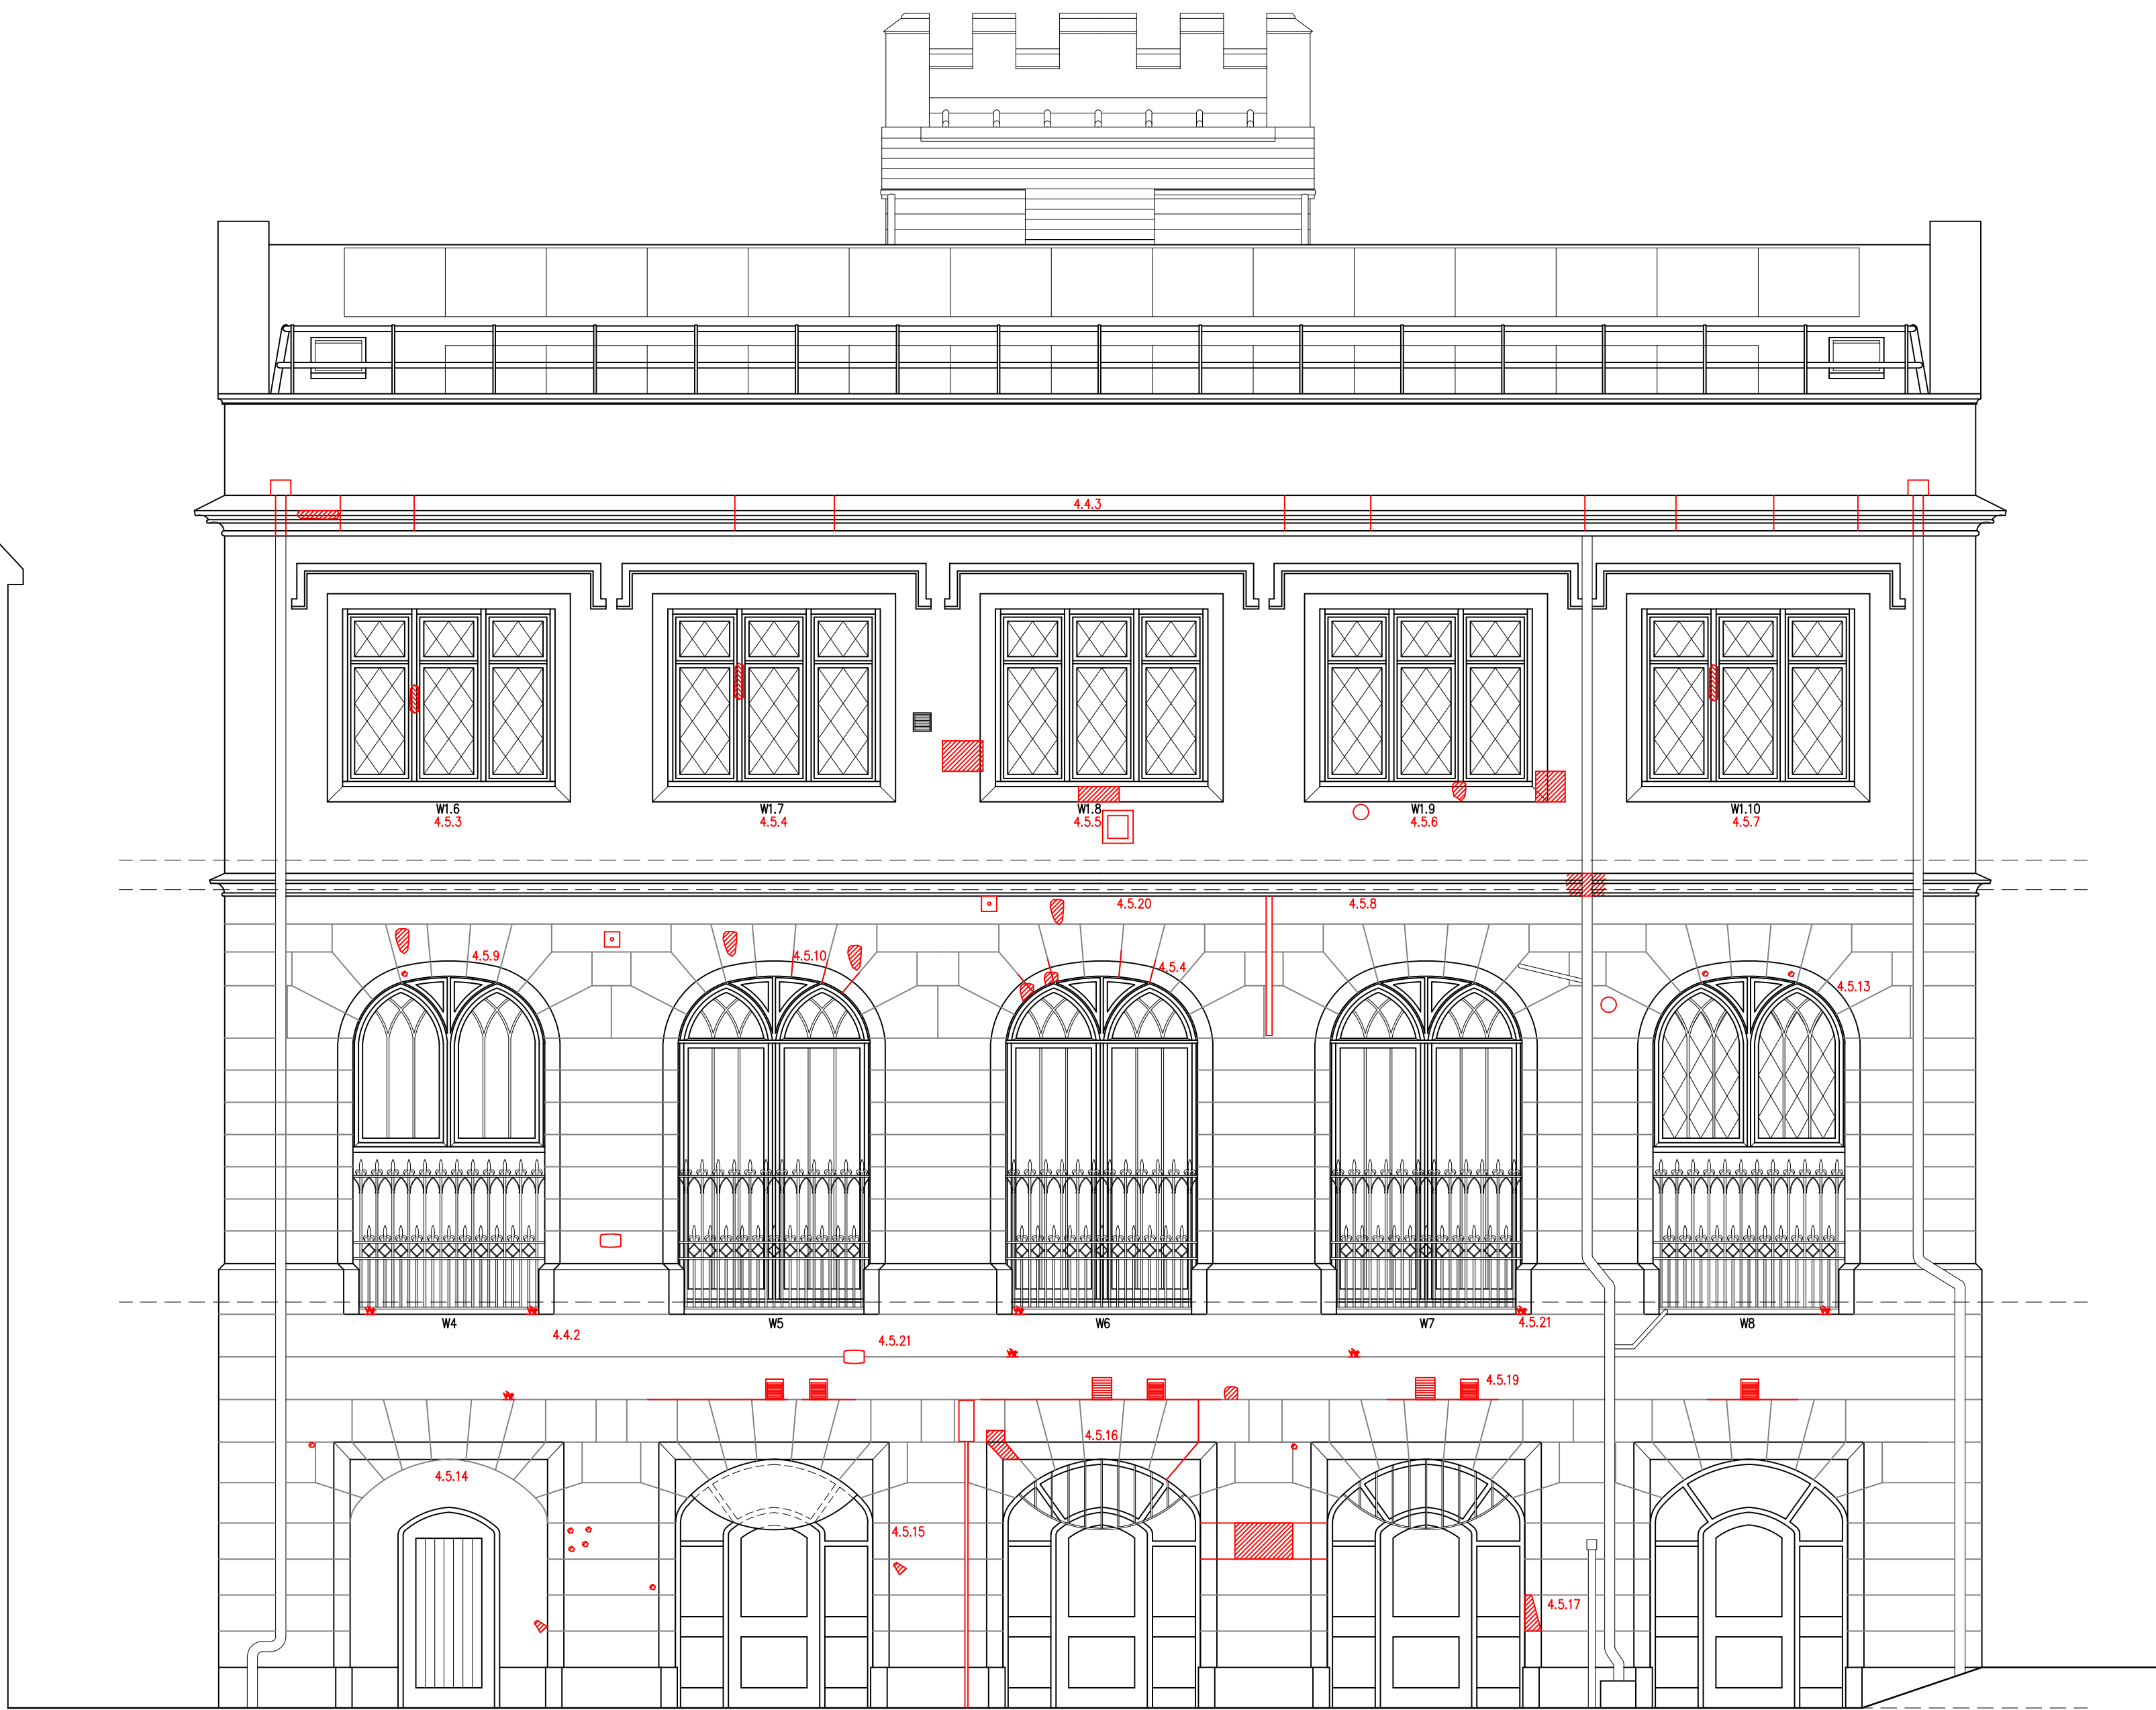
South Elevation

4.4 South elevation

- 4.4.1 Castellations to the South elevation parapet were removed mid-century, and lintels and mullions of the windows to the upper level were replaced with cast concrete. Postcards from the 30s record the previous condition with windows matching those remaining to the North.

- 4.4.2 There are numerous saplings and plants growing from the ledges between lower ground and ground floor levels which should be removed as 4.1 above.

- 4.4.4 Check cohesion of cast stone lintel to W1.6 (hairline cracks visible to the underside), and allow to remove any loose material, rake out and point cracks. Check historic mortar repair to LH mullion. Remove small section of blown cement-rich sill to LH end of the window, clean back to reinforcement, treat exposed metal and re-cast sill section to match existing. On completion apply Kingfisher Stormseal to all cast stone components in accordance with manufacturer's written instructions.

- 4.4.6 Cut back previous failed mortar repairs and blown face of ashlar stone (greensand) to the west side of W1.8, and to sloping sill, and piece-in new splayed stones shaped to suit. Rake back any loose material internally to the sill to expose reinforcement. Treat metal with jennolite or similar approved rust converter in accordance with manufacturer's instructions and mortar repair to match existing profile. Remove redundant heater flue from beneath window, and piece-in new stone to match coursing adjacent. All as C41. On completion apply Kingfisher Stormseal to all cast stone components in accordance with manufacturer's written instructions.

- 4.4.7 Cut back previous failed mortar repair and blown face of ashlar stone (greensand) to the east side of W1.9, and piece-in new splayed stone shaped to suit the window reveal. Rake back any loose material internally to the sill to expose reinforcement. Treat metal with jennolite or similar approved rust converter in accordance with manufacturer's instructions and mortar repair to match existing profile. Remove redundant downpipe from beneath window, and piece-in new stone to match coursing adjacent. All as C41. On completion apply Kingfisher Stormseal to all cast stone components in accordance with manufacturer's written instructions.

- 4.4.3 Remove moss and vegetation to the cornice as described in 4.1 above, and gently brush off exfoliation and scaling to the underside. Point open joints to the cornice, (allow to fully repoint 8 no joints to this elevation). All as C41.

- 4.4.5 Rake back any loose material to the LH mullion of window W1.7 to expose reinforcement. Treat metal with jennolite or similar approved rust converter in accordance with manufacturer's instructions and mortar repair to match existing profile as C41. On completion apply Kingfisher Stormseal to all cast stone components in accordance with manufacturer's written instructions.

- 4.4.8 Rake back any loose material to the LH mullion of window W1.10, and to internal sill to expose reinforcement. Treat metal with jennolite or similar approved rust converter in accordance with manufacturer's instructions and mortar repair to match existing rounded profile externally and sill internally as C41. On completion apply Kingfisher Stormseal to all cast stone components in accordance with manufacturer's written instructions.

- 4.4.9 Gently brush off string course to remove exfoliation. Infill missing detail from mould as shown on drawing and using mortar repair, and repoint (2) open joints. Piece in section of new stone moulding where plastic soil pipe is removed. All as C41.

- 4.4.10 Rake out loose material and fill 3 no cavities in voussours over W4 using mortar repairs as C41. Allow to point open joints to the lower portion of the window (sill and plinth line) following removal of plants.

- 4.4.11 Rake out loose material and fill 6 no cavities in voussours over W5 using mortar repairs as C41. Allow to point open joints to the lower portion of the window (sill and plinth line) following removal of plants.

- 4.4.12 Rake out loose material and fill 3 no small cavities in voussours over W6, and 1 number cavity over voussours using mortar repairs as C41. Allow to rake out and repoint open joints to the RHS of the arch where voussours have dropped. Cut out damaged stone to two number damaged voussours to the LHS of the head, and piece in new stone to match. Pin and point as section C41. Repoint joint beneath window following removal of plants.

- 4.4.13 Allow to point open joints to the lower portion of W7 following removal of plants.
- 4.4.14 Fill 2 no cavities in the splayed section of voussours over W8 using mortar repairs as C41. Allow to point open joints to the lower portion of the window following removal of plants.

- 4.4.15 Fill 8 no small cavities in the stone to the sides of D0.1 using mortar repairs as C41. Allow to point open joints over the splayed head following removal of plants.

- 4.4.16 Fill 2 no small cavities in the stone to the sides of D0.2 using mortar repairs as C41.
- 4.4.17 Cut back blown voussour to the west side of D0.3 and piece-in new splayed stone shaped to suit. Rub dropped voussour to east of arch to smooth unsightly edge and make good. All as C41. Allow to point open joints over the splayed head following removal of plants.

- 4.4.18 Make good fractured stone to the jamb of D0.4 using mortar repair as C41.

- 4.4.19 Make good pocked stone to the jamb of D0.4 using mortar repair as C41.

- 4.4.20 Allow to remove 4 number redundant extract grilles over lower ground floor openings (leaving 4 functional grilles). Piece in new greensand stone down to the course line below, and piece in a new stone of full course depth. Tool face to match existing. All as C41.
- 4.4.21 Allow to pin the blown face of 10 ashlar stones across the entire elevation as C41.
- 4.4.22 Carefully remove 2 no security boxes remove any plugs and make good stone following.
- 4.4.23 Decorate metal window frames, railings and tie patress plates/bar as specified in M60.
- 4.4.24 Redecorate previously painted brickwork beneath openings as M60.

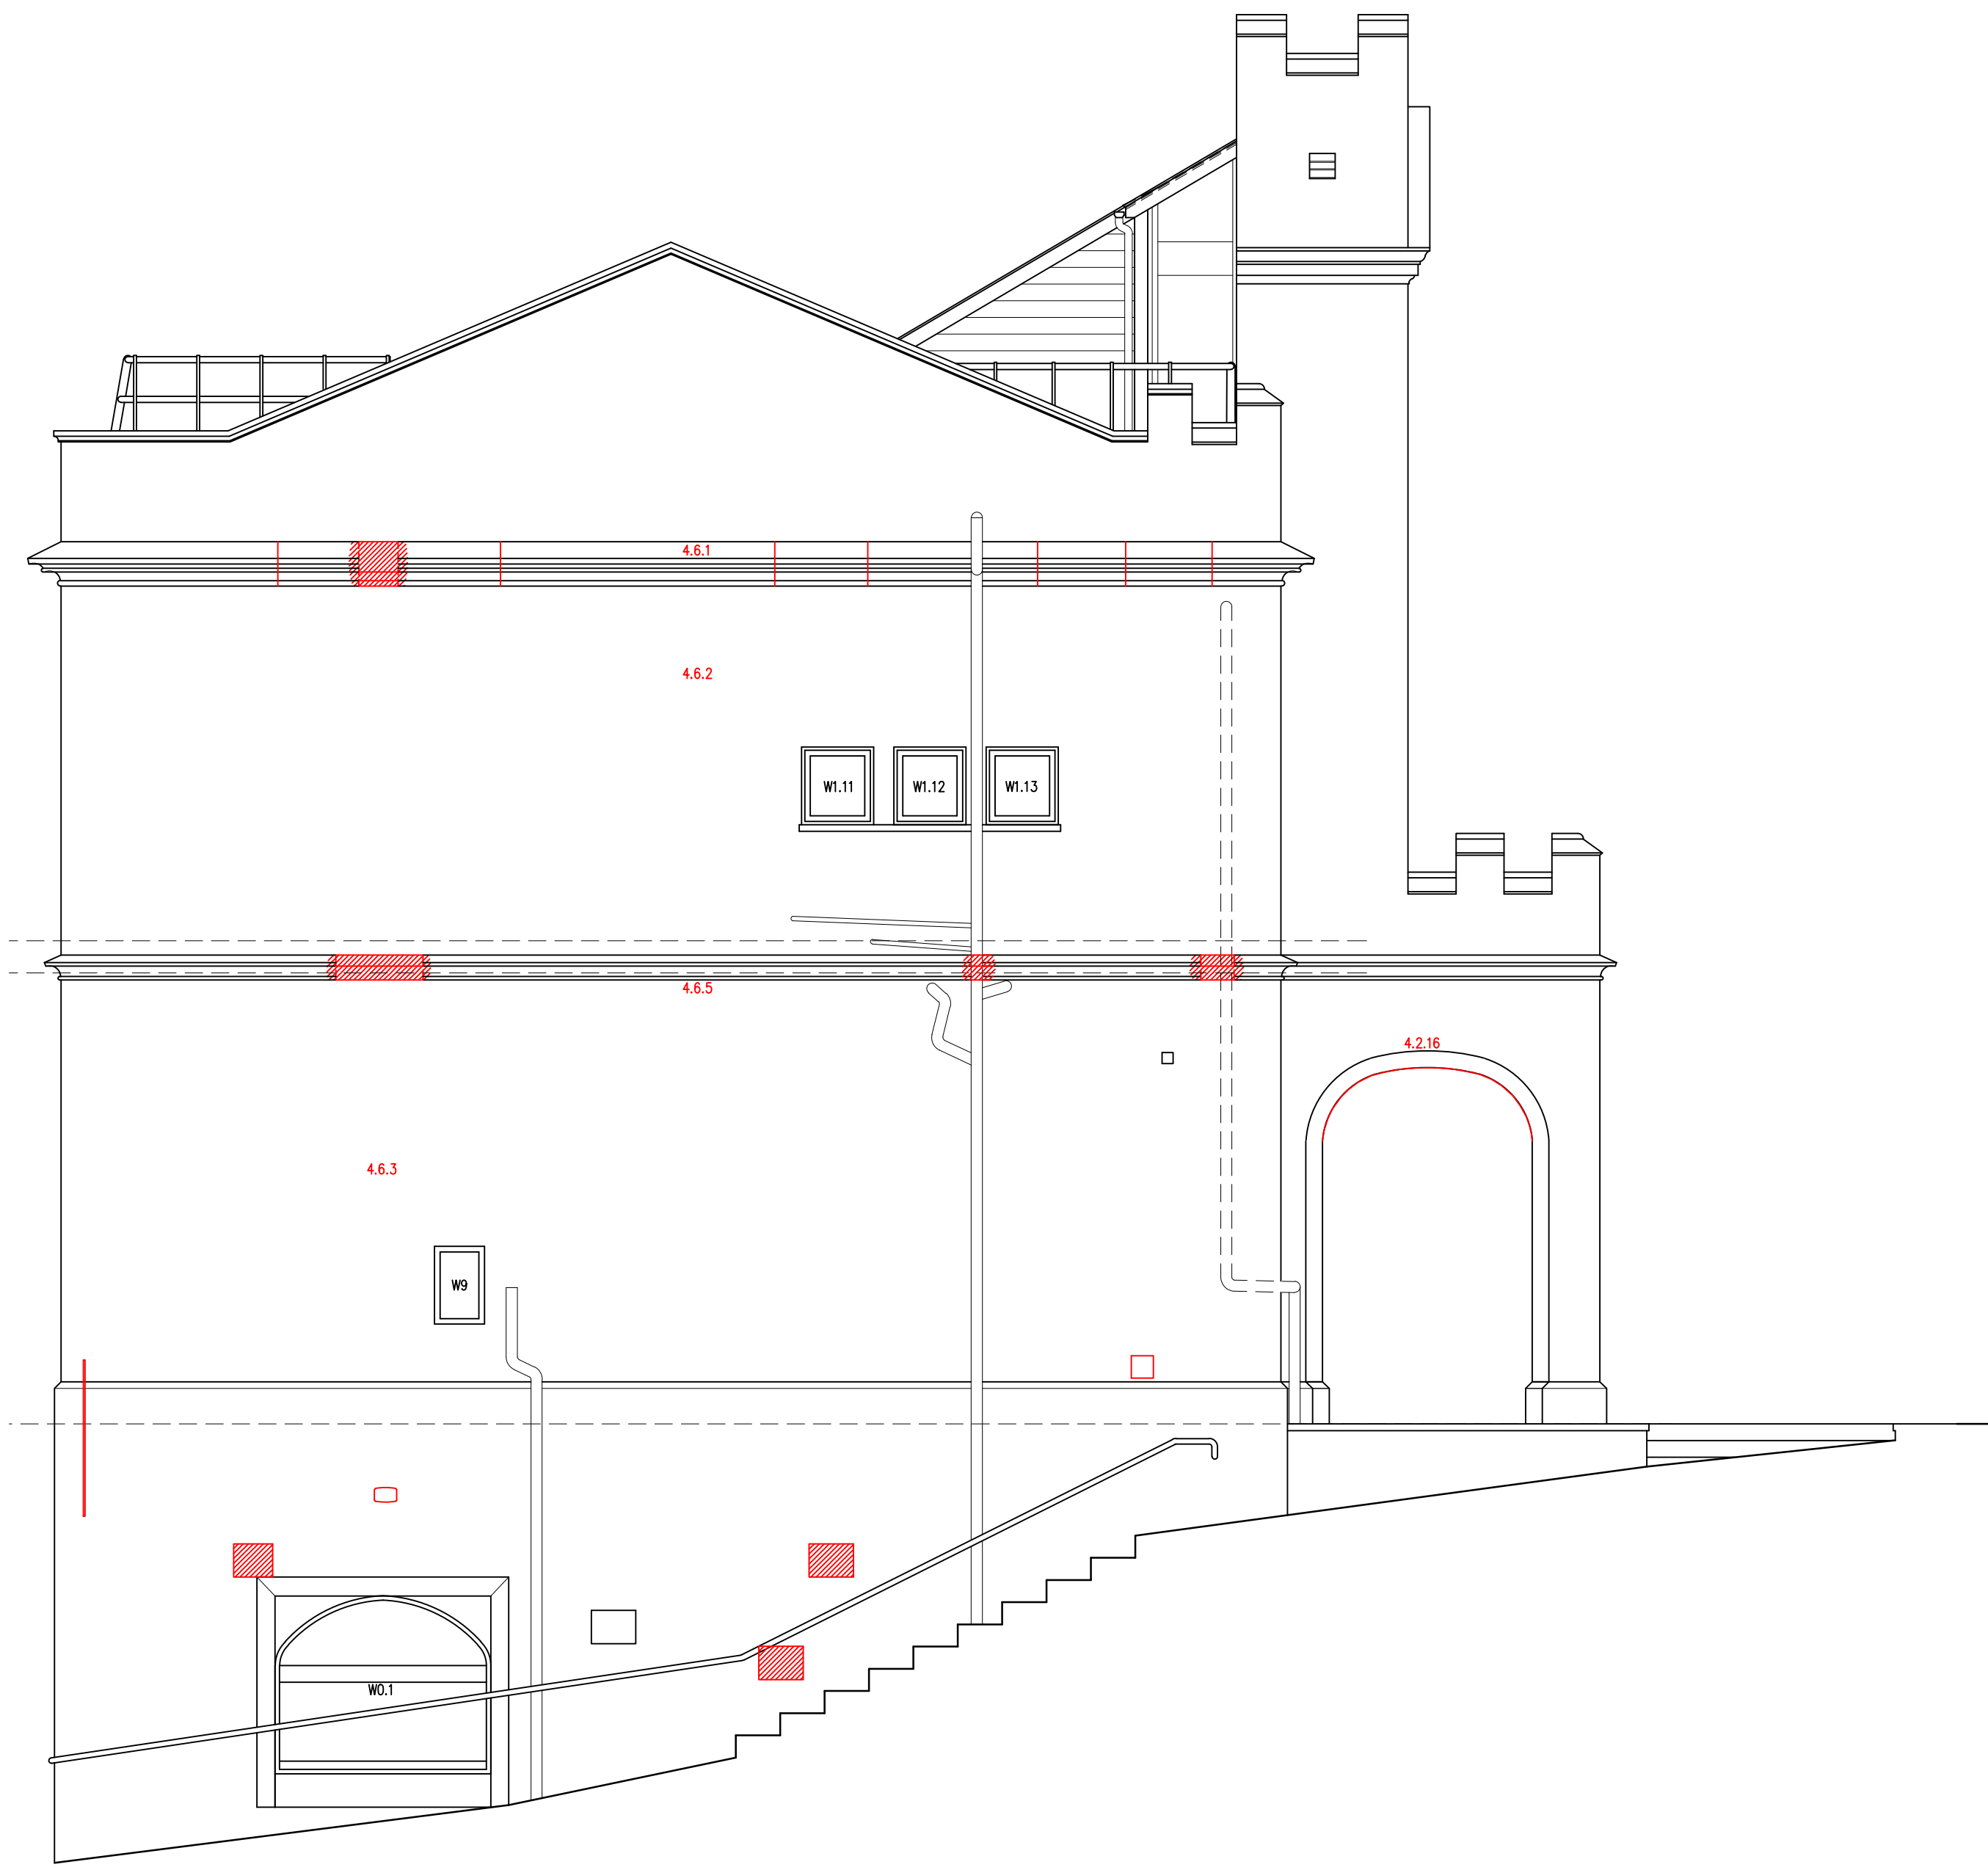
East Elevation

4.5 East elevation

- 4.5.2 This elevation has many open joints, perhaps over 50% are without mortar. Allow to repoint all open joints (including those to the gable) as C41.

- 4.5.1 Remove moss and vegetation to the cornice as described in 4.1 above, and gently brush off exfoliation and scaling to the underside. Point open joints to the cornice, (allow to fully repoint 8 no joints to this elevation). Cut out stone behind missing section of cornice and insert new piece to match existing profile (approx. 600mm length) All as C41.

- 4.5.3 Remove remaining ferrous metal fittings where a flue has been removed from the south end of the elevation. Clean traces of the flue (mastic?) from surrounding stone and make good resulting holes with mortar repairs as C41.

- 4.5.4 Cut out failing in-situ cast concrete window sills to W1.11, W1.12 & W1.13, and cast new including stainless steel reinforcement and ties to existing masonry.

- 4.5.6 Gently brush off string course to remove exfoliation. Cut out stone behind missing section of string course (where flue previously fitted/removed) and insert new piece to match existing profile (approx. 1000mm length). An old mortar repair to the string course beneath the w.c. windows has also failed revealing the corroding armature. Cut out the defective stone and mortar repair and piece in new stone moulding to match (approx. 600mm length). Cut out string course where RWDP relocated as shown on drawings, and piece in new to match (approx. 600mm length). All as C41.

- 4.5.7 Replace plastic stack pipe with cast as R11, and relocate rdwy to north elevation as described above.
- 4.5.8 Remove redundant fittings, sign bracket, coiled telephone cables, flue and cage, Partnership Security box and make good stone.

- 4.5.9 Decorate metal frames, handrail, and railings as specified in M60.
