#### Visual Inspection of Roof Timbers 25-11-2023

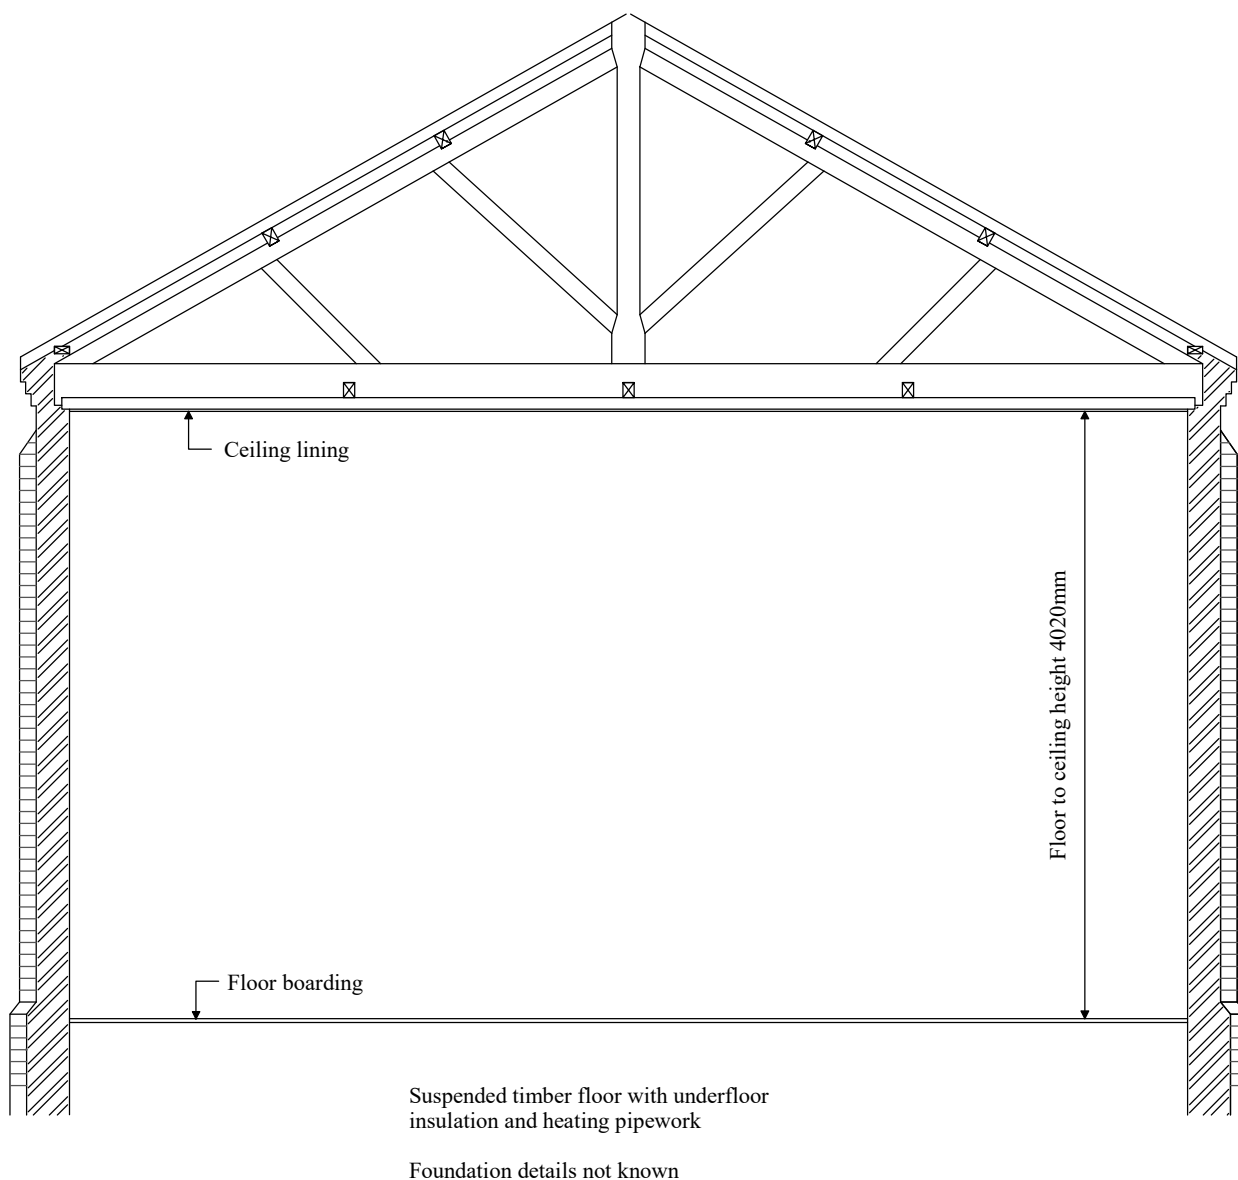
Purlin sag - 30mm in 1.8m  
 Ceiling binder sag - 12mm in 1.8m  
 King post truss diagonal cord sag - 12mm in 1.8m  
 King post beam cord sag - none

Metal strapping has been added to joints between King post truss beam and post cords  
 Timber bracing has been added between the gable ends and the adjacent King post truss

Roof ventilation provided by some holes in the gable end brickwork, natural building construction joints at the eaves, and by ventilation grilles in the ceiling

Plaster and lath ceiling has been overtacked with plasterboard with remains of laths showing in places but with no original plaster
