## Inspection Report 7111

The Caretaker's House Fish Farm Moor Lane Calverton

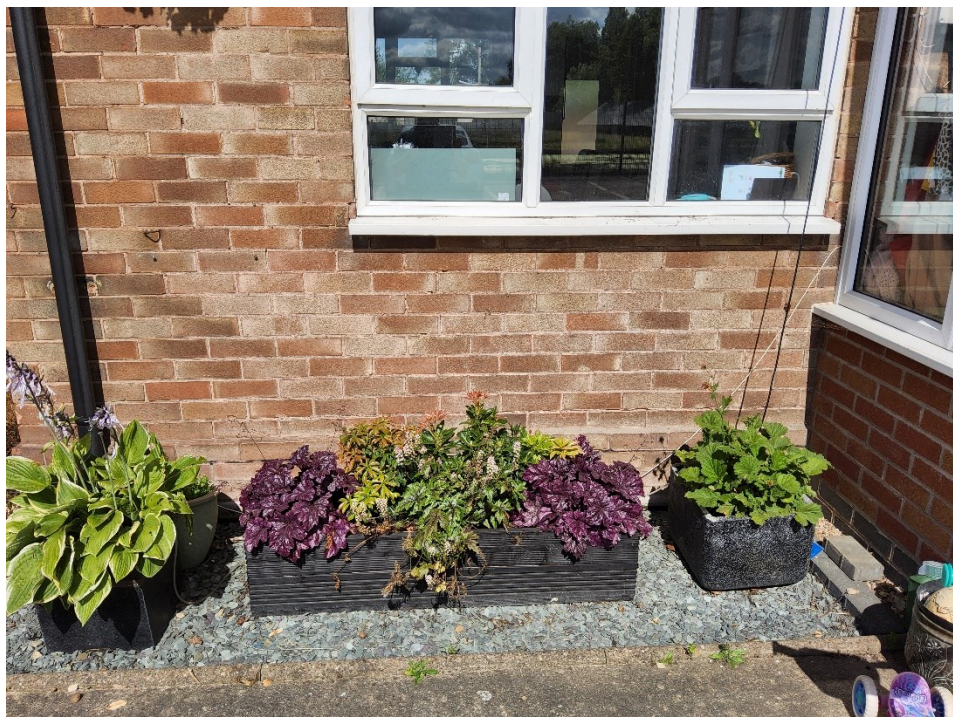
- 3.1. A minor stepped crack was noted the ground floor window to the left-hand side of the front elevation. A stepped cracking was also noted above the same window.

Figure 2 – Stepped crack below window (front elevation)

- 5.1. The cracks noted to the front elevation are minor in nature and only require repointing.
- 5.2. Repointing is also required to fill the section of brickwork noted to be suffering from mortar loss. This is required to prevent water penetration and stop insects (i.e. bees) from getting into the cavity and starting an infestation.
- 5.3. The cracks to the side elevations were not significant and require some repoint. As for the front elevation, make sure all section suffering from mortar loss are adequately repointed.
- 5.4. The cracks to the left-hand side of the rear wall are probably due to drainage failure. We recommend the drainage be scanned against potential leakage and repaired as required. All cracked brickwork sections to be adequately repointed.

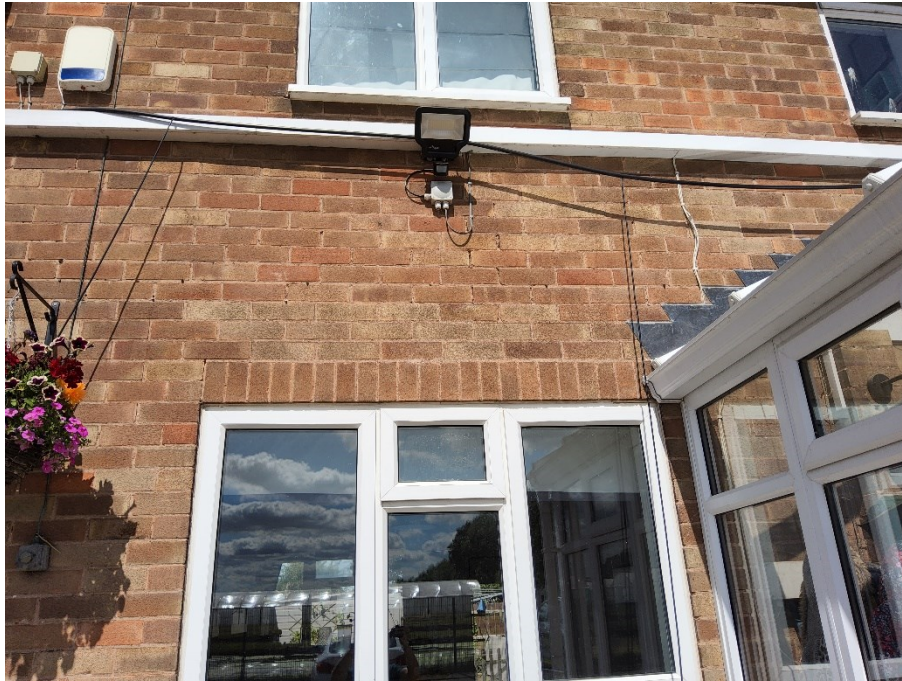
Figure 3 - Cracking above window (front elevation)

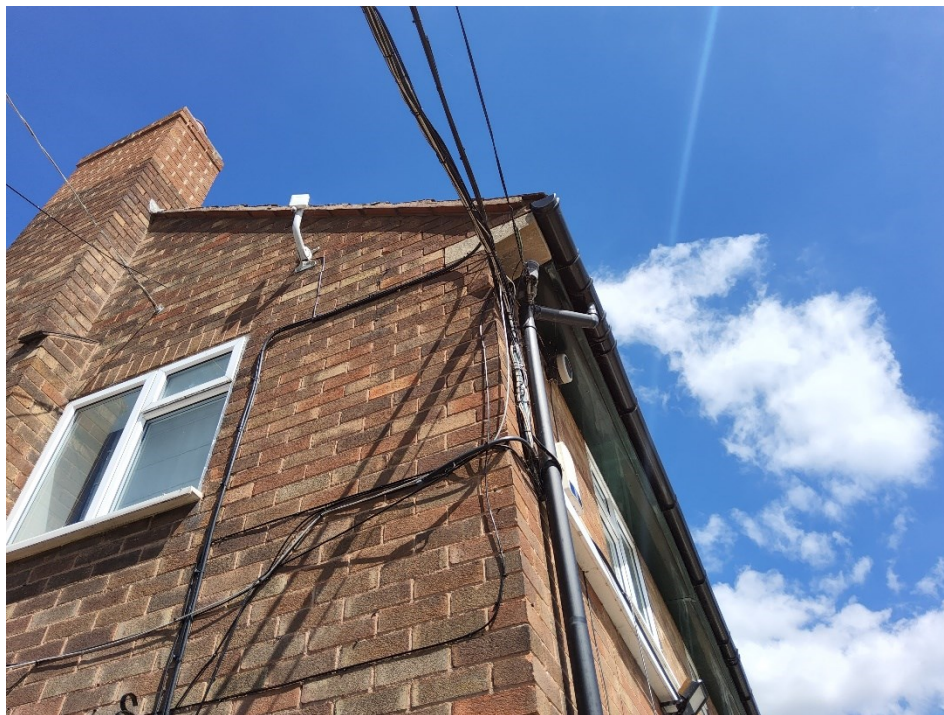
- 3.2. Number of holes in the mortar were noted to the section of brickwork to the left-hand side of the front elevation.
- 3.3. A separation to the brickwork and a displaced brick were noted to the top left corner of the front elevation.

Figure 4 – Crack and displaced brick to top corner of building

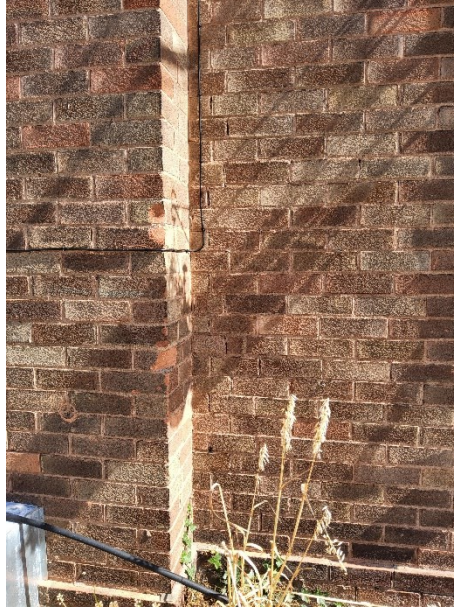
- 3.4. Some separation and mortar loss were noted to the section of brickwork next to the right-hand side of the chimney to the side elevation.
- 3.5. Some minor cracks were also noted to the lower section of brickwork to the left-hand side of the chimney.

Figure 5 – Crack to brickwork next to chimney (side elevation)

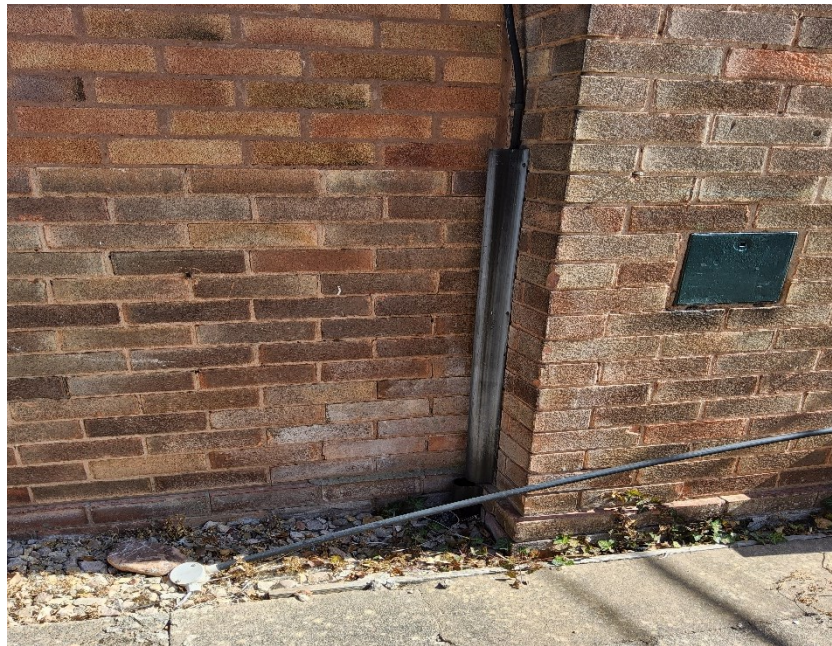
Figure 6 – Minor crack to lower section of wall next to chimney (side elevation).

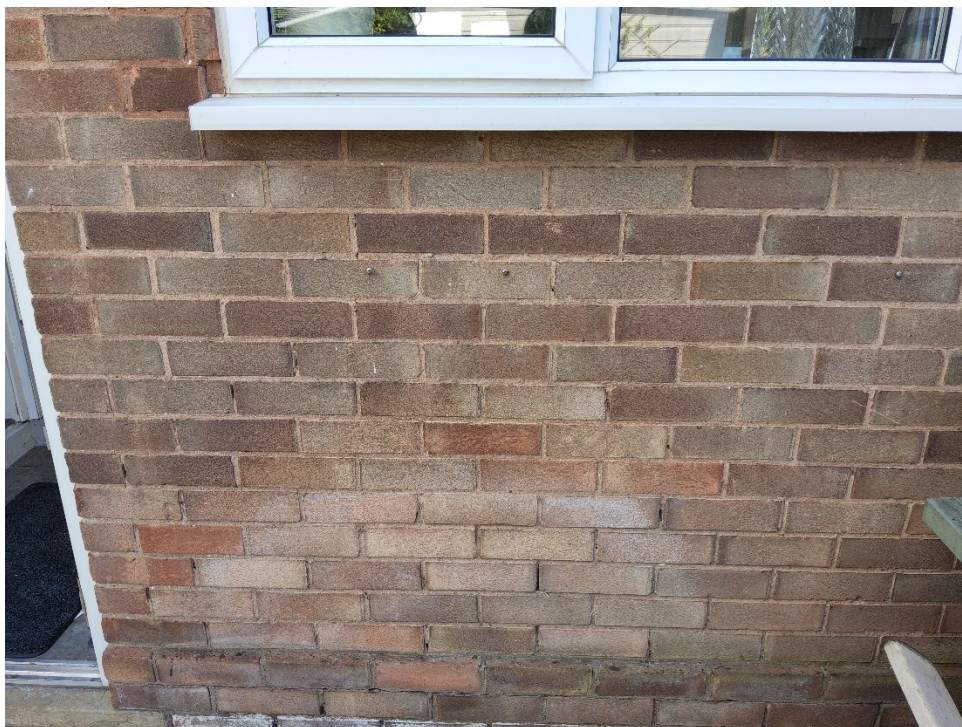
- 3.8. Some mortar loss was noted to the section of brickwork below the ground floor window to the right-hand side of the rear elevation.

Figure 8 –Mortar loss below window (rear elevation)

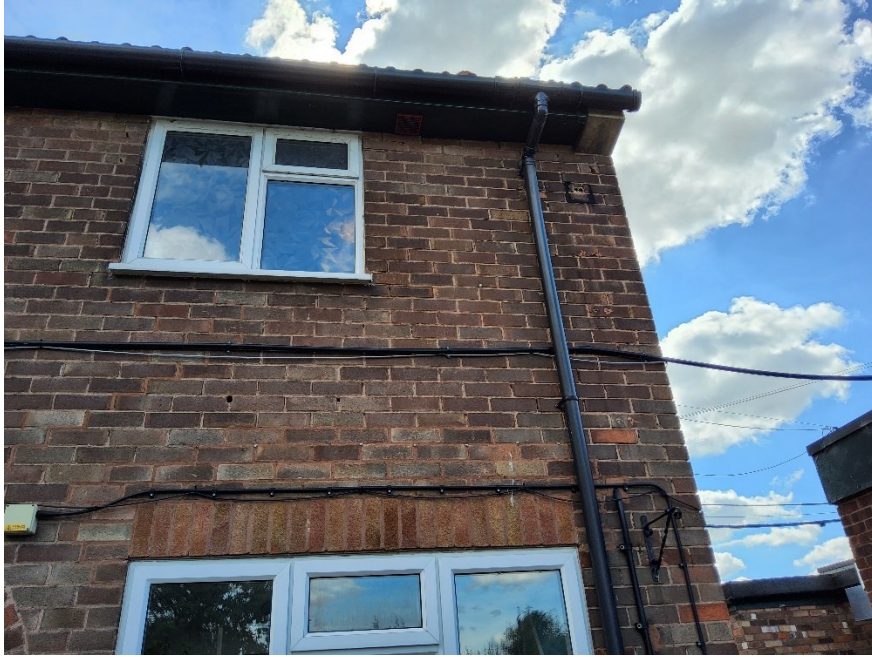
- 3.9. Minor cracking and mortar loss were also noted to the section of wall to the right-hand side of the rear elevation (next to the first floor window).

Figure 9 – Mortar loss and minor cracking

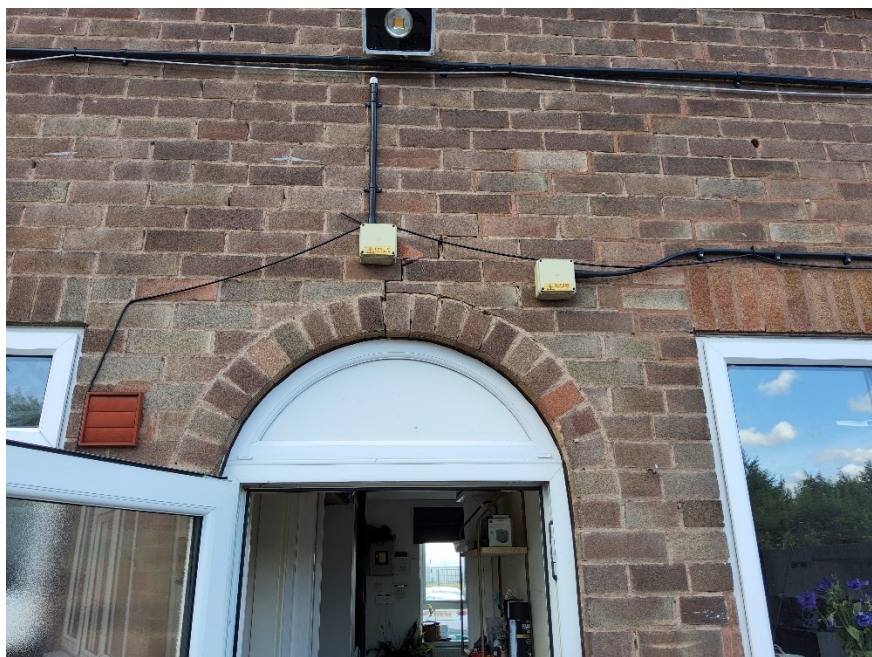
- 3.10. Cracking/separation was noted to the section of brickwork forming the rear door arch. It appeared that the crack was monitored for an unknown period of time, as it seems that a tell-tale crack monitoring was previously applied across the crack and then removed. Result was not available.

Figure 10 – Cracked arch

- 5.5. As already mentioned before, several holes in the mortar were noted to the rear wall. Fill all holes to prevent water penetration and stop insects from entering the cavity.
- 5.6. With regard to the cracked arch, as referred by the tenant, this failure seems to have occurred a number of years ago and based on its current status, it seems to have stabilised. As aforementioned, a tell-tale crack monitor was applied in the past (probably after the failure occurred) and removed afterward suggesting that the movement is no longer ongoing. It is therefore recommended the cracked section being adequately repointed to improve the strength of the arch.
- 5.7. With regard to the roof purlin, it is recommended that a steel plate be bolted to the side of the purlin and across the joined section to improve its strength. See detail below.

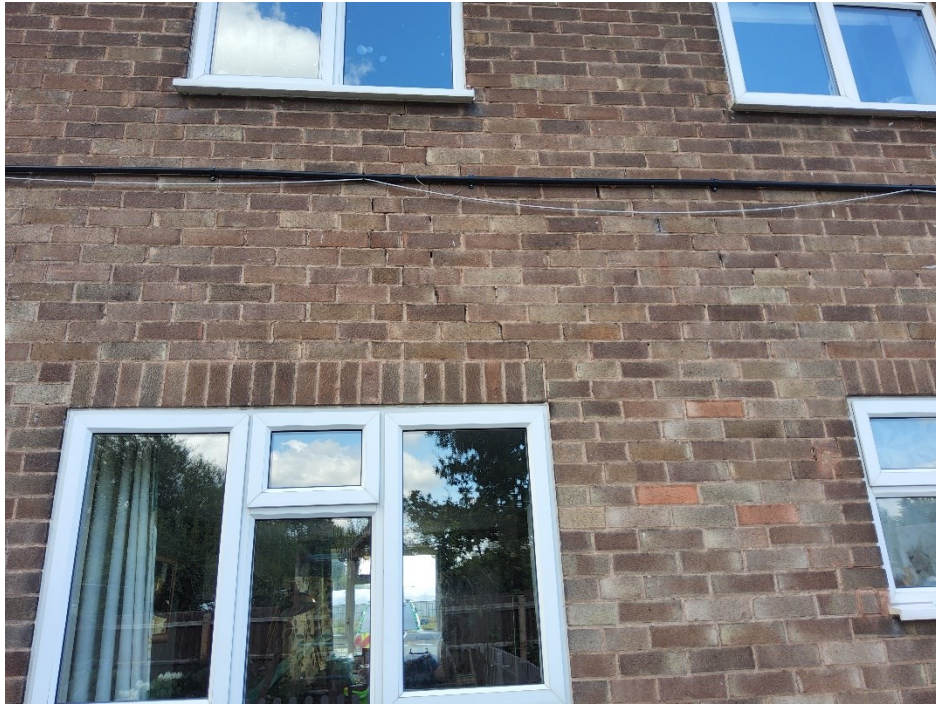
- 3.11. Some stepped cracks were noted to the section of brickwork over and below the ground floor window to the left-hand side of the rear elevation. A tell-tale crack monitoring was noted to be applied across one of the cracks below the window, but no information was available during the inspection to determine whether the movement is still ongoing or not.

Figure 11 – Stepped cracking over window (rear elevation)

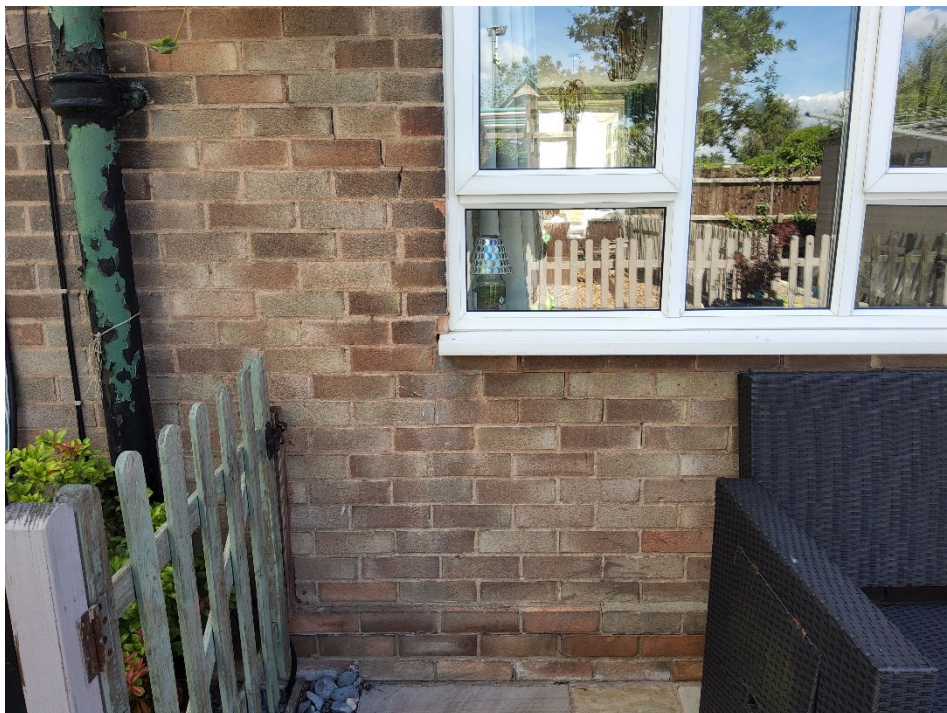
Figure 12 – Further cracks probably due to drainage leakage.

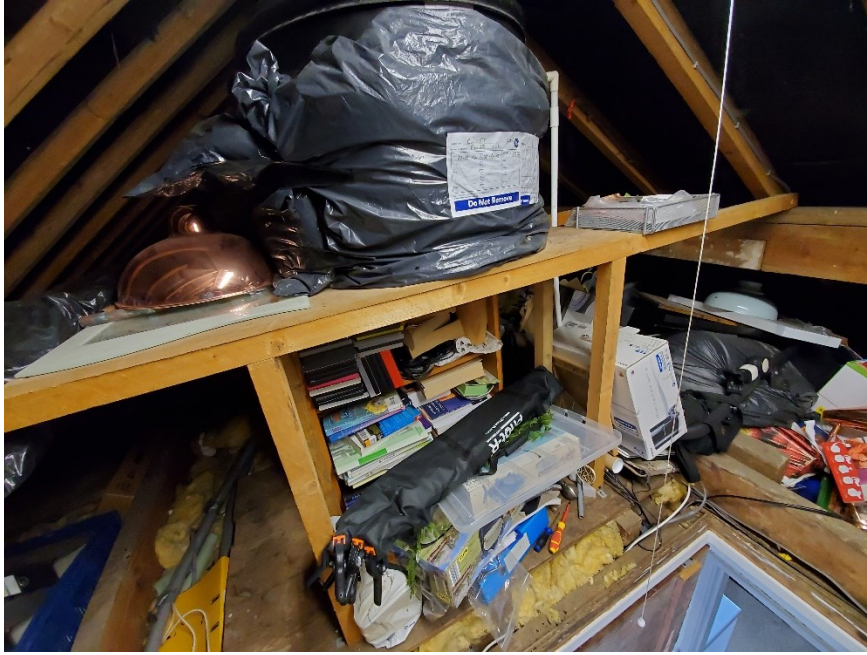
- 4.1. The roof loft was also inspected, and access was obtained through a ceiling hatch.
- 4.2. A 25 gallons water tank was noted to be located in the roof space and supported by a timber structure formed from 3No. 47x47 timber beams supported by the existing purlins and by 2No. 47x47 intermediate timber columns (beneath each beam). The timber columns are in turn sat on a timber platform supported by 3No. 75x95 joists (approx. 950mm long) sat on a solid wall at each end.
- 4.3. One of the purlins was noted to have been split in 3 sections and joined together by notching the ends of each section. The same purlin was also noted to be suffering from excessive deflection across the joined section.

Figure 13 – Water tank and timber structure

- 5.8. The timber structure supporting the water tank is not structurally adequate. We recommend all 47x47 timber elements (vertical and horizontal) be replaced with 100x100 C24 section. If preferred, for simplicity, the new elements can be placed next to the existing where possible.

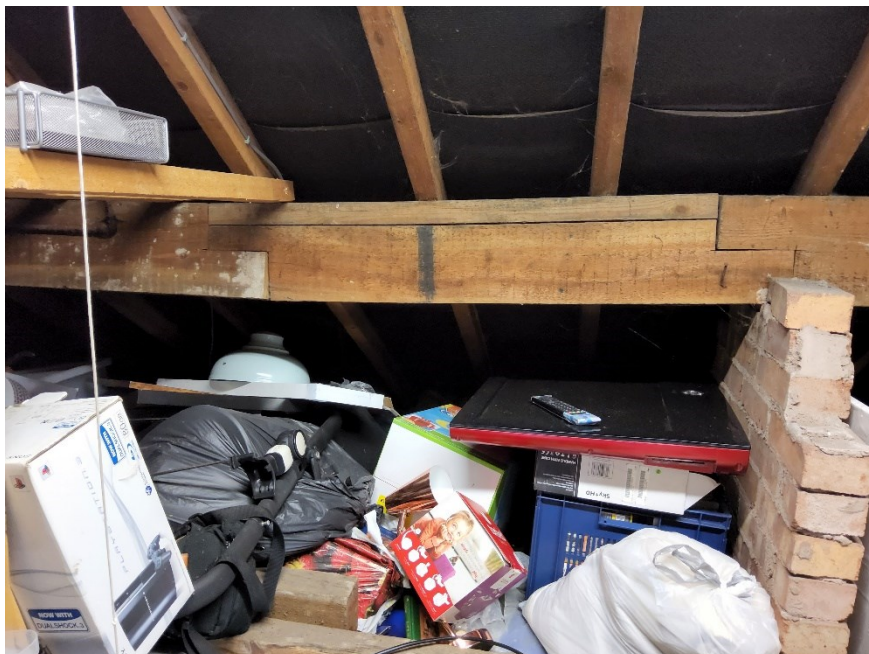
Figure 14 – Purlin to be repaired
