J P Chick & Partners Limited

ST PETER'S CHURCH, THETFORD

STRUCTURAL INSPECTION REPORT

**ST PETER'S CHURCH
THETFORD
CLIENT: THETFORD TOWN COUNCIL**

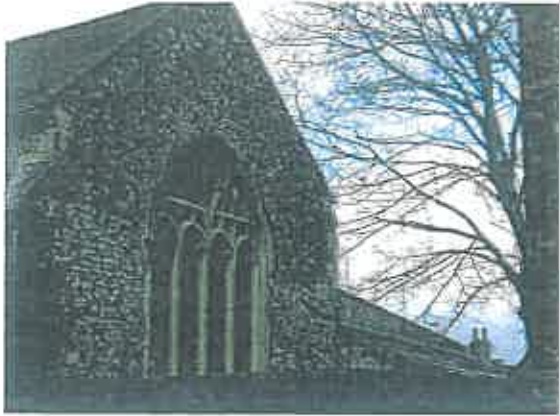
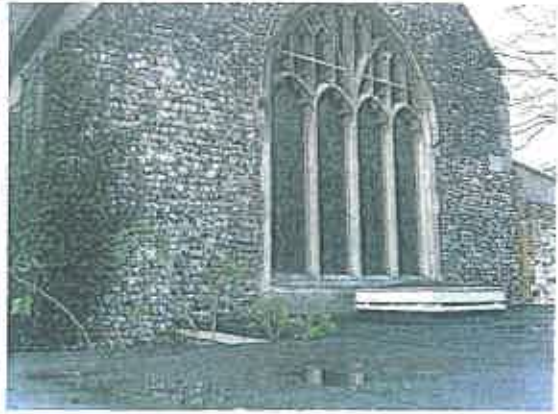
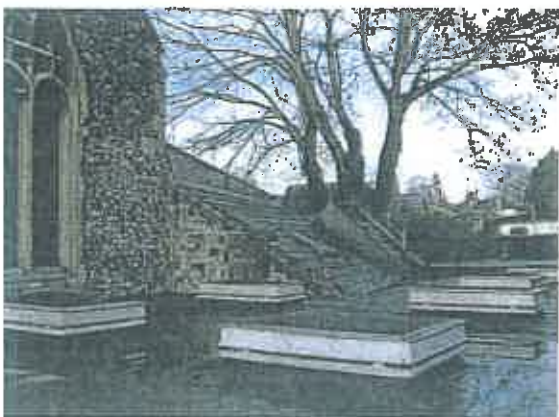
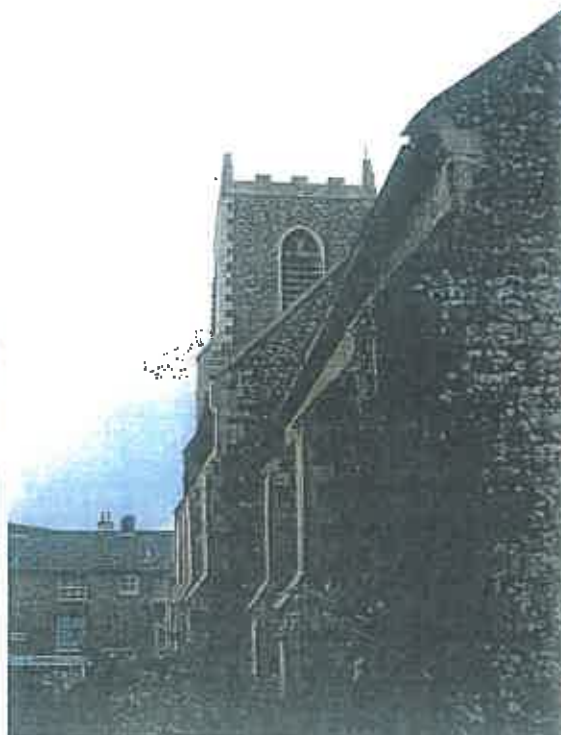
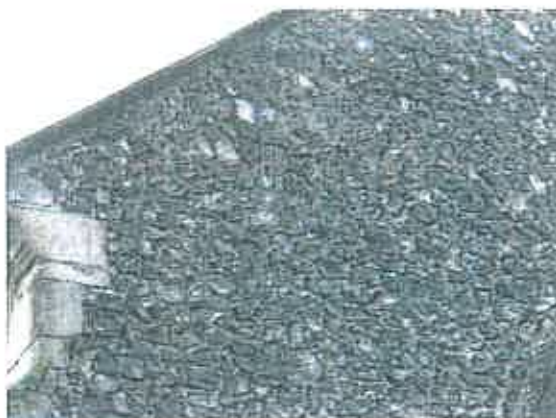
Chancel – East Elevation

- 6.1.1.1 The east elevation of the chancel is largely obscured by the later flat roofed structure, which is built in close proximity to it. From that which is visible it can be noted that the majority of the flint work to the top of the arch height of the window has been undertaken in common and un-knapped flints, giving a lighter appearance. Immediately beneath the south facing window brickwork is evident, which is considered possibly to have been undertaken as later works. All flint work appears to be relatively stable with no obvious movement or damage, although some loss or erosion of lime mortar can be noted at high level.

- 6.1.1.2 At high level to the window the arch to the north is noted to have suffered degradation to the projecting stonework. Coping stones to the parapet detail all appear secure with weathering and long term degradation to the jointing, especially on the northern slope.

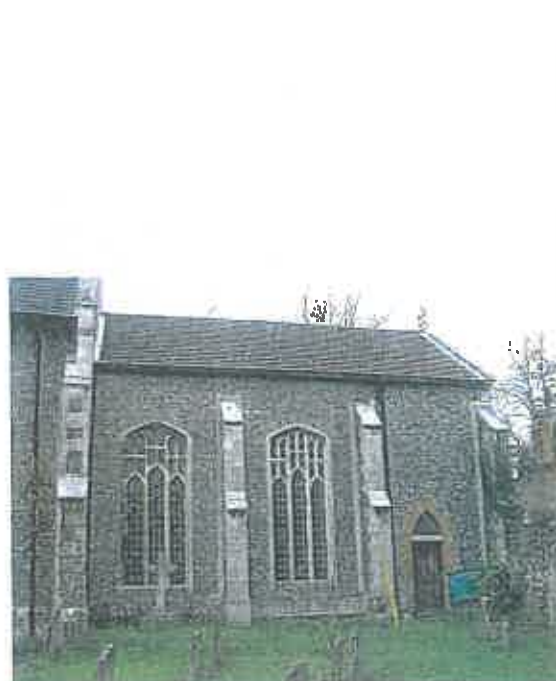
Chancel – South Elevation

6.1.1.6 Buttreassing to the south have lead flashings, which appear in reasonable condition. Cracking is noted to the interface of the same between key stones and the flints, which were noted to continue full height and are a maximum of 1mm in width. Similarly at the plinth level the limestone to all buttresses appears to have longstanding cracks which have weathered and worn accordingly. Central buttresses have suffered some outward rotation considered to be in the region of 30 – 40mm over their height. Low level stonework making up the plinth is seen to be weathered in places. The tiled roof would appear to be in good condition with flashings intact, no slipped tiles and a consistent ridge level. The south facing perpendicular windows both appear in good condition with no obvious indications of significant movement or deterioration.

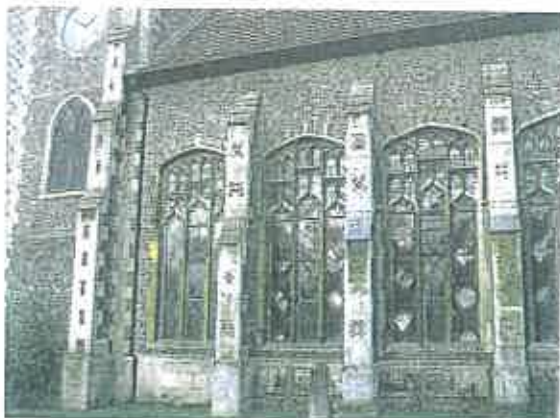
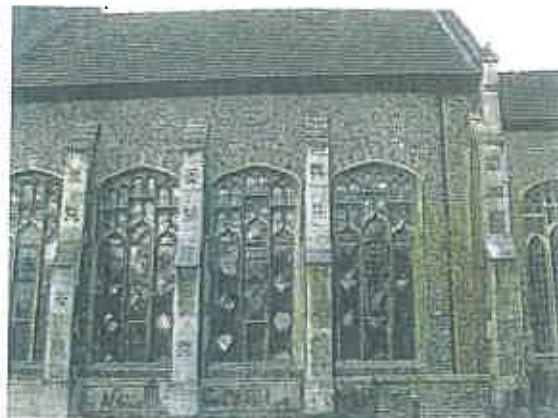
Nave – South Elevation

6.1.2.2 Windows to the south elevation of the nave typically remain intact, although movement is evident where the lead is suffering from age. Inset ironwork is also seen to be rusting and there are early indications that this is causing spalling where embedded into the stonework.

6.1.2.3 As with buttressing to the chancel, cracks are present at the interface between the lime key stones and the knapped flints with cracks of a maximum of 2 – 2.5mm width. These typically continue up to the first step height and do not appear to continue above this level. These abutments are again seen to be overturning with the eastern most of the central abutments, overturning by approximately 60mm over the lower stage alone.

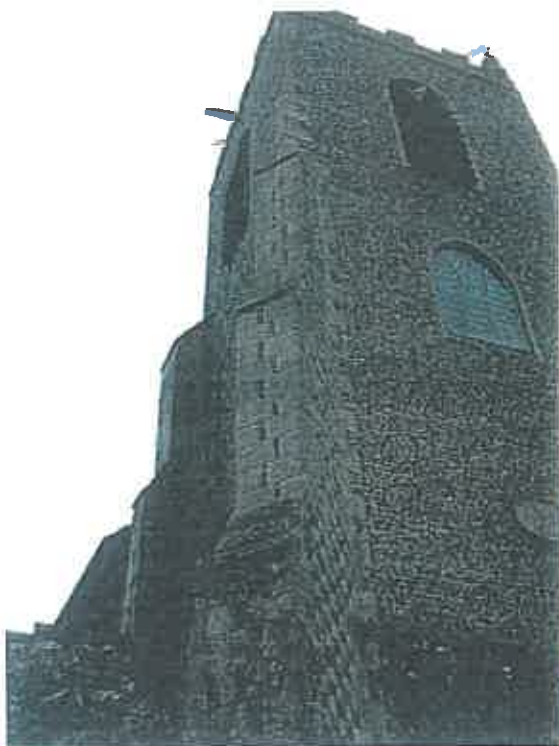
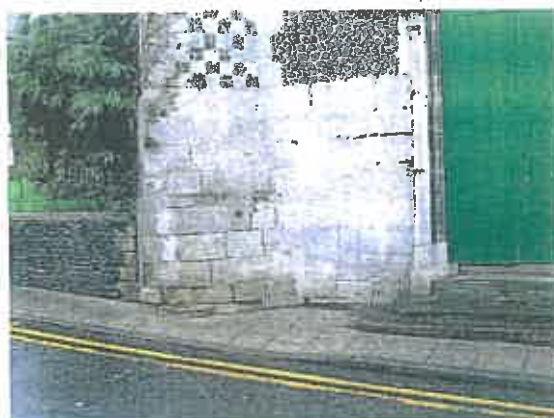
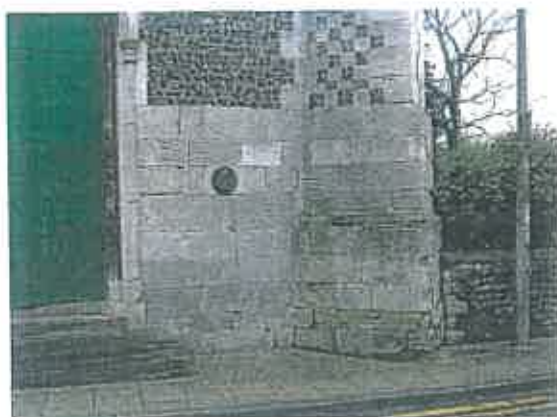
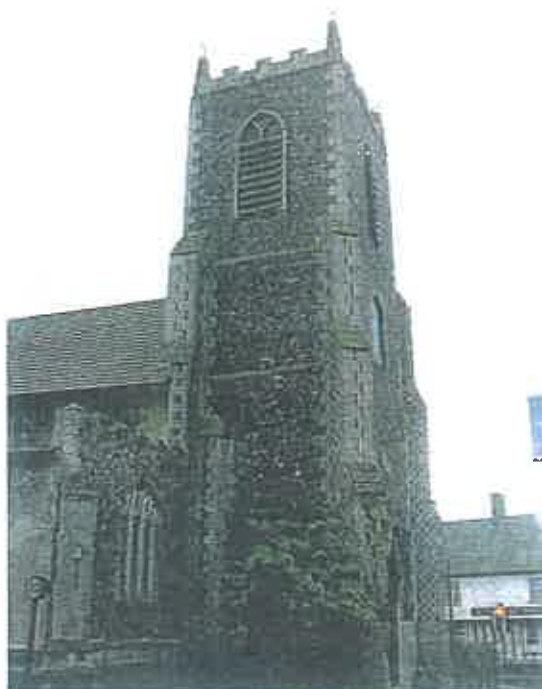
Tower - West

6.1.3.2 Minor cracking is noted to the stone surround of the west window of the clock tower as well as slight misalignment of the same. Timber louvers to the belfry appear weathered, although largely intact. Their fixings could not be closely inspected and we therefore remain unaware of their condition.

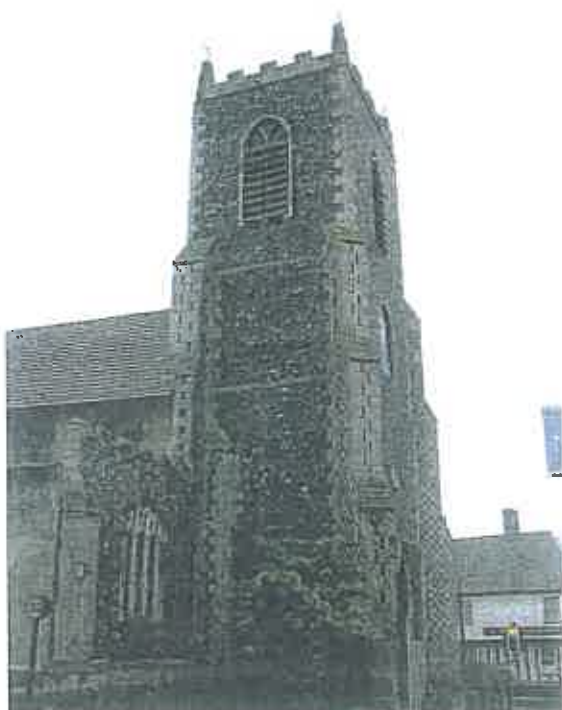
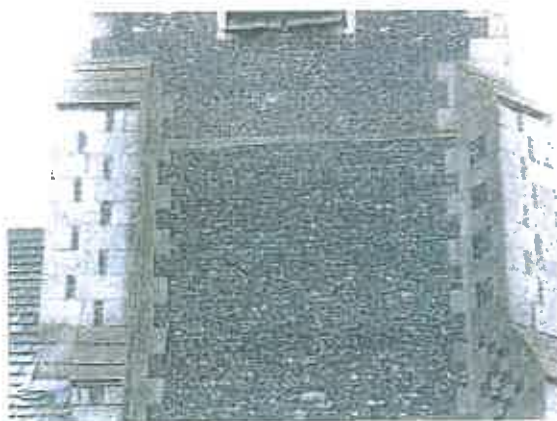
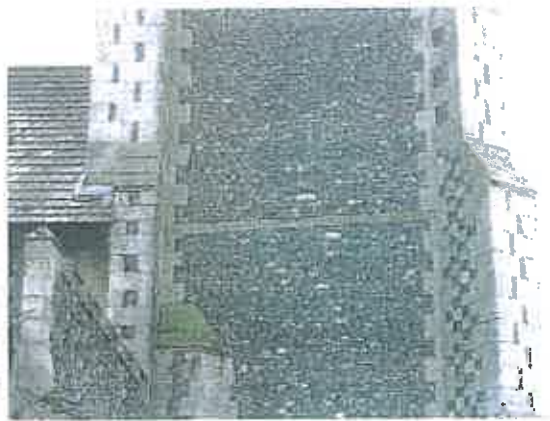
Tower - North

6.1.3.1 Stepped buttresses to the west tower all remain plumb with cracking noted only to the north eastern side abutment, which occurs above the northern aisle at the interface of the key stones and the knapped flints. This runs to full height where the buttress diminishes at belfry level. The flint work and the pointing to the same appears in good condition, although the limestone quoining is suffering weathering to all four corners, which has caused surface spalling to relatively widespread areas. Minor cracking is also noted at the interface between the stone quoining and the flint work at first floor to the south west abutment typically no more than 1mm in width occurring in an isolated 1m length. The faces of the diagonal buttresses have cracking existing between the quoining and the inset knapped flints, which typically exists to the lower staging only. The bases of the exposed abutments have suffered some weathering, especially those that extend on to the pavement of White Hart Street. Typically, stonework within the 'splash zone' has seen significant deterioration to the face and subsequent patch repairs, which have been made over time are again falling.

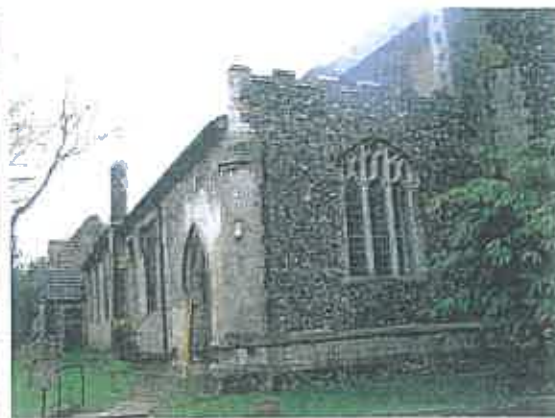
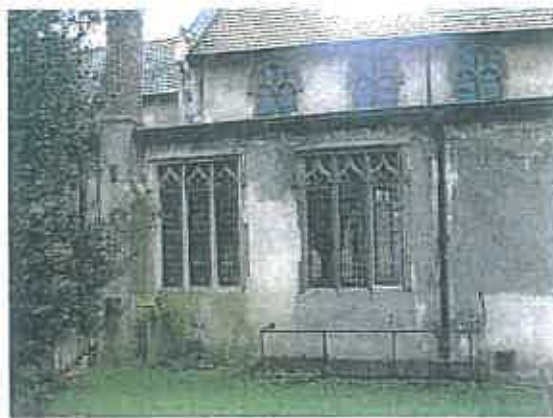
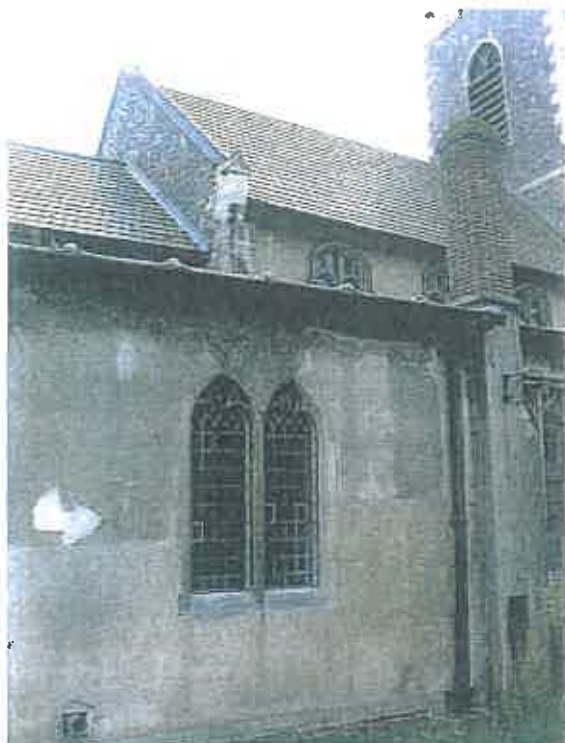
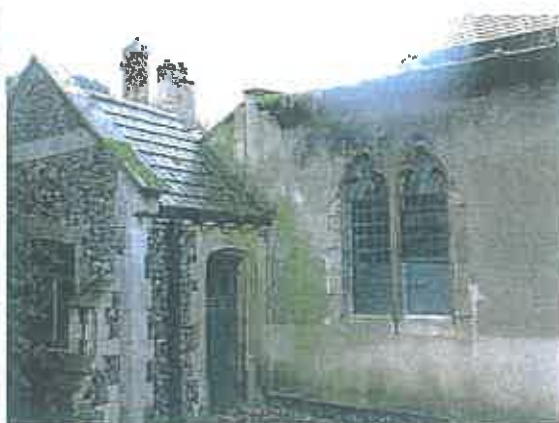
North Aisle

6.1.4.2 The external wall to the north aisle has had an applied render, which over the years has been patch repaired. Currently there is extensive evidence of spalling and debonding, in particular to the eastern end against the chimneystack at the junction with the north chapel / chancel. The external walling in particular the area where windows are situated is seen to be overturning by approximately 150mm over its height in the worst affected area. The damp results from rainwater goods being blocked and entirely ineffective. Similarly, windows have suffered weathering again with ironwork causing spalling where it is embedded into the stone and leading in some areas is perished. This is the same for the clerestory windows at high level, some of which would appear to have had historic repairs. From that which can be seen of the walling to the face of the clerestory this appears in reasonable condition having been rendered, although there is evidence of some flaking to the surface finish and damp staining in the locality of rainwater downpipes, which are likely to either be leaking or have leaked historically.

6.1.4.3 The northern pitch to the nave appears to be in good condition with no slipped or broken tiles and flashings appear largely intact with the exception to that to the bottom of the upstand to the east where a short section is missing. The leaded roof to the north aisle appears to be reaching the end of its serviceable life and shows signs of wear and tear. This is not helped by the significantly blocked guttering, which services this roof, which in turn is having an adverse effect on the external walling also.

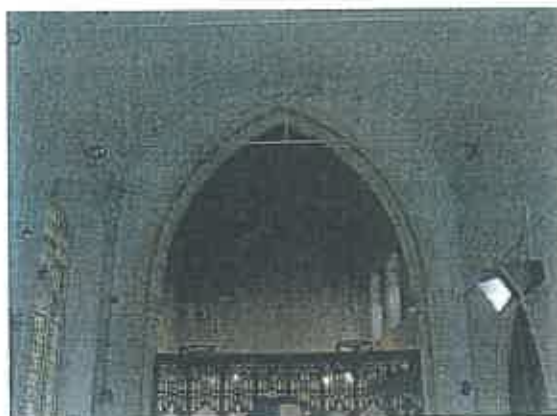
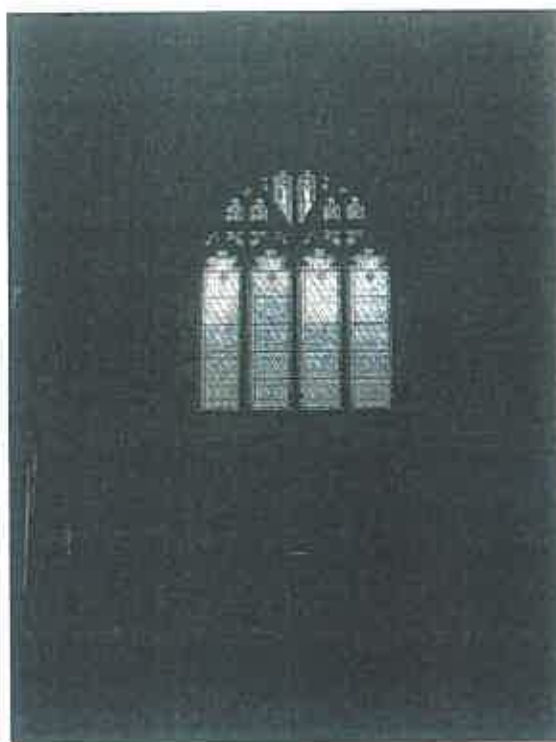
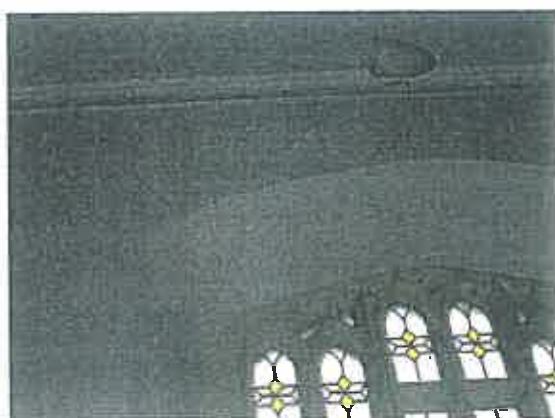
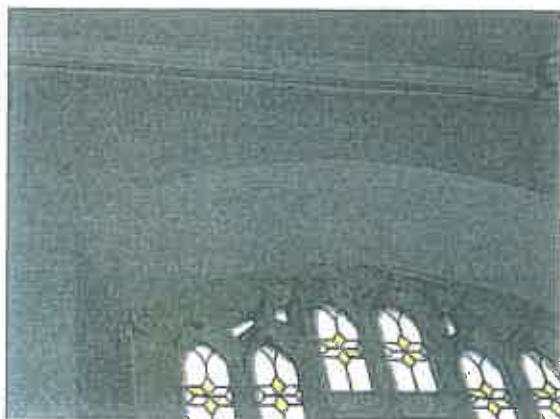
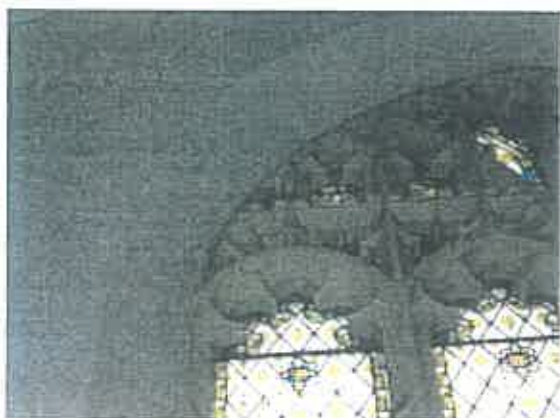
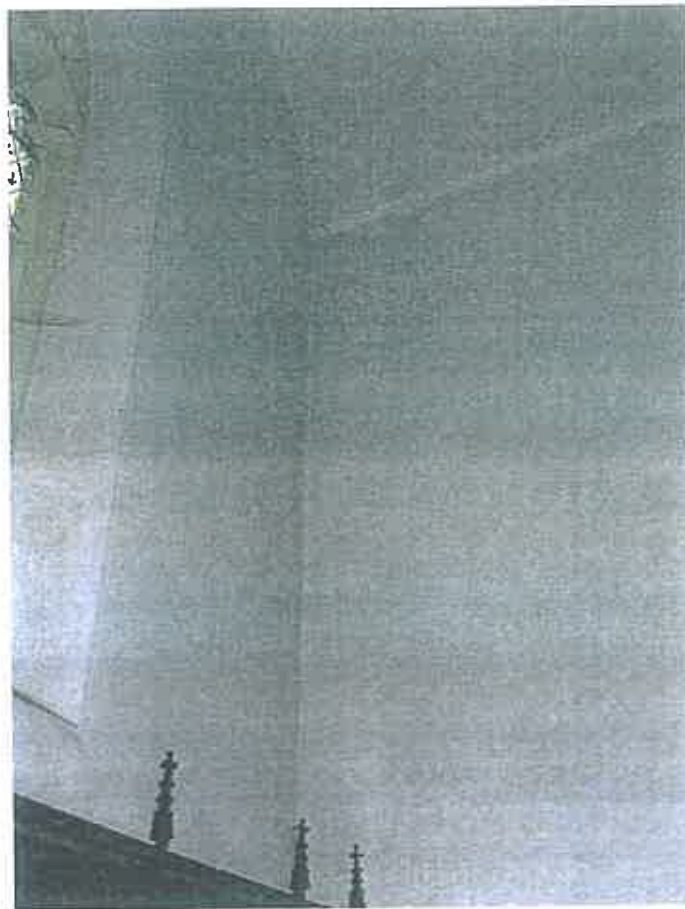
Chancel

6.2.2.1 Within the chancel cracking is noted at the intersection with the nave, which would appear slightly worse to the south side. Further cracking is noted above the windows to the south elevation and also above the eastern most arch to the north elevation. These would appear to be no more than 1 – 2mm in width. Further cracking of a similar magnitude is present above the east window running into the fabric of the ceiling; the decoration of which is seen to be spalling and flaking. There is a vertical crack present approximately 300mm from the east wall, which would appear to continue from ground level up to plate height. This would appear to taper marginally from high level where the crack width is considered to be in the region of 2 – 3mm. This has historically been repaired.

6.2.2.2 The window appears to be in reasonable condition with some fractures noted at high level within the stonework. Glazing and lead work appears to be generally in good condition.

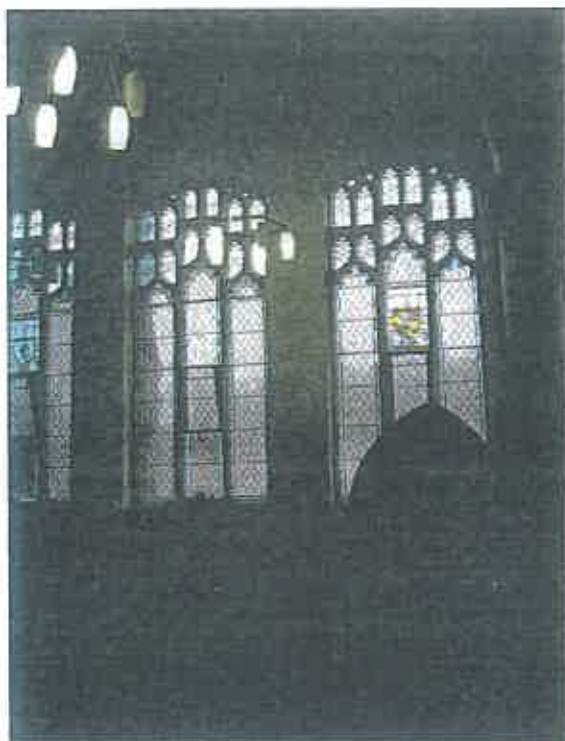
Nave

6.2.1.3 To the south wall bulging plasterwork can be seen at low level, indicating some damp penetration. Cracking is present above the eastern and western most windows, which would appear to emanate from the bottom of the hammer beam and runs into the window reveal itself, continuing down to sill height, whilst that to the east horizontal cracking is present which continues down to the window head and onto the connecting wall with the chancel. These would appear to be no more than 2mm in width.

6.2.1.4 The verticality of the windows was checked and these would appear to be rotating outward by in the region of 100mm over their height. The roof structure of the nave consists of single hammer beams at approximately 2.7m centres with two rows of purlins to each pitch. This is over a span of approximately 7m. The roof structure and all the jointing etc appears to be in good condition, with no obvious signs of distress.

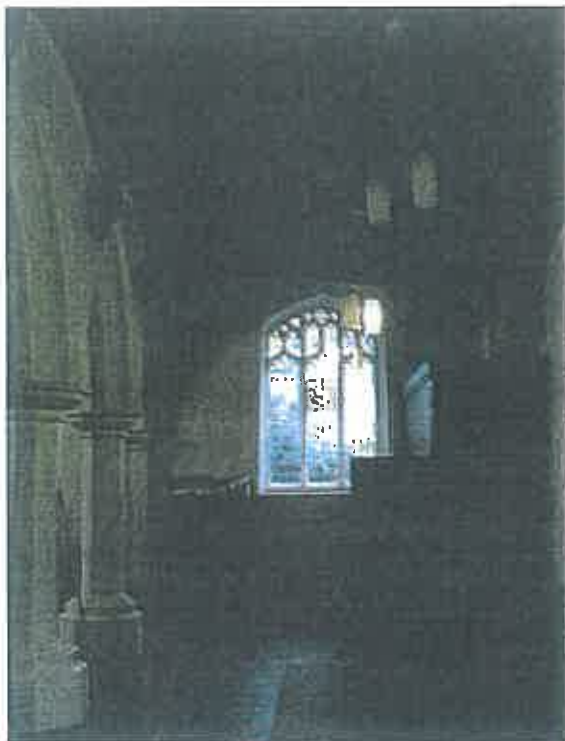
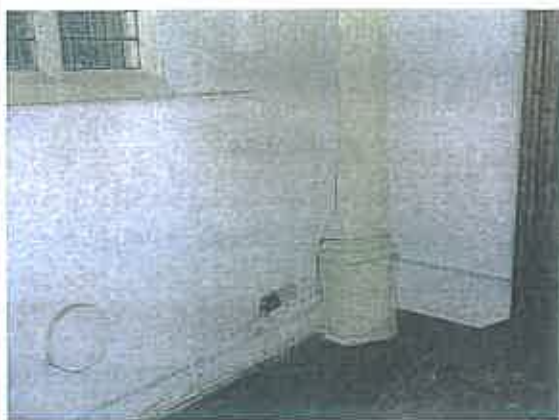
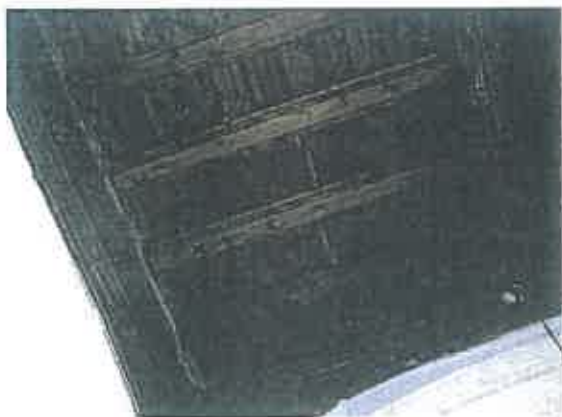
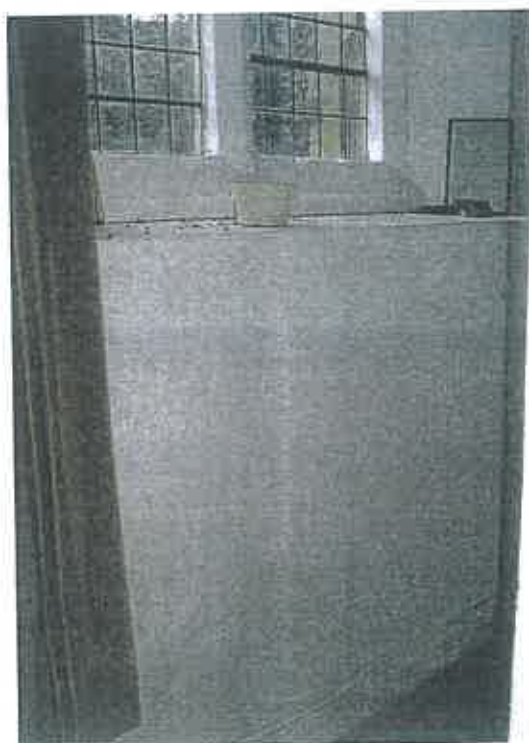
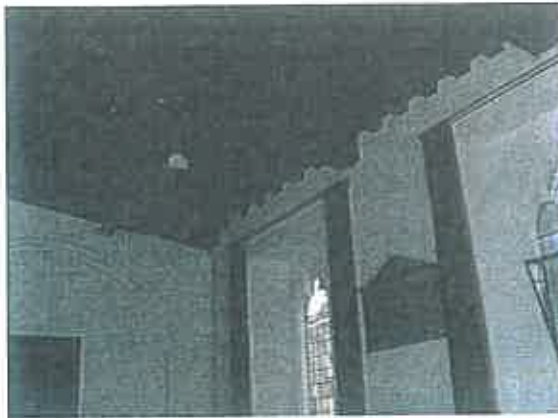
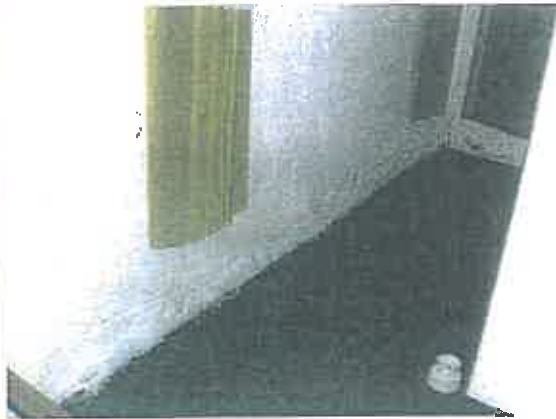
North Aisle

6.2.1.2 Separating the nave from the north aisle are three octagonal pillars linked with high arches. The two pillars situated to the east are seen to be rotating into the north chancel by approximately 40mm over the shaft height. None of this movement would appear to be recent, or has resulted in any obvious damage. Only hairline cracking exists to the second arch from the west, which emanates from the top up to the clerestory in the form of a hairline crack.

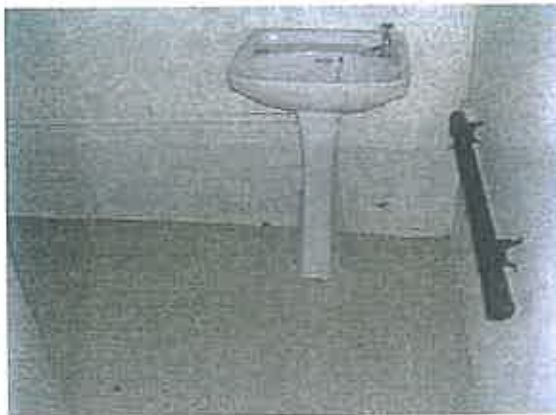
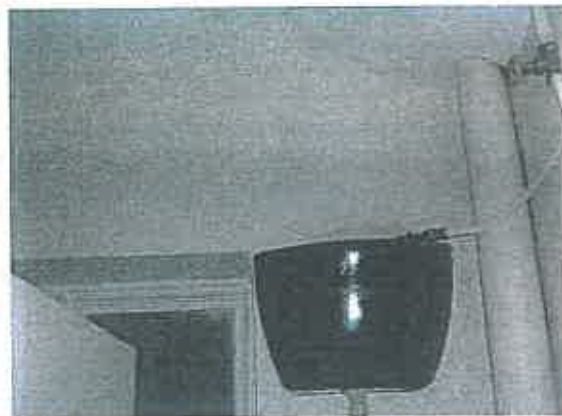
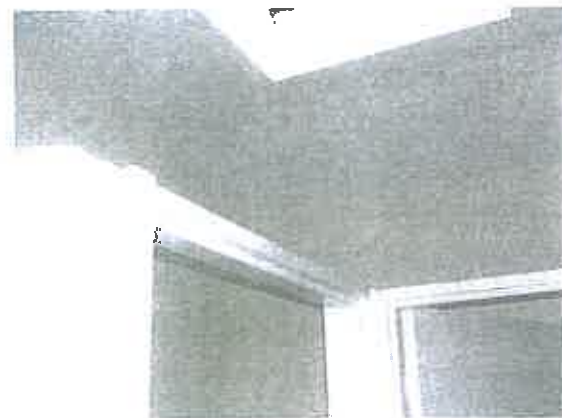
Vestry

6.2.4.1 Within the vestry which has been converted to toilets it can be noted that low level damp penetration is present to all walls within this area, as well as some lintel movement above the north facing window. To the south east corner within the ladies toilets there would appear to be some limited high level moisture penetration which may be entering via the velux style window.

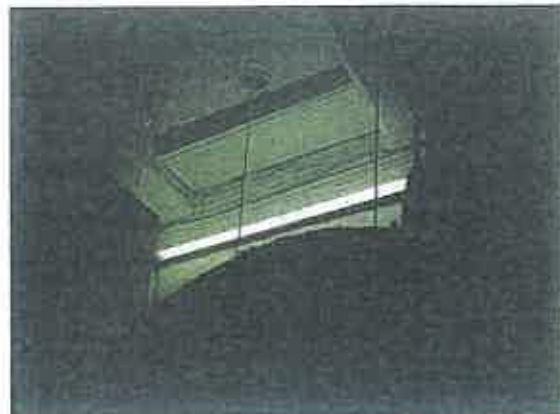
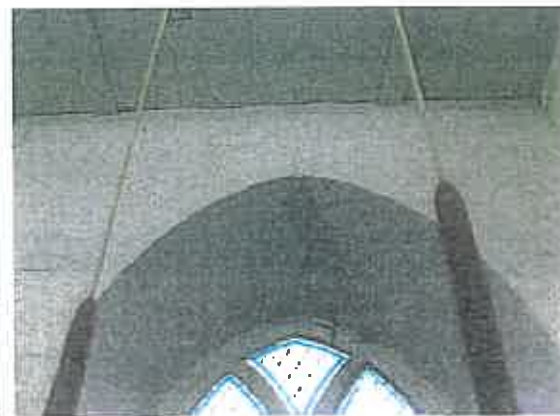
Ringling Chamber

6.2.5.2 The ringing chamber is brick lined in an English bond. There is a single window to the south with a recessed arch to the east. Indications are that the walls are approximately 1200mm thick. To the top of the arch to the south window there is a crack which steps up through the brickwork and can be seen running the full depth of the wall. This would appear to be relatively longstanding having possibly being decorated over. Two main ceiling beams are visible at this level spanning east west, which are approximately 250mm deep and of similar dimension in width. Smaller section joists span from the north and south walls between these two main beams. All appear to be in good order.

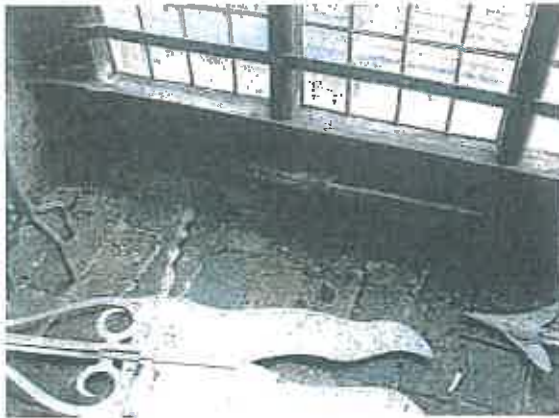
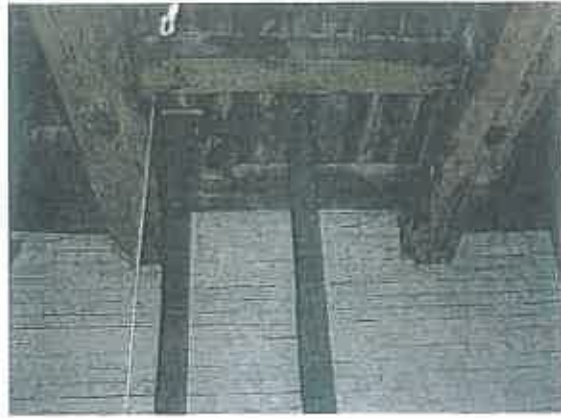
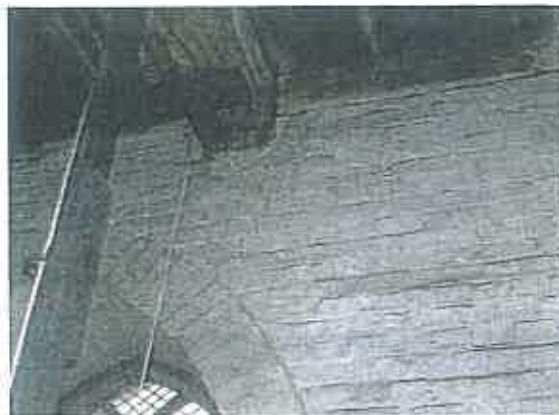
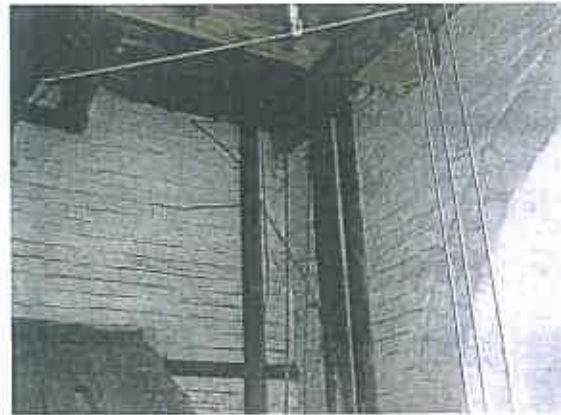
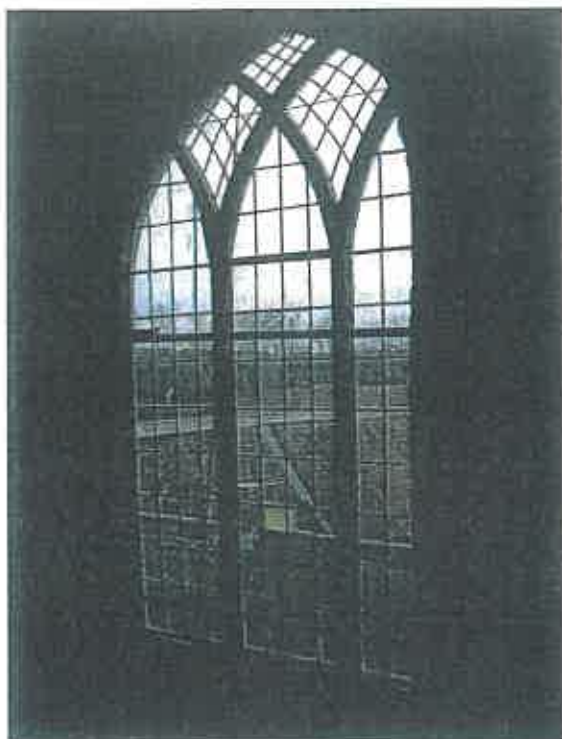
Clock Tower

6.2.5.3 Within the clock tower of the second lift there are again two main beams spanning east west. These typically have a very large section being approximately 350mm wide and 400mm deep. Intermediate joists of varying dimension span north to south. Bolt ends can be seen to the bottom face of the main beams, which are thought to bolt through to the belfry timbers spanning north south above. At this level a repaired crack is visible beneath the most northern of the beams to the west face, which shows no further signs of re-opening. Exposed timbers at this stage appear to be in good condition with wear occurring to the boards which have a felt covering there are no obvious wormholes or any evidence of deathwatch beetle or other timber degrading spores.

6.2.5.4 There is a west facing window with plain glass lights, which would appear to be in reasonable condition. The hardwood frame shows signs of weathering and moisture staining, although at this juncture has not adversely affected its performance.

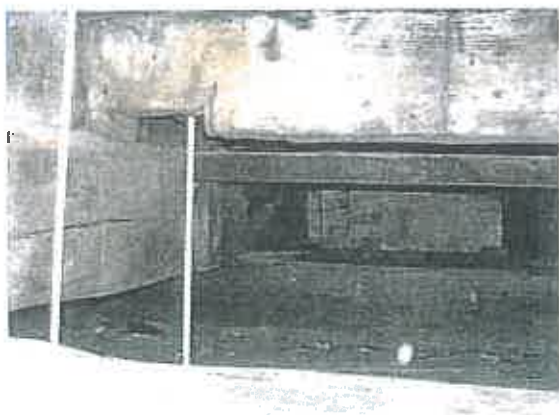
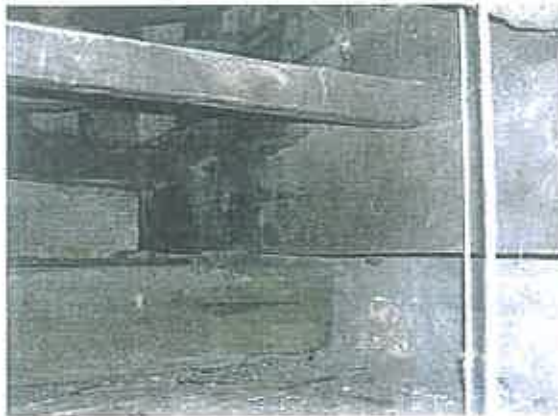
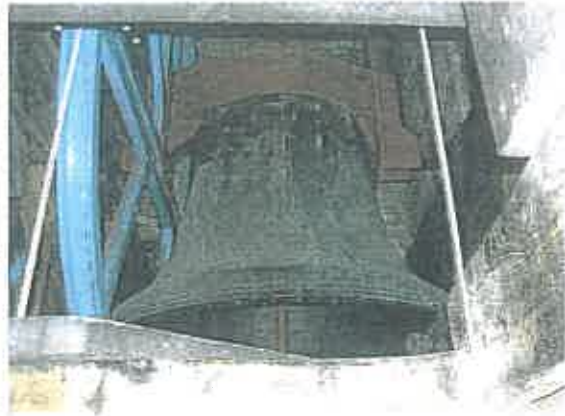
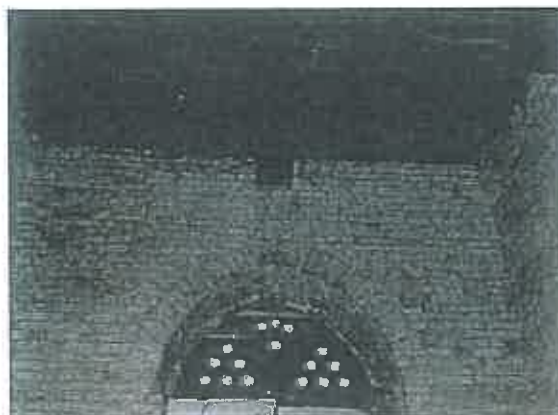
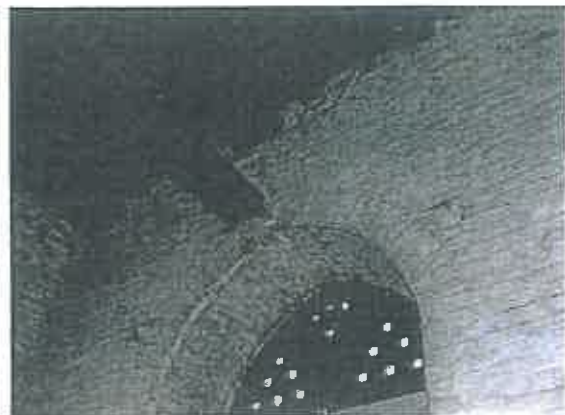
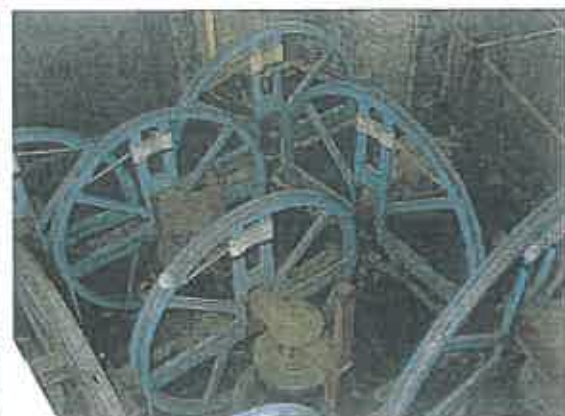
Belfry

6.2.5.5 Within the belfry at the third lift all four walls have openings, all of which are bordered with sheet material. Minor cracking can be traced from the end of the arch to the north and south walls where the main timber for the roof support is seated, although these would appear to be longstanding. Elsewhere faces of red bricks have spalled in randomly occurring places.

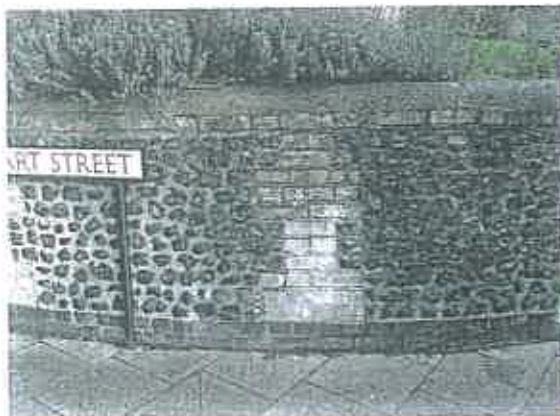
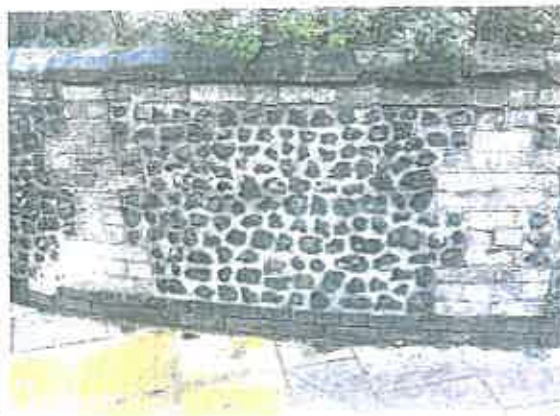
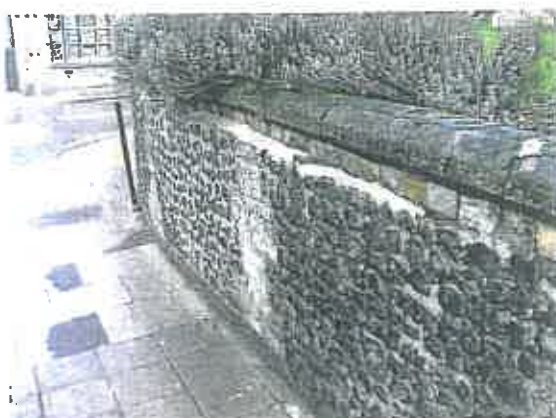
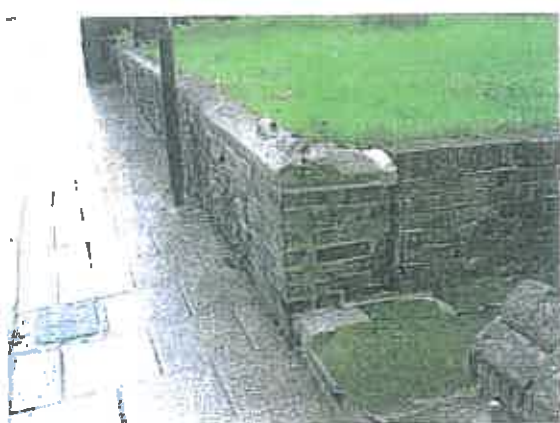
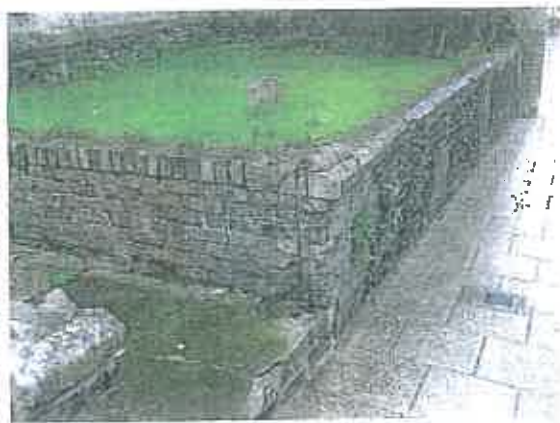
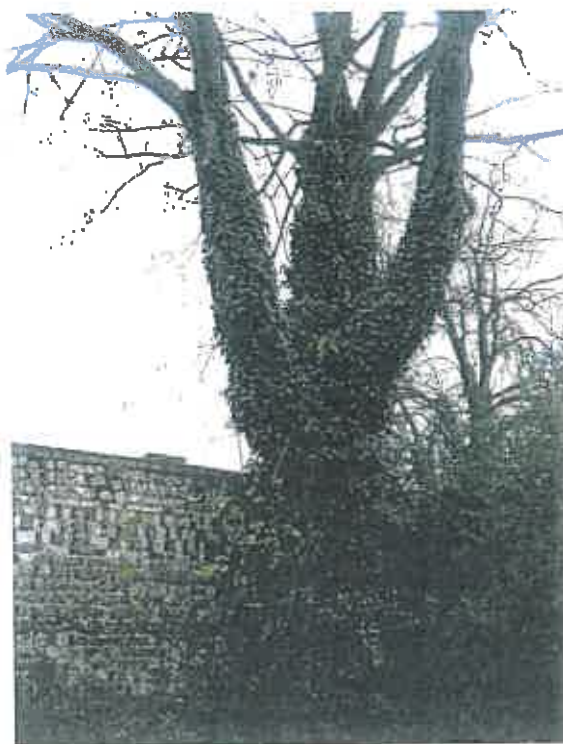
Churchyard & Peripherals

6.3.1 To the south east corner of the chancel abutting the church is a flint and brick wall which has a stone archway set within the wall providing access to the churchyard from King's House car park. The flint element nearest the church would appear to be in reasonable condition with the transition into the brickwork which includes the stone arch suffering rotational movement, which would appear to be longstanding in nature. On the east side within the car park the lower level has a more recent brick face addition, which is no doubt offering significant support. It does not show signs of any movement. At high level the chamfered and coping course of brickwork has seen movement and deterioration as has the flint work beneath, which has been eroding over a long period.

- 6.3.3 Churchyard walling to the south and west is constructed of similar knapped flints as the church with brick piers. It is anticipated that this may historically have been rebuilt providing three courses of engineering bricks at ground level. Outwardly, the wall would appear to be in good condition however vertical cracks are present, typically occurring between the flint panels and the brick piers. Some of these cracks extend to approximately 5mm. These are seen more so to the radius to the south west corner with some rotation noted on the first two panels against King Street. Mortar work has been re-pointed against the brick string and coping course to prevent significant weather ingress, which has been undertaken recently and would appear to have not moved significantly since its application.

- 6.3.4 Pedestrian access to the north aisle is via a stepped footway from White Hart Street. Cracking is present to the dwarf retaining walls to either side, indicating that historic rotation of the retained wall against the footpath of White Hart Street has taken place. There is what would appear to be a gully outlet to the face of this wall possibly serving the drain for the tower top. This appeared dry despite rainfall on the day of inspection.
