# HMS WARRIOR - Recommendations for Survey and Maintenance of Mooring Arrangements

Reference: DSL/38651/006852/2

Date: January 2019

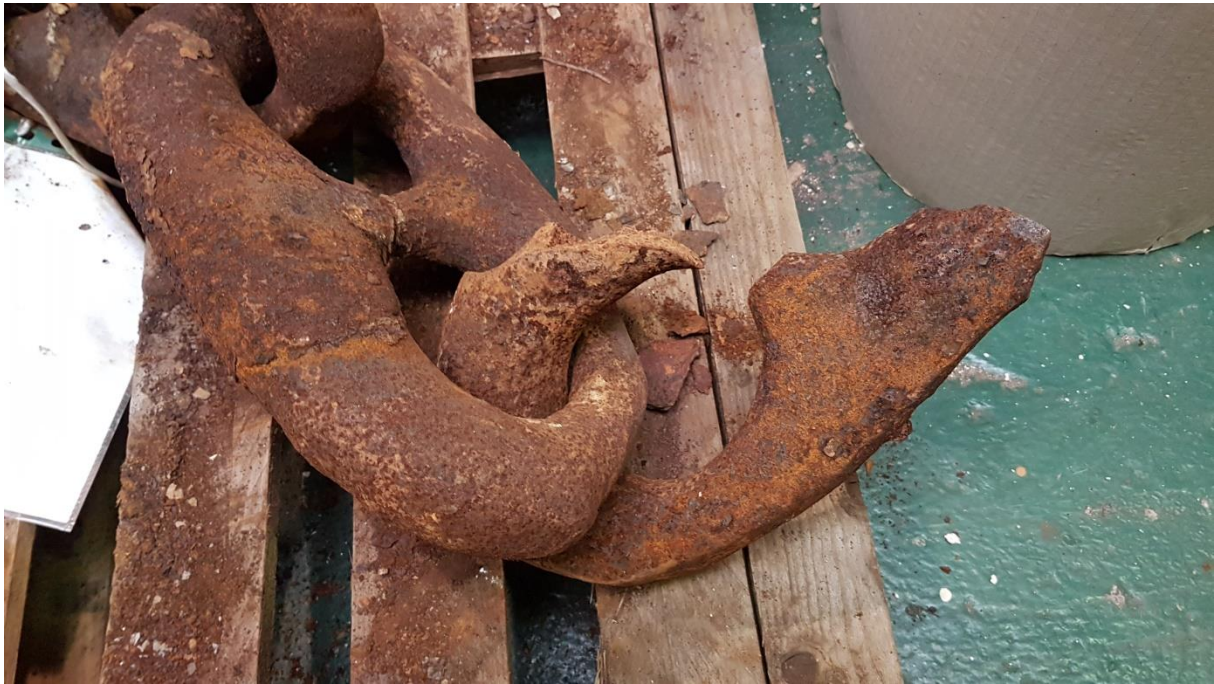
Figure 3 Example of Damaged Baldt cable (01)

- 2.3.1 Surveys of the damaged cable from the surge incident conducted by Minton, Treharne & Davies Limited (Ref MTD160299UM) indicated that the links had been attacked by Sulphite Reducing Bacteria (SRB) and that the bacteria responsible were of two types; one of which acted aerobically and the other acting anaerobically.
- 2.3.2 Discussions with the NMRN representatives indicated that the level of SRB was increasing in the area and that there were concerns regarding the material state of the buried cable.
- 2.3.3 Additionally, the cable is subject to corrosion (rusting) due to exposure to sea water and a lack of protective coating.

2.3.4 The result of this is quantified in Para 3.2.4 of the Minton report which states that for several of the links the "Reduction in diameter of ~45% at the eroded locations of the link is equivalent to a ~70% loss in cross sectional area".

2.4.3 The effects of corrosion, wear (abrasion) and SRB damage on the removed Baldt chain links can be seen in:

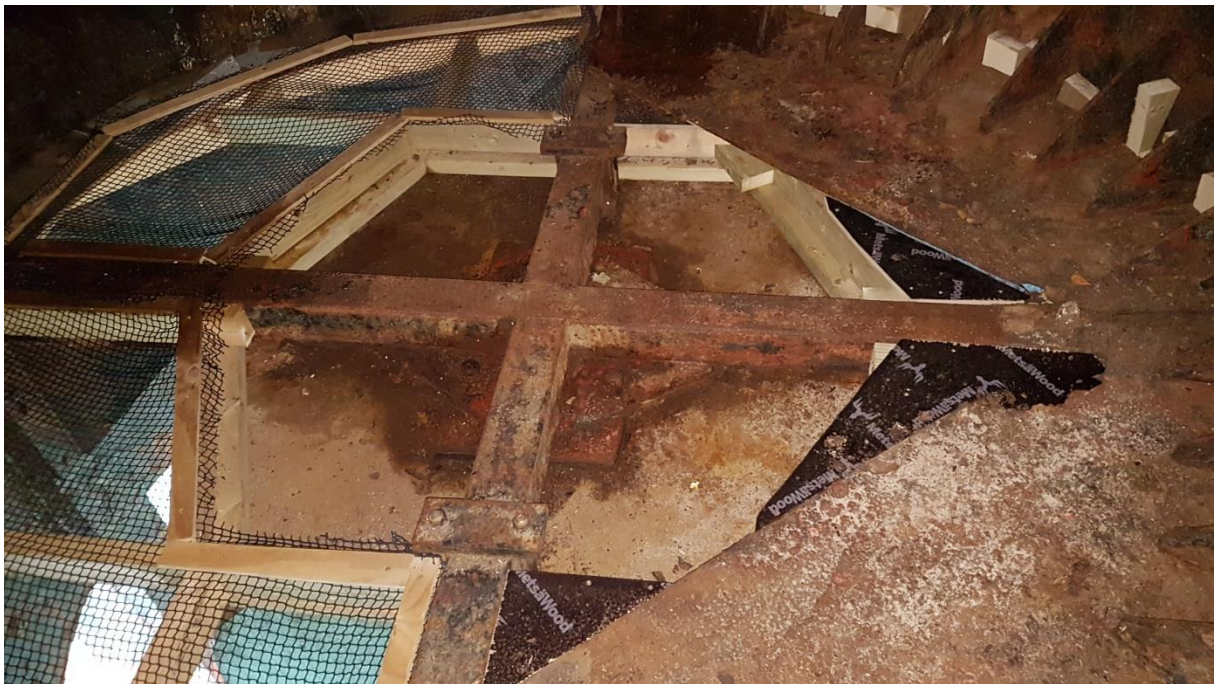
Figure 6 Internal Structure of Propeller Well (01)

- 3.2.8 During a survey undertaken as part of this project, the structure of the propeller well was identified as a potential weak spot in the onboard mooring arrangement. The condition of the Propeller Well as of December 2017 can be seen in:
