Homes & Communities Agency (Bristol)

Northfleet, Crete Hall Road, Old Sun
Wharf, Gravesend, DA11 9AA

WYG Asbestos Demolition Survey Report

20 Mar 2015

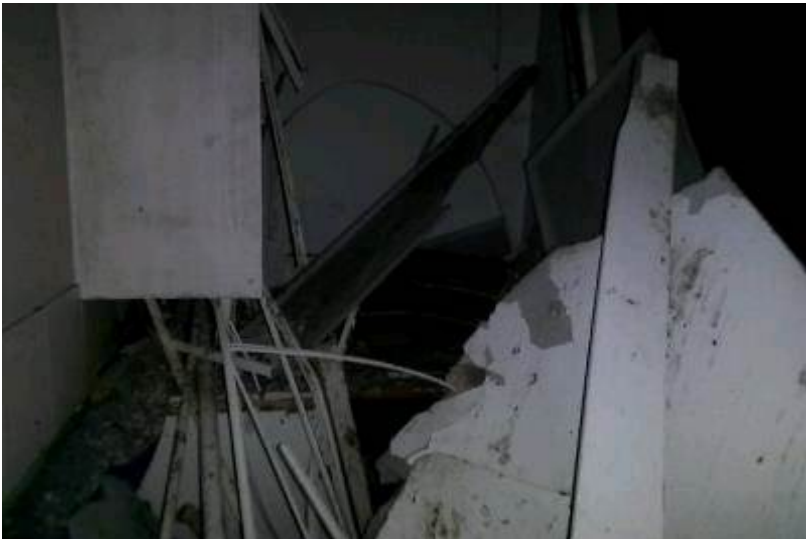
| Inspection Number | | Reference Number: | N/A |

| Inspection / Sample | Visual Inspection | Inspection Cross Reference / Visual I.D. | Asbestos Inaccessible (Presumed) |
| Notes | Limitad access due to stored materials | | |

| Extent of Damage | | 0 |

| Recommendation | Inspect Prior to Disturbance |

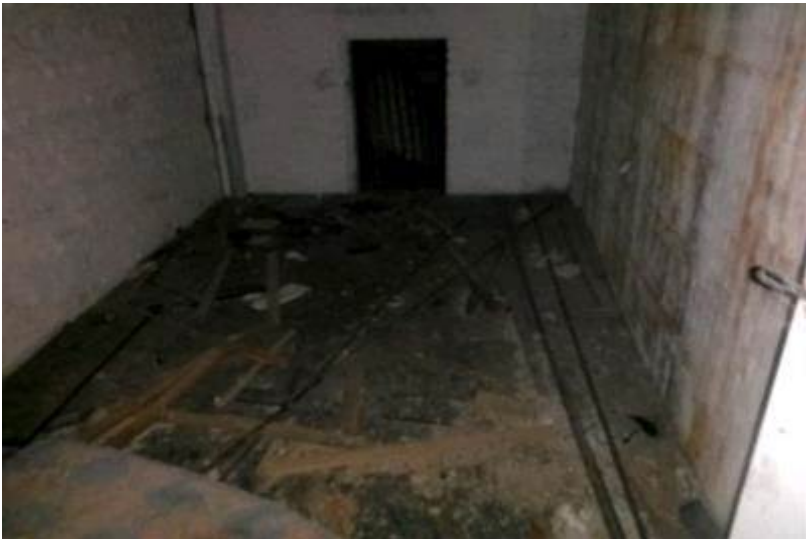
| Inspection Number | 1 | Reference Number: | BE001309 |

| Inspection / Sample | Sample taken | Inspection Cross Reference / Visual I.D. | N.A.D.I.S |

| Extent of Damage | Low damage - a few scratches or surface marks; broken edges on boards, tiles etc. | 0 |

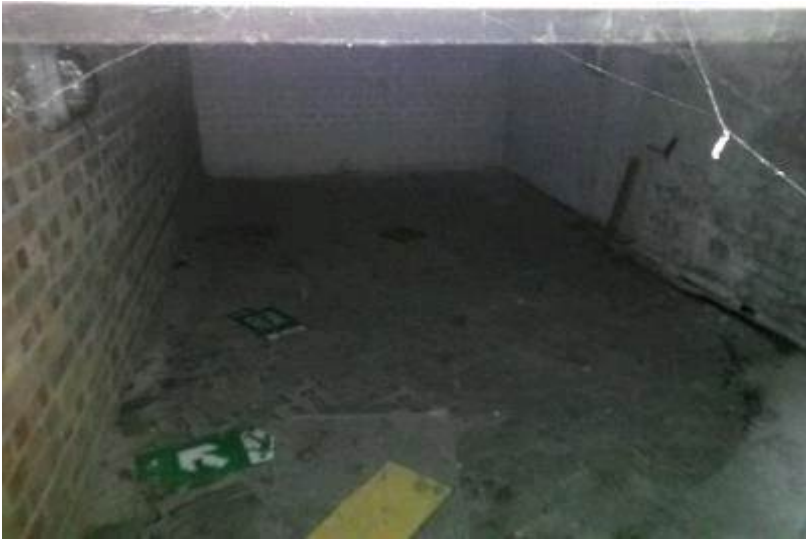
| Inspection Number | 3 | Reference Number: | As Sample BE001309 |

| Inspection / Sample | Visually similar to | Inspection Cross Reference / Visual I.D. | As Sample |

| Extent of Damage | Low damage - a few scratches or surface marks; broken edges on boards, tiles etc. | 0 |

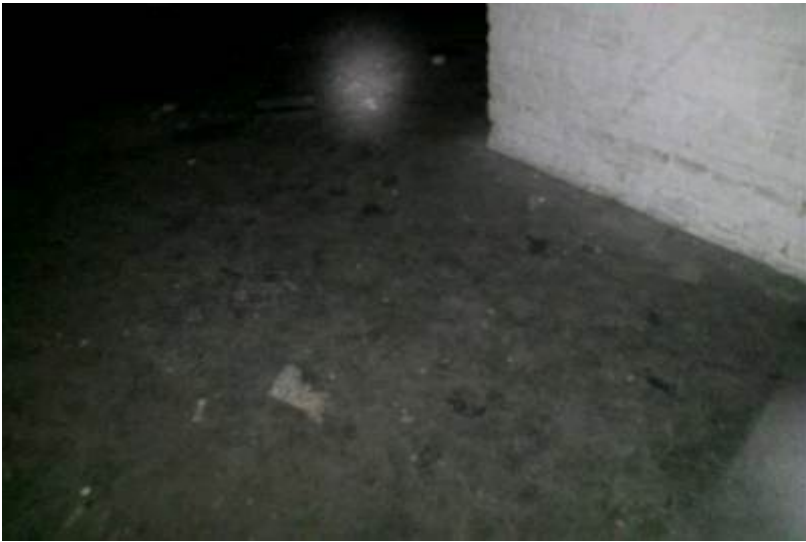
| Inspection Number | 5 | Reference Number: | As Sample BE001309 |

| Inspection / Sample | Visually similar to | Inspection Cross Reference / Visual I.D. | As Sample |

| Extent of Damage | Low damage - a few scratches or surface marks; broken edges on boards, tiles etc. | 0 |

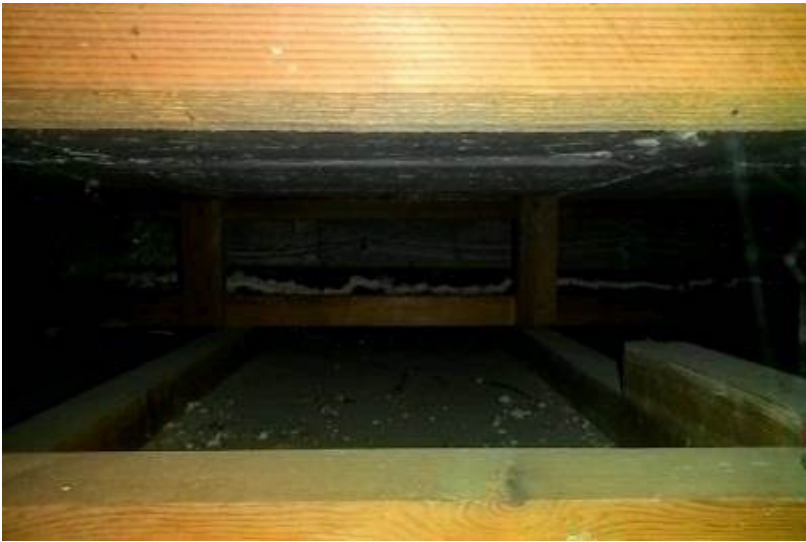
| Inspection Number | 10 | Reference Number: | As Sample BE001314 |

| Inspection / Sample | Visually similar to | Inspection Cross Reference / Visual I.D. | As Sample |

| Product Score | High Fibre Release - Thermal insulation (e.g. pipe and boiler lagging) sprayed asbestos, loose asbestos, asbestos mattresses and packing | 3 |
| Extent of Damage | Medium damage - significant breakage of materials or several small areas where material has been damaged revealing loose asbestos fibres | 2 |

| Recommendation | Restrict access and remove |

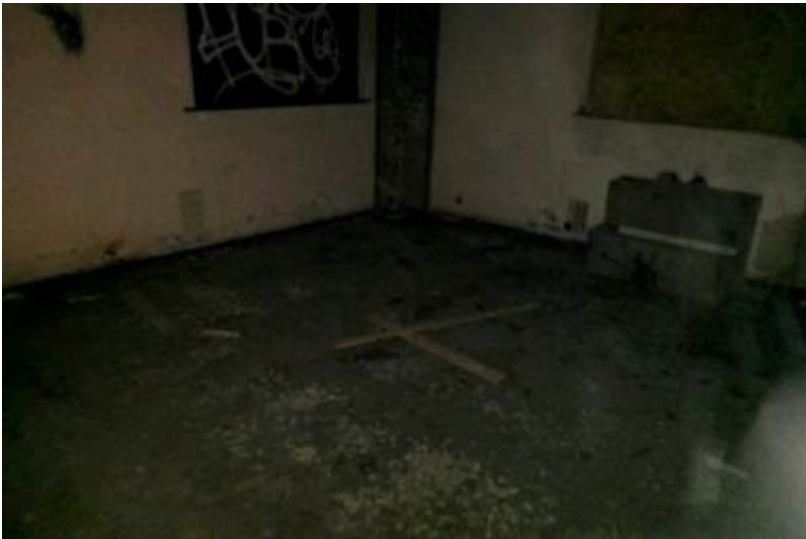
| Inspection Number | 14 | Reference Number: | As Sample BE001312 |

| Inspection / Sample | Visually similar to | Inspection Cross Reference / Visual I.D. | As Sample |

| Extent of Damage | Low damage - a few scratches or surface marks; broken edges on boards, tiles etc. | 0 |

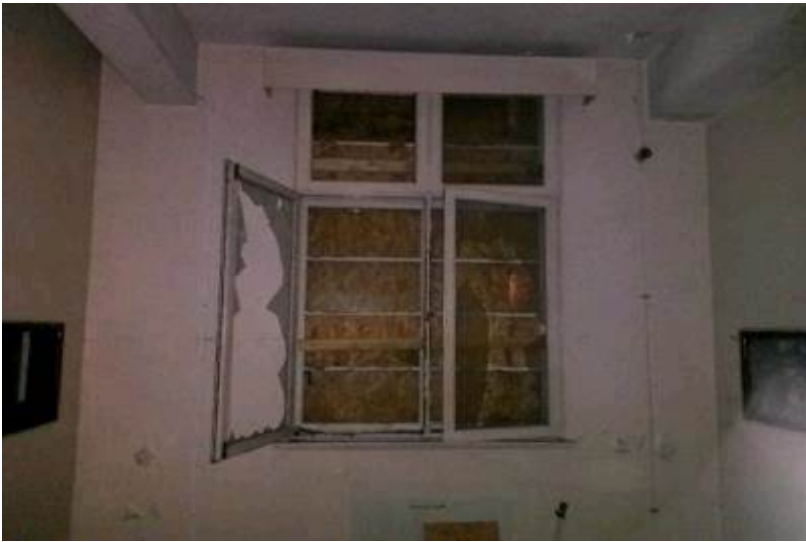
| Inspection Number | 16 | Reference Number: | As Sample BE001316 |

| Inspection / Sample | Visually similar to | Inspection Cross Reference / Visual I.D. | As Sample |

| Extent of Damage | Low damage - a few scratches or surface marks; broken edges on boards, tiles etc. | 0 |

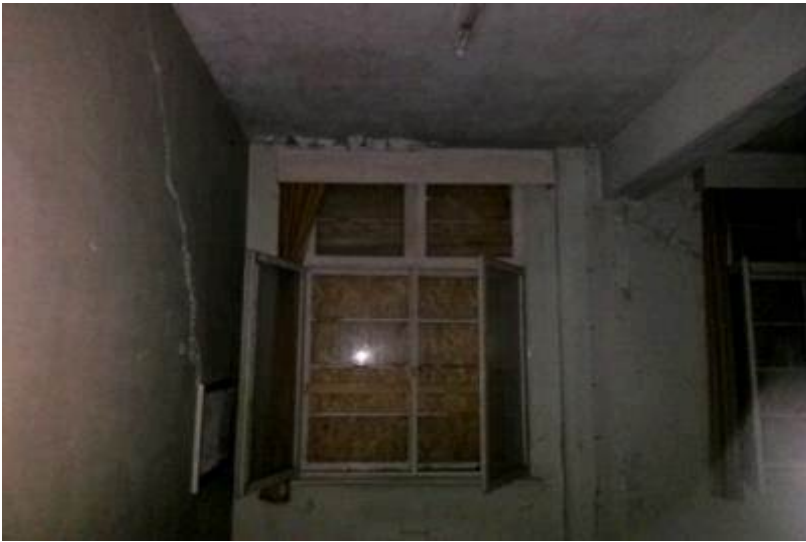
| Inspection Number | 18 | Reference Number: | As Sample BE001316 |

| Inspection / Sample | Visually similar to | Inspection Cross Reference / Visual I.D. | As Sample |

| Extent of Damage | Low damage - a few scratches or surface marks; broken edges on boards, tiles etc. | 0 |

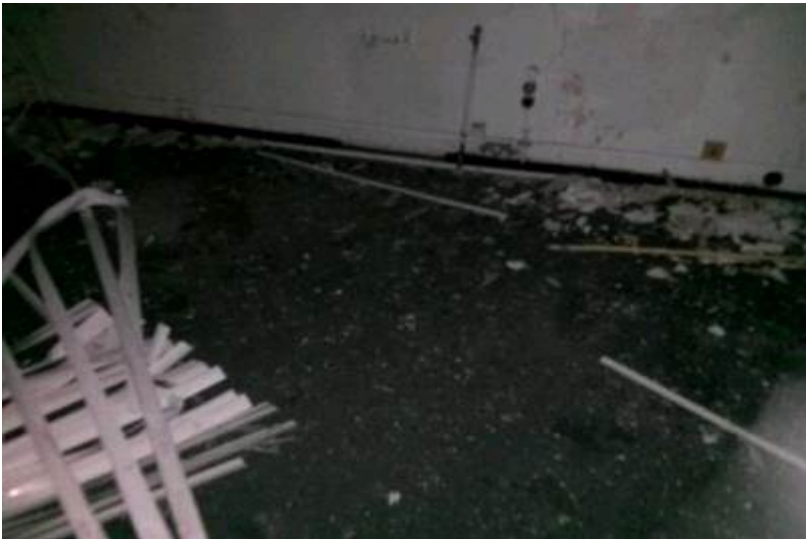
| Inspection Number | 19 | Reference Number: | As Sample BE001310 |

| Inspection / Sample | Visually similar to | Inspection Cross Reference / Visual I.D. | As Sample |

| Extent of Damage | Low damage - a few scratches or surface marks; broken edges on boards, tiles etc. | 0 |

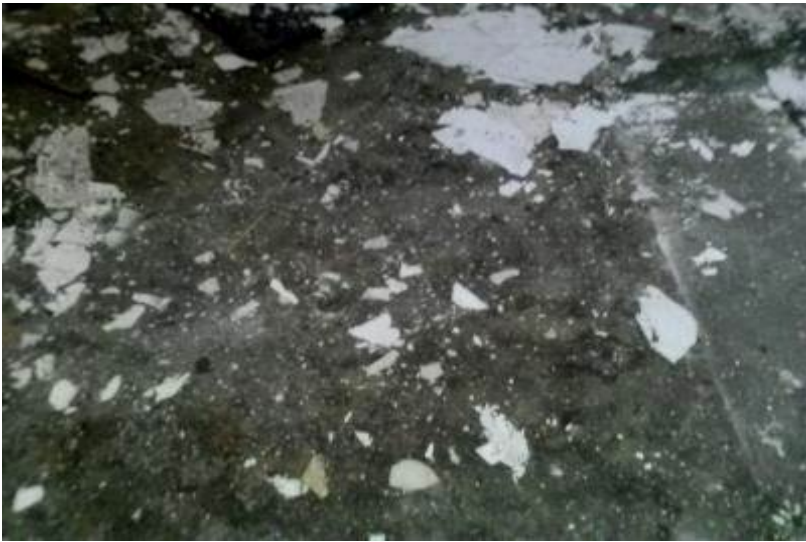
| Inspection Number | 21 | Reference Number: | As Sample BE001310 |

| Inspection / Sample | Visually similar to | Inspection Cross Reference / Visual I.D. | As Sample |

| Extent of Damage | Low damage - a few scratches or surface marks; broken edges on boards, tiles etc. | 0 |

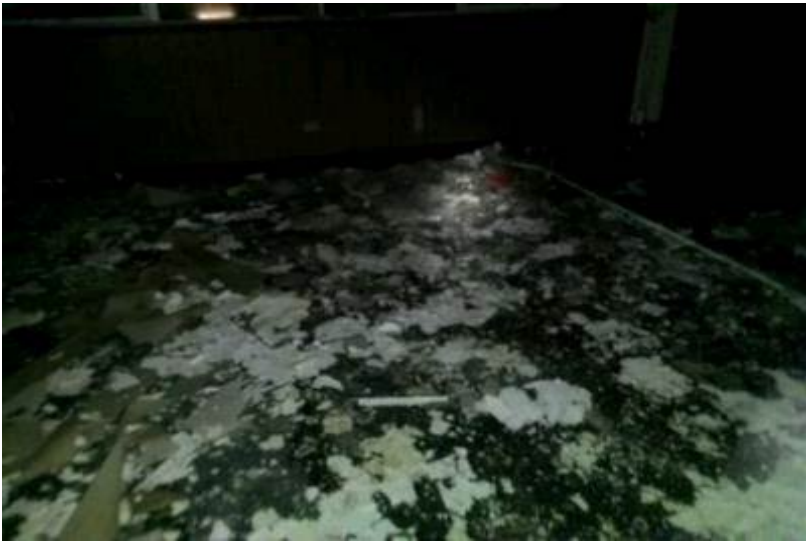
| Inspection Number | 22 | Reference Number: | As Sample BE001309 |

| Inspection / Sample | Visually similar to | Inspection Cross Reference / Visual I.D. | As Sample |

| Extent of Damage | Low damage - a few scratches or surface marks; broken edges on boards, tiles etc. | 0 |

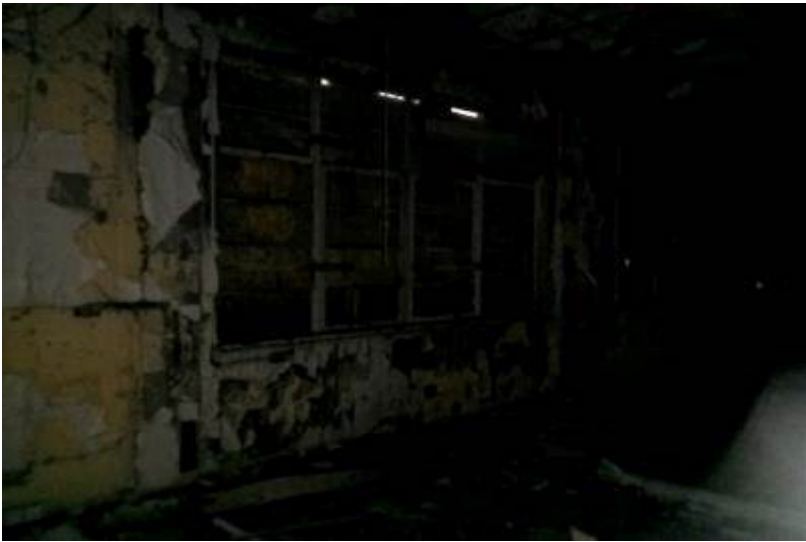
| Inspection Number | 24 | Reference Number: | As Sample BE001316 |

| Inspection / Sample | Visually similar to | Inspection Cross Reference / Visual I.D. | As Sample |

| Extent of Damage | Low damage - a few scratches or surface marks; broken edges on boards, tiles etc. | 0 |

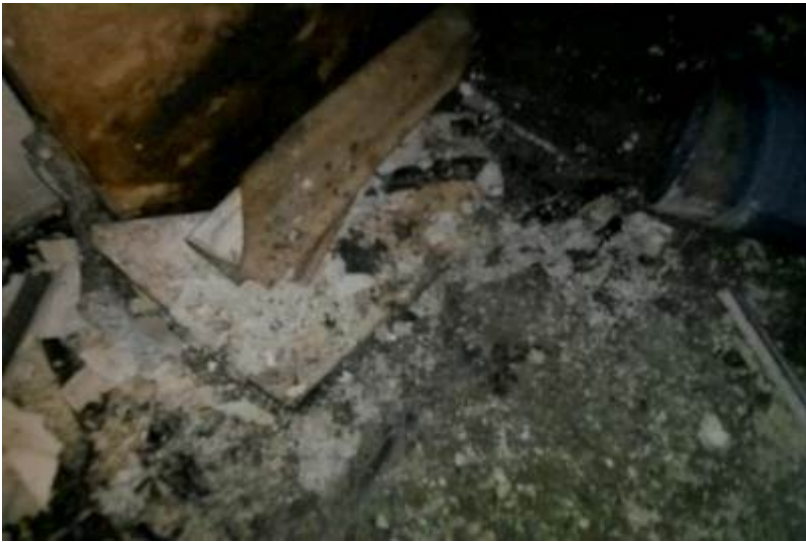
| Inspection Number | 25 | Reference Number: | As Sample BE001310 |

| Inspection / Sample | Visually similar to | Inspection Cross Reference / Visual I.D. | As Sample |

| Extent of Damage | Low damage - a few scratches or surface marks; broken edges on boards, tiles etc. | 0 |

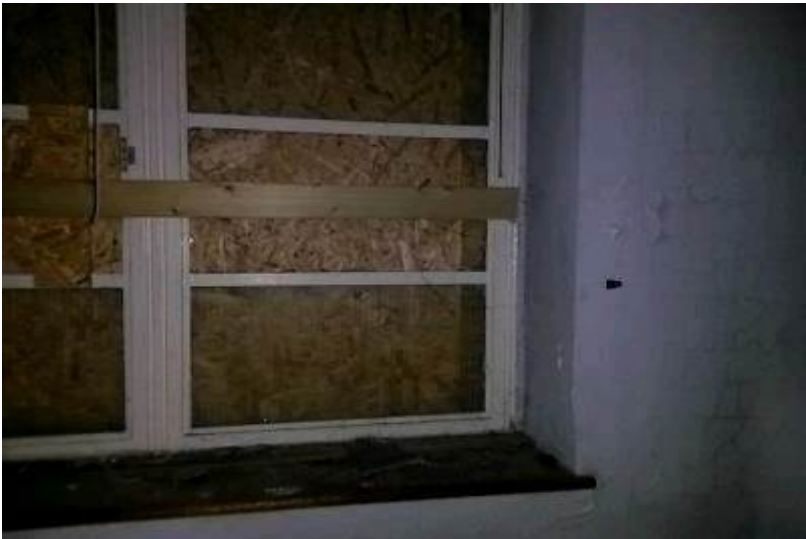
| Inspection Number | 26 | Reference Number: | As Sample BE001316 |

| Inspection / Sample | Visually similar to | Inspection Cross Reference / Visual I.D. | As Sample |

| Extent of Damage | Low damage - a few scratches or surface marks; broken edges on boards, tiles etc. | 0 |

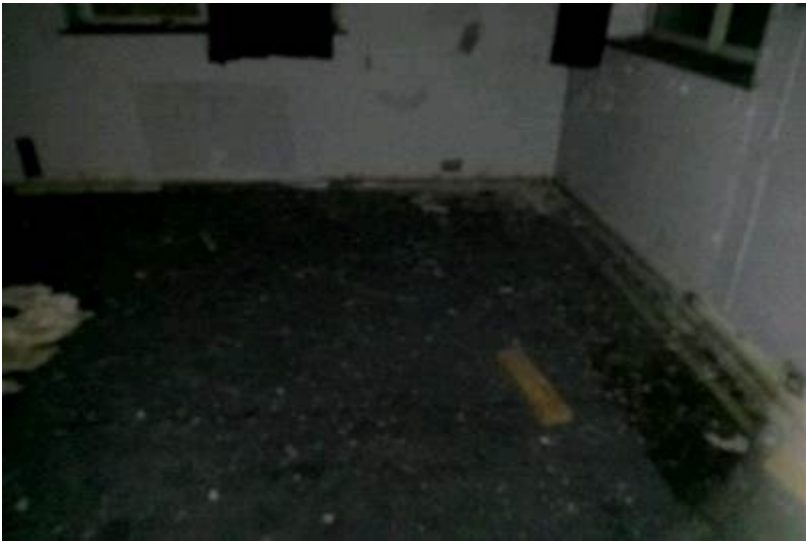
| Inspection Number | 27 | Reference Number: | As Sample BE001310 |

| Inspection / Sample | Visually similar to | Inspection Cross Reference / Visual I.D. | As Sample |

| Extent of Damage | Low damage - a few scratches or surface marks; broken edges on boards, tiles etc. | 0 |

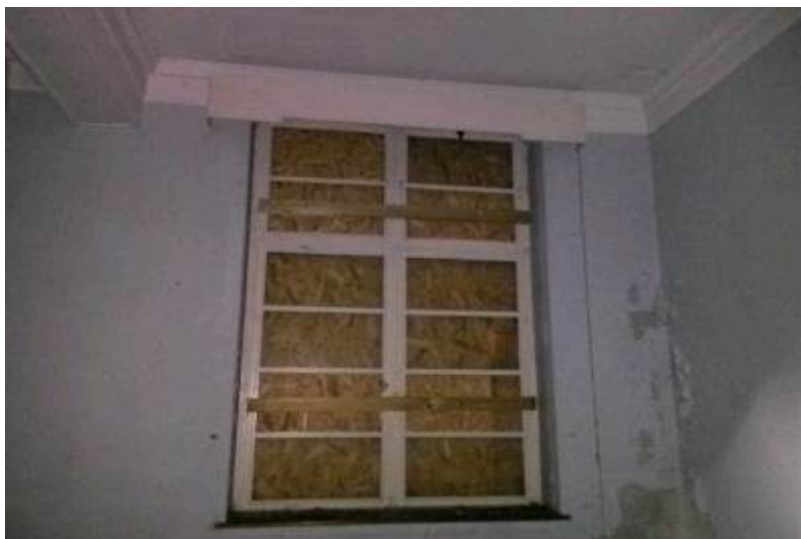
| Inspection Number | 28 | Reference Number: | As Sample BE001316 |

| Inspection / Sample | Visually similar to | Inspection Cross Reference / Visual I.D. | As Sample |

| Extent of Damage | Low damage - a few scratches or surface marks; broken edges on boards, tiles etc. | 0 |

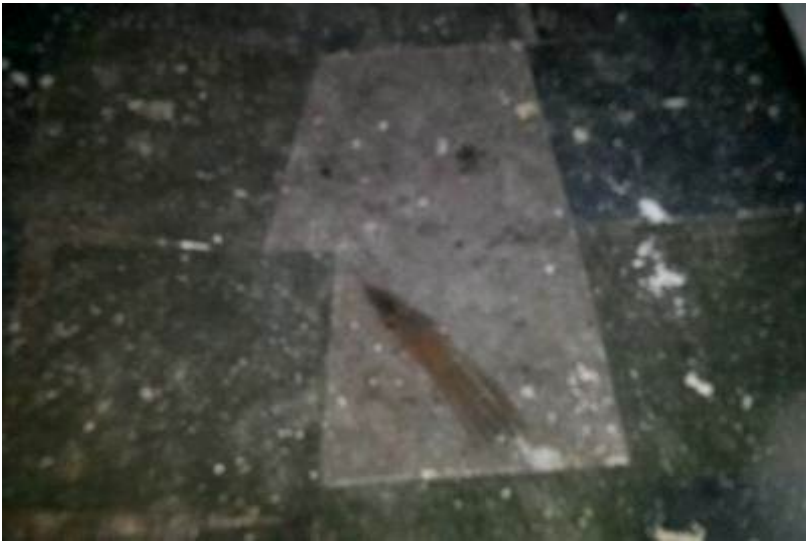
| Inspection Number | 29 | Reference Number: | As Sample BE001310 |

| Inspection / Sample | Visually similar to | Inspection Cross Reference / Visual I.D. | As Sample |

| Extent of Damage | Low damage - a few scratches or surface marks; broken edges on boards, tiles etc. | 0 |

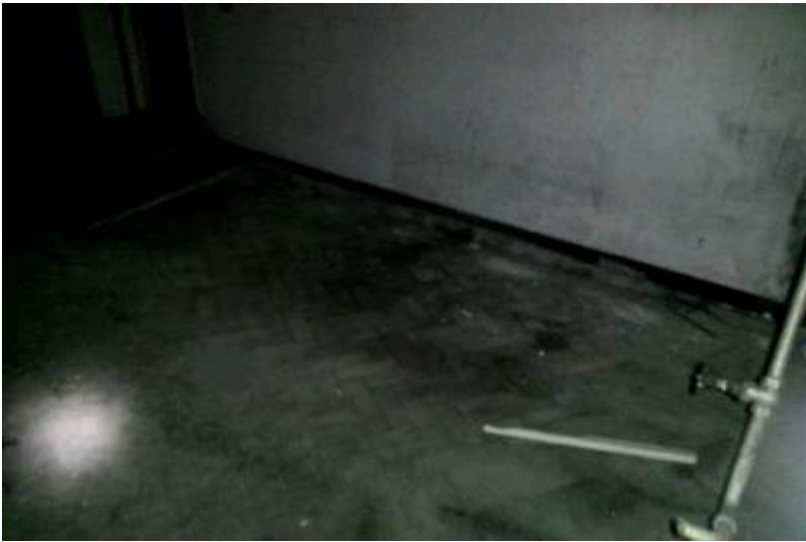
| Inspection Number | 30 | Reference Number: | BE001318 |

| Inspection / Sample | Sample taken | Inspection Cross Reference / Visual I.D. | N.A.D.I.S |

| Extent of Damage | Low damage - a few scratches or surface marks; broken edges on boards, tiles etc. | 0 |

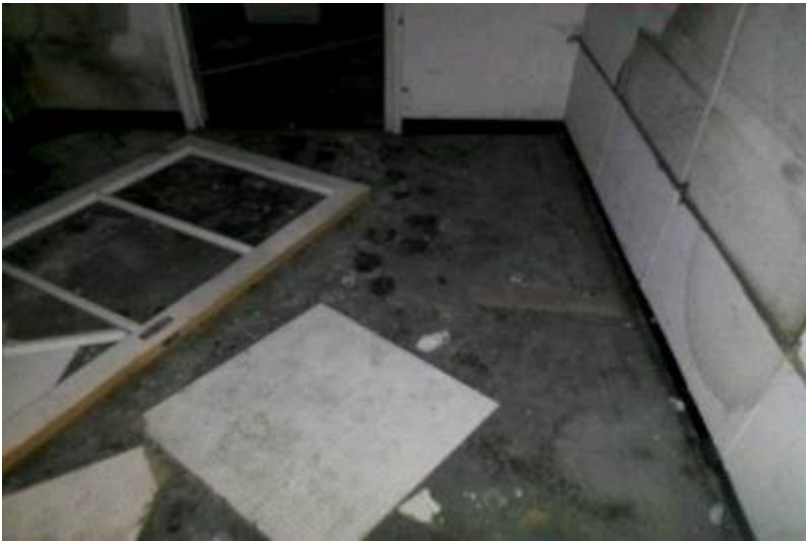
| Inspection Number | 32 | Reference Number: | As Sample BE001318 |

| Inspection / Sample | Visually similar to | Inspection Cross Reference / Visual I.D. | As Sample |

| Extent of Damage | Low damage - a few scratches or surface marks; broken edges on boards, tiles etc. | 0 |

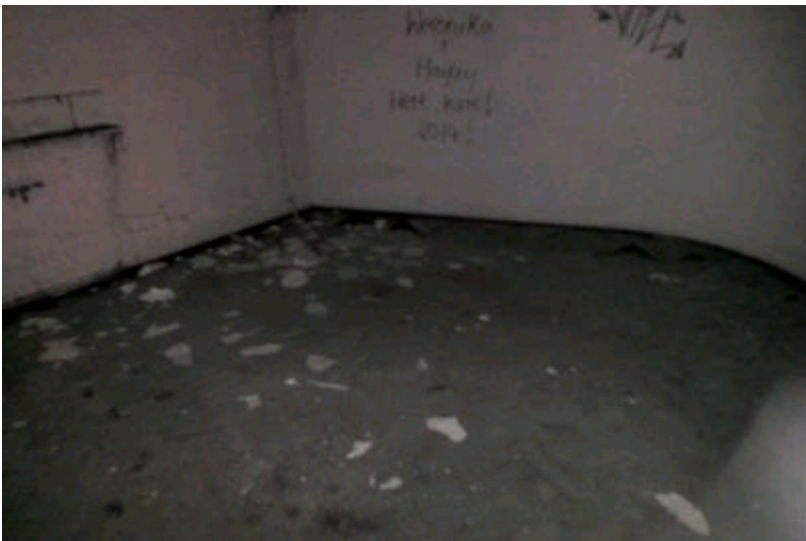
| Inspection Number | 33 | Reference Number: | As Sample BE001318 |

| Inspection / Sample | Visually similar to | Inspection Cross Reference / Visual I.D. | As Sample |

| Extent of Damage | Low damage - a few scratches or surface marks; broken edges on boards, tiles etc. | 0 |

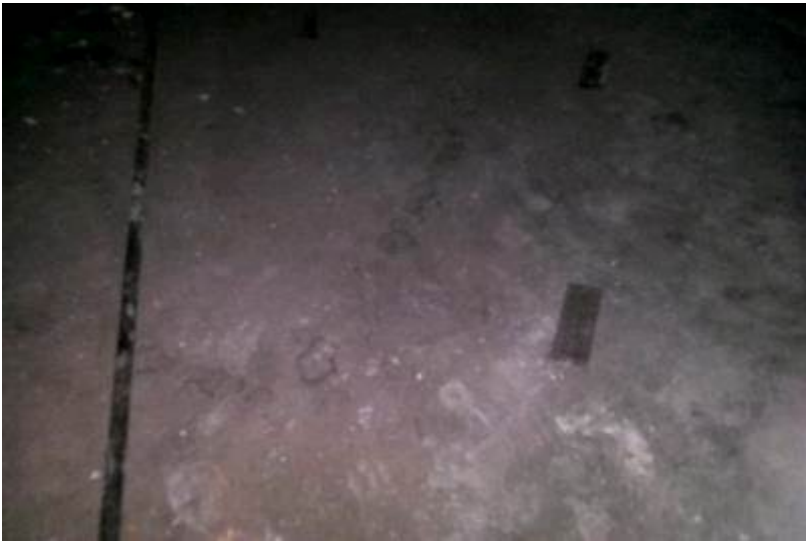
| Inspection Number | 34 | Reference Number: | As Sample BE001318 |

| Inspection / Sample | Visually similar to | Inspection Cross Reference / Visual I.D. | As Sample |

| Extent of Damage | Low damage - a few scratches or surface marks; broken edges on boards, tiles etc. | 0 |

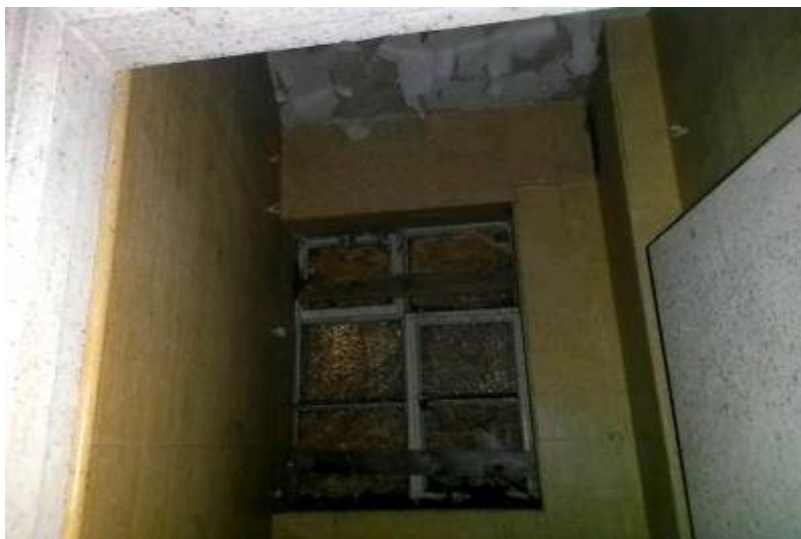
| Inspection Number | 35 | Reference Number: | As Sample BE001320 |

| Inspection / Sample | Visually similar to | Inspection Cross Reference / Visual I.D. | As Sample |

| Extent of Damage | Low damage - a few scratches or surface marks; broken edges on boards, tiles etc. | 0 |

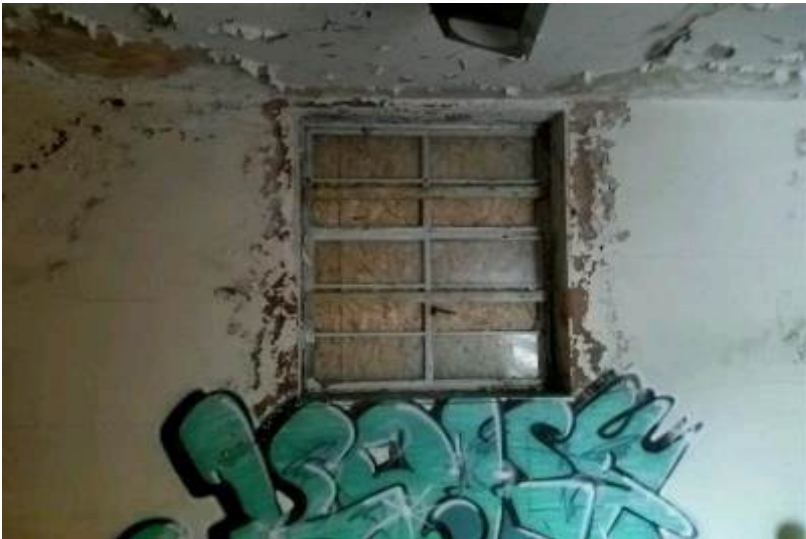
| Inspection Number | 36 | Reference Number: | As Sample BE001320 |

| Inspection / Sample | Visually similar to | Inspection Cross Reference / Visual I.D. | As Sample |

| Extent of Damage | Low damage - a few scratches or surface marks; broken edges on boards, tiles etc. | 0 |

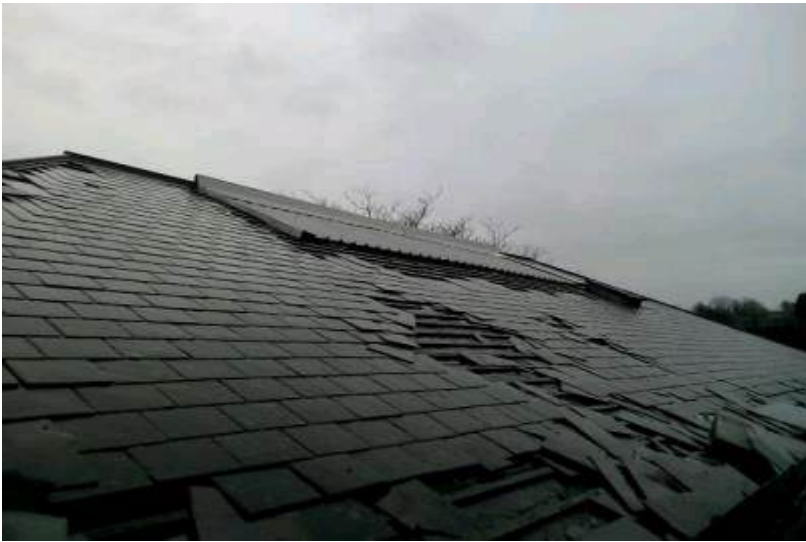
| Inspection Number | 38 | Reference Number: | N/A |

| Inspection / Sample | Visual Inspection | Inspection Cross Reference / Visual I.D. | Asbestos Presumed |

| Extent of Damage | Low damage - a few scratches or surface marks; broken edges on boards, tiles etc. | 1 |

| Recommendation | Remove if likely to be disturbed |

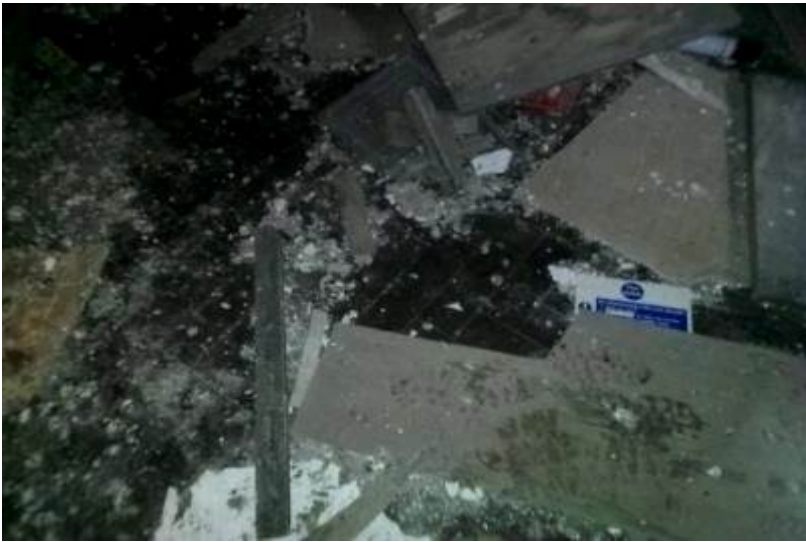
| Inspection Number | 40 | Reference Number: | As Sample BE001310 |

| Inspection / Sample | Visually similar to | Inspection Cross Reference / Visual I.D. | As Sample |

| Extent of Damage | Low damage - a few scratches or surface marks; broken edges on boards, tiles etc. | 0 |

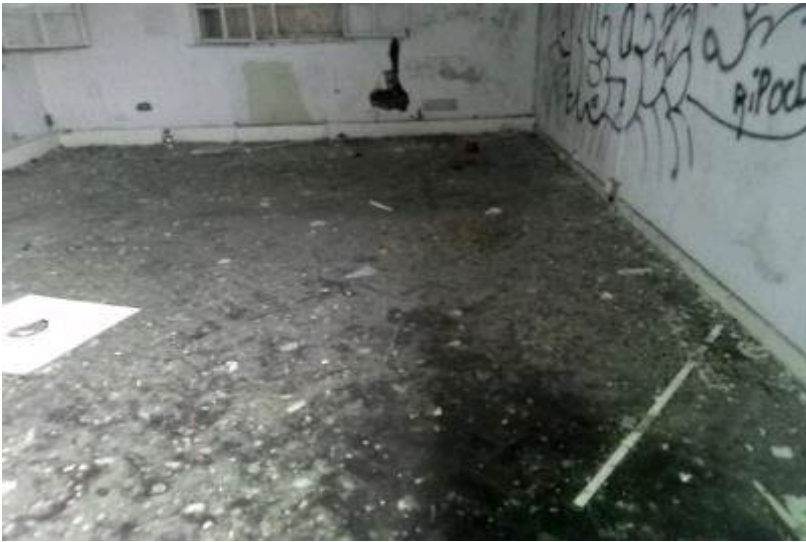
| Inspection Number | 41 | Reference Number: | As Sample BE001310 |

| Inspection / Sample | Visually similar to | Inspection Cross Reference / Visual I.D. | As Sample |

| Extent of Damage | Low damage - a few scratches or surface marks; broken edges on boards, tiles etc. | 0 |

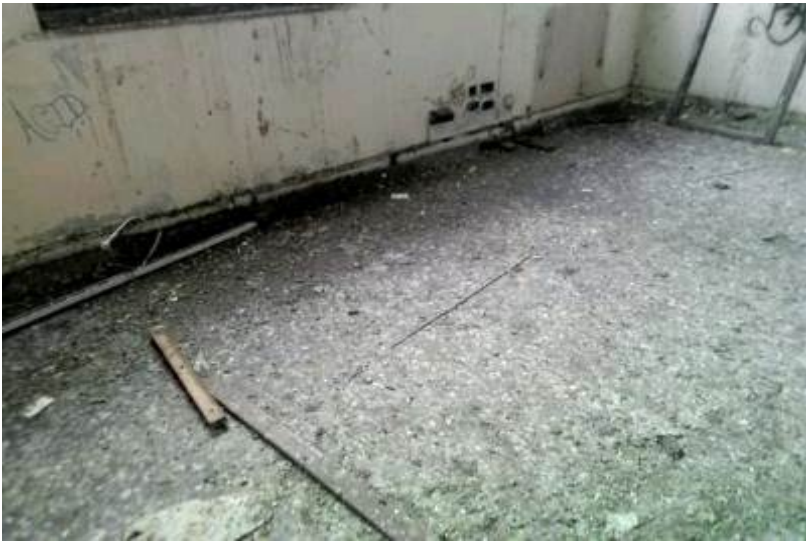
| Inspection Number | 42 | Reference Number: | As Sample BE001310 |

| Inspection / Sample | Visually similar to | Inspection Cross Reference / Visual I.D. | As Sample |

| Extent of Damage | Low damage - a few scratches or surface marks; broken edges on boards, tiles etc. | 0 |

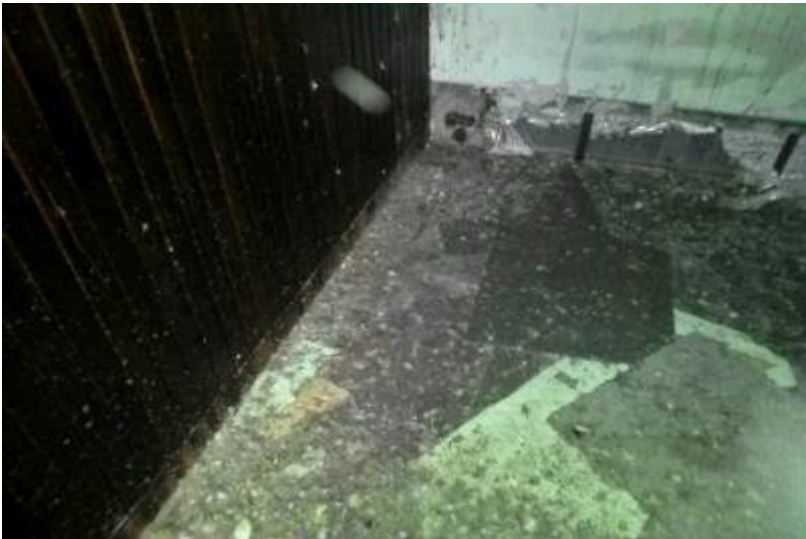
| Inspection Number | 43 | Reference Number: | As Sample BE001310 |

| Inspection / Sample | Visually similar to | Inspection Cross Reference / Visual I.D. | As Sample |

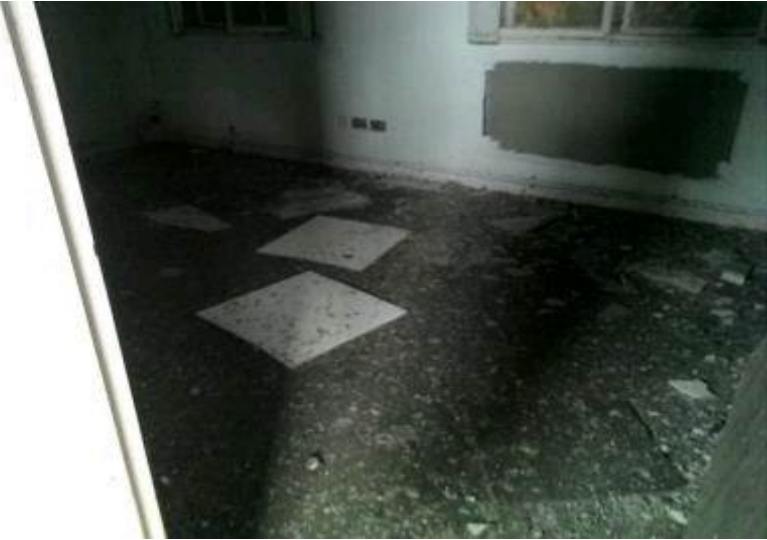
| Inspection Number | 44 | Reference Number: | As Sample BE001310 |

| Inspection / Sample | Visually similar to | Inspection Cross Reference / Visual I.D. | As Sample |

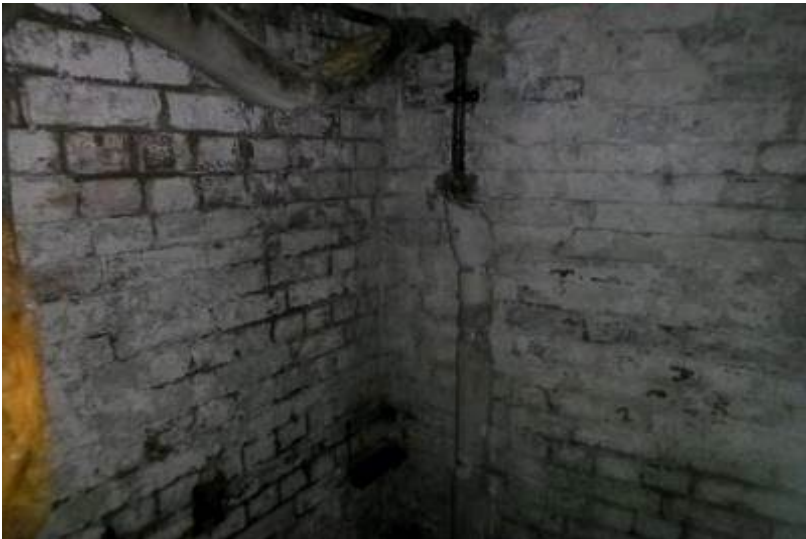
| Inspection Number | 48 | Reference Number: | N/A |

| Inspection / Sample | Visual Inspection | Inspection Cross Reference / Visual I.D. | Asbestos Presumed |
| Notes | Chrysotile identified in 2012 Management Survey - presume still present | | |
