Annual Inspection

Central Swindon North Parish Council

Alanbrooke Close

Inspection Ref: 2248288

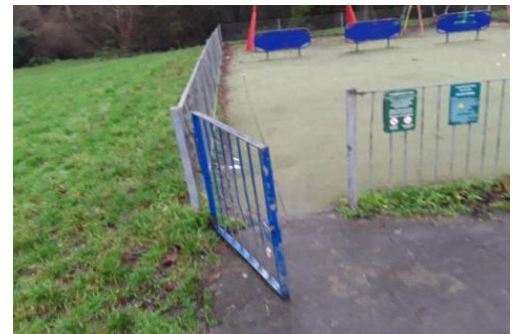
The item has been damaged - Monitor for any further deterioration and replace as required

The gate is not operating correctly - Take effective action to ensure the gate closes between 4 and 8 seconds

The rubber buffer is missing from the latch plate - Replace rubber buffer

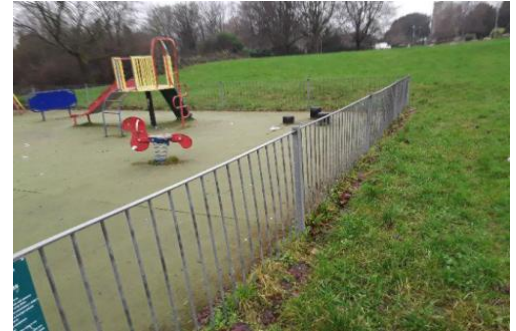
There is some damage to the fence sections - Monitor for any further deterioration and repair as required

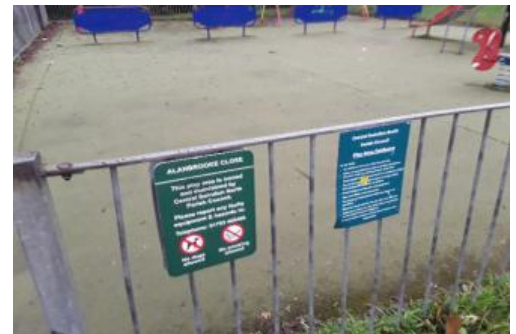
This item is satisfactory - no work required -

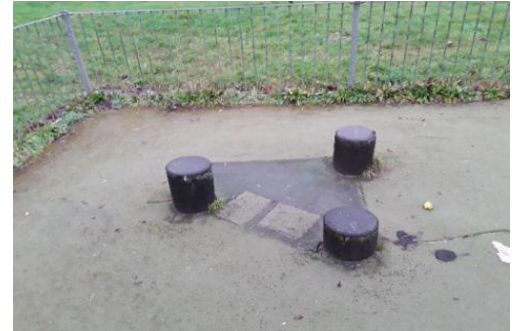
The step between the items is quite large and users may not be able to complete the step without touching ground, the items could therefore be considered to be within the falling space of each other, however the intention of the play activity continuity is easily apparent and foreseeable to the user - Monitor - No remedial work recommended

The fence forms a hard object within the falling space of the equipment in contravention of the requirements of BS EN 1176 Part 1 - Monitor - No remedial work recommended

The item has been damaged - Monitor for any further deterioration and replace as required

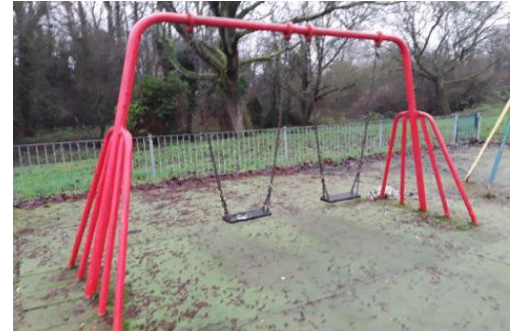
The connecting links are in excess of 8.6mm and less than 12mm and fail the requirements of BS EN 1176 Part 1; clause 4.2.13, Chains - Monitor - No remedial work recommended

There is some notable evidence of chain wear - Monitor for any further deterioration and replace when 40% worn

There is some wear to the shackles. - Monitor for any further deterioration and replace when 40% worn

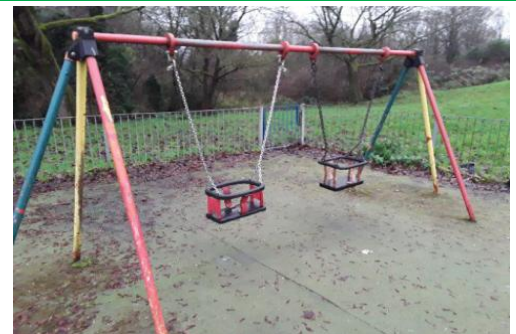
The paintwork on this item has been damaged or worn exposing the metal underneath which is rusting / corroding - Treat affected areas and repaint

There is some wear to the shackles. - Monitor for any further deterioration and replace when 40% worn

The connecting links are in excess of 8.6mm and less than 12mm and fail the requirements of BS EN 1176 Part 1; clause 4.2.13, Chains - Monitor - No remedial work recommended

There is some notable evidence of chain wear - Monitor for any further deterioration and replace when 40% worn

The seat has minor damage or wear - Monitor for any further deterioration and replace as required

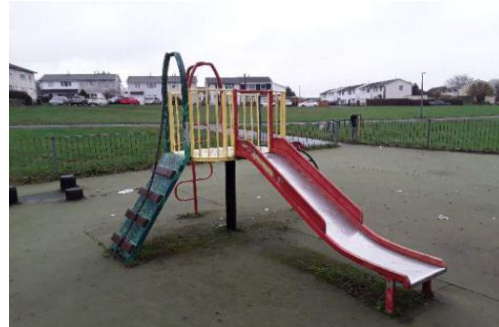
There are a number of dents in the slide surface - Monitor for any further deterioration and repair as required

There is/are finger entrapment/s in the slide start section and the item fails to meet the requirements of BS EN 1176 Part 1 4.2.7.6 Entrapment of fingers - Monitor - No remedial work recommended

The connecting links are in excess of 8.6mm and less than 12mm and fail the requirements of BS EN 1176 Part 1; clause 4.2.13, Chains - Monitor - No remedial work recommended

The paintwork on this item has been damaged or worn exposing the metal underneath which is rusting / corroding - Treat affected areas and repaint

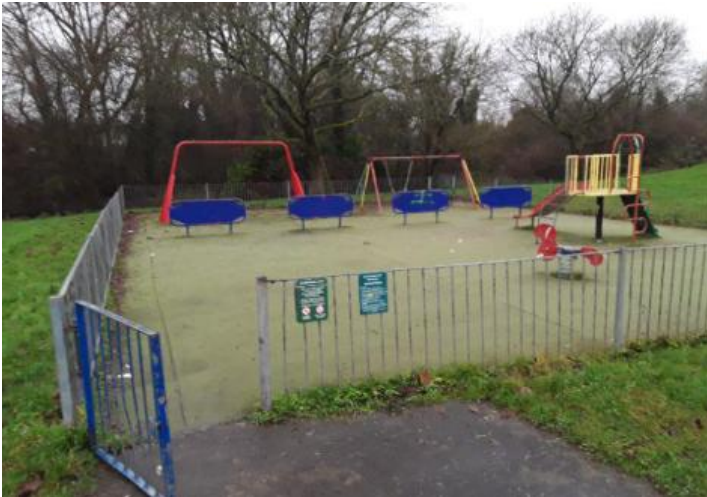
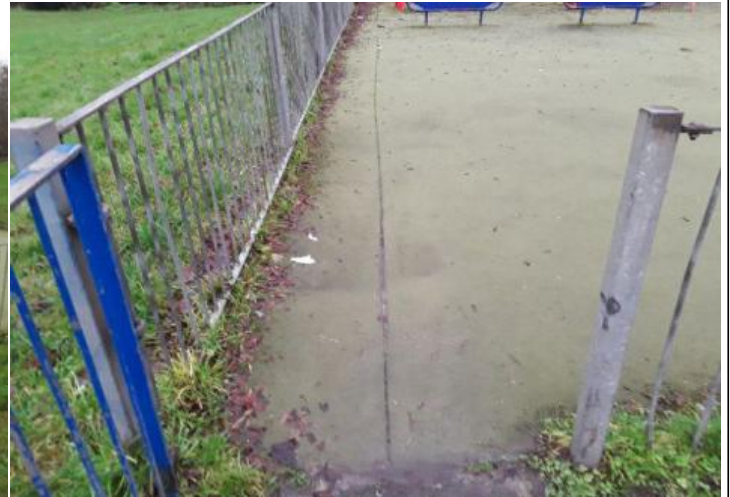
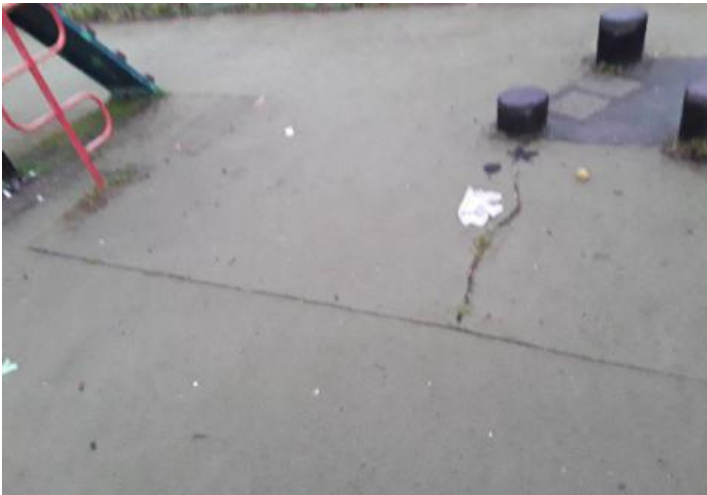
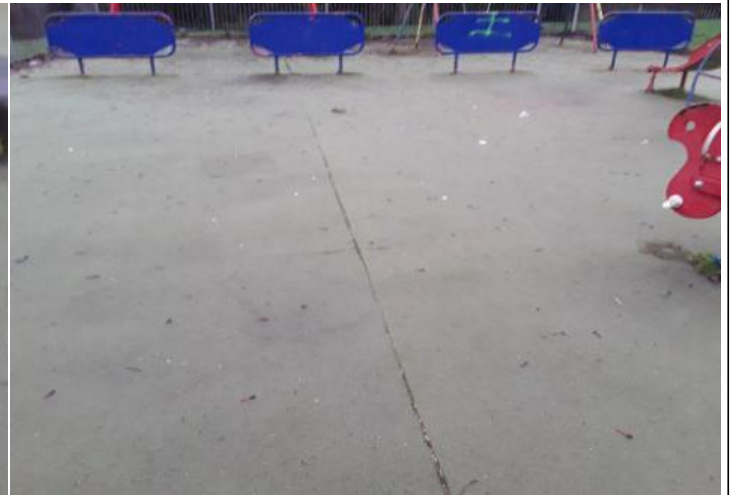
Finding: There are gaps opening between the surfacing

Action: Reinststate surface

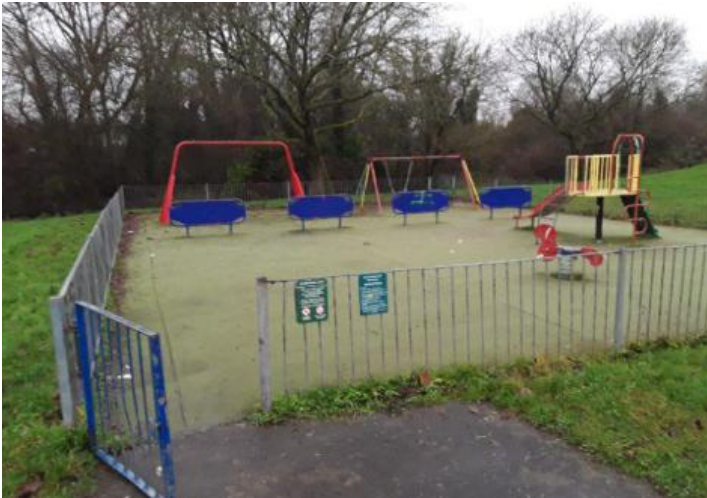
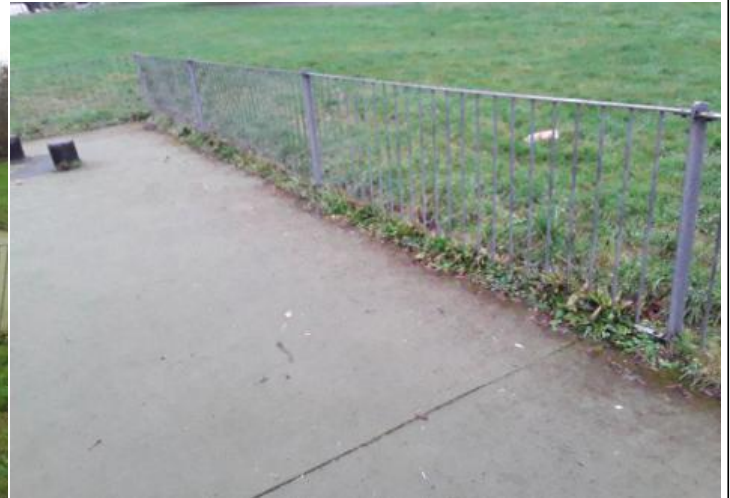
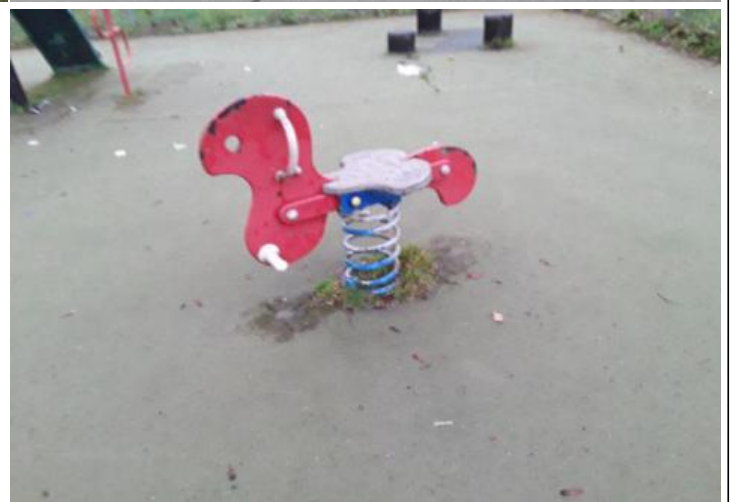
Finding: There is weed / vegetation growth on, between, or around the edges of the surfacing **Action:** Remove weed / vegetation growth

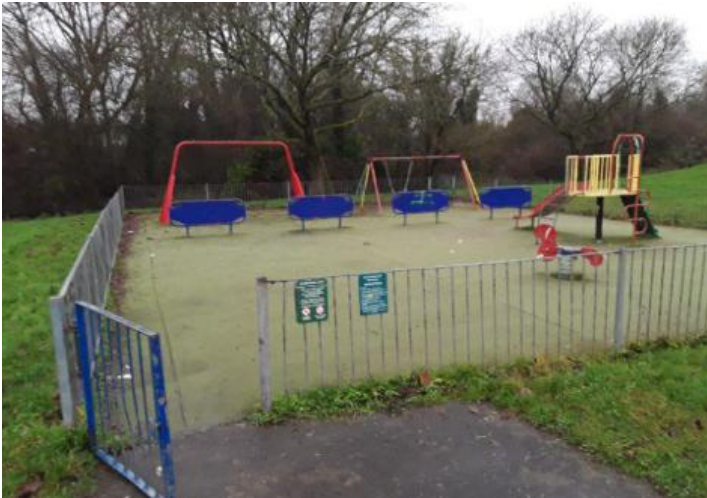
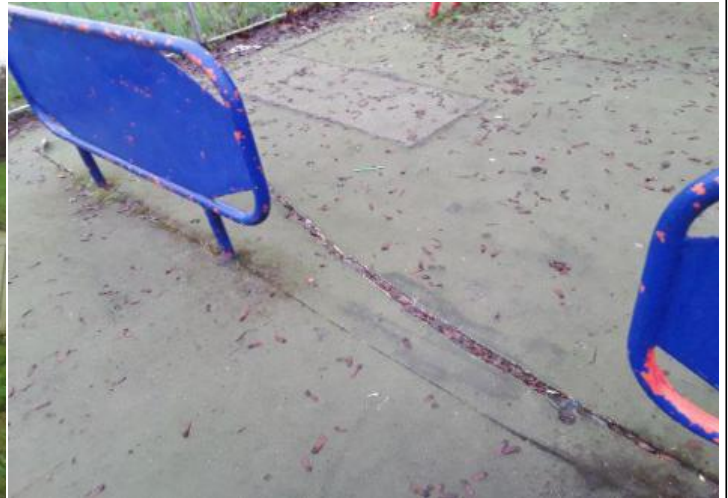
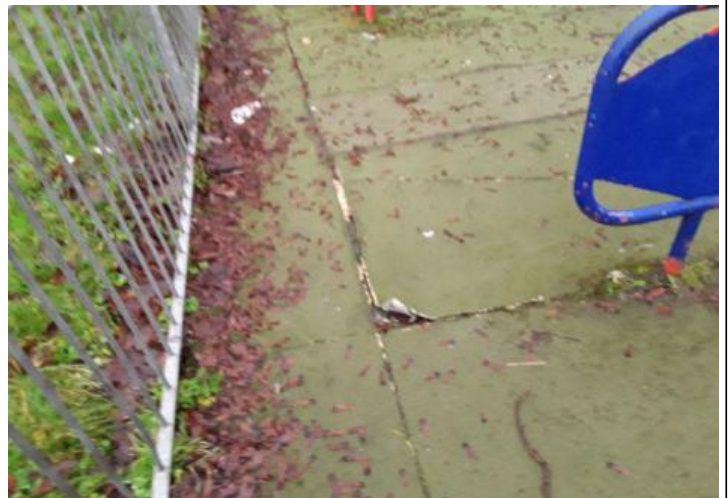
i 8 - Low Risk (Finding 3)

Finding: There is moderate damage to the surface

Action: Repair the damaged areas of surfacing

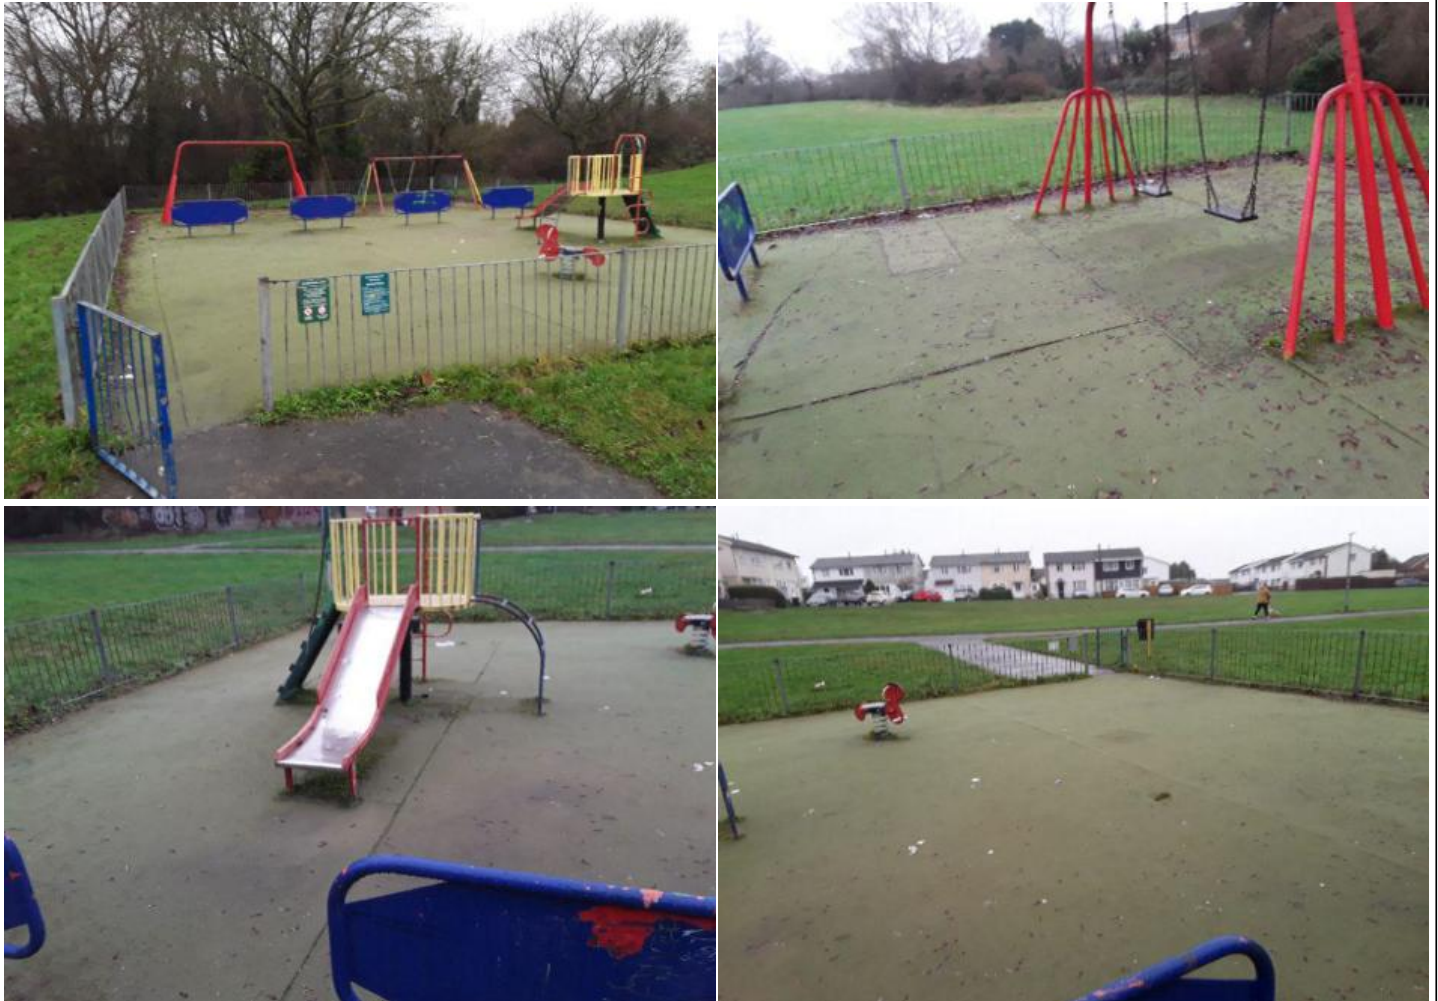
Finding: The safety surface around the area is beginning to wear
Action: Monitor for any further deterioration and repair as required

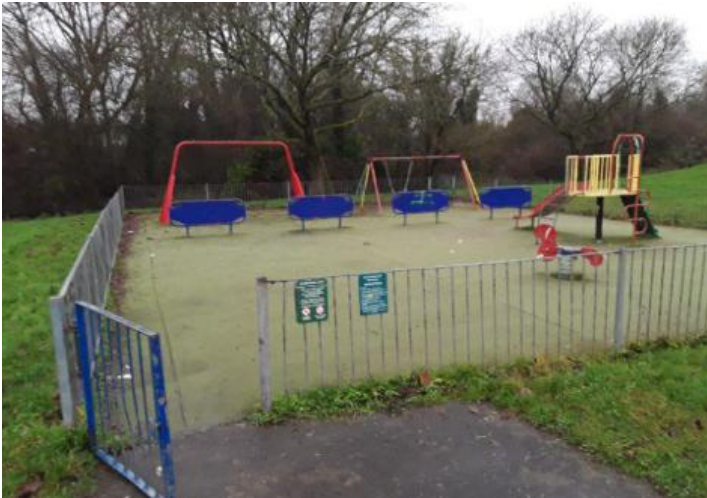
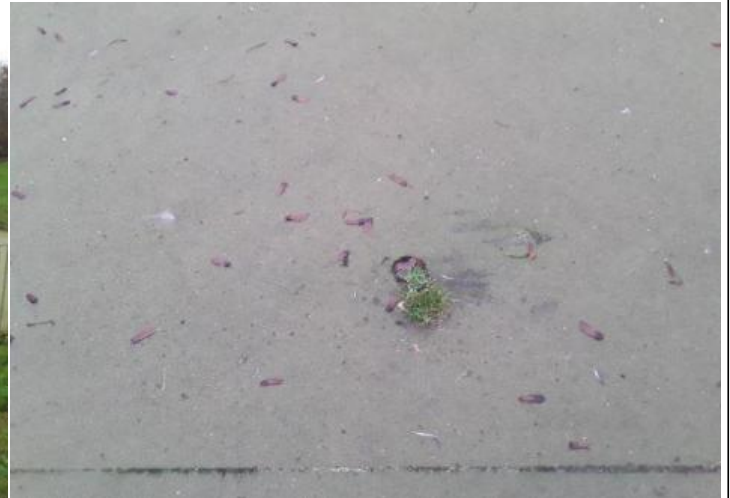
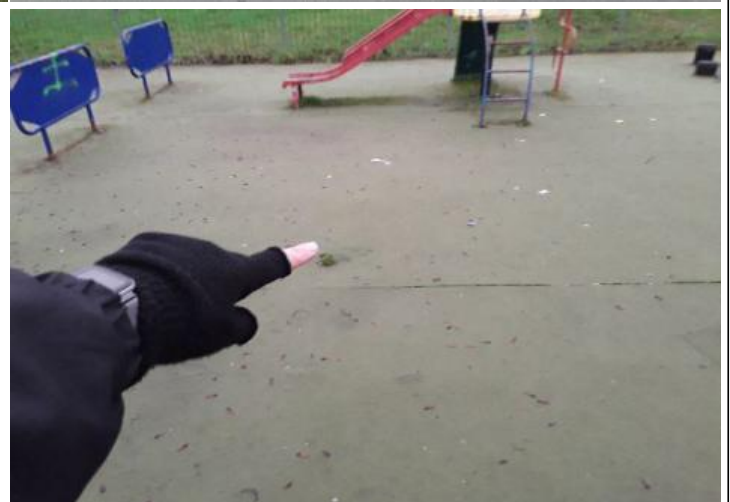
i 8 - Low Risk (Finding 5)

Finding: There is moderate damage to the surface

Action: Repair the damaged areas of surfacing

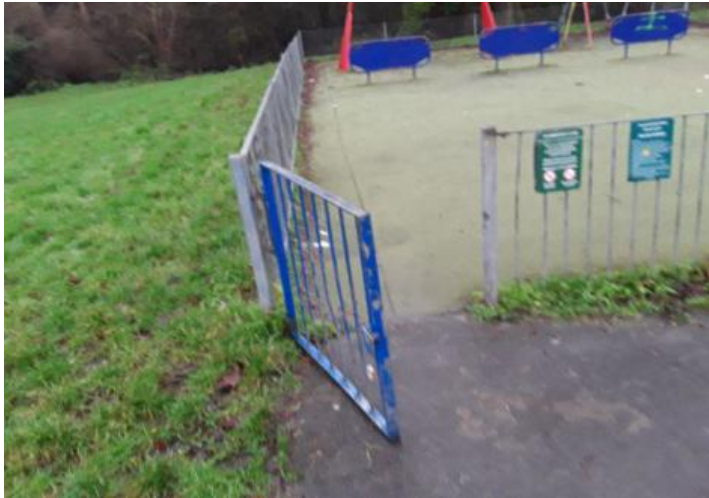
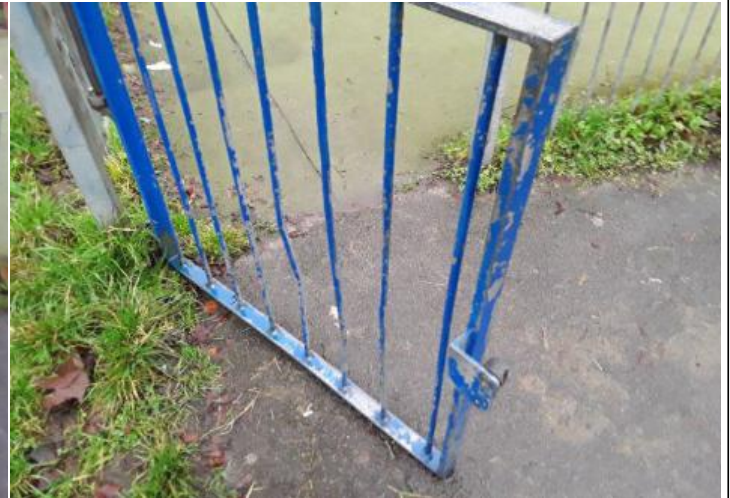
Finding: The item has been damaged

Action: Monitor for any further deterioration and replace as required

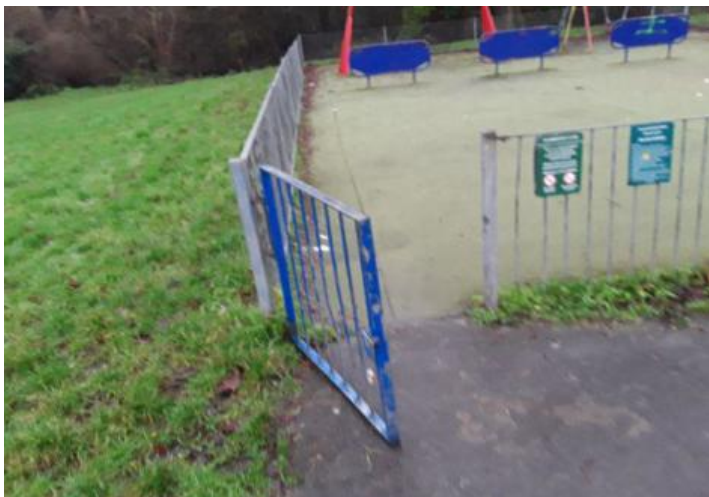
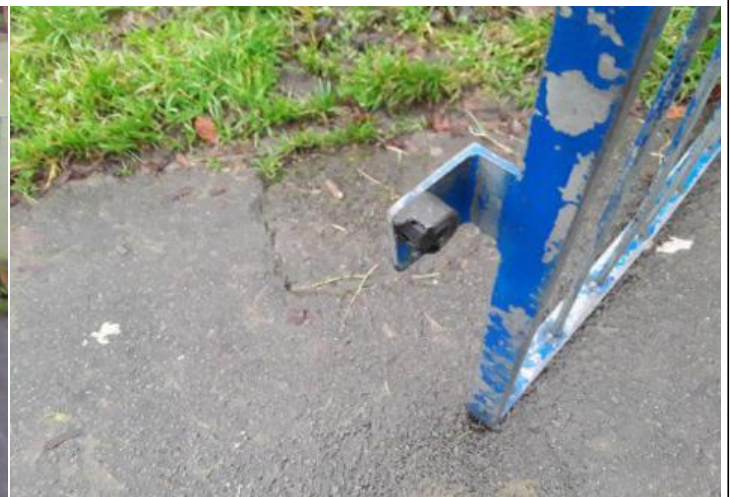
Finding: The rubber buffer is missing from the latch plate

Action: Replace rubber buffer

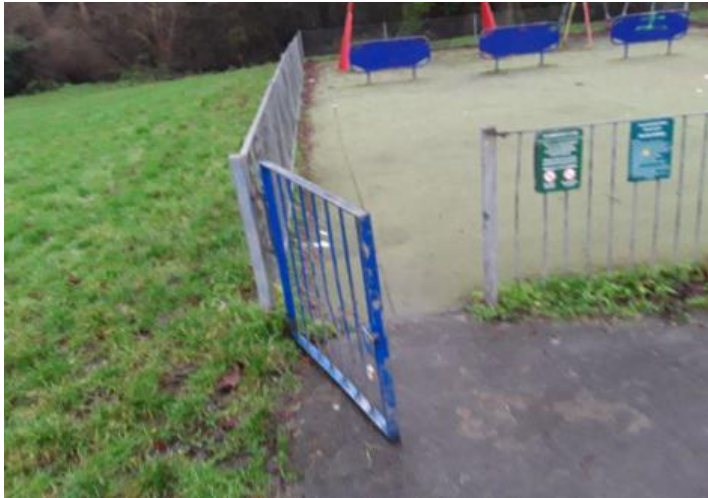
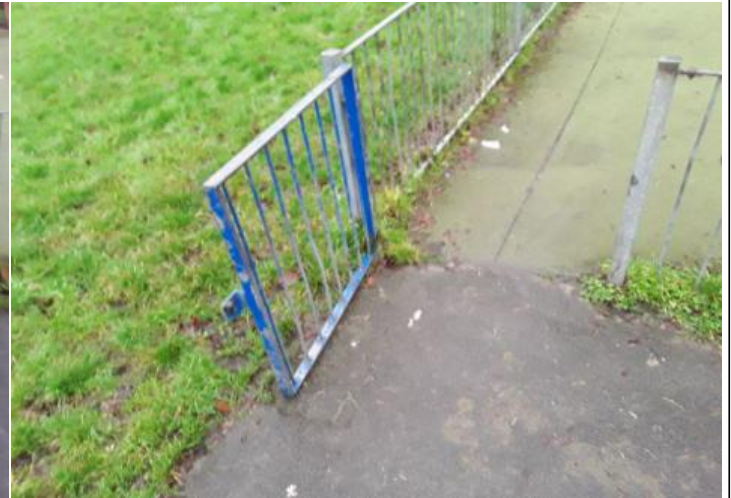
Finding: The gate is not operating correctly

Action: Take effective action to ensure the gate closes between 4 and 8 seconds

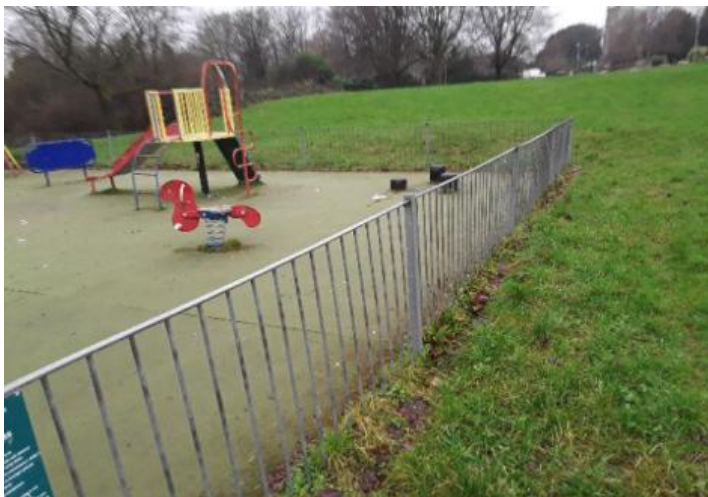
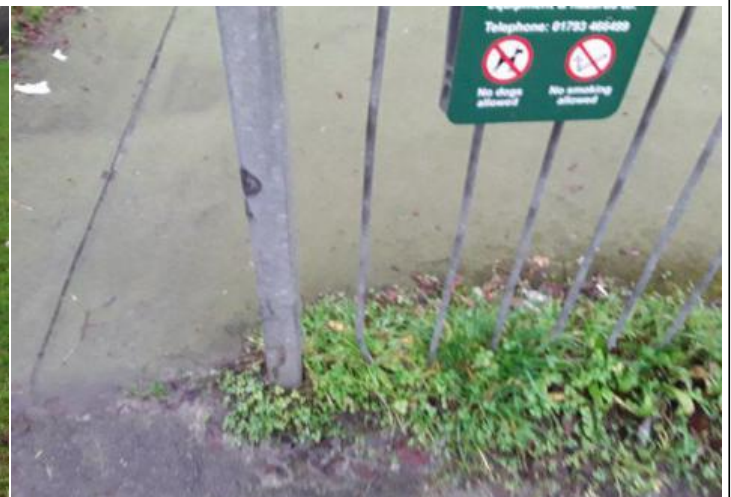
Finding: There is some damage to the fence sections

Action: Monitor for any further deterioration and repair as required

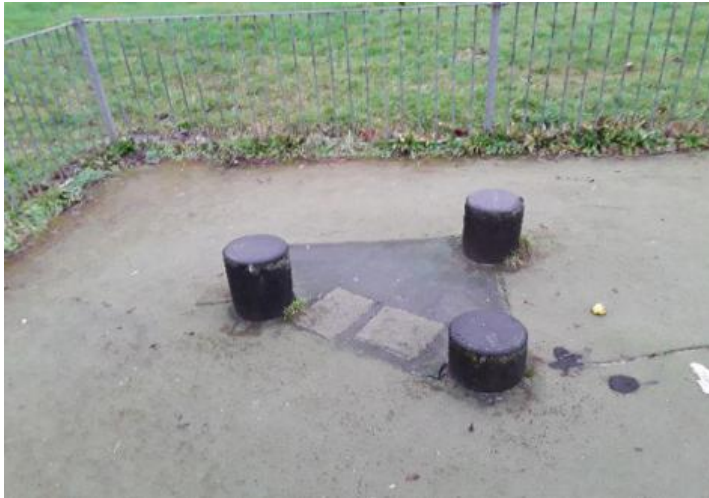
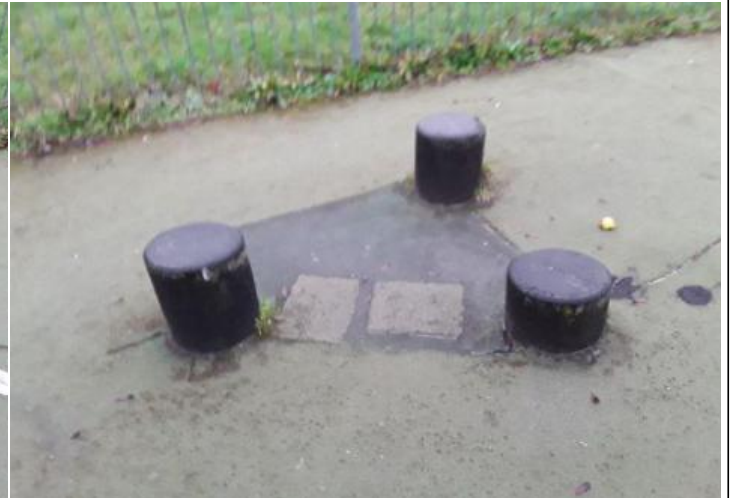
Finding: The step between the items is quite large and users may not be able to complete the step without touching ground, the items could therefore be considered to be within the falling space of each other, however the intention of the play activity continuity is easily apparent and foreseeable to the user

Action: Monitor - No remedial work recommended

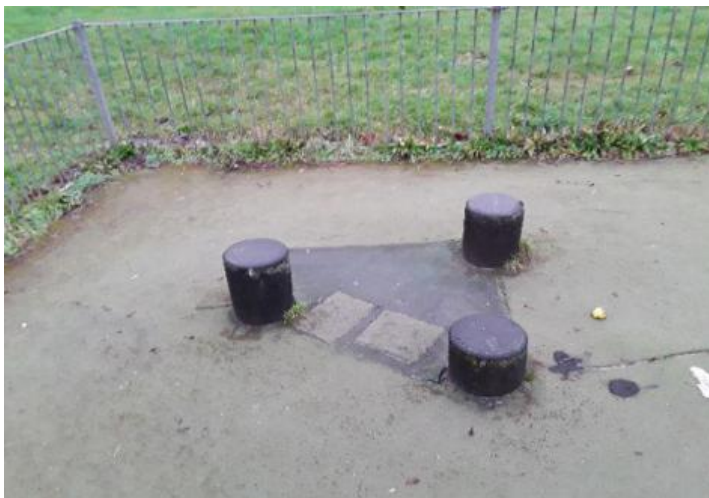
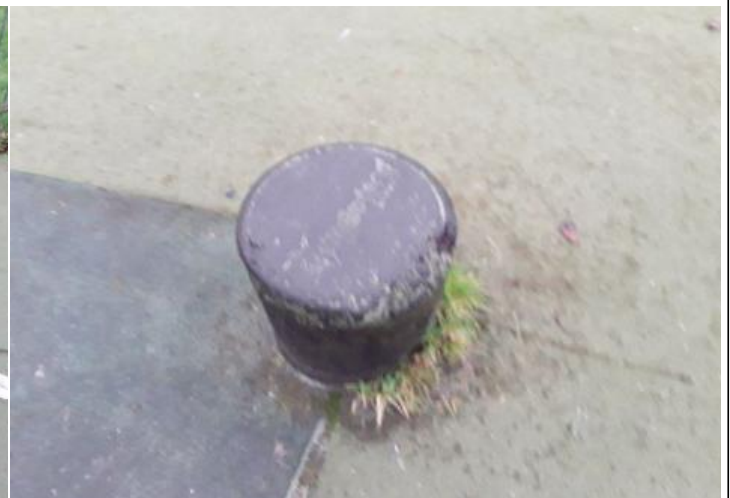
Finding: The item has been damaged

Action: Monitor for any further deterioration and replace as required

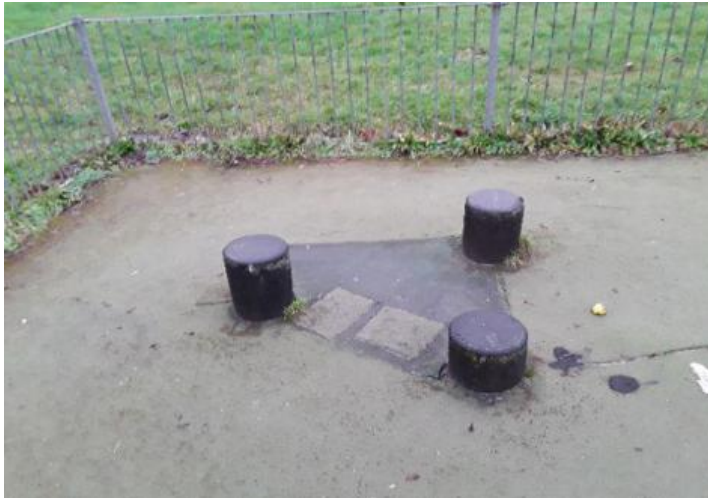
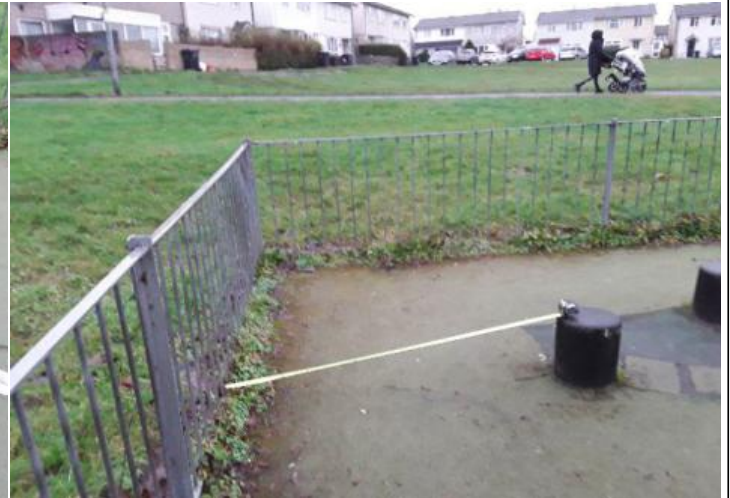
Finding: The fence forms a hard object within the falling space of the equipment in contravention of the requirements of BS EN 1176 Part 1

Action: Monitor - No remedial work recommended

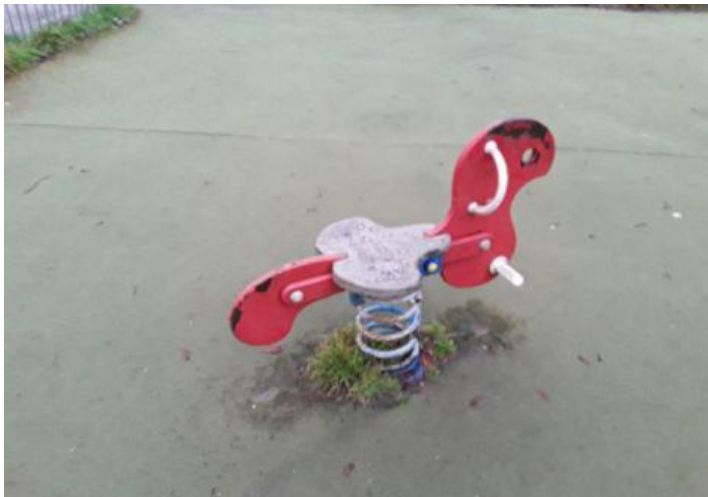
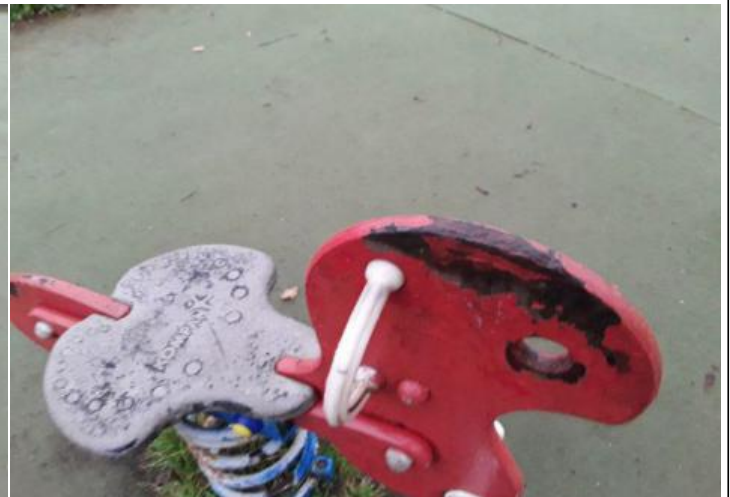
Finding: Parts of the timber are rough or splintered

Action: Remove all rough or sharp edges

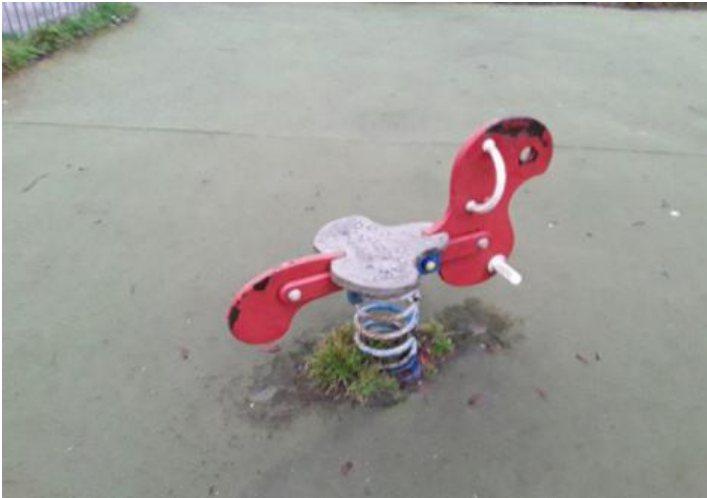
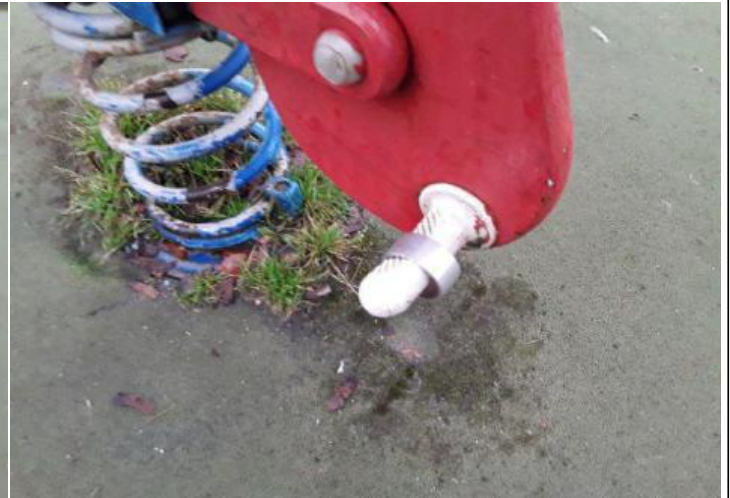
The end of handgrips and/or footrests have a cross section of less than 15cm² and fail to meet the requirements of BS EN 1176 Part 6 - Monitor - No remedial work recommended

Finding: The end of handgrips and/or footrests have a cross section of less than 15cm² and fail to meet the requirements of BS EN 1176 Part 6
Action: Monitor - No remedial work recommended

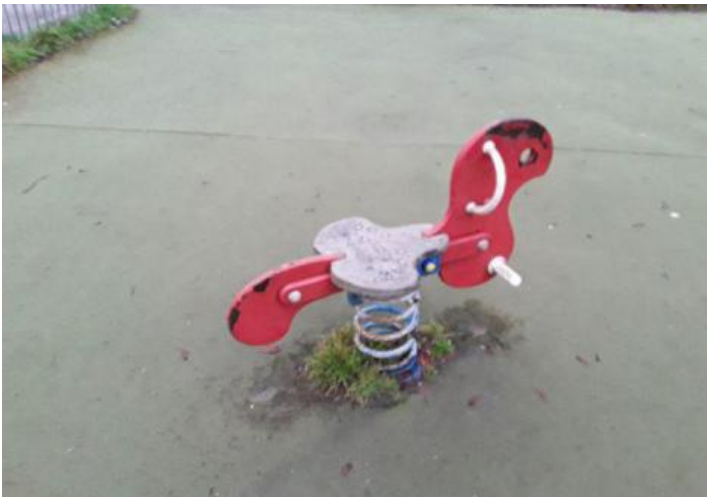
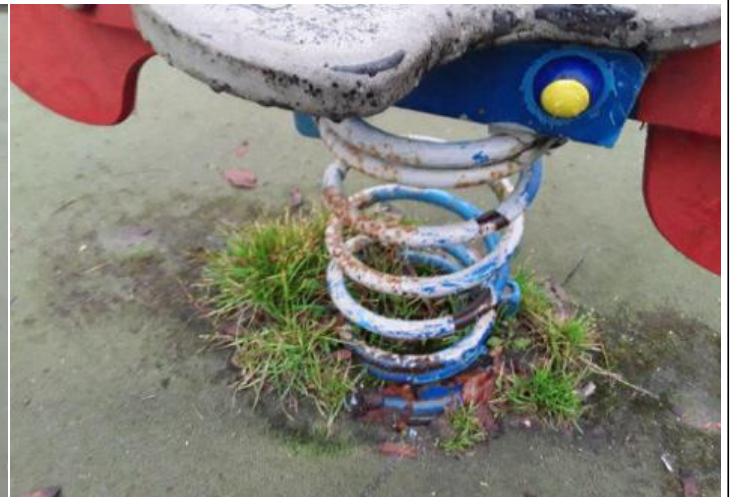
i 6 - Low Risk (Finding 3)

The paintwork on the spring has been damaged or worn exposing the metal underneath which is rusting - Treat any rusting components and repaint

Finding: The paintwork on the spring has been damaged or worn exposing the metal underneath which is rusting
Action: Treat any rusting components and repaint

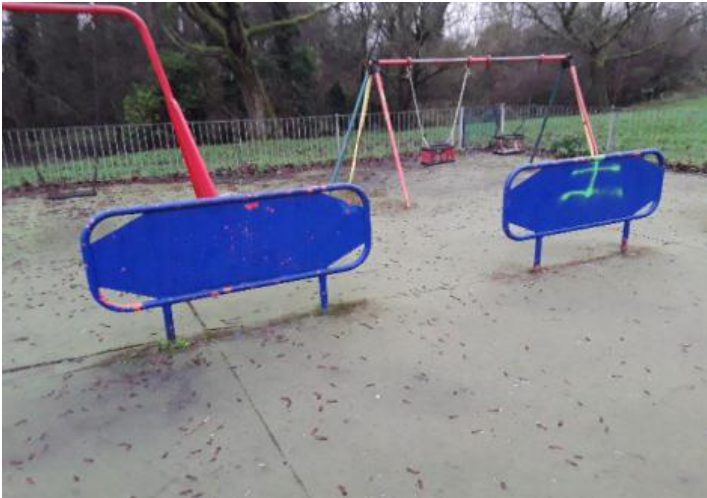
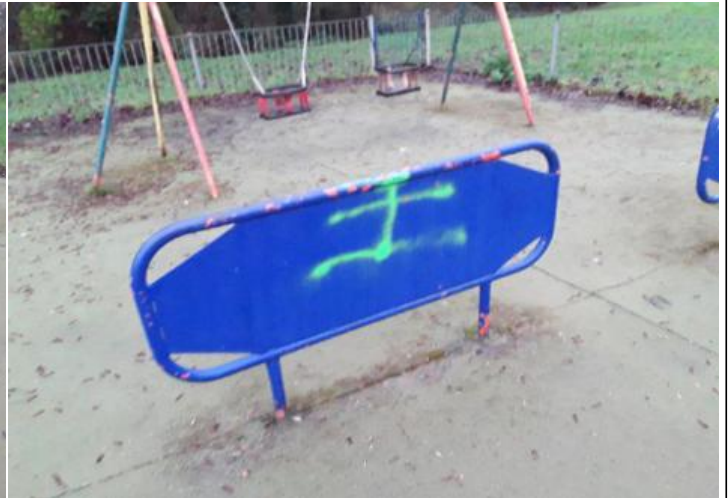
i 5 - Very Low Risk (Finding 1)

Finding: There is some graffiti present

Action: Remove the graffiti

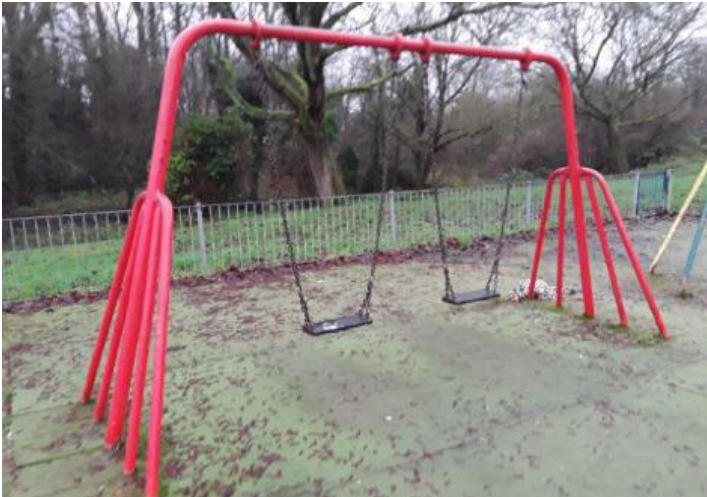
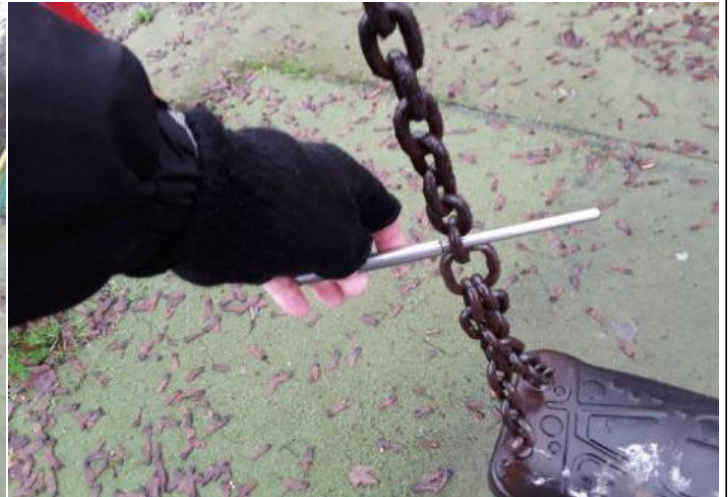
Finding: The connecting links are in excess of 8.6mm and less than 12mm and fail the requirements of BS EN 1176 Part 1; clause 4.2.13, Chains

Action: Monitor - No remedial work recommended

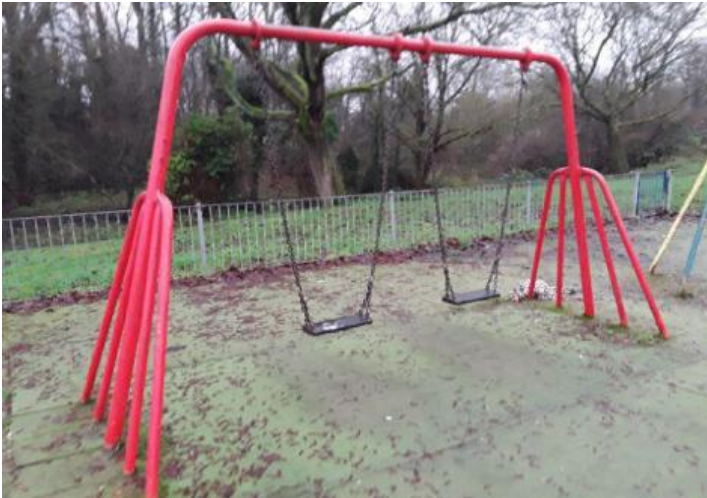
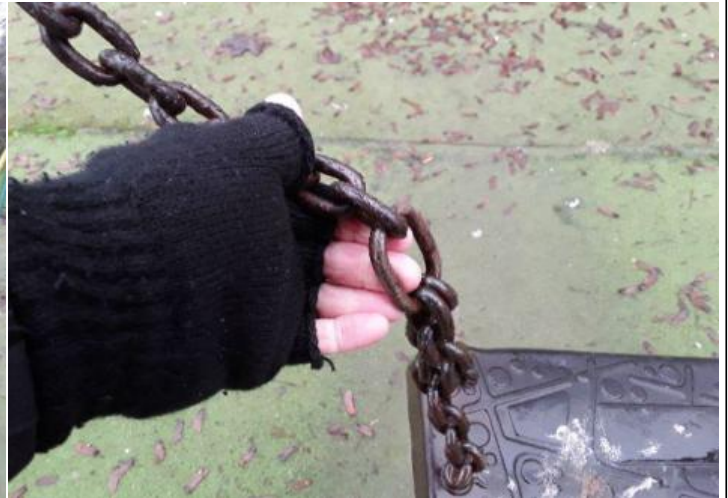
Finding: There is some notable evidence of chain wear

Action: Monitor for any further deterioration and replace when 40% worn

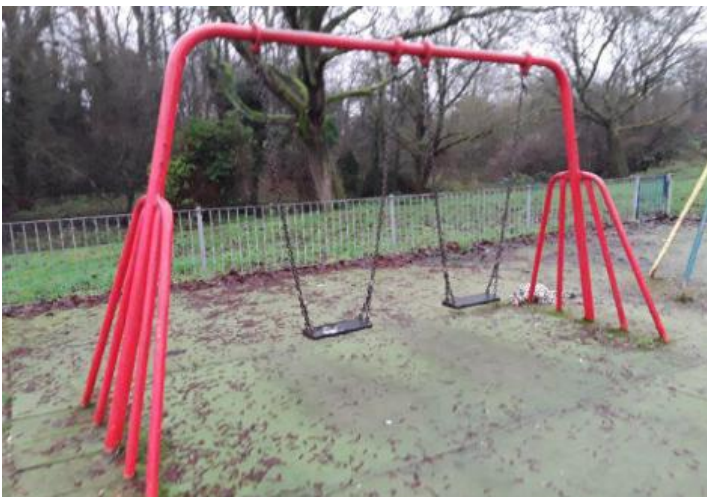
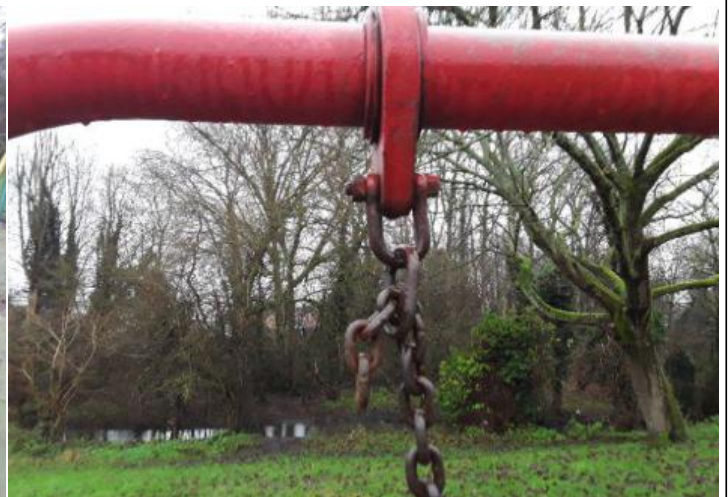
Finding: There is some wear to the shackles.

Action: Monitor for any further deterioration and replace when 40% worn

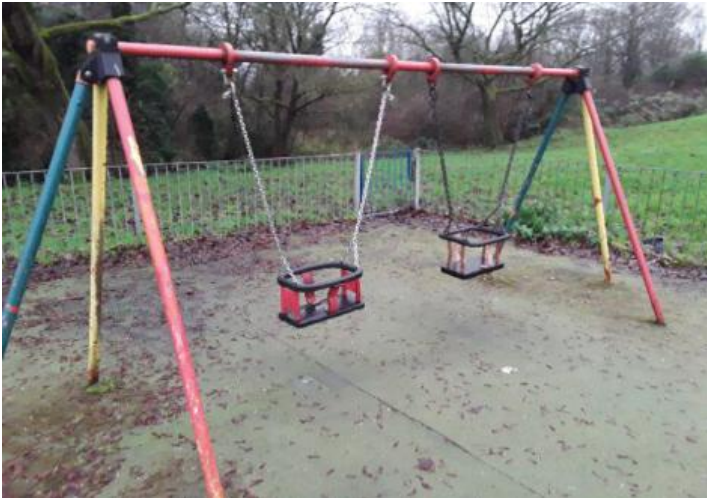
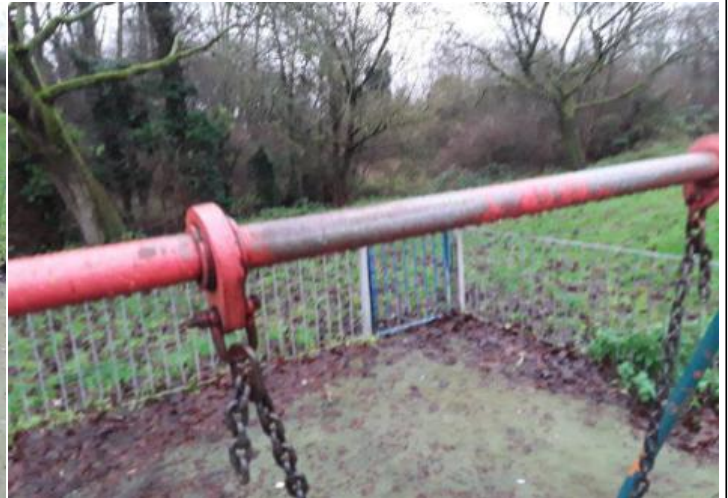
Finding: The paintwork on this item has been damaged or worn exposing the metal underneath which is rusting / corroding

Action: Treat affected areas and repaint

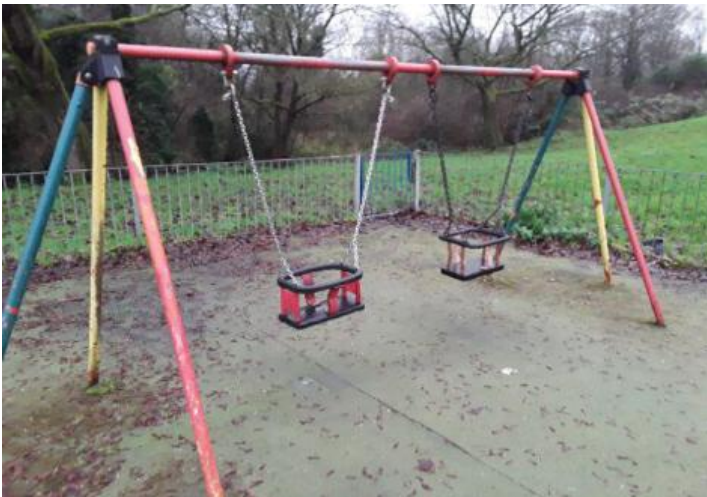
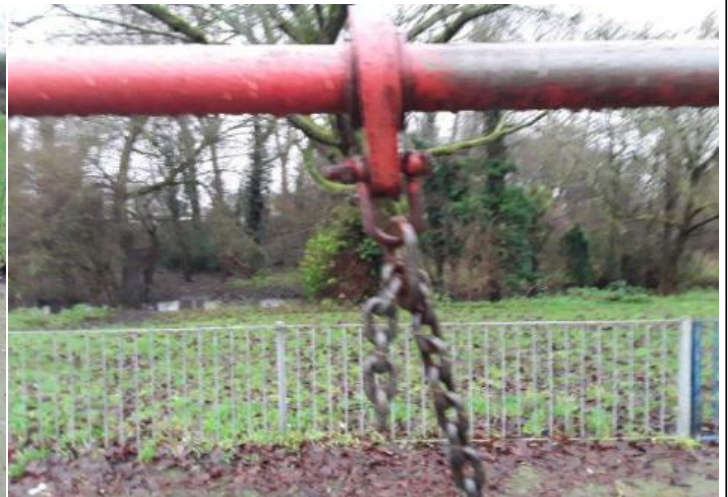
Finding: There is some wear to the shackles.

Action: Monitor for any further deterioration and replace when 40% worn

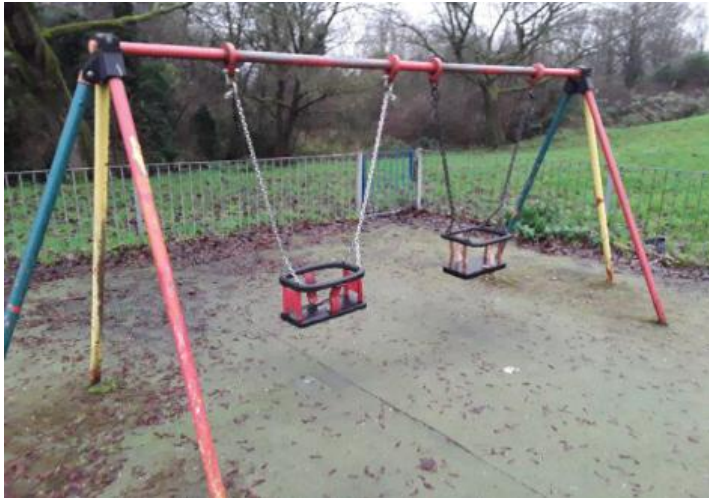
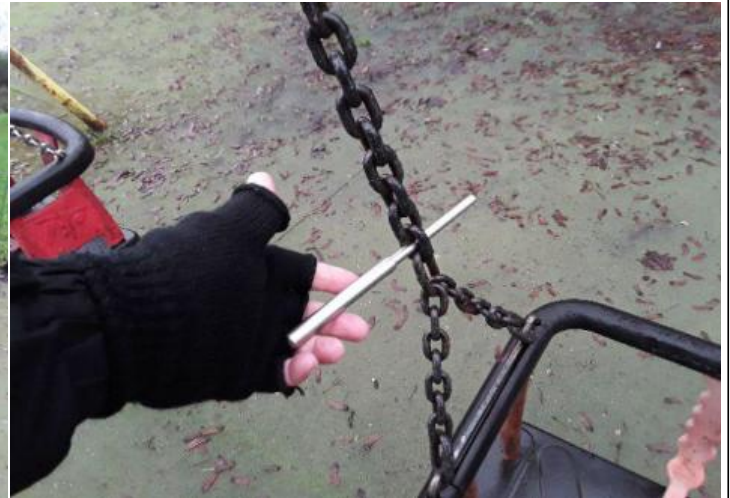
Finding: The connecting links are in excess of 8.6mm and less than 12mm and fail the requirements of BS EN 1176 Part 1; clause 4.2.13, Chains

Action: Monitor - No remedial work recommended

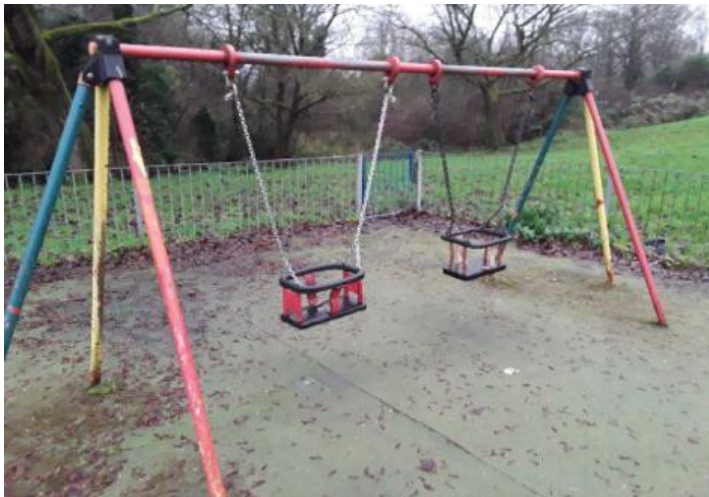
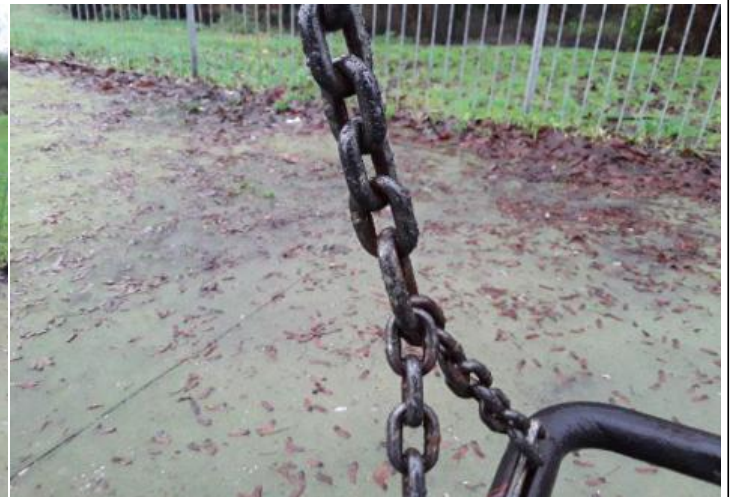
Finding: There is some notable evidence of chain wear

Action: Monitor for any further deterioration and replace when 40% worn

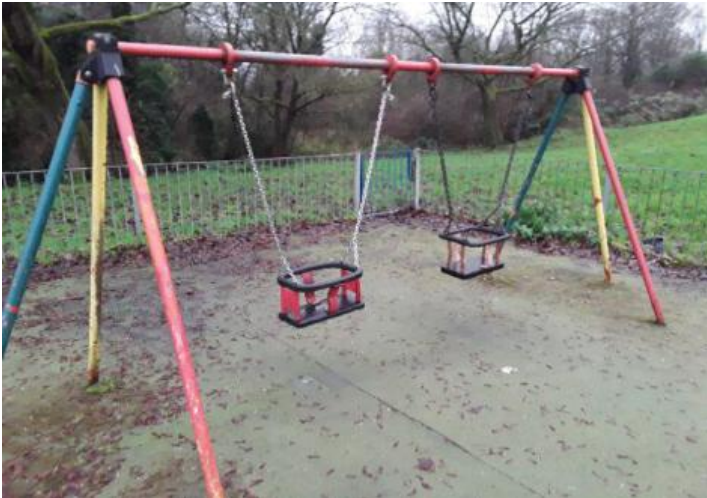
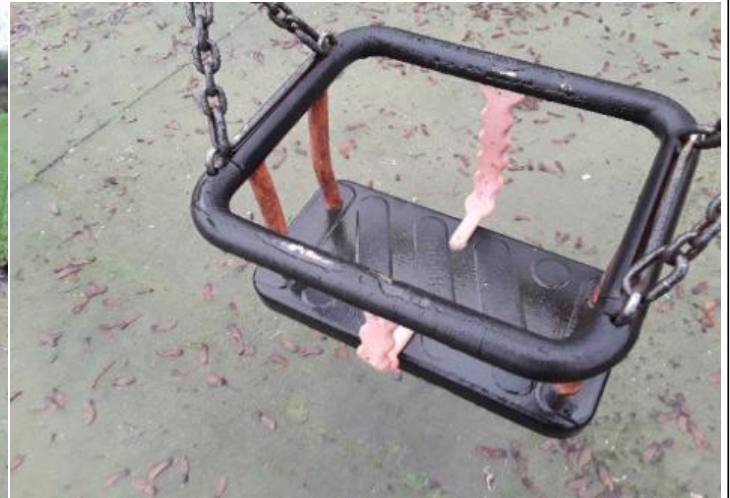
Finding: The seat has minor damage or wear

Action: Monitor for any further deterioration and replace as required
