Annual Inspection

Central Swindon North Parish Council

Alanbrooke Close

Inspection Ref: 2248288

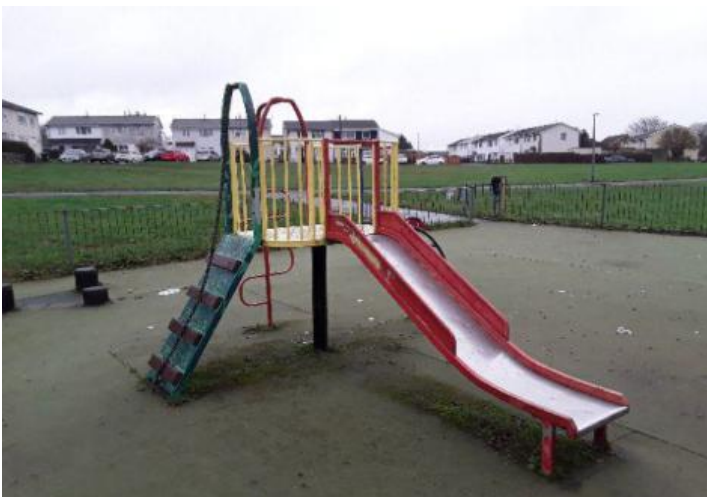
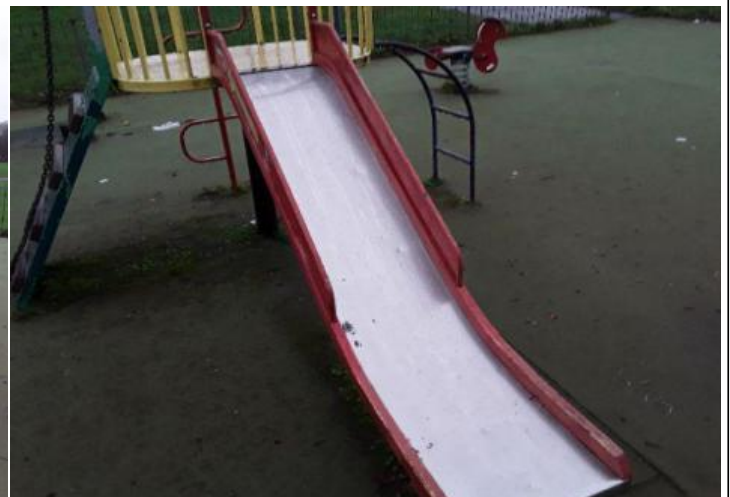
Finding: There are a number of dents in the slide surface

Action: Monitor for any further deterioration and repair as required

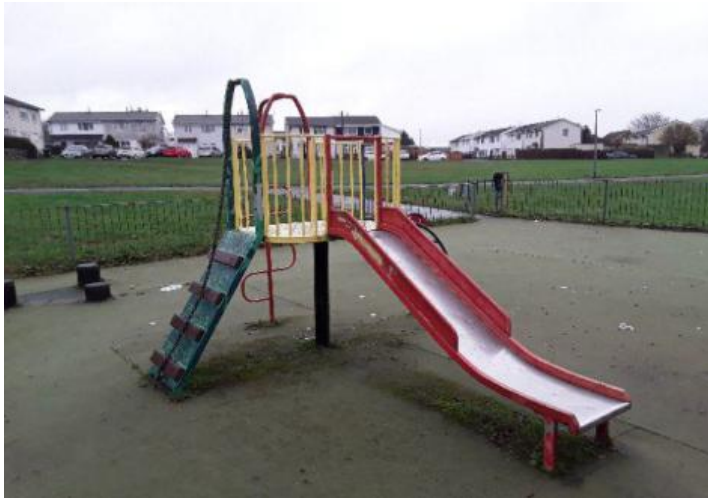
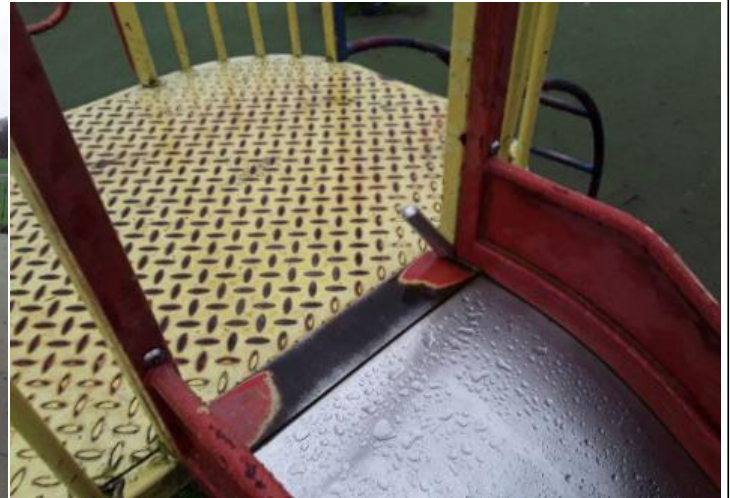
Finding: There is/are finger entrapment/s in the slide start section and the item fails to meet the requirements of BS EN 1176 Part 1 4.2.7.6 Entrapment of fingers

Action: Monitor - No remedial work recommended

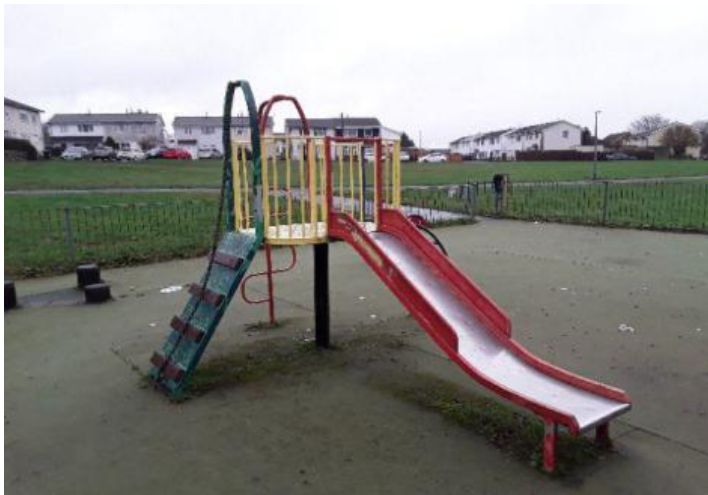
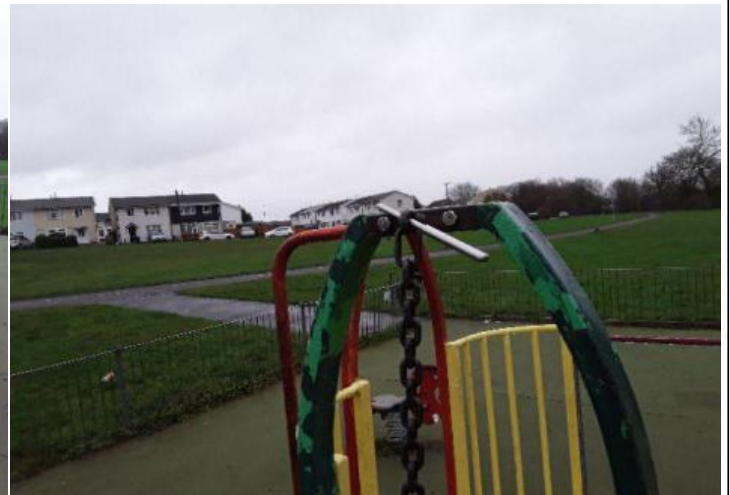
Finding: The connecting links are in excess of 8.6mm and less than 12mm and fail the requirements of BS EN 1176 Part 1; clause 4.2.13, Chains

Action: Monitor - No remedial work recommended

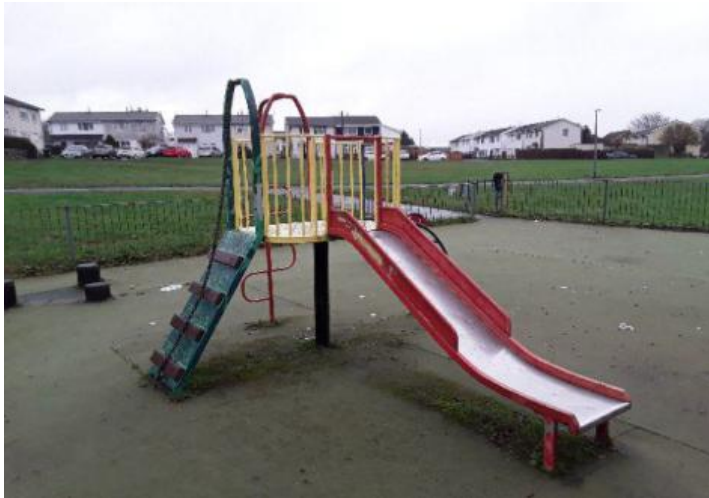
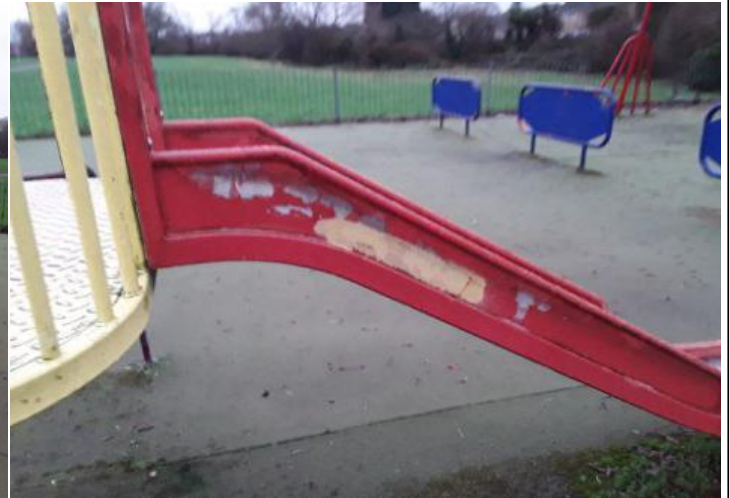
Finding: There is some graffiti present

Action: Remove the graffiti

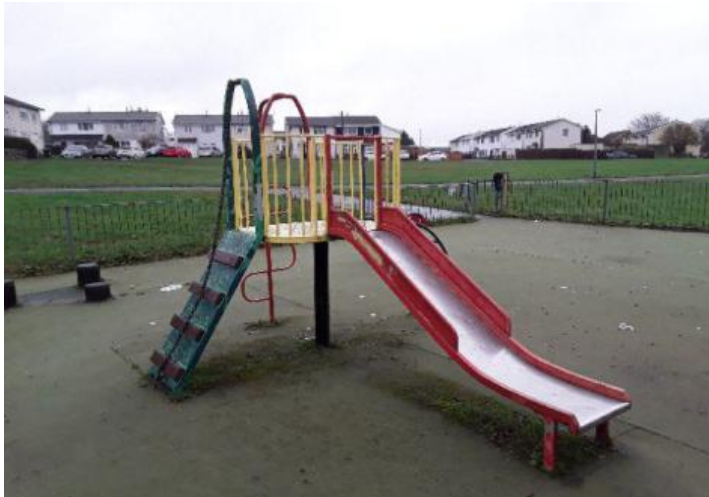
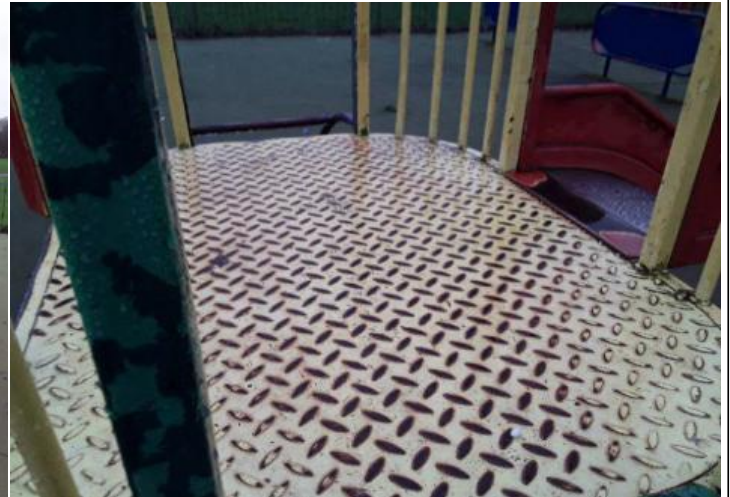
Finding: The paintwork on this item has been damaged or worn exposing the metal underneath which is rusting / corroding

Action: Treat affected areas and repaint
