**ST HELENS CHAMBER**

**Asbestos Refurbishment and Demolition Survey**

**4-6 Hardshaw Street  
WA10 1RE**

**Our Ref: A-29413**

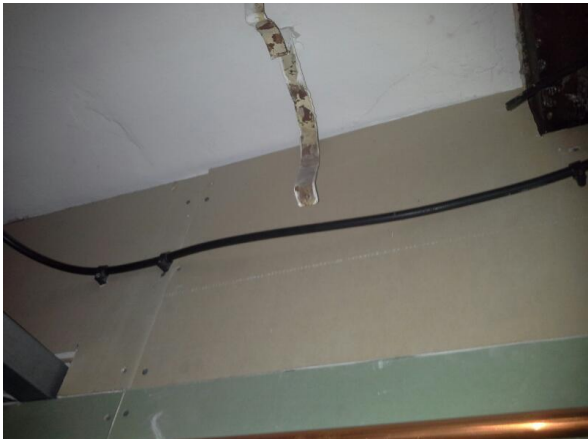
Sample No.	A-29413/S002	
Property	4-6 Hardshaw Street WA10 1RE	
Building / Floor	Main Building	0
Location	first floor men's w/c	
Position	insulation to old pipe hanger above suspended ceiling	
Material	Insulation	
Extent:	0.1	
Analytical Results	Chrysotile	
Material Assessment	6 - Low	
Description of remedial works required / comments

Encapsulate, label & manage. Remove if planned works will impact upon material.
--

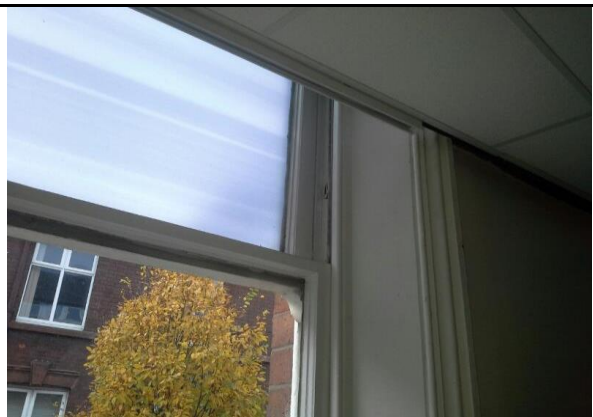
Sample No.	A-29413/S003

Property	4-6 Hardshaw Street WA10 1RE		
Building / Floor	Main Building	0	
Location	first floor room c		
Position	x2 ropes to windows		
Material	Gaskets (rope/woven)		
Extent:			
Analytical Results	NAD		
Material Assessment			
Description of remedial works required / comments			No recommendation required

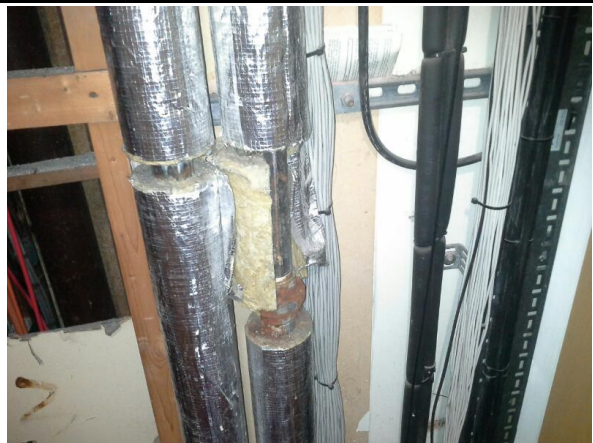
Sample No.	A-29413/S004

Property	4-6 Hardshaw Street WA10 1RE		
Building / Floor	Main Building	0	
Location	ground floor corridor cupboard		
Position	paper to wall		
Material	Gaskets (compressed)		
Extent:			
Analytical Results	NAD		
Material Assessment			
Description of remedial works required / comments			No recommendation required

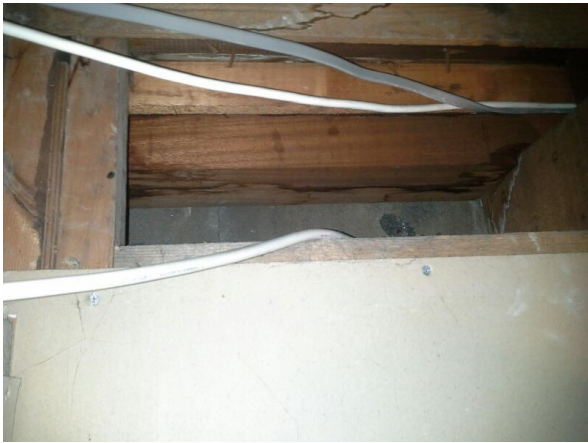
Sample No.	A-29413/S006

Property	4-6 Hardshaw Street WA10 1RE		
Building / Floor	Main Building	0	
Location	ground floor reception		
Position	panels above window above suspended ceiling		
Material	Insulating Board		
Extent:			
Analytical Results	NAD		
Material Assessment			
Description of remedial works required / comments			No recommendation required

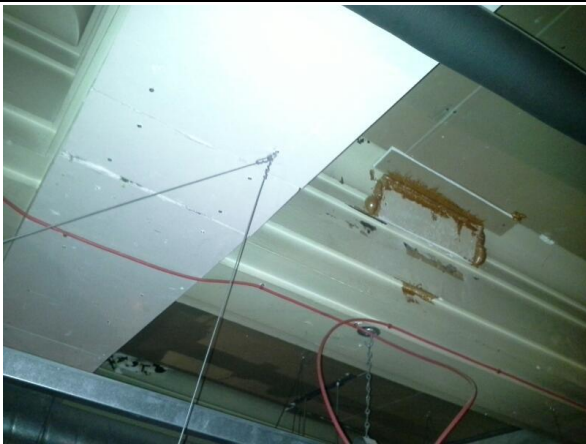
Sample No.	A-29413/S005

Property	4-6 Hardshaw Street WA10 1RE		
Building / Floor	Main Building	0	
Location	ground floor reception		
Position	panels to beam above suspended ceiling		
Material	Insulating Board		
Extent:			
Analytical Results	NAD		
Material Assessment			
Description of remedial works required / comments			No recommendation required

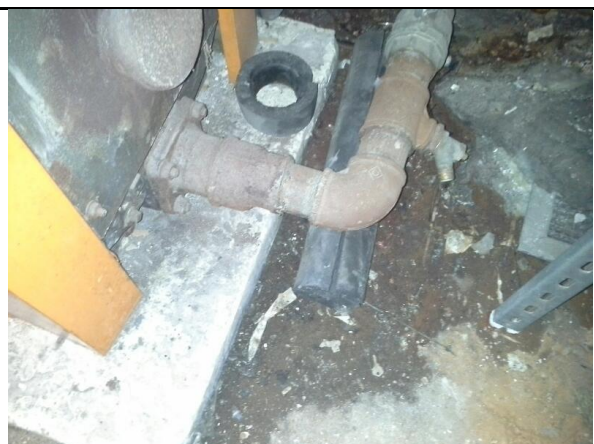
Sample No.	A-29413/S008

Property	4-6 Hardshaw Street WA10 1RE		
Building / Floor	Main Building	0	
Location	basement boiler room		
Position	debris to floor		
Material	Insulation		
Extent:			
Analytical Results	NAD		
Material Assessment			No recommendation required
Description of remedial works required / comments

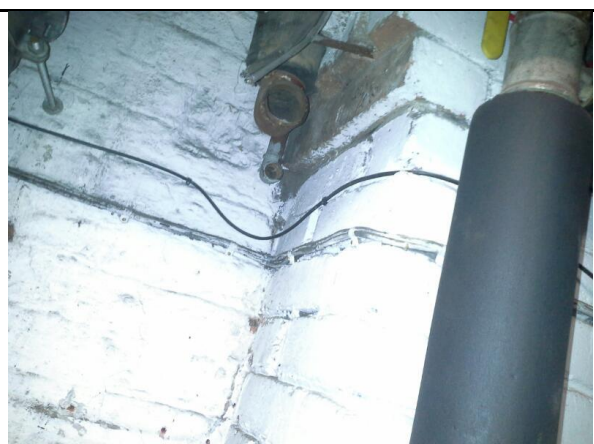
Sample No.	A-29413/S007

Property	4-6 Hardshaw Street WA10 1RE		
Building / Floor	Main Building	0	
Location	basement boiler room		
Position	debris to wall		
Material	Insulation		
Extent:			
Analytical Results	NAD		
Material Assessment			No recommendation required
Description of remedial works required / comments

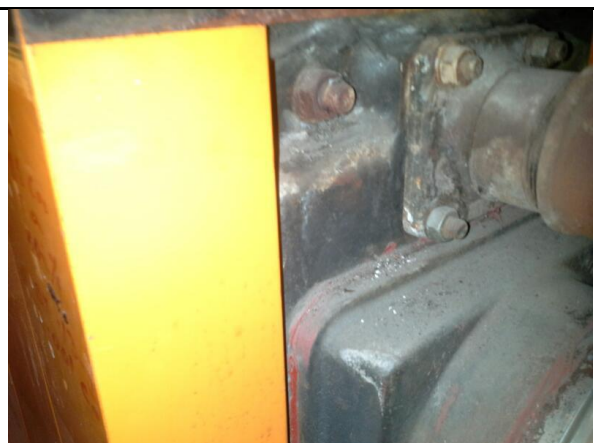
Sample No.	A-29413/S009

Property	4-6 Hardshaw Street WA10 1RE		
Building / Floor	Main Building	0	
Location	basement boiler room		
Position	debris to boiler		
Material	Insulation		
Extent:			
Analytical Results	NAD		
Material Assessment			
Description of remedial works required / comments			No recommendation required

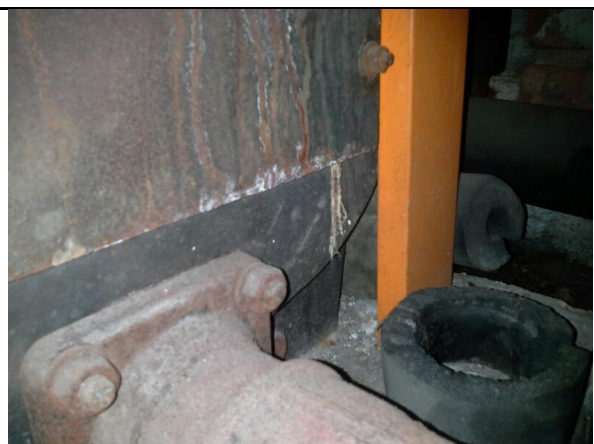
Sample No.	A-29413/S010

Property	4-6 Hardshaw Street WA10 1RE		
Building / Floor	Main Building	0	
Location	basement boiler room		
Position	rope to boiler		
Material	Gaskets (rope/woven)		
Extent:	0.1m <sup>2</sup>		
Analytical Results	Chrysotile		
Material Assessment	5 - Low		
Description of remedial works required / comments			Encapsulate, label & manage. Remove if planned works will impact upon material.
