**National Asset Delivery  
Technical Surveys and Testing**

**Site Information for 570127  
M4 J15-16 EB MP125.9 – Drainage  
Survey**

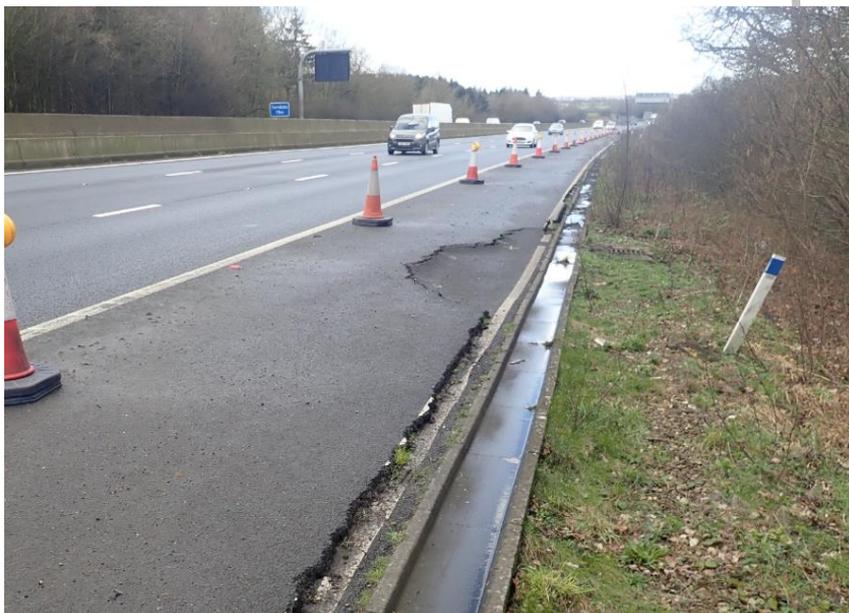
Plate 2 – Overview of defect (February 2020)

The motorway at the location is built on split level carriageways, with the eastbound carriageway on a shallow embankment, varying from less than 1m height at MP125.8 to 3.2m at MP126.0. The scheme aims to investigate the cause of hard shoulder cracking and subsidence, and kerb drainage dislocation, along approximately 60m centred at EB Marker Post MP125.9 (Figure 2).

As noted above and as shown in Plate 1, there is subsidence in the hard shoulder pavement and cracking between the pavement and the drainage channel.

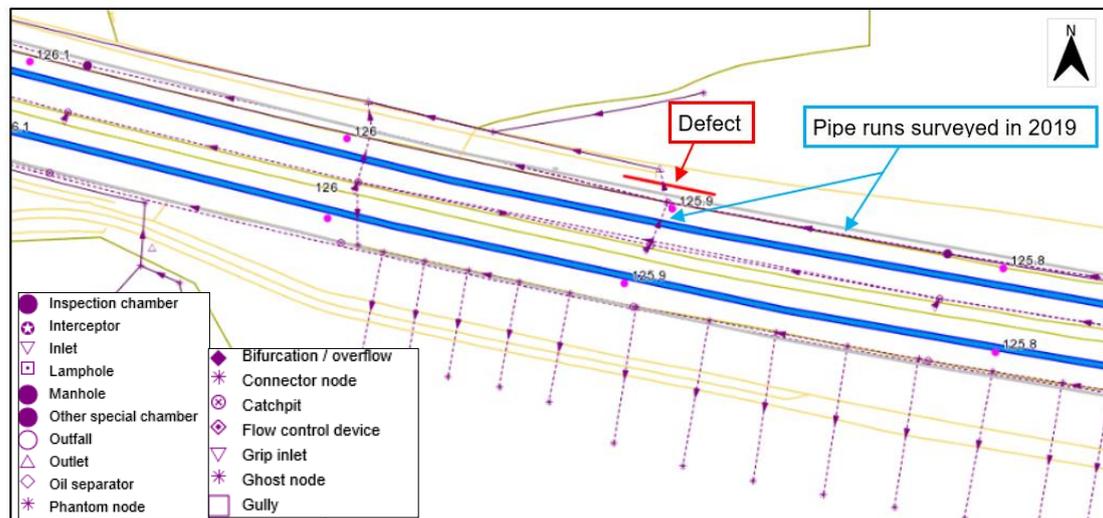
Figure 2– Drainage Assets (from HA DDMS)

HA DDMS indicates kerb drainage at the location consists of a concrete surface water channel along the edge of the eastbound carriageway, outfalling into verge catchpits. A carrier pipe (Ø305mm) and a filter drain (Ø229mm) are recorded along the eastbound verge, both flowing towards west. Two carrier pipes (Ø300mm, Ø150mm) are also recorded within the central reservation flowing west. Cross carriageway pipework (Ø150mm) is present at the defect location (MP125.9) discharging the central reservation drainage into a catchpit within the verge and from this into the ditch at the toe of the embankment. A similar arrangement is indicated at MP126.0. Batter sub-soil drains at 5m intervals are present along the westbound verge – these do not flow in the direction of the arrows shown in the as-built drawing and replicated on HADDMS, but in the opposite direction, towards the batter toe due North. Drainage assets on HA DDMS are illustrated in Figure 2 below.

Very little post construction condition information is available on HADDMS and existing information relates mainly to the central reservation, indicating generally poor condition (Grade 5). No condition information is available for the eastbound verge buried assets, including connections to the toe ditch at MP125.9 and MP126. Outfalls at these locations are recorded as unvalidated.

Highways England commissioned a CCTV survey in November 2019 covering only the eastbound cross carriageway pipe at MP125.9 and the motorway drainage pipe along the verge between MP125.9 and MP125.8 (indicated on Figure 2). The survey indicated no defects on the  $\text{\O}300\text{mm}$  verge carrier drain (Structural Grade 1, Service Grade 1). The cross carriageway pipe ( $\text{\O}150\text{mm}$ ) was found in poor condition: Structural Grade 5, Service Grade 2. Significant debris causing up to 95% area loss was found requiring jetting to allow full survey. Significant structural defects were found, including holes at joints at 1.3m from the verge catchpit, under the failed section of hardshoulder, and at 4.4m, under Lane 1.

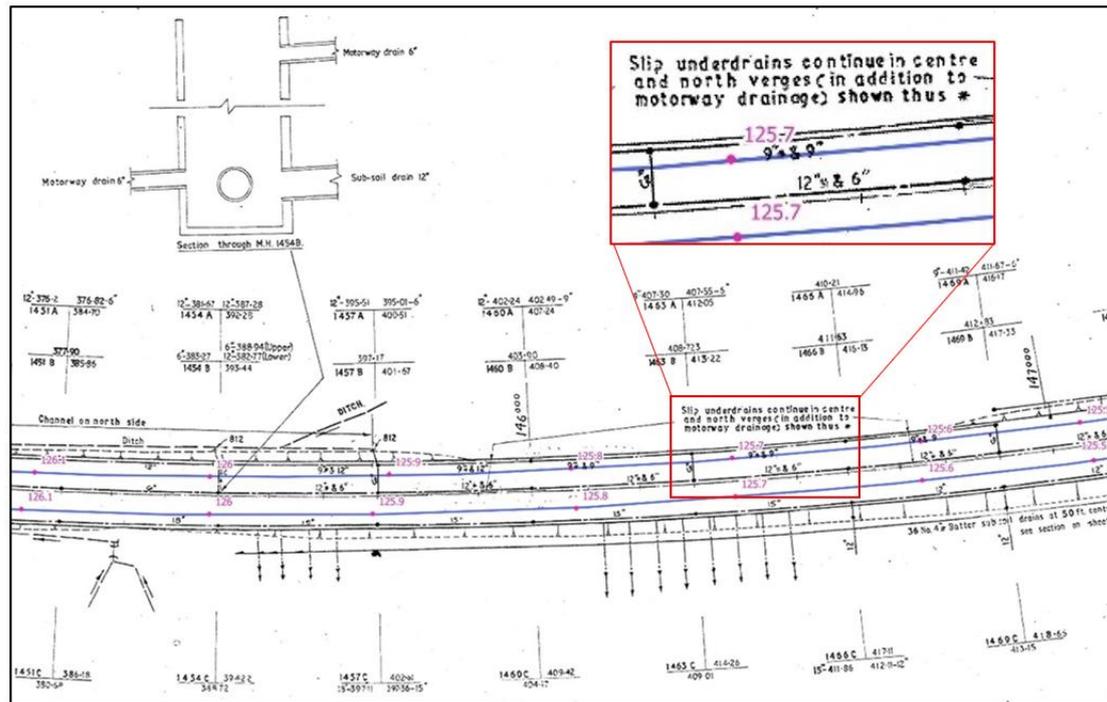
Figure 3 - Extract of drainage as-built drawing 3878/C2/069 (1972), with marker post layer overlay.

The asset inventory and condition on HADDMS is indicated as recorded based on existing as-built information. Existing as built record drawing 3878/C2/69 (extract on Figure 3, a copy of the drawing is provided with this document), clarifies that the paired pipes through the central reserve and eastbound verge comprise an upper motorway drain and a lower sub-soil drain, connecting an old landslip area to the east (Burdorpe Wood landslip) to the catchpit and ditch outfall at MP126.0 (and possibly MP125.9).

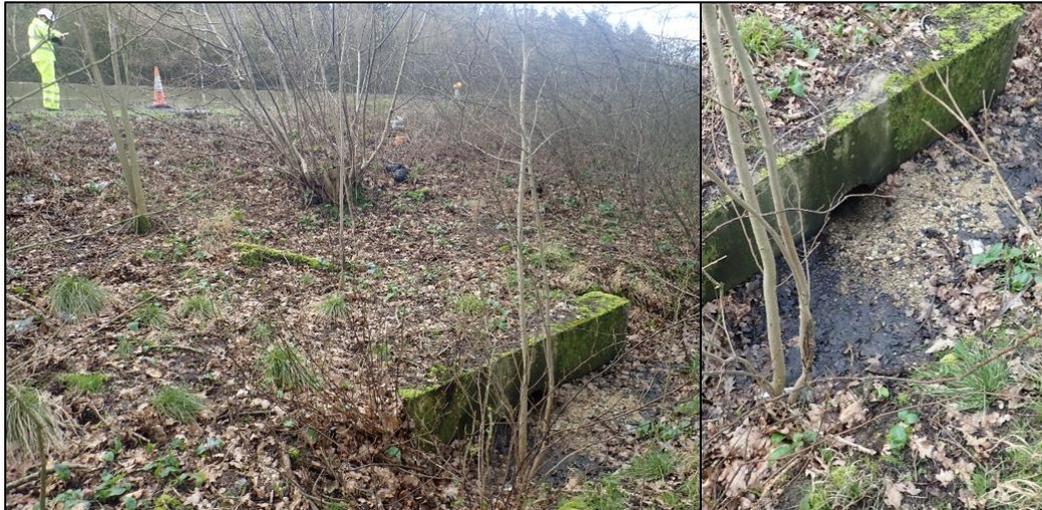
Recent site visits found significant debris accumulation at the outfall to the ditch at MP125.9 (Figure 4).

Figure 4 – View of embankment at MP125.9 EB. Debris accumulation at outfall (February 2020)
