# Preliminary Viability Investigation

Pendeen Community Cemetery

## 31 May 2018

Wheal Jane Consultancy Old Mine Offices, Wheal Jane, Baldhu, Truro, Cornwall, TR3 6EE 01872 560200 www.wheal-jane-consultancy.co.uk consultancy@wheal-jane.co.uk Ref: SI19416

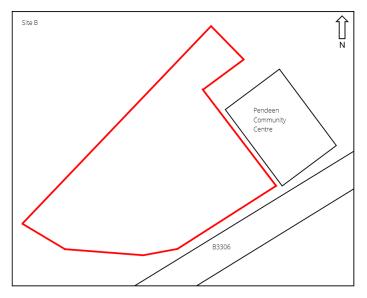
Figure 2.2: Current Site Layout for the preferred site option (Site B)

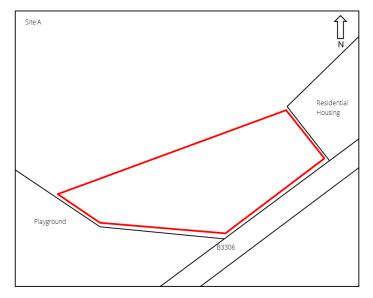
Figure 2.3: Current Site Layout for the second site option (Site A)
