Refurbishment Survey

Survey Reference Number: X-01062

Survey Date: 12 December 2017

9 Parsons Field
St Marys
Isles Of Silly
TR21 0JJ

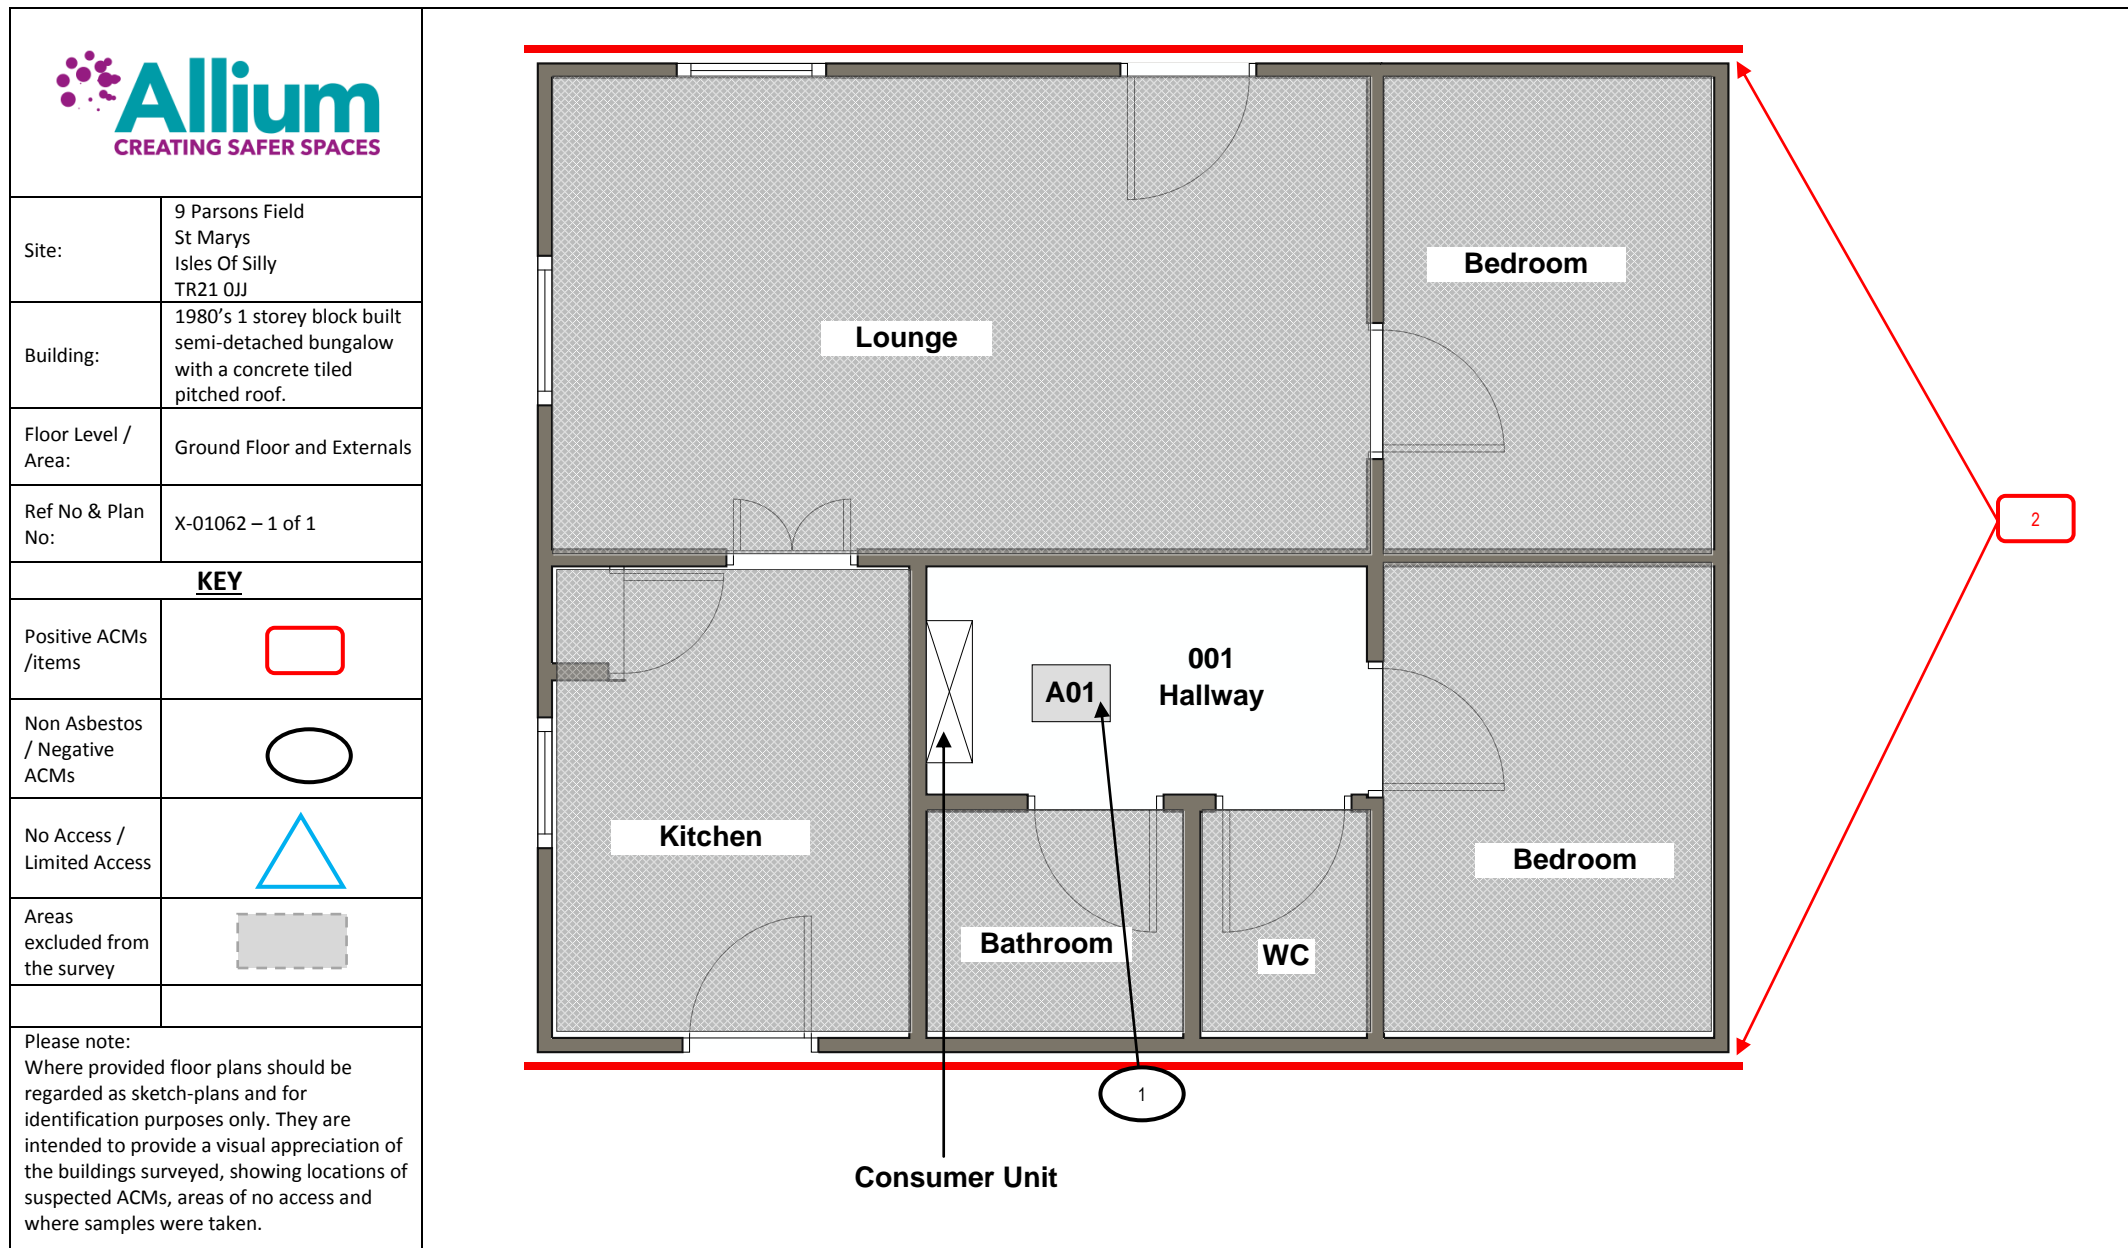
THIS PLAN SHOULD BE READ IN CONJUNCTION WITH THE MAIN BODY OF THE REPORT AND INDIVIDUAL ITEM RECORDS
