# **National Asset Delivery Technical Surveys and Testing**

## **569243 - A46 NB SB Sixhills Geotech – Water Erosion**

The contract is A46 NB SB Sixhills Geotech – Water Erosion

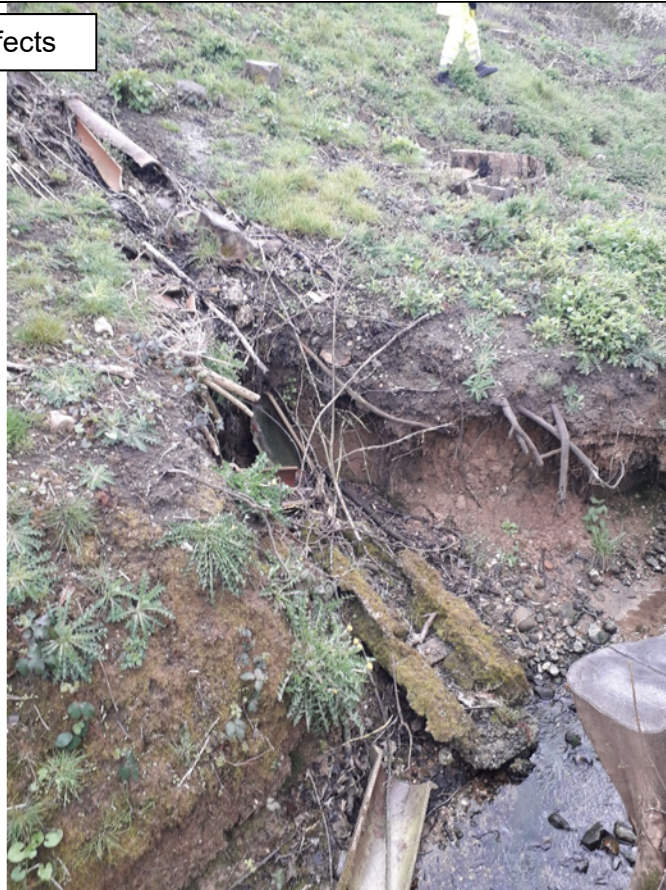
NB Defects

The northbound embankment hosts two significant earthwork defects. The first main defect relates to the defective drainage associated to the earthwork. A culvert outlet headwall has become undermined through water erosion due to the constant flow of a stream through the culvert that runs perpendicular to the earthwork, projecting the stream water directly onto the unlined ditch. Subsequently, the unlined ditch has become severely undermined on either side and resulted in the earthwork toe overhanging the ditch. The second main defect pertains to clay pipe drainage existing on the earthwork slope and has been subject to freeze-thaw over the years and shattered. The drainage water now flows out onto the earthwork toe and has resulted in a large gorge developing. The earthwork hosts geotechnical defects such as a soil bulge at the toe of the slope and substantial subsidence across the earthworks mid slope. It is not yet conclusive whether these defects have developed due to the defective drainage associated to the earthwork. Dense vegetation obscures the earthwork making the full extent of the defects uncertain.

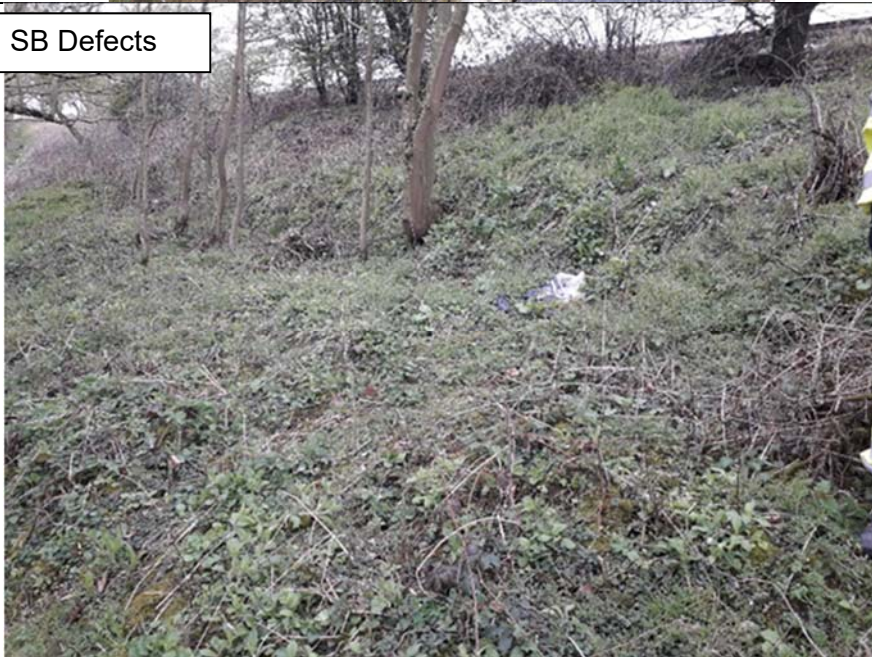
SB Defects

The southbound embankment hosts two significant earthwork defects. Both defects consist of large 1m soil slips near the crest with the addition of tension cracks, animal burrows and soil bulging. The defects are located in close proximity to the culvert, which has caused issues on the northbound earthwork, and has therefore raised questions as to whether the southbound earthwork is in a similar condition which can only be investigated once vegetation is cleared. Historic observations of an “undermined pipe” have been recorded on the earthwork but could not be elaborated upon or confirmed whether it relates to the culvert inlet due to dense vegetation. There are also a number of observations relating to water erosion channels down the earthwork face.
