Drawing Title
**Works to Shelter
Alexandra Gardens
Play Park**

Project
**Penzance Town Council
Condition Surveys
Remedial Works**

Drawn RH	Drawing No. 2622 EX08
--------------------	---------------------------------

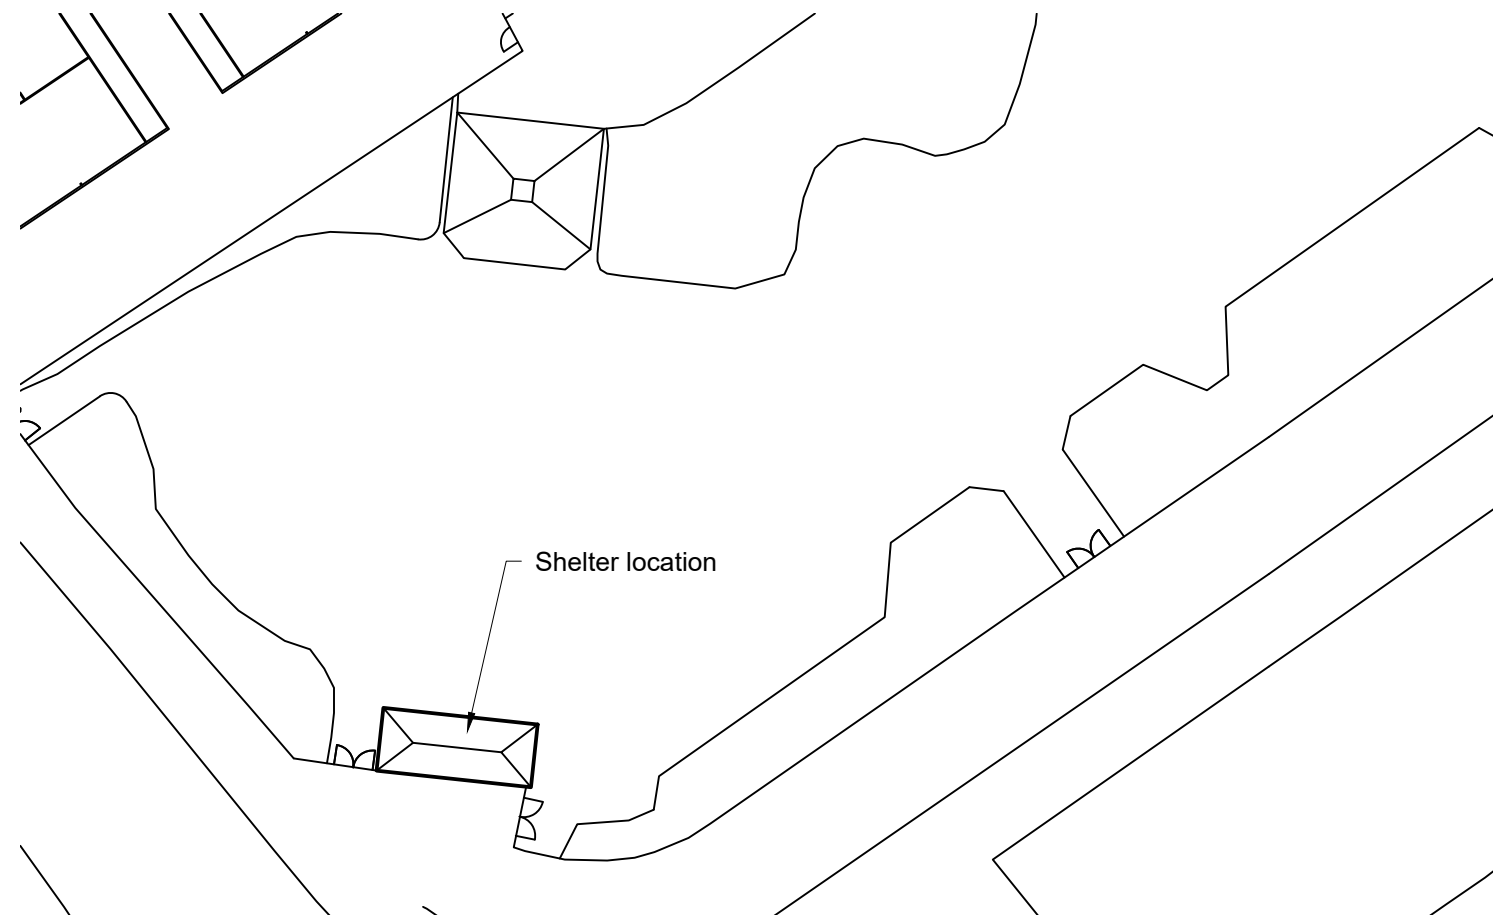
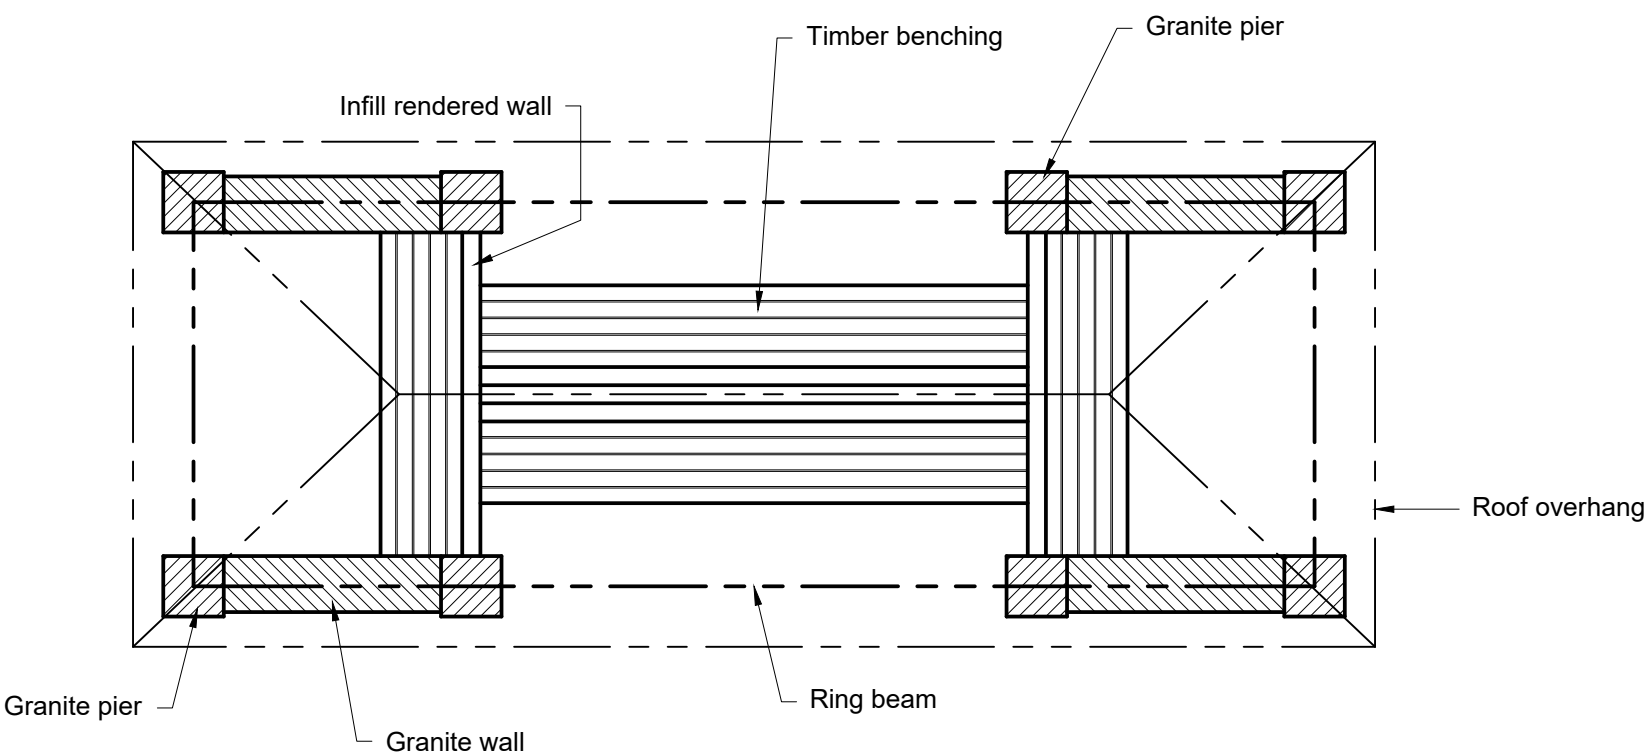
Generally the structure appears to be in reasonable condition with minor repairs visible at the time of survey.

The granite walling is in need of repair with loose mortar joints. This is possibly due to roof movement over time. We believe that at some point the roof void was boarded over to enclose the space. As such visual inspection of the roof structure is difficult and therefore the Contractor shall open out the timber boarded ceiling to enable inspection of the roof trusses and purlins. This shall be carried out on the northern side first to gauge the condition prior to any further opening works.

The roof is covered in places with algal moss growth and this should be removed with a mix of mechanical removal (scraping / pressure washing) and a gentle soft wash method using a moss killer biocide. Prior to handover the Contractor shall reapply the moss killer biocide to ensure complete coverage and to minimise the risk of spore growth.

The granite piers are generally in good condition with a few areas showing displaced mortar. This is most obvious where the roof ring beam structure passes through and the mortar bedding has moved and fallen out.

Once opened the Contractor shall inform the engineer who will visit site to inspect the structure.

The Contractor shall allow for reinstating the ceiling boarding to enclose the roof void after any inspection / works are carried out.

The Contractor shall inspect the piers and remove any loose mortar and replace with new similar coloured mix to suit the existing mortar.

Pointing between stones shall be repaired where necessary with the mortar trowelled and finished to leave a smooth finish.

The lower dwarf walls shall be pressure washed and wire brushed to remove any loose material and paint. They shall be repainted in black using a quality masonry paint such as Dulux Trade Weathershield Smooth Masonry Paint in black.

The structure shall have its woodwork refreshed. This shall include the roof structure, boarding and bench seating. The Contractor shall carefully remove any loose or flaky paint by scraping and sanding to leave a sound smooth substrate.

The woodwork shall be painted with 2 coats of Dulux Trade Weathershield flexible undercoat and finished off with 1 coat (minimum to achieve even coverage) of Dulux Trade Weathershield Gloss in RAL 6005 Moss Green.
