C129/JULY/2017

STRUCTURAL INSPECTION

**AT
JANE PIT, MOSSBAY ROAD, WORKINGTON**

**FOR
WORKINGTON TOWN COUNCIL**

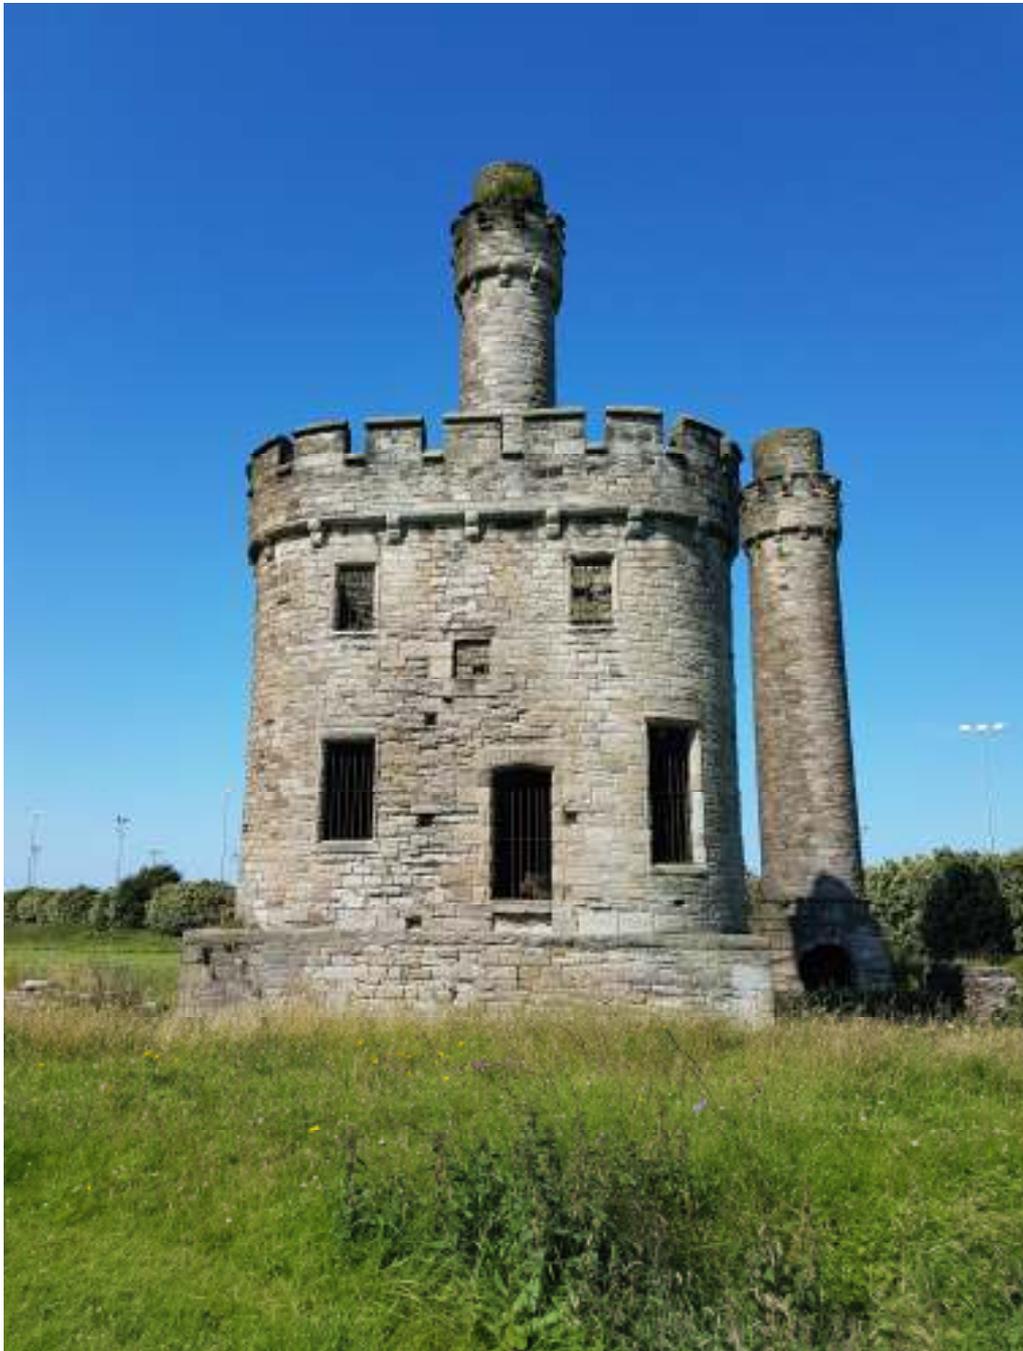
4.2 East elevation presenting to Mossbay Road

The elevation is reasonably plumb throughout.

The central castellation upstand in the parapet arrangement leans out slightly.

At each end of the main curved structure above plinth level, the masonry and pointing is generally in good order. Throughout the centre of the elevation, for the majority of its height, there is extensive spalling of the masonry units which appears to be associated with the inappropriate pointing of the masonry in an Ordinary Portland Cement (OPC) based mortar.

There is severe weathering of the lintel member of the small high level central window opening.

There is spalling of the jamb stones forming the lower left hand window opening at the right.

Below the cill of the large lower window opening to the right of centre there is spalling of the facing masonry to reveal rubble masonry inner stonework.

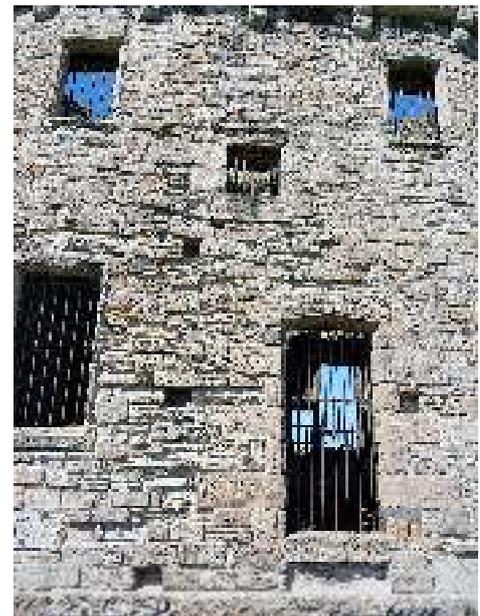
There are a number of missing masonry units (6No significant units) – see photograph right.

The quoined corners of the lower rectangular plinth arrangement are generally in good order with only localised spalling of masonry. Down the centre of the elevation within the lower plinth there is spalling of the masonry facing. There is evidence of re-pointing with ordinary Portland cement mortar and the spalling may be associated with this poor practice.

There is extensive (more than 20% of the total area) shaling and spalling of masonry. The worst areas include the center of the East Elevation and in the North West corner. Much of this appears to be the very poor practice of pointing the historic lime mortar bedded masonry with brittle OPC Mortar. Much of the masonry facing loss will not be compromising the integrity of the elevations as a whole but where loss exceeds 50mm depth this is clearly undesirable. From an aesthetic view point, replacing areas where the depth of spalling exceed 50mm and leaving others would be undesirable. Consequently, our advice would be to treat all areas where spalling exceeds 50mm depth locally. Where local areas of spalled masonry (less than 0.25m²) exist, these can remain without remediation unless Client budget permit the replacement of all spalled masonry. All remediated areas should include the removal of any OPC Mortar pointing, cutting out shaled or spalled masonry, replacing missing masonry units and making good with new masonry in lime mortar beds to match the surrounding elevation.

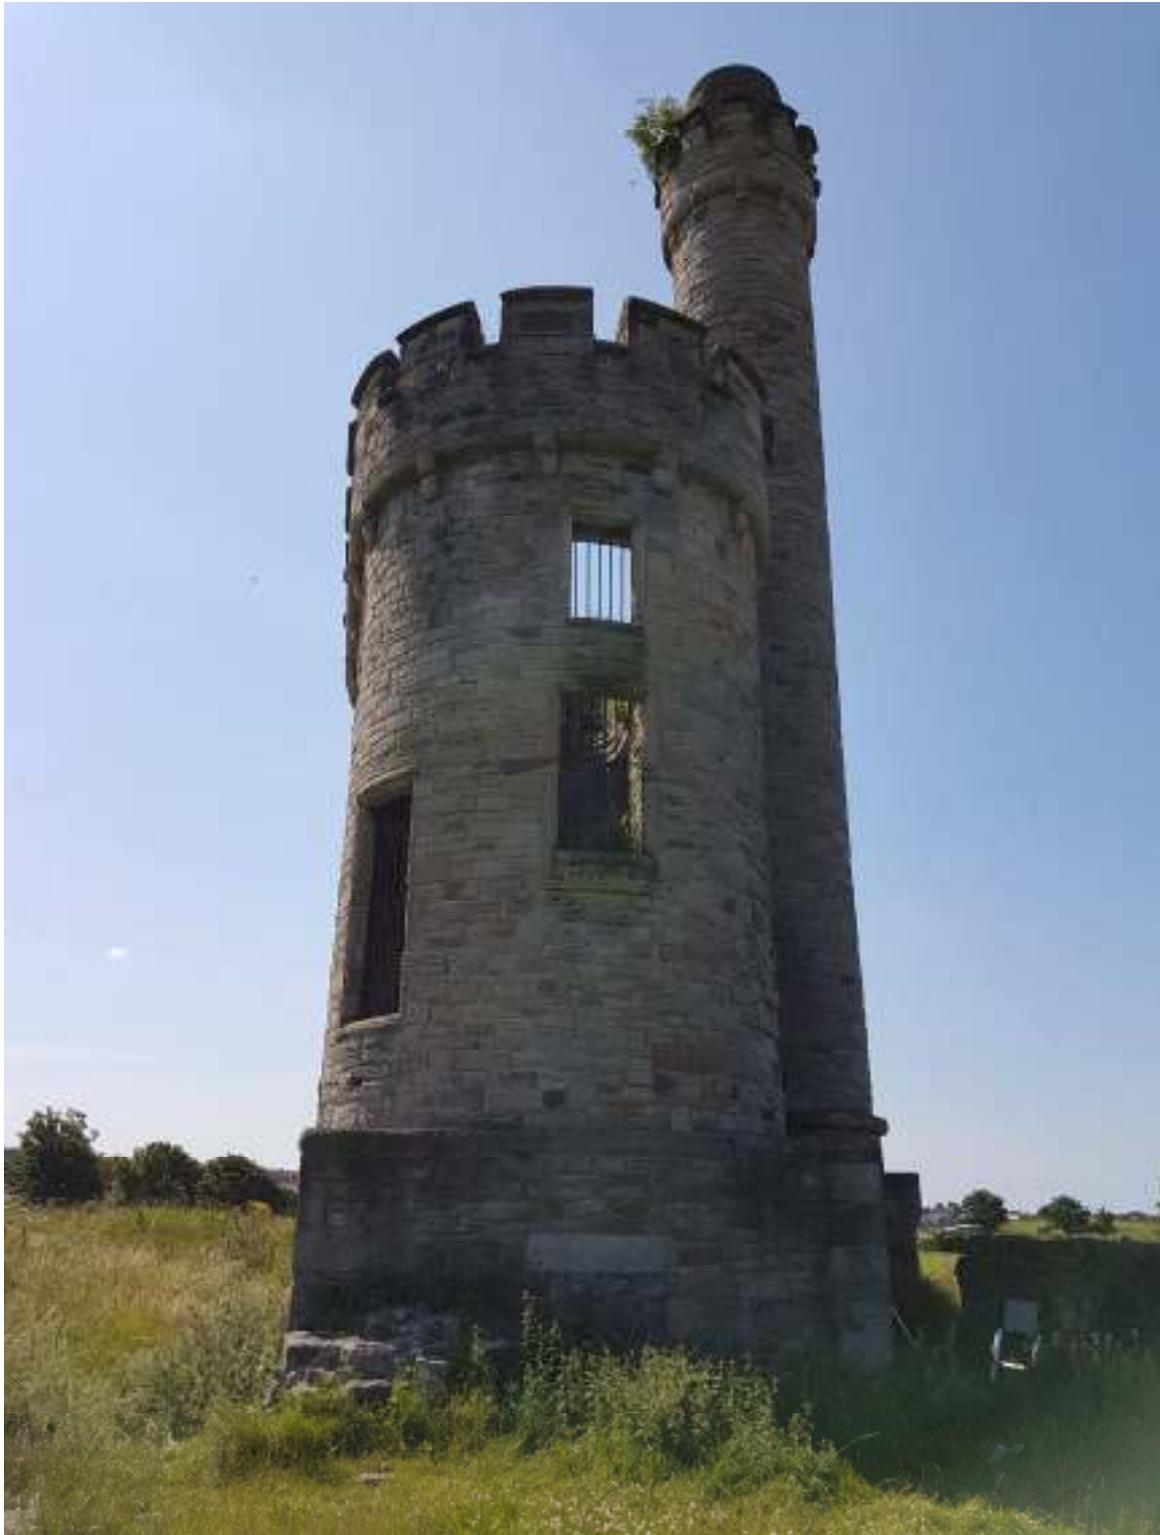
4.3 North elevation

There is an in-filled window opening at the base of the plinth structure at the base of the elevation with a dressed lintel over, in-filled to a poor quality with rubble masonry in OPC mortar beds.

There is a rope tied around the castellation upstand to the left of centre.

There is a missing masonry unit just above the base plinth level at the approximate right hand quarter point of the curved elevation.

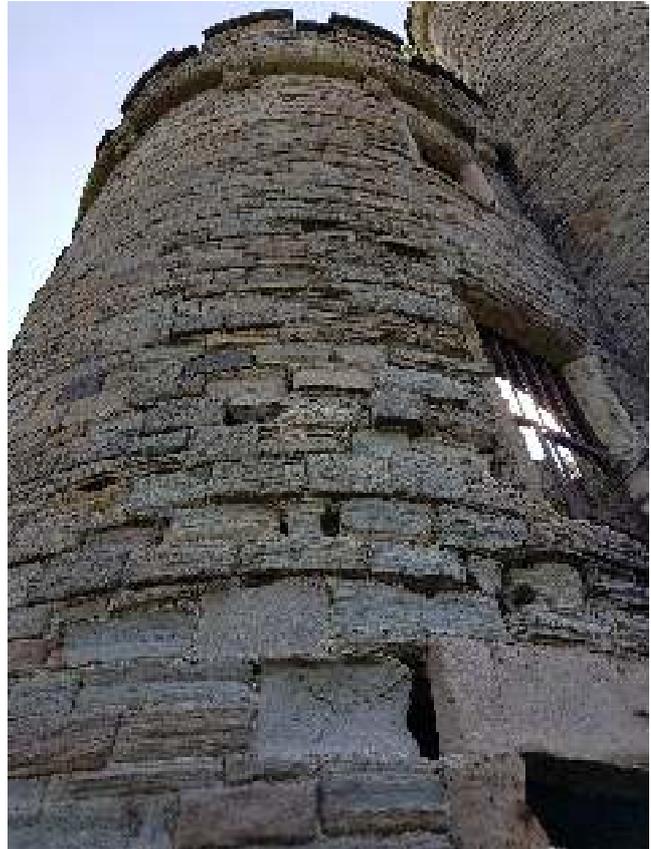
The masonry in the curved main structure is generally in good order towards the centre and left but at the right running into the West elevation there is extensive spalling of the facing of the dressed stone masonry which appears to be associated with the poor practice of re-pointing in OPC mortar. The spalling includes almost complete loss of the thickness of some of the masonry facing units, particularly at low level resulting in holing of the elevation as shown in the photograph - right.

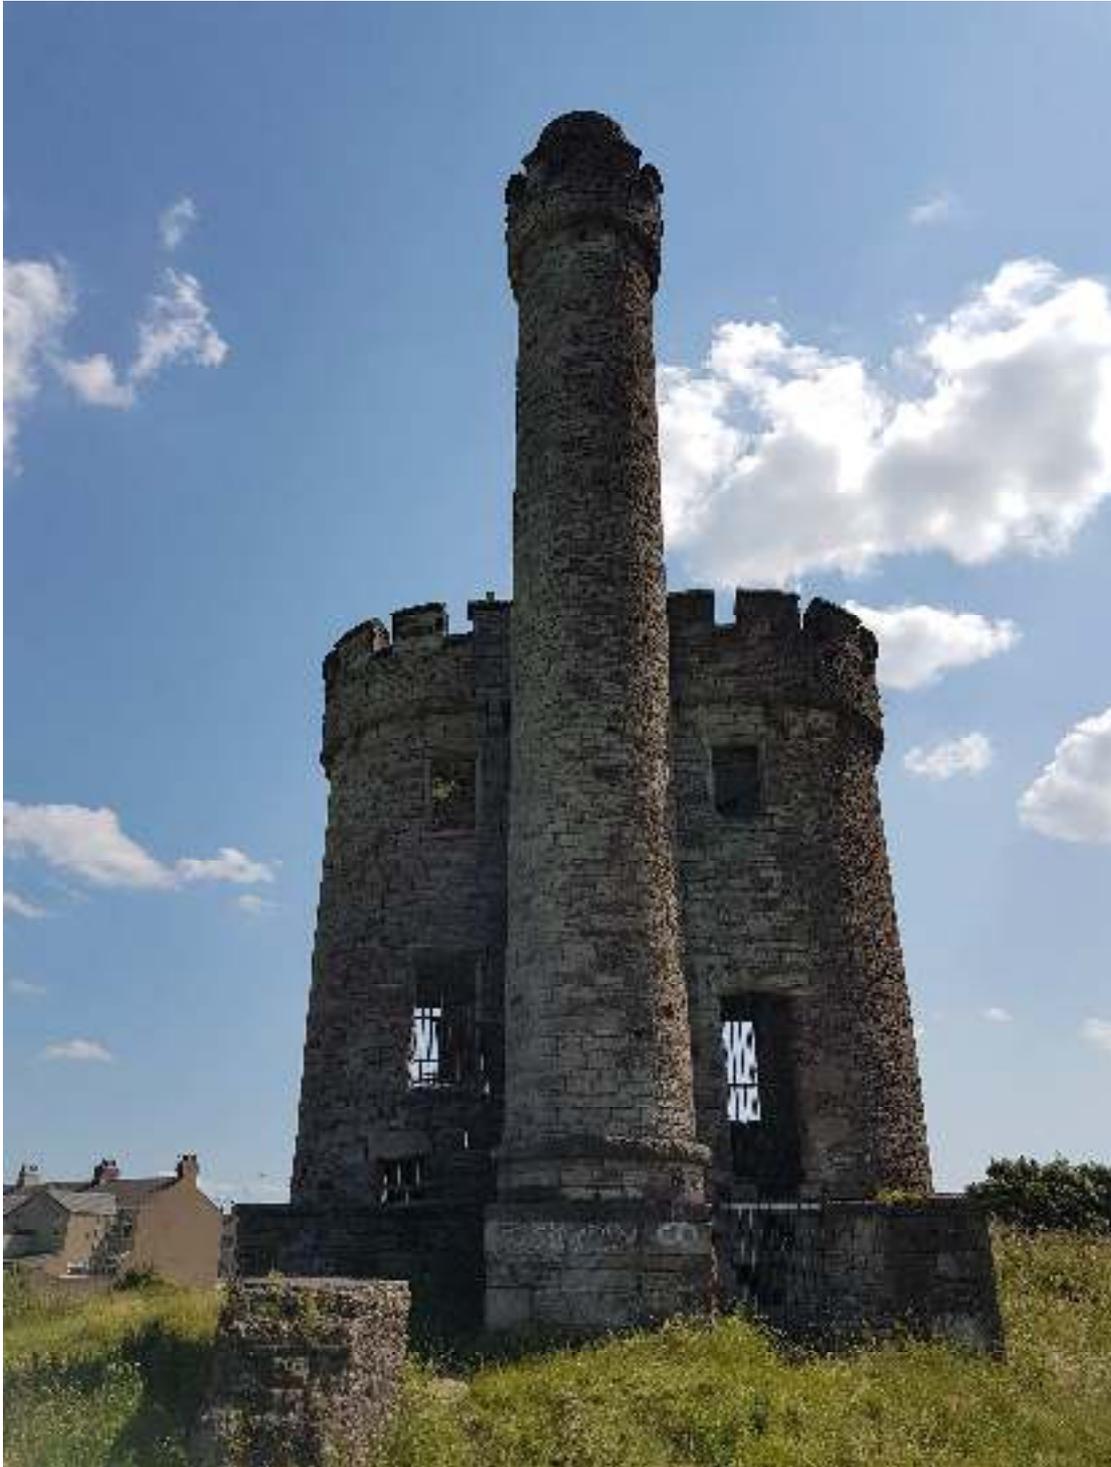
4.4 West elevation presenting towards the Irish Sea and including a tall central circular/semi-circular tower stack at the centre

To the left of the central tower stack structure the elevation of the main structure is severely weathered with spalling masonry and to the right of the large lower window opening there is complete loss of masonry with the lower right hand jamb stone standing as an independent column supporting the central quoin stone and masonry above. The defect is a continuation of that noted to the right of the North elevation. The holing of the masonry to the right of the lower ground floor window is being guarded with mild steel strapping. There is cracking and dislodgement of masonry above and right of the lower large ground floor window probably associated with loss of masonry below. Below the area of missing masonry, below and right of the lower window opening there is a missing masonry unit.

A fire has been lit in the corner between the elevation and the central tower stack at the left which has charred and blackened the stonework. In addition there is Graffiti on the elevation.

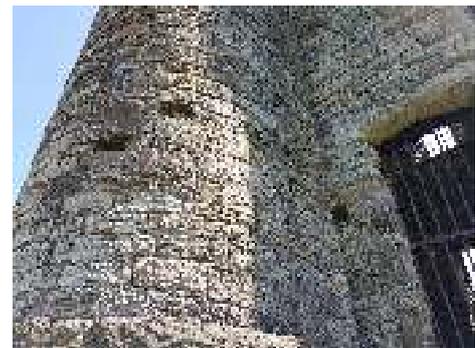
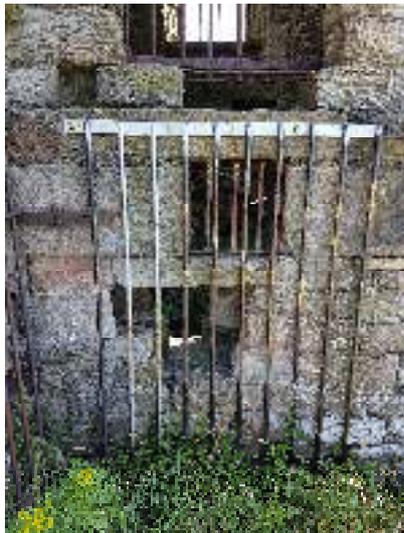
There are 4No missing masonry units towards the right of the tower stack and in the main structure at the right – see photograph right.

In the plinth structure to the main building to the right of the tower stack there is holing in the wall due to missing masonry and this has been covered by steel railings as per the photograph below. There is further missing masonry to the left of this in the base of the tower stack.

There is a crack estimated less than 5mm wide through the lintel of the right hand upper window opening. Above this, a steel rod projects from the elevation and the crack damage may be associated with expansive corrosion of this. There is cracking above the window running up into the parapet corbel arrangement.

There is a crack through the lintel over the West elevation, upper right hand window. There is a steel rod above this which must be removed. The lintel should be repaired in accordance with the attached specification including bonding the crack and introducing an epoxy resin bonded stitch bar installed into a discreet chase cut under the soffit of the lintel (see image below). The crack above should be repaired also in accordance with the Specification incorporating stitching.

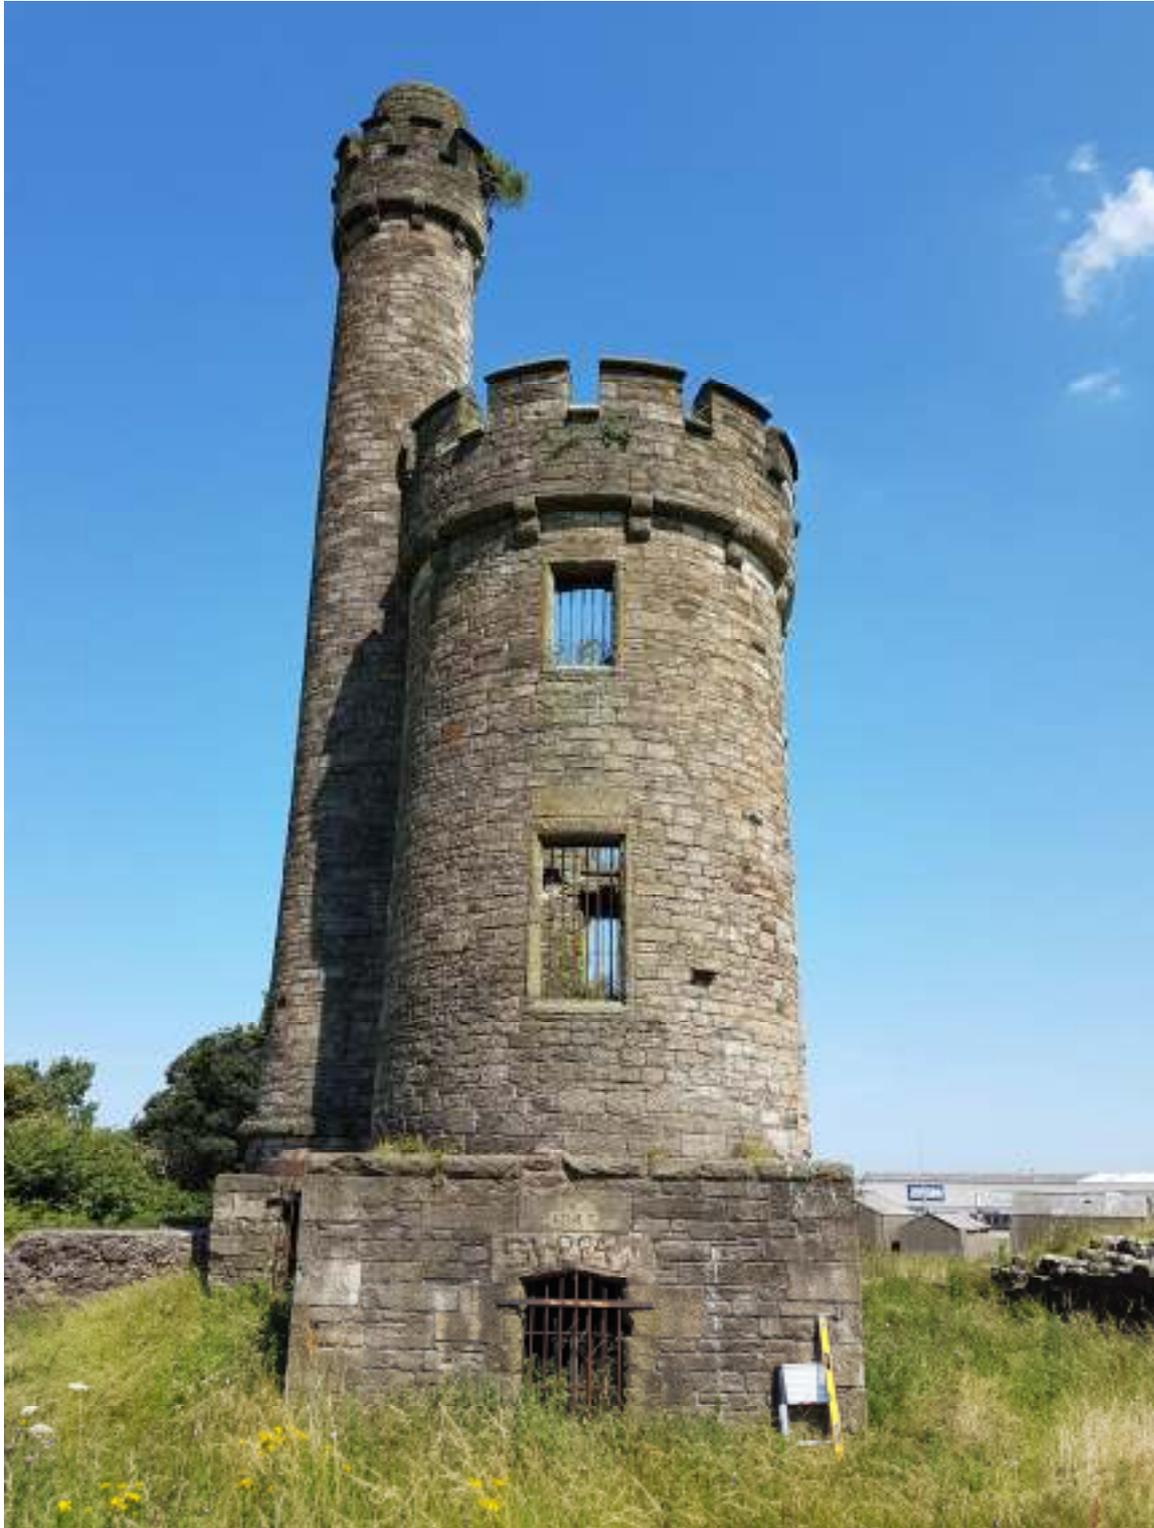
4.5 South elevation

There is a missing masonry unit at the right quarter point just above the lower window cill level.

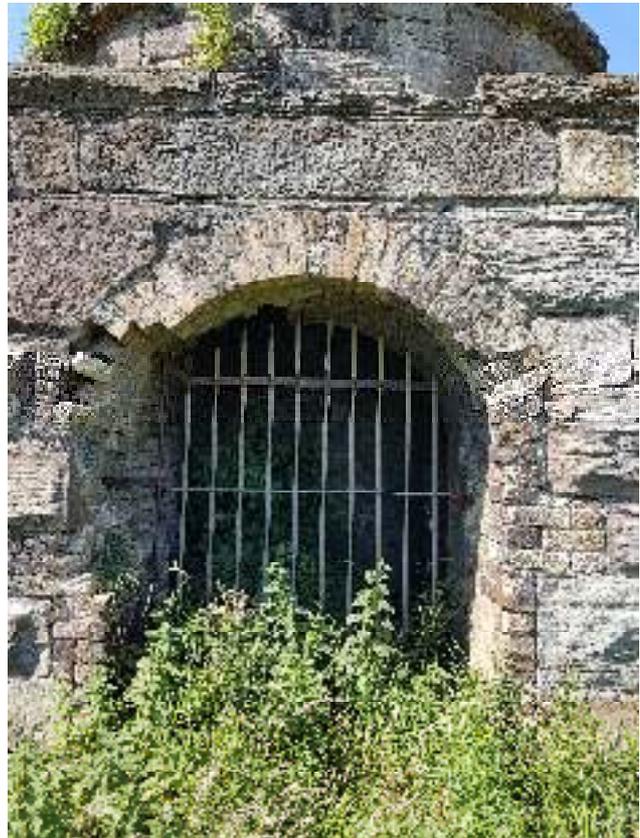
There is an opening with steel rail protection in the East elevation formed by a clay brickwork arch. The arch masonry has spalled towards the right and there is total loss towards the left as per the photograph right. There is no access internally however, the stack can be seen to be lined in clay brickwork masonry.

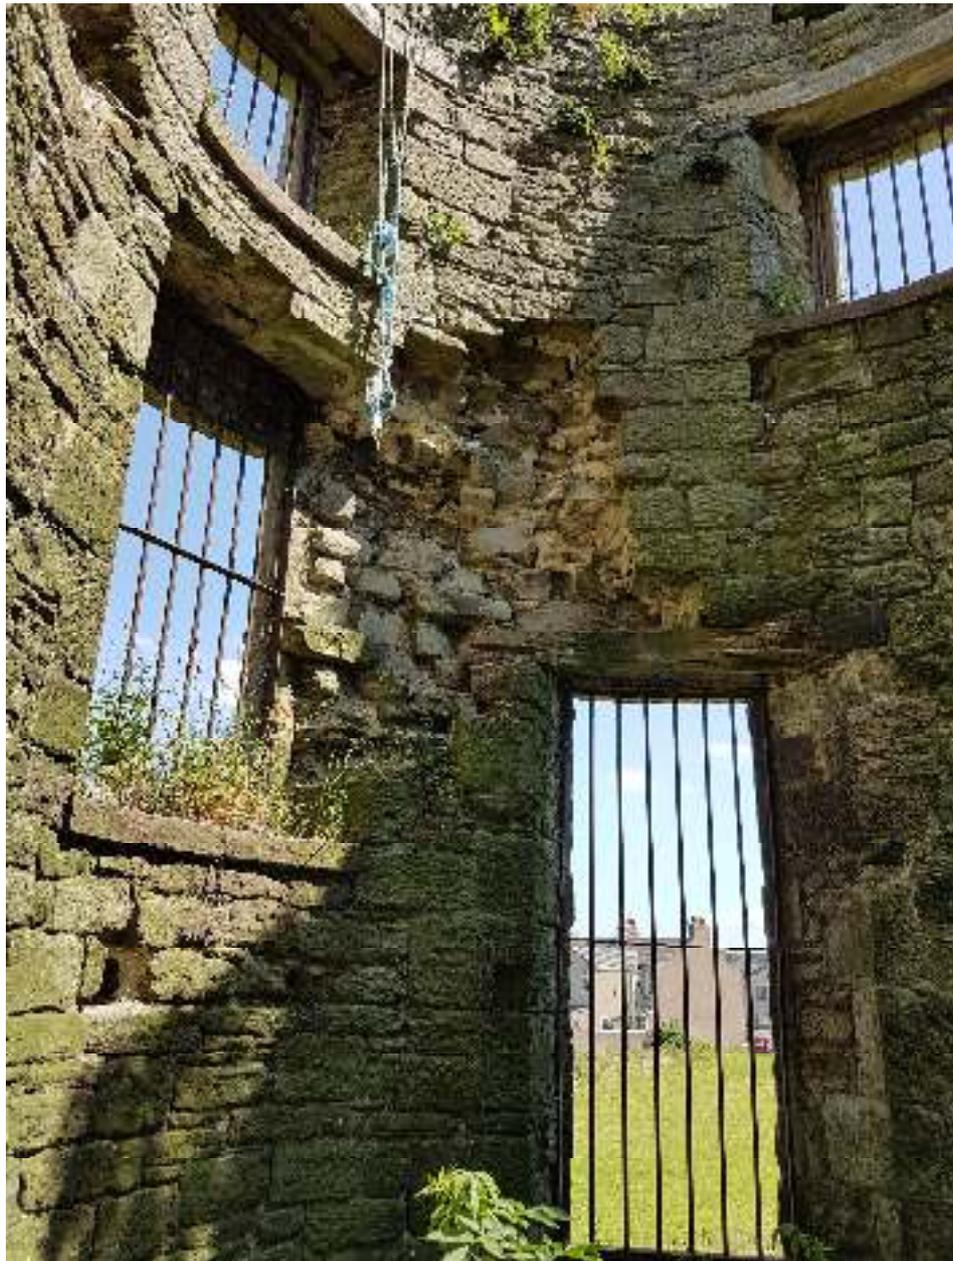
In the North elevation infestation in the North window opening to the East elevation and loss of the lintel over the lower window to the North elevation has resulted in localised collapse of the inner leaf of masonry covering an area estimated to be approximately 4m²- see Photograph below.

Due to exposure to the elements, the originally internal timber lintels have been exposed to (often inclement) West Cumbrian weather. The lintels are probably Oak, but none the less several are suffering from infestation and a few have been totally lost resulting in masonry collapse. We would recommend that the areas of localized collapse be reinstated to ensure the long term stability of the fabric of the structure. This should include:-

- a) Temporary propping and safe access provision as necessary
- b) Removal of loose masonry to form solid bases
- c) Building in dressed or rubble sandstone masonry in lime mortar beds to infill areas of lost masonry – width and style to match the existing. The reconstruction process should include for stainless steel fixed, stainless steel remedial wall ties all in compliance with BS EN 1996-2:2006.
- d) Replacement of all lost or infested timber lintels with new treated Oak members to match the original elements.
- e) Final pinning of unsupported masonry onto the new fabric should be a pressure pointing with lime putty.

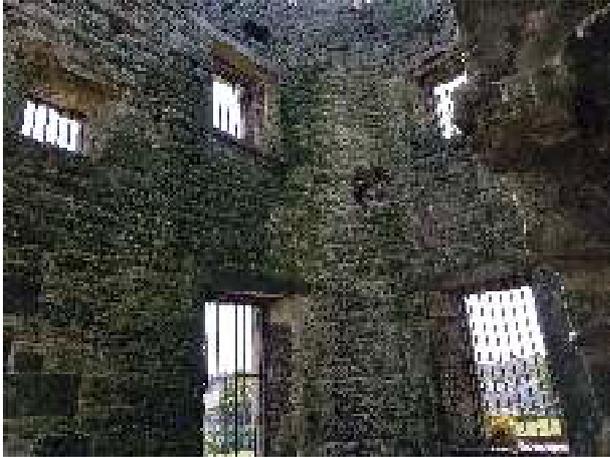
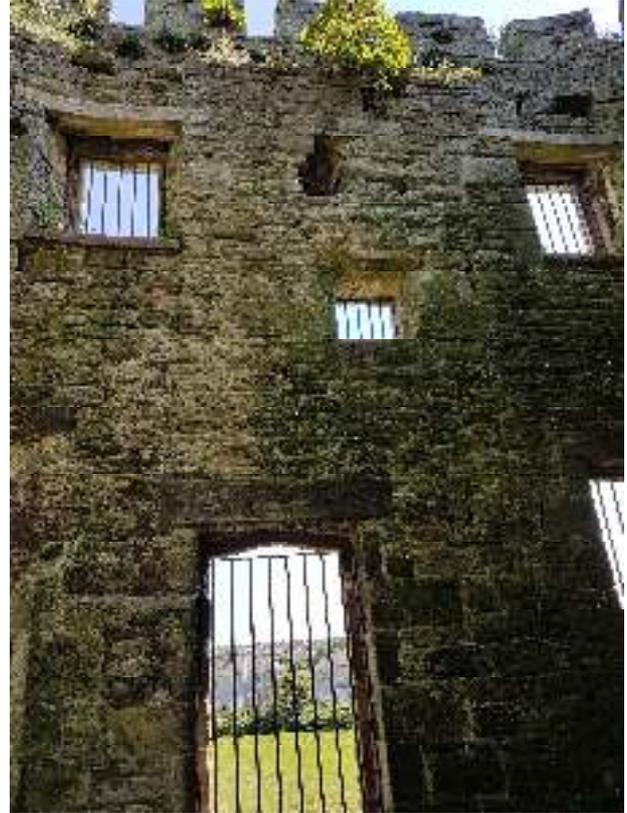
There are localised areas of missing masonry in the East and South elevation on the line of the inner leaf each being less than 1m^2 as per the following photographs.

The castellated parapet arrangement at the head of the wall is substantially thinner than the main wall itself resulting in a significant ledge at the base of the parapet and there is extensive vegetation growth including small saplings as shown by the photograph right.

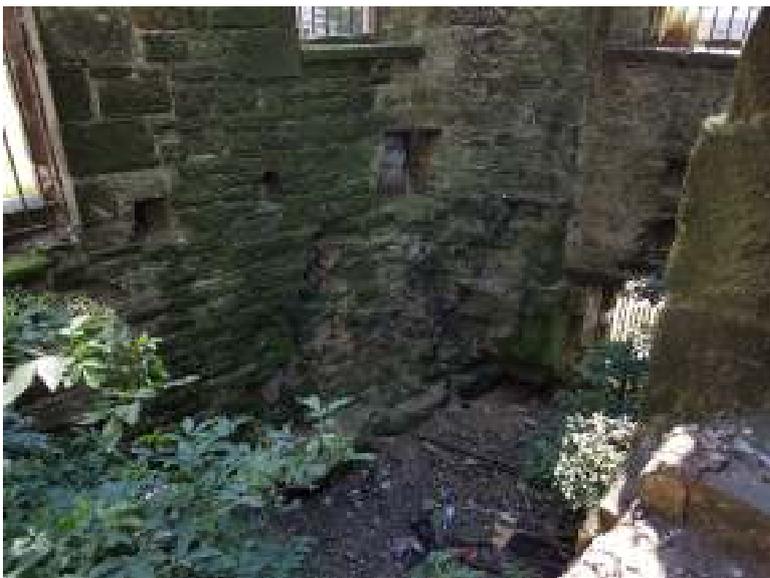
There is vegetation including sapling growth and litter in the base of the main structure which hampered the limited inspection available at low level. Notwithstanding, in the South East corner there is an area of poor quality rubble masonry extending over an area estimated to be approximately 4m^2 including corbelling out of the dressed stone masonry to the left as per the following photograph.

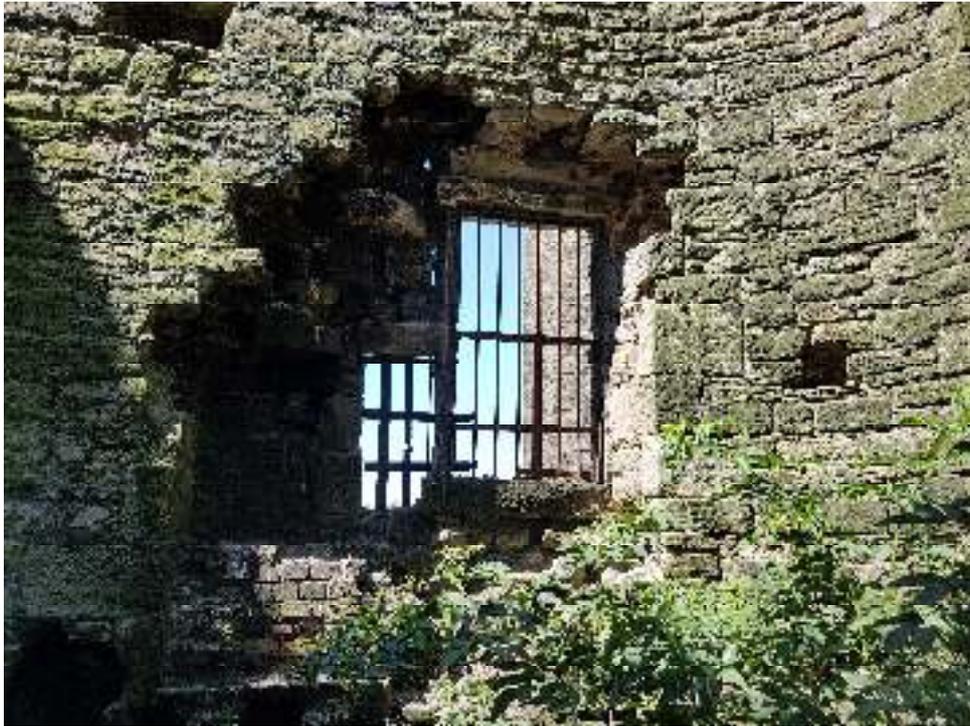
At the internal face of the lower substantial window opening in the West wall, there is significant loss of masonry covering an area estimated to be 2.5m wide by 3m high maximum. This includes the significant loss of masonry noted from the West elevation where the window jamb stone is acting as an independent column. The original timber lintel over this window has been lost resulting in the masonry collapsing and arching above. To the left of the window when viewed internally is an original fire with the flue leading to the main stack. The destabilisation of masonry between the fire and the adjacent window forms part of the masonry loss – see photograph below.

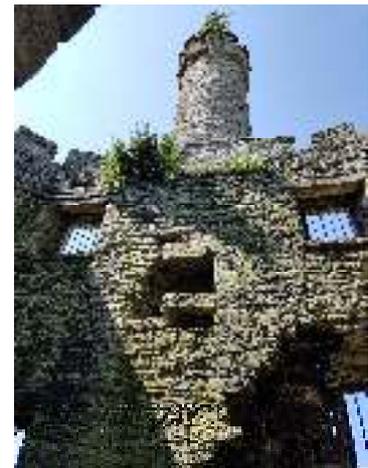
In the West elevation adjacent to the main tower stack at high level, there is a substantial opening in the wall with a partially un-supported lintel arrangement possibly forming a fireplace of some kind. This is forming a void estimated to be approximately 1m². Depending on the historical importance of this opening, it either needs infilling or restoring to the original arrangement to ensure stability of the masonry. The opening is shown on the photograph right.
