TASK NO.	TASK/DESCRIPTION	NOTES
H7.04	<p data-bbox="694 295 933 353">H7 BILGES</p> <p data-bbox="411 387 992 421"><b>Bow Door and Vehicle Ramp Compartment</b></p>

TASK NO.	TASK/DESCRIPTION	NOTES
	H8 INTERNAL DECKS, DOORS AND LADDERS	
H8.01	<p data-bbox="403 387 815 421"><b>Internal Training Door Frames</b></p> <div data-bbox="403 439 1201 882">

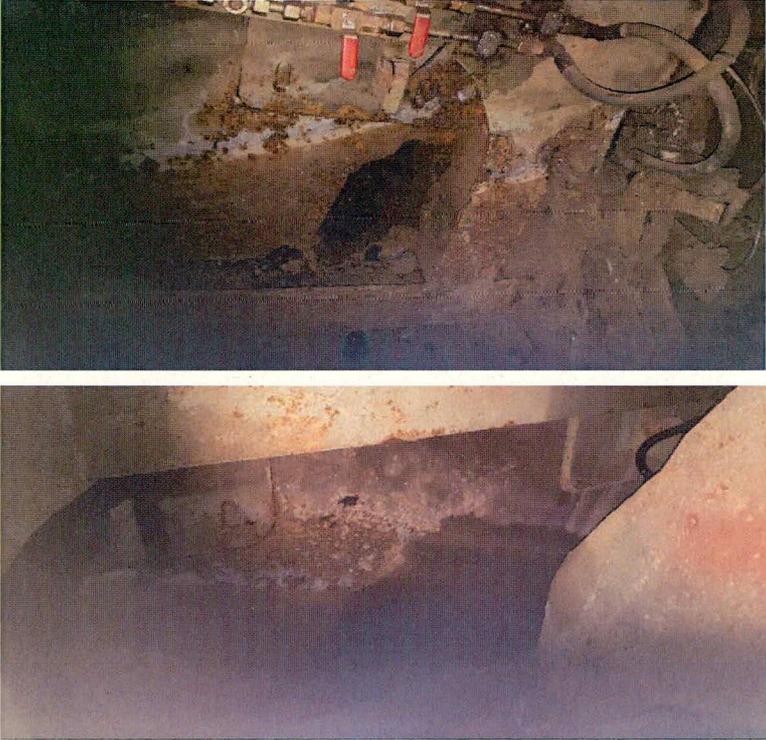
<p data-bbox="411 1191 1252 1310">Although dry at time of visit, evidence of previous free standing water in bilge of compartment which has lead to total breakdown of bilge coatings resulting in active corrosion. Bilges to be cleaned and dried to allow for scaling back, preparing and REPRESENTATION of affected areas.</p> <p data-bbox="411 1321 853 1355">ALLOW for 20m<sup>2</sup> REPRESENTATION.</p>	<p data-bbox="1252 392 1452 504">IAW Paint scheme -General 12 and Annex B refer.</p> <p data-bbox="1252 537 1412 649">Contractor to remove and dispose of all arisings.</p> <p data-bbox="1252 683 1452 851">Adequate ventilation to be arranged before work commences IAW General 3.2.</p>

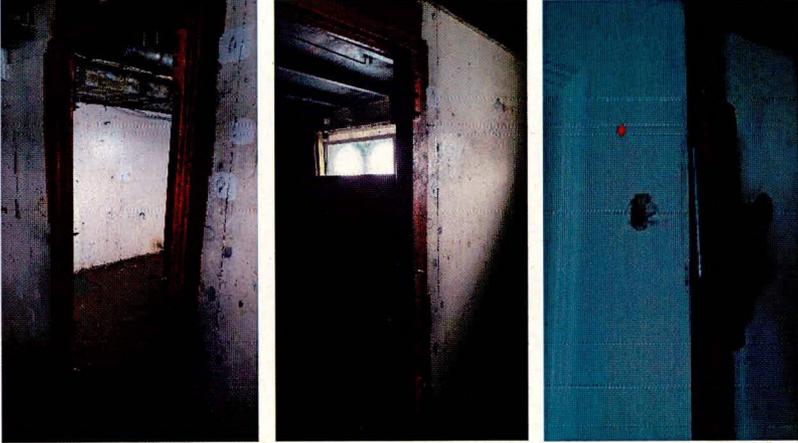
</div> <p data-bbox="403 898 1214 1095">Manufacture and RENEW 15 doorframes, and manufacture 5 further as spares. These door frames are fitted to the temporary bulkheads which divide the galley area into training zones. Each frame is used to easily hang a standard 176mm x 198mm x 35mm internal door which normally only lasts as long as each training session. The steel frames have themselves now been damaged after repeated use and require RENEWAL.</p> <p data-bbox="403 1106 1214 1229">The existing frames are manufactured from 2 sizes of mild steel square section to produce the outer frame and inner door stop. On the hinge side there are 2 clamp plates which allows a standard hinge to be quickly secured. The doors are secured shut by a simple rotating latch.</p> <p data-bbox="368 1234 1214 1290">All frames and surrounding area to be PRESERVED in red paint as shown.</p> <p data-bbox="403 1301 847 1335">ALLOW for 10m<sup>2</sup> REPRESENTATION.</p>	<p data-bbox="1249 387 1453 562">Hotwork Required – Appropriate precautions to be taken iaw General 8.4.</p>

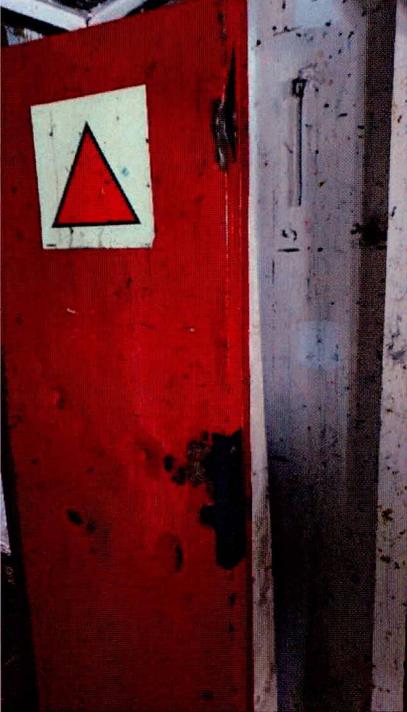
TASK NO.	TASK/DESCRIPTION	NOTES
	H8 INTERNAL DECKS, DOORS AND LADDERS	
H8.02	<p data-bbox="408 389 584 421"><b>Galley Doors</b></p>

<p data-bbox="408 1171 1214 1279">The main steel galley access doors (x3) have been damaged and the latching mechanism no longer functions correctly. Doors to be REFURBISHED. If unable to repair then new doors to be supplied and RENEWED.</p>
