## Pre Refurbishment Survey

Site:	Ocklynge Cemetery, 3 Willingdon Road, Eastbourne, BN21 1TL
Client:	Eastbourne Borough Council
Report No:	J002516
Survey Date:	8th July 2014
Report Date:	14th July 2014
Surveyors:	Paul Veness
<b>Report Produced By:</b>	<b>Report Reviewed By:</b>

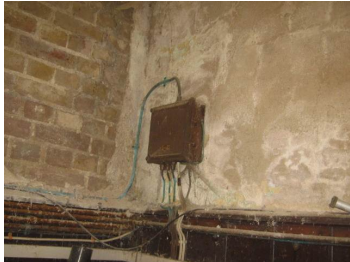
<p>Picture 1</p>
Strongly Presumed	grounds keeper's building	Ground Floor	possible rope materials	room 1 / old fuse boxes	<1m	Bonded	Metal	(1) Chrysotile	
Recommendations					Assessment Scores			Risk Code	
					Material	Priority	Total		
Low risk ACM (bound in matrix) remove, repair or encapsulate under controlled conditions. Work on this material does not require a license. Work on this material may be notifiable to the appropriate enforcing authority. Disposal of asbestos waste by a licensed contractor only. All work must conform to the 'Control of Asbestos Regulations 2012'.					5			C	
Reinspection Due		12 months	Actions Taken		Time Scale			Action Completed Sign & Date

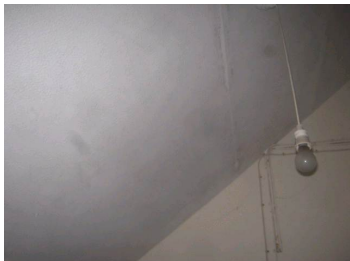
<p>Picture 2</p>
BE001633	chapel	Ground Floor	textured coating	vestry / pitched ceiling	10m <sup>2</sup>	Nailed	Timber	(1) Chrysotile	
Recommendations					Assessment Scores			Risk Code	
					Material	Priority	Total		
Low risk ACM (bound in matrix) remove, repair or encapsulate under controlled conditions. Work on this material does not require a license. Work on this material may be notifiable to the appropriate enforcing authority. Disposal of asbestos waste by a licensed contractor only. All work must conform to the 'Control of Asbestos Regulations 2012'.					4			D	
Reinspection Due		12 months	Actions Taken		Time Scale			Action Completed Sign & Date

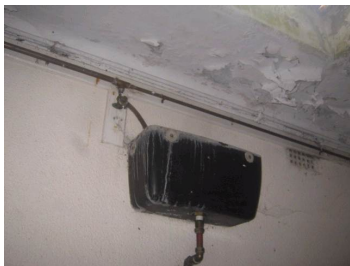
<p>Picture 3</p>
BE001634	toilet block	Ground Floor	toilet cistern	male toilet / above urinal	1m <sup>2</sup>	Bolted	Brick	(2) Amosite	
Recommendations					Assessment Scores			Risk Code	
					Material	Priority	Total		
Low risk ACM (bound in matrix) remove, repair or encapsulate under controlled conditions. Work on this material does not require a license. Work on this material may be notifiable to the appropriate enforcing authority. Disposal of asbestos waste by a licensed contractor only. All work must conform to the 'Control of Asbestos Regulations 2012'.					4			D	
Reinspection Due		12 months	Actions Taken		Time Scale			Action Completed Sign & Date

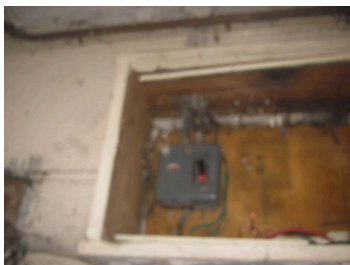
<p>Picture 4</p>
Strongly Presumed	toilet block	Ground Floor	possible rope material	male toilet / fuse box	<1lm	Bolted	Metal	(1) Chrysotile	
Recommendations					Assessment Scores			Risk Code	
					Material	Priority	Total		
Low risk ACM (bound in matrix) remove, repair or encapsulate under controlled conditions. Work on this material does not require a license. Work on this material may be notifiable to the appropriate enforcing authority. Disposal of asbestos waste by a licensed contractor only. All work must conform to the 'Control of Asbestos Regulations 2012'.					5			C	
Reinspection Due		12 months	Actions Taken		Time Scale			Action Completed Sign & Date

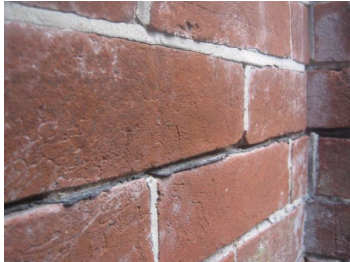
<p>Picture 5</p>
BE001635	toilet block	External	bitumen DPC	external elements / low level walls	36lm	Bonded	Brick	(1) Chrysotile	
Recommendations					Assessment Scores			Risk Code	
					Material	Priority	Total		
Low risk ACM (bound in matrix) remove, repair or encapsulate under controlled conditions. Work on this material does not require a license. Work on this material may be notifiable to the appropriate enforcing authority. Disposal of asbestos waste by a licensed contractor only. All work must conform to the 'Control of Asbestos Regulations 2012'.					2			D	
Reinspection Due	12 months	Actions Taken			Time Scale			Action Completed Sign & Date

20	BE001635	toilet block	External	1	external elements	bitumen DPC low level walls	36lm	Bonded, Brick	(1) Well Bound Material	(0) Good Condition	0	(1) Chrysotile	2	D
21	BE001636	toilet block	External	1	external elements	hot poured asphalt roof	60m <sup>2</sup>	-	-	-	-	(0) No Asbestos Detected	-	
external elements : slab roof, bare brick walls, original timber door frames, timber door heads

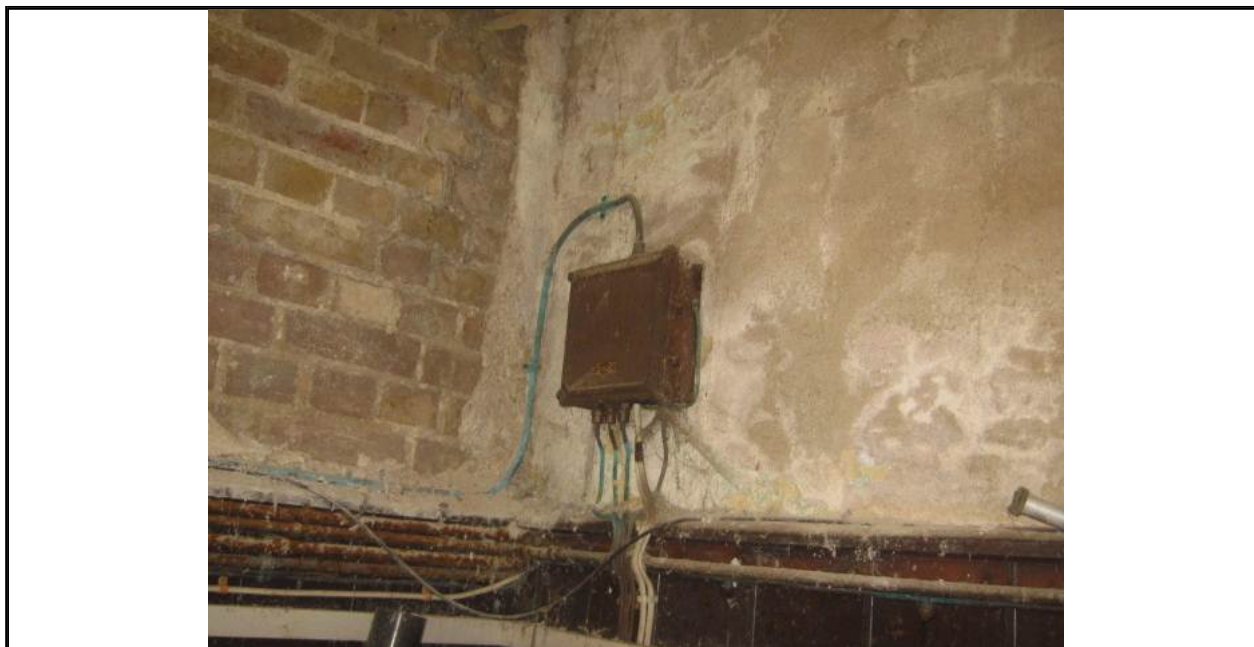
Sample No:	Strongly Presumed
Item No:	4
Survey Date:	08/07/14
Building:	grounds keeper's building
Floor:	Ground Floor
Room No:	possible rope materials old fuse boxes
Position:	room 1
Extent:	<1lm
Substrate:	Bonded, Metal
Material:	(2) Asbestos Textiles/Paper
Asbestos Type:	(1) Chrysotile
Risk Category:	C
Recommended Action:	Low risk ACM (bound in matrix) remove, repair or encapsulate under controlled conditions. Work on this material does not require a license. Work on this material may be notifiable to the appropriate enforcing authority. Disposal of asbestos waste by a licensed contractor only. All work must conform to the 'Control of Asbestos Regulations 2012'.

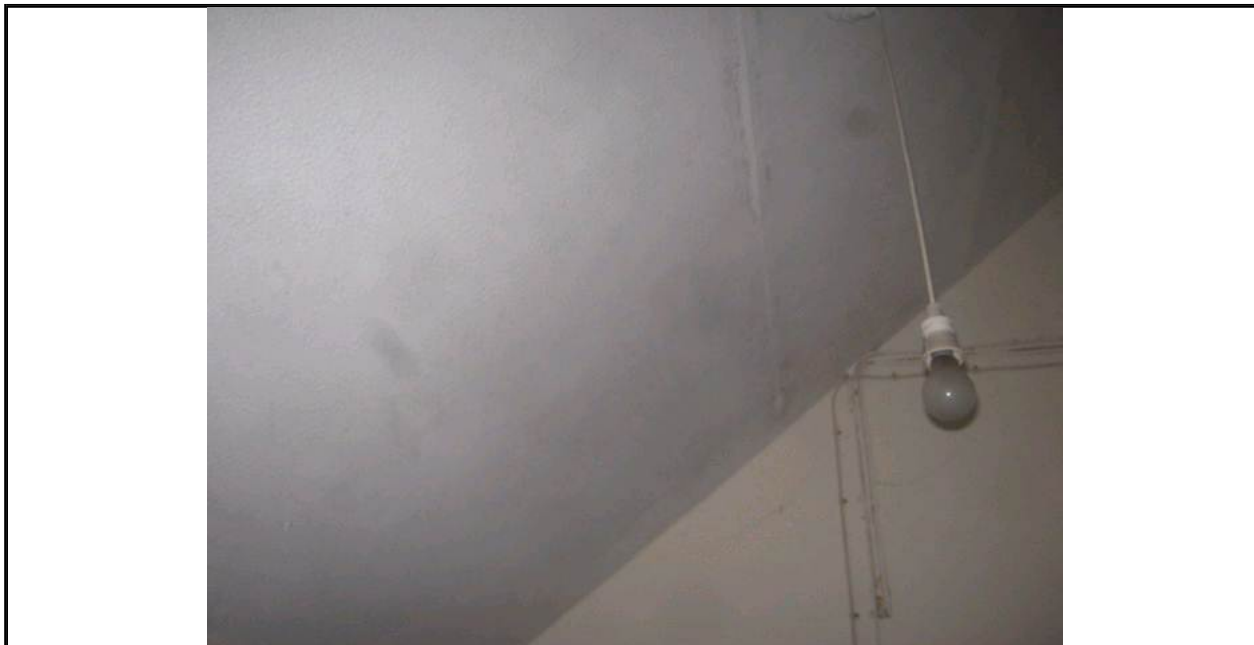
Sample No:	BE001633
Item No:	14
Survey Date:	08/07/14
Building:	chapel
Floor:	Ground Floor
Room No:	textured coating pitched ceiling
Position:	vestry
Extent:	10m <sup>2</sup>
Substrate:	Nailed, Timber
Material:	(1) Textured Coating
Asbestos Type:	(1) Chrysotile
Risk Category:	D
Recommended Action:	Low risk ACM (bound in matrix) remove, repair or encapsulate under controlled conditions. Work on this material does not require a license. Work on this material may be notifiable to the appropriate enforcing authority. Disposal of asbestos waste by a licensed contractor only. All work must conform to the 'Control of Asbestos Regulations 2012'.

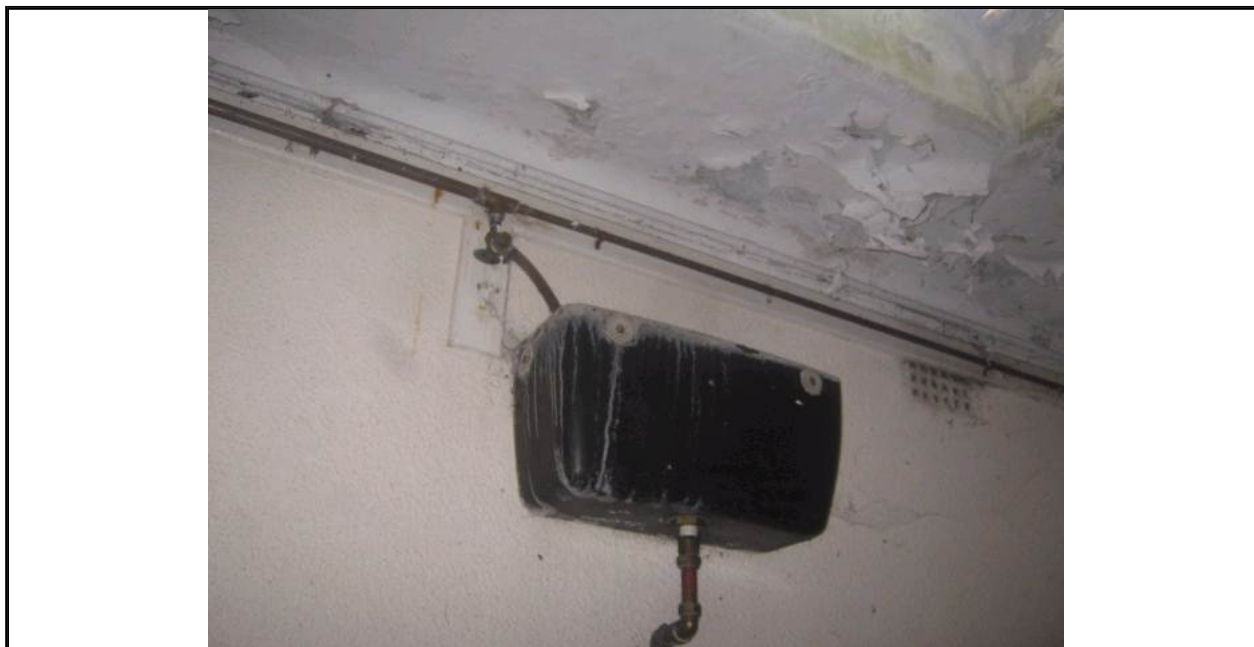
Sample No:	BE001634
Item No:	18
Survey Date:	08/07/14
Building:	toilet block
Floor:	Ground Floor
Room No:	toilet cistern above urinal
Position:	male toilet
Extent:	1m <sup>2</sup>
Substrate:	Bolted, Brick
Material:	(1) Reinforced Composite
Asbestos Type:	(2) Amosite
Risk Category:	D
Recommended Action:	Low risk ACM (bound in matrix) remove, repair or encapsulate under controlled conditions. Work on this material does not require a license. Work on this material may be notifiable to the appropriate enforcing authority. Disposal of asbestos waste by a licensed contractor only. All work must conform to the 'Control of Asbestos Regulations 2012'.

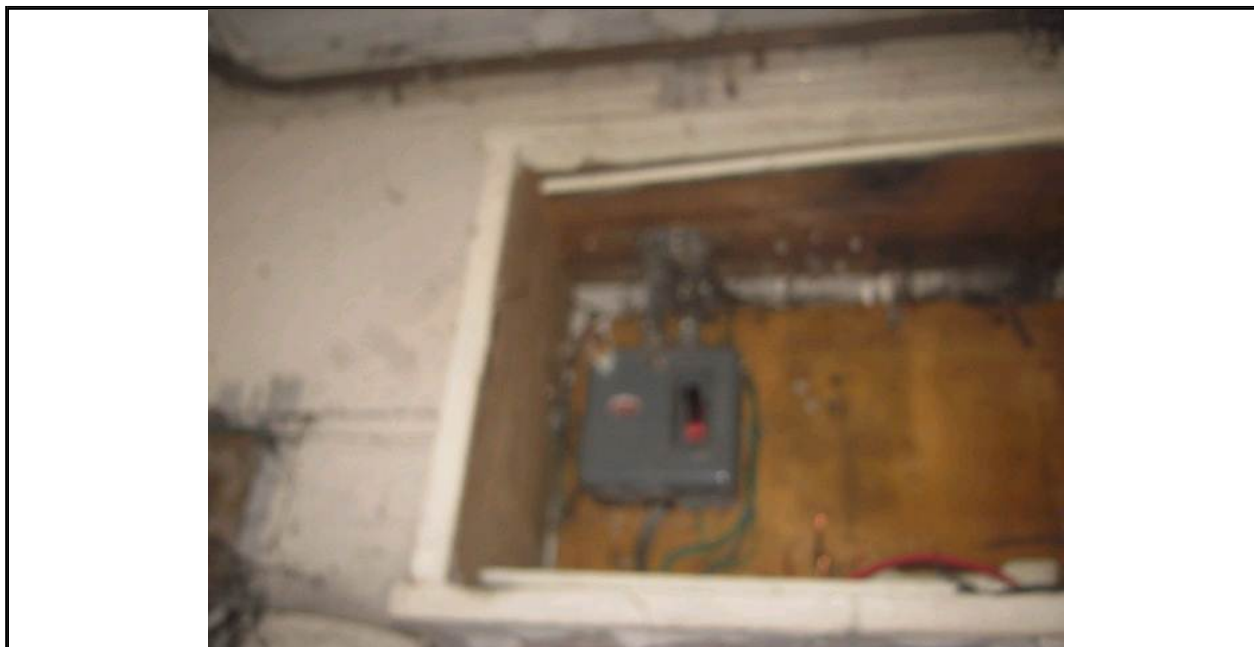
Sample No:	Strongly Presumed
Item No:	19
Survey Date:	08/07/14
Building:	toilet block
Floor:	Ground Floor
Room No:	possible rope material fuse box
Position:	male toilet
Extent:	<1lm
Substrate:	Bolted, Metal
Material:	(2) Asbestos Textiles/Paper
Asbestos Type:	(1) Chrysotile
Risk Category:	C
Recommended Action:	Low risk ACM (bound in matrix) remove, repair or encapsulate under controlled conditions. Work on this material does not require a license. Work on this material may be notifiable to the appropriate enforcing authority. Disposal of asbestos waste by a licensed contractor only. All work must conform to the 'Control of Asbestos Regulations 2012'.

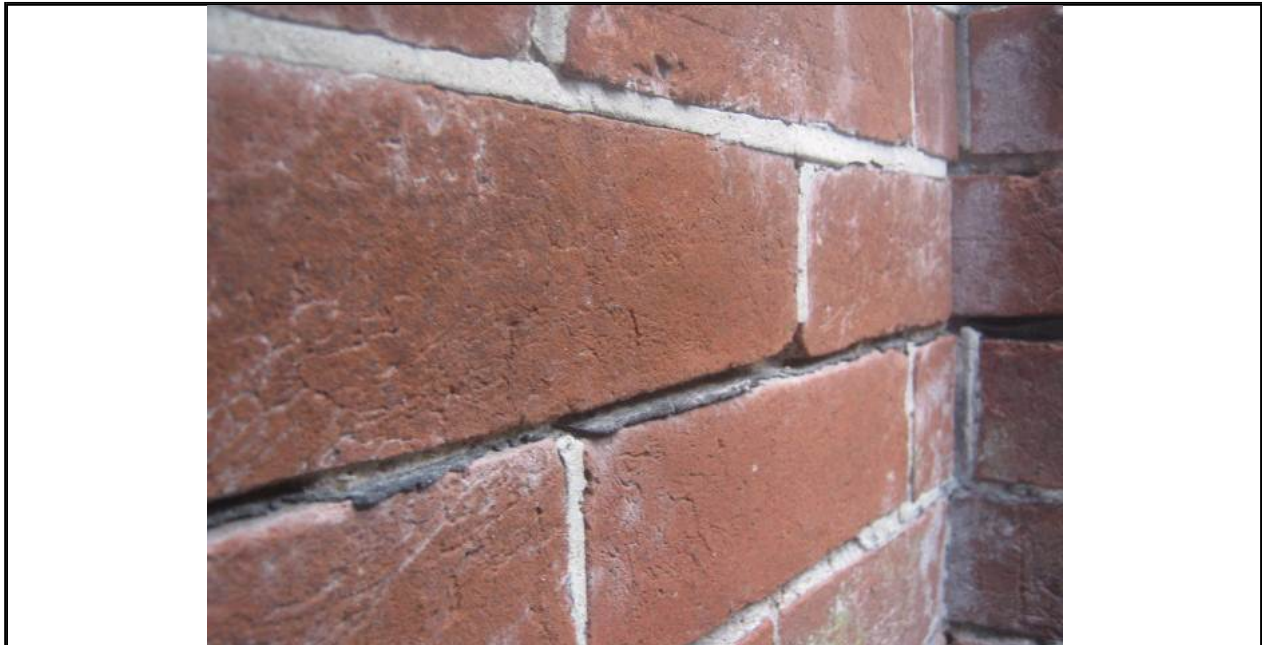
Sample No:	BE001635
Item No:	20
Survey Date:	08/07/14
Building:	toilet block
Floor:	External
Room No:	bitumen DPC low level walls
Position:	external elements
Extent:	36lm
Substrate:	Bonded, Brick
Material:	(1) Well Bound Material
Asbestos Type:	(1) Chrysotile
Risk Category:	D
Recommended Action:	Low risk ACM (bound in matrix) remove, repair or encapsulate under controlled conditions. Work on this material does not require a license. Work on this material may be notifiable to the appropriate enforcing authority. Disposal of asbestos waste by a licensed contractor only. All work must conform to the 'Control of Asbestos Regulations 2012'.
