**CBC Asbestos Management Survey Report
Studfall Avenue - Canopy, Corby
12th March 2019**

CBC undertook an Asbestos Management Survey at Studfall Avenue - Canopy, Corby.

Daniel Payne undertook the survey on 12th March 2019.

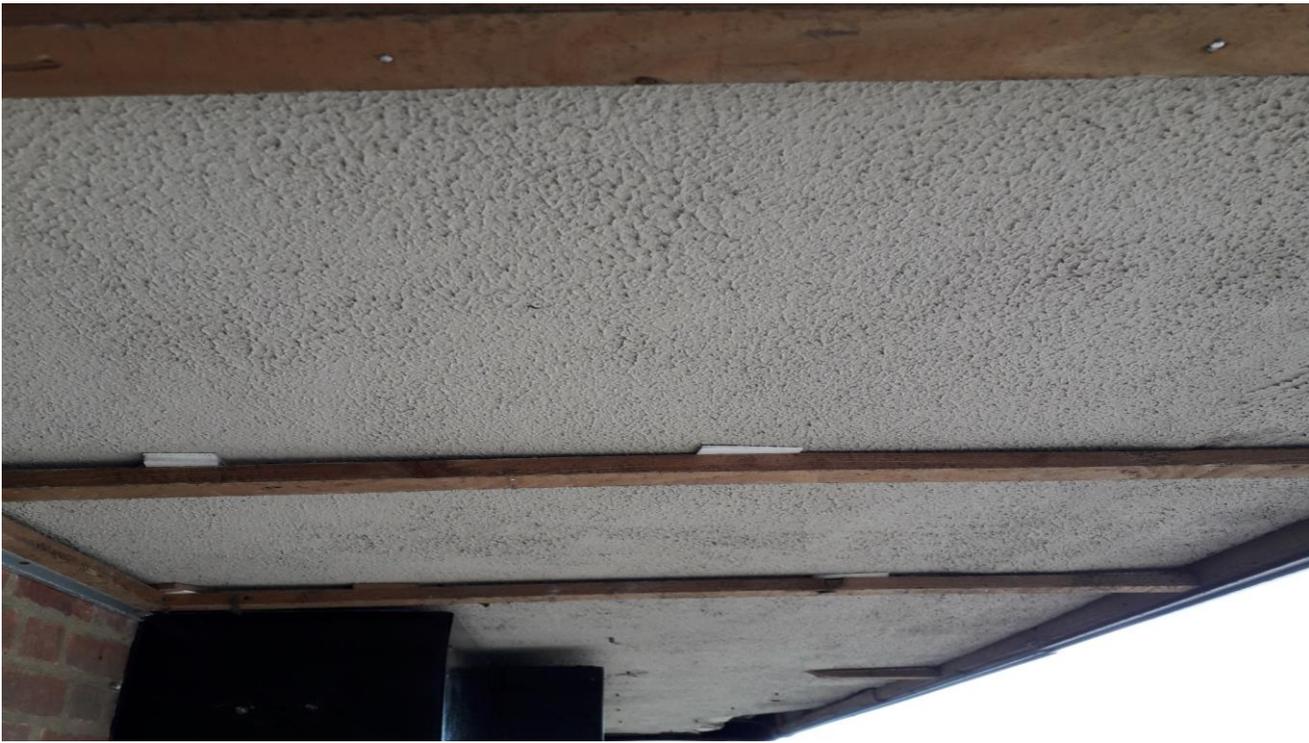
Photo Number	1	Reference number	120319DP01
Inspection / Sample	Sample	Inspection Cross Reference / Visual I.D.	Not Applicable

Notes	NADIS: No asbestos detected in sample

Building	Studfall Shops	Condition	Good	0
Floor Level	External	Surface Treatment	Composite materials, reinforced plastics, resin, vinyl materials	0
Location	01 / Canopy	Material Friability	Low	1
Feature	Render Finish to concrete	Asbestos Type	N.A.D.I.S	0
Material Type	Textured Coating			
Extent	87 m.			
Recommendation	No action necessary	Assessment Score		0
		Assessment Band		E
