Assembly Rooms Barton upon Humber
Condition Report on external joinery windows (excepting ground floor front).

9am 7th January 2023

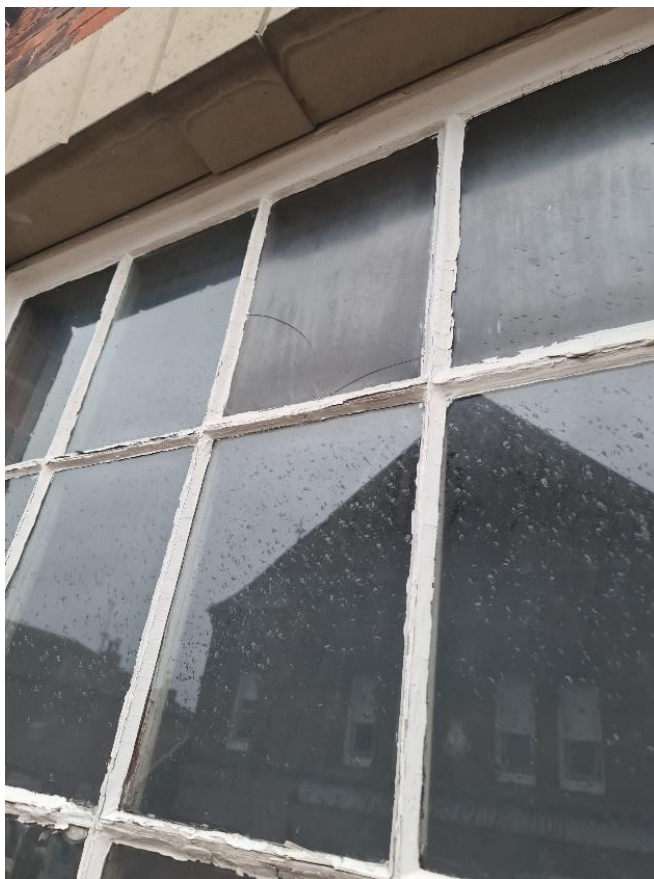
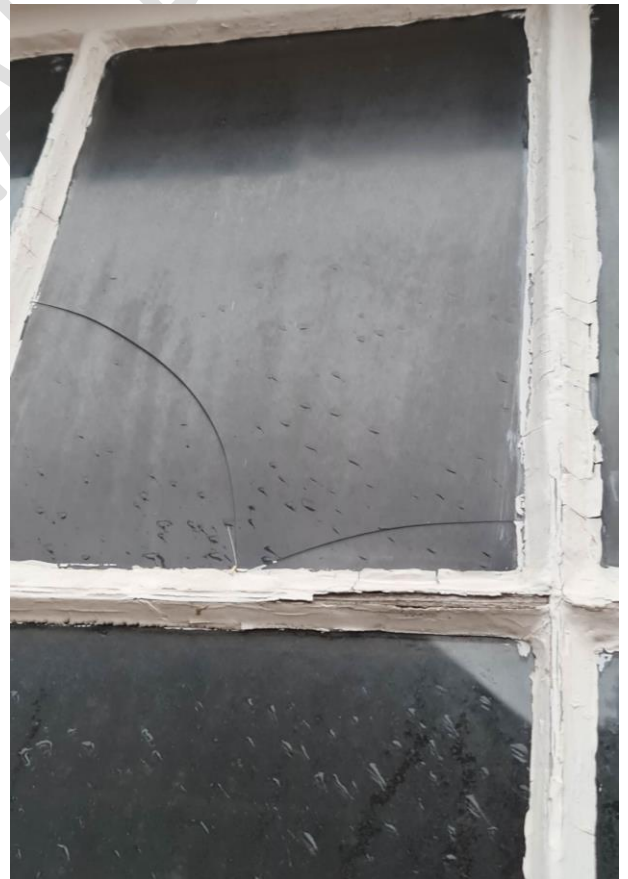
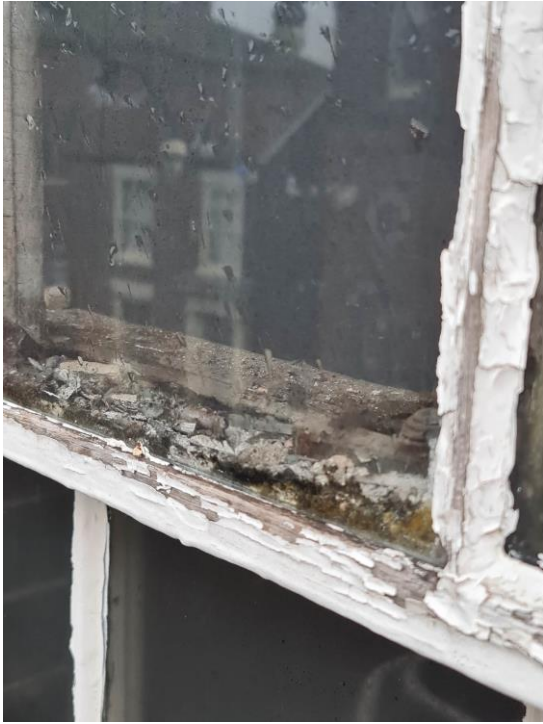
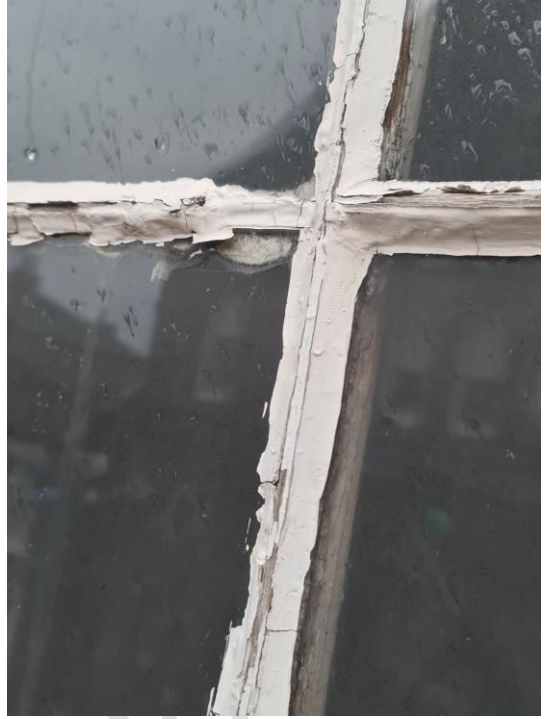
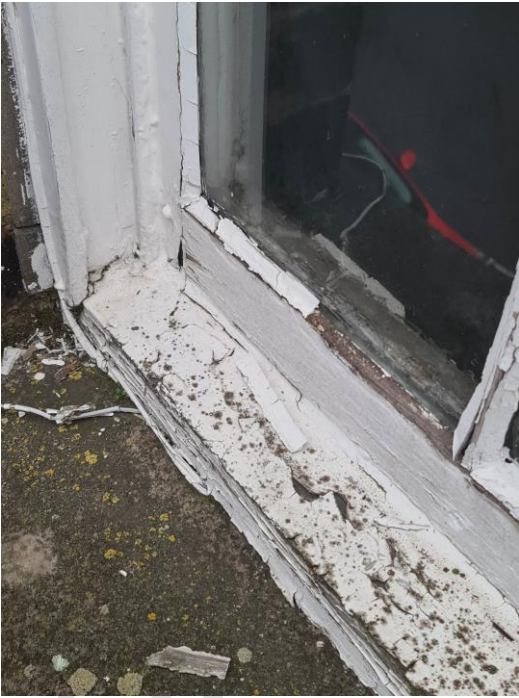
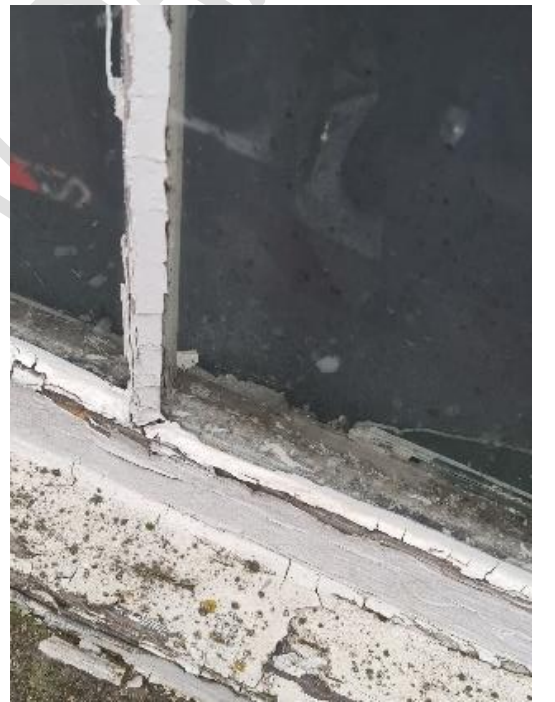
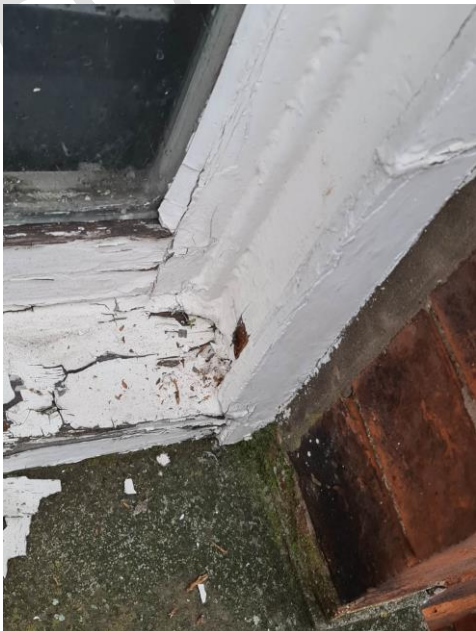
Window 1

There is a broken pane in the top sash.

Meeting rails, styles and glazing bars are defective, both sashes should be removed and replicated as they are uneconomic to repair.

This frame is boarded internally so the sashes will have to be removed outwardly, this will require the removal of at least one outer lining and parting beads. Neither are in good condition, there is a historic repair on the right so both linings should be replaced and the cill which is also defective.

This window is enclosed to the inside by being boarded over and bisected by the bar shutter; There is no ventilation or maintenance access to the frame. It would be sensible therefore to fit removable ventilated panels around the bar shutter to allow access and ventilation to the frame.

With the sashes removed repairs can be undertaken to the pulley linings, cill and any further repairs that present themselves.

Both sashes should be removed and replicated as they are uneconomic to repair.

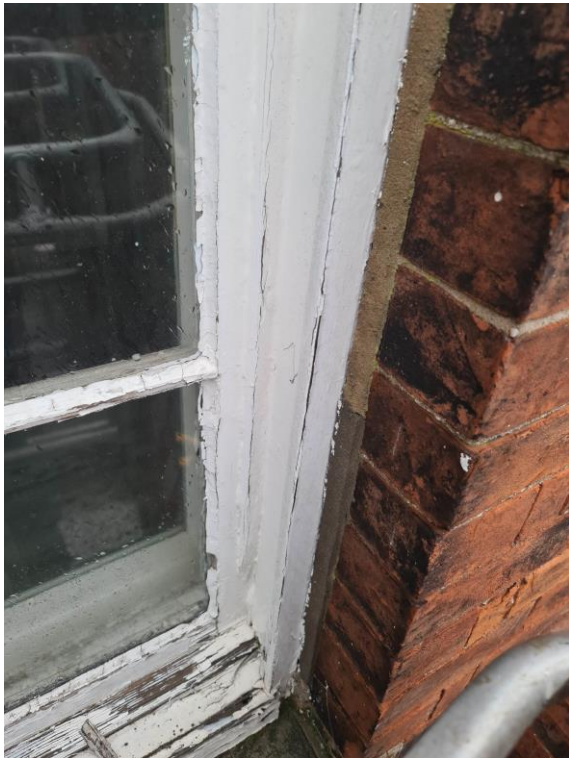
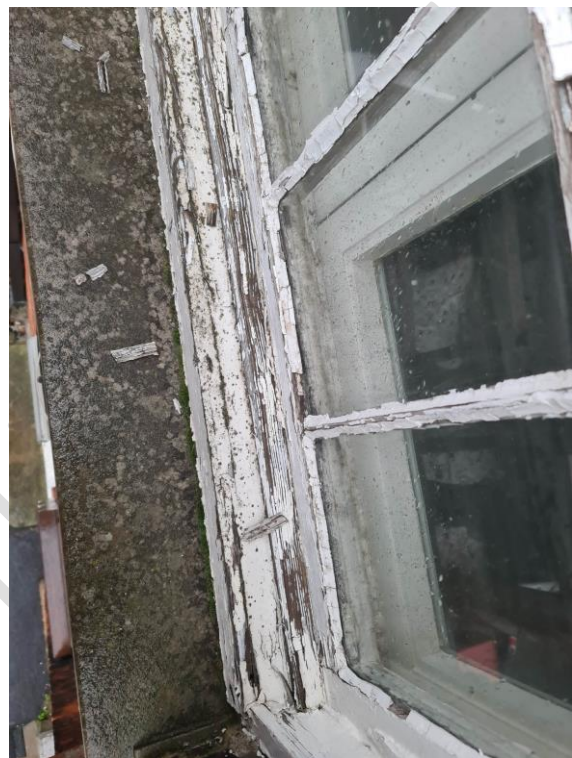
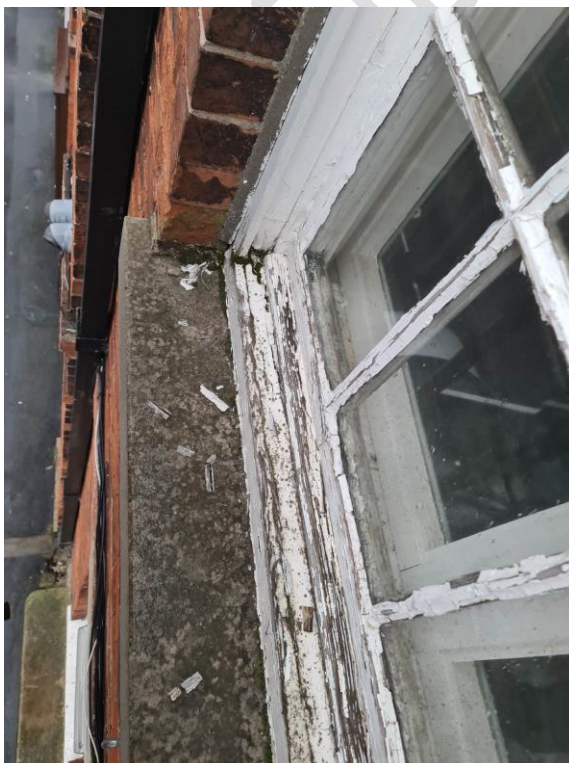
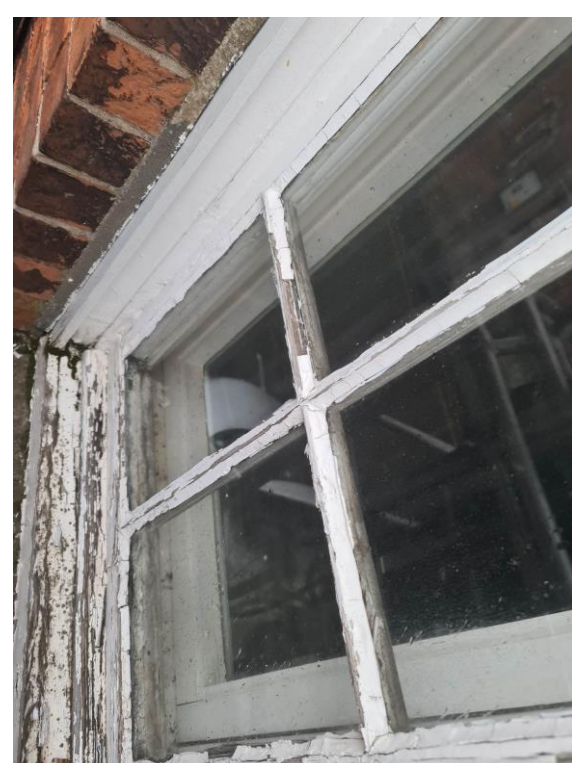
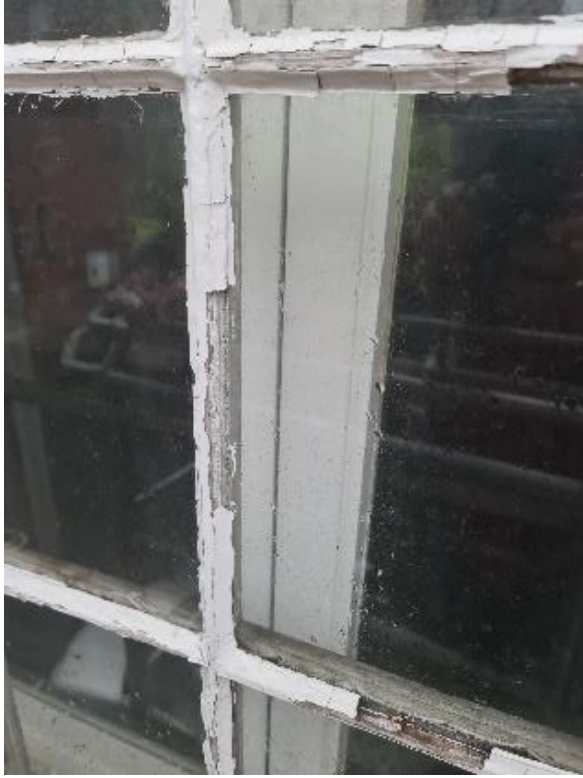
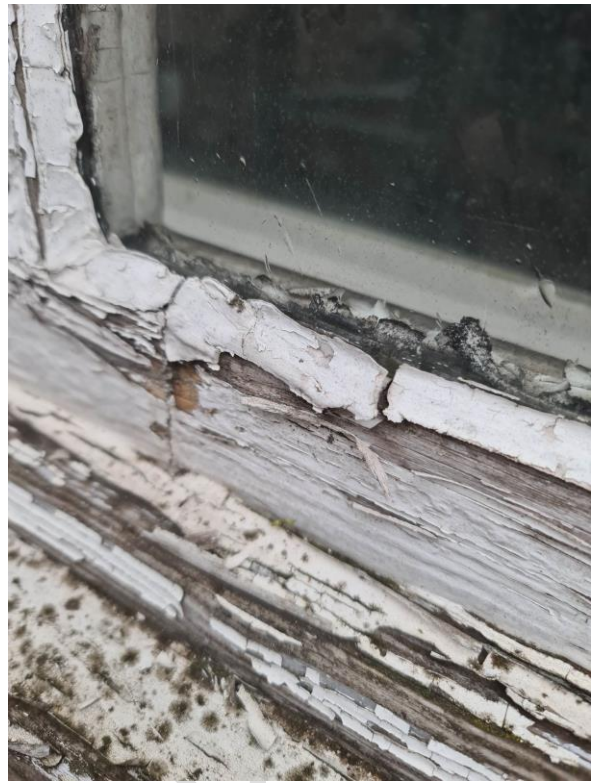
Window 2

Meeting rails, styles and glazing bars are defective, there is a historic repair to the bottom rail. Both sashes should be removed and replicated as they are uneconomic to repair.

The Cill, Pulley lining left hand and Outer linings are defective. The frame requires removal and a new replacement Cill and linings fitted and re-installed.

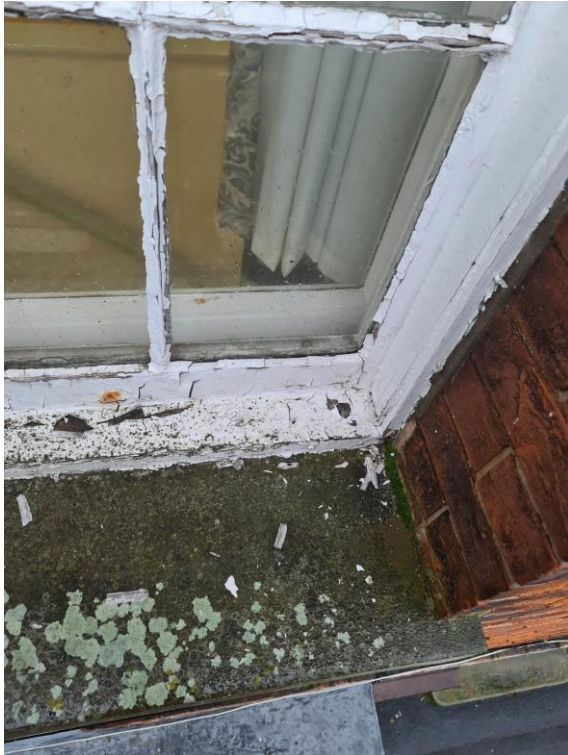
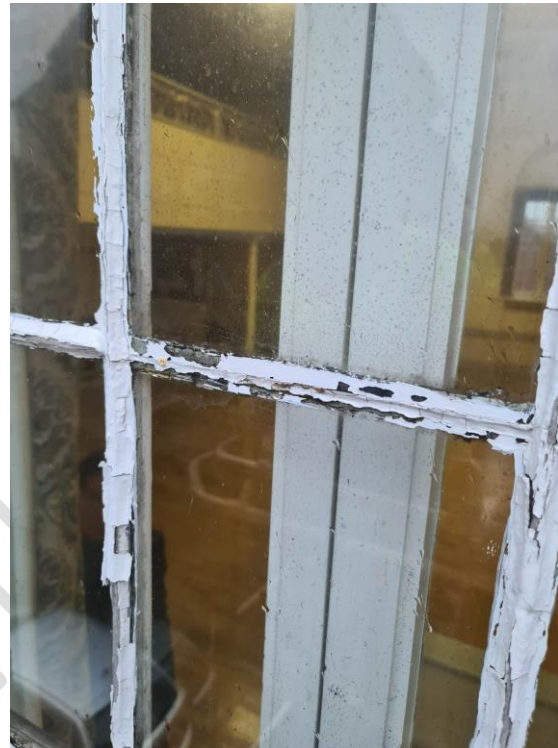
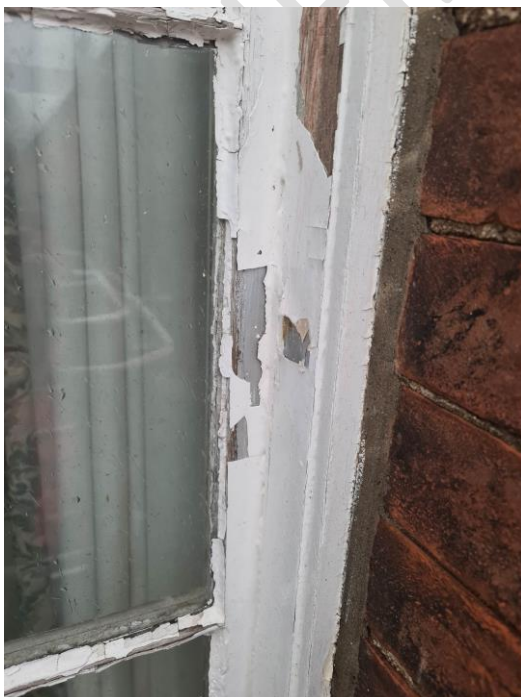
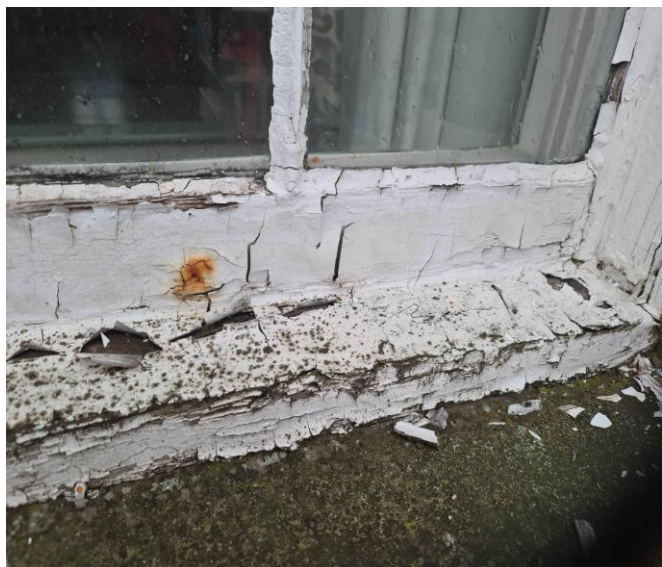
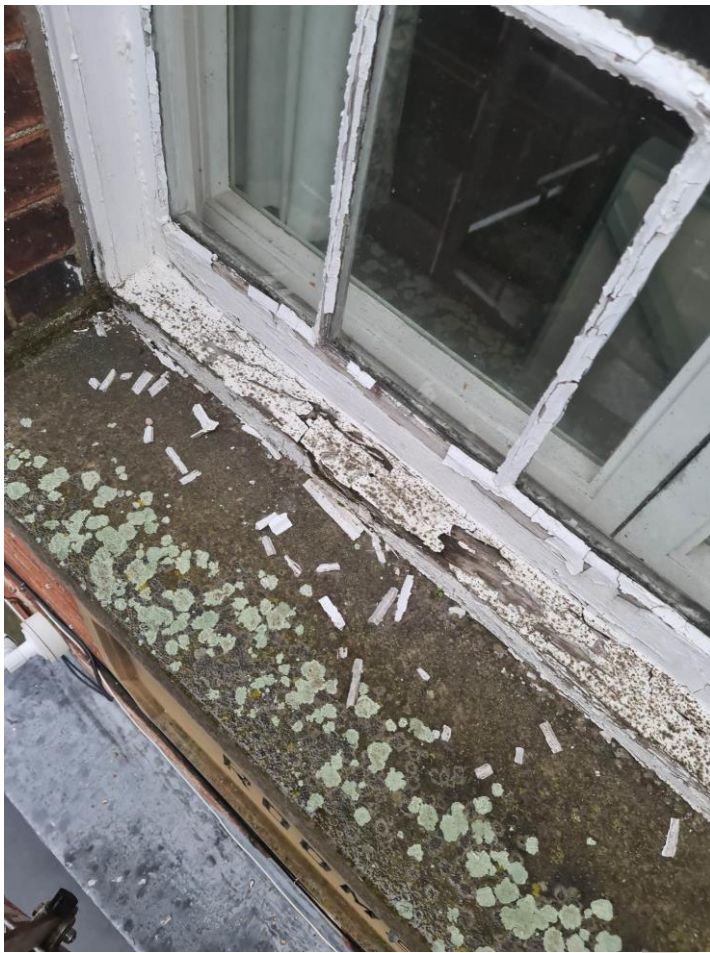
Window 3

Meeting rails, styles and glazing bars are defective, both sashes should be removed and replicated as they are uneconomic to repair.

The Cill and Pulley linings are defective. The frame requires removal and a new replacement Cill and linings fitted and re-installed.

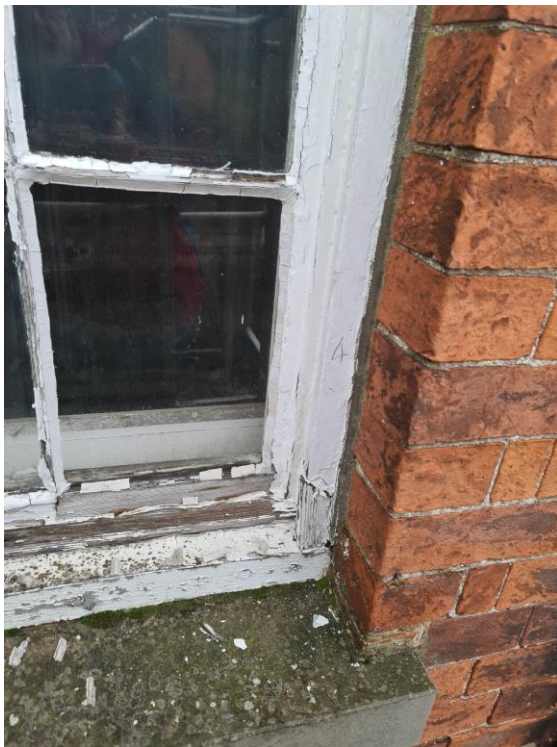
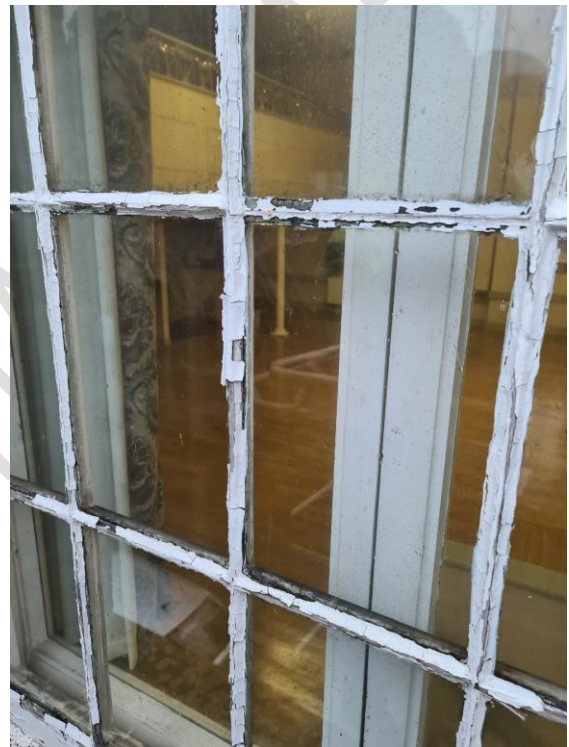
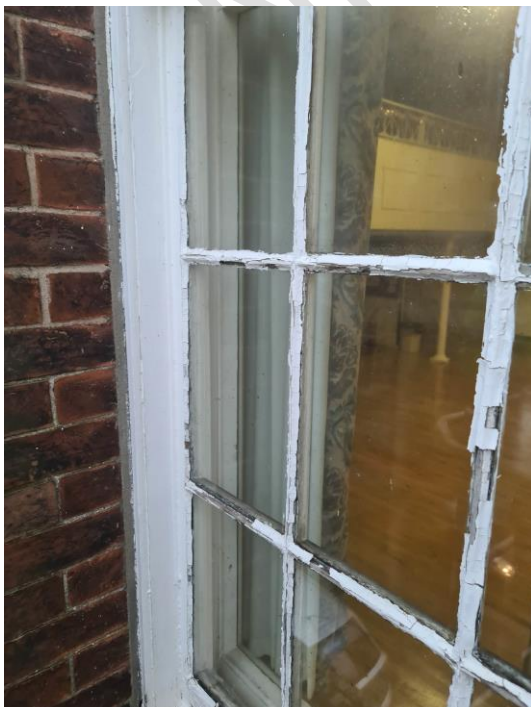
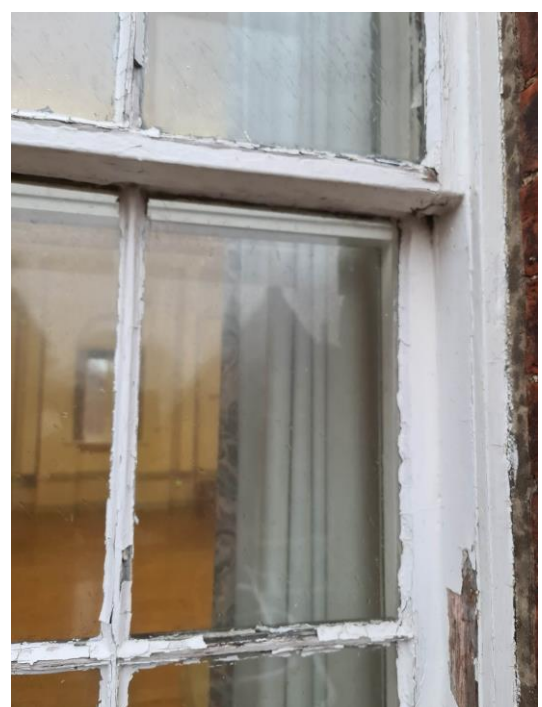
Window 4

Meeting rails R/H, bottom rail, styles and glazing bars are defective, both sashes should be removed and replicated as they are uneconomic to repair.

There is a historic repair to the bottom rail.

The Cill and Pulley linings and Parting bead are defective. Outer linings are defective, there is a historic repair to the R/H lining.

The frame requires removal and a new replacement Cill and linings fitted and re-installed.

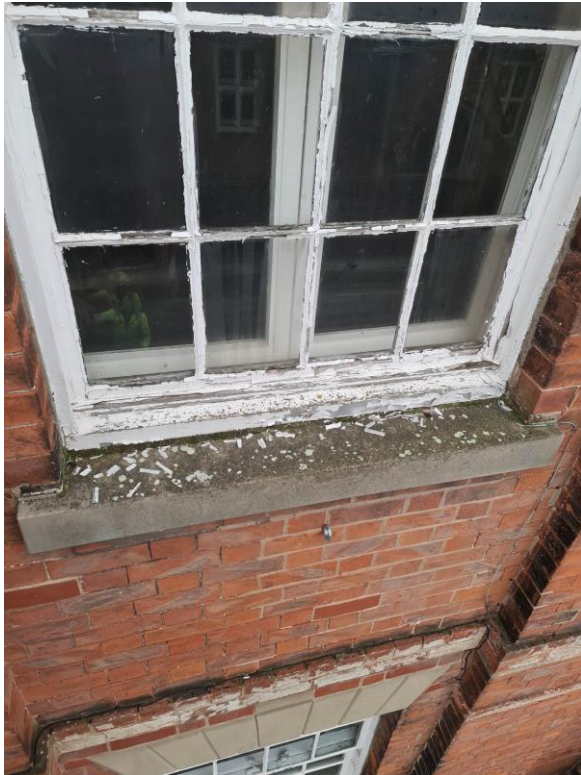
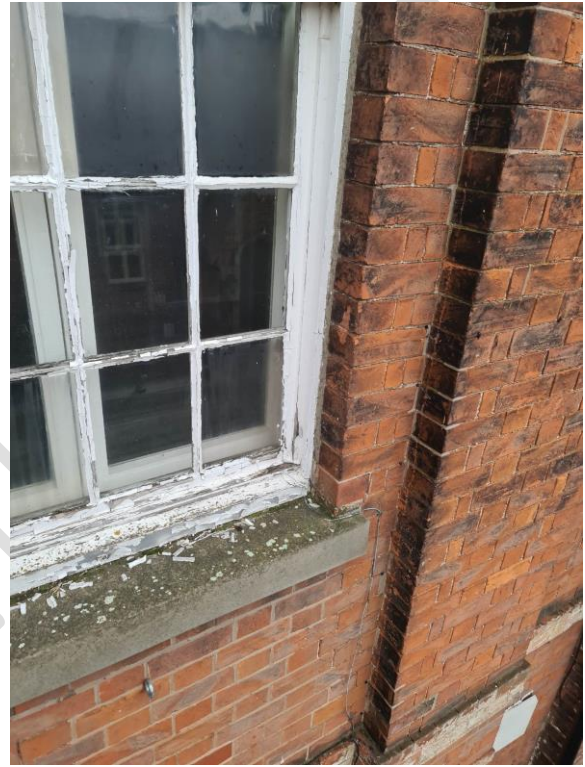
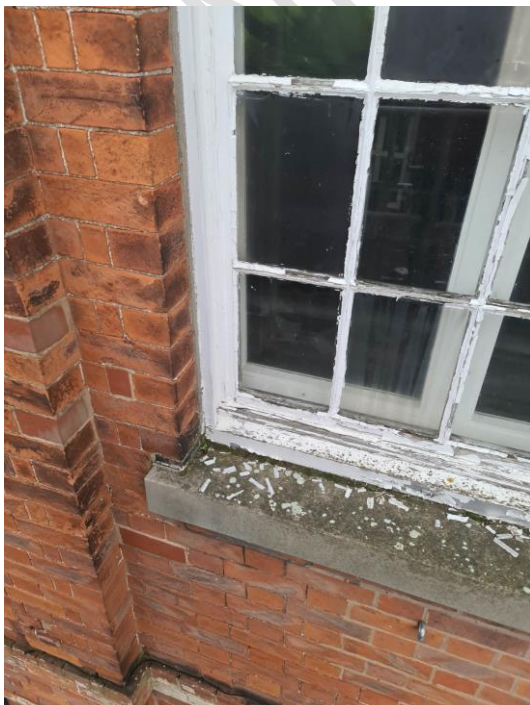
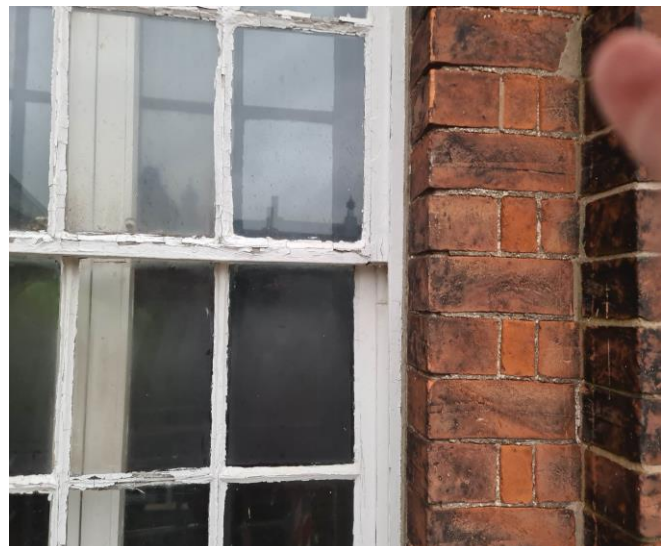
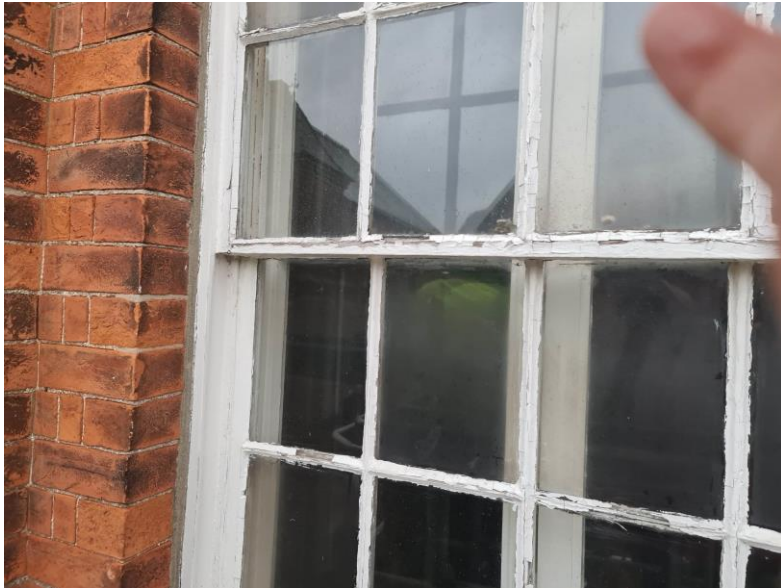
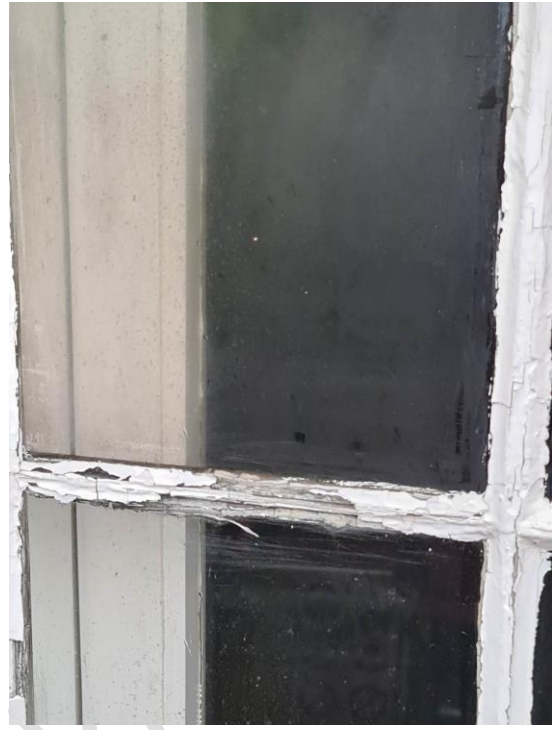
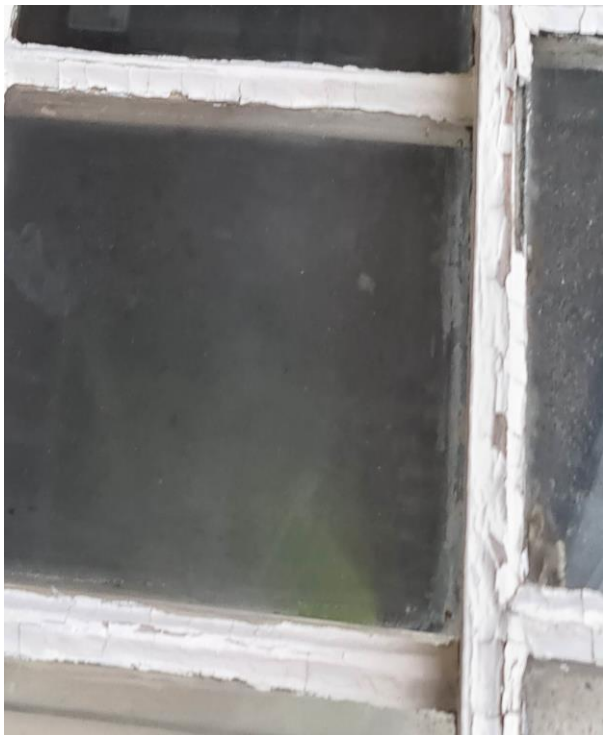
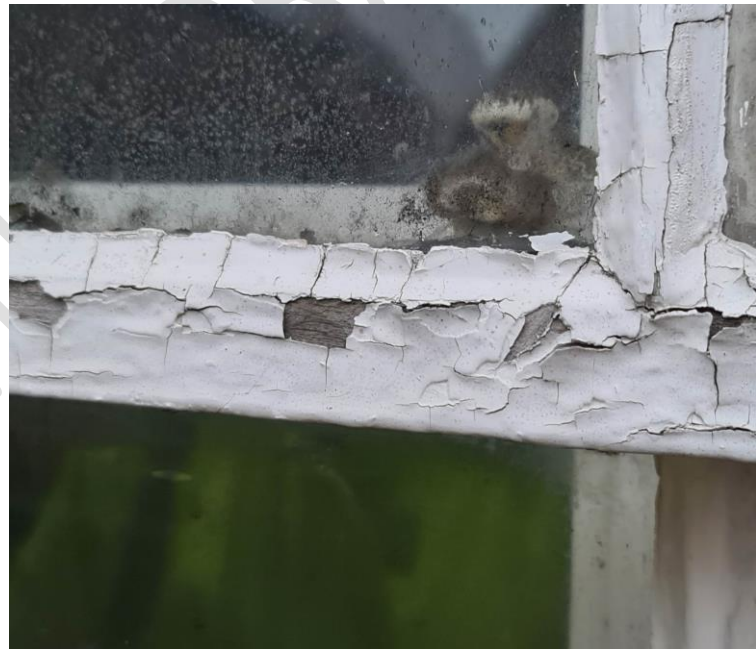
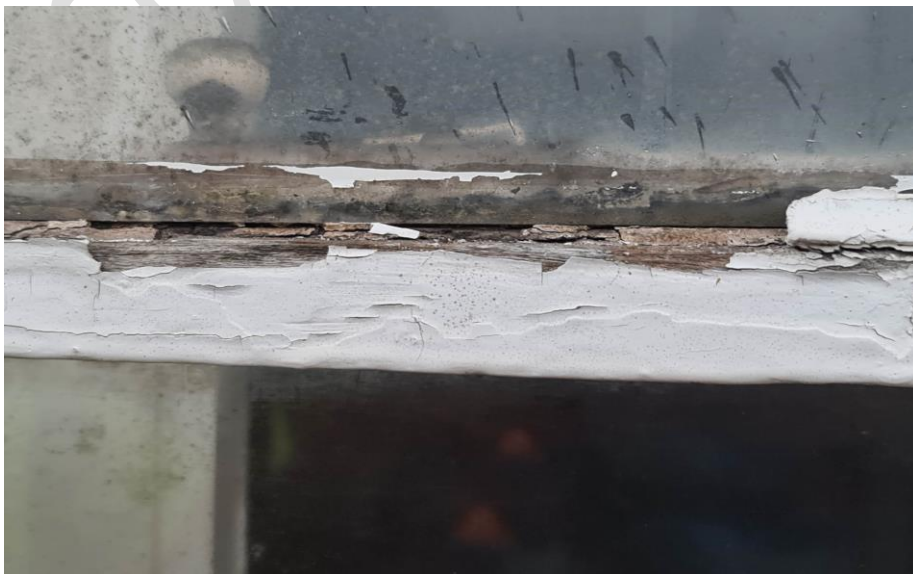
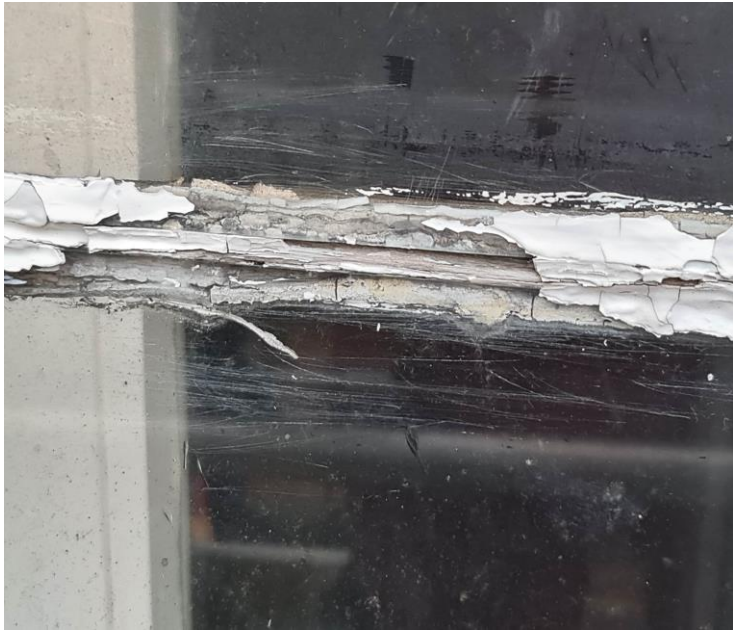
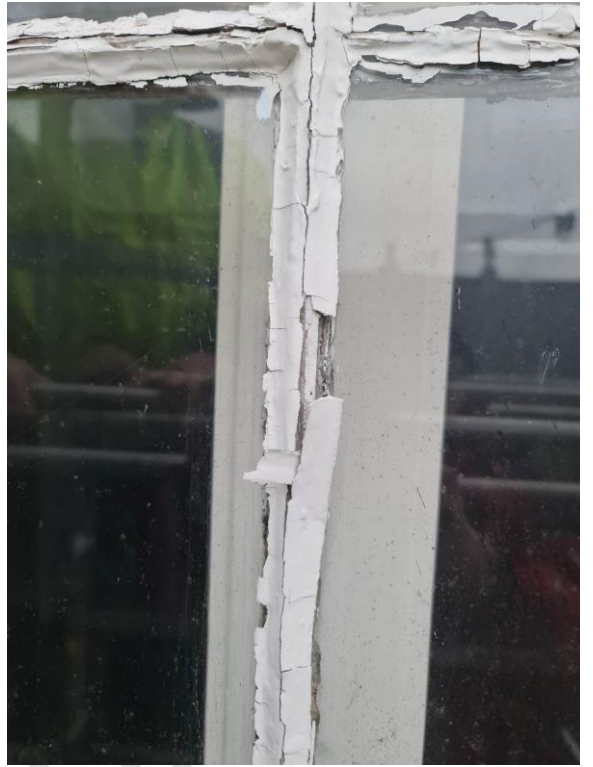
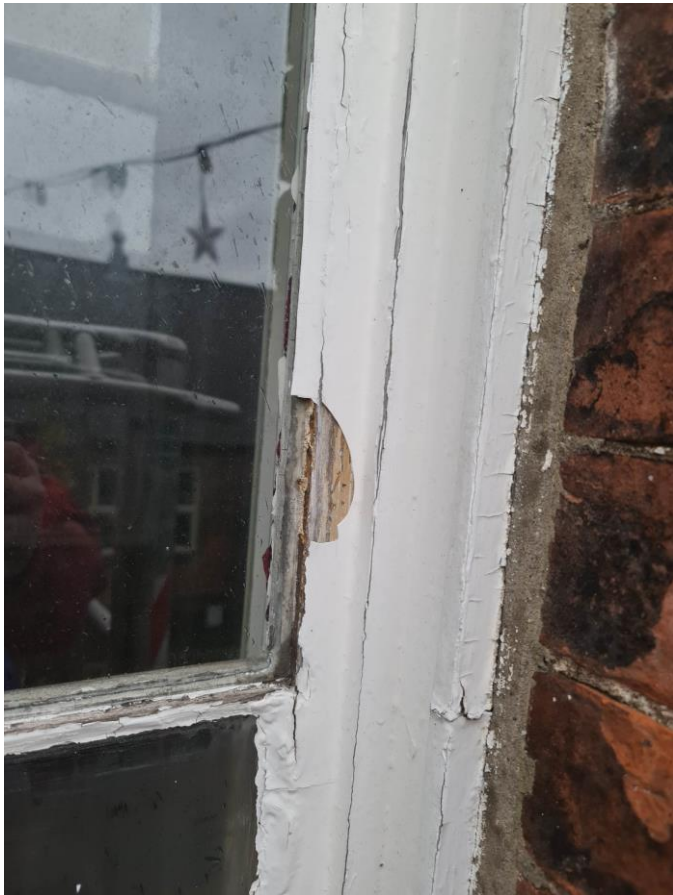
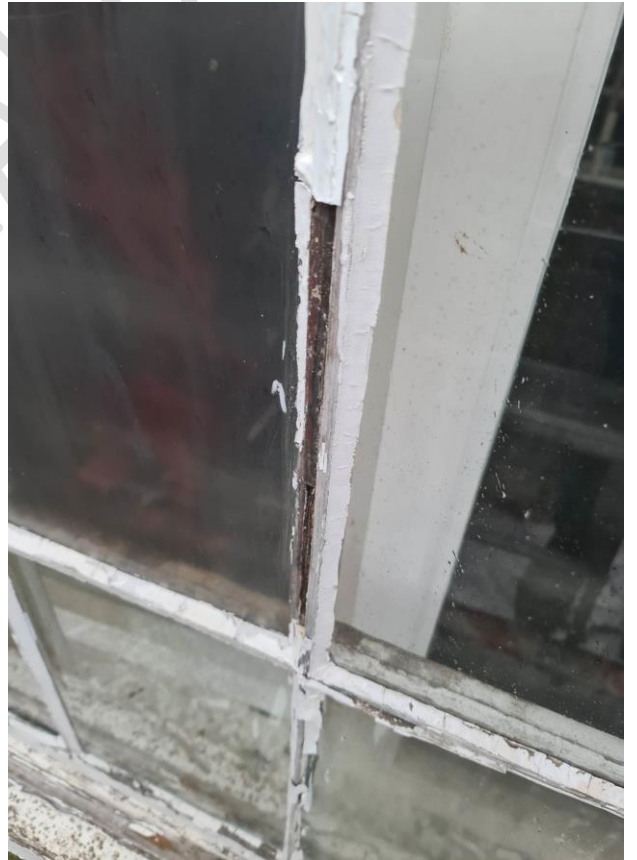
Window 5

Styles and glazing bars are defective, all putty is loose but there is a lot of putty on the stone Cill from previous re-glazing and pointing failure. Meeting rails and bottom rail are defective.

The Cill, Pulley linings and Outer linings are defective. The frame requires removal and a new replacement Cill and linings fitted and re-installed.

Both sashes should be removed and replicated as they are uneconomic to repair.

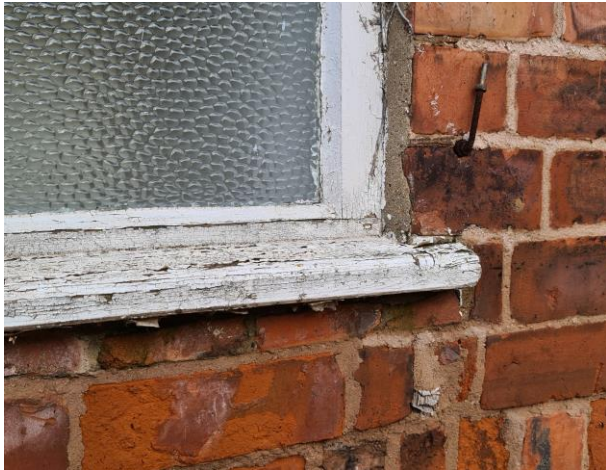
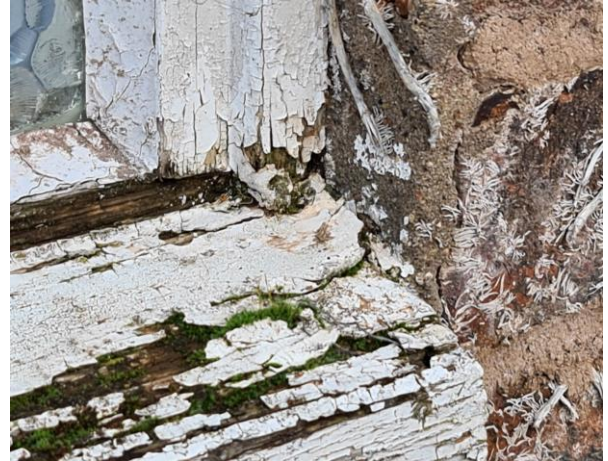
Ground Floor office windows

These windows are in a poor state will not hold paint and are unlikely to be cost effective to repair.

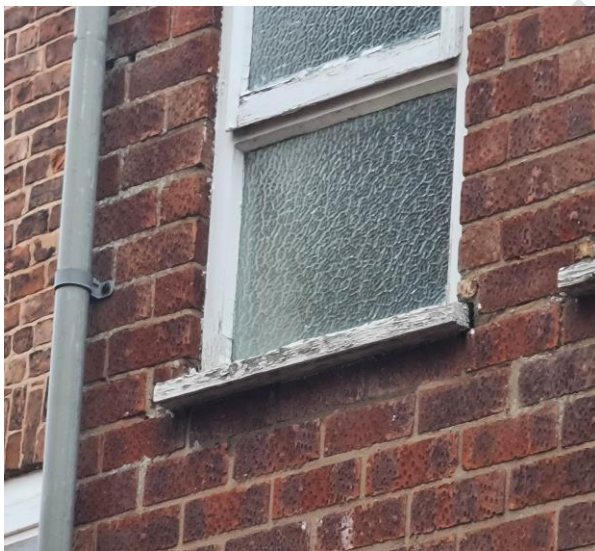
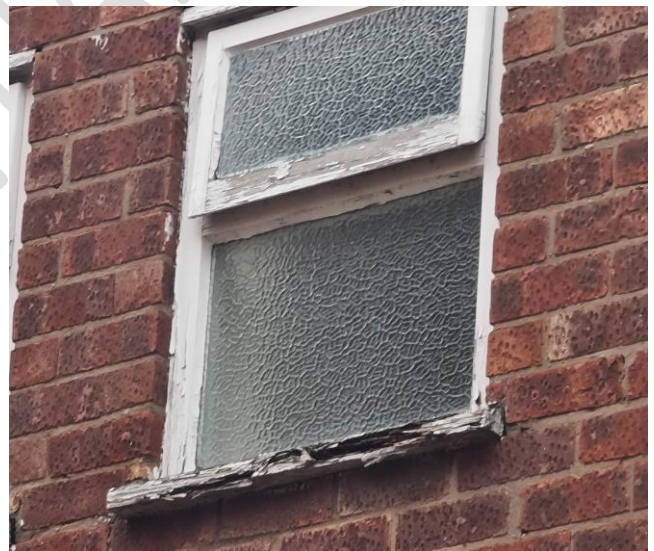
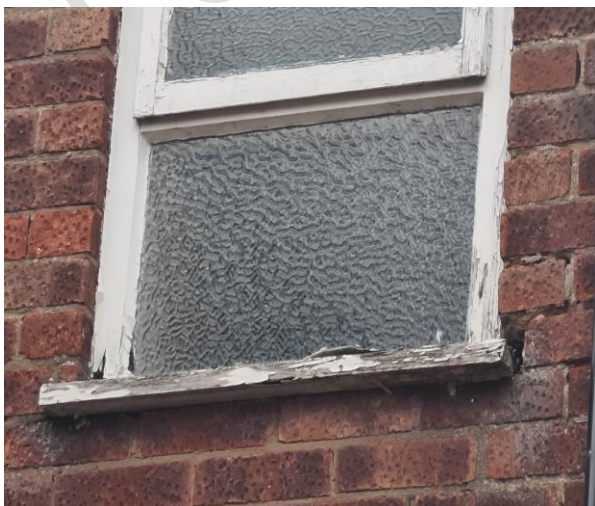
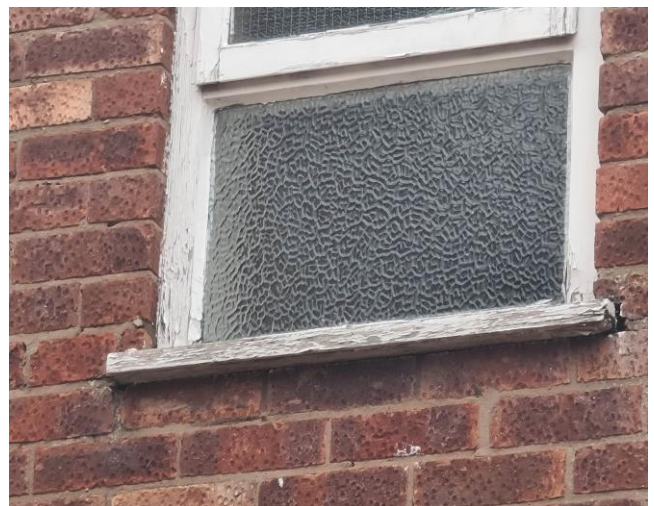
First Floor ladies toilets, observed from ground level

The cills are evidently defective and it is probable that the jambs are too. This is visible in three of the four frames.

These frames are unlikely to be economic to repair, and should be replaced.

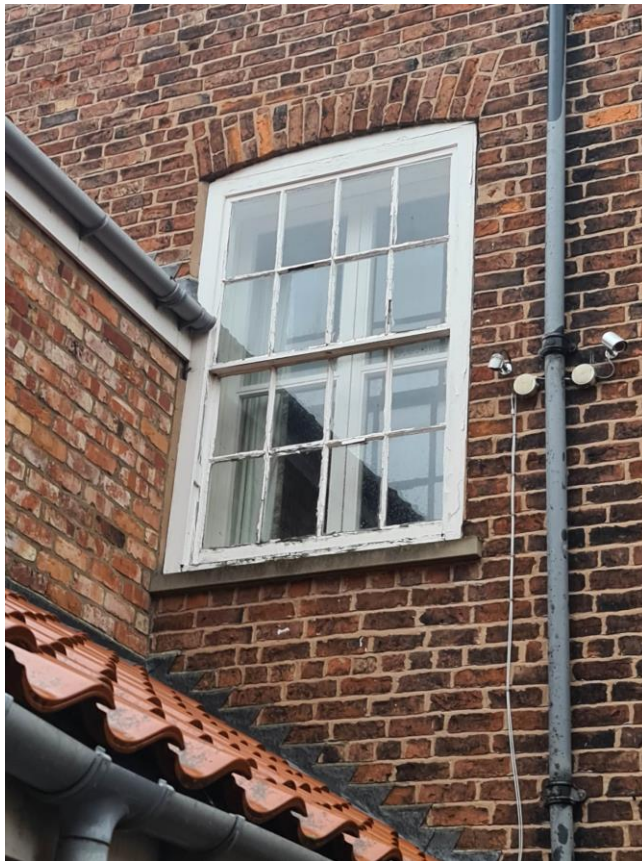
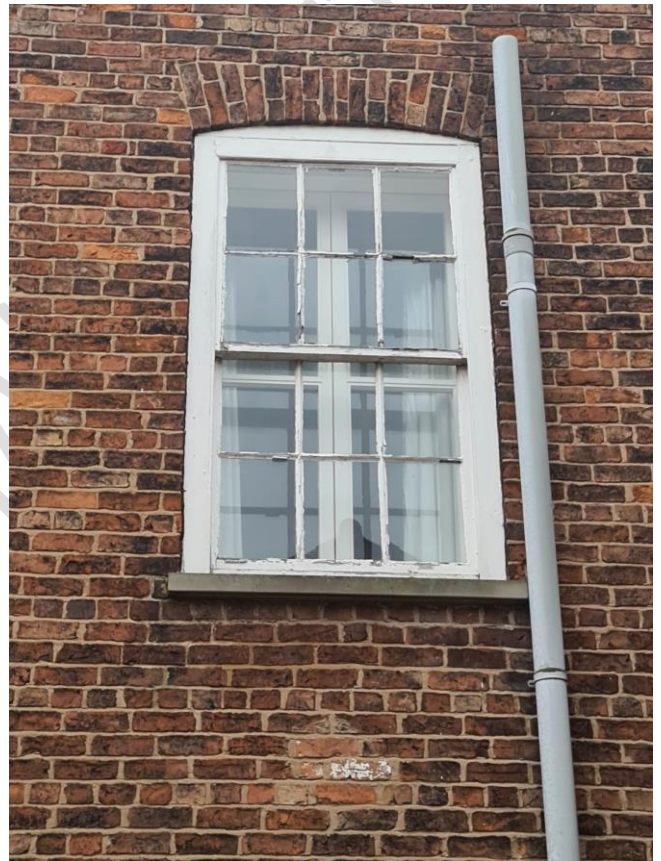
Window 1

Glazing bars observed to be in poor condition, meeting rails and bottom rail appear poor.

Sashes should be removed, cleaned and assessed for repair or replication.

On removal of sashes inspection of linings and cill to assess repair. This frame is fitted in the brick face work and so can be worked on without the need to remove it.

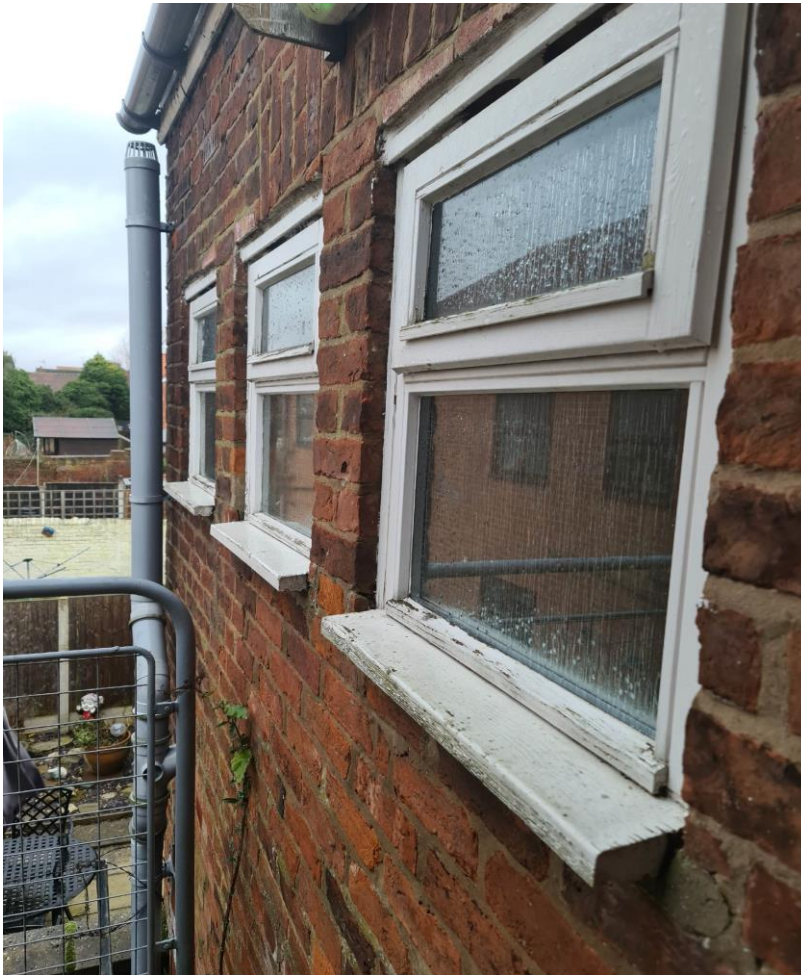
First Floor Gents toilet windows

These three frames are in good condition. They look like a propriety frame and other than possibly glazing beads on closer investigation do not require any further work.

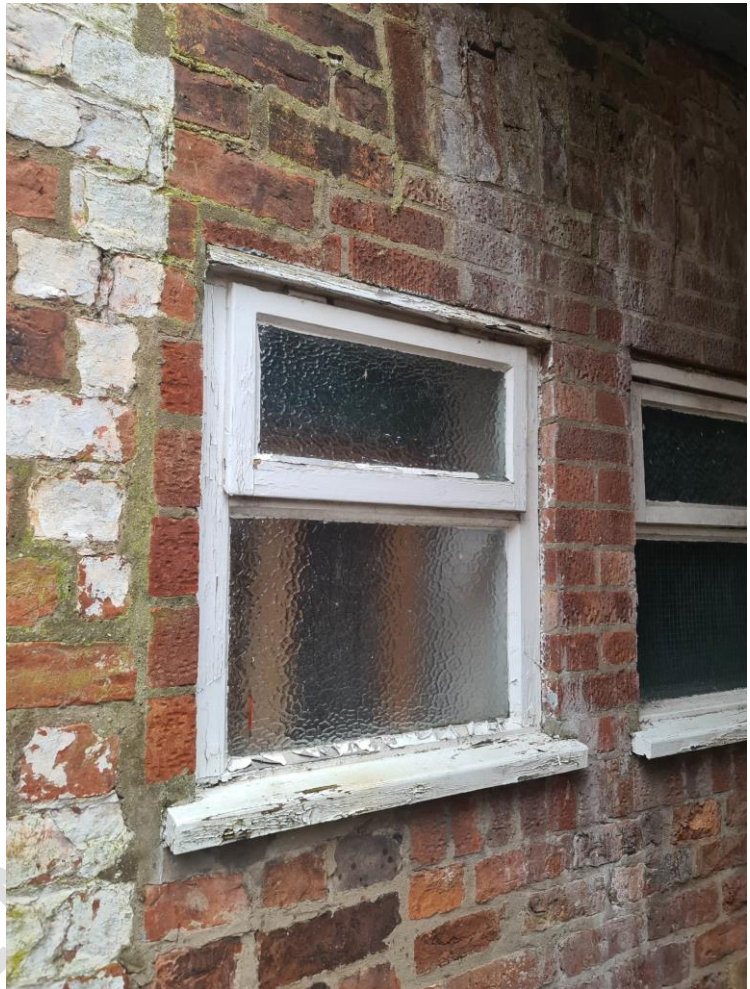
Ground Floor Committee room toilet windows.

Bottom light is broken. Frame and sash are defective and uneconomic to repair. This frame should be replaced.

This frame has historic repairs to both jambs, it is in poor condition and uneconomic to further repair. This frame should be replaced.

As this frame is sheltered from the elements by the fire escape it is in serviceable condition and will paint.

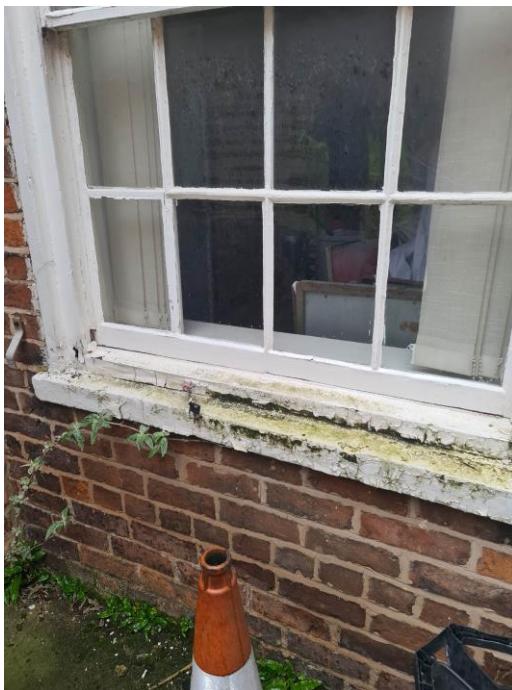
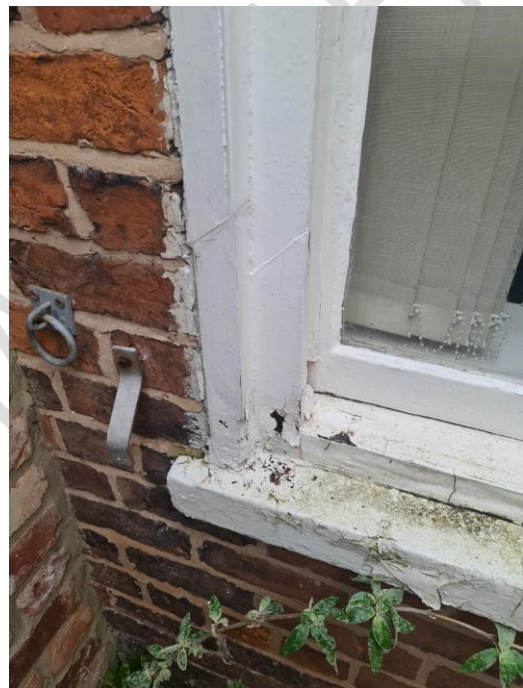
Window 1

The sashes appear to be in reasonable serviceable condition.

A historic repair to the outer linings (L/H) is defective as well as the cill. The repair does not respect the beaded lining.

These frames are on the outside brick face and so can be repaired in situ. The outer lining should be replaced in one piece rather than patched which leaves a vulnerable join. The pulley lining can be replaced up to the pocket, if necessary. A new cill nosing at least is required.

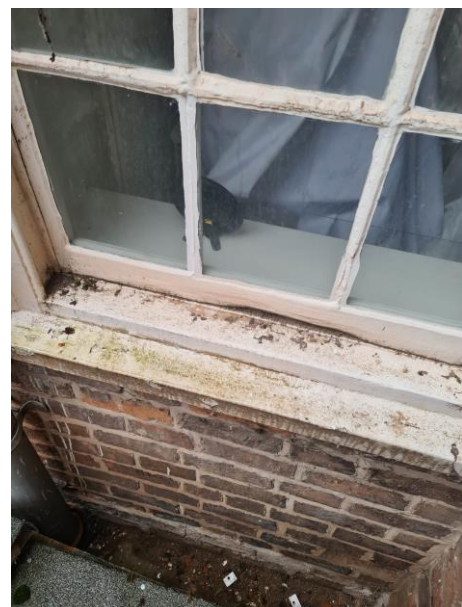
Window 2

The bottom sash rail appears to have been filled and should be investigated further and replaced if necessary.

The frame appears to be in serviceable condition.

Where not otherwise stated repair components to box sash windows should be in their entirety rather than patching in. Linings for example should be replaced rather than repaired. If this is not practical then repairs should be done in such a way that joints are cloaked by the joinery to protect them from the elements. Cill nosings tucked under sash bottom rails, for example.
