Assembly Rooms Barton upon Humber
Condition Report on external joinery windows (excepting ground floor front).

9am 7th January 2023

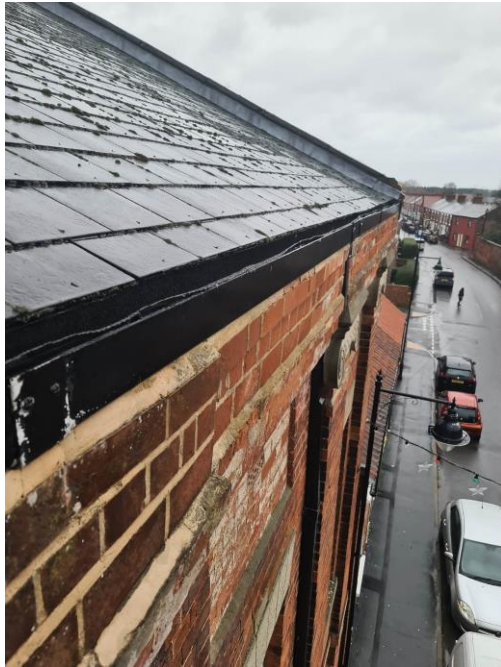
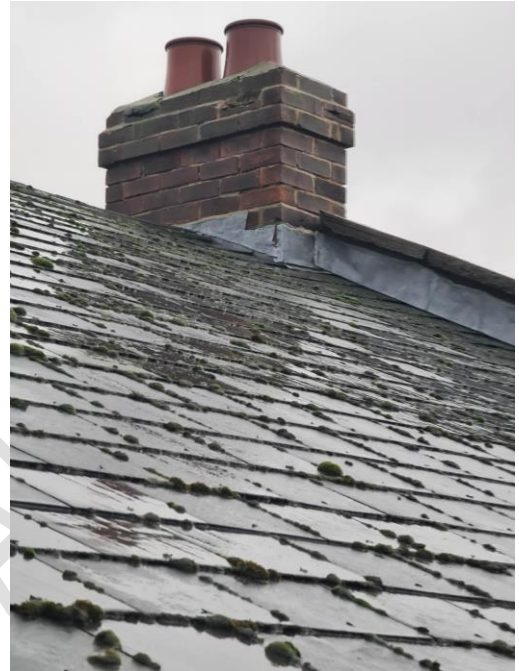
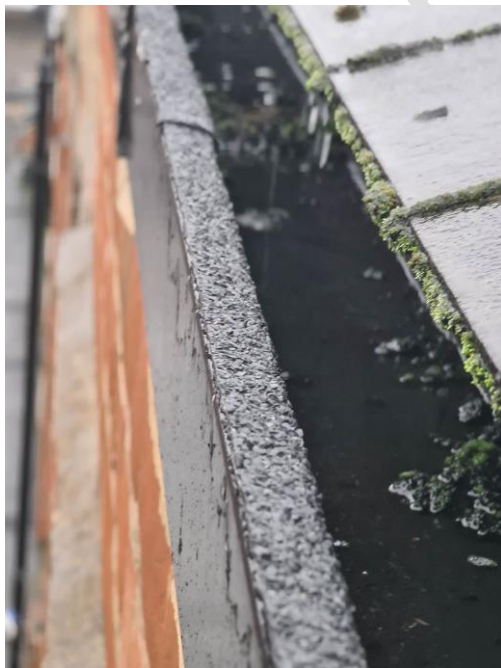
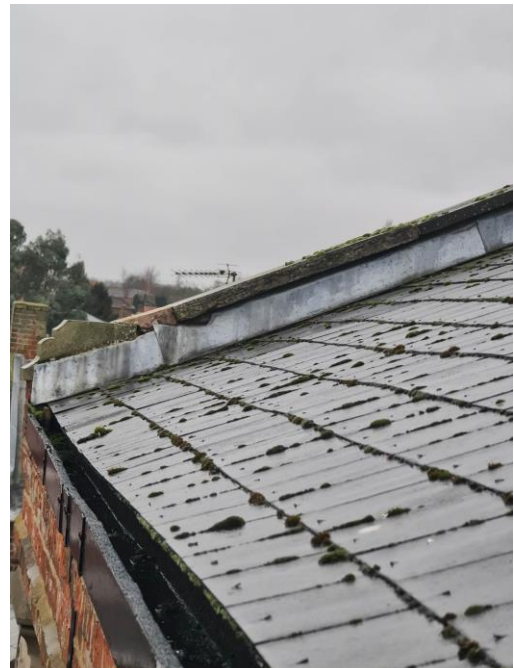
Roof

The alloy box gutter has been lined with green mineral felt at some point, presumably to prevent water egress, the felt has though come away from the gutter at the outer edge thus allowing water into the gutter raising the possibility that water is leaching into the brickwork.

Note also the condition of the copings, particularly on the high street facing gable.
