ASBESTOS REFURBISHMENT SURVEY

Client:
Old Bolsover Town Council

Site Location:
Assembly Halls
Hill Top
Bolsover
Derbyshire
S44 6NG

**Job
reference:**
D-03165

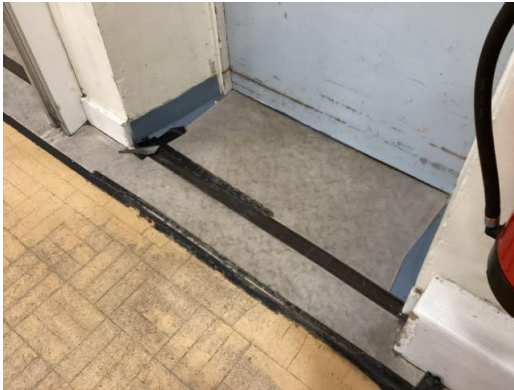
Sample	Icon	Location	Sample description	Quantity	Asbestos type
S001

GF003	Floor - Vinyl Flooring	2m ²	NADIS

No further action required

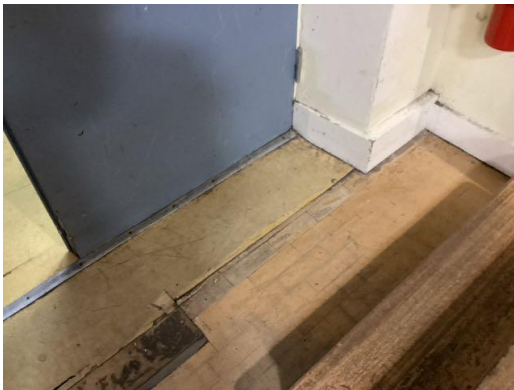
Sample	Icon	Location	Sample description	Quantity	Asbestos type
S002

GF003	Floor - Vinyl Flooring	1m ²	NADIS

No further action required

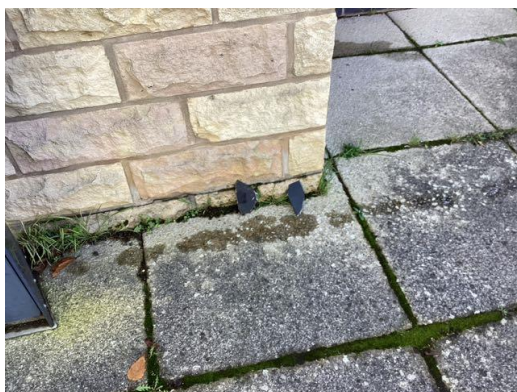
Sample	Icon	Location	Sample description	Quantity	Asbestos type
S003

External	External - Roof tile debris	<1m ²	NADIS

Source of tiles unknown. Main roofs are natural slate.

No further action required

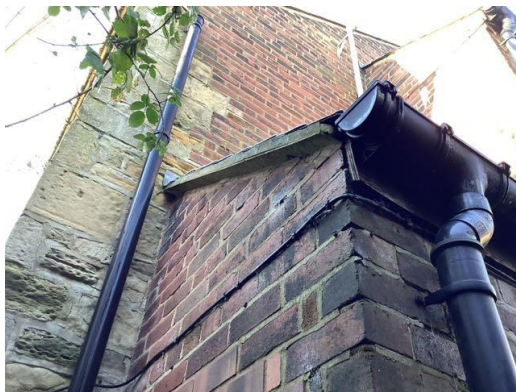
Sample	Icon	Location	Sample description	Quantity	Asbestos type
S004

External	External - Verge boards	2LM	NADIS

No further action required

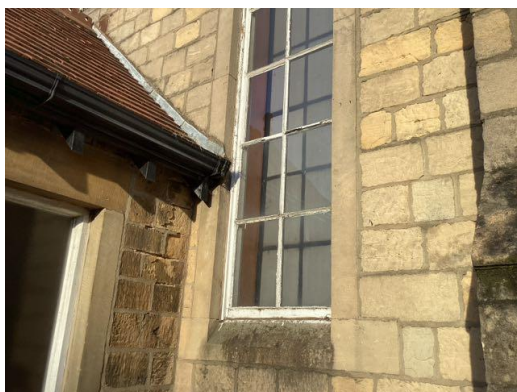
Sample	Icon	Location	Sample description	Quantity	Asbestos type
S005

External	External - Mastic to windows	NQ	NADIS

No further action required

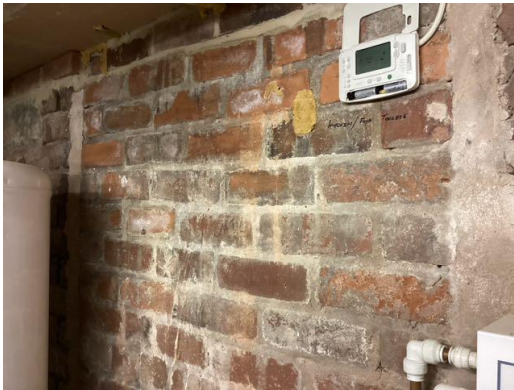
Sample	Icon	Location	Sample description	Quantity	Asbestos type
S006

BA1	Internal wall - Insulation residues to wall	NQ	NADIS

No further action required

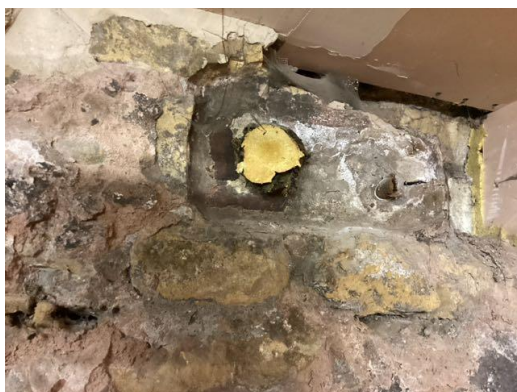
Sample	Icon	Location	Sample description	Quantity	Asbestos type
S007

BA1	Internal wall - Wrap to pipe	1LM	NADIS

No further action required

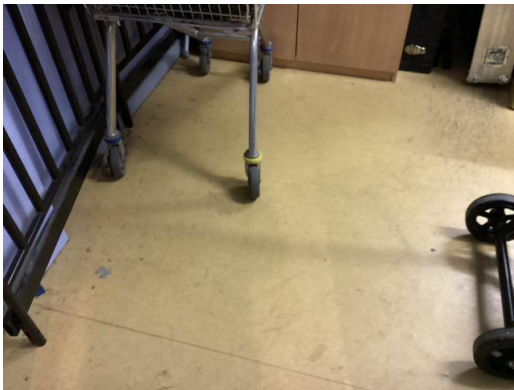
Sample	Icon	Location	Sample description	Quantity	Asbestos type
V002/a	V	GF004	Floor - Vinyl Flooring	15m ²	NADIS

No further action required

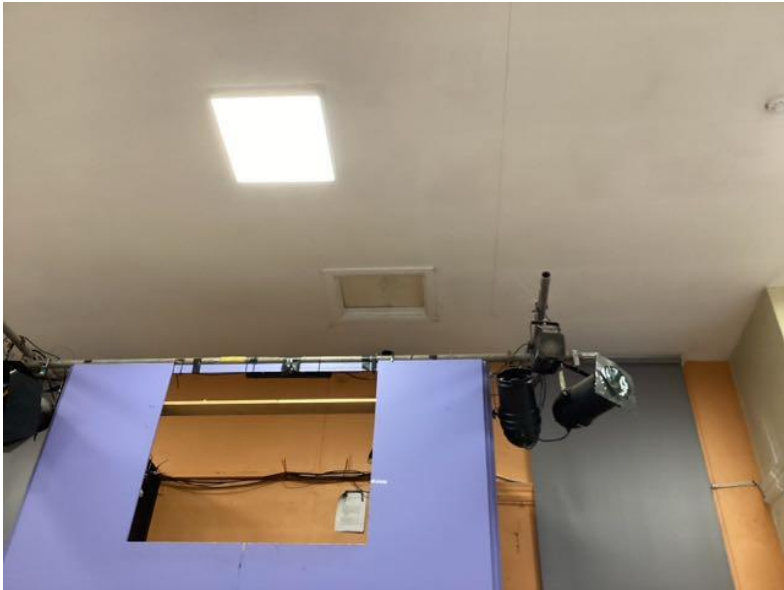
Location:	GF3

Notes:	The room could not be accessed due to height.

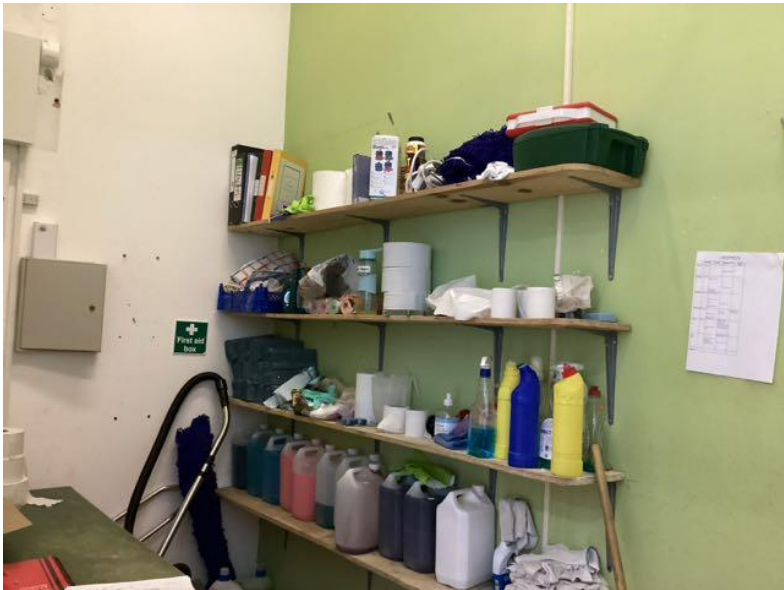
Location:	GF4

Notes:	Plaster ceilings and walls with concrete flooring.

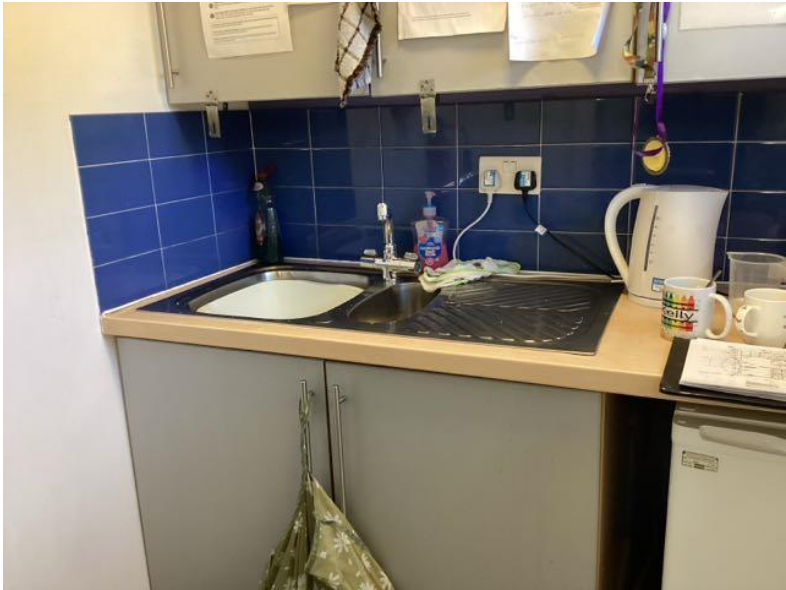
Location:	GF10

Notes:	Modern sink unit.

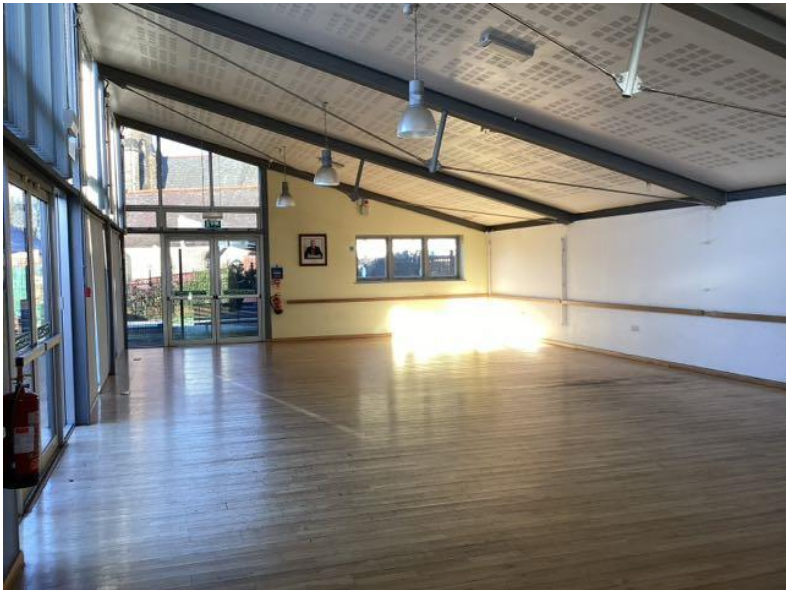
Location:	1F12

Notes:	Plasterboard ceiling and walls, steel beams and timber flooring.

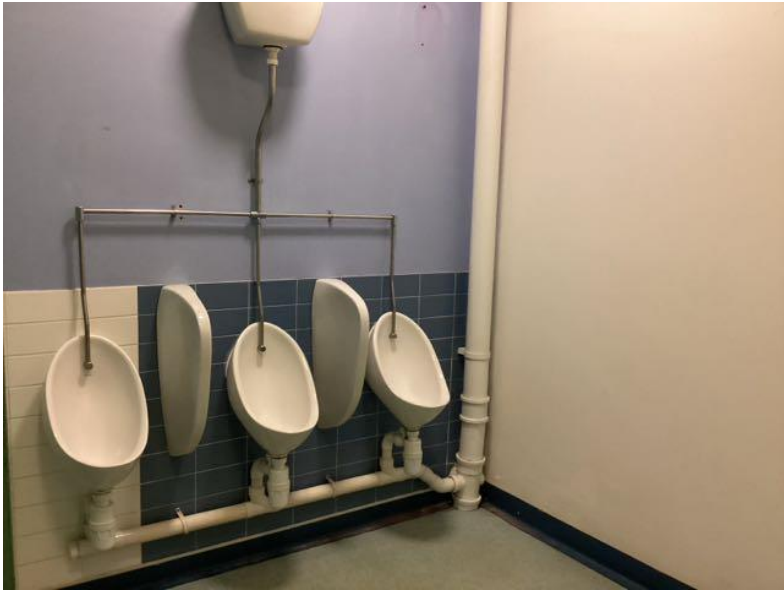
Location:	GF14

Notes:	Plasterboard ceiling and walls, ceramic sanitary ware with modern vinyl flooring.

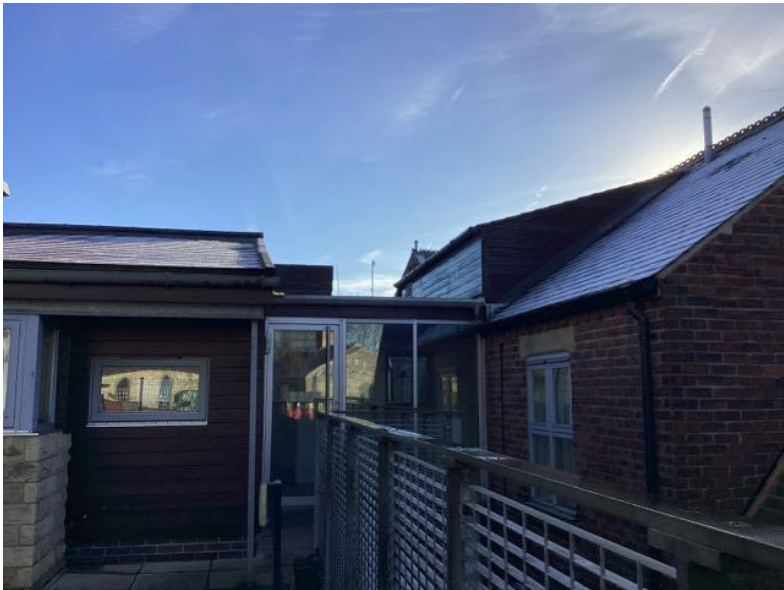
Location:	External

Notes:	Slate roof tiles.

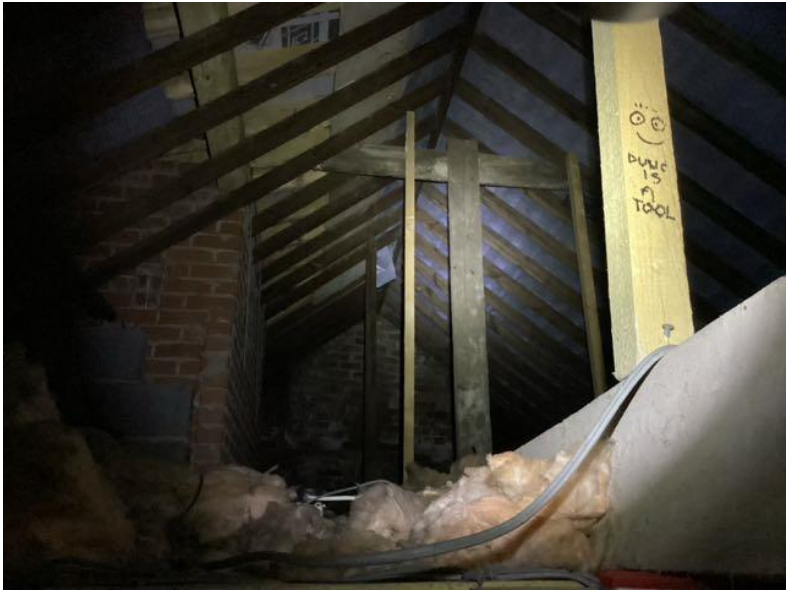
Location:	1F4 ceiling void

Notes:	Modern sarking felt, timber frame, brick walls and MMMF insulation.

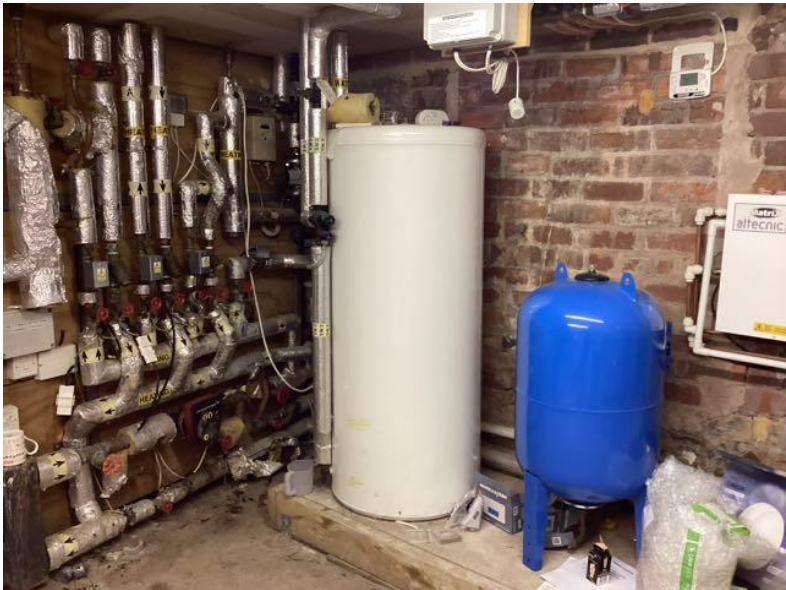
Location:	BA1

Notes:	Modern water heater.

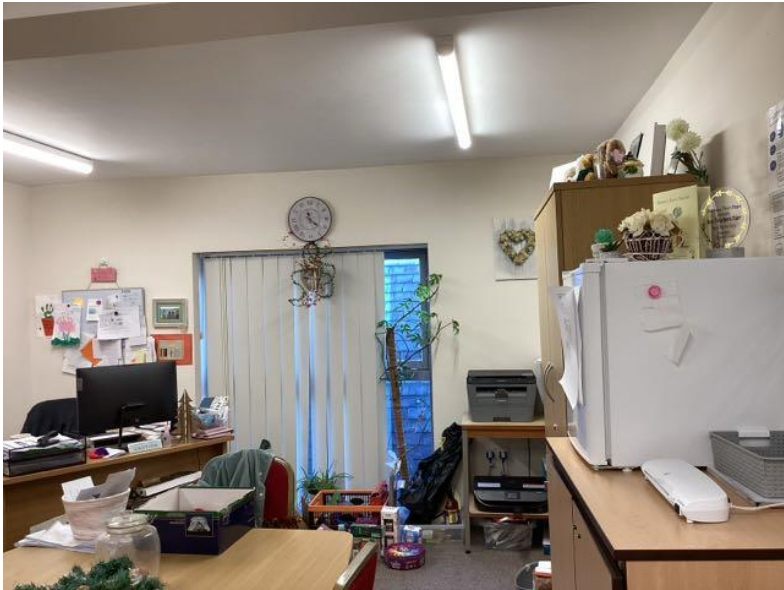
Location:	1F4

Notes:	Plasterboard ceiling and walls with carpet flooring.

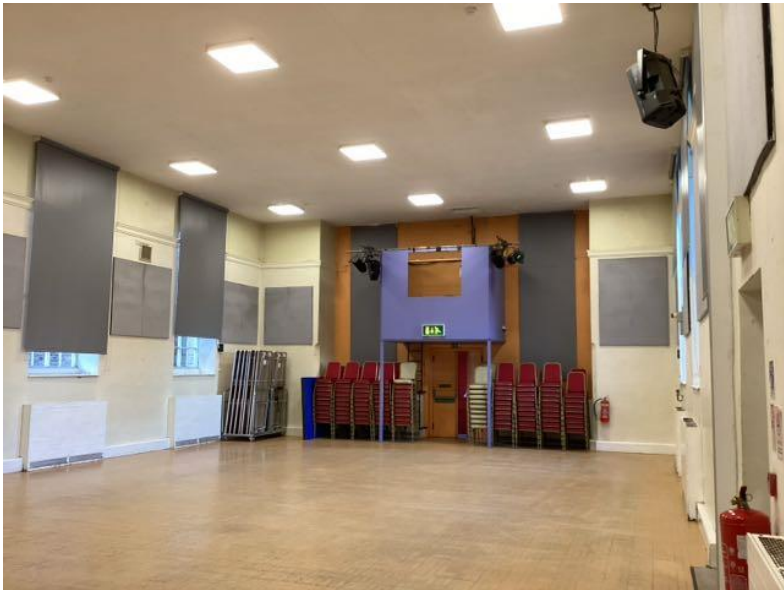
Location:	GF3

Notes:	Plasterboard ceiling and walls, ceramic tile floor, timber stage and modern plastic skirting.

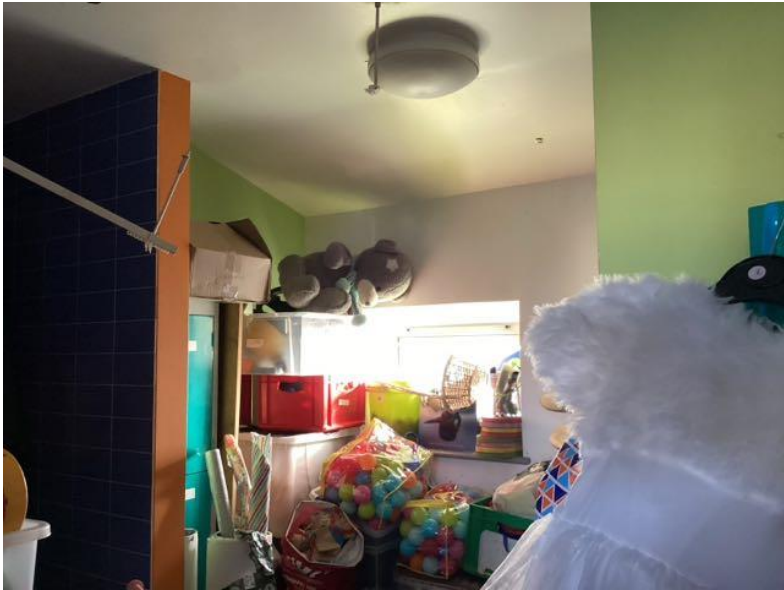
Location:	1F5

Notes:	Plasterboard ceiling and walls with modern vinyl flooring.

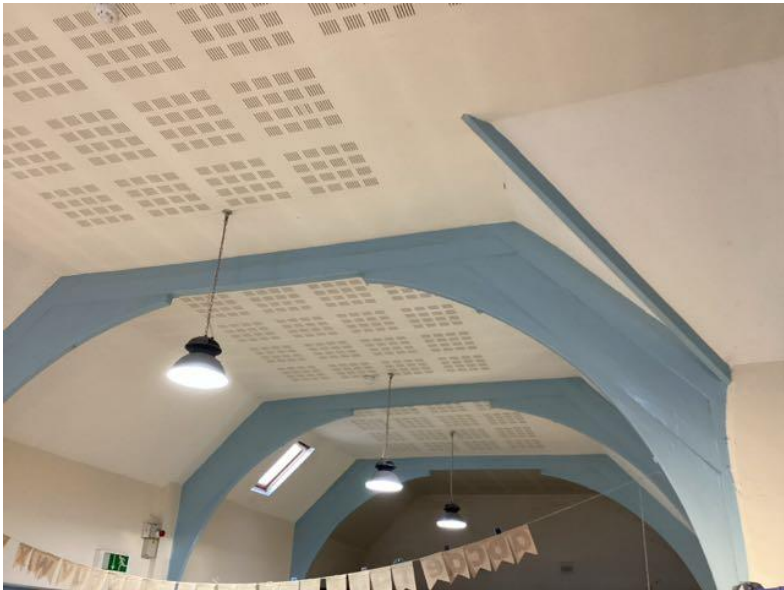
Location:	GF7

Notes:	Plaster ceiling, timber beams and plaster walls with laminate flooring.

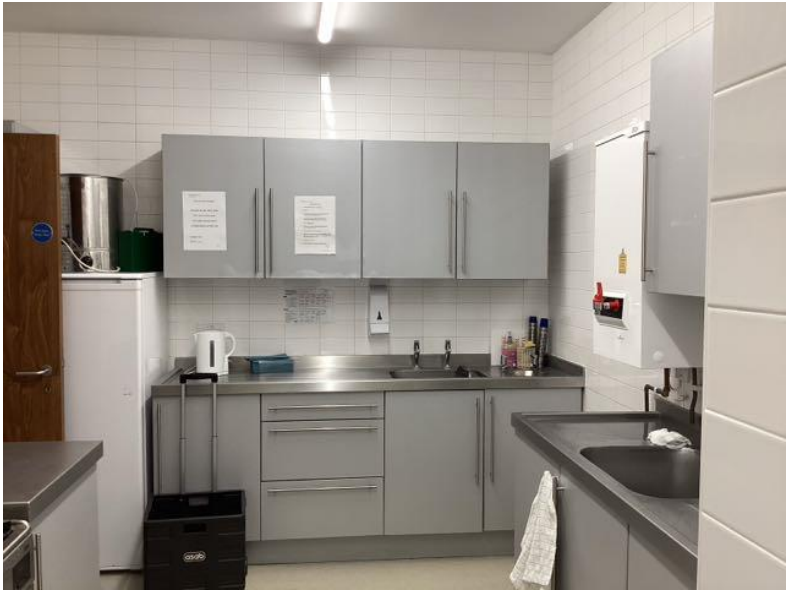
Location:	GF16

Notes:	Plasterboard ceiling and walls, modern sink and water heater with modern vinyl flooring.

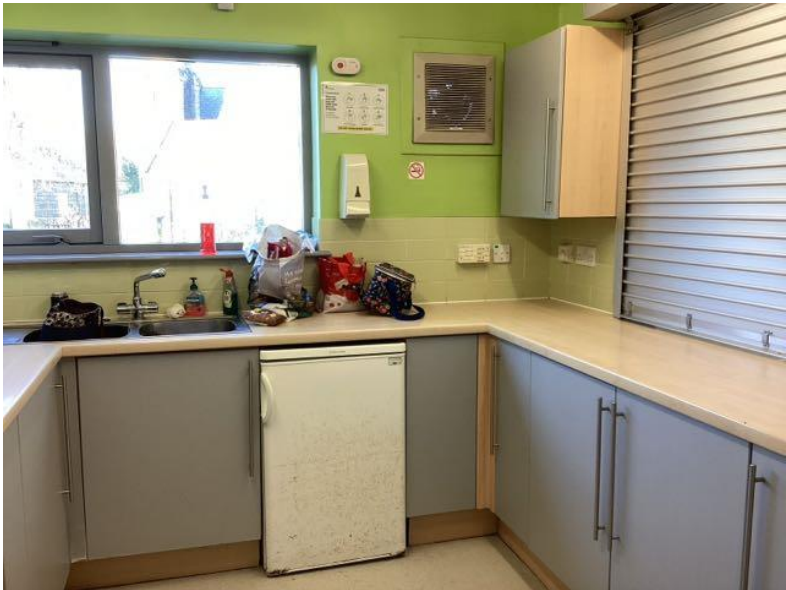
Location:	1F8

Notes:	Plasterboard ceiling and walls, modern sink unit with modern vinyl flooring.

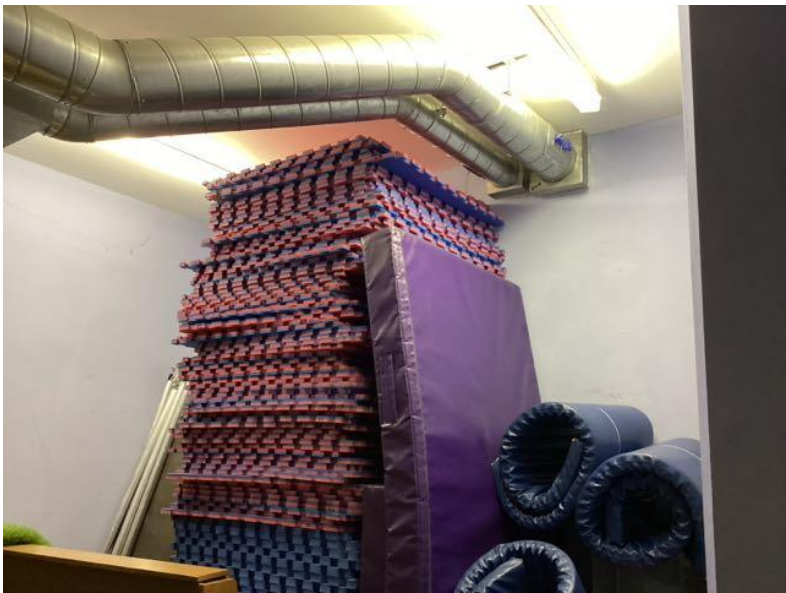
Location:	GF4

Notes:	Plasterboard ceiling and walls with metal ducting.

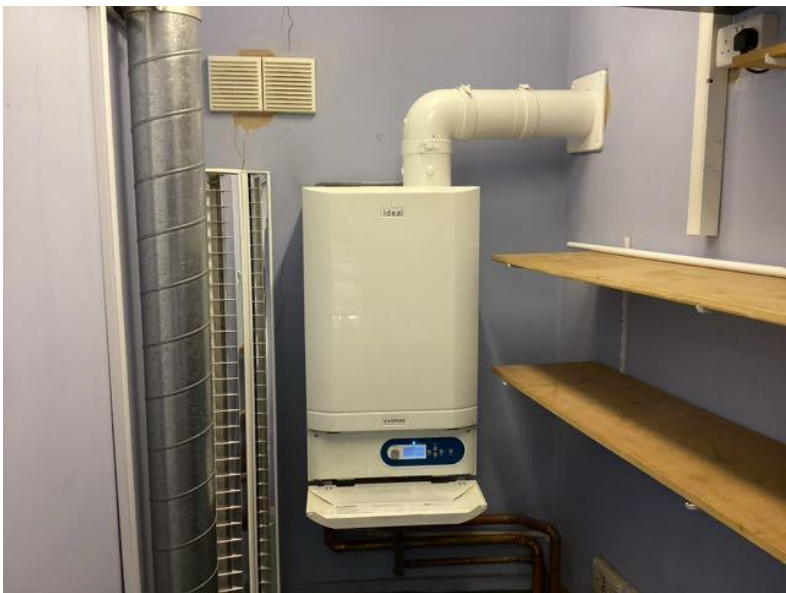
Location:	1F3

Notes:	Modern boiler unit.

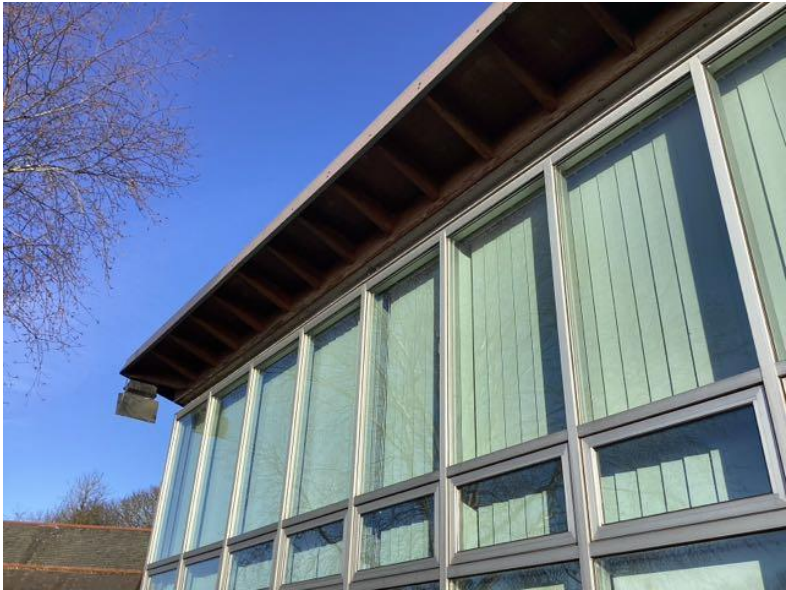
Location:	External

Notes:	Metal windows and timber soffits.

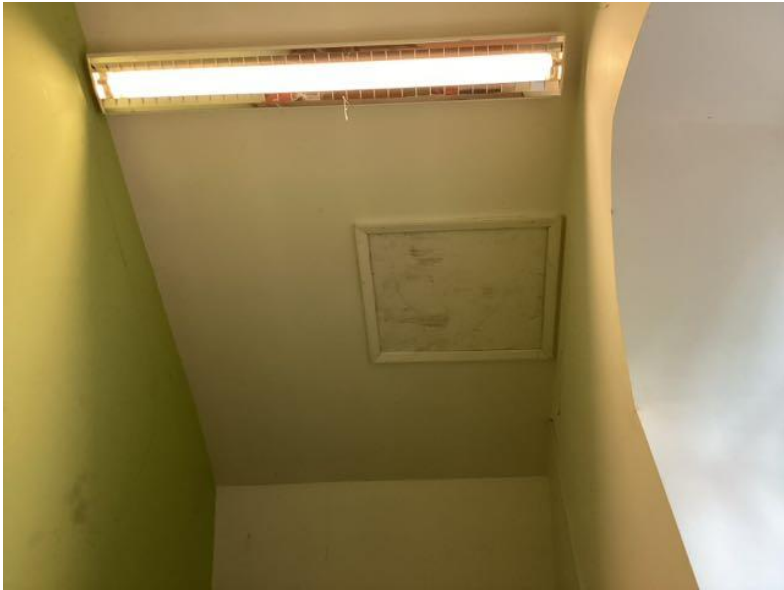
Location:	GF4

Notes:	The room could not be accessed due to height.
