Report and Register on Management Asbestos Survey

**The Explosion Museum
Priddy's Hard
Gosport
Hampshire**

Ref: 12.7352

January 2013

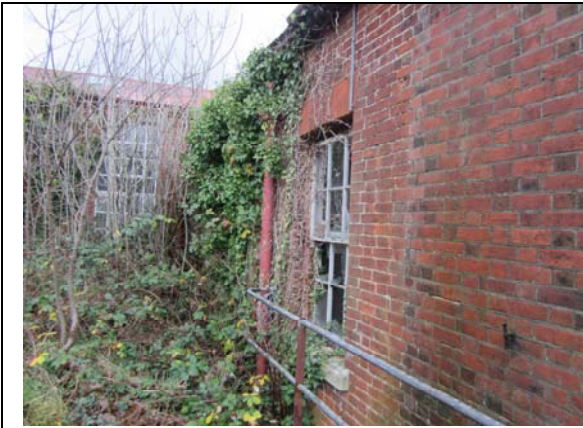
Photo 4

Ref	Int/ Ext	Zone/ Building	Description	Photo	Asbestos	Type	Quantity Extent	Comment
1	Ext	Rear of building 217	Rainwater down pipe	4,5	Asbestos Cement	Chrysotile	1no, 3m	NS/SP
2	Int	Building 214	Gasket card	6,7	Asbestos Card	Chrysotile	2m ²	In workshop area
3	Int	403b Toilet area	Toilet cistern	10,11	Asbestos reinforced Composite	Amosite	1no	NS/SP
4	Int	Building 305b	Pad to underside of sink	12,13	N.A.D.I.S	N.A.D.I.S		No Asbestos Detected in Sample
5	Int	Building 212	Pad to underside of sink	17,18	N.A.D.I.S	N.A.D.I.S		Reference sample 4

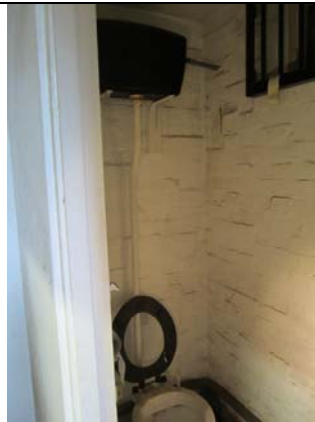
Photo 10

Ref	Building	Int/ Ext.	Sample Ref. or Vis ID	Photo Ref.	Description / Comments	Prod Type 1, 2 or 3	Damage 0, 1, 2 or 3	Surface Treat 0, 1, 2 or 3	Asbestos Type 0, 1, 2 or 3	Total Points	Access Low 1 Med 2 High 3	ID P SP A	Rmd E R MM None Other	Risk
A	Through out site	Int Ext	Vis ID	114	Flash guards to fuse & junction boxes	2	0	1	1	4	3	SP	MM	V Low
B	Through out site	Int Ext	Vis ID	174 175	Flash guards to older style lamp posts	2	0	1	1	4	3	SP	MM	V Low
C	Through out site	Int Ext	Vis ID	176 177	Bituminous board to junction boxes	1	0	0	1	2	2	SP	MM	V Low
1	Rear of building 217	Ext	Vis ID	4,5	Rain water down pipe	1	1	1	1	4	2	SP	MM	V Low
2	403b Toilet area	Int	2	6,7	Gasket card	2	0	1	2	5	3	A	MM	Low
3	403b Toilet area	Int	Vis ID	10,11	Black toilet cistern	1	0	0	2	3	3	SP	MM	V Low

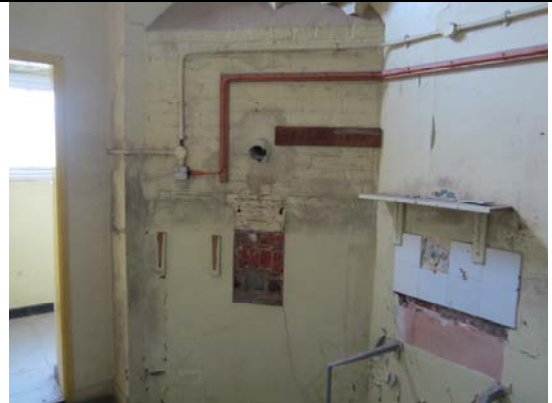
Photo 80

Ref	Building	Int/ Ext.	Sample Ref. or Vis ID	Photo Ref.	Description / Comments	Prod Type 1, 2 or 3	Damage 0, 1, 2 or 3	Surface Treat 0, 1, 2 or 3	Asbestos Type 0, 1, 2 or 3	Total Points	Access Low 1 Med 2 High 3	ID P SP A	Rmd E R MM None Other	Risk
6	Conservat -ion office 212	Int	Vis ID	14,15, 16	ACM located above ceiling partition	2	0	1	2	5	2	SP	MM	Low
7	Conservat -ion office 212	Int	Vis ID	19,20	Fire resistant safe	2	0	1	2	5	1	SP	MM	Low
8	Building 416	Int	Vis ID	21,22	Flash guards to fuse box	1	0	0	1	2	2	SP	MM	V Low
40	Building 217	Int	40	105	Vinyl tile floor covering	1	1	0	1	3	3	A	MM	V Low
42	Building 217	Int	Vis ID	107, 108	Internal panel to partition wall	2	1	2	2	7	3	SP	MM	Med
43	Admin 208	Int	Vis ID	80,81	Flue remnants to wall in toilet area	1	1	1	1	1	3	SP	MM	V Low

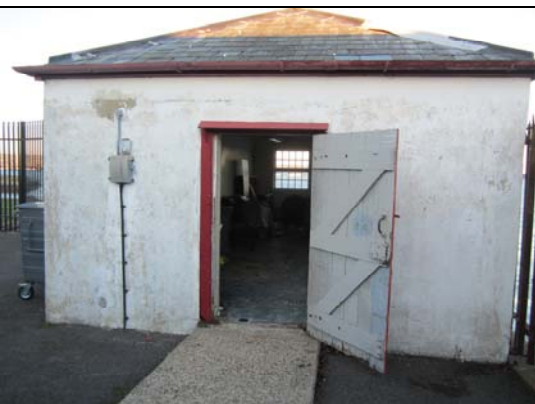
Photo 112

Ref	Int/ Ext	Zone/ Building	Description	Photo	Asbestos	Type	Quantity Extent	Comment
56	Int	Building 314	Vinyl floor tile and adhesive	112 113	Asbestos Reinforced Composite	Chrysotile	20m ²	Some damaged tiles
A	Ext	Through out site	Flash guards to fuse and junction boxes	114	Asbestos Textile	Chrysotile		Fuse and junction boxes located through out site
B	Ext	Through out site	Flash guards to lamp post fuses	174 175	Asbestos Textile	Chrysotile		To older lamp posts through out site.
C	Ext	Through out site	Bituminous board to junction boxes	176 177	Asbestos Reinforced Compound	Chrysotile

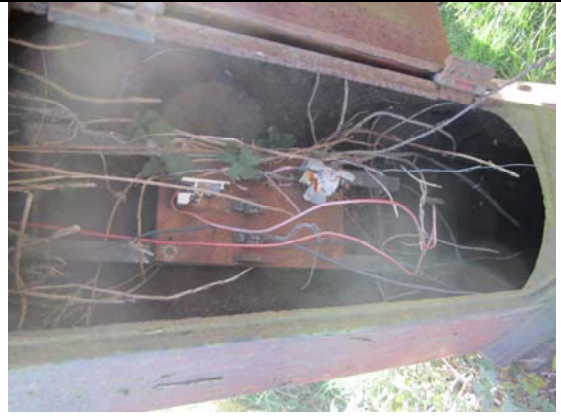
Photo 174

Ref	Building	Int/ Ext.	Sample Ref. or Vis ID	Photo Ref.	Description / Comments	Prod Type 1, 2 or 3	Damage 0, 1, 2 or 3	Surface Treat 0, 1, 2 or 3	Asbestos Type 0, 1, 2 or 3	Total Points	Access Low 1 Med 2 High 3	ID P SP A	Rmd E R MM None Other	Risk
52	Admin 208 Roof void	Int	Vis ID	95,96	Panels to underside of roof	1	0	1	1	3	3	SP	MM	V Low
53	Through out Admin 208	Int	53	98,99, 100	Lagging residue to pipes passing through walls	3	3	3	2	11	3	A	E R	High
54	Building 208,318	Ext	Vis ID	101	Rainwater goods	1	0	1	1	3	3	SP	MM	V Low
55	Museum	Int	Vis ID	109 110 111	Gaskets to exhibits	2	0	0	1	3	2	SP	MM	V Low
56	Building 314	Int	Vis ID	174 175	Vinyl tile floor covering	1	1	0	1	3	3	A	MM	V Low
