REFURBISHMENT SURVEY REPORT

SITE SURVEYED:
Midsomer Norton Town Hall
The Island
Midsomer Norton
BA3 2HQ

SURVEYED ON:
25/08/2021

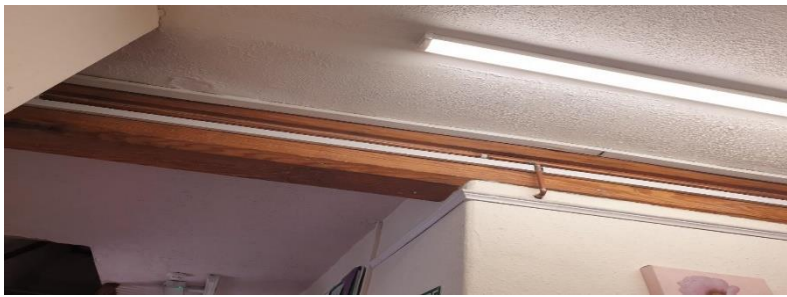
10	BS041340	1 st	Corridor				20m ²	
ID	Material Description		Product Type				Asbestos Type	
AD	Textured Coating to Ceiling		Textured Coating				Chrysotile	
Accessibility	Product Type	Extent of Damage	Surface Treatment	Asbestos Type	Total	Priority	Recommendation	Comments
High	1	1	1	1	4	Low	Remove if affected by refurbishment works	Work with this material to be carried out in accordance with the Control of Asbestos Regulations (2012). All waste to be disposed of in accordance with The Hazardous Waste Regulations 2005 as amended 2009.

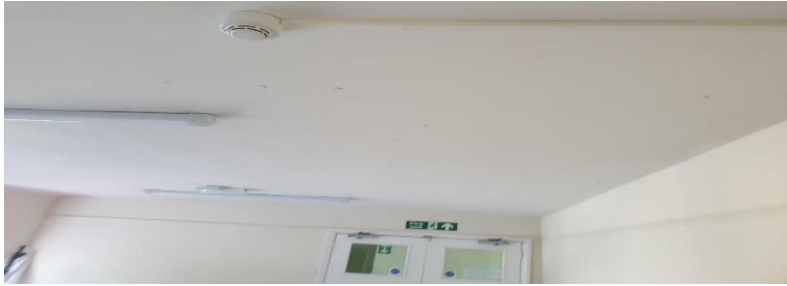
12	BS041342	1 st	Throughout				180m ²	
ID	Material Description		Product Type				Asbestos Type	
AD	Ceiling Boards		Cement				Chrysotile	
Accessibility	Product Type	Extent of Damage	Surface Treatment	Asbestos Type	Total	Priority	Recommendation	Comments
Med	1	1	1	1	4	Low	Remove if affected by refurbishment works	Work with this material to be carried out in accordance with the Control of Asbestos Regulations (2012). All waste to be disposed of in accordance with The Hazardous Waste Regulations 2005 as amended 2009.

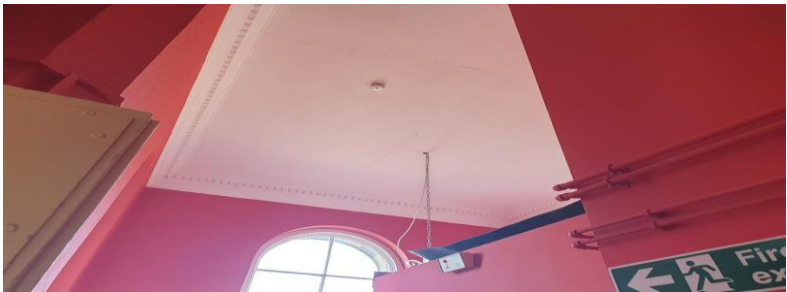
21	Front Stairwell	Ceiling Boards & Textured Coating	PTCA	Chrysotile	15m ²	Low
----	-----------------	---	------	------------	------------------	-----

21	Visual Inspection	2 nd	Front Stairwell				15m ²	
ID	Material Description		Product Type				Asbestos Type	
PTCA	Textured Coating to Ceiling/ Ceiling Boards		Textured Coating				Presumed Chrysotile	
Accessibility	Product Type	Extent of Damage	Surface Treatment	Asbestos Type	Total	Priority	Recommendation	Comments
Low	2	0	1	1	4	Low	Remove if affected by refurbishment works	Artex could be on an asbestos AIB or Cement board Work with this material to be carried out in accordance with the Control of Asbestos Regulations (2012). All waste to be disposed of in accordance with The Hazardous Waste Regulations 2005 as amended 2009.

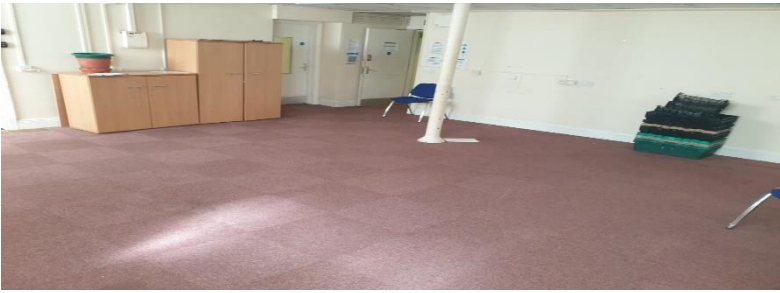
1	BS041331	Ground	Hall				N/A	
ID	Material Description		Product Type				Asbestos Type	
NADIS	Vinyl Floor Tiles		N/A				N/A	
Accessibility	Product Type	Extent of Damage	Surface Treatment	Asbestos Type	Total	Priority	Recommendation	Comments
N/A	N/A	N/A	N/A	N/A	N/A	N/A	N/A

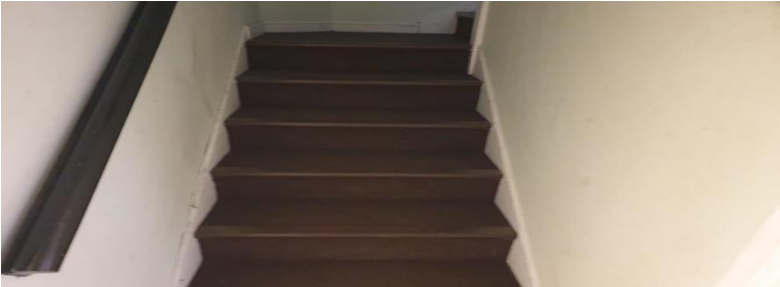
2	BS041332	Ground/ 1 st	Middle Stairwell				N/A	
ID	Material Description		Product Type				Asbestos Type	
NADIS	Stair Nosing		N/A				N/A	
Accessibility	Product Type	Extent of Damage	Surface Treatment	Asbestos Type	Total	Priority	Recommendation	Comments
N/A	N/A	N/A	N/A	N/A	N/A	N/A	N/A

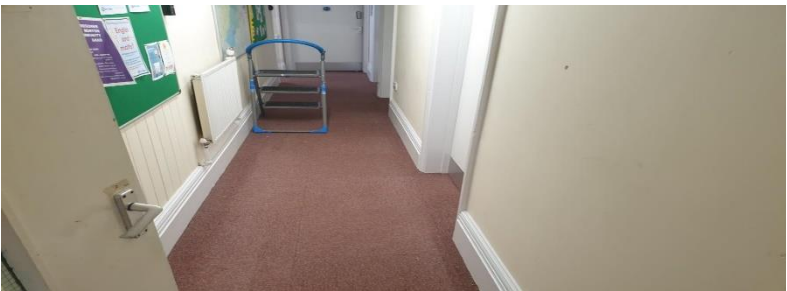
3	BS041333	Ground	Meeting Rooms				N/A	
ID	Material Description		Product Type				Asbestos Type	
NADIS	Floor Adhesive		N/A				N/A	
Accessibility	Product Type	Extent of Damage	Surface Treatment	Asbestos Type	Total	Priority	Recommendation	Comments
N/A	N/A	N/A	N/A	N/A	N/A	N/A	N/A

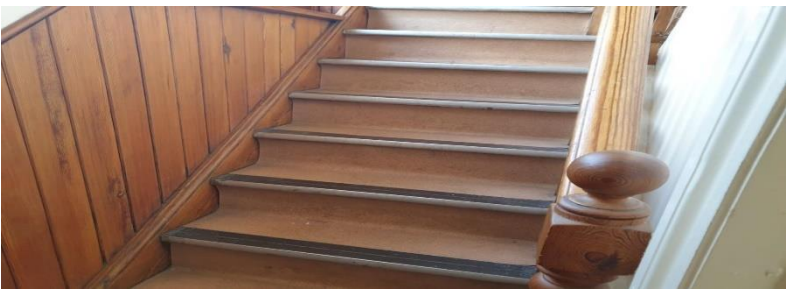
4	BS041334	Ground, 1 st & 2 nd	End Stairwell				N/A	
ID	Material Description		Product Type				Asbestos Type	
NADIS	Stair Nosing		N/A				N/A	
Accessibility	Product Type	Extent of Damage	Surface Treatment	Asbestos Type	Total	Priority	Recommendation	Comments
N/A	N/A	N/A	N/A	N/A	N/A	N/A	N/A

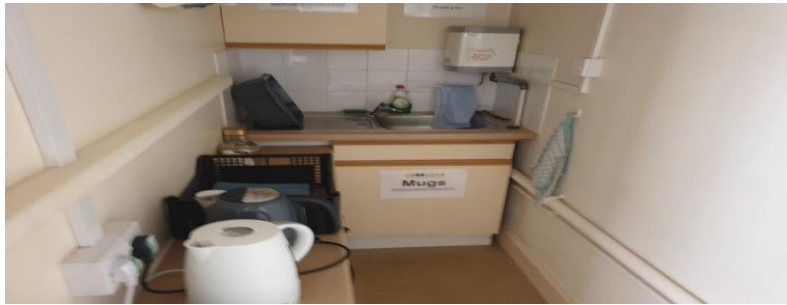
5	BS041335	Ground	Kitchen				N/A	
ID	Material Description		Product Type				Asbestos Type	
NADIS	Sink Pad		N/A				N/A	
Accessibility	Product Type	Extent of Damage	Surface Treatment	Asbestos Type	Total	Priority	Recommendation	Comments
N/A	N/A	N/A	N/A	N/A	N/A	N/A	N/A

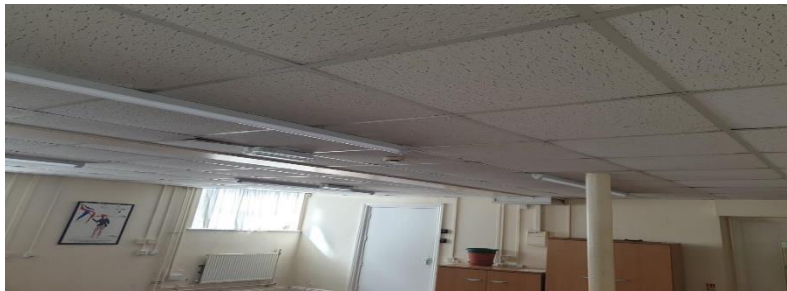
6	BS041336	Ground	Throughout				N/A	
ID	Material Description		Product Type				Asbestos Type	
NADIS	Ceiling Tiles		N/A				N/A	
Accessibility	Product Type	Extent of Damage	Surface Treatment	Asbestos Type	Total	Priority	Recommendation	Comments
N/A	N/A	N/A	N/A	N/A	N/A	N/A	N/A

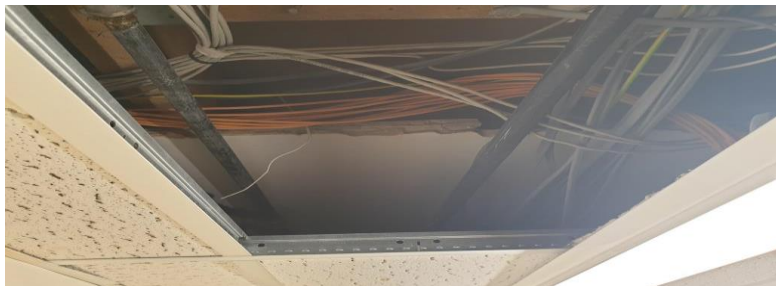
7	BS041337	Ground	Throughout				N/A	
ID	Material Description		Product Type				Asbestos Type	
NADIS	Ceiling Boards		N/A				N/A	
Accessibility	Product Type	Extent of Damage	Surface Treatment	Asbestos Type	Total	Priority	Recommendation	Comments
N/A	N/A	N/A	N/A	N/A	N/A	N/A	N/A

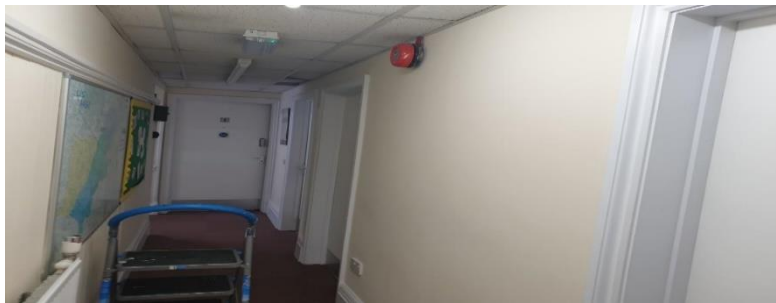
8	BS041338	Ground	Throughout				N/A	
ID	Material Description		Product Type				Asbestos Type	
NADIS	Wall sample		N/A				N/A	
Accessibility	Product Type	Extent of Damage	Surface Treatment	Asbestos Type	Total	Priority	Recommendation	Comments
N/A	N/A	N/A	N/A	N/A	N/A	N/A	N/A

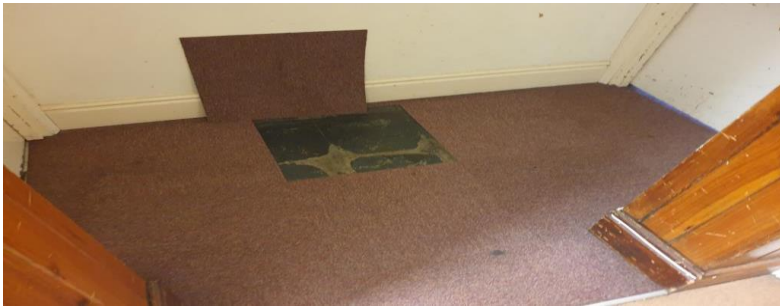
9	BS041339	1 st	Corridor				N/A	
ID	Material Description		Product Type				Asbestos Type	
NADIS	Floor Covering		N/A				N/A	
Accessibility	Product Type	Extent of Damage	Surface Treatment	Asbestos Type	Total	Priority	Recommendation	Comments
N/A	N/A	N/A	N/A	N/A	N/A	N/A	N/A

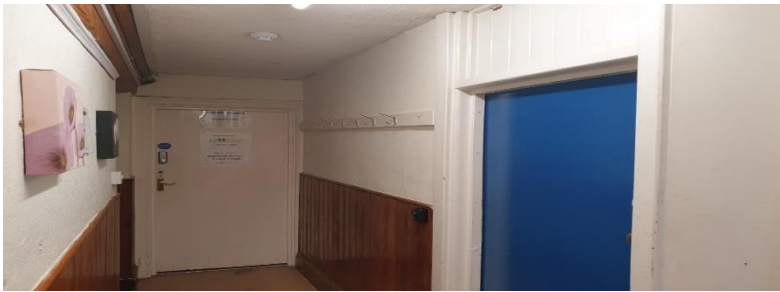
11	BS041341	1 st	Throughout				N/A	
ID	Material Description		Product Type				Asbestos Type	
NADIS	Wall Sample		N/A				N/A	
Accessibility	Product Type	Extent of Damage	Surface Treatment	Asbestos Type	Total	Priority	Recommendation	Comments
N/A	N/A	N/A	N/A	N/A	N/A	N/A	N/A

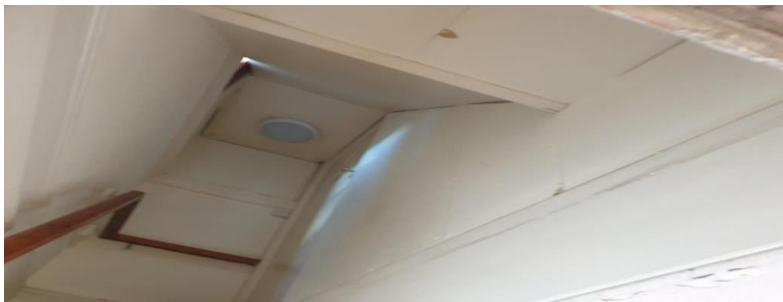
13	BS041343	2 nd	Stairwell				N/A	
ID	Material Description		Product Type				Asbestos Type	
NADIS	Wall Boards		N/A				N/A	
Accessibility	Product Type	Extent of Damage	Surface Treatment	Asbestos Type	Total	Priority	Recommendation	Comments
N/A	N/A	N/A	N/A	N/A	N/A	N/A	N/A

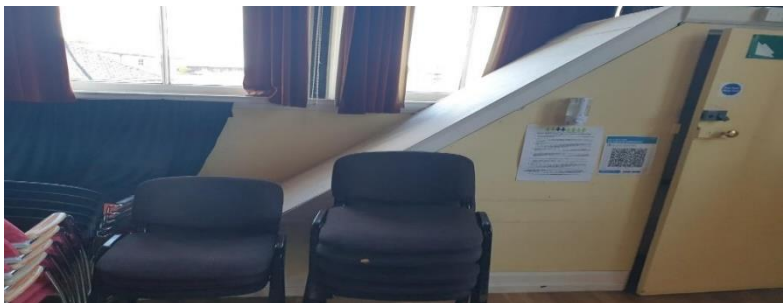
14	BS041344	2 nd	Stairwell				N/A	
ID	Material Description		Product Type				Asbestos Type	
NADIS	Wall Boards		N/A				N/A	
Accessibility	Product Type	Extent of Damage	Surface Treatment	Asbestos Type	Total	Priority	Recommendation	Comments
N/A	N/A	N/A	N/A	N/A	N/A	N/A	N/A

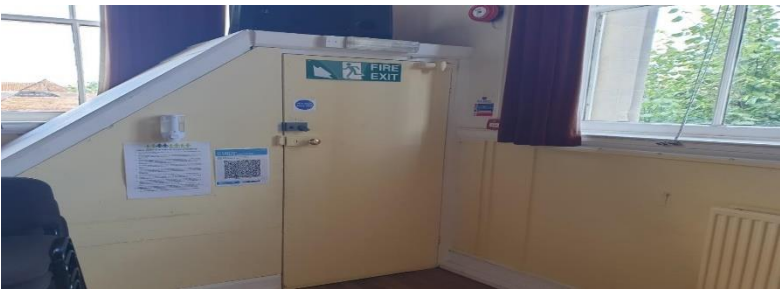
15	BS041345	2 nd	Stairwell				N/A	
ID	Material Description		Product Type				Asbestos Type	
NADIS	Door Lining		N/A				N/A	
Accessibility	Product Type	Extent of Damage	Surface Treatment	Asbestos Type	Total	Priority	Recommendation	Comments
N/A	N/A	N/A	N/A	N/A	N/A	N/A	N/A

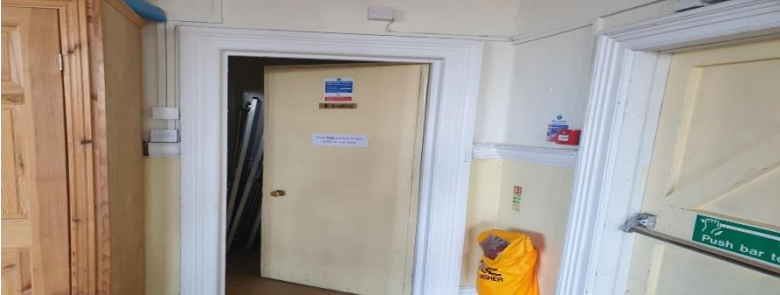
16	BS041346	2 nd	Toilet				N/A	
ID	Material Description		Product Type				Asbestos Type	
NADIS	Door Lining		N/A				N/A	
Accessibility	Product Type	Extent of Damage	Surface Treatment	Asbestos Type	Total	Priority	Recommendation	Comments
N/A	N/A	N/A	N/A	N/A	N/A	N/A	N/A

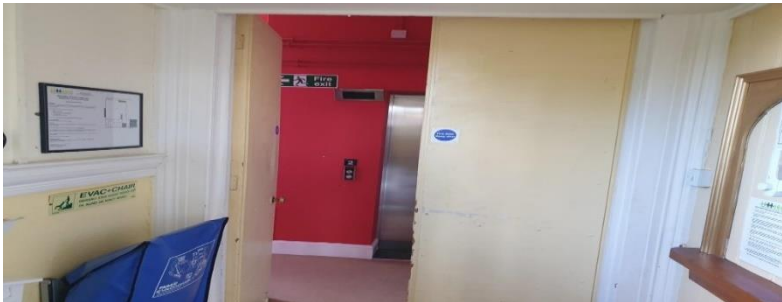
17	BS041347	2 nd	Hall				N/A	
ID	Material Description		Product Type				Asbestos Type	
NADIS	Door Lining		N/A				N/A	
Accessibility	Product Type	Extent of Damage	Surface Treatment	Asbestos Type	Total	Priority	Recommendation	Comments
N/A	N/A	N/A	N/A	N/A	N/A	N/A	N/A

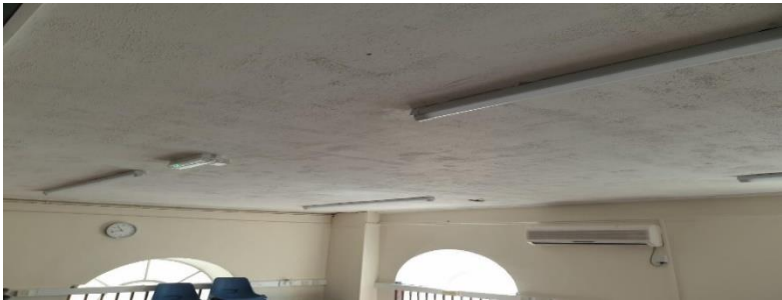
18	BS041348	1 st	Meeting Room				N/A	
ID	Material Description		Product Type				Asbestos Type	
NADIS	Textured Coating to Ceiling		N/A				N/A	
Accessibility	Product Type	Extent of Damage	Surface Treatment	Asbestos Type	Total	Priority	Recommendation	Comments
N/A	N/A	N/A	N/A	N/A	N/A	N/A	N/A

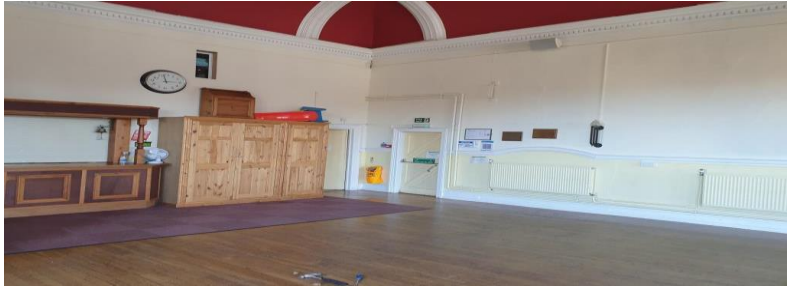
19	BS041349	2 nd	Throughout				N/A	
ID	Material Description		Product Type				Asbestos Type	
NADIS	Wall Sample		N/A				N/A	
Accessibility	Product Type	Extent of Damage	Surface Treatment	Asbestos Type	Total	Priority	Recommendation	Comments
N/A	N/A	N/A	N/A	N/A	N/A	N/A	N/A

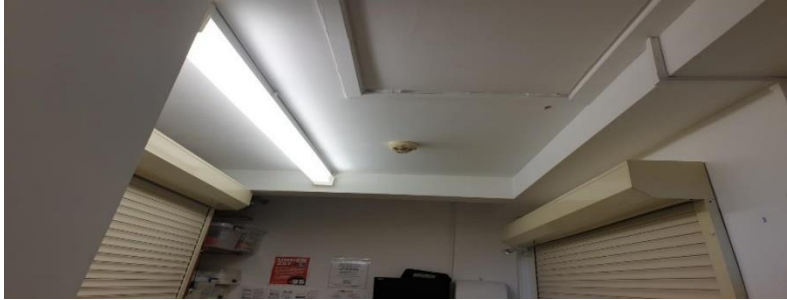
20	BS041350	2 nd	Throughout				N/A	
ID	Material Description		Product Type				Asbestos Type	
NADIS	Ceiling Boards		N/A				N/A	
Accessibility	Product Type	Extent of Damage	Surface Treatment	Asbestos Type	Total	Priority	Recommendation	Comments
N/A	N/A	N/A	N/A	N/A	N/A	N/A	N/A
