Chinley Community Centre

We are instructed to inspect the premises and report on its condition, with focus on the roof, cladding and floor structure. The cost and feasibility of a 5 to 10 year life extension is to be considered by the Parish Council.

Real View Building Surveyors Ltd

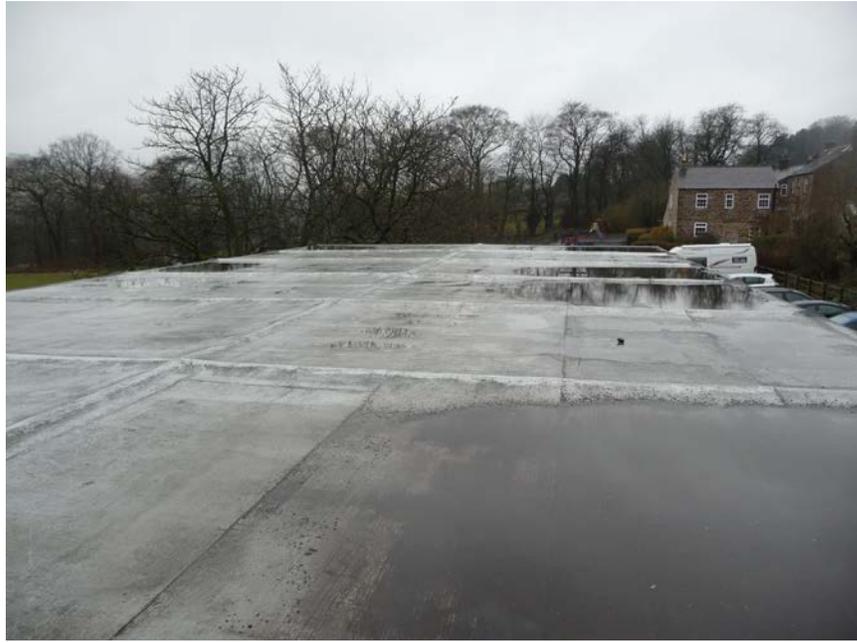
The flat roofs are covered in built up felt with solar coating. The roofs have ponding water due to inadequate falls. We were unable to view the roof joists or decking. Sample core exposure of the roofs could be undertaken to confirm the make-up. We noted a timber soffit and some insulation above the electrical board. This suggests a "cold" roof design.

Roof over the hall. Ponding due to inadequate fall

If a ten year life is required then an overlay system can be considered – such as felt or liquid applied coatings – 10 year warranties can be obtained from both options. This approach does not however improve the thermal efficiency. The more robust, long term solution would be to strip the existing, carry out underlying repairs then insulate and waterproof. 20 year warranties can be obtained.

We would recommend as a first step that a core is taken to check on the current level of insulation and the nature of the roof deck.

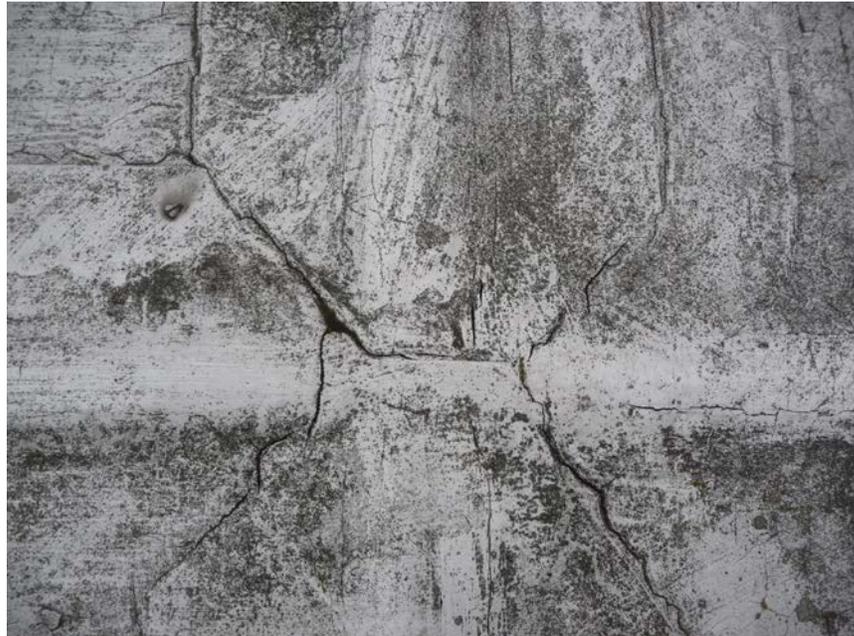
Turning to the roof areas, the felt has received a solar reflective application. Some crazing and surface cracks were noted at rib positions. There are also some soft spots to the deck – mostly to the left section. Overall however, the felt roof can be maintained for 5 years or so and possibly longer with some surface rejuvenation such as suitable coatings.

Surface cracks/crazing in the roof felt and coating

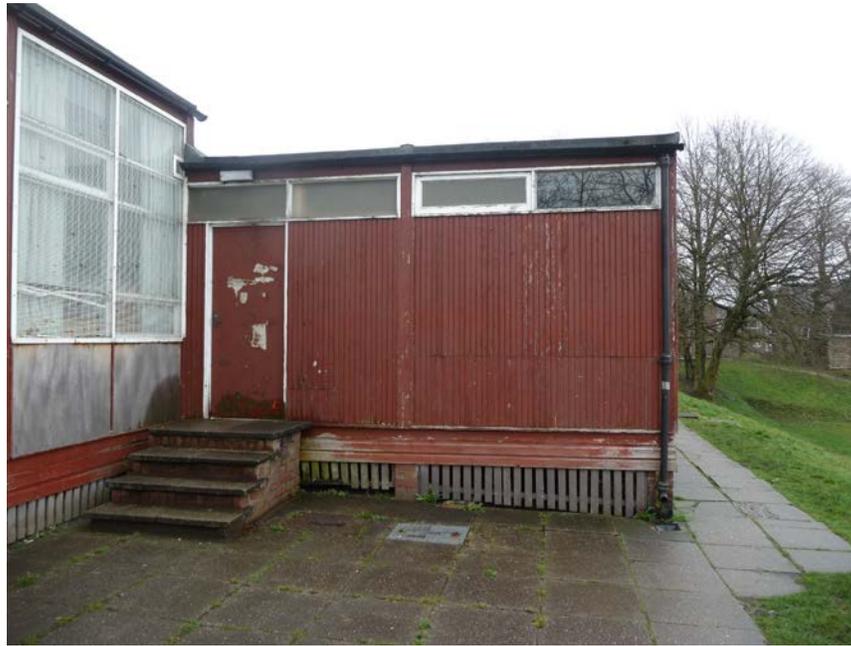
We noted one rotten section of flooring in the area of the male changing room by the external door. (There is a leak here). The decayed floor is also apparent from within. We would anticipate finding other areas – there is a higher risk along the front elevation where the floor gap is tight. Overall however, the majority of the timber floor appears in fair condition for its age. There is a slight raised lip in the hall (possibly the position of a former room?). The good level of ventilation has no doubt helped the floor resist more severe decay. We would advise against insulating the underside of the floor as this would restrict air movement to the timbers.

Typical elevation. The floor is rotten by the door

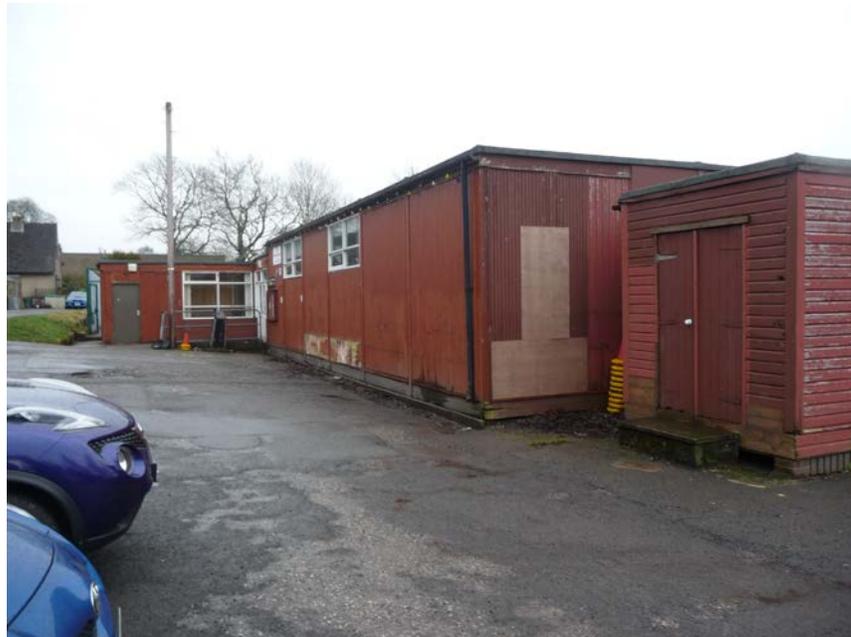
The site slopes gently from front to rear as shown by the modest sized ramp to the front compared with the substantial ramp to the rear doors.

It is understood the right hand store will be removed. Note sloping site, front to rear

We understand the right store extension is likely to be removed.

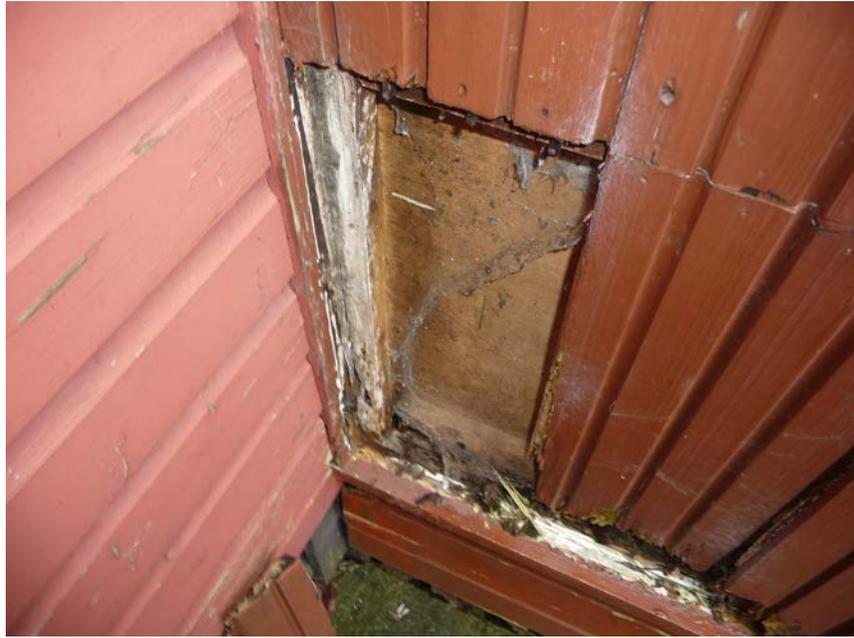
To the perimeter walls, there are clearly some decayed interim timber studs and batten sections within the “system”. Internal and external corner positions appear particularly affected. It is also likely that the timber sections framing out the window and door openings are more decayed than generally.

Decayed sub-framing

The timber cladding itself is in very poor condition. It will all have to be replaced. Its removal will allow the repair or replacement of the decayed interim sections noted above. At the same time, breathable membranes can be included and new insulation.

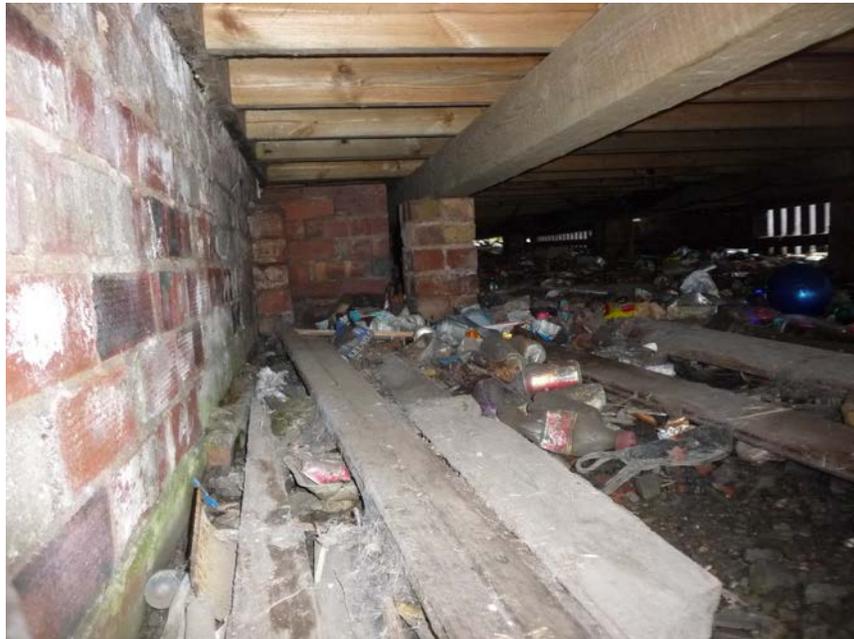
We could not get under the floor due to the perimeter slatted panels and also the sub-floor void is strewn with rubbish and this would need clearing out first due to remove any hazards. We could view the sub-floor void from the perimeter in a few locations at the rear. See photos.

Floor void at the rear

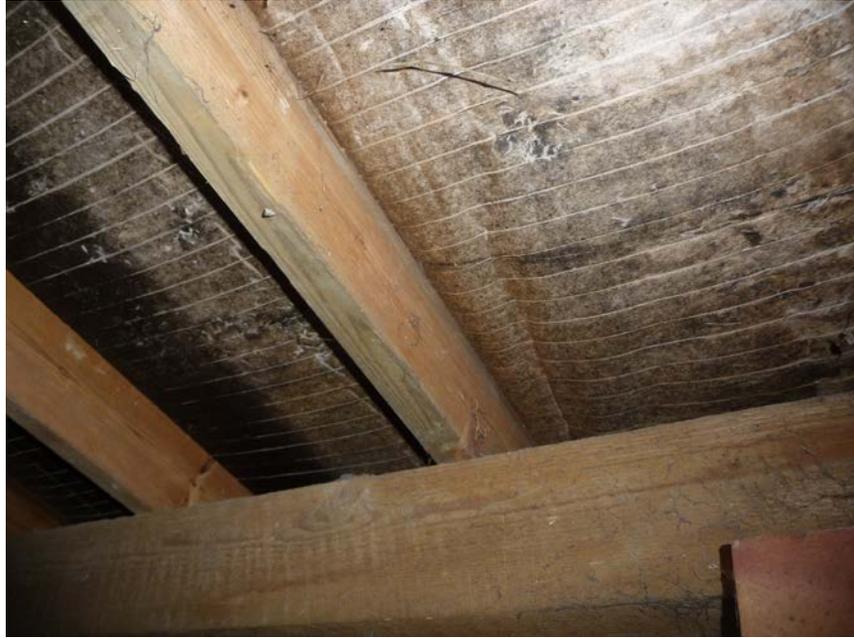
The floor for the remainder of the building comprises a grid of timber floor beams with timber joists and overlaid in timber panel flooring – seemingly plywood based on the floor that is visible in the chair store off the hall. There is a material membrane to the underside of the floor boarding. To the perimeter there is a timber wall plate at the base of the cladding.

Membrane to the underside of the floor

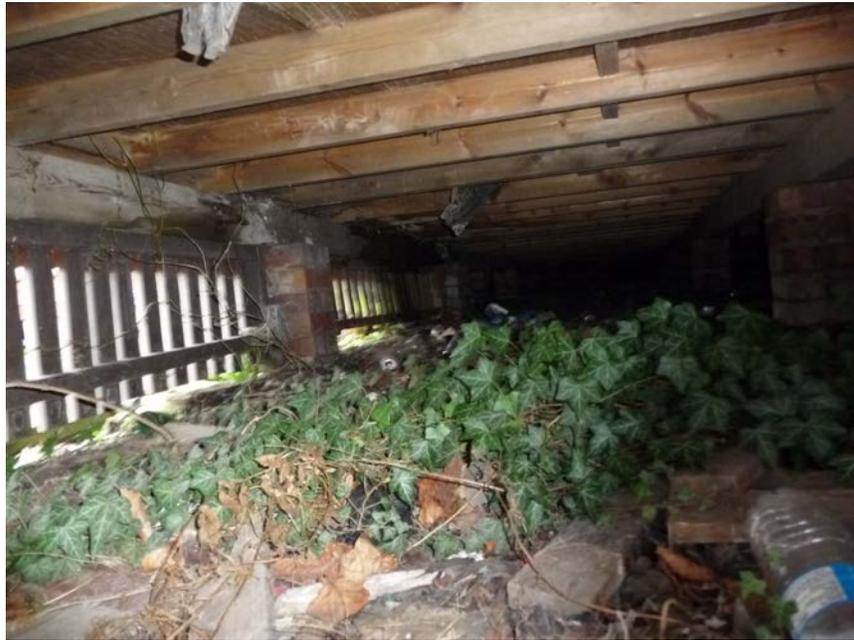
Floor void at the rear
