**St. Osyth Priory, Essex.
Repairs and Alterations
To the
Tithe Barn, Dairy and Cart Lodge**

Enabling Works Schedule

September 2022
Carden & Godfrey
33 Clerkenwell Close
London EC1R 0AU

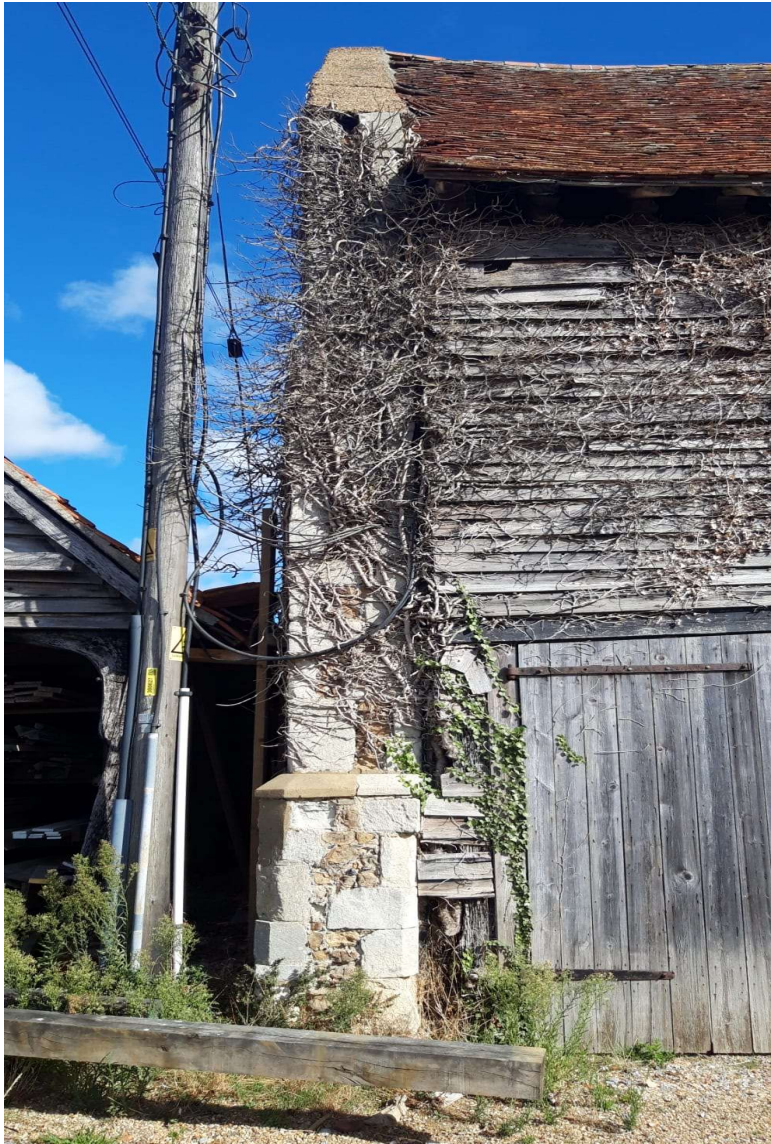
- 2.1.2 Externally, cut and remove the ivy from the full height of the southwest corner. Take care releasing the branches from the electrical sub-main cables which enter the barn at mid height from the adjacent timber pylon.

2.1.3 Subject to further inspection once ivy has been sufficiently cleared, construct a raking shore to buttress the southwest corner from the south, with horizontal timber ground plate, extending out from corner southwards, vertical board set against the subsided southwest framing post, and three diagonal raking struts fixed between the two plates, one from the top and two from either side of the first floor plate level.

Highlight and protect the outer base of the shore/buttress from vehicular damage, by securing a bright large warning bollard or similar.

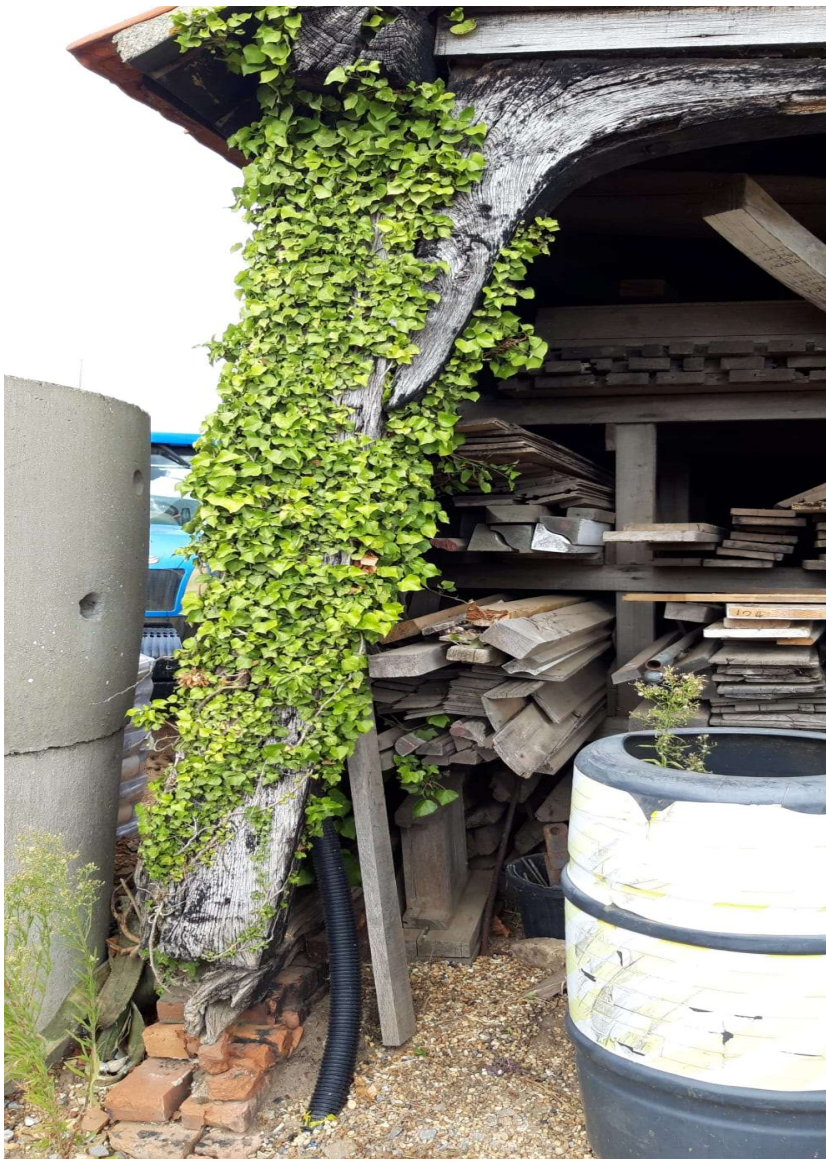
- 2.3.2 At south end similarly provide propping to the southwest post, where the sole plate and brick plinth have collapsed.

The prop needs to support the wall plate within the shed, just north of the post, and needs to be coordinated with the bracing and buttressing of this racked south elevation.

The prop is to be founded on the higher solid floor of the lodge interior.

First cut and clear away the ivy.

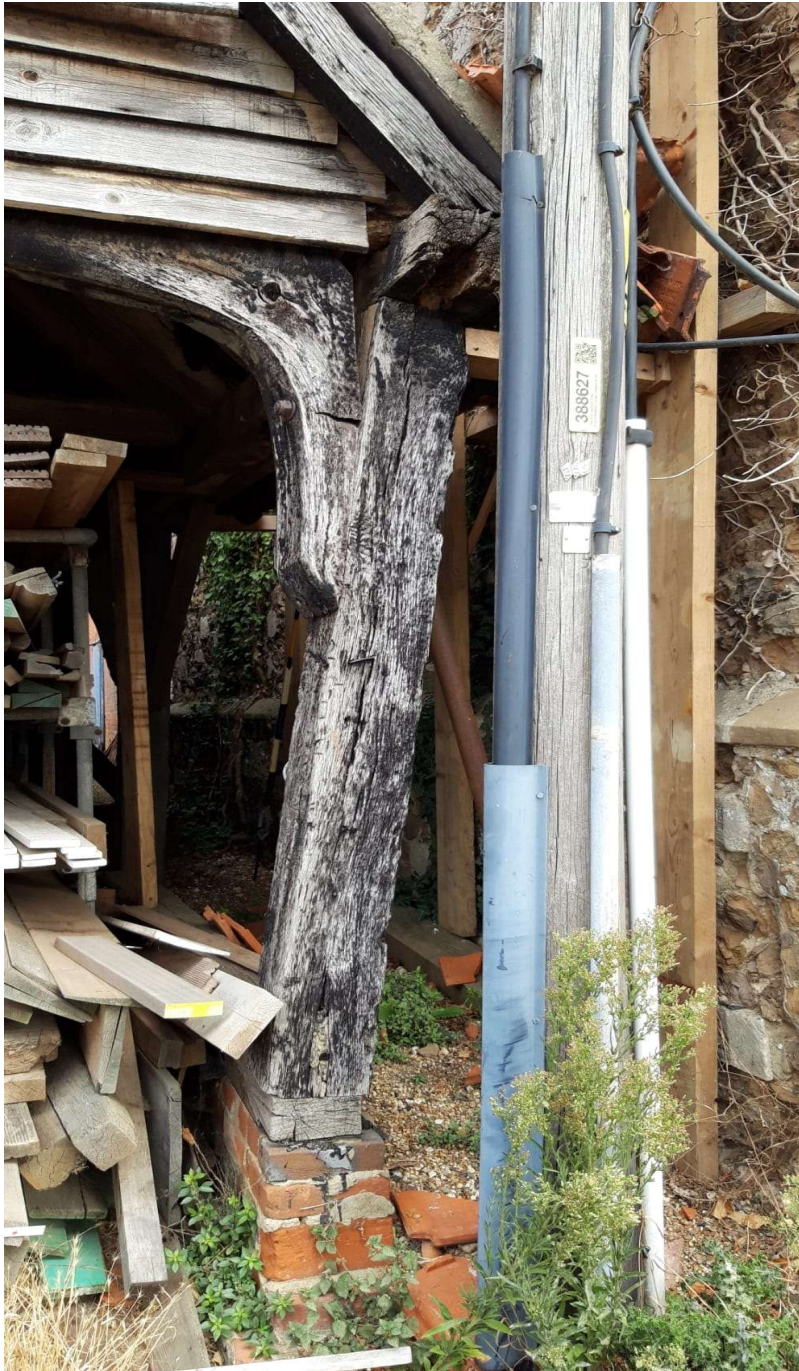
- 2.3.3. At the Southeast corner where the southeast mainframe post has been moved by roof thrust and failed principal tie beam joint approx.. 150 mm. away to the east, causing the bolted oak brace to fracture at its junction with the post. The movement strain is not being adequately restrained by the existing timber shores, which ought to be (not removed) supplemented by additional Accrow props and jacks boarded off the Tithe Barn's west wall plinth offset opposite.

The slipped Belgian clay pantiles should be removed from the base of the east roof slope and set aside for re-use on the Lodge.
