ASBESTOS TARGETED DEMOLITION SURVEY

MCA Beer

PROJECT NO. 70050787

DATE: May 2020

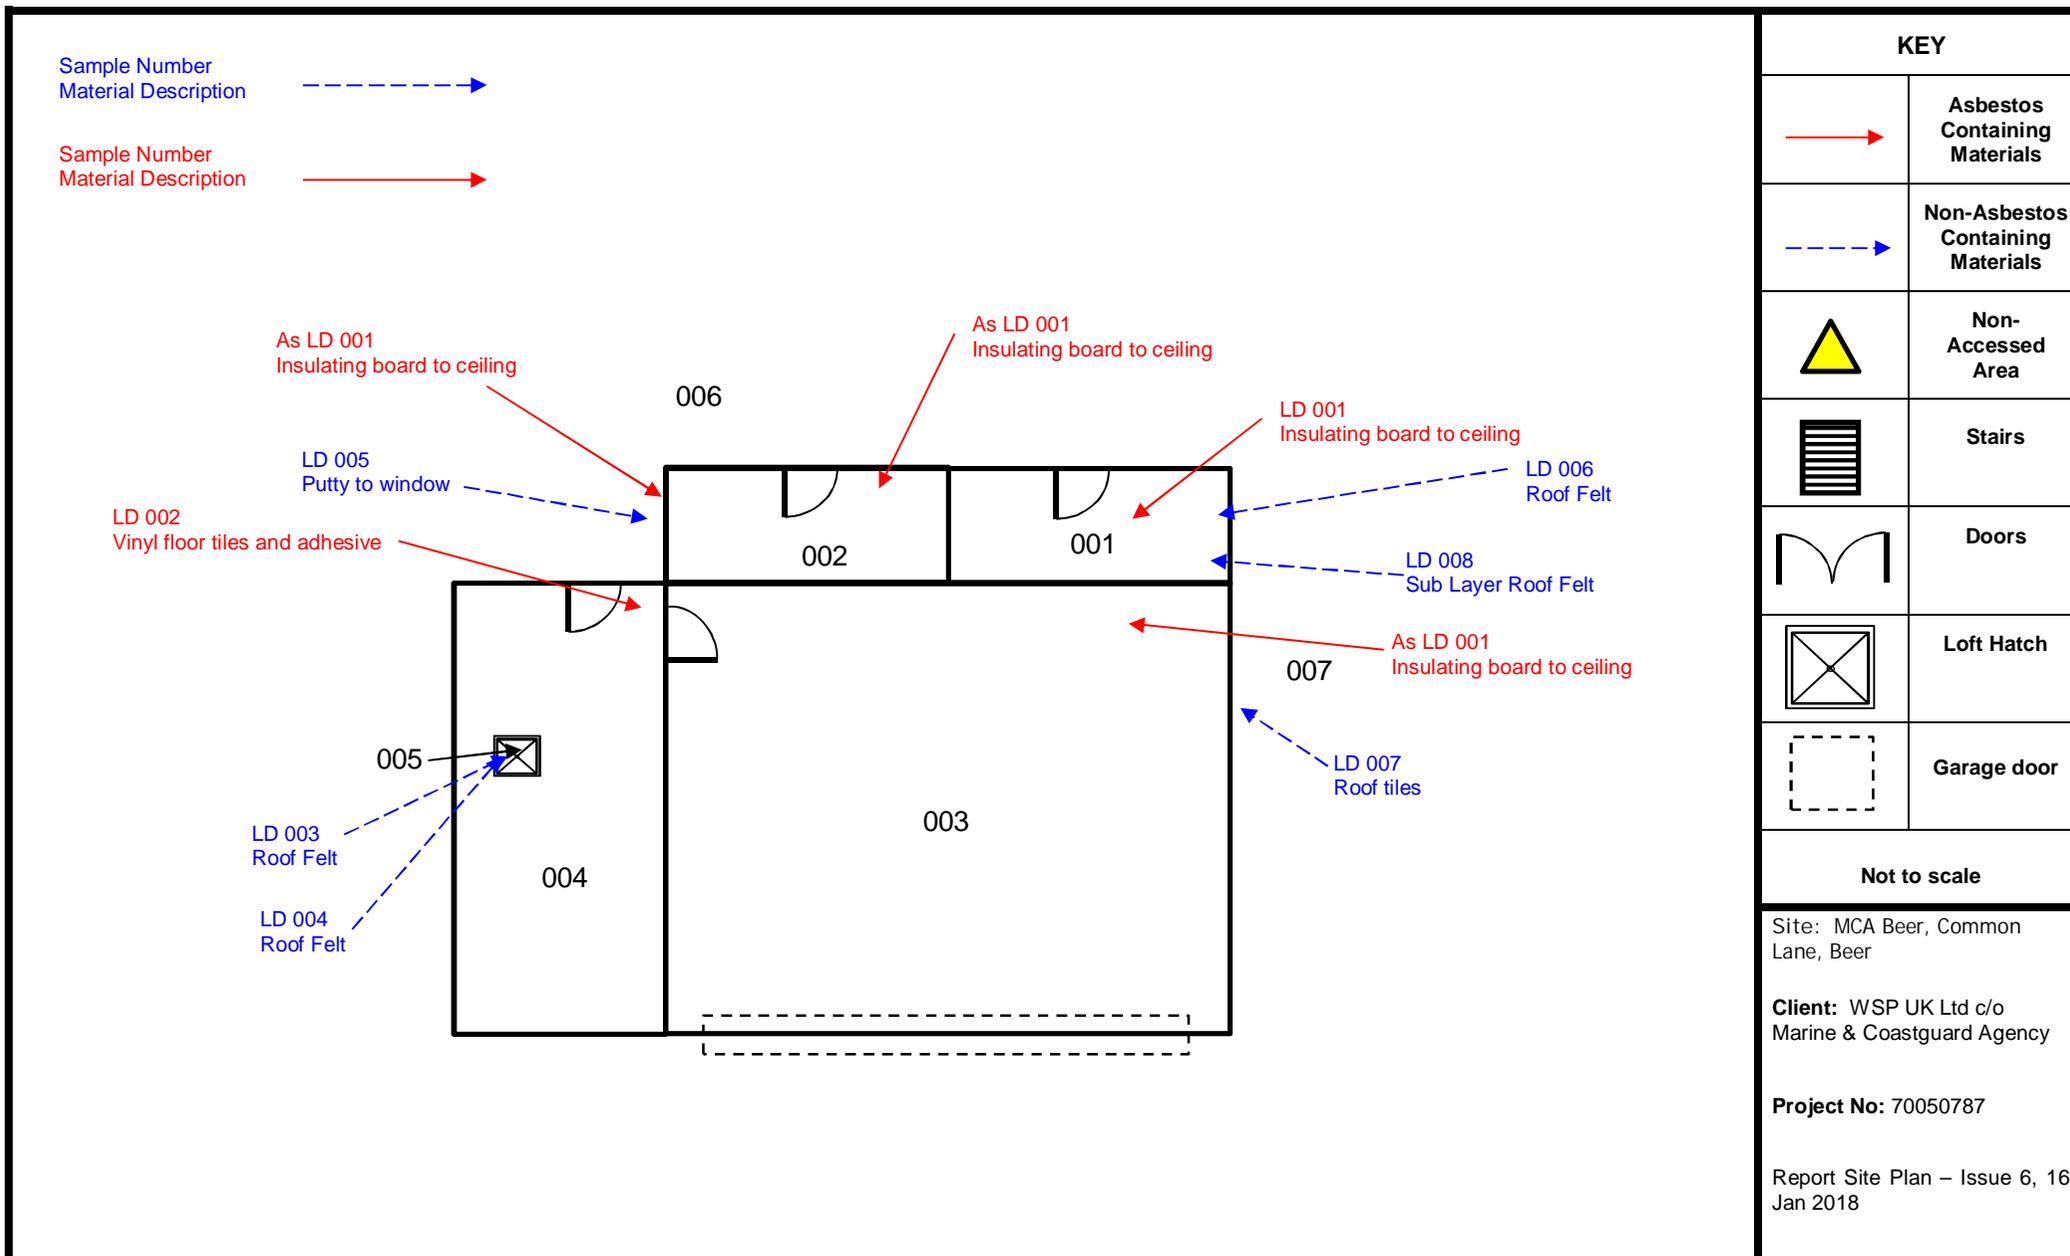
SITE PLANS

Location	Description	Extent	Recommendation
Ground Floor 001 Store	Insulation board to ceiling	2 m ²	Remove
Ground Floor 002 WC	Insulation board to ceiling	2 m ²	Remove
Ground Floor 003 Garage	Insulation board to ceiling	10 m ²	Remove
External 006 External areas	Insulation board to soffit	10 m ²	Remove

Location	Description	Extent	Recommendation
Ground Floor 004 Office	Vinyl to floor	6 m ²	Remove prior to works that may cause disturbance
