ASBESTOS MANAGEMENT SURVEY

**NOCTON VILLAGE HALL
MAIN STREET
NOCTON
LINCOLN
LN4 2BH**

ACMS: 2136
02/09/2014
08/09/2014
08/09/2015
G. ROSS
GEOFF ROSS

REPORT PREPARED FOR
STEVE ALTRIDGE
C/o
NOCTON PARISH COUNCIL

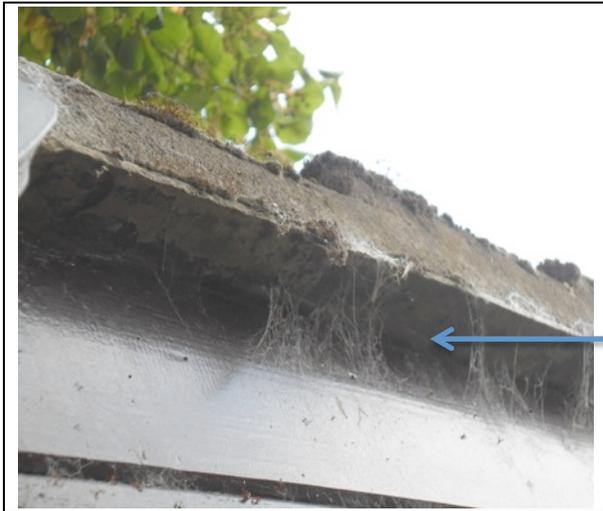
Sample No.	Floor Level	Room / Area	Sample Description	Asbestos Type
01	External	Roof eaves	Asbestos Cement	Chrysotile
02	Ground	Bar area	Sink pad	Chrysotile

Sample No.	Photograph No.
01	01
Sample Locations:	
Tile edge Undercloaking	
Sample Description:	
Asbestos cement	
Asbestos Type:	
Chrysotile

Visual Observations / Recommendations
Manage

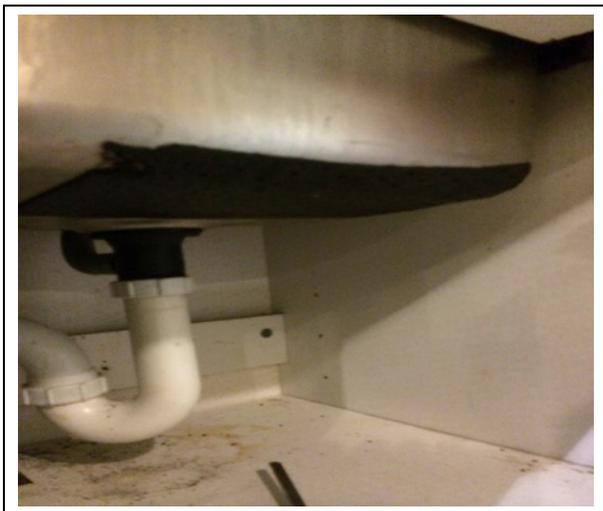
Sample No.	Photograph No.
02	02
Sample Locations:	
Sink in Bar area	
Sample Description:	
Acoustic pad	
Asbestos Type:	
Chrysotile

Visual Observations / Recommendations
Manage

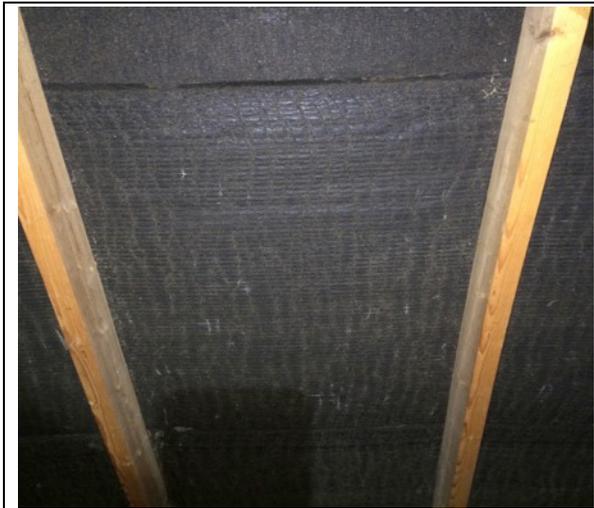
Sample No.	Photograph No.
03	03
Sample Locations:	
Roof void	
Sample Description:	
Roof felt under lining	
Asbestos Type:	
No Asbestos Detected

Visual Observations / Recommendations
No Action Required
