### Asbestos Survey Report and Register

Survey Type:	Asbestos Refurbishment Survey
Site:	Mayfield House, St James Terrace, Mayfield Road, Leicester, LE2 1LQ
Surveyor:	Daniel Webster
Contract:	S-13915
Survey Date:	01 October 2020
Report Date:	22 October 2020
Re-Inspection Due:	01 October 2021
Client:	Action Homeless (Leicester) Limited Ridgeway House, Little Hill, Newton Lane, Wigston, LE18 3SE

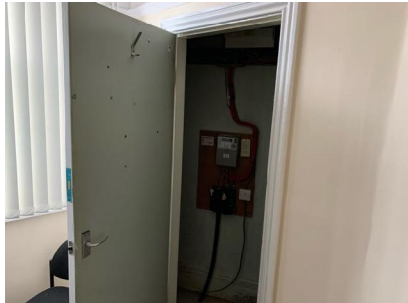
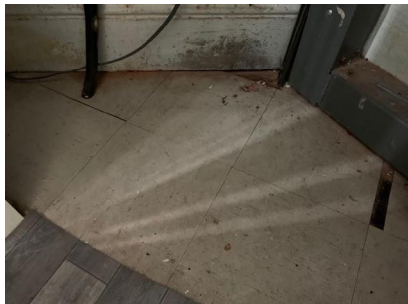
<b>Contract No:</b> S-13915	<b>Client:</b> Action Homeless (Leicester) Limited	<b>ID Number:</b> 234594	
<b>Site:</b> Mayfield House, St James Terrace, Mayfield Road, Leicester, LE2 1LQ		<b>Survey Date:</b> 01 October 2020	
<b>Building:</b>	Mayfield House

<b>Floor:</b>	Ground Floor		
<b>Room Area:</b>	003 Electric Cupboard		
<b>Description:</b>	Vinyl Tiles and Bitumen to Floor		
<b>Quantity:</b>	1

<b>Accessibility:</b>	Easy		
<b>Product Type:</b>	1 - Vinyl Products		
<b>Damage Extent:</b>	1 - Low Damage		
<b>Surface Treatment:</b>	0 - Composite	<b>Re-inspection Due:</b>	01/10/2021
<b>Asbestos Type:</b>	1 - Chrysotile	<b>Sample Ref:</b>	S01
<b>Material Assessment:</b>		<b>Risk Score = 3</b> <b>Very Low</b>	
<b>Comments:</b> - Grey tiles exposed to floor.			
<b>Recommendations:</b> Remove If the identified asbestos containing material is likely to be disturbed during refurbishment works, it should be removed and disposed of in full accordance with current and relevant legislation. If refurbishment works are not likely to impact upon the identified asbestos containing material then it should be managed in accordance with current legislation. For adequate management asbestos materials must be in a good condition and products other than cement and composite materials should be sealed and or protected. As such should the identified asbestos containing material be damaged then it will require repair and for materials other than cement and composites it will require encapsulation and or protection. Where asbestos materials are beyond repair they should be removed. Although labelling and or signage is not a legal requirement it should be considered to avoid accidental damage.

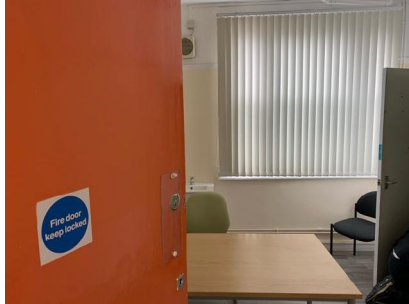
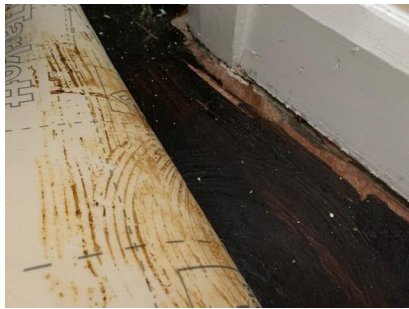
<b>Contract No:</b> S-13915	<b>Client:</b> Action Homeless (Leicester) Limited	<b>ID Number:</b> 234577	
<b>Site:</b> Mayfield House, St James Terrace, Mayfield Road, Leicester, LE2 1LQ		<b>Survey Date:</b> 01 October 2020	
<b>Building:</b>	Mayfield House

<b>Floor:</b>	Ground Floor		
<b>Room Area:</b>	002 Staff Room		
<b>Description:</b>	Bitumen Adhesive to Floor		
<b>Quantity:</b>	6m <sup>2</sup>

<b>Accessibility:</b>	Easy		
<b>Product Type:</b>	1 - Bituminous Product		
<b>Damage Extent:</b>	1 - Low Damage		
<b>Surface Treatment:</b>	0 - Composite	<b>Re-inspection Due:</b>	01/10/2021
<b>Asbestos Type:</b>	1 - Chrysotile	<b>Sample Ref:</b>	Sample Reference 01
<b>Material Assessment:</b>		<b>Risk Score = 3</b> <b>Very Low</b>	
<b>Comments:</b> - Beneath modern linoleum.			
<b>Recommendations:</b> Remove If the identified asbestos containing material is likely to be disturbed during refurbishment works, it should be removed and disposed of in full accordance with current and relevant legislation. If refurbishment works are not likely to impact upon the identified asbestos containing material then it should be managed in accordance with current legislation. For adequate management asbestos materials must be in a good condition and products other than cement and composite materials should be sealed and or protected. As such should the identified asbestos containing material be damaged then it will require repair and for materials other than cement and composites it will require encapsulation and or protection. Where asbestos materials are beyond repair they should be removed. Although labelling and or signage is not a legal requirement it should be considered to avoid accidental damage.

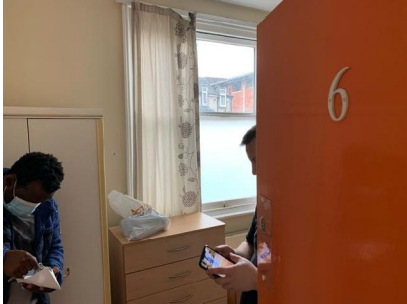
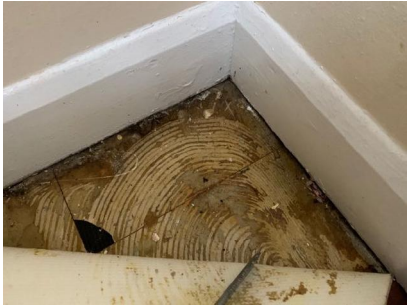
<b>Contract No:</b> S-13915	<b>Client:</b> Action Homeless (Leicester) Limited	<b>ID Number:</b> 234582	
<b>Site:</b> Mayfield House, St James Terrace, Mayfield Road, Leicester, LE2 1LQ		<b>Survey Date:</b> 01 October 2020	
<b>Building:</b>	Mayfield House

<b>Floor:</b>	Ground Floor		
<b>Room Area:</b>	005 Bedroom		
<b>Description:</b>	Vinyl Tiles and Bitumen Adhesive to Floor		
<b>Quantity:</b>	10m <sup>2</sup>

<b>Accessibility:</b>	Easy		
<b>Product Type:</b>	1 - Vinyl Products		
<b>Damage Extent:</b>	1 - Low Damage		
<b>Surface Treatment:</b>	0 - Composite	<b>Re-inspection Due:</b>	N/A
<b>Asbestos Type:</b>	No Asbestos Detected	<b>Sample Ref:</b>	S02
<b>Material Assessment:</b>		<b>No Asbestos Detected</b>	
<b><u>Comments:</u></b> - Beneath linoleum.			
<b><u>Recommendations:</u></b> No action required

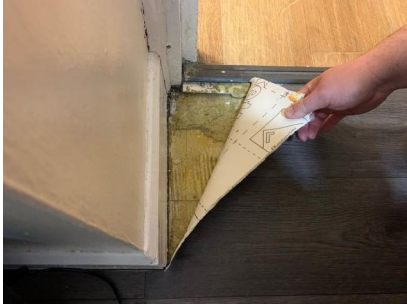
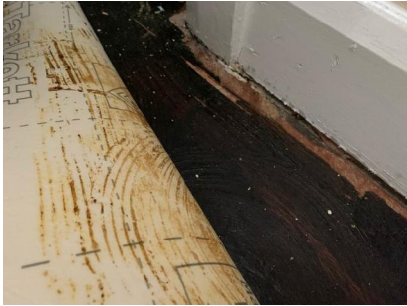
<b>Contract No:</b> S-13915	<b>Client:</b> Action Homeless (Leicester) Limited	<b>ID Number:</b> 234592	
<b>Site:</b> Mayfield House, St James Terrace, Mayfield Road, Leicester, LE2 1LQ		<b>Survey Date:</b> 01 October 2020	
<b>Building:</b>	Mayfield House

<b>Floor:</b>	Ground Floor		
<b>Room Area:</b>	007 Bedroom		
<b>Description:</b>	Vinyl Tiles and Bitumen Adhesive to Floor		
<b>Quantity:</b>	6m <sup>2</sup>

<b>Accessibility:</b>	Easy		
<b>Product Type:</b>	1 - Bituminous Product		
<b>Damage Extent:</b>	1 - Low Damage		
<b>Surface Treatment:</b>	0 - Composite	<b>Re-inspection Due:</b>	N/A
<b>Asbestos Type:</b>	No Asbestos Detected	<b>Sample Ref:</b>	Sample Reference 02
<b>Material Assessment:</b>		<b>No Asbestos Detected</b>	
<b>Comments:</b> - Beneath modern linoleum.			
<b>Recommendations:</b> No action required

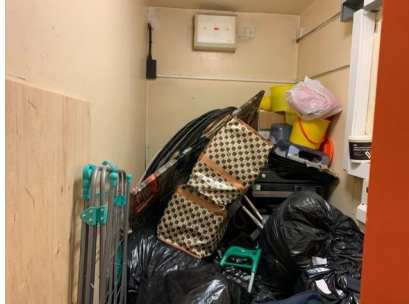
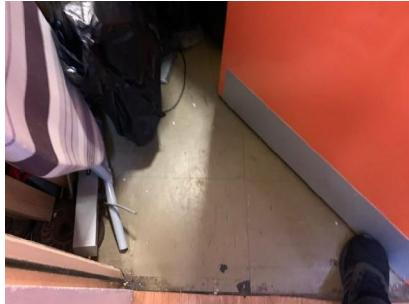
<b>Contract No:</b> S-13915	<b>Client:</b> Action Homeless (Leicester) Limited	<b>ID Number:</b> 234588	
<b>Site:</b> Mayfield House, St James Terrace, Mayfield Road, Leicester, LE2 1LQ		<b>Survey Date:</b> 01 October 2020	
<b>Building:</b>	Mayfield House

<b>Floor:</b>	Ground Floor		
<b>Room Area:</b>	012 Store		
<b>Description:</b>	Vinyl Tiles and Bitumen Adhesive to Floor		
<b>Quantity:</b>	6m <sup>2</sup>

<b>Accessibility:</b>	Easy		
<b>Product Type:</b>	1 - Bituminous Product		
<b>Damage Extent:</b>	1 - Low Damage		
<b>Surface Treatment:</b>	0 - Composite	<b>Re-inspection Due:</b>	N/A
<b>Asbestos Type:</b>	No Asbestos Detected	<b>Sample Ref:</b>	Sample Reference 02
<b>Material Assessment:</b>		<b>No Asbestos Detected</b>	
<b>Comments:</b> - Exposed to floor.			
<b>Recommendations:</b> No action required

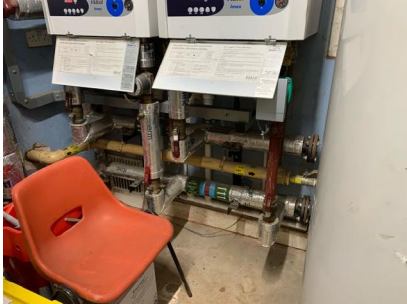
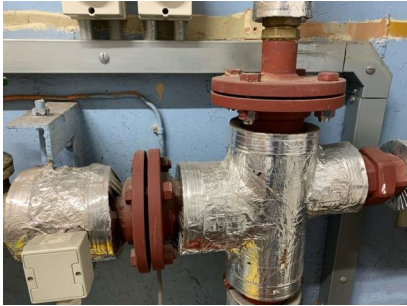
<b>Contract No:</b> S-13915	<b>Client:</b> Action Homeless (Leicester) Limited	<b>ID Number:</b> 234586	
<b>Site:</b> Mayfield House, St James Terrace, Mayfield Road, Leicester, LE2 1LQ		<b>Survey Date:</b> 01 October 2020	
<b>Building:</b>	Mayfield House

<b>Floor:</b>	Ground Floor		
<b>Room Area:</b>	015 Boiler Room		
<b>Description:</b>	Gaskets to Pipework		
<b>Quantity:</b>	6 units

<b>Accessibility:</b>	Difficult		
<b>Product Type:</b>	2 - Gaskets (compressed)		
<b>Damage Extent:</b>	1 - Low Damage		
<b>Surface Treatment:</b>	2 - Part-sealed	<b>Re-inspection Due:</b>	01/10/2021
<b>Asbestos Type:</b>	1 - Chrysotile	<b>Sample Ref:</b>	S03
<b>Material Assessment:</b>		<b>Risk Score = 6</b> <b>Low</b>	
<b>Comments:</b> - To pipe flanges.			
<b>Recommendations:</b> Remove If the identified asbestos containing material is likely to be disturbed during refurbishment works, it should be removed and disposed of in full accordance with current and relevant legislation. If refurbishment works are not likely to impact upon the identified asbestos containing material then it should be managed in accordance with current legislation. For adequate management asbestos materials must be in a good condition and products other than cement and composite materials should be sealed and or protected. As such should the identified asbestos containing material be damaged then it will require repair and for materials other than cement and composites it will require encapsulation and or protection. Where asbestos materials are beyond repair they should be removed. Although labelling and or signage is not a legal requirement it should be considered to avoid accidental damage.

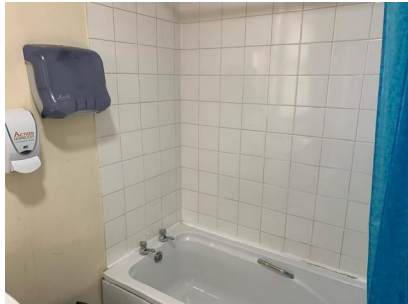
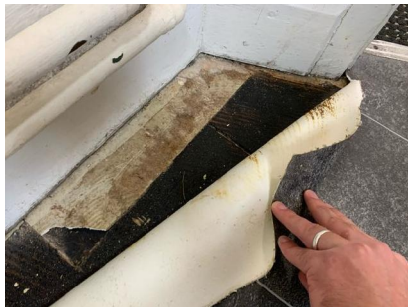
<b>Contract No:</b> S-13915	<b>Client:</b> Action Homeless (Leicester) Limited	<b>ID Number:</b> 234580	
<b>Site:</b> Mayfield House, St James Terrace, Mayfield Road, Leicester, LE2 1LQ		<b>Survey Date:</b> 01 October 2020	
<b>Building:</b>	Mayfield House

<b>Floor:</b>	1st Floor		
<b>Room Area:</b>	020 Bathroom		
<b>Description:</b>	Vinyl Tiles and Bitumen Adhesive to Floor		
<b>Quantity:</b>	6m <sup>2</sup>

<b>Accessibility:</b>	Easy		
<b>Product Type:</b>	1 - Vinyl Products		
<b>Damage Extent:</b>	1 - Low Damage		
<b>Surface Treatment:</b>	0 - Composite	<b>Re-inspection Due:</b>	01/10/2021
<b>Asbestos Type:</b>	1 - Chrysotile	<b>Sample Ref:</b>	S05
<b>Material Assessment:</b>		<b>Risk Score = 3</b> <b>Very Low</b>	
<b>Comments:</b> - Beneath linoleum.			
<b>Recommendations:</b> Remove If the identified asbestos containing material is likely to be disturbed during refurbishment works, it should be removed and disposed of in full accordance with current and relevant legislation. If refurbishment works are not likely to impact upon the identified asbestos containing material then it should be managed in accordance with current legislation. For adequate management asbestos materials must be in a good condition and products other than cement and composite materials should be sealed and or protected. As such should the identified asbestos containing material be damaged then it will require repair and for materials other than cement and composites it will require encapsulation and or protection. Where asbestos materials are beyond repair they should be removed. Although labelling and or signage is not a legal requirement it should be considered to avoid accidental damage.

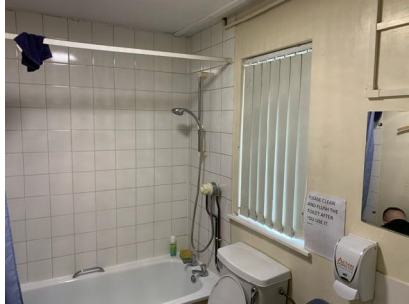
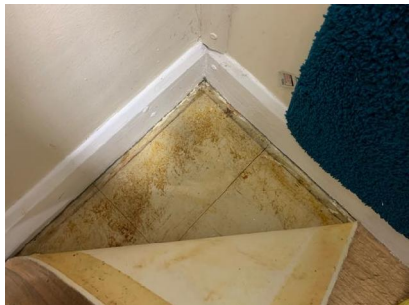
<b>Contract No:</b> S-13915	<b>Client:</b> Action Homeless (Leicester) Limited	<b>ID Number:</b> 234575	
<b>Site:</b> Mayfield House, St James Terrace, Mayfield Road, Leicester, LE2 1LQ		<b>Survey Date:</b> 01 October 2020	
<b>Building:</b>	Mayfield House

<b>Floor:</b>	Ground Floor		
<b>Room Area:</b>	032 Bathroom		
<b>Description:</b>	Vinyl Tiles and Bitumen to Floor		
<b>Quantity:</b>	4m <sup>2</sup>

<b>Accessibility:</b>	Easy		
<b>Product Type:</b>	1 - Vinyl Products		
<b>Damage Extent:</b>	1 - Low Damage		
<b>Surface Treatment:</b>	0 - Composite	<b>Re-inspection Due:</b>	01/10/2021
<b>Asbestos Type:</b>	1 - Chrysotile	<b>Sample Ref:</b>	Sample Reference 01
<b>Material Assessment:</b>		<b>Risk Score = 3</b> <b>Very Low</b>	
<b>Comments:</b> - Beneath linoleum.			
<b>Recommendations:</b> Remove If the identified asbestos containing material is likely to be disturbed during refurbishment works, it should be removed and disposed of in full accordance with current and relevant legislation. If refurbishment works are not likely to impact upon the identified asbestos containing material then it should be managed in accordance with current legislation. For adequate management asbestos materials must be in a good condition and products other than cement and composite materials should be sealed and or protected. As such should the identified asbestos containing material be damaged then it will require repair and for materials other than cement and composites it will require encapsulation and or protection. Where asbestos materials are beyond repair they should be removed. Although labelling and or signage is not a legal requirement it should be considered to avoid accidental damage.

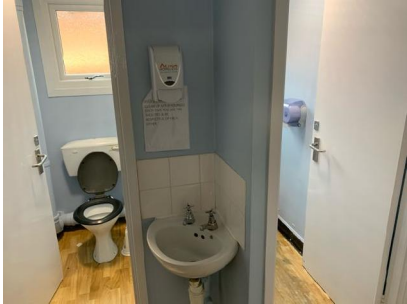
<b>Floor:</b>	Ground Floor		
<b>Room Area:</b>	036 WC and Lobby		
<b>Description:</b>	Vinyl Tiles and Bitumen Adhesive to Floor		
<b>Quantity:</b>	8m <sup>2</sup>	 	
<b>Accessibility:</b>	Easy		
<b>Product Type:</b>	1 - Bituminous Product		
<b>Damage Extent:</b>	1 - Low Damage		
<b>Surface Treatment:</b>	0 - Composite	<b>Re-inspection Due:</b>	N/A
<b>Asbestos Type:</b>	No Asbestos Detected	<b>Sample Ref:</b>	Sample Reference 02
<b>Material Assessment:</b>		<b>No Asbestos Detected</b>	
<b>Comments:</b> - Beneath linoleum.			
<b>Recommendations:</b> No action required

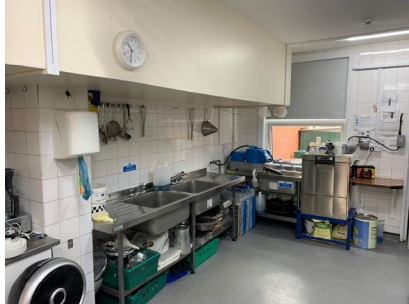
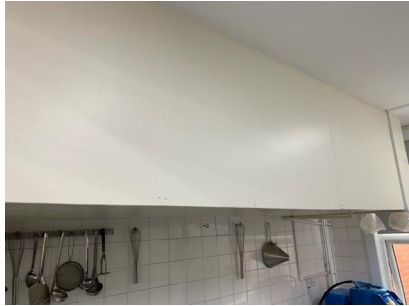
<b>Floor:</b>	Ground Floor		
<b>Room Area:</b>	038 Commercial Kitchen		
<b>Description:</b>	Insulating Board Panels		
<b>Quantity:</b>	10m <sup>2</sup>

<b>Accessibility:</b>	Medium		
<b>Product Type:</b>	2 - Insulating Board		
<b>Damage Extent:</b>	1 - Low Damage		
<b>Surface Treatment:</b>	1 - Sealed	<b>Re-inspection Due:</b>	N/A
<b>Asbestos Type:</b>	No Asbestos Detected	<b>Sample Ref:</b>	S06
<b>Material Assessment:</b>		No Asbestos Detected	
<b>Comments:</b> - Above sinks.			
<b>Recommendations:</b> No action required

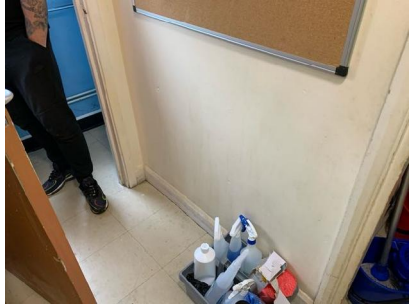
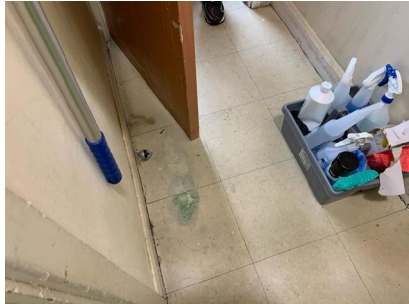
<b>Floor:</b>	Ground Floor		
<b>Room Area:</b>	041 and 042 Stores		
<b>Description:</b>	Vinyl Tiles and Bitumen Adhesive to Floor		
<b>Quantity:</b>	6m <sup>2</sup>

<b>Accessibility:</b>	Easy		
<b>Product Type:</b>	1 - Bituminous Product		
<b>Damage Extent:</b>	1 - Low Damage		
<b>Surface Treatment:</b>	0 - Composite	<b>Re-inspection Due:</b>	N/A
<b>Asbestos Type:</b>	No Asbestos Detected	<b>Sample Ref:</b>	Sample Reference 02
<b>Material Assessment:</b>		<b>No Asbestos Detected</b>	
<b>Comments:</b> - Exposed to floor. To both store areas.			
<b>Recommendations:</b> No action required

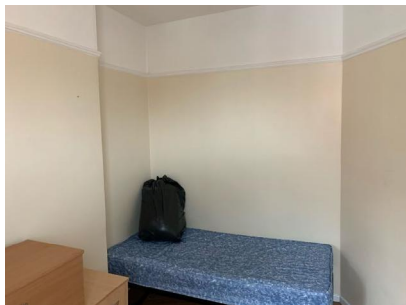
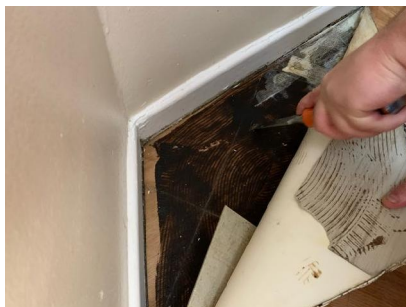
<b>Floor:</b>	1st Floor		
<b>Room Area:</b>	045 Store		
<b>Description:</b>	Vinyl Tiles and Bitumen Adhesive to Floor		
<b>Quantity:</b>	8m <sup>2</sup>

<b>Accessibility:</b>	Easy		
<b>Product Type:</b>	1 - Vinyl Products		
<b>Damage Extent:</b>	1 - Low Damage		
<b>Surface Treatment:</b>	0 - Composite	<b>Re-inspection Due:</b>	01/10/2021
<b>Asbestos Type:</b>	1 - Chrysotile	<b>Sample Ref:</b>	S07
<b>Material Assessment:</b>		<b>Risk Score = 3</b> <b>Very Low</b>	
<b>Comments:</b> - Beneath linoleum.			
<b>Recommendations:</b> Remove If the identified asbestos containing material is likely to be disturbed during refurbishment works, it should be removed and disposed of in full accordance with current and relevant legislation. If refurbishment works are not likely to impact upon the identified asbestos containing material then it should be managed in accordance with current legislation. For adequate management asbestos materials must be in a good condition and products other than cement and composite materials should be sealed and or protected. As such should the identified asbestos containing material be damaged then it will require repair and for materials other than cement and composites it will require encapsulation and or protection. Where asbestos materials are beyond repair they should be removed. Although labelling and or signage is not a legal requirement it should be considered to avoid accidental damage.

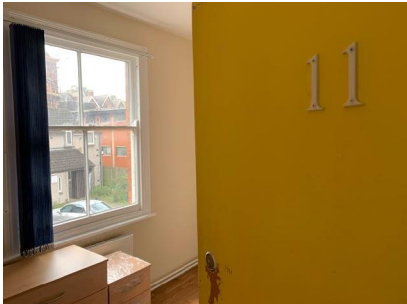
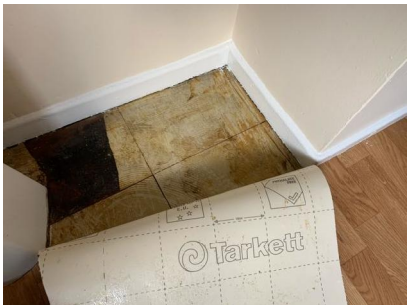
<b>Floor:</b>	1st Floor		
<b>Room Area:</b>	048 Bedroom		
<b>Description:</b>	Vinyl Tiles and Bitumen Adhesive to Floor		
<b>Quantity:</b>	8m <sup>2</sup>

<b>Accessibility:</b>	Easy		
<b>Product Type:</b>	1 - Vinyl Products		
<b>Damage Extent:</b>	1 - Low Damage		
<b>Surface Treatment:</b>	0 - Composite	<b>Re-inspection Due:</b>	01/10/2021
<b>Asbestos Type:</b>	1 - Chrysotile	<b>Sample Ref:</b>	Sample Reference 07
<b>Material Assessment:</b>		<b>Risk Score = 3</b> <b>Very Low</b>	
<b>Comments:</b> - Beneath linoleum.			
<b>Recommendations:</b> Remove If the identified asbestos containing material is likely to be disturbed during refurbishment works, it should be removed and disposed of in full accordance with current and relevant legislation. If refurbishment works are not likely to impact upon the identified asbestos containing material then it should be managed in accordance with current legislation. For adequate management asbestos materials must be in a good condition and products other than cement and composite materials should be sealed and or protected. As such should the identified asbestos containing material be damaged then it will require repair and for materials other than cement and composites it will require encapsulation and or protection. Where asbestos materials are beyond repair they should be removed. Although labelling and or signage is not a legal requirement it should be considered to avoid accidental damage.

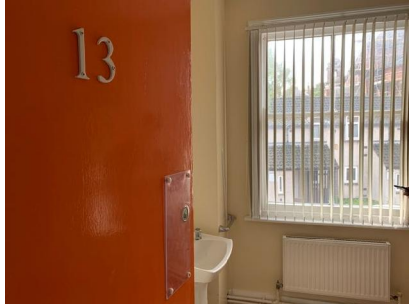
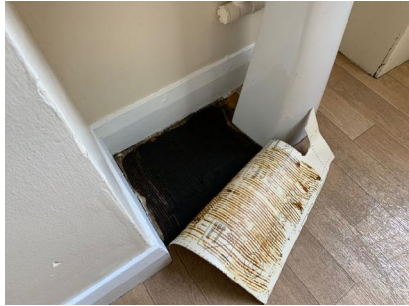
<b>Floor:</b>	1st Floor		
<b>Room Area:</b>	050 Bedroom		
<b>Description:</b>	Bitumen Adhesive to Floor		
<b>Quantity:</b>	8m <sup>2</sup>

<b>Accessibility:</b>	Easy		
<b>Product Type:</b>	1 - Vinyl Products		
<b>Damage Extent:</b>	1 - Low Damage		
<b>Surface Treatment:</b>	0 - Composite	<b>Re-inspection Due:</b>	01/10/2021
<b>Asbestos Type:</b>	1 - Chrysotile	<b>Sample Ref:</b>	Sample Reference 07
<b>Material Assessment:</b>		<b>Risk Score = 3</b> <b>Very Low</b>	
<b>Comments:</b> - Beneath linoleum. Bitumen only.			
<b>Recommendations:</b> Remove If the identified asbestos containing material is likely to be disturbed during refurbishment works, it should be removed and disposed of in full accordance with current and relevant legislation. If refurbishment works are not likely to impact upon the identified asbestos containing material then it should be managed in accordance with current legislation. For adequate management asbestos materials must be in a good condition and products other than cement and composite materials should be sealed and or protected. As such should the identified asbestos containing material be damaged then it will require repair and for materials other than cement and composites it will require encapsulation and or protection. Where asbestos materials are beyond repair they should be removed. Although labelling and or signage is not a legal requirement it should be considered to avoid accidental damage.

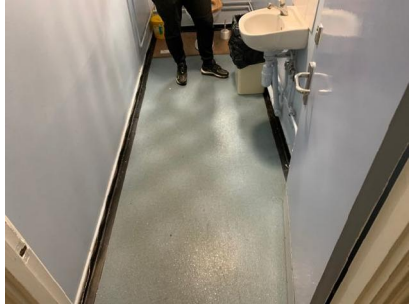
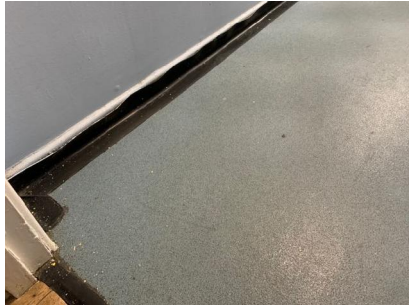
<b>Floor:</b>	1st Floor		
<b>Room Area:</b>	051 WC		
<b>Description:</b>	Vinyl Tiles and Bitumen Adhesive to Floor		
<b>Quantity:</b>	8m <sup>2</sup>

<b>Accessibility:</b>	Easy		
<b>Product Type:</b>	1 - Vinyl Products		
<b>Damage Extent:</b>	1 - Low Damage		
<b>Surface Treatment:</b>	0 - Composite	<b>Re-inspection Due:</b>	01/10/2021
<b>Asbestos Type:</b>	1 - Chrysotile	<b>Sample Ref:</b>	Sample Reference 07
<b>Material Assessment:</b>		<b>Risk Score = 3</b> <b>Very Low</b>	
<b>Comments:</b> - Beneath linoleum.			
<b>Recommendations:</b> Remove If the identified asbestos containing material is likely to be disturbed during refurbishment works, it should be removed and disposed of in full accordance with current and relevant legislation. If refurbishment works are not likely to impact upon the identified asbestos containing material then it should be managed in accordance with current legislation. For adequate management asbestos materials must be in a good condition and products other than cement and composite materials should be sealed and or protected. As such should the identified asbestos containing material be damaged then it will require repair and for materials other than cement and composites it will require encapsulation and or protection. Where asbestos materials are beyond repair they should be removed. Although labelling and or signage is not a legal requirement it should be considered to avoid accidental damage.

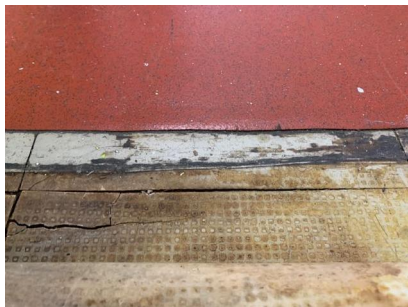
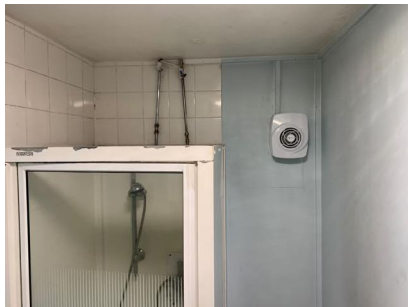
<b>Floor:</b>	1st Floor		
<b>Room Area:</b>	053 Shower Room		
<b>Description:</b>	Vinyl Tiles and Bitumen Adhesive to Floor		
<b>Quantity:</b>	5m <sup>2</sup>

<b>Accessibility:</b>	Easy		
<b>Product Type:</b>	1 - Vinyl Products		
<b>Damage Extent:</b>	1 - Low Damage		
<b>Surface Treatment:</b>	0 - Composite	<b>Re-inspection Due:</b>	01/10/2021
<b>Asbestos Type:</b>	1 - Chrysotile	<b>Sample Ref:</b>	Sample Reference 07
<b>Material Assessment:</b>		<b>Risk Score = 3</b> <b>Very Low</b>	
<b>Comments:</b> - Beneath linoleum.			
<b>Recommendations:</b> Remove If the identified asbestos containing material is likely to be disturbed during refurbishment works, it should be removed and disposed of in full accordance with current and relevant legislation. If refurbishment works are not likely to impact upon the identified asbestos containing material then it should be managed in accordance with current legislation. For adequate management asbestos materials must be in a good condition and products other than cement and composite materials should be sealed and or protected. As such should the identified asbestos containing material be damaged then it will require repair and for materials other than cement and composites it will require encapsulation and or protection. Where asbestos materials are beyond repair they should be removed. Although labelling and or signage is not a legal requirement it should be considered to avoid accidental damage.

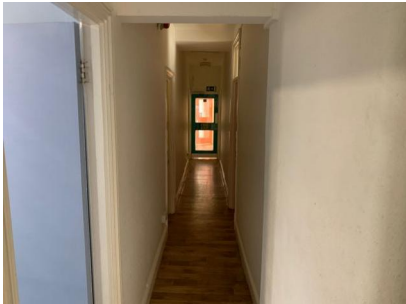
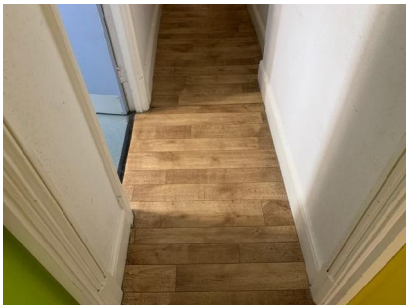
<b>Floor:</b>	1st Floor		
<b>Room Area:</b>	054 Corridor		
<b>Description:</b>	Vinyl Tiles and Bitumen Adhesive to Floor		
<b>Quantity:</b>	30m <sup>2</sup>

<b>Accessibility:</b>	Easy		
<b>Product Type:</b>	1 - Vinyl Products		
<b>Damage Extent:</b>	1 - Low Damage		
<b>Surface Treatment:</b>	0 - Composite	<b>Re-inspection Due:</b>	01/10/2021
<b>Asbestos Type:</b>	1 - Chrysotile	<b>Sample Ref:</b>	Sample Reference 07
<b>Material Assessment:</b>		<b>Risk Score = 3</b> <b>Very Low</b>	
<b>Comments:</b> - Beneath linoleum. To entire corridor.			
<b>Recommendations:</b> Remove If the identified asbestos containing material is likely to be disturbed during refurbishment works, it should be removed and disposed of in full accordance with current and relevant legislation. If refurbishment works are not likely to impact upon the identified asbestos containing material then it should be managed in accordance with current legislation. For adequate management asbestos materials must be in a good condition and products other than cement and composite materials should be sealed and or protected. As such should the identified asbestos containing material be damaged then it will require repair and for materials other than cement and composites it will require encapsulation and or protection. Where asbestos materials are beyond repair they should be removed. Although labelling and or signage is not a legal requirement it should be considered to avoid accidental damage.

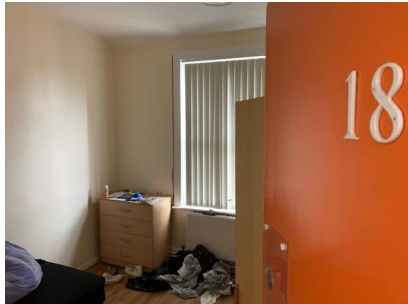
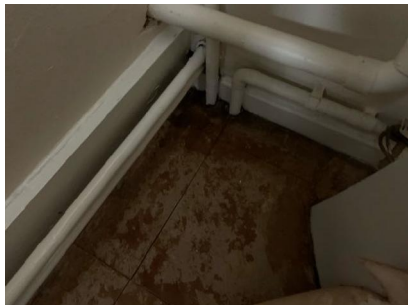
<b>Floor:</b>	1st Floor		
<b>Room Area:</b>	058 Bedroom		
<b>Description:</b>	Vinyl Tiles and Bitumen Adhesive to Floor		
<b>Quantity:</b>	10m <sup>2</sup>

<b>Accessibility:</b>	Easy		
<b>Product Type:</b>	1 - Vinyl Products		
<b>Damage Extent:</b>	1 - Low Damage		
<b>Surface Treatment:</b>	0 - Composite	<b>Re-inspection Due:</b>	01/10/2021
<b>Asbestos Type:</b>	1 - Chrysotile	<b>Sample Ref:</b>	Sample Reference 07
<b>Material Assessment:</b>		<b>Risk Score = 3</b> <b>Very Low</b>	
<b>Comments:</b> - Beneath linoleum.			
<b>Recommendations:</b> Remove If the identified asbestos containing material is likely to be disturbed during refurbishment works, it should be removed and disposed of in full accordance with current and relevant legislation. If refurbishment works are not likely to impact upon the identified asbestos containing material then it should be managed in accordance with current legislation. For adequate management asbestos materials must be in a good condition and products other than cement and composite materials should be sealed and or protected. As such should the identified asbestos containing material be damaged then it will require repair and for materials other than cement and composites it will require encapsulation and or protection. Where asbestos materials are beyond repair they should be removed. Although labelling and or signage is not a legal requirement it should be considered to avoid accidental damage.

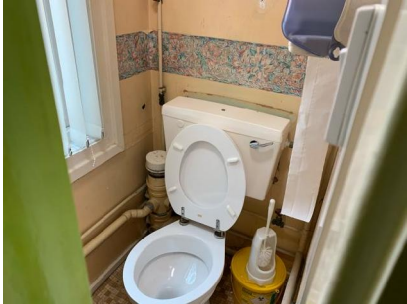
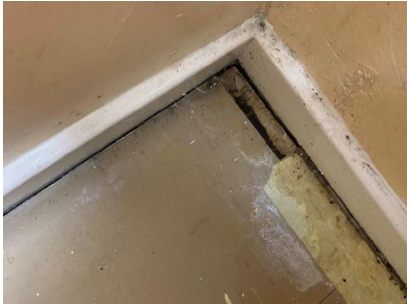
<b>Floor:</b>	1st Floor		
<b>Room Area:</b>	064 WC and Shower Room		
<b>Description:</b>	Vinyl Tiles and Bitumen Adhesive to Floor		
<b>Quantity:</b>	6m <sup>2</sup>

<b>Accessibility:</b>	Easy		
<b>Product Type:</b>	1 - Vinyl Products		
<b>Damage Extent:</b>	1 - Low Damage		
<b>Surface Treatment:</b>	0 - Composite	<b>Re-inspection Due:</b>	N/A
<b>Asbestos Type:</b>	No Asbestos Detected	<b>Sample Ref:</b>	S08
<b>Material Assessment:</b>		<b>No Asbestos Detected</b>	
<b>Comments:</b> - Beneath linoleum.			
<b>Recommendations:</b> No action required

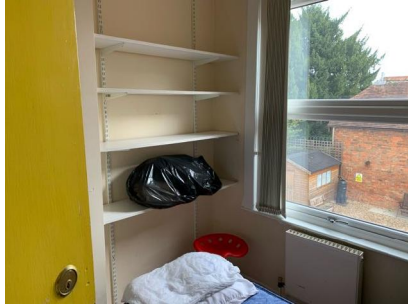
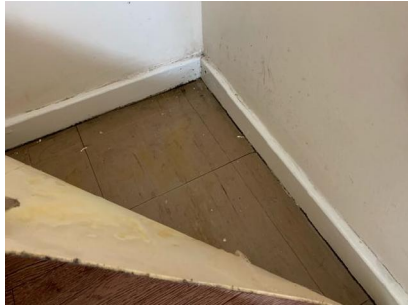
<b>Floor:</b>	1st Floor		
<b>Room Area:</b>	065 Office		
<b>Description:</b>	Vinyl Tiles and Bitumen Adhesive to Floor		
<b>Quantity:</b>	6m <sup>2</sup>

<b>Accessibility:</b>	Easy		
<b>Product Type:</b>	1 - Vinyl Products		
<b>Damage Extent:</b>	1 - Low Damage		
<b>Surface Treatment:</b>	0 - Composite	<b>Re-inspection Due:</b>	N/A
<b>Asbestos Type:</b>	No Asbestos Detected	<b>Sample Ref:</b>	Sample Reference 08
<b>Material Assessment:</b>		<b>No Asbestos Detected</b>	
<b>Comments:</b> - Beneath linoleum.			
<b>Recommendations:</b> No action required

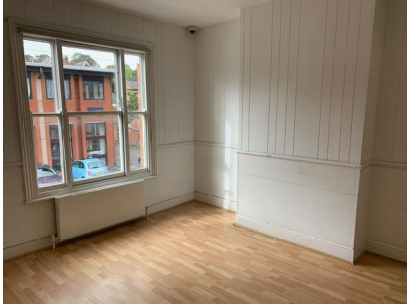
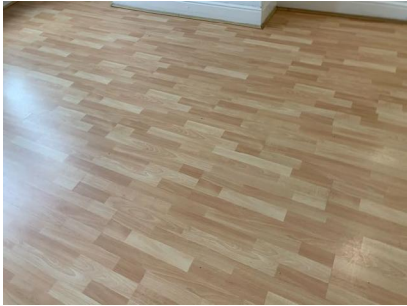
<b>Floor:</b>	1st Floor		
<b>Room Area:</b>	063 Games Room		
<b>Description:</b>	Vinyl Tiles and Bitumen Adhesive to Floor		
<b>Quantity:</b>	20m <sup>2</sup>

<b>Accessibility:</b>	Easy		
<b>Product Type:</b>	1 - Vinyl Products		
<b>Damage Extent:</b>	1 - Low Damage		
<b>Surface Treatment:</b>	0 - Composite	<b>Re-inspection Due:</b>	N/A
<b>Asbestos Type:</b>	No Asbestos Detected	<b>Sample Ref:</b>	Sample Reference 08
<b>Material Assessment:</b>		<b>No Asbestos Detected</b>	
<b>Comments:</b> - Presumed beneath modern laminate. Could not lift floor as sealed down.			
<b>Recommendations:</b> No action required

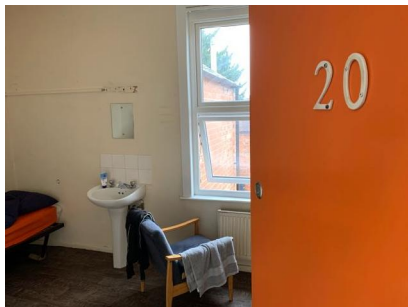
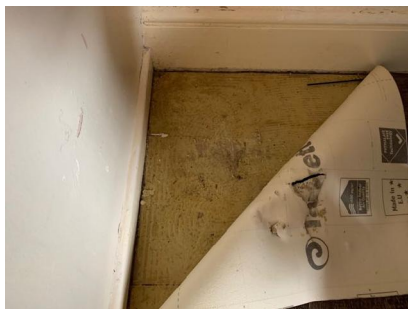
<b>Floor:</b>	1st Floor		
<b>Room Area:</b>	066 Bedroom		
<b>Description:</b>	Vinyl Tiles and Bitumen Adhesive to Floor		
<b>Quantity:</b>	8m <sup>2</sup>

<b>Accessibility:</b>	Easy		
<b>Product Type:</b>	1 - Vinyl Products		
<b>Damage Extent:</b>	1 - Low Damage		
<b>Surface Treatment:</b>	0 - Composite	<b>Re-inspection Due:</b>	01/10/2021
<b>Asbestos Type:</b>	1 - Chrysotile	<b>Sample Ref:</b>	Sample Reference 07
<b>Material Assessment:</b>		<b>Risk Score = 3</b> <b>Very Low</b>	
<b>Comments:</b> - Beneath linoleum.			
<b>Recommendations:</b> Remove If the identified asbestos containing material is likely to be disturbed during refurbishment works, it should be removed and disposed of in full accordance with current and relevant legislation. If refurbishment works are not likely to impact upon the identified asbestos containing material then it should be managed in accordance with current legislation. For adequate management asbestos materials must be in a good condition and products other than cement and composite materials should be sealed and or protected. As such should the identified asbestos containing material be damaged then it will require repair and for materials other than cement and composites it will require encapsulation and or protection. Where asbestos materials are beyond repair they should be removed. Although labelling and or signage is not a legal requirement it should be considered to avoid accidental damage.

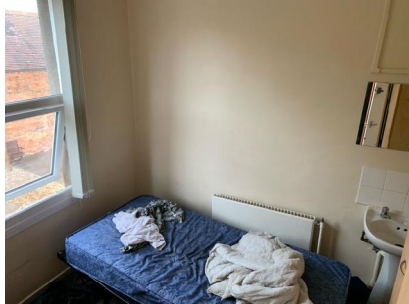
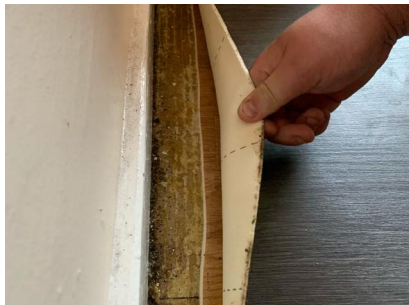
<b>Floor:</b>	1st Floor		
<b>Room Area:</b>	071 Bedroom		
<b>Description:</b>	Vinyl Tiles and Bitumen Adhesive to Floor		
<b>Quantity:</b>	8m <sup>2</sup>

<b>Accessibility:</b>	Easy		
<b>Product Type:</b>	1 - Vinyl Products		
<b>Damage Extent:</b>	1 - Low Damage		
<b>Surface Treatment:</b>	0 - Composite	<b>Re-inspection Due:</b>	01/10/2021
<b>Asbestos Type:</b>	1 - Chrysotile	<b>Sample Ref:</b>	Sample Reference 07
<b>Material Assessment:</b>		<b>Risk Score = 3</b> <b>Very Low</b>	
<b>Comments:</b> - Beneath linoleum.			
<b>Recommendations:</b> Remove If the identified asbestos containing material is likely to be disturbed during refurbishment works, it should be removed and disposed of in full accordance with current and relevant legislation. If refurbishment works are not likely to impact upon the identified asbestos containing material then it should be managed in accordance with current legislation. For adequate management asbestos materials must be in a good condition and products other than cement and composite materials should be sealed and or protected. As such should the identified asbestos containing material be damaged then it will require repair and for materials other than cement and composites it will require encapsulation and or protection. Where asbestos materials are beyond repair they should be removed. Although labelling and or signage is not a legal requirement it should be considered to avoid accidental damage.

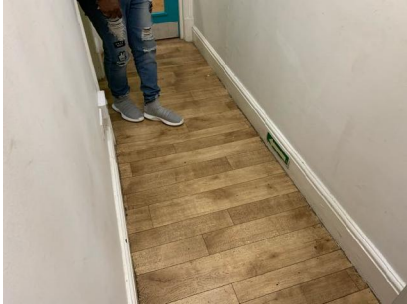
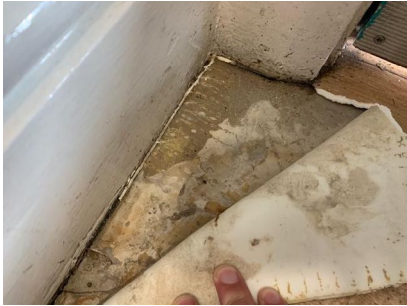
<b>Floor:</b>	1st Floor		
<b>Room Area:</b>	075 Hall		
<b>Description:</b>	Vinyl Tiles and Bitumen Adhesive to Floor		
<b>Quantity:</b>	10m <sup>2</sup>

<b>Accessibility:</b>	Easy		
<b>Product Type:</b>	1 - Vinyl Products		
<b>Damage Extent:</b>	1 - Low Damage		
<b>Surface Treatment:</b>	0 - Composite	<b>Re-inspection Due:</b>	N/A
<b>Asbestos Type:</b>	No Asbestos Detected	<b>Sample Ref:</b>	Sample Reference 08
<b>Material Assessment:</b>		<b>No Asbestos Detected</b>	
<b>Comments:</b> - Beneath modern laminate.			
<b>Recommendations:</b> No action required
