*Project ref: TV250210*

*06<sup>th</sup> Feb 2025*

SITE: Battle Sports Pavilion

# ***CCTV Survey Report***

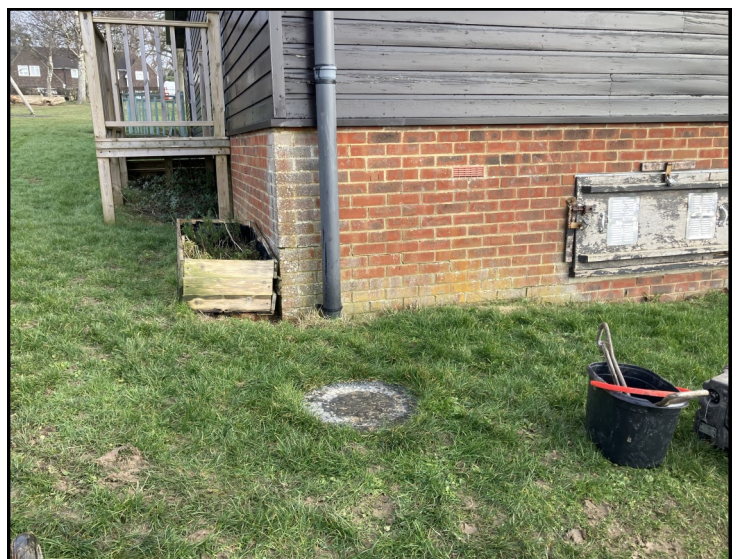
LOCATION OF IC6

IC6.  
UNABLE TO LIFT - SCREWS SEIZED

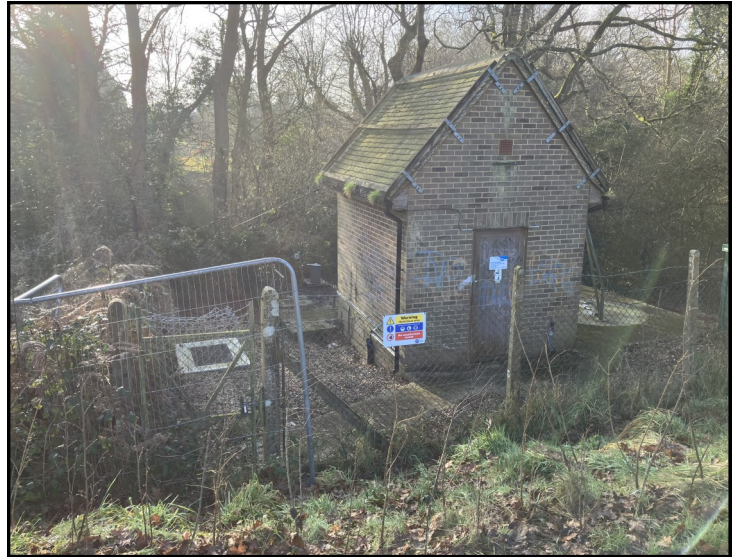
LOCATION OF TQ7416200P

TQ7416200P.  
PUMP STATION - NO ACCESS

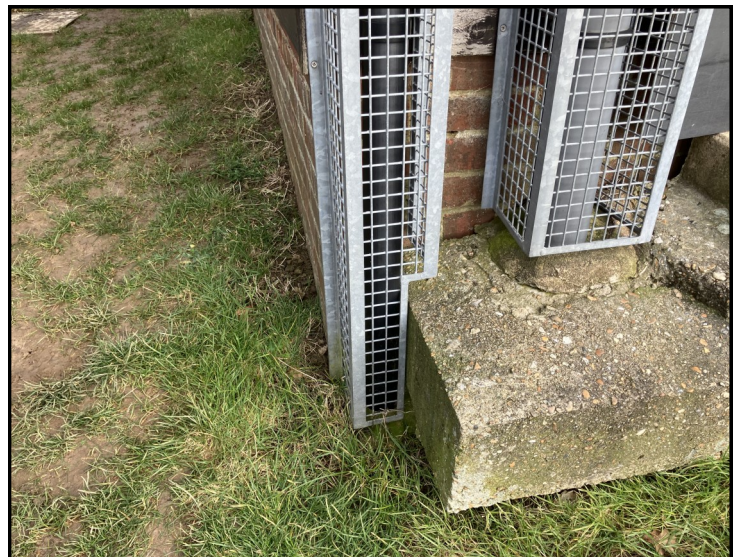
LOCATION OF RWP 1

RWP 1.  
INTO GROUND

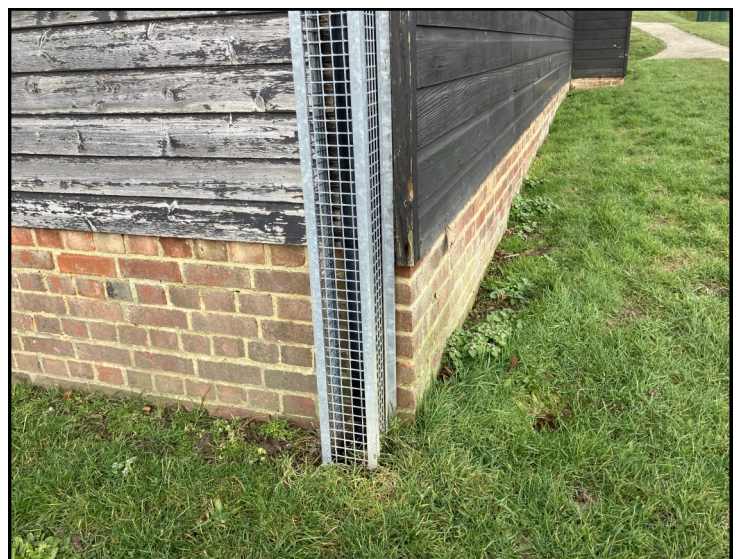
LOCATION OF RWP 2

RWP 2.  
INTO GROUND

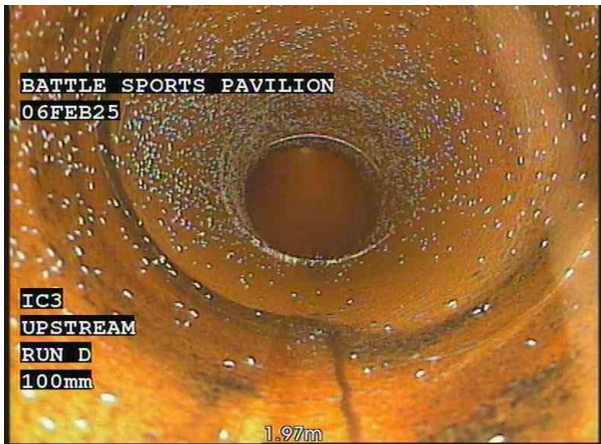
1, 00:00:27, 1.97 m  
Crack, circumferential from 03 o'clock to 06 o'clock

| Section number | Upstream manhole | Flow direction | Downstream manhole | Recommendations / Notes |
|---|---|---|---|---|
| 8 | IC3-D | Upstream | IC3 | Repair defect(s) by lining |

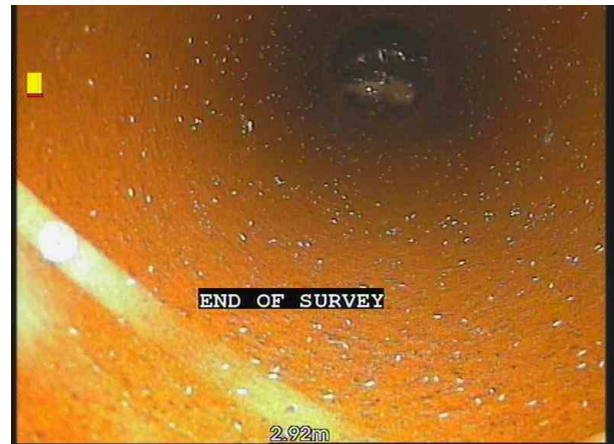
2, 00:01:07, 2.92 m  
Finish node, outfall, reference: IC3-D, At assumed capped / redundant end

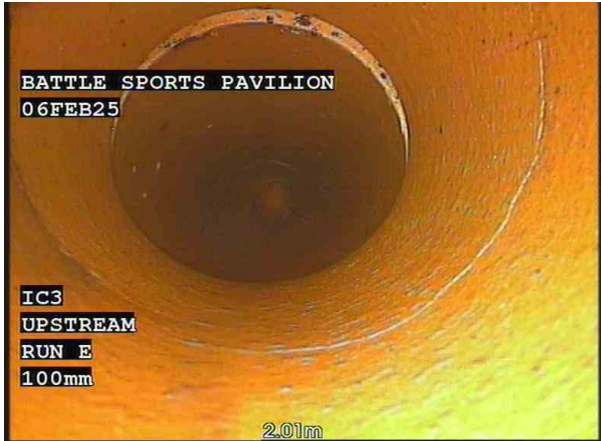
1, 00:00:20, 2.01 m  
Crack, circumferential from 03 o'clock to 06 o'clock

| Section number | Upstream manhole | Flow direction | Downstream manhole | Recommendations / Notes |
|---|---|---|---|---|
| 9 | IC3-E | Upstream | IC3 | Repair defect(s) by lining |

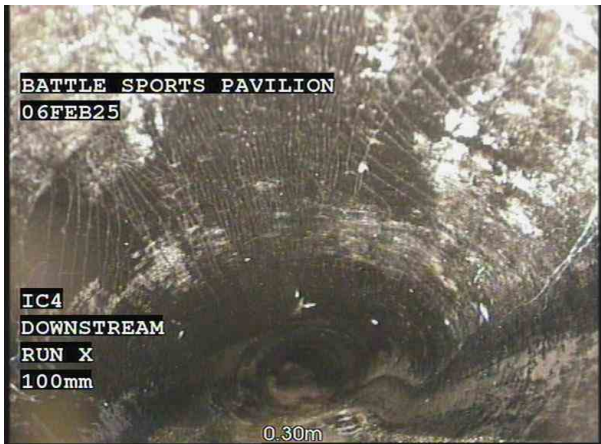
1, 00:00:04, 0.30 m  
Deformed sewer or drain, 10%, start

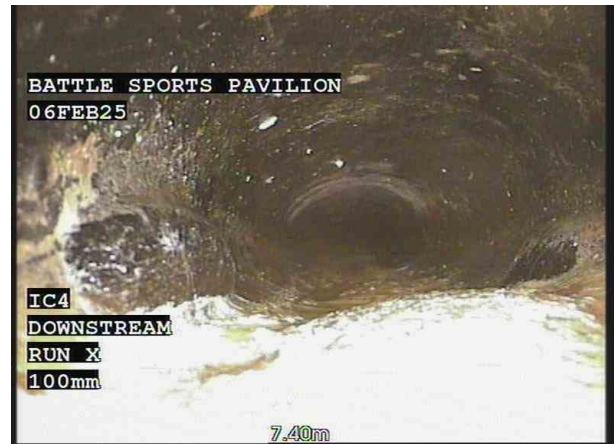
2, 00:00:56, 7.40 m  
Deformed sewer or drain, 20%, start

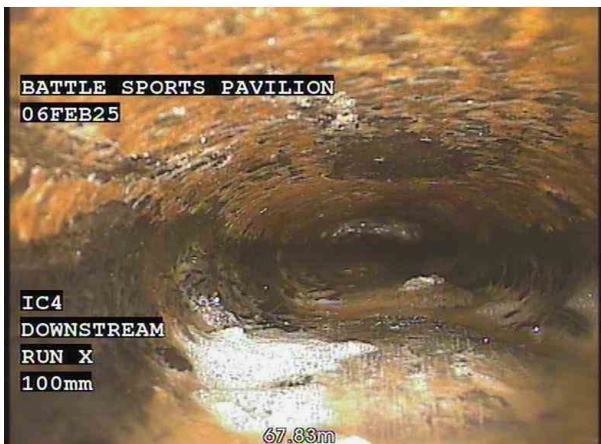
| Section | PLR | Grade | Description |
|---|---|---|---|
| 15 | IC4X | 5 | Deformed sewer or drain, 40%, finish |

3, 00:04:06, 67.83 m  
Deformed sewer or drain, 40%, start

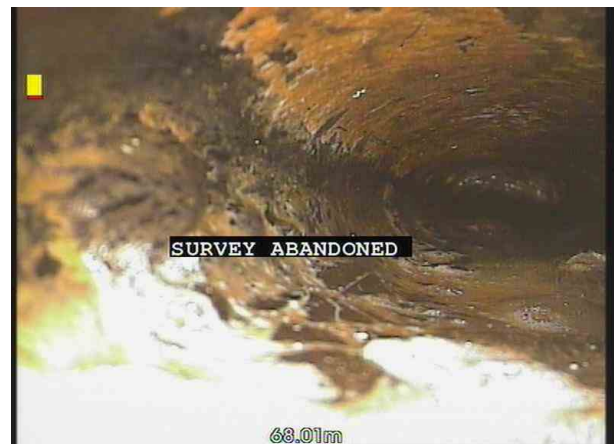
4, 00:04:41, 68.01 m  
Survey abandoned, Unable to continue

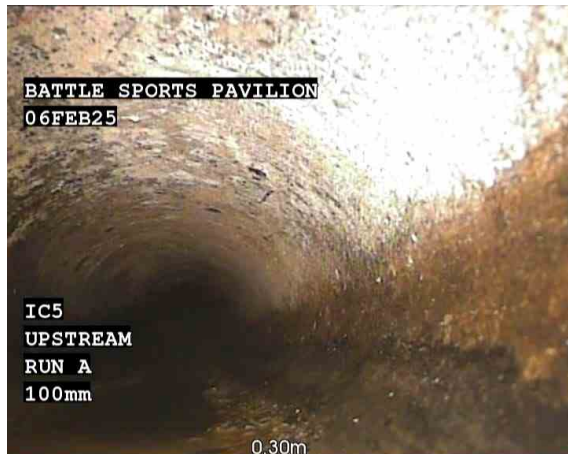
1, 00:00:00, 0.30 m  
Deformed sewer or drain, 10%, start

| Section number | Upstream manhole | Flow direction | Downstream manhole | Recommendations / Notes |
|---|---|---|---|---|
| 16 | IC4 | Upstream | IC5 | Pitch fibre pipework is deforming or delaminating, consider renovating or replacing the pipework |

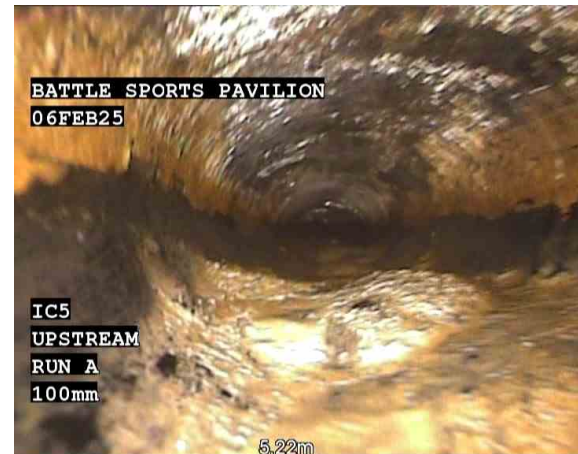
| Section | PLR | Grade | Description |
|---|---|---|---|
| 16 | IC4Y | 3 | Deformed sewer or drain, 20%, finish |

2, 00:00:27, 5.22 m  
Deformed sewer or drain, 20%, start

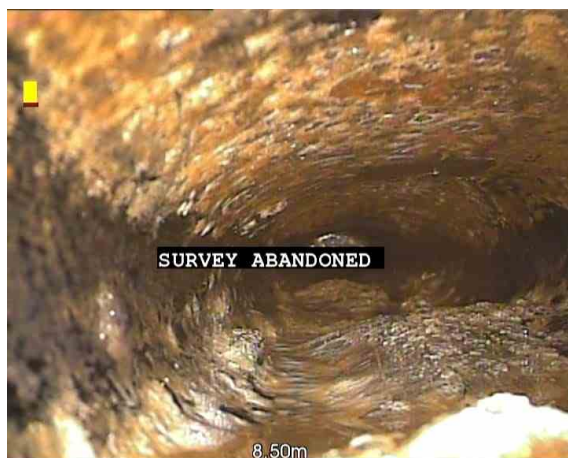
3, 00:00:50, 8.50 m  
Survey abandoned, Unable to continue

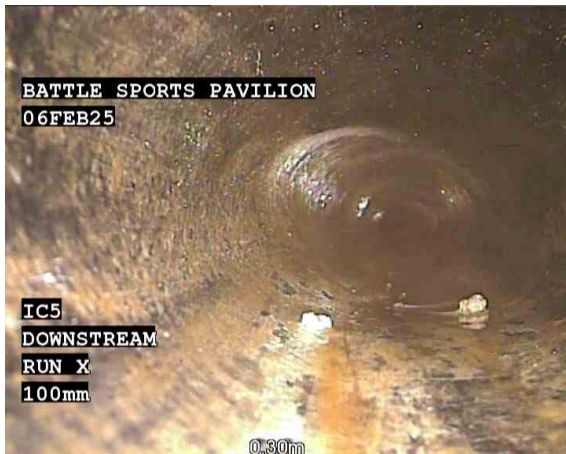
1, 00:00:00, 0.30 m  
Deformed sewer or drain, 5%, start

| Section number | Upstream manhole | Flow direction | Downstream manhole | Recommendations / Notes |
|---|---|---|---|---|
| 17 | IC5 | Downstream | RUN X | Pitch fibre pipework is deforming or delaminating, consider renovating or replacing the pipework |

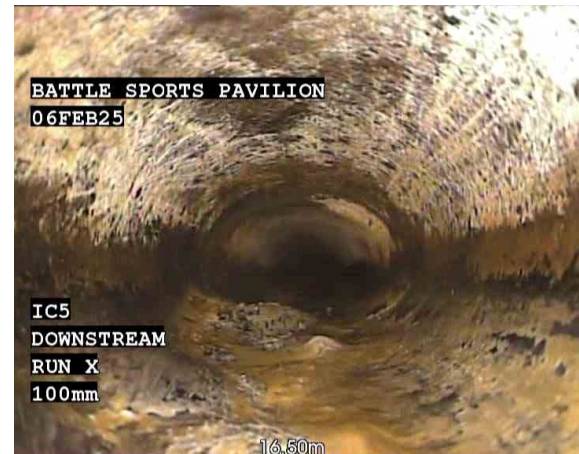
| Section | PLR | Grade | Description |
|---|---|---|---|
| 17 | IC5X | 3 | Deformed sewer or drain, 10%, finish |

2, 00:00:41, 16.50 m  
Deformed sewer or drain, 10%, start
