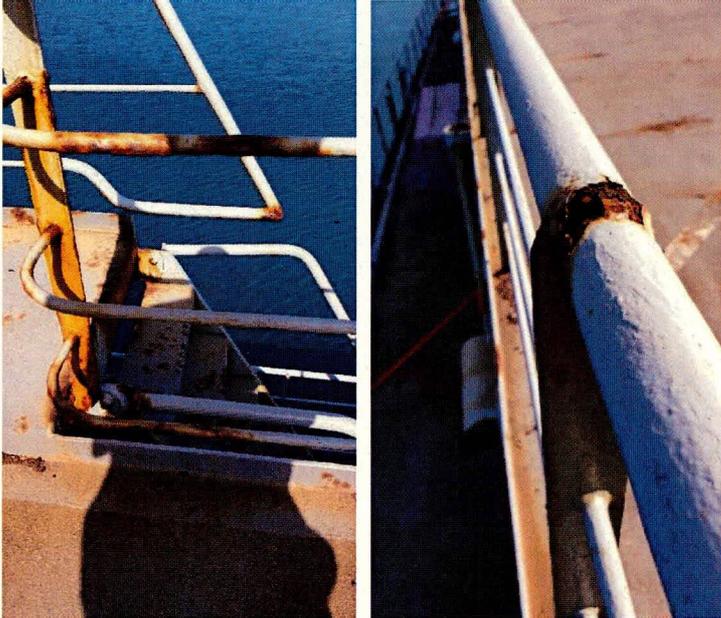
TASK NO.	TASK/DESCRIPTION	NOTES
H3.07	<p data-bbox="395 389 715 421">Flight Deck Guardrails</p> <div data-bbox="408 439 1129 1057">

</div> <p data-bbox="408 1075 1212 1160">The flight deck guardrails have areas of paint coating breakdown and active corrosion present. The top rail has suffered full thickness corrosion penetration and requires RENEWAL in certain areas.</p> <p data-bbox="408 1196 1212 1249">ALLOW for 8m top rail RENEWAL ALLOW for 10m² REPRESENTATION of all rails.</p>	<p data-bbox="1251 394 1450 564">Hotwork Required – Appropriate precautions to be taken IAW General 8.4.</p> <p data-bbox="1251 595 1450 703">IAW Paint scheme -General 12 and Annex B refer.</p> <p data-bbox="1251 734 1450 792">Complete IAW Ref. 5.</p>

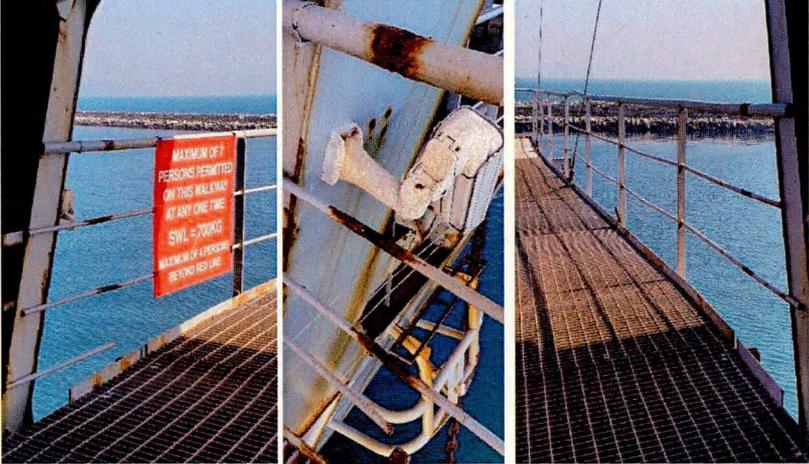
TASK NO.	TASK/DESCRIPTION	NOTES
H3.08	<p data-bbox="400 383 884 416">Aft Suspended Walkway Guardrails</p>

<p data-bbox="400 913 1209 1088">The aft suspended walkway guardrails are damaged and have areas of full thickness penetration due to corrosion on the top rail. REPLACE damaged lengths of top rail and also lengths of damaged/corroded/missing intermediate rails. ALLOW for 8m top rail and 30m intermediate rail RENEWAL. ALLOW for 15m² REPRESENTATION.</p>	<p data-bbox="1251 387 1449 555">Hotwork Required – Appropriate precautions to be taken iaw General 8.4.</p> <p data-bbox="1251 589 1449 696">IAW Paint scheme -General 12 and Annex B refer.</p> <p data-bbox="1251 730 1422 786">Complete IAW Ref. 5.</p>

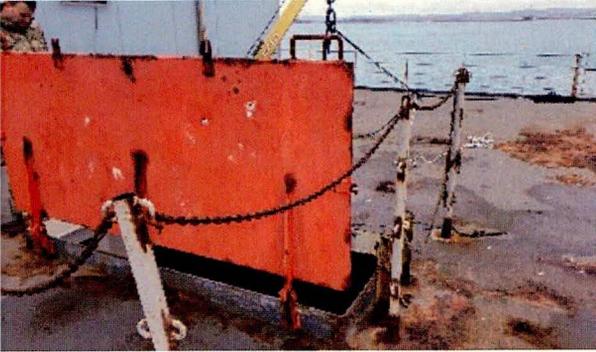
TASK NO.	TASK/DESCRIPTION	NOTES
H4.01	<p data-bbox="404 387 631 421">CASEVAC Hatch</p>

<p data-bbox="404 801 1196 958">The CASEVAC hatch located fwd on the vehicle deck is stiff to open and the hold-back facility inoperative. REMOVE and REFURBISH Vehicle deck CASEVAC hatch and hold back facility. REPRESENT all affected areas on completion. ALLOW for 4m² REPRESENTATION.</p>	<p data-bbox="1232 387 1420 562">Hotwork Required – Appropriate precautions to be taken iaw General 8.4.</p> <p data-bbox="1232 589 1420 701">IAW Paint scheme -General 12 and Annex B refer.</p> <p data-bbox="1232 728 1420 817">To be completed in conjunction with H3.02.</p>

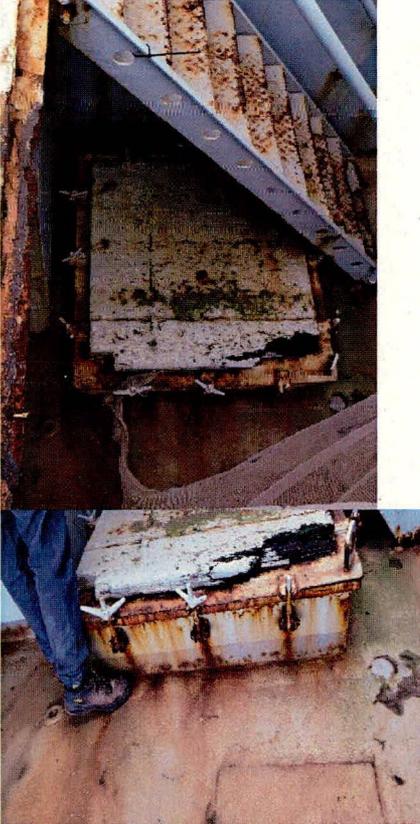
TASK NO.	TASK/DESCRIPTION	NOTES
	H4 EXTERNAL DOORS, OPENINGS AND HATCHES	
H4.02	<p data-bbox="403 387 724 416">Stbd Shade Deck Hatch</p>

<p data-bbox="403 1279 1214 1391">Fwd stbd shade deck hatch has unrequired wooden cover. Cover to be removed to inspect condition of hatch beneath. REPRESENT/REPAIR hatch as required. REPRESENT coatings on hatch and hatch combing on completion</p> <p data-bbox="403 1406 831 1431">ALLOW for 8m² REPRESENTATION.</p>	<p data-bbox="1254 394 1452 562">Hotwork Required – Appropriate precautions to be taken iaw General 8.4.</p> <p data-bbox="1254 595 1452 701">IAW Paint scheme -General 12 and Annex B refer.</p>
