FAAM Bridge – Photo Record – as of 16th August 2017.

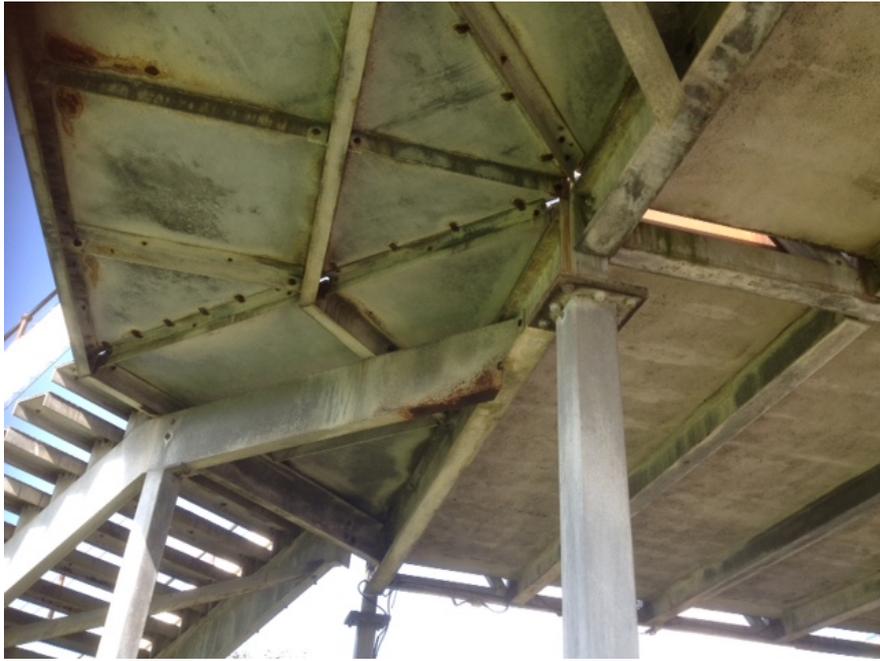
Fig 4 - General view under bridge area from roadway. Corrosion to both fixings and surfaces alike.

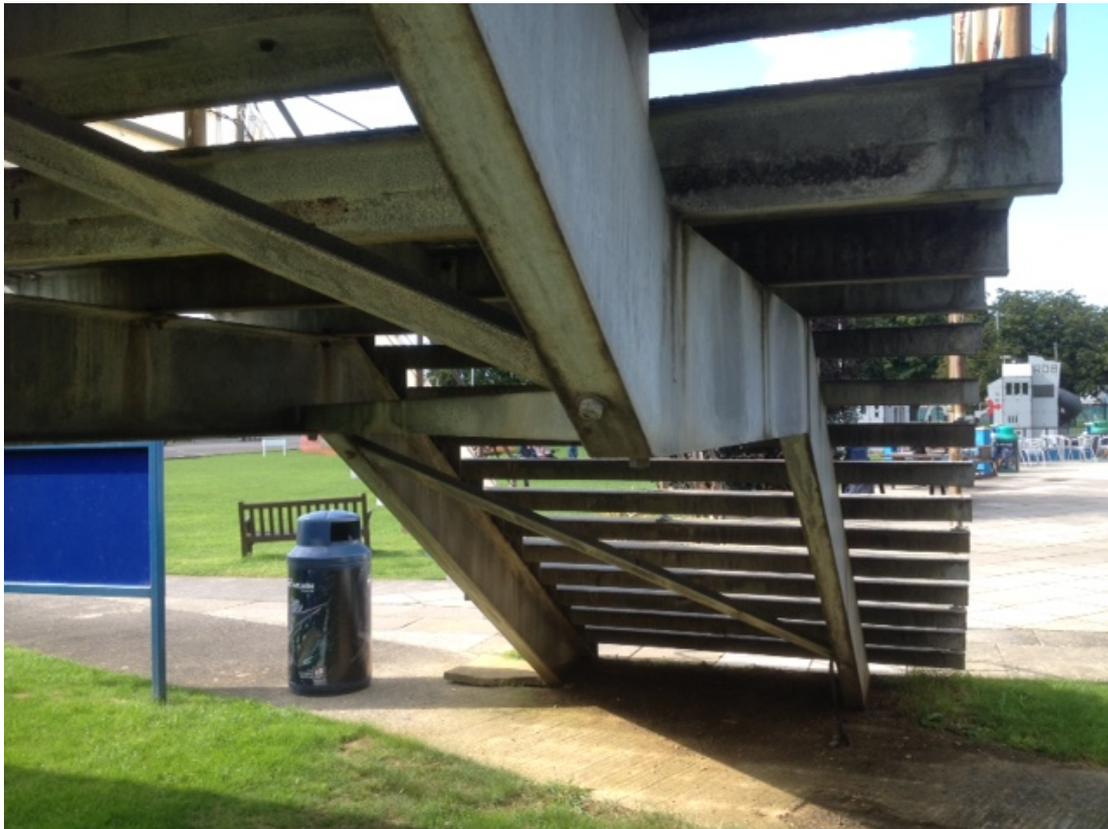
Fig 5 - General view under staircase. Corrosion to both fixings and surfaces alike.

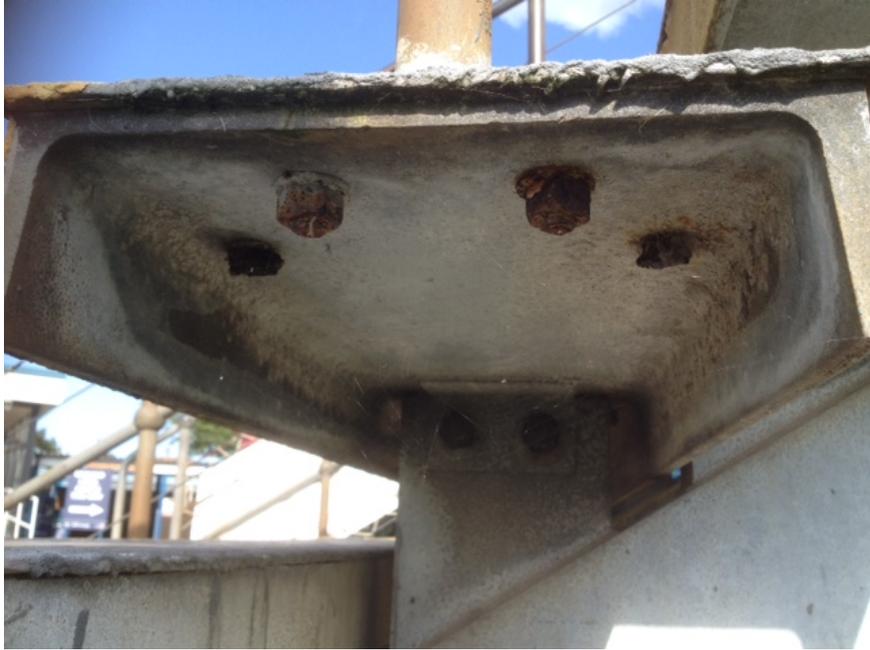
Fig 6 – Corrosion to both surfaces and bolts / nuts securing main bridge steps to truss etc.

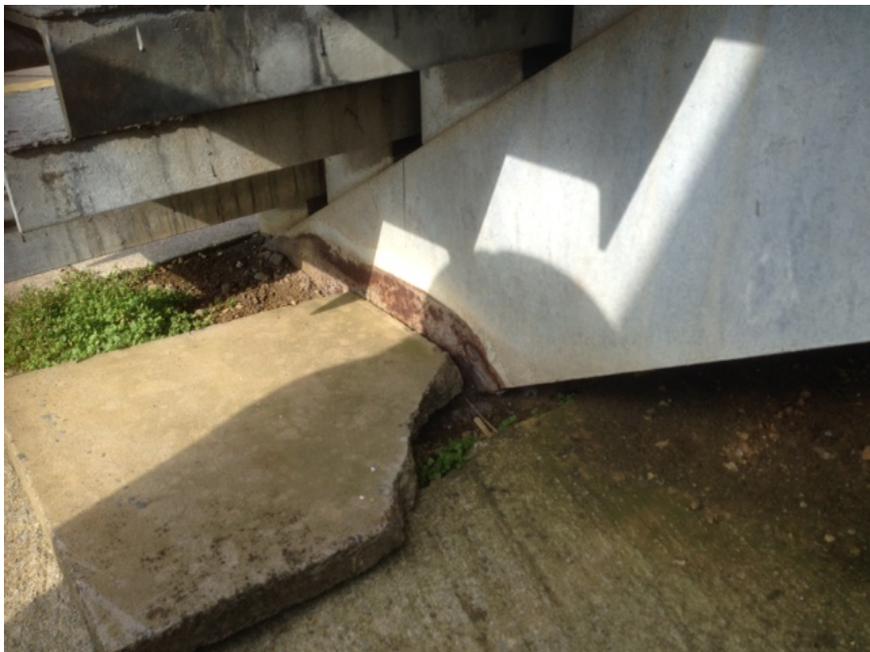
Fig 7 – Corrosion to staircase angle base support truss, area where base support meets ground.

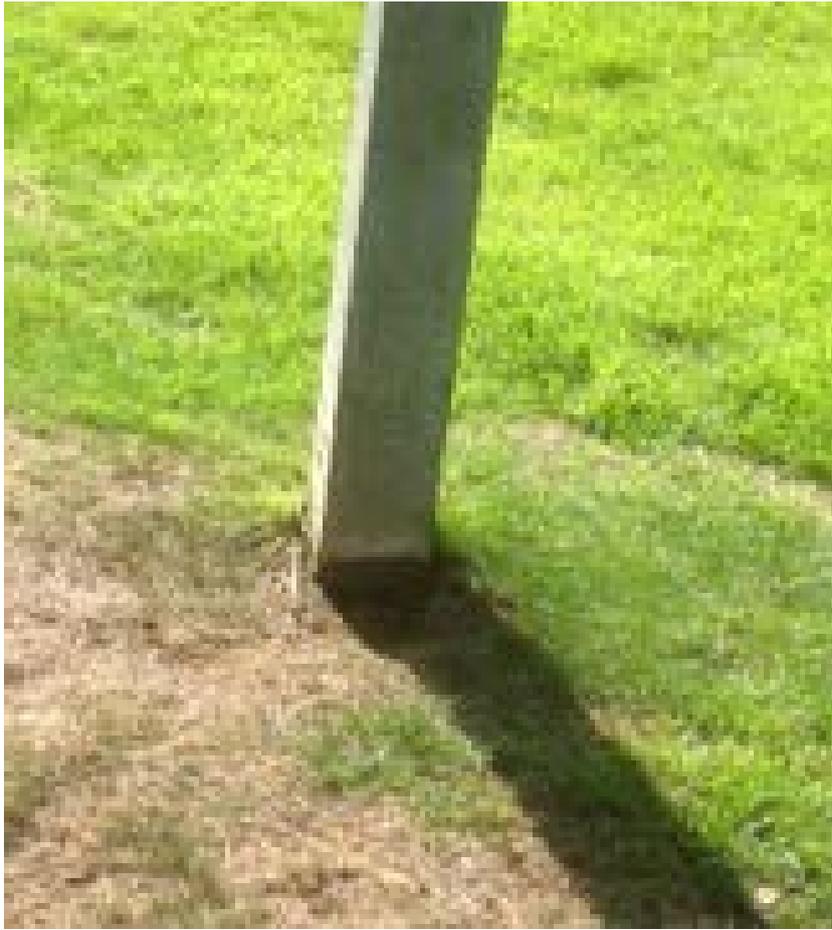
Fig 8 - Corrosion to buried steel truss support structure (under ground level).

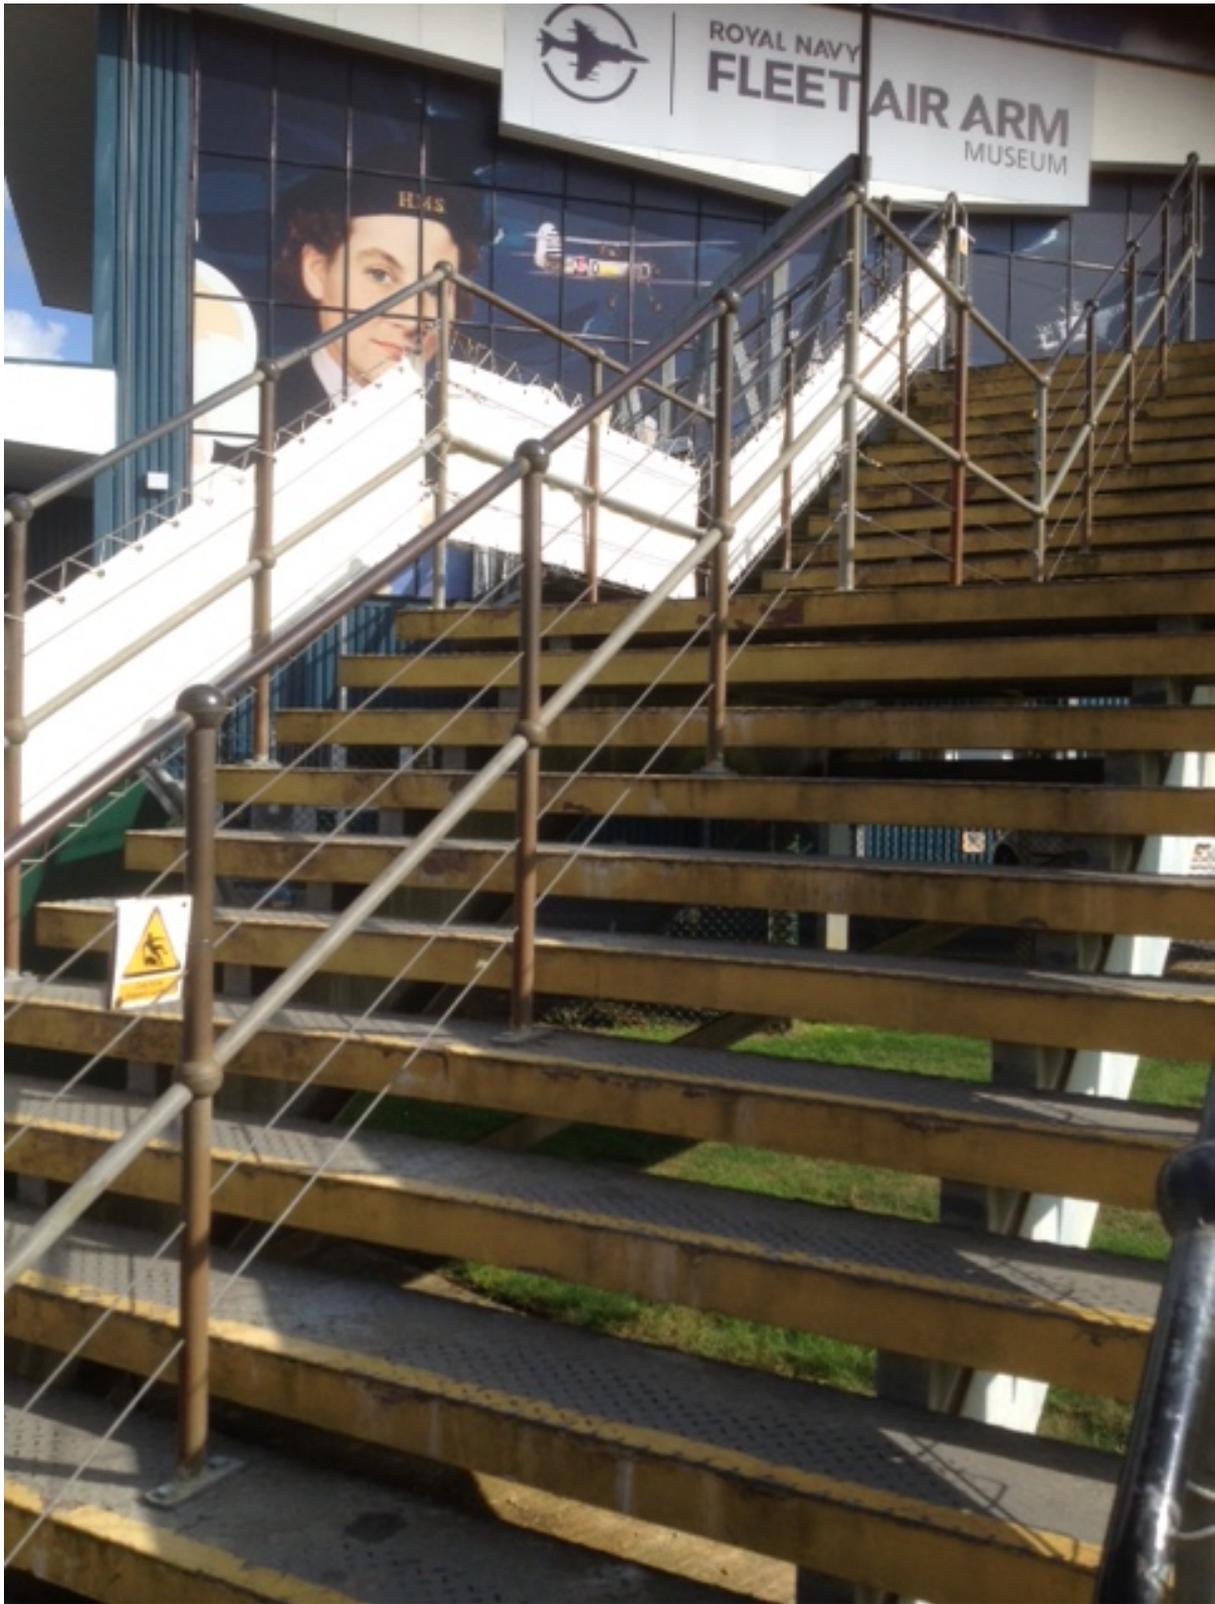
Fig 9 – Railings and Cable, some corrosion and discolouring.

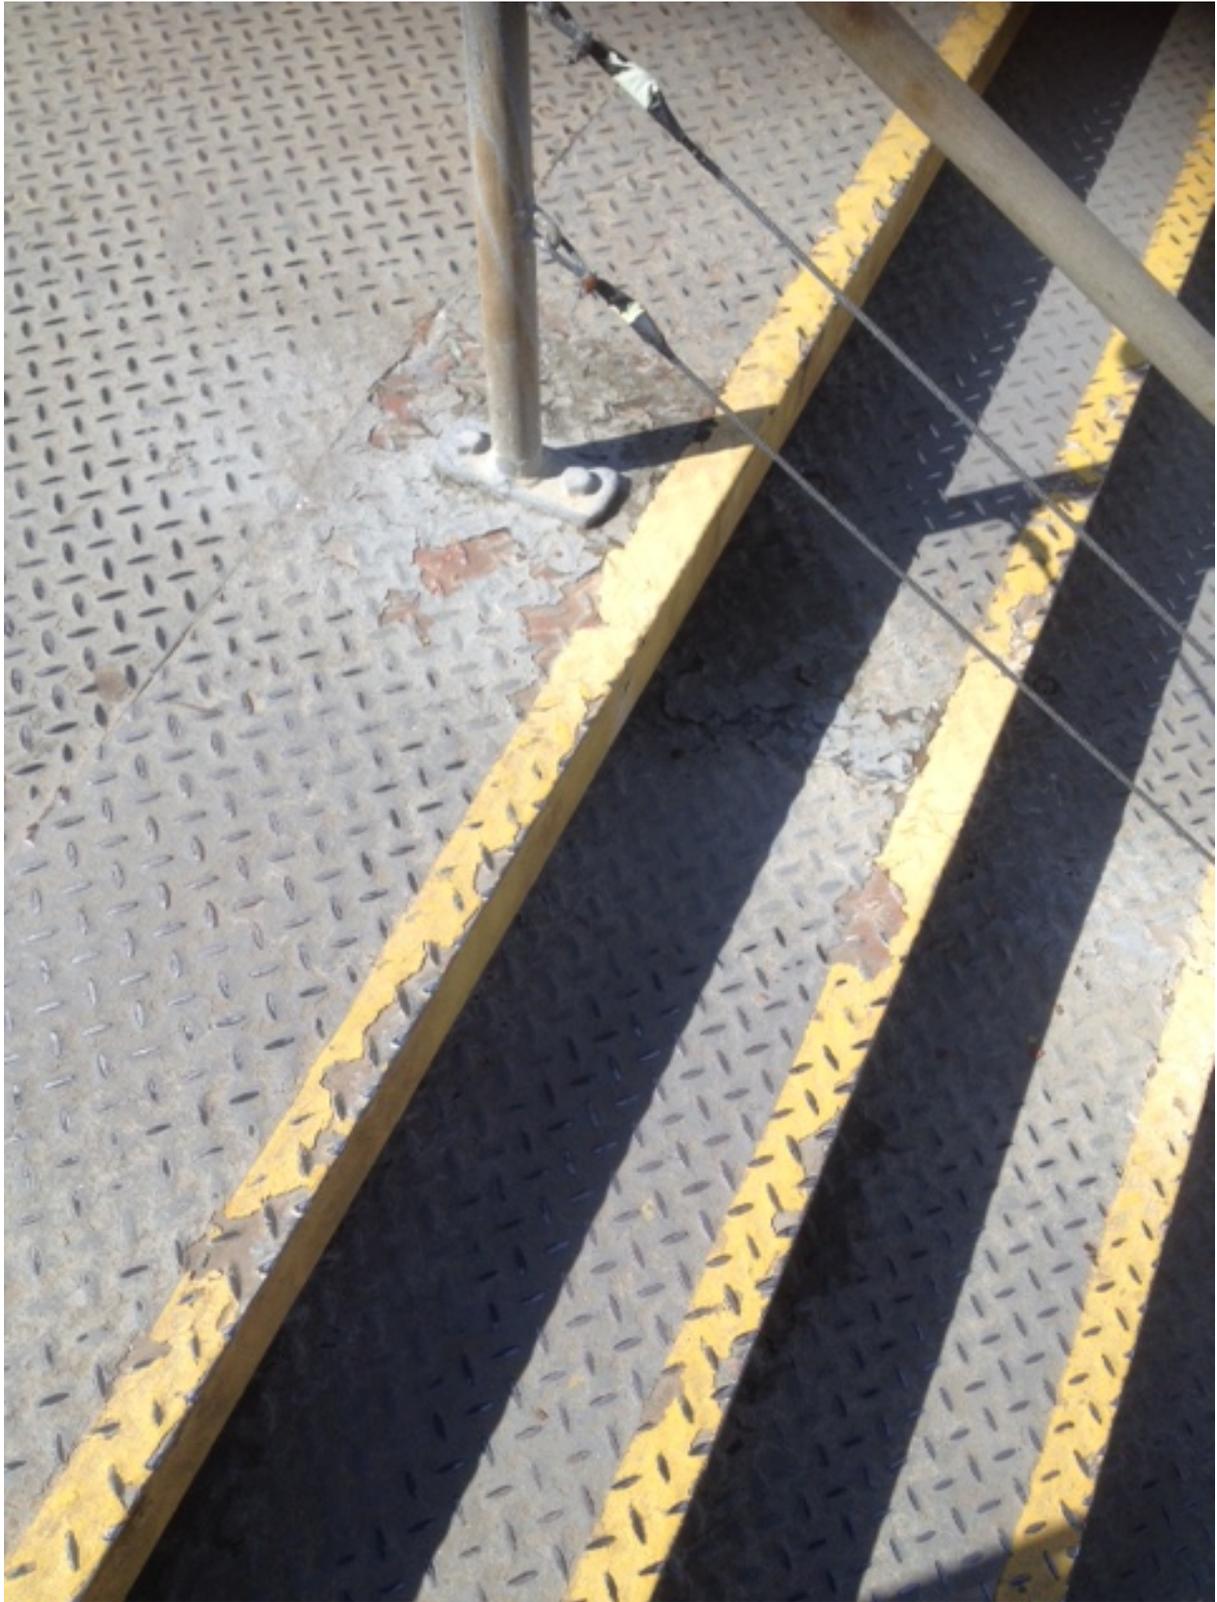
Fig 10 – Corrosion and Wear to Anti Slip Step Plate and Surfacing.

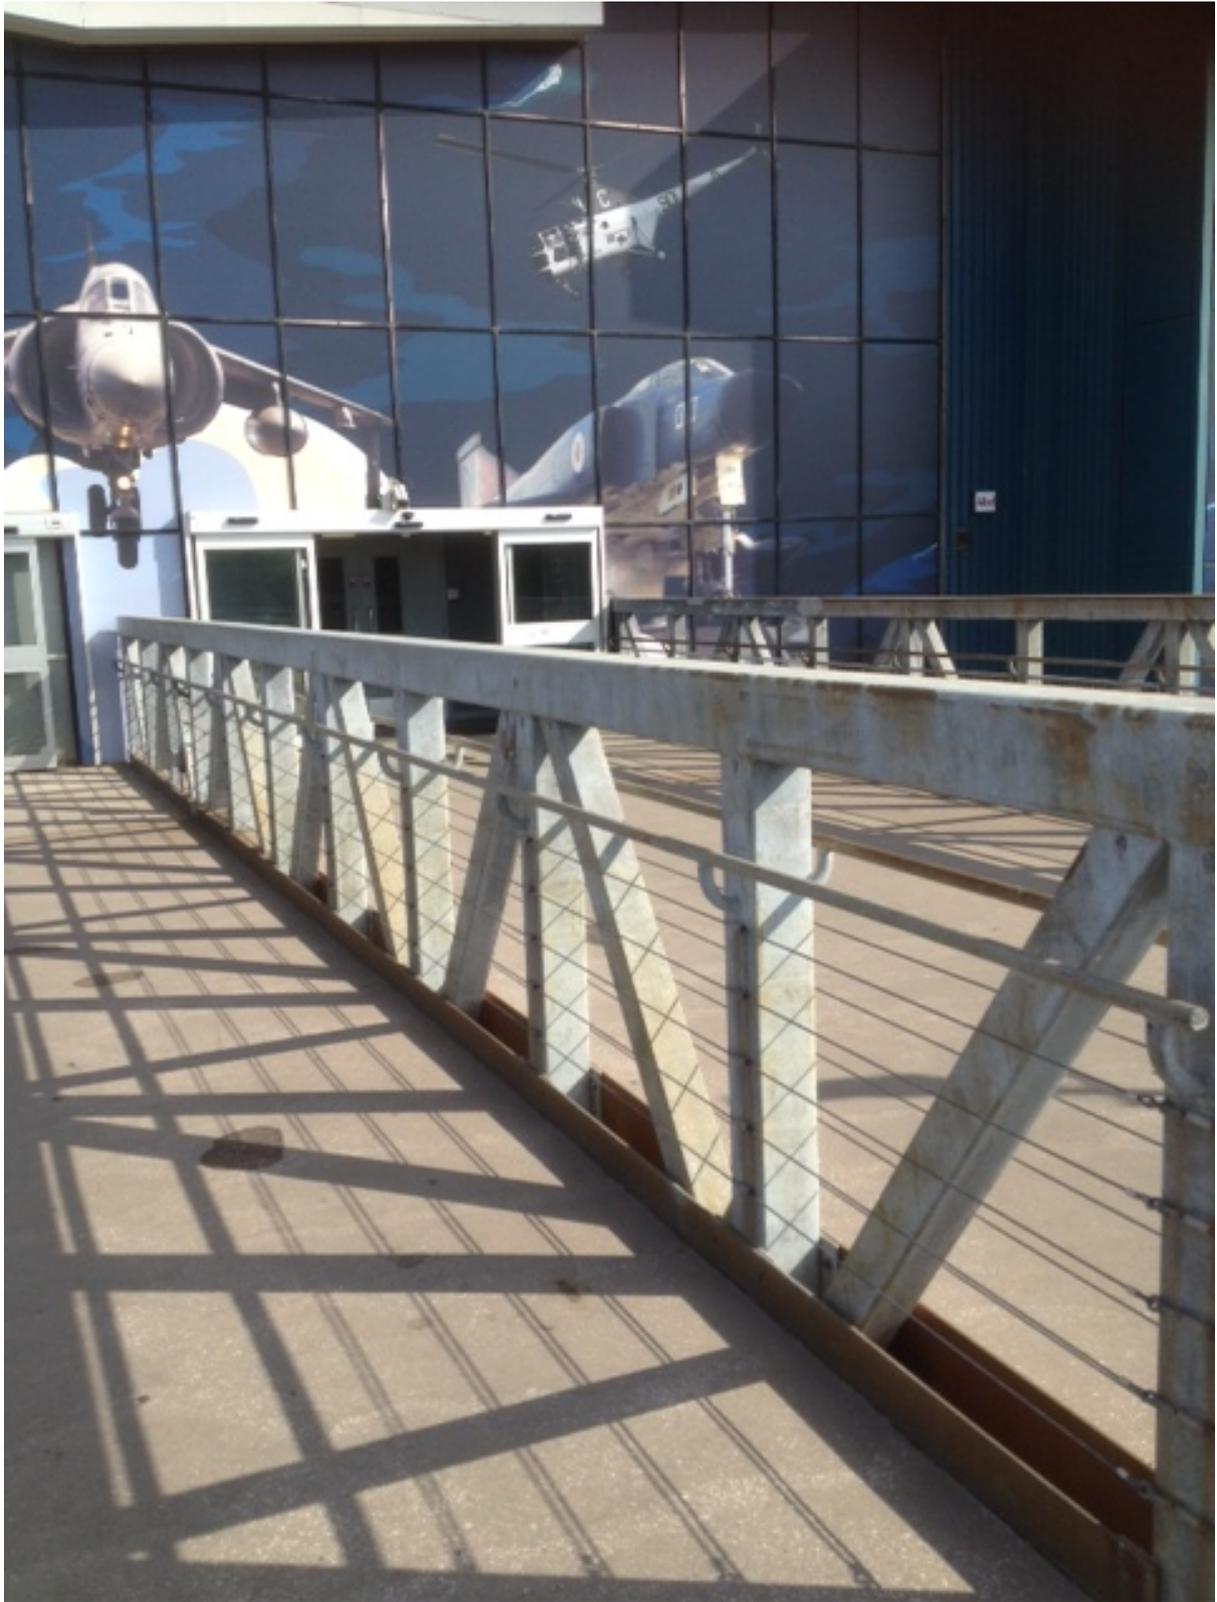
Fig 11 - Fig 9 – Support Rails and Cable, some corrosion and discolouring.
