Report Number 50599

Asbestos survey at
Didcot Town Council
Lloyds Rec. and Edmonds Park
Various Buildings

ON BEHALF OF: *Didcot Town Council*

SURVEY DATE: *6th September 2005*

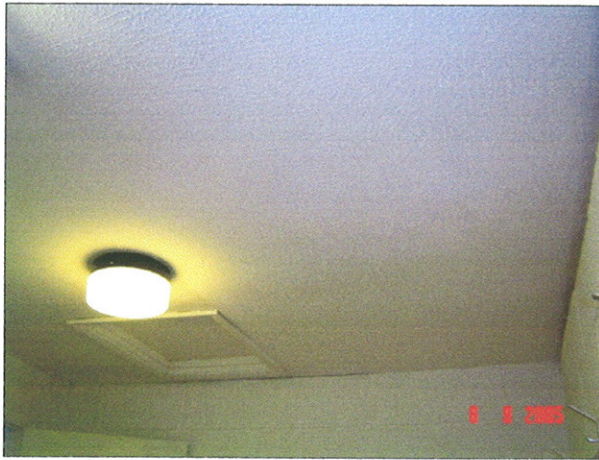
Area Lloyds Rec pavillion	Location Internal	Photo

Installation Artex ceiling		
Type of material Decorative coating	Condition 0 - Non asbestos	
Content N.A.D.I.S	Extent Throughout	
Risk Category E	General remarks No asbestos was detected within the sample.	
		Sample No. 001

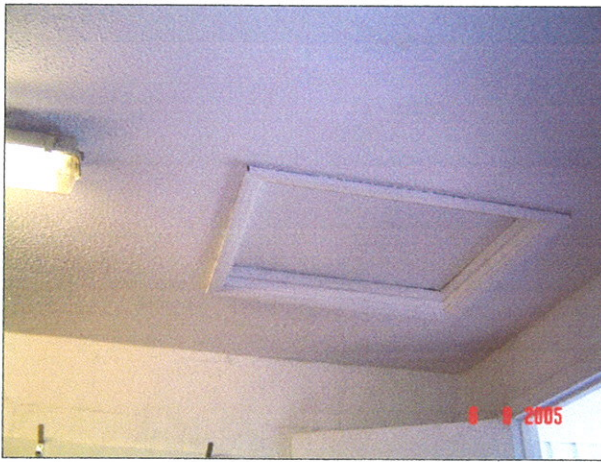
Area Lloyds Rec pavillion	Location Internal	Photo

Installation Artex ceiling		
Type of material Decorative coating	Condition 0 - Non asbestos	
Content N.A.D.I.S	Extent Throughout	
Risk Category E	General remarks No asbestos was detected within the sample.	
		Sample No. 002

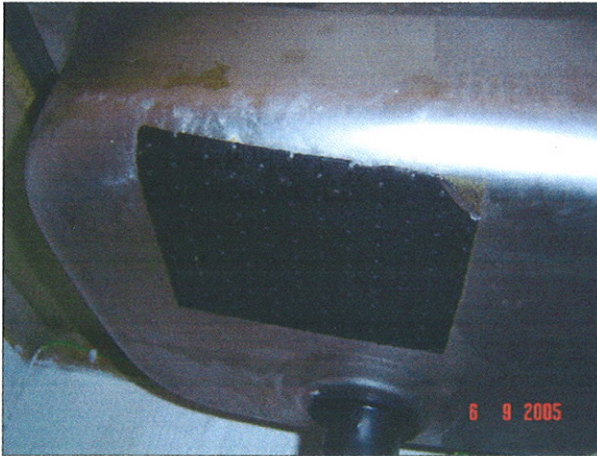
Area Lloyds Rec pavillion	Location Internal	Photo

Installation Sink pad		
Type of material Bitumastic	Condition 0 - Non asbestos	
Content N.A.D.I.S	Extent 1 No.	
Risk Category E	General remarks No asbestos was detected within the sample.	
		Sample No. 003

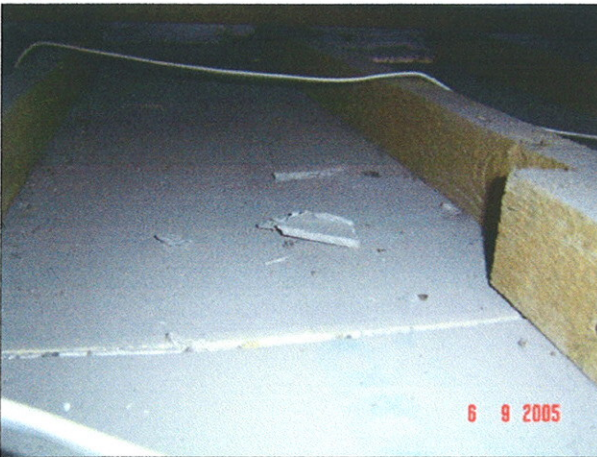
Area Lloyds Rec pavillion	Location Internal roof space	Photo

1. This building is a sports ground changing room facility of brick/block construction and plaster/plasterboard internal linings. The roof is pitched and clad in profiled corrugated roof sheets. The internal ceilings have an artex decorative coating applied to their surface. Both the profiled roof sheets and the artex coatings were sampled and found not to contain any asbestos fibres. This was also true of the kitchen sink pad.
2. Within the loft areas, and lying on the back of the plasterboard ceilings, broken profiled cement debris was observed that has been tested and found to contain Chrysotile asbestos fibres in significant quantities. This appears to be the remains of the original asbestos cement roof sheets that have been poorly removed when the roof sheets were replaced. This debris is scattered throughout the whole of the roof space.

Installation Debris		
Type of material Asbestos cement	Condition 6 - Low risk	
Content Chrysotile - significant	Extent Scattered throughout	
Risk Category C	General remarks The debris lies on the back of the plasterboard ceilings. It is the remains of the asbestos cement roof that has been previously removed.	
		Sample No. 004

1. The roof space above the ceiling within the Lloyds Rec. pavilion should be placed under restricted access until the debris can be removed and the area decontaminated.
2. The Insulation board ceiling to the Edmonds park pavilion requires some patch repair and sealing. It should also be labelled as a hazard. The roof space above should not be accessed by anyone due to the broken roof debris but also due to the fact that the insulation board ceiling is raw and untreated on the upward facing side. Consideration should be given to the complete removal of the insulation board ceiling to the shower area.
3. The profiled sheets above the suspended ceiling within the Motorcycle workshop are located out of harms way and are not visible from below. However they should be labelled as a hazard.

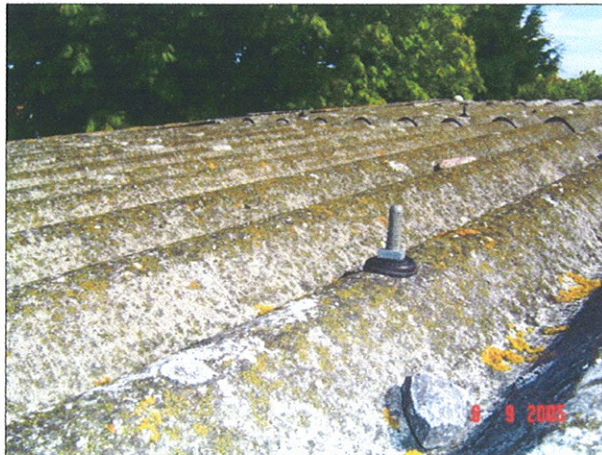
Area Lloyds Rec pavillion	Location External
Installation Roof	
Type of material Profiled sheets	Condition 0 - Non asbestos
Content N.A.D.I.S	Extent 54m2

Risk Category E

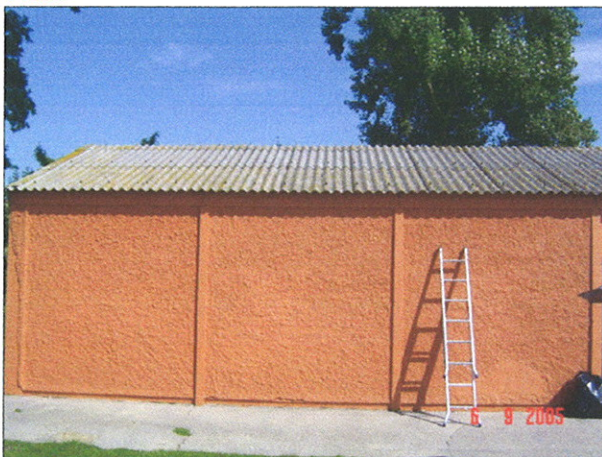
Area Edmonds Park pavillion	Location External
Installation Roof	
Type of material Profiled sheets	Condition 0 - Non asbestos
Content N.A.D.I.S	Extent 100m2

Risk Category E

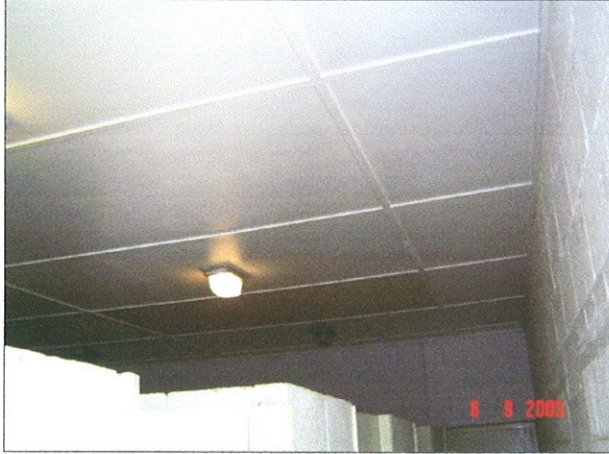
Area Edmonds Park pavillion	Location Internal Showers	Photo

Installation Ceilings		
Type of material Insulation board	Condition 8 - Medium risk	
Content Amosite - significant	Extent 40m2	
Risk Category B	General remarks The ceiling has some visible damage which requires repair and protection.	
		Sample No. 02

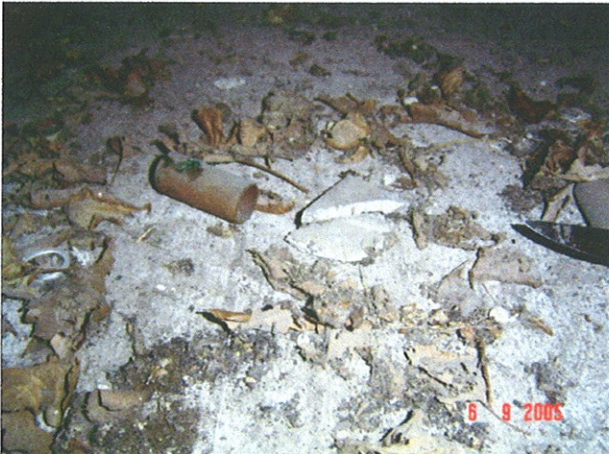
Area Edmonds Park pavillion	Location Internal roof space	Photo

replaced. This debris is scattered throughout the whole of the shower area roof space. The ceilings to the other areas of the facility have been replaced or installed since the roof was replaced and are therefore unaffected by old roof debris.

Installation Above shower ceiling		
Type of material Asbestos cement	Condition 6 - Low risk	
Content Chrysotile - significant	Extent Scattered throughout	
Risk Category C	General remarks The debris is lying on the back of the asbestos insulation board ceiling. It is the remains of the previously removed asbestos cement roof.	
		Sample No. 03

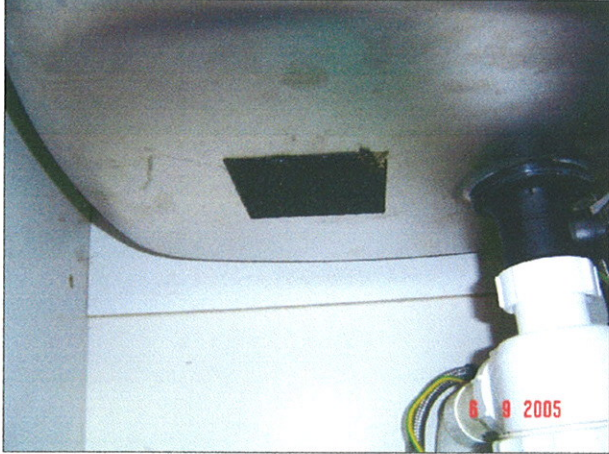
Area Edmonds Park pavillion	Location Internal	Photo

Installation Sink pad		
Type of material Bitumastic	Condition 0 - Non asbestos	
Content N.A.D.I.S	Extent 1 No.	
Risk Category E		
General remarks No asbestos was detected within the sample.		Sample No. 04

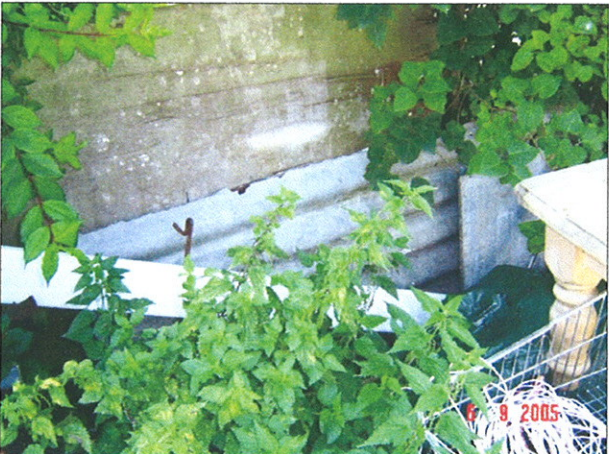
Area Edmonds Park storage	Location External	Photo

Installation Stacked sheets		
Type of material Profiled sheets	Condition 0 - Non asbestos	
Content N.A.D.I.S	Extent 4 No.	
Risk Category E		
General remarks No asbestos was detected within the sample.		Sample No. 04xa

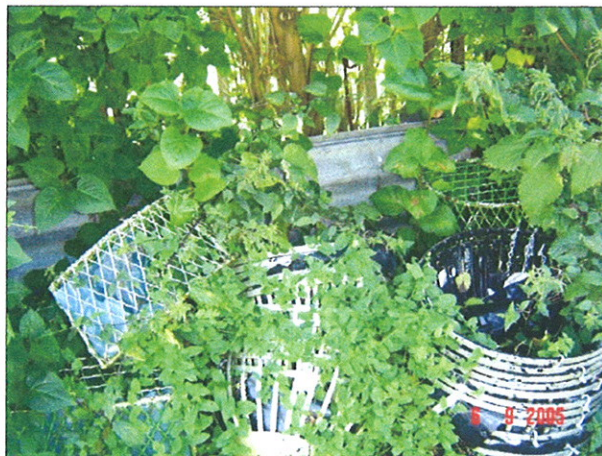
Type of material	Condition
Profiled sheets	0 - Non asbestos

Content	Extent
N.A.D.I.S	4 No.

Risk Category
E

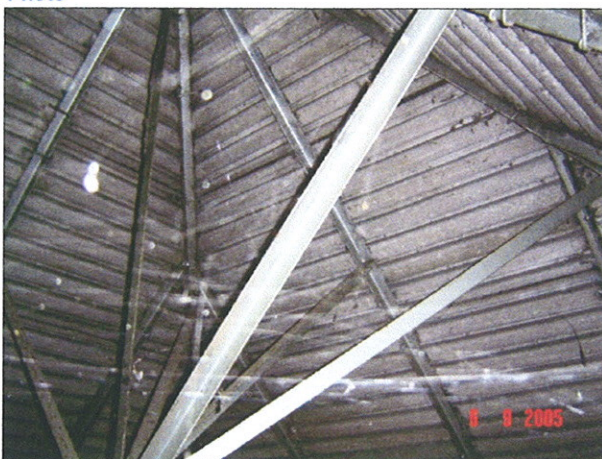
Type of material	Condition
Asbestos cement	6 - Low risk

Content	Extent
Chrysotile - significant	Throughout

Risk Category
C

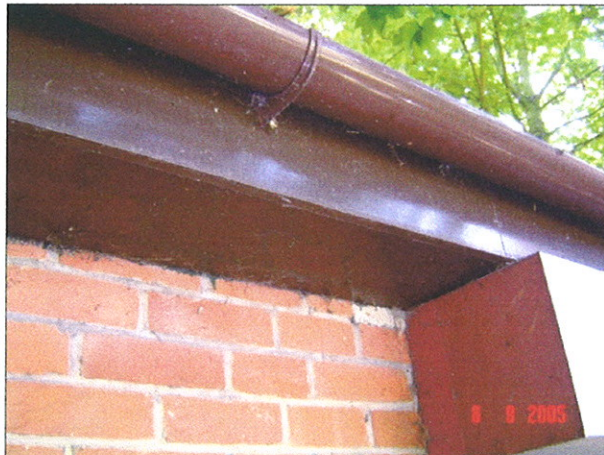
1. This is a former electrical sub-station building now converted into a workshop for the repair and maintenance of motorcycles. It is of brick/block construction with a pitched roof clad in clay tiles. Internal linings are of plaster/plasterboard with a plasterboard lay in grid suspended ceiling. Above the suspended ceiling an internal rood lining was observed constructed from profiled sheets that have been tested and found to contain Chrysotile asbestos in significant quantities. The external roof eaves soffit board was also observed to be the same asbestos cement material.

Type of material	Condition
Asbestos cement	4 - Very low risk

The eaves soffit boards are external and they are painted and sealed.
