Re: Asbestos Survey

# **ASBESTOS SURVEY REPORT**

**Leigh Adult CC  
Elm Road  
Leigh on Sea  
Essex  
SS9 1SP**

**Survey Report No: 1605**

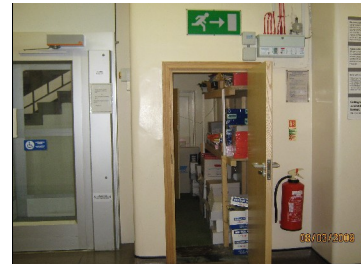
Photo No: 85

Block: N/A. Floor : Ground. Area: Cleaners cupboard.

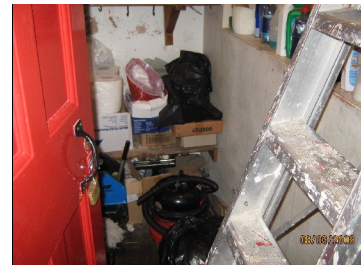
Photo No: 86

Block: N/A. Floor : Ground. Area: Cleaners cupboard.

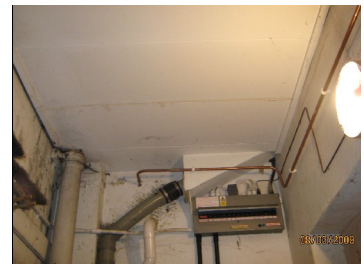
Photo No: 87

The only asbestos on this type 2 survey was to the cleaners cuboard ceiling ( redundant flue ).  
Recommended monitor

Block: N/A. Floor : Ground. Area: Cleaners cupboard.

Material Assessment	Priority Assessment
Product type: 1	Occupancy: 1
Extent of damage: 1	Disturbance: 1
Surface: 0	Exposure: 1
Type: 1	Maintenance: 0
Material score: 3	Priority score: 3
Total Assessment score: 6

**Recommendation: Monitor**

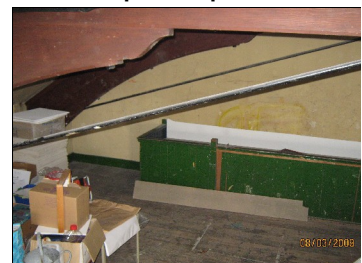
Photo No: 113

Notes on sample: Wood, metal ducting, loose fill insulation.

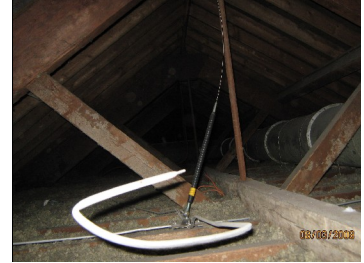
Photo No: 114

Block: N/A. Floor : First. Area: External.
