Blakemoore Flats Ruins
Recommendations for Conservation **DRAFT**

February 2022

██████████ was approached by the client, Mr Simon Cooter of Natural England, to consider options and prepare costs for the consolidation and conservation of the ruined remains of two stone buildings within the area known as Blakemoorflat. The site is designated a Scheduled Ancient Monument and is currently considered by Historic England to be at risk. Natural England (the owners) propose to fund a project to conserve the site and the ruins in such a way as to be 'readable' and understood as part of the story and contemporary experience of the Stiperstones upland landscape.

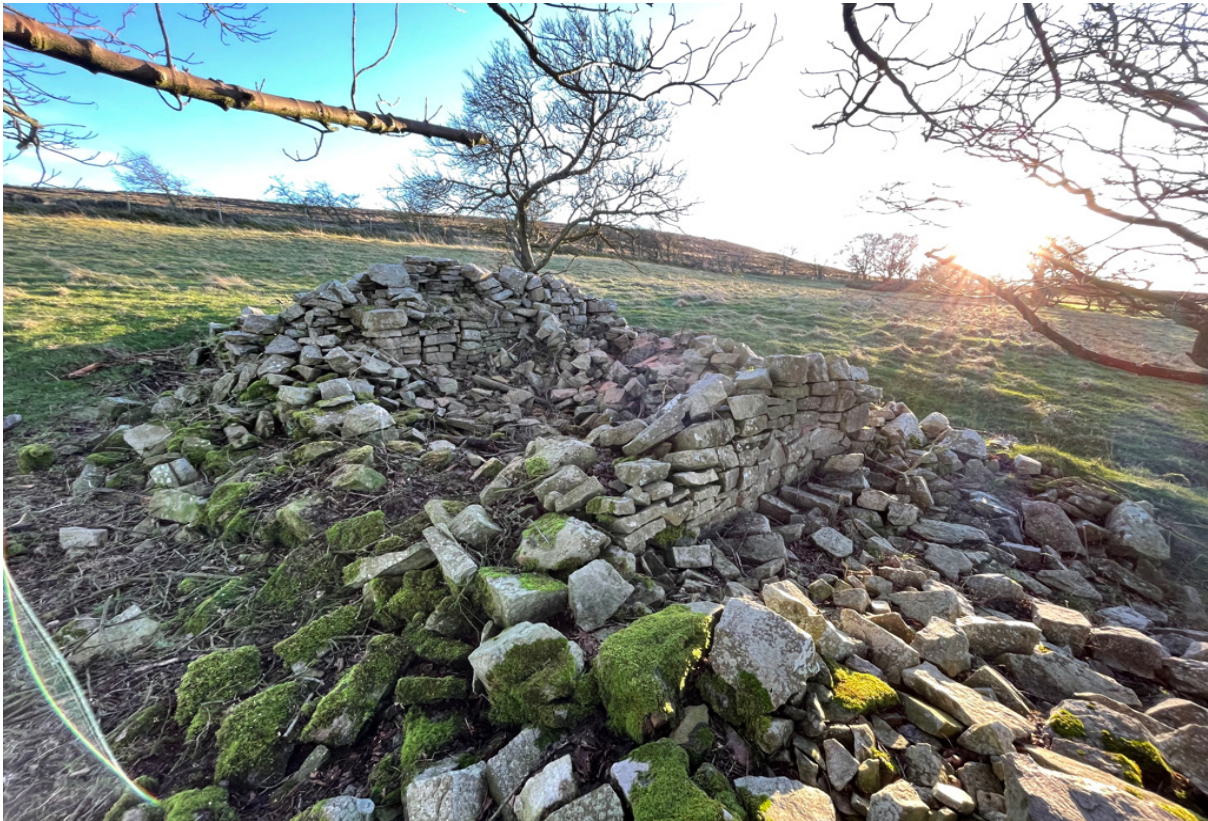
The construction generally is of random coursed rubble stone. Earth mortar is apparent within the core of the structure with evidence of a low ratio lime binder and mud mortar used on the outermost pointed masonry face. The structural condition of the remaining masonry is very poor, with much of the core construction and pointing mortars washed out, leaving the structure with the appearance of a 'drystone' construction. Individual stones are therefore very loose and the whole is highly vulnerable to further erosion and collapse. The stone walls of the primary structure survive to approximately 1m high, and approximately 1.6m high at the south gable wall. The dimensions, including widths and constructional details are still readily discernible. The roof, all internal fixtures and fittings, and all joinery are absent, although some remains may be buried below the collapsed masonry. The stone type has not been formally assessed, however, reference to the English Heritage 'Strategic Stone Study' (A Building Stone Atlas of Shropshire) Published May 2012 by Andrew Jenkins of the Shropshire Geological Society identifies the stone in the immediate vicinity to be 'Stiperstones Quartzite' (Formation). The stone is described as a 'very hard sandstone', and this would correspond with observations made on site.

Notable features of the remains include the possibility of a chimney piece in the south gable, visible doorways and an offset internal wall located parallel to the outer west wall. The latter may be an informal repair, possibly to allow the ruinous building to be used as a store/ shelter, prior to its further demise.

Image 01. Structure No.1 As viewed from the Northeast.

During the on-site meeting with Historic England, it was agreed that to stabilise the remains, some limited unpicking of the collapsed masonry both internally and externally would be required, followed by some rebuilding of the walls necessary to provide improved visibility and stability of the structure generally. Rebuilding is to include the collapsed Northwest and Northeast corners and the East wall. The height of those areas of the wall to be reconstructed should be no less than 1m.

It was agreed that much of the structure comprised an earth mortar, and some unpicking will help to ascertain further constructional details. If, as recommended, earth mortar is to be re-used in the construction of the core, a lime binder in small proportions should be added to help improve the longevity of the construction material. Under the guidance of Natural England, an area nearby should be selected as a source of earth for construction. Due to the presence of a lime/earth mortar within the pointed (Outer) stone face, it was agreed that this should be replicated. It was agreed that the wall tops will benefit from being soft capped and with guidance from Natural England, the turfs could be taken from the immediate vicinity, the bare earth then allowed to regenerate naturally from the local seedbank. It was noted that natural soft capping had developed on Structure No. 2.

It was agreed that trees and vegetation should be cut back from the walls and the inside of the structure.

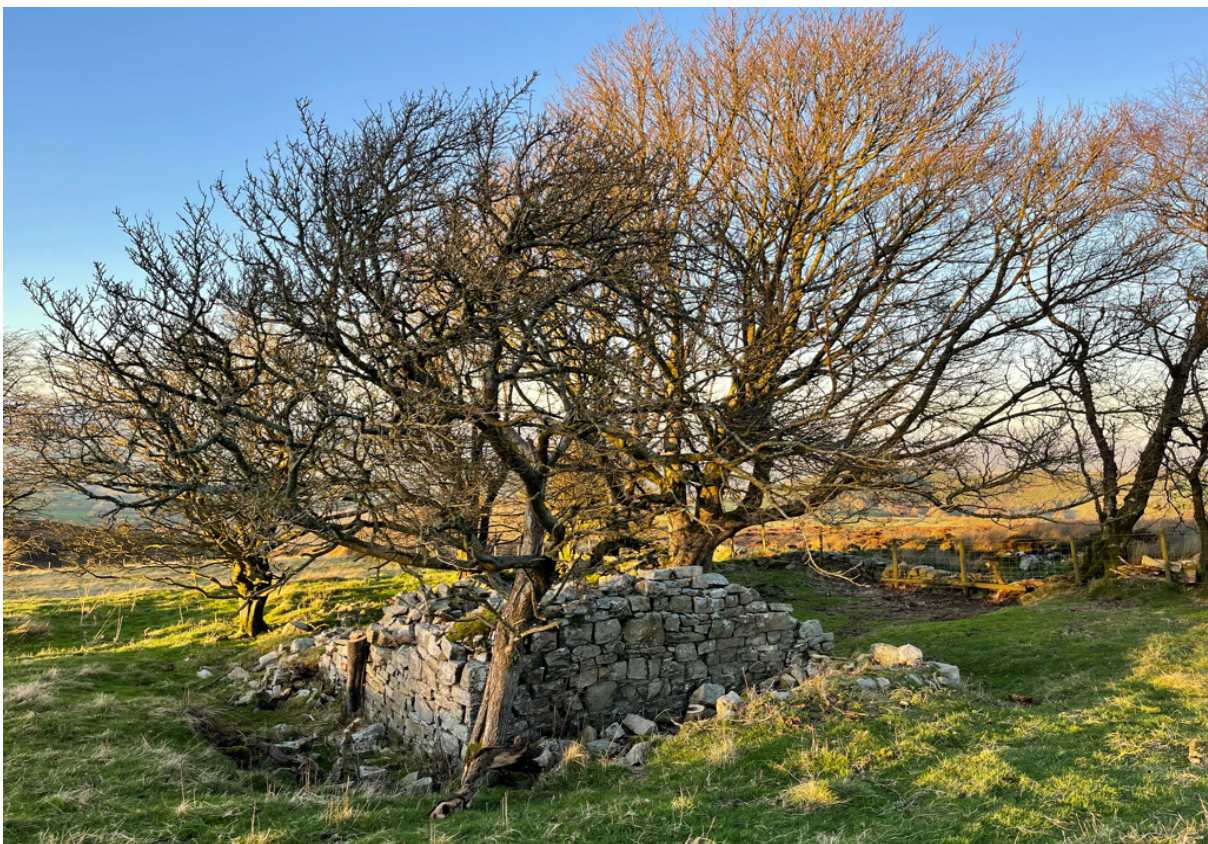
Image 02. Structure No.1 As viewed from the Southwest.

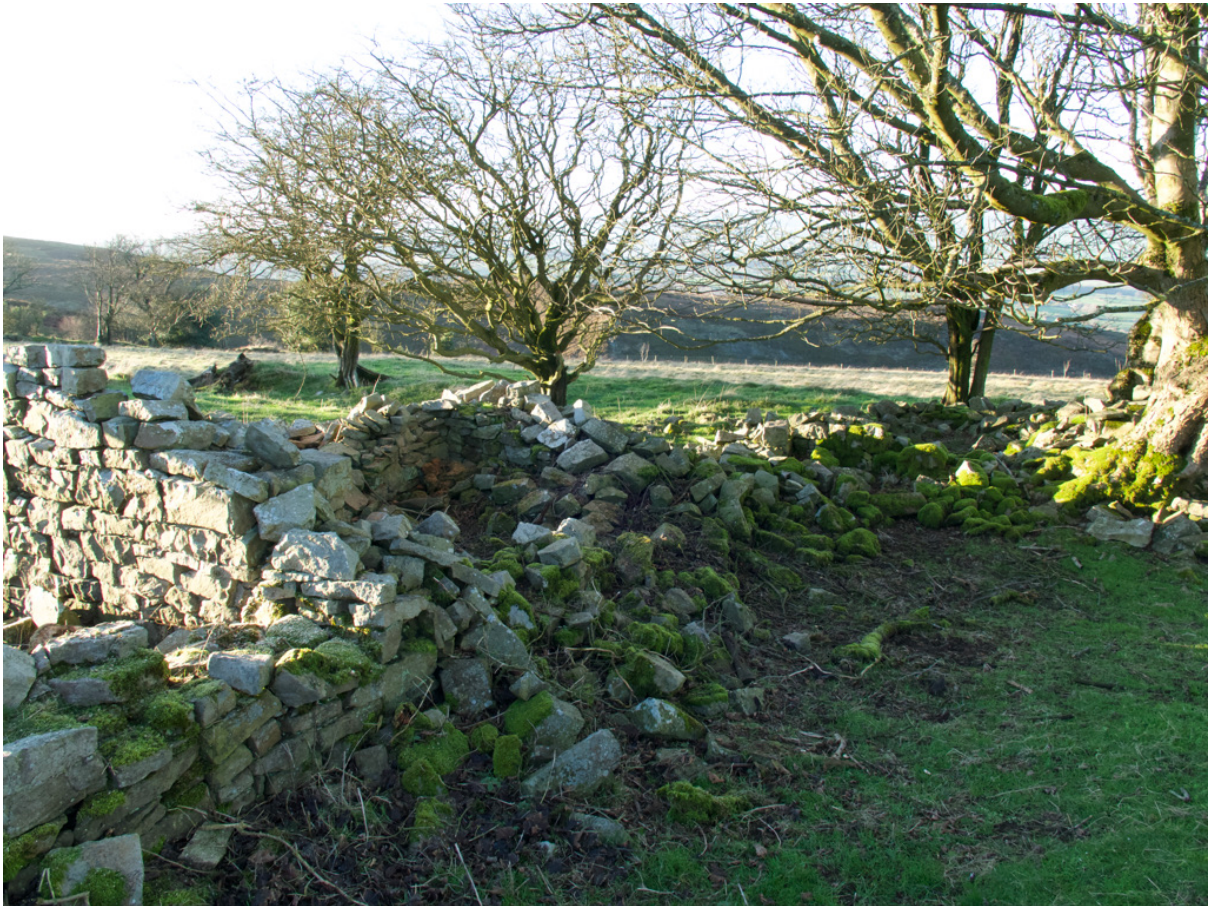
Image 03. Structure No.1 As viewed from the Southeast.

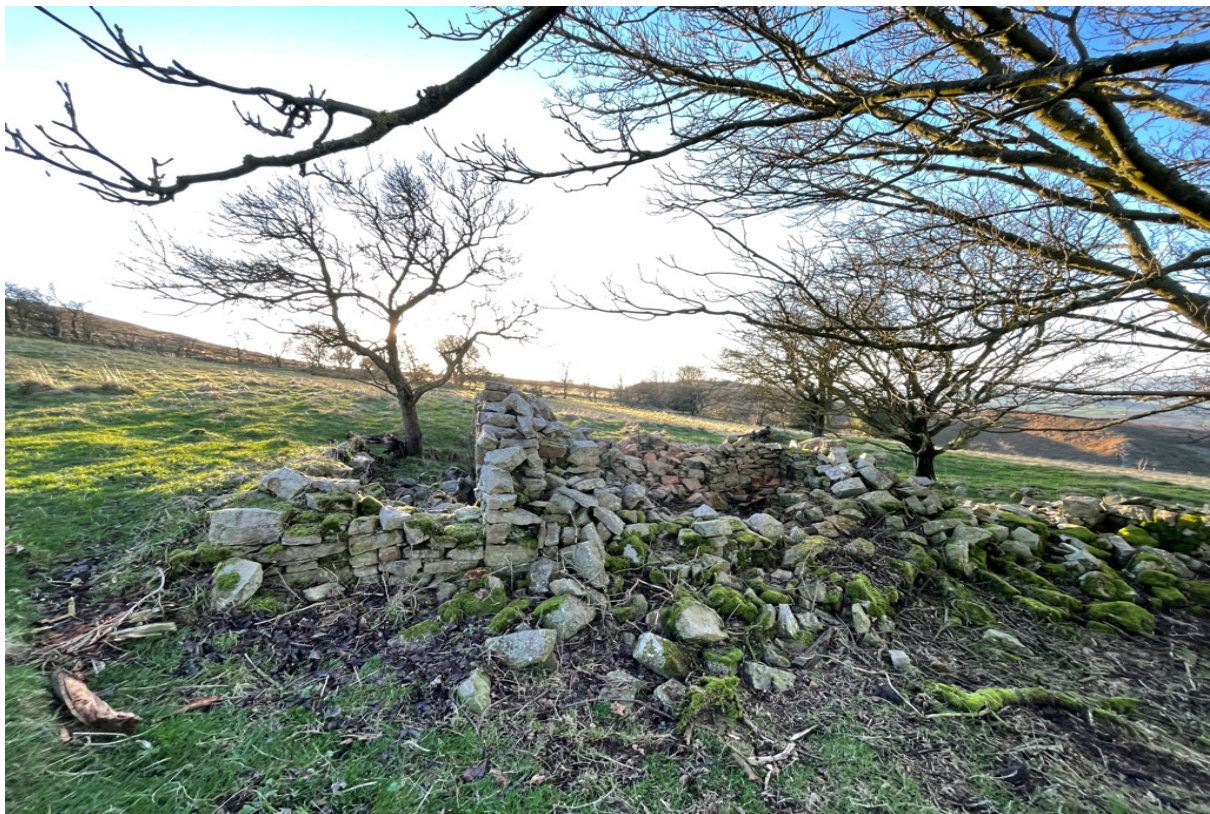
Image 04. Structure No.1 As viewed from the East.

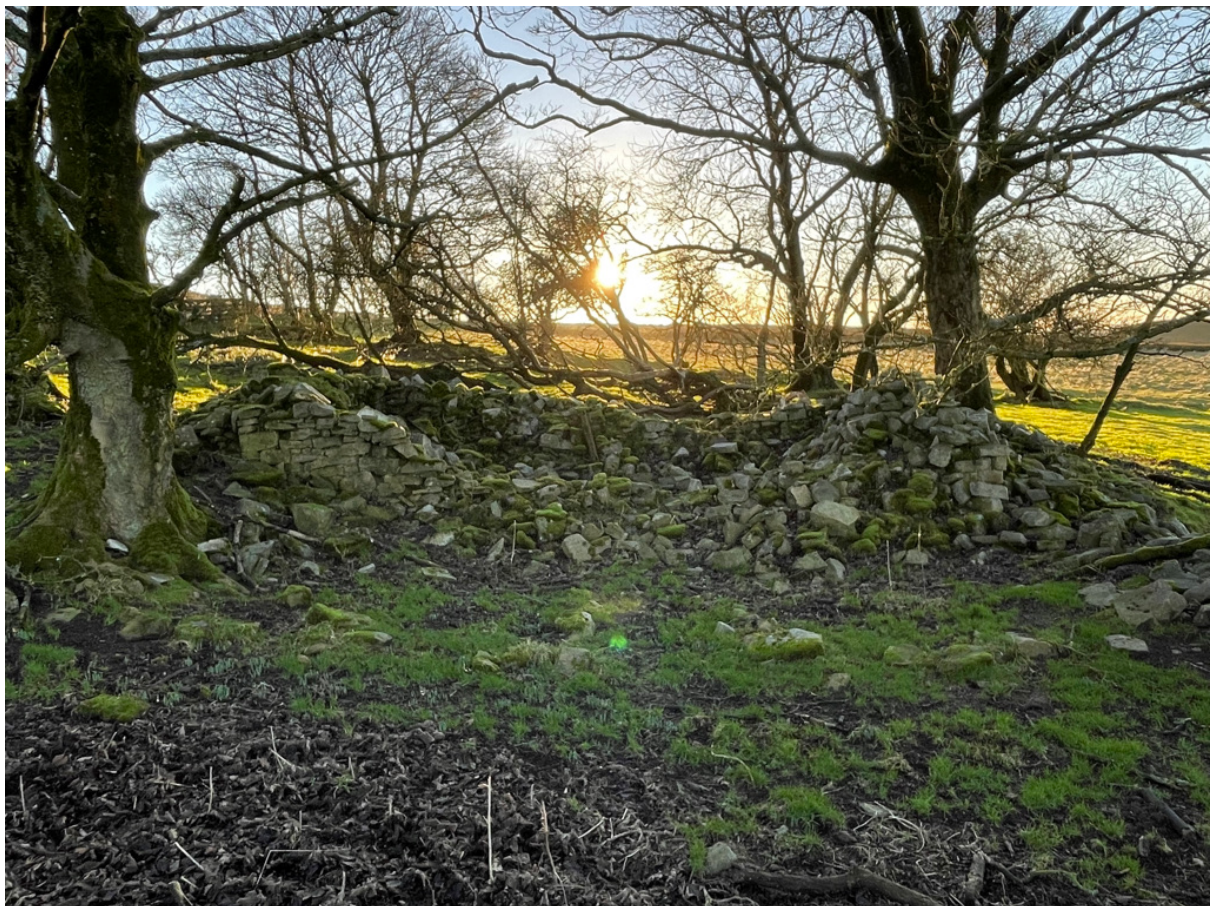
Located to the south of the scheduled area. The primary structure is larger than that of Structure No.1 being approximately 7.8m long and x 4.2m wide. The presence of clay roofing tiles, items of window joinery along with domestic items such as a bed frame and cooking pots strongly suggests that this served as a dwelling. This appears to be the primary occupation site of Blakemoorflat and it is possible that Structure (Area) No.1 is a barn or store that economically and socially belongs to Structure (Area) No.2.

Image 05. Structure No.2 As viewed from the Northeast.

It was agreed that the overall approach here should be the same as for Structure (Area) No.1, except for the treatment of the internal collapsed masonry, which currently provides support for the remains of the standing walls and serves to prevent grazing animals from sheltering within; the collapsed masonry within the building should therefore remain in situ. It was agreed some external clearance and dismantling should be undertaken to permit limited rebuilding of corners and to repair and arrest areas of active collapse. Some fixtures and fittings are present and notable items include bed irons, a window frame and cooking pots, It was agreed that all such items should be left at the site. Structure (Area) No2 has well defined yard areas confined within low stone walls and include remains of possible supporting/ ancillary structures. The area is largely stable with extensive and naturally occurring soft capping. There are some areas that will need limited unpicking and stabilising. It was agreed that trees and shrubs should be cut back from the walls and inside the structures.

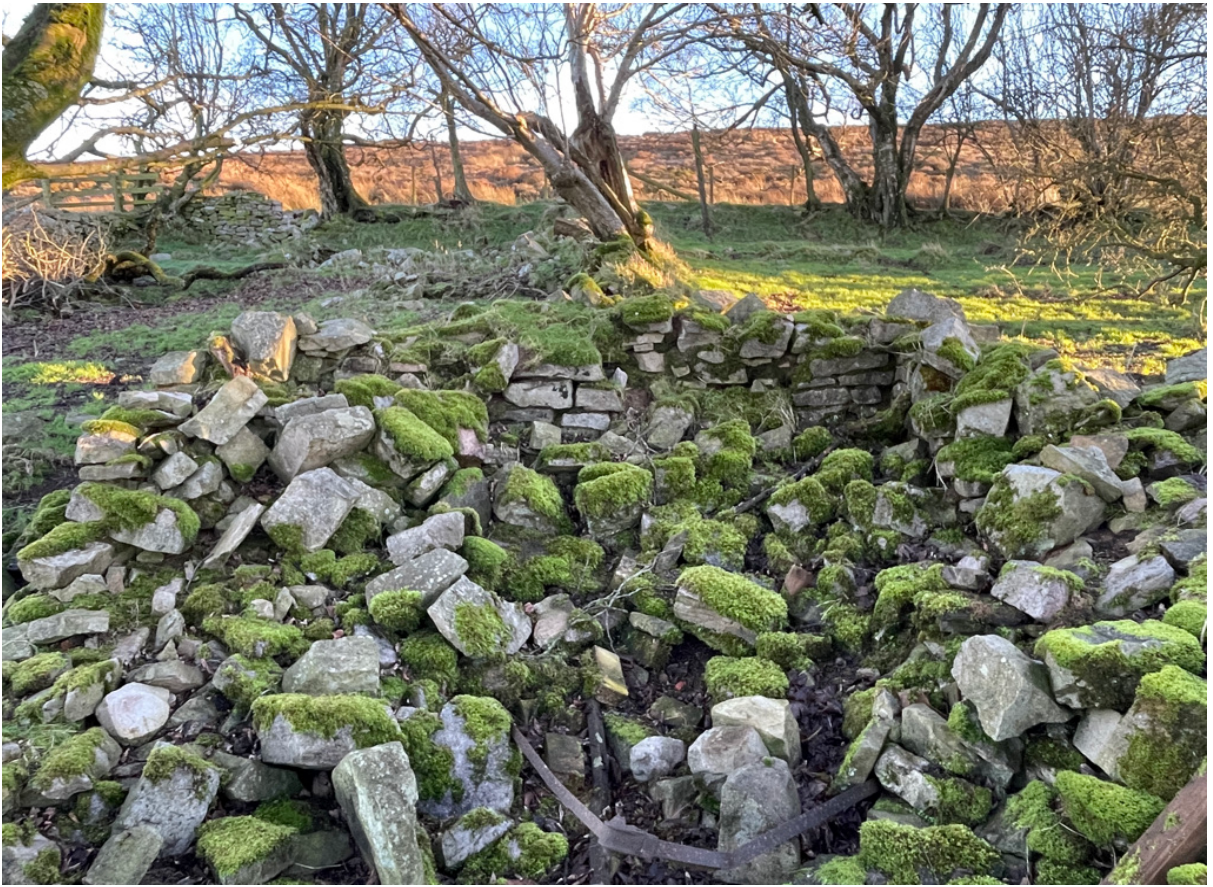
Image 06. Structure No.2 As viewed from the West.

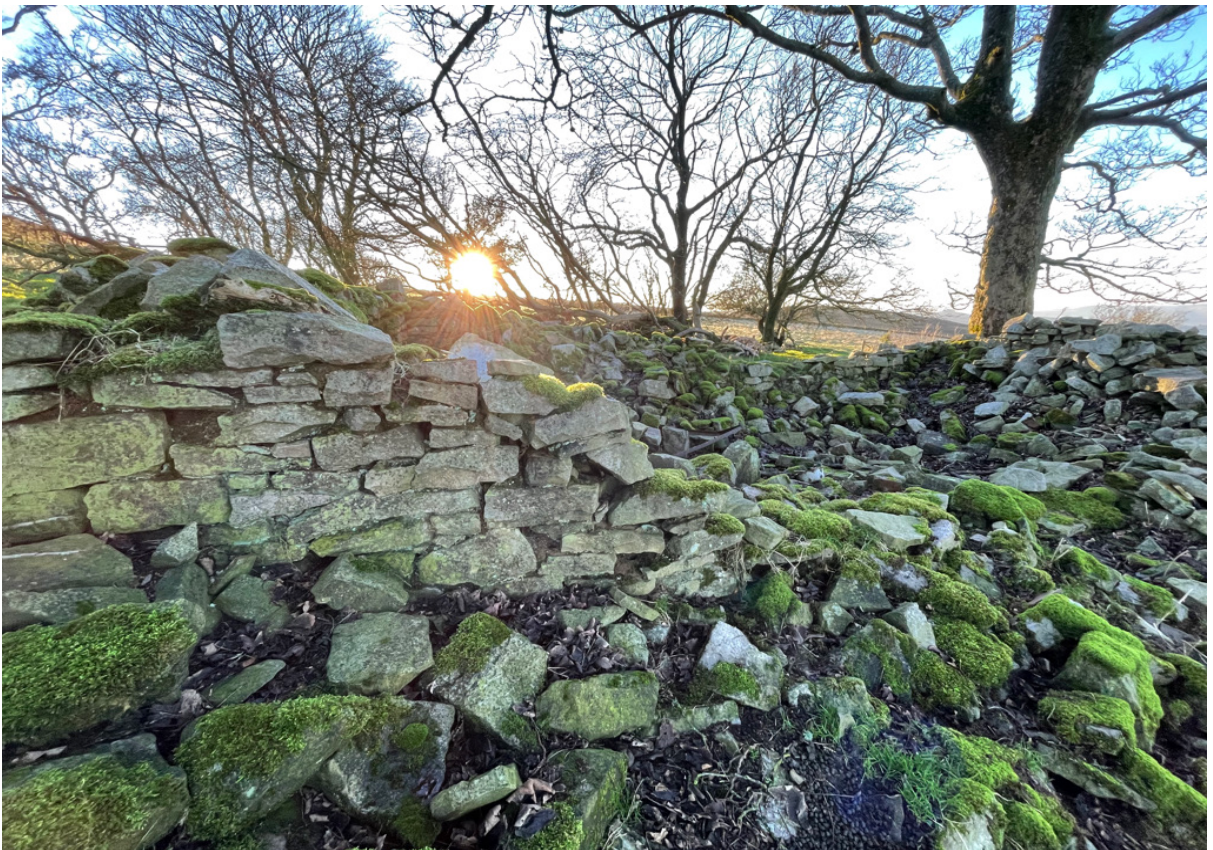
Image 07. Structure No.2 As viewed from the Northeast
